**AN ARCHAEOLOGICAL
EVALUATION AT
GLAPWELL NURSERIES,
GLAPWELL, DERBYSHIRE**

OS Grid Ref SK 4805 6636 (centred)
TPA Project Code: GNE.1
October 2011

Trent & Peak Archaeology
Lenton Fields
University Park
Nottingham
NG7 2RD

A Report on Trial Trenching 2011

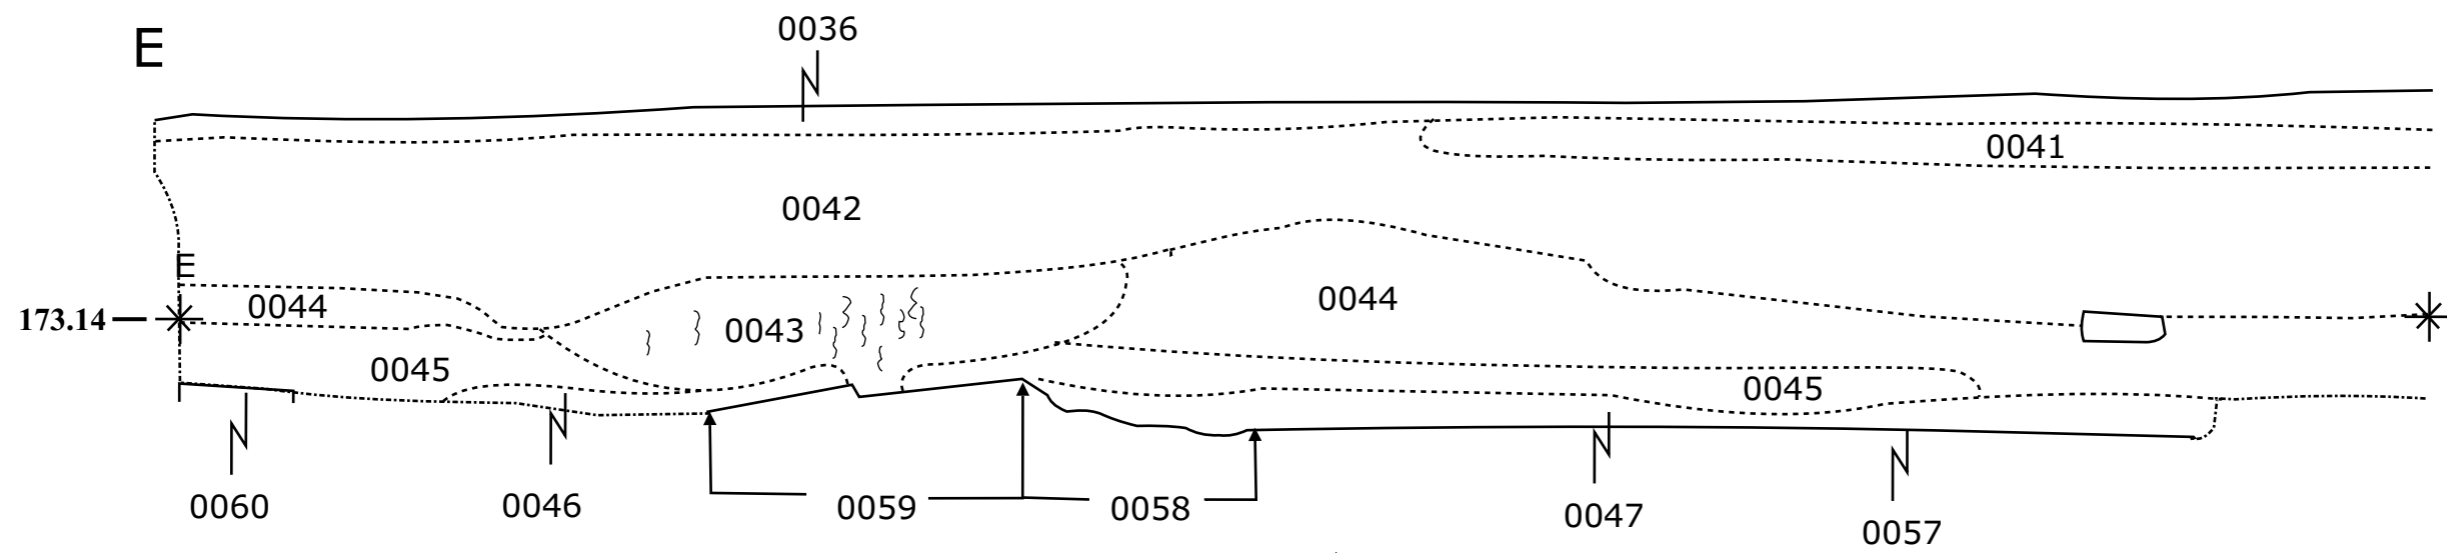
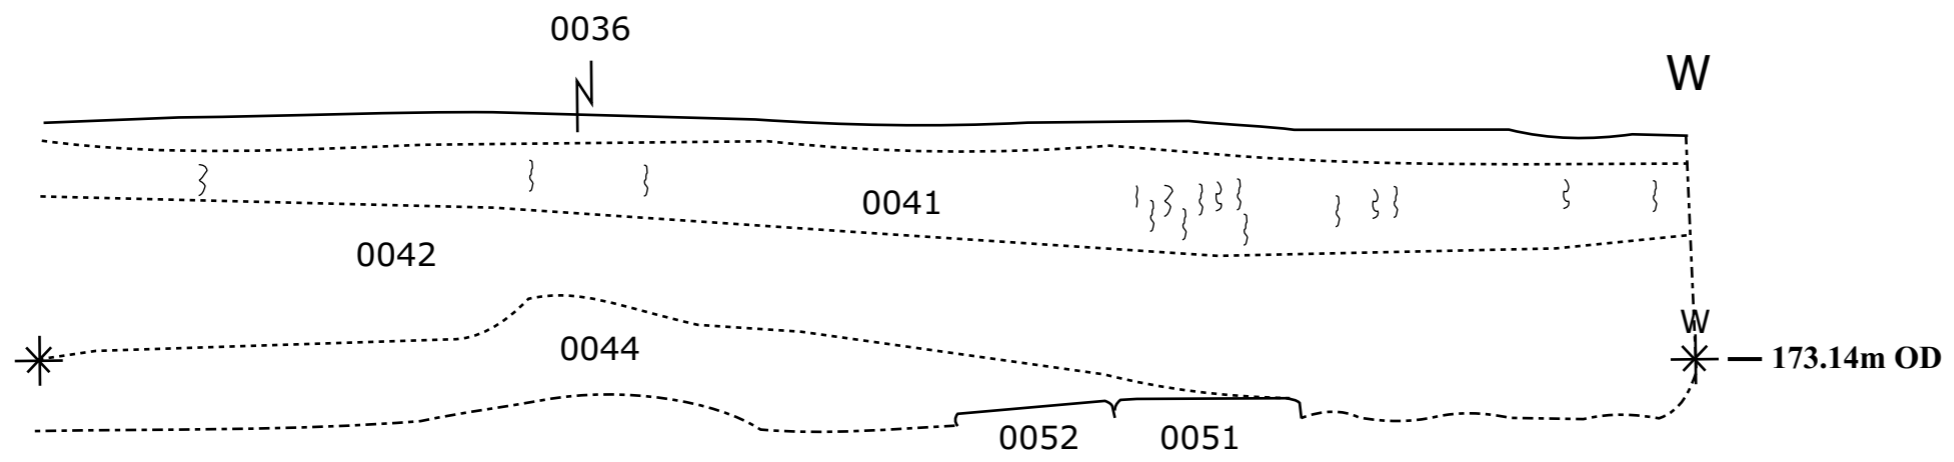
GNE: Glapwell Nurseries Evaluation
 Figure 8. Trench 01: North facing section. Scale 1:20 at A3.

Beneath the modern levelling material in the eastern half of the trench there were deposits probably associated with the demolition of the Hall in 1952. The highest deposit was a mid grey clay loam (0045) containing hand-made bricks of post-medieval date measuring 8¼ x 2¼ x 4 inches (212 x 58 x 103mm) in size. It overlaid two further deposits, the first (0046), being comprised of a loose light yellow sandstone and mudstone containing post-medieval brick fragments. It had been deposited into the void created by the partial robbing of a flagged area (0059) - see below. The second deposit (0047) was a loose mortar layer that also contained post-medieval brick fragments and also large quantities of glass. In the western half of the trench demolition layers had been removed and replaced by National Coal Board associated rubble (0044). Below the demolition layers (0045-0047) and modern rubble (0044), at a depth of between 0.70m and 0.90m, the remains of the north wing of Glapwell Hall were uncovered.

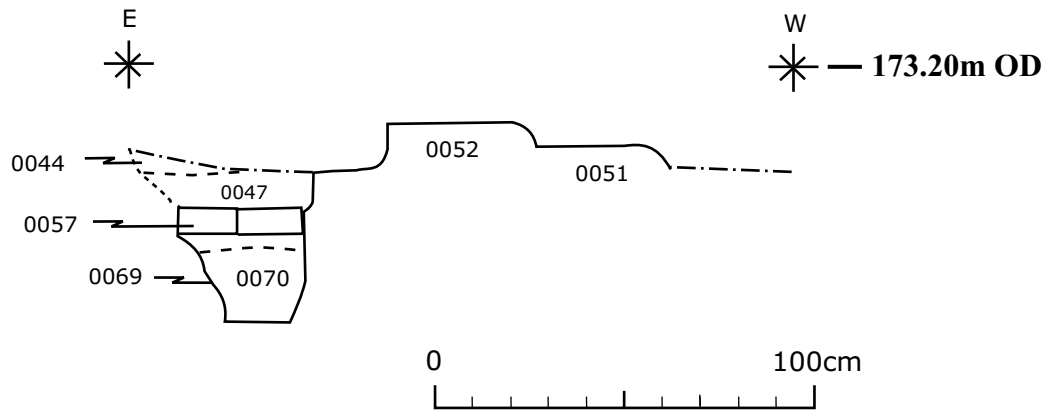
GNE: Glapwell Nurseries Evaluation
 Figure 9. Trench 01: Slot 01, north facing section. Scale 1:20.

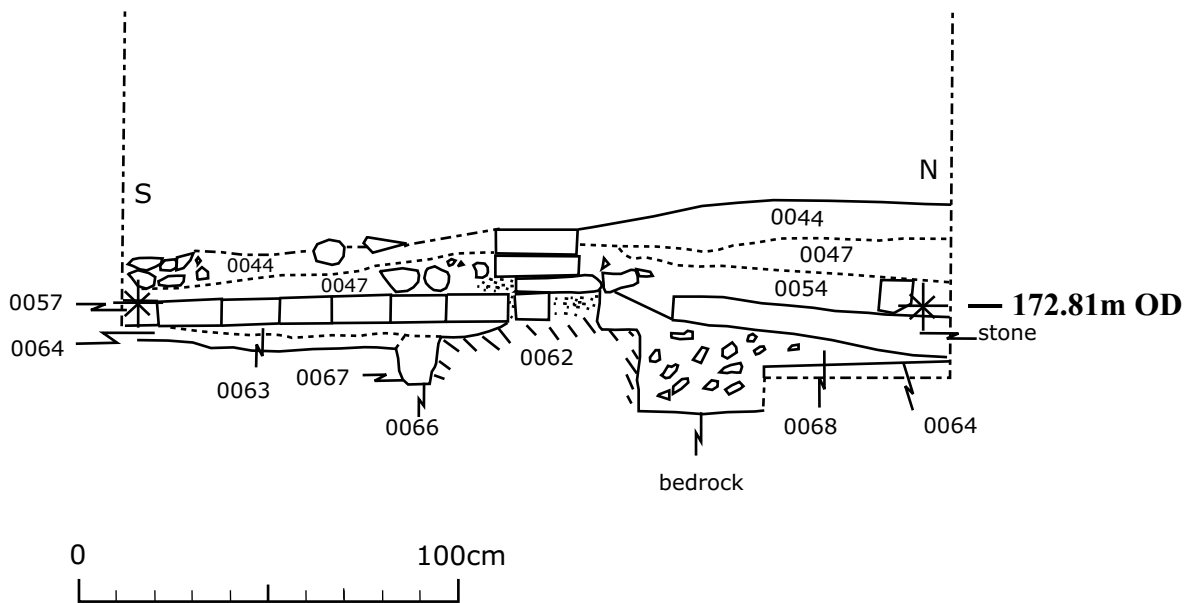
GNE: Glapwell Nurseries Evaluation
 Figure 10. Trench 01: Slot 02, east facing section. Scale 1:20.

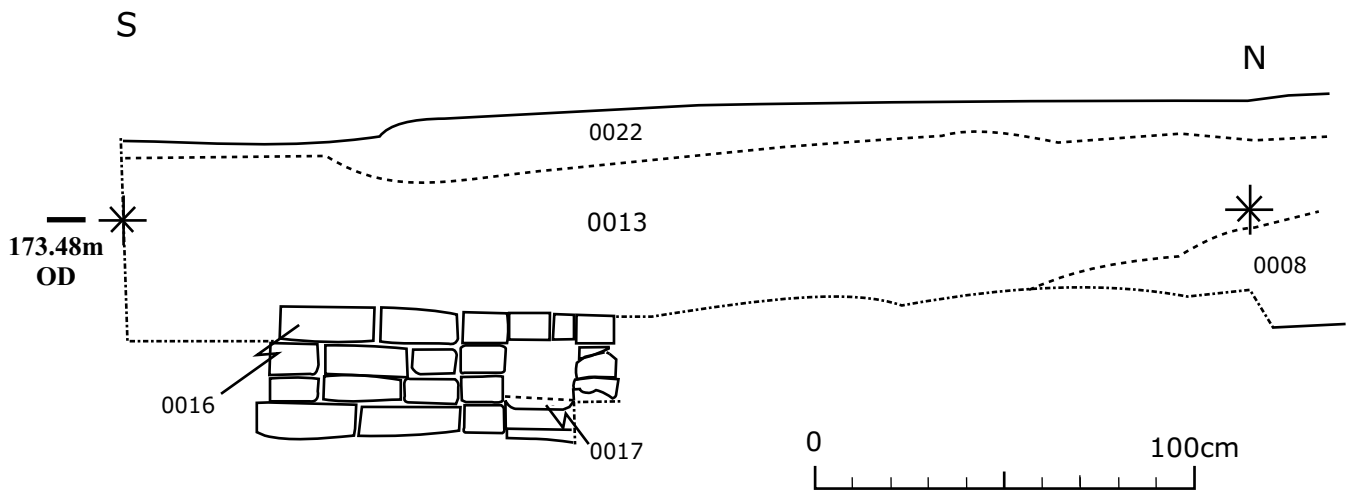
GNE: Glapwell Nurseries Evaluation
 Figure 12. Trench 04: East facing section, southern end. Scale 1:20.

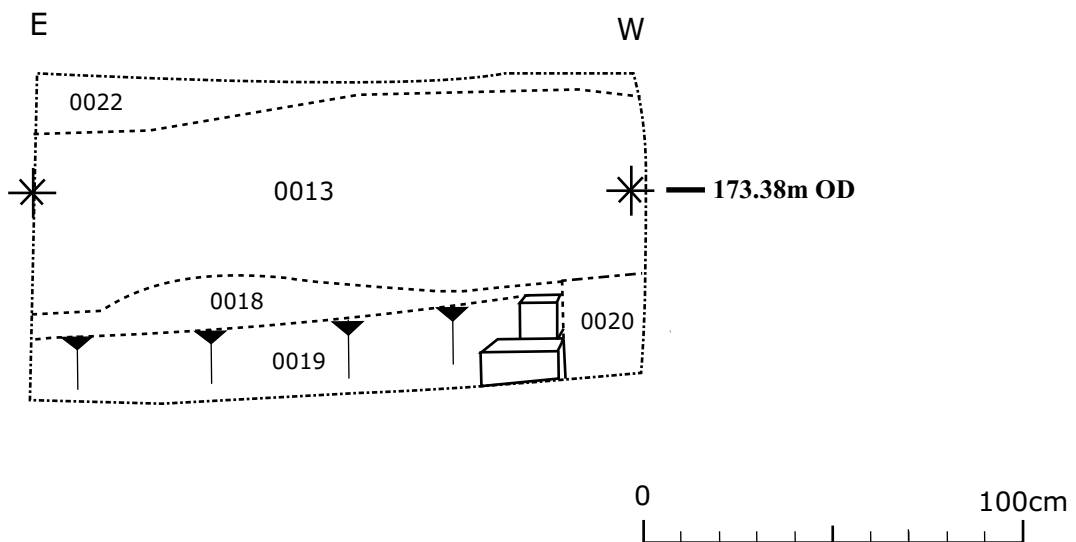
GNE: Glapwell Nurseries Evaluation
 Figure 13. Trench 04: North facing section, southern end. Scale 1:20.

At the south end of the trench and cutting through 0008 there was a small brick structure surviving to four courses in height (0016). It comprised two cells constructed of machine-made bricks measuring $3\frac{1}{8} \times 8\frac{3}{4} \times 4$ inch (8 x 22 x 10cm). The inside of the southern cell measured 0.34m x 0.24m and the northern cell slightly less at 0.22m x 0.24m. There was evidence of burning in the northern cell (0017). The structure extended to the east with robbed out wall footings visible from the northern cell, and to the south there were remains of a plaster floor (0018) on a foundation of compacted sandy clay (0019). Infilling the structure was (0020), a rubble deposit containing large quantities of glass and flower pot fragments. In the south-west corner this may have overlain a lower projecting corner to 0016, partly exposed in the north-facing section (Fig. 13).

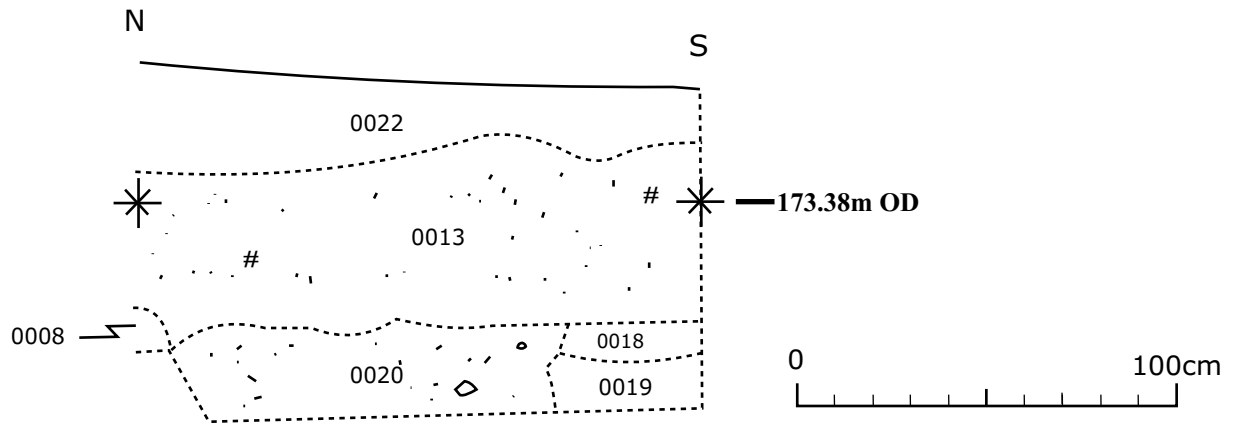
GNE: Glapwell Nurseries Evaluation
Figure 14. Trench 04: West facing section, southern end. Scale 1:20.

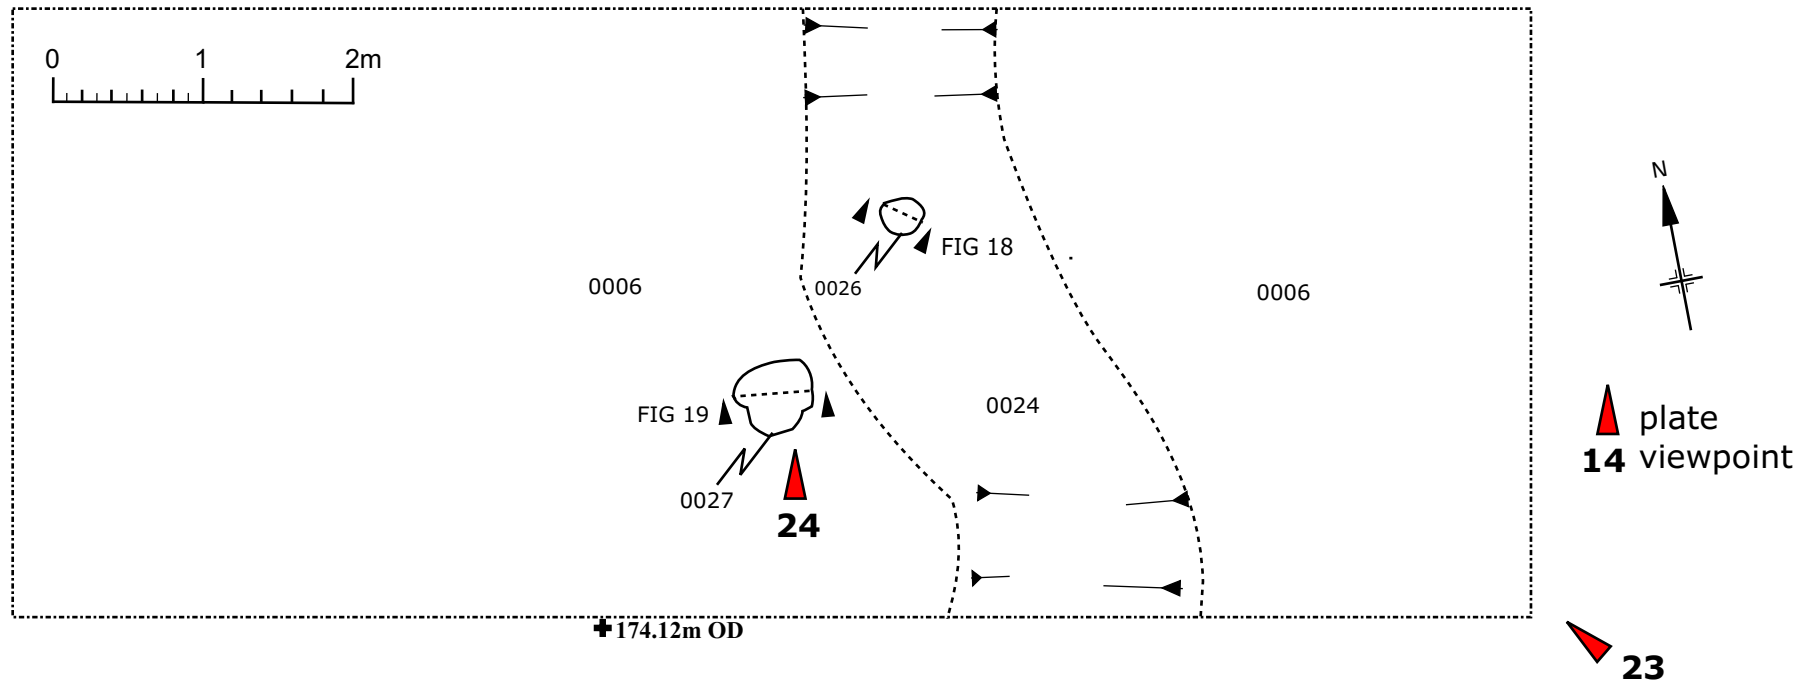
GNE: Glapwell Nurseries Evaluation. Figure 17. Trench 16: Plan. Scale 1:50 at A4.

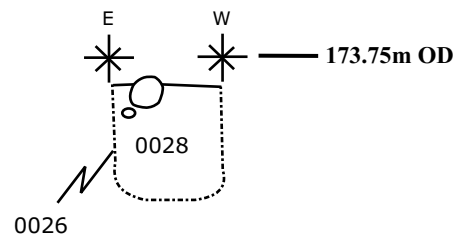
Figure 18. Trench 16: South-west facing section of 0026. Scale 1:20.

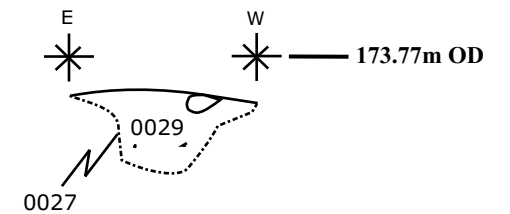
Figure 19. Trench 16: South facing section of 0027. Scale 1:20.

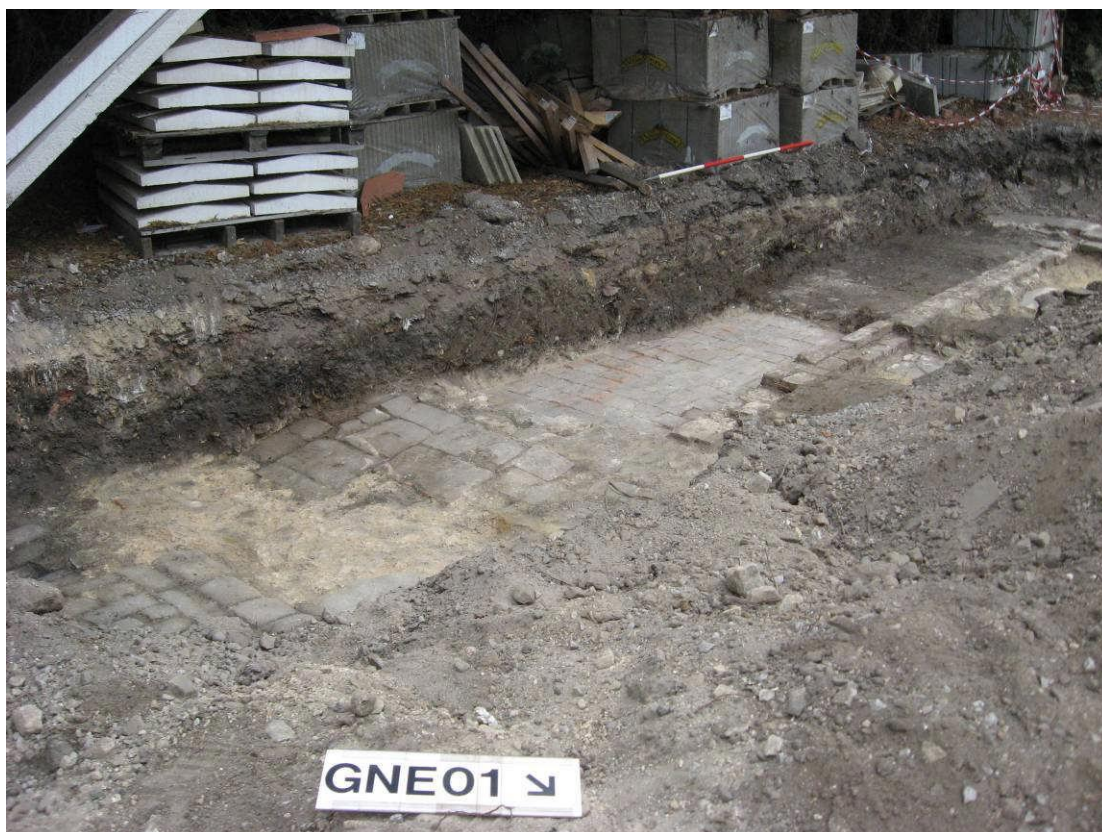
Plate 3: Trench 01 south facing section, looking south-west.

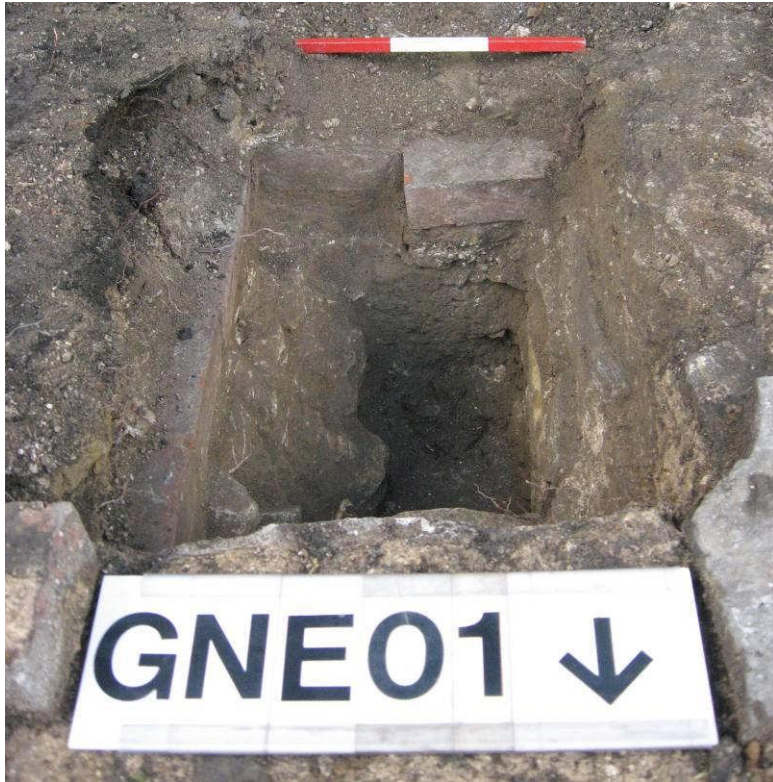
Plate 5: Trench 01 Slot 01 north facing section, looking south.

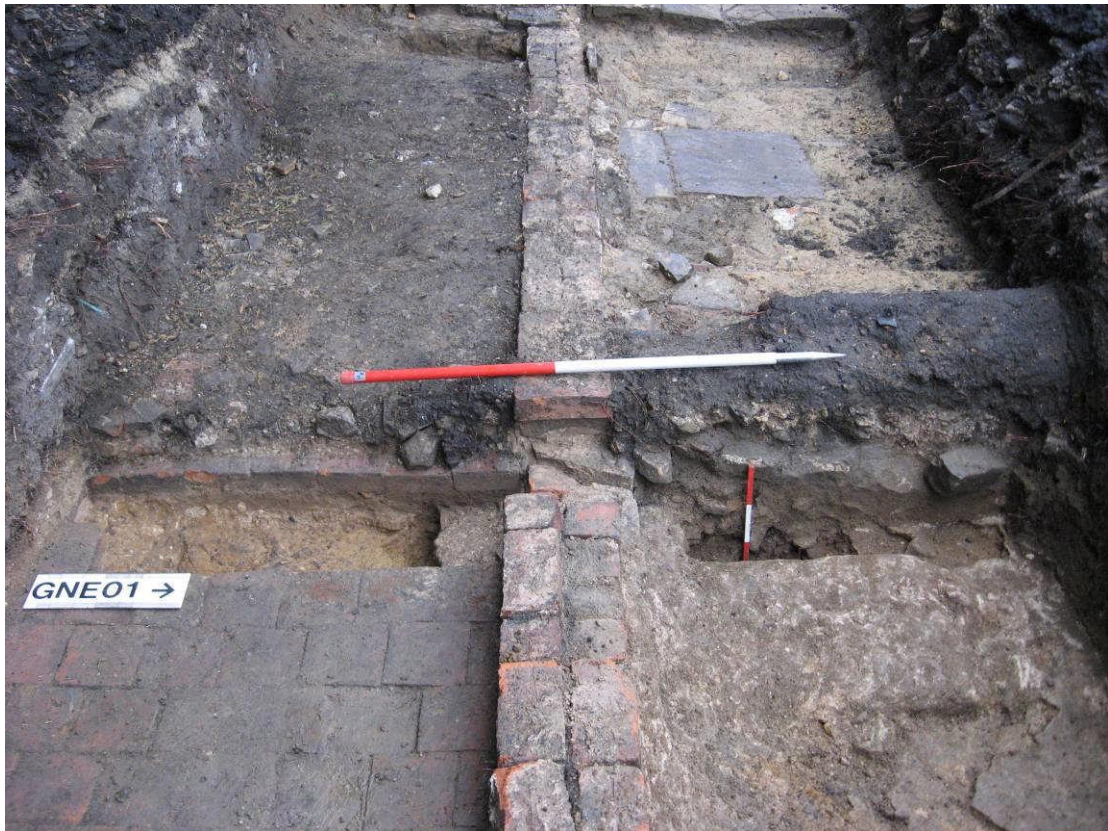
Plate 6: Trench 01 Slot 02 east facing section, looking west.

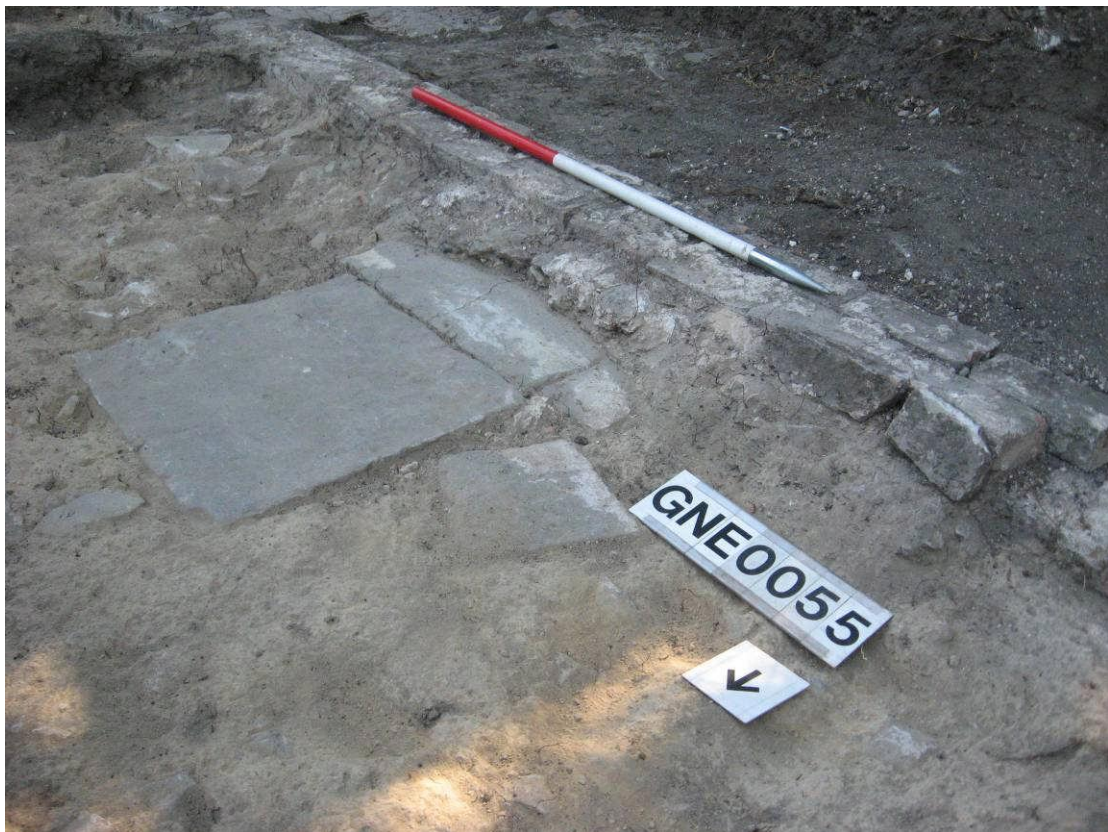
Plate 8: Trench 01 Floors 0055 and 0056, looking south-east.

The area north of dividing wall was entered through a doorway in the west corner, where two stone steps (0050) descended to what remained of a former flag stone floor (0055). The flags have been mainly robbed and replaced with loose bright yellow sand containing modern pottery (0054). The ceramic evidence suggests that this robbing probably relates to the 1952 demolition rather than to an earlier phase of alteration. It was directly beneath the easternmost flagstone that the foundation 0071 was uncovered. This suggests that the northern room may have been sub-divided into two rooms, the western one 3.40m in width and the eastern one 1.80m, with the flagstone overlying the foundation (0071) being a threshold stone. A continuation of 0071 was sought to the south of 0053 but it was found to be absent. A pale grey to pale orange hard mortar (0056) bonded onto wall 0053 was found overlaying part of the flag stone floor 0055; this was suggestive of a later floor may have been laid over the original one. The stone flag floor indicated that this room may have been used for some utilitarian purpose.

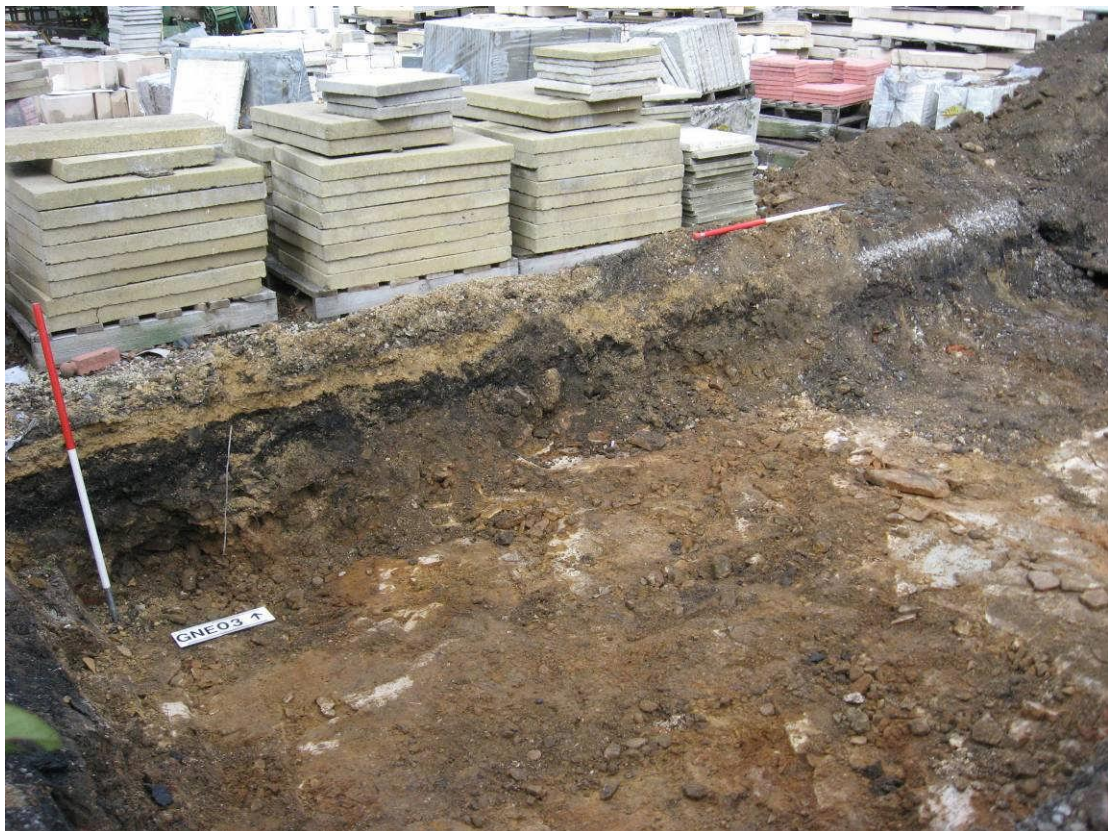
Plate 10: Trench 03 south facing section, looking north-east.

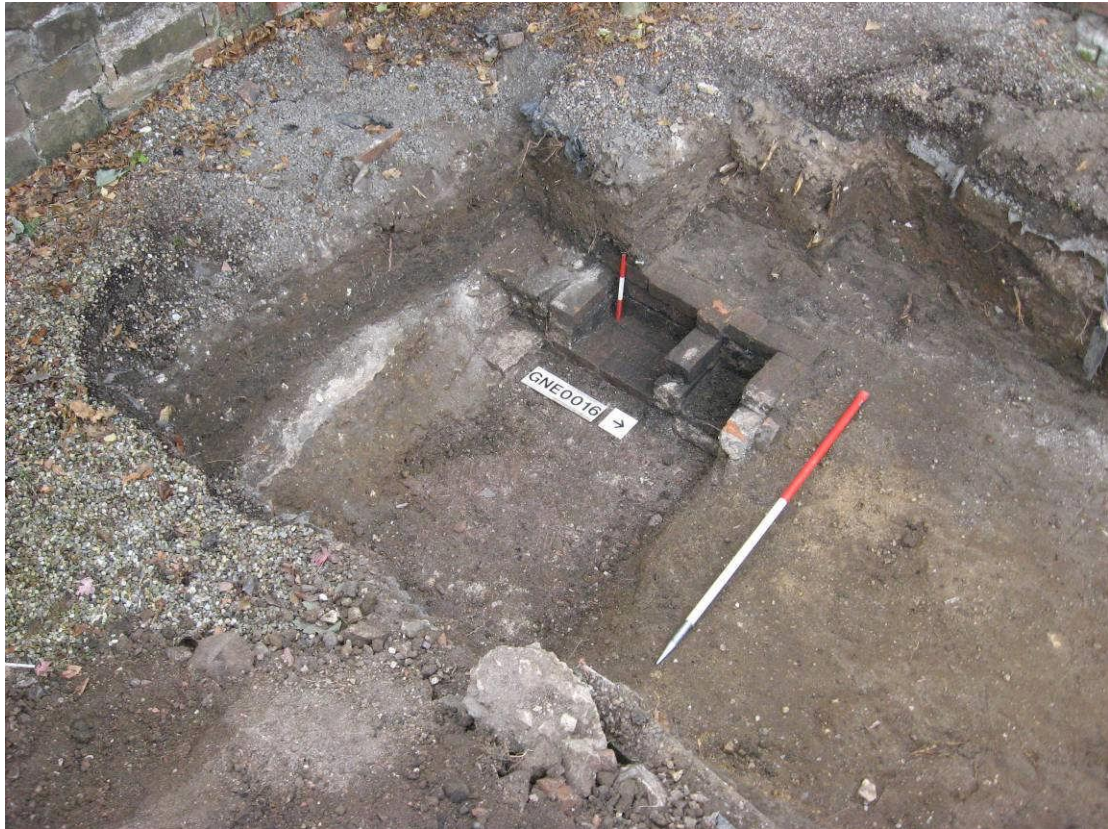
Plate 11: Trench 04 conservatory remains general view, looking south-west.

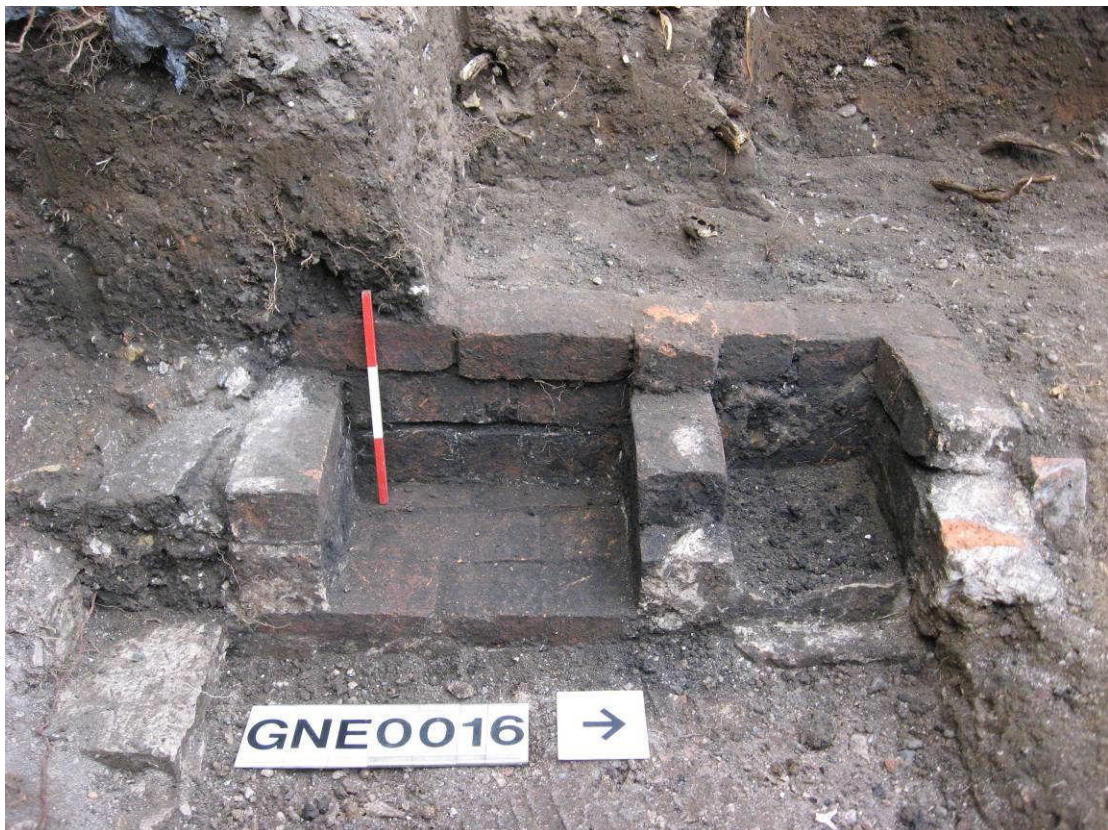
Plate 12: Trench 04 fumigator / heater 0016, looking west.

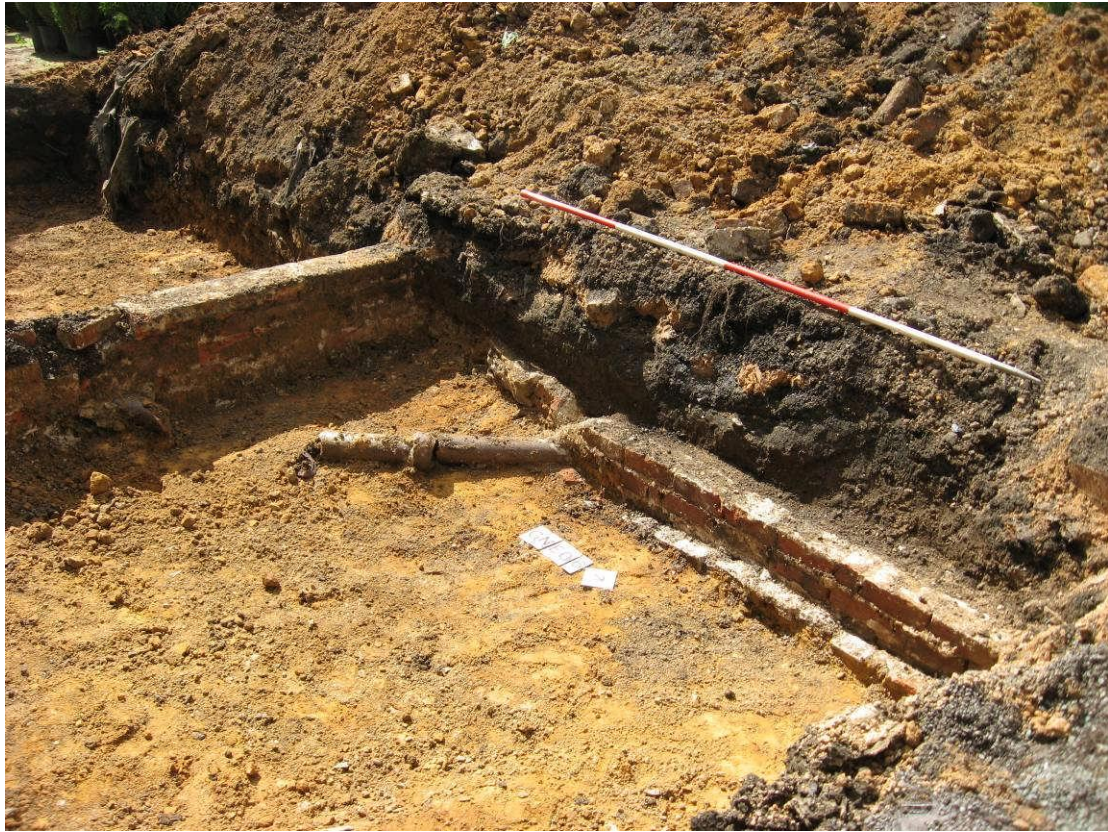
Plate 15: Trench 06, walls 0001 and 0002, looking south-west.

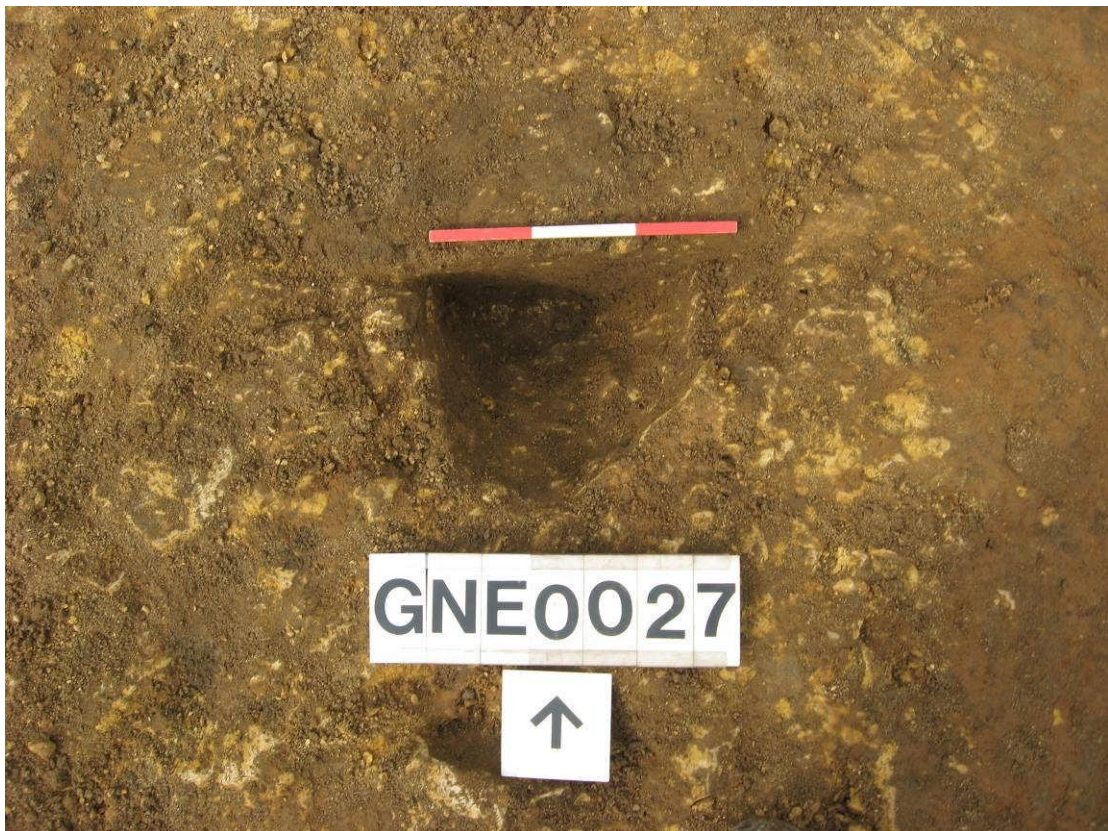
Plate 24: Trench 16, feature 0027 post-excitation, looking north.
