**AN ARCHAEOLOGICAL
EVALUATION AT
RUTLAND STREET, ILKESTON,
DERBYSHIRE (SITE A)**

OS Grid Ref SK 4676 4255 (centred)
TPA Project Code: RSI.1
November 2011

A Report on Trial Trenching 2011

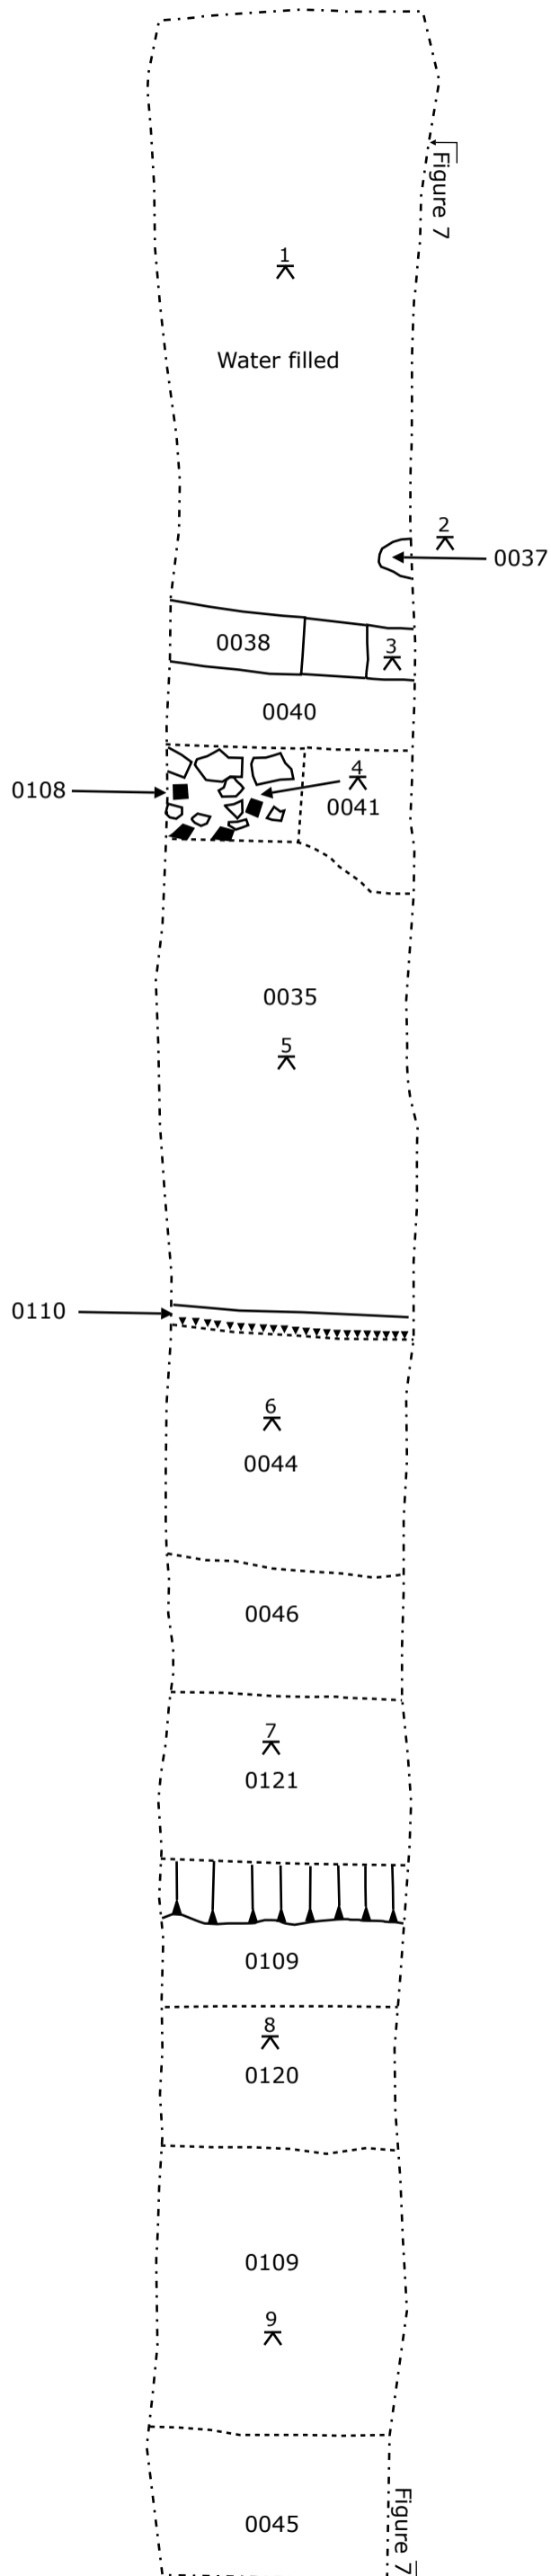
RSI Ilkeston Gas Works Evaluation
Figure 6 Trench 01 Plan
Scale at A3 1:50

In Trench 01 demolition deposits were found to depth of around 0.75m. They comprised 0033, a modern layer of brick, concrete, and sand relating to the recent re-landscaping of the site below which were further layers of demolition material, 0034-0035 and 0041-0049, comprising principally of bricks and mortar. The deposits in the southern part of the trench 0043-0049

may relate alterations made to the site between 1915 and 1937 including the re-modelling of one building which included the levelling of a portion of its northern part to make way for an extension of the rail network. The loose nature of deposits 0044-0047 suggests that they are the backfill of a cellar belonging to this building. Below the demolition layers in the north of the trench was a 0.5m thick curving outer wall of a holding tank **0038** that was sealed on its outside by light grey clay 0040. This wall had been partly exposed during the environmental test-pitting and found to extend to a depth of at least 2m. The top of the wall had an infilled break of 0.40m where a supply / exit pipe had probably passed through it. Fragments of a brick wall **0037** were present 1m to the north of **0038**. It was not possible to establish with certainty whether this was the inner holding tank wall as it had been truncated by modern services and further work being undertaken was prevented by water entering the trench. The holding tank had been infilled with a layer of dark brown silty clay (0036). Providing that the holding tank was not replaced during the lifetime of the gas works, the walls represent the holding tank shown on the 1876 plan. A brick and stone surface **0108** was exposed to the south west of **0038**. It was 1.30m in width and did not extend across the whole trench suggesting that it may have been the base for a support bracket for an elevated railway track which was present from the maps of 1900 onwards. Further to the south, another hardened surface **0109** of compacted brick fragments concrete and mortar was probably the base of a later replacement railway track shown running east-west to a coal store on the 1937 Ordnance Survey map.

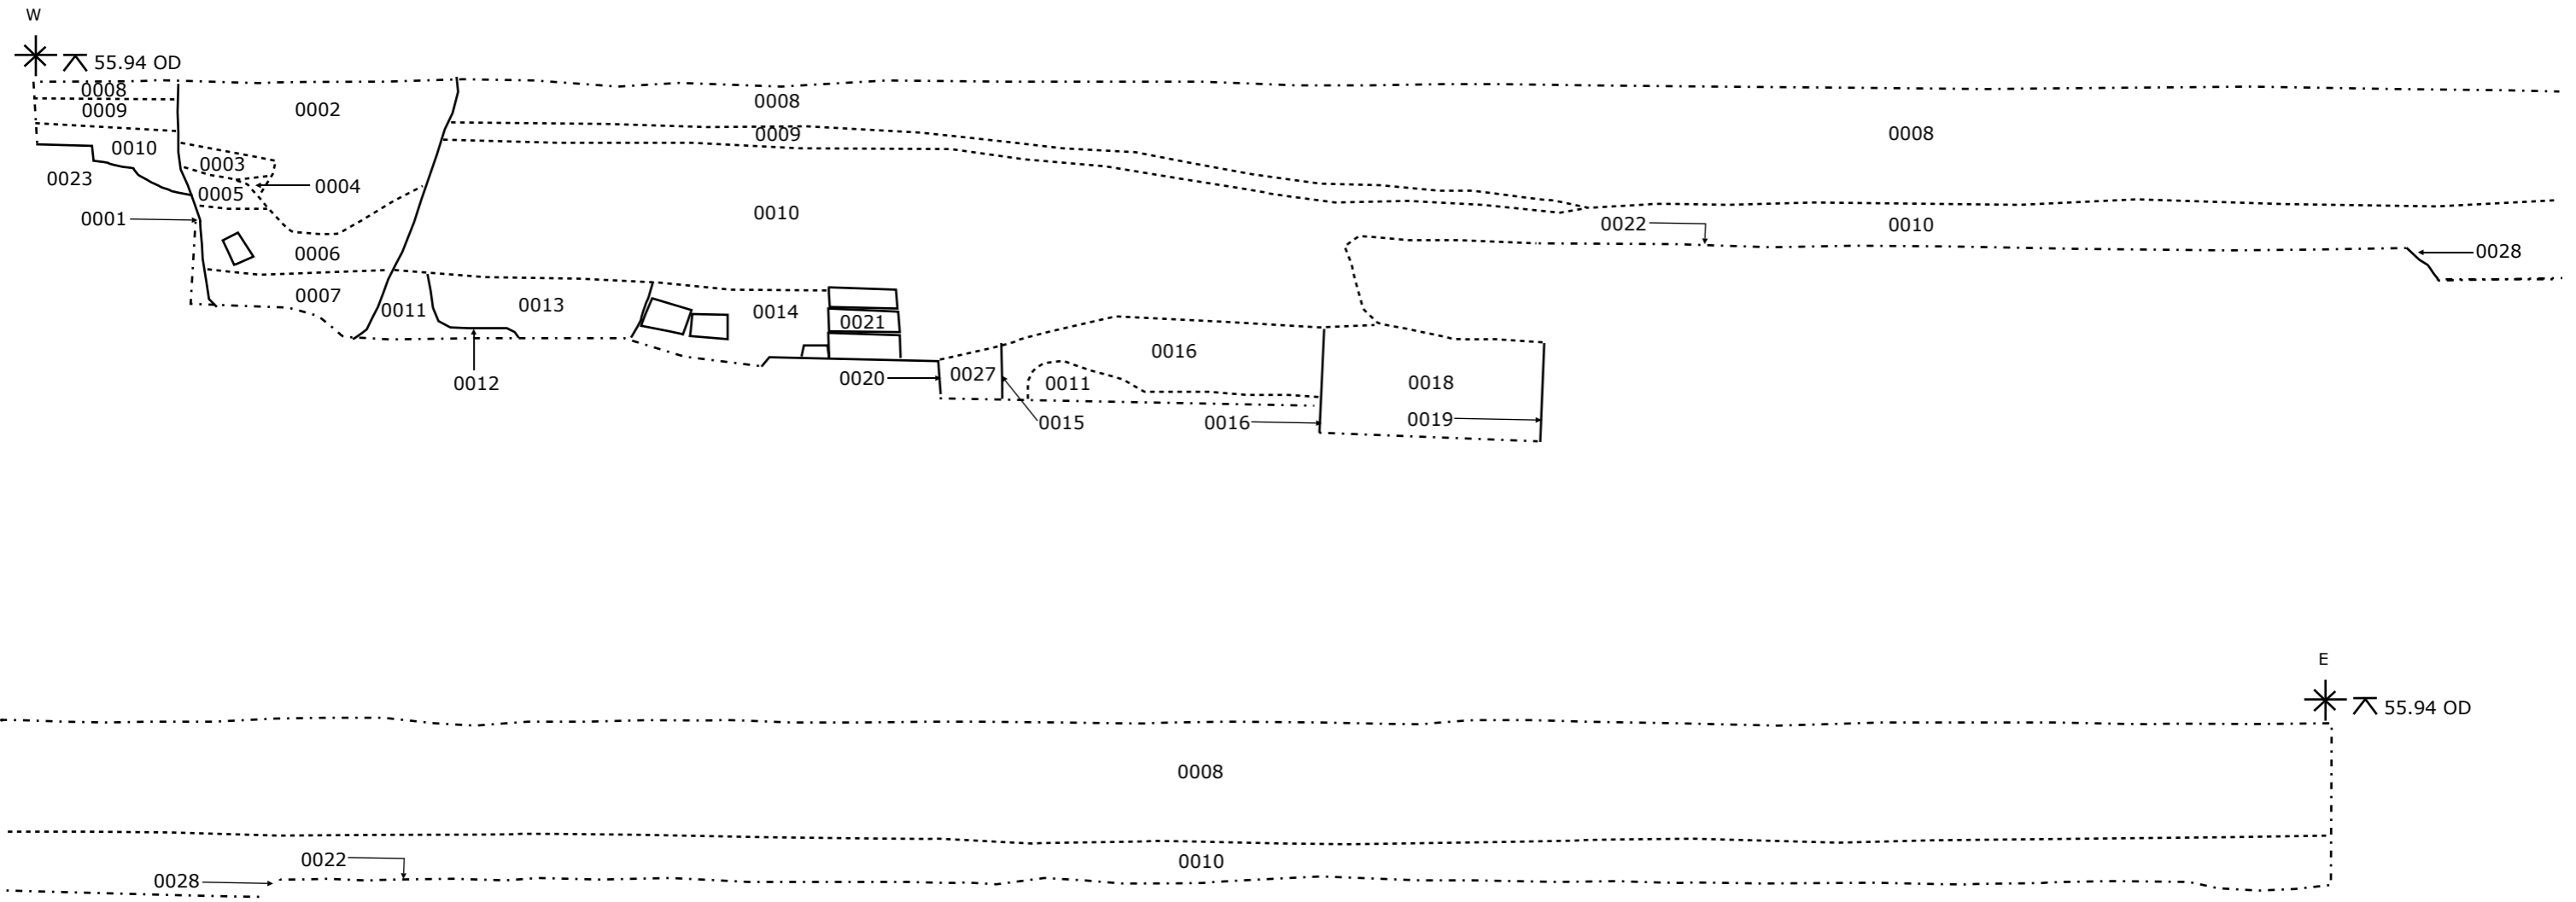
RSI Ilkeston Gas Works Evaluation
 Figure 9 Trench 02 South Facing Section
 Scale at A3 1:20

The east to west aligned portion of Trench 02 established that modern demolition deposits 0008, 0009, and 0010, were present extending to a maximum depth of 0.62m. In the west end of the trench the demolition layers were cut by **0001**, a pit 0.68m in width and exceeding 0.82m in depth. It had steep, straight sides and was infilled with layers of clay, ash and brick rubble 0002-0007. To the east of **0001** at a depth of 0.90m was a concrete slab **0020**. It was orientated north to south and extended beneath both respective baulks. It was 0.52m in width and exceeded 0.10m in depth. It had been truncated by a modern service trench, one of three such services located in the west of the trench. **0020** was the foundation for brick wall **0021**. The wall was a single 0.23m (9 inches) brick in width, three courses of which survived. This was the east wall of a building shown on the 1937 OS map. A second brick wall **0019**, was found to the east of **0021**. It was 0.25m wide and was probably part of the rail network shown on the 1876-78 Ordnance Survey map. It was largely overlain by a hardened surface of brick and other rubble 0022, thought at first to be the base of a former tiled floor. This extended to the far east end of the trench. Because of some uncertainty about the nature of this surface a deep trench was excavated by machine at the east end of the trench revealing a brick, ash and clay layer 0114 to a depth of 1m beneath 0022. Further machining exposed a 0.3m (12 inch) thick brick wall **0111** running east-west, and another north-south **0112**, both still showing at a depth of 2m. Brick rubble 0114 between the two walls indicates likely cellar-infill. Similar brick infill had previously been exposed in Test Pit 06 located to the east.

Following this, a north-south extension 10m long and 3m wide was machine-dug. The hardened surface 0022 was found to extend the full length of this extension, with no sign of intervening walling. The west side of the trench was then taken deeper and this uncovered at a depth of 0.80m the west wall and a north-west corner **0116** of the last retort house on the site. The wall was 0.61m in width (24 inch) and had at least four courses surviving. To the east of the walls an infilled basement / cellar was uncovered 0117. A wall **0115** measuring 0.86m (34 inch) in width was excavated to the south and identified as part of the base of a former chimney. A metal pipe **0118** was also found that had been truncated by the retort house wall. Overlying the retort house wall was a later undocumented narrow brick wall **0119** measuring 0.23m in width (9 inch).

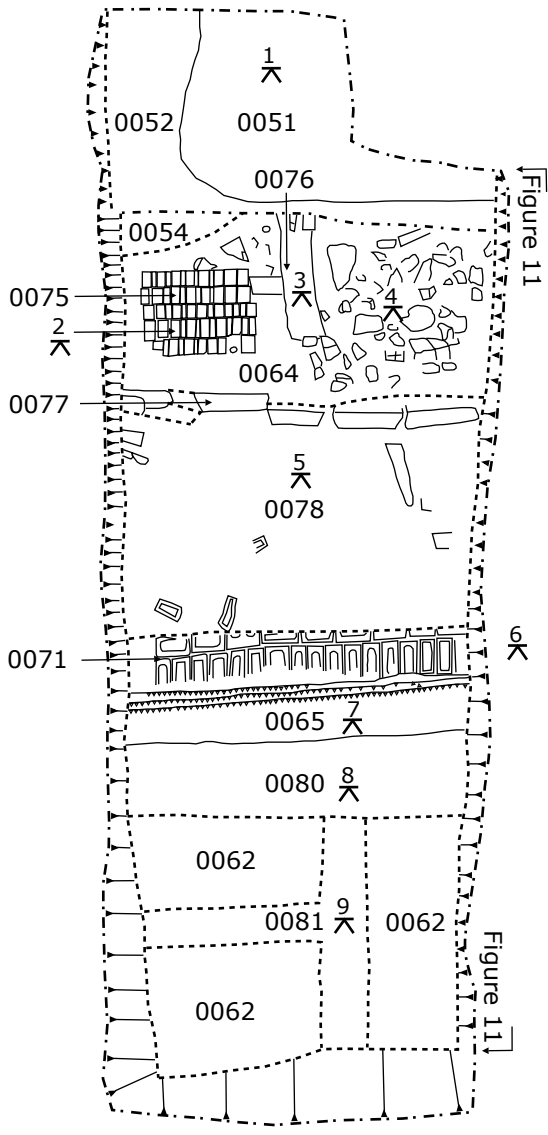
RSI Ilkeston Gas Works Evaluation
Figure 10 Trench 03 Plan
Scale at A4 1:50

Modern demolition deposits 0050, and 0052 and a modern compacted surface 0053 extended across the whole site to a depth of between 0.3 and 0.35m.

Beneath the modern deposits in the centre of the trench was a solidly mortared west to east aligned brick wall **0071**, abraded on its south edge and with stepped lower courses set on a concrete base (**0065**). Five brick courses survived and it exceeded 0.4m in width. This was probably the north wall of a building shown on the 1937 OS map in the north-west part of the site. On its internal south side there were found layers of silty clay and brick material 0056-61, 0065, 0068-70 and 0072-74 infilling a possible cellar or lower floor level of the building. Beneath these dumped layers natural bluish grey silty clay 0062 was encountered that had two potential features, **0080** and **0081** cutting it. Feature **0080** was west to east aligned and filled dark bluish grey soft clay. It could be the robbed out footings of a wall but could equally be the foundation trench for concrete base **0065**. It cut an earlier feature, 0081 which comprised two trenches, one aligned north to south, with a further trench extending to the west. The feature was up to 0.12m in width and infilled with mid bluish grey soft clay containing brick rubble. These could be the robbed out wall footings of the building present on the map of 1900. On the north side of **0071** there was a hardened rubble surface 0064 with a concrete kerb edge **0077**. This may have been the south edge to an earlier tank, infilled with rubble and a curious rectangular patch of tightly packed bricks set on edge **0075** found to be sealing a deposit of tar.

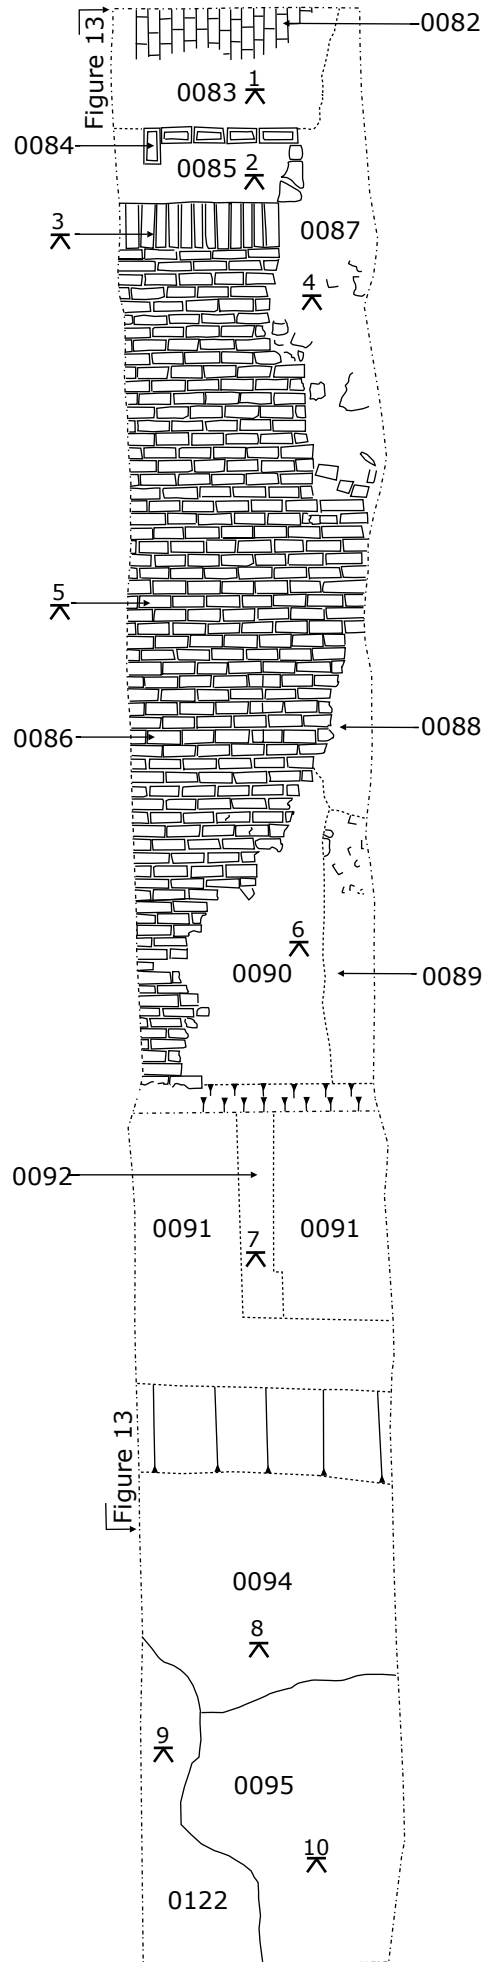
RSI Ilkeston Gas Works Evaluation
 Figure 12 Trench 04 Plan
 Scale at A4 1:50

In Trench 04 modern demolition deposits made up predominantly of tarmac, brick, concrete and stone 0087, 0088, 0094-0095, 0097-98, and 0102-4 extended across the whole trench to a maximum depth of 0.28m. Beneath these layers in the north of the trench at a depth of only 0.2m a well preserved brick floor 0086 was encountered. It had been truncated to the south by a drain 0089 and to the north by modern demolition work 0087. In the south it was constructed on a foundation of concrete 0122 and in contrast to the north the bricks were bedded into sand 0090. A large concrete base 0123 was also encountered which again may have been support for the floor or alternatively a foundation for a wall. The concrete foundations 0122 and 0123 were probably required as the ground is not as stable to the south on account of there being evidence of earlier ground workings comprising a possible north to south aligned robber trench 0092 cutting re-deposited natural bluish grey clay 0091. A further possible robbed wall footing (0124) was observed in the east facing section. Unfortunately, water entering the trench prevented examination of these potentially earlier features. Abutting 0086 to the north was a 0.45m (17 ¾ inch) wide concrete and brick wall footing 0084 and 0085 beyond which was a cement floor base 0083 that overlies a red tile floor 0082. The floors and wall base probably belong to a building shown on the 1937 OS map. The potential robbed wall footings may relate to a house present on the site shown on the 1876-78 OS maps or alternatively to buildings on the 1900 and 1915 OS map.

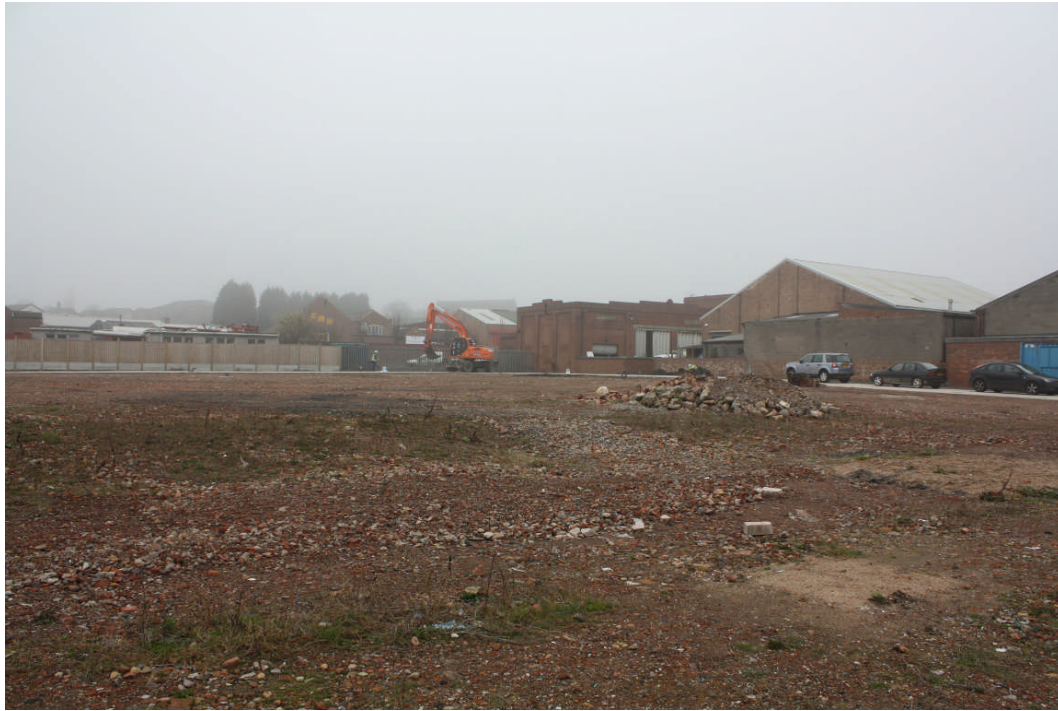
Plate 1: The site prior to evaluation taken from the south-east corner, viewed looking north-west

Rutland Street Gas Works, the former gasworks of Ilkeston, is located in the north-east part of the town, on the north side of Rutland Street and west of its junction with Belfield Street. The site has been vacant for several years and has no remaining structures on it (Plate 1). The site currently has two separate ownerships dividing the site into a western, Site A, and eastern half, Site B (Figure 2). Trent & Peak Archaeology was commissioned to carry out an archaeological site evaluation of the west part of the site (Site A).

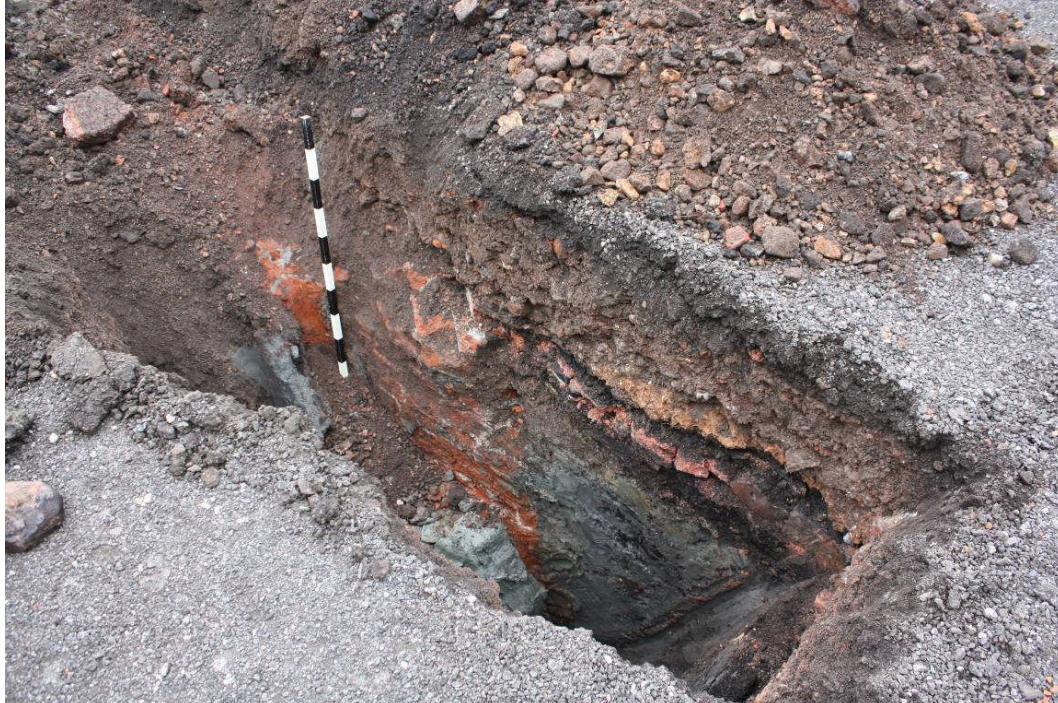
In Test Pit 01 demolition deposits comprising mid brown hardcore within a matrix of sandy silt were encountered to a depth of 0.50m. Beneath the demolition deposits a brick surface was encountered abutting the remains of the brick gas holding tank which extended to a depth of over 2m. The underlying grey silty clay mudstone deposits were present outside the holding tank to the north.

Plate 2: Test Pit 01 north-east facing section showing the walling of the gas holder, viewed looking south-west

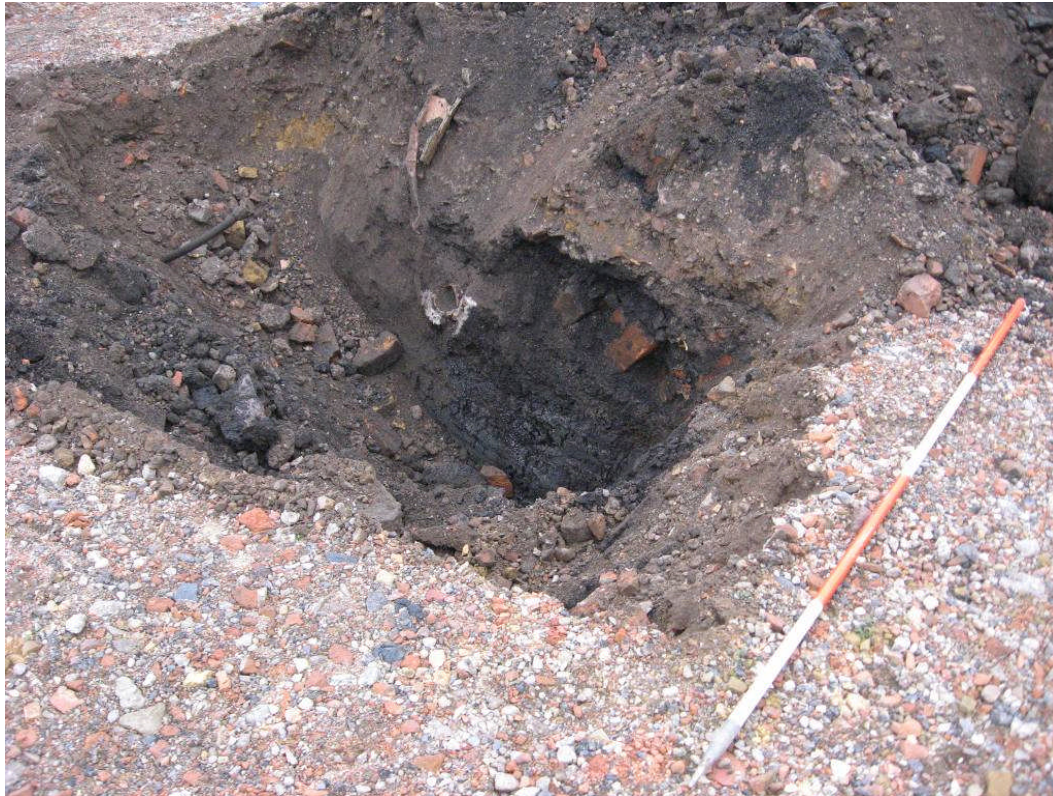
In Test Pit 02 demolition deposits comprising mid brown hardcore within a matrix of sandy silt were encountered to a depth of 0.35m. Beneath the demolition deposits a layer of black tar and ash was encountered with a metal pipe running through it which may have been an entry / exit pipe to one of the tar tanks present on the 1876-78 OS map. The underlying grey silty clay mudstone deposits were present beneath the tar deposit at a depth of 1m.

Plate 3: Test Pit 02 west facing section showing a metal pipe possibly associated with a tar tank, viewed looking north-east

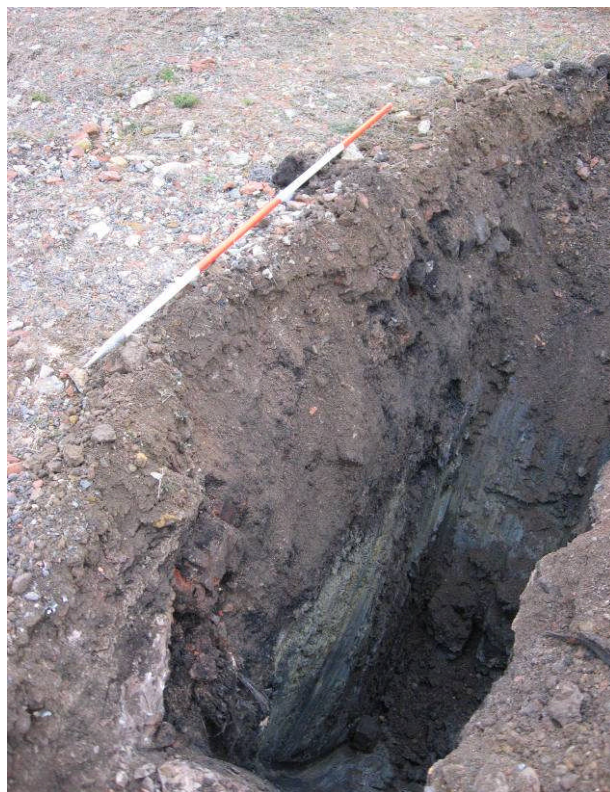
In Test Pit 04 demolition deposits of brick and concrete in a matrix of sandy silt were encountered to a depth of 0.88m beneath which were the underlying grey silty clay mudstone.

Plate 4: Test Pit 04 south-west facing section, viewed looking east

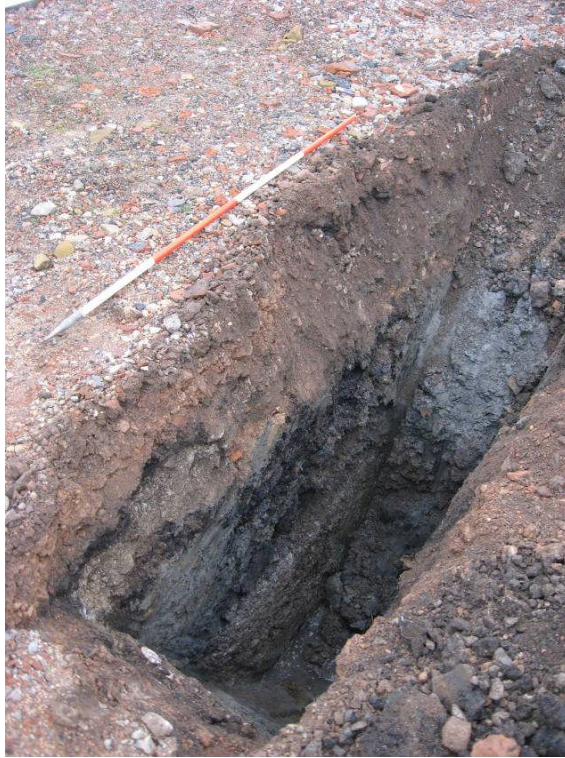
In Test Pit 05 hardcore demolition deposits were present to a depth of 0.60m beneath which was a layer of re-deposited grey silty clay up to 0.90m thick which was overlying, in the west facing section only, a concrete structure 0.60m thick. It is possible that this is the base for the elevated railway track shown on the 1876-78 and 1900 OS maps. Beneath the concrete, at a depth of 2.10m the underlying mudstone deposits were reached.

Plate 5: Test Pit 05 west facing section with concrete footing, potentially for the railway, towards the base, viewed looking south-east

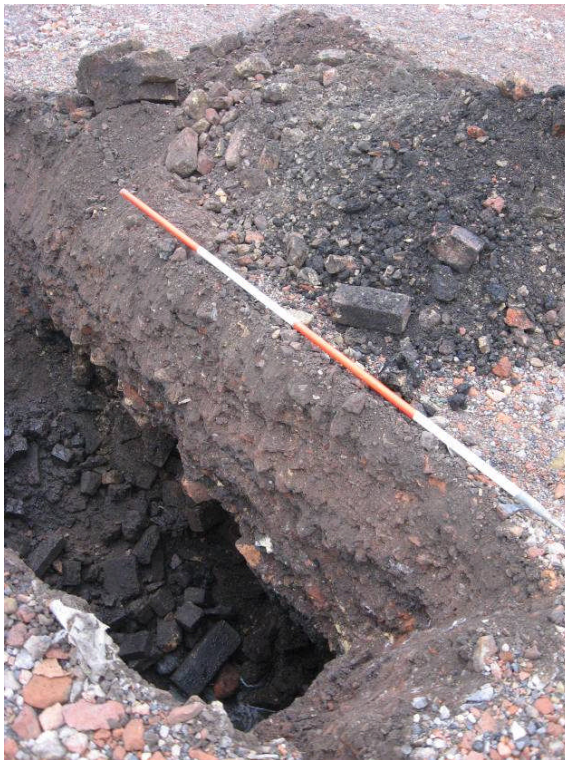
In Test Pit 06 hardcore demolition deposits were present to a depth of 0.60m beneath which loose bricks, suggestive of a backfilled cellar, were encountered extending to the base of the pit at 2.30m.

Plate 6: Test Pit 06 west facing section showing potential brick infilled cellar beneath demolition deposits, viewed looking north-east

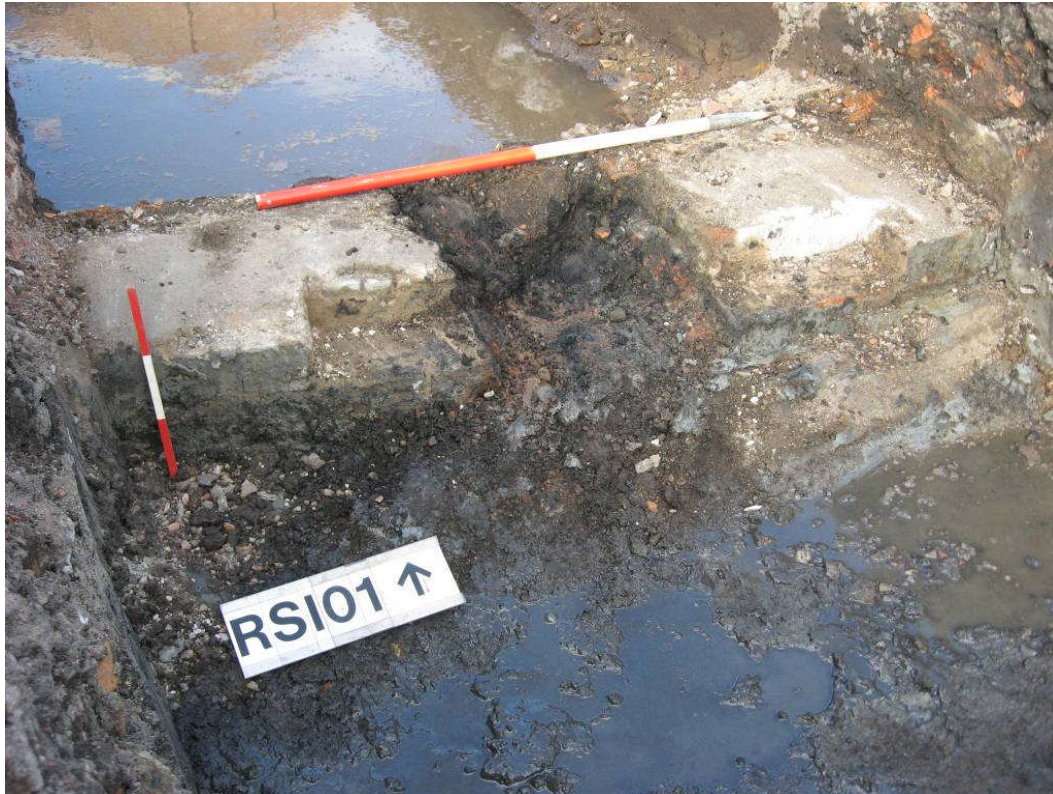
- 0038 Outer holding tank wall, 0.50m wide, curvilinear, exceeds 2.0m in depth, bricks 23 x 8 x 8cm, white mortar/concrete bond. Central gap 0.4m in wall for pipe?

Plate 07: Trench 01 outer holding tank wall 0038, viewed looking north east

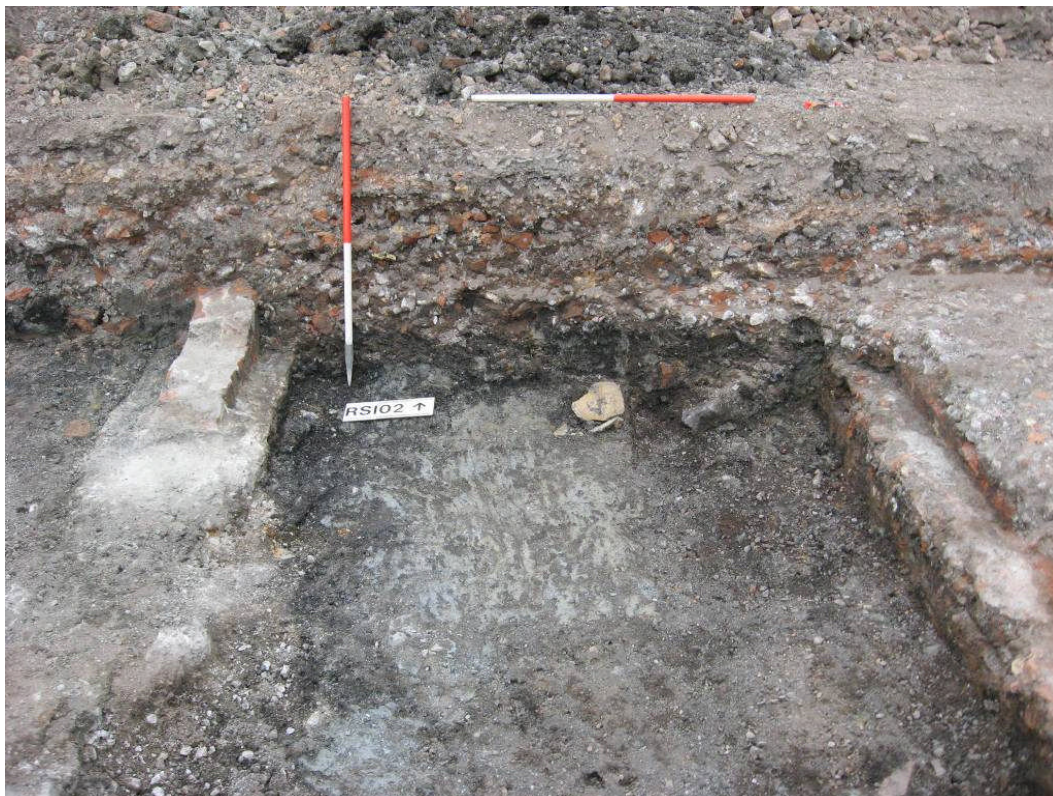
Plate 08: Trench 02 wall 0021 and railway structure 0019, viewed looking north

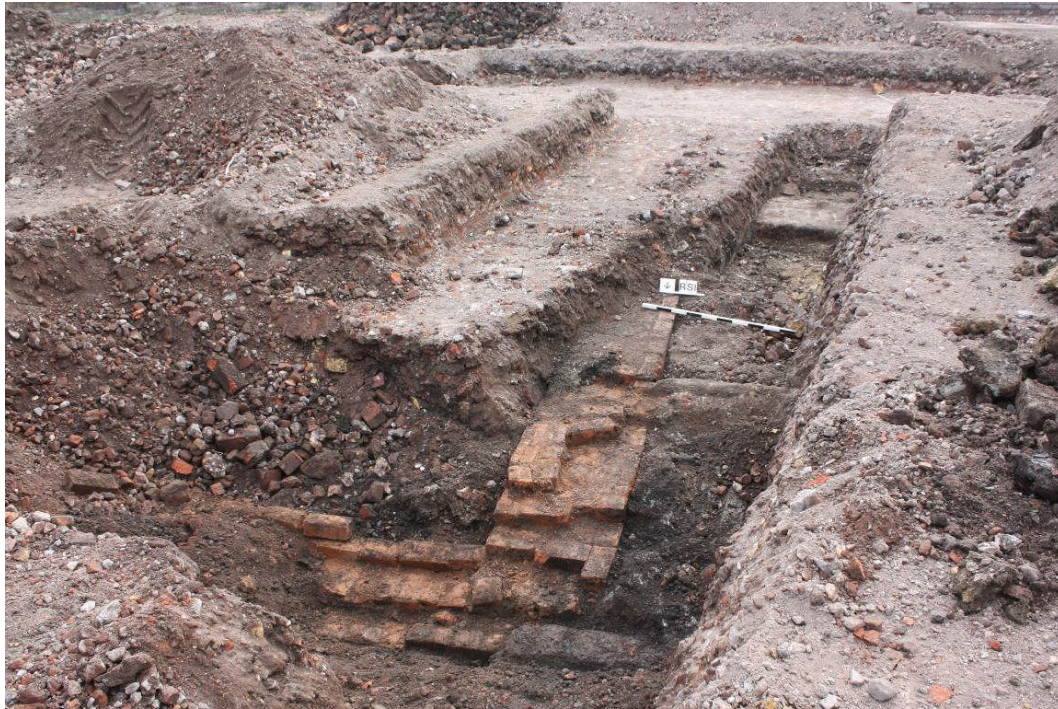
Plate 9: Trench 02 brick walling of former retort house and wall of chimney in the background, viewed looking south

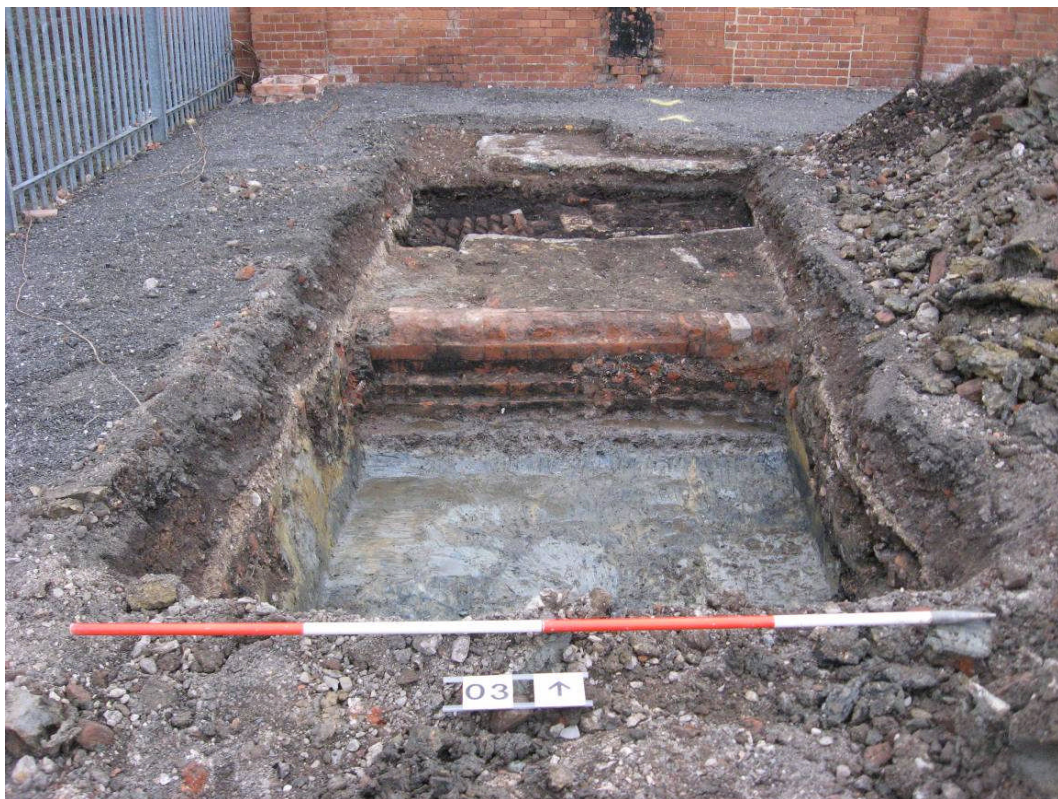
Plate 10: Trench 03 general view from the south, viewed looking north

Trench 03 (Figures 5, 10-11 Plates 10 and 11)

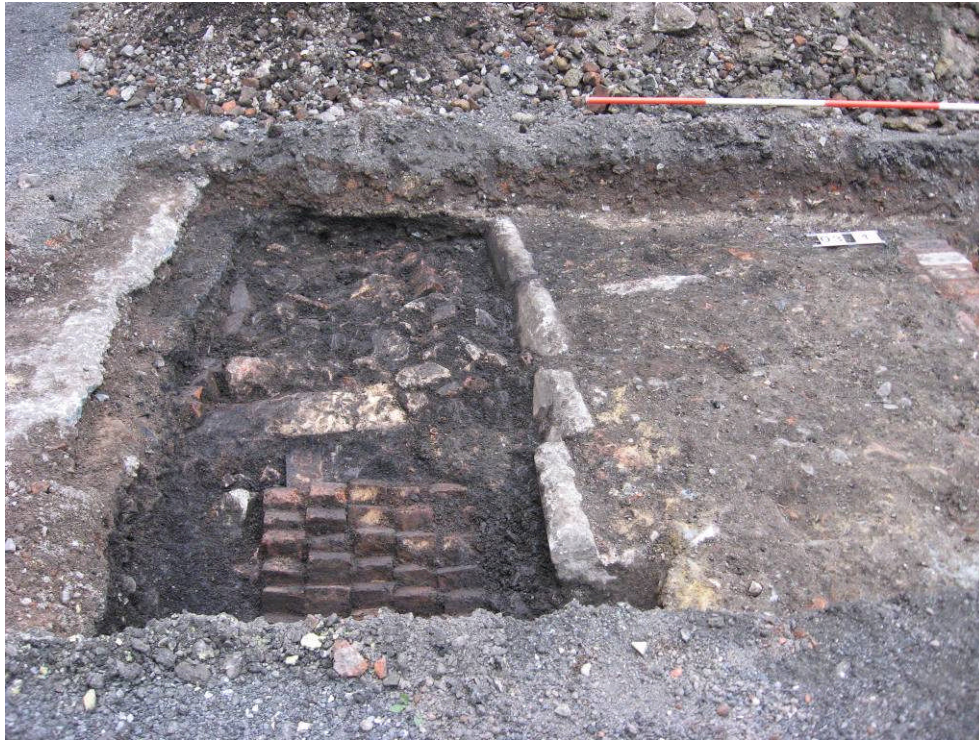
Plate 11: Trench 03 concrete kerb 0077 and rubble infill including bricks set on edge 0075 sealing a tar deposit, viewed looking east

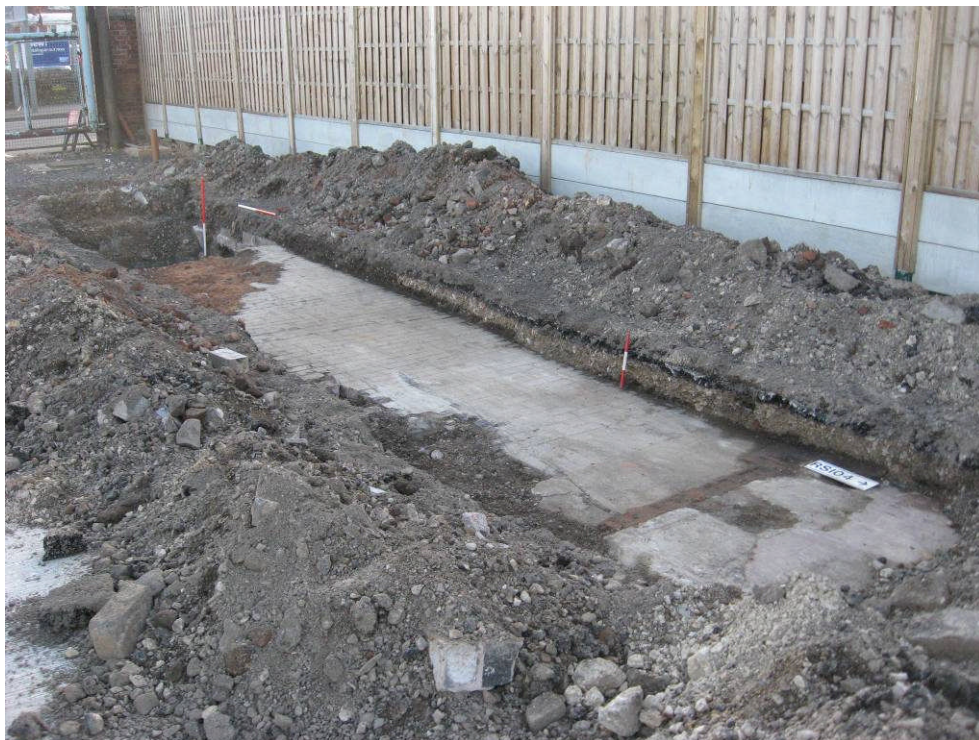
- 0082 Tile floor, tiles 14cm x 6cm, set in concrete, 1.20 x 0.35m survives
- 0083 Concrete base for 0082, 1.50m x 0.80m survive
- 0084 Possible wall, originally 0.5m wide, intermittent single course survives, on a concrete foundation 0085, bricks 22 x 11 bonded by white concrete mortar

- 0085 Wall foundation for 0084
- 0086 Floor surface made of blue bricks 23 x 8 bonded by white concreted mortar, extending over much of the trench, 0.12m thick

Plate 12: Trench 04 brick floors and walls 0082-0086, viewed looking south-west
