**HISTORIC BUILDING PHOTOGRAPHIC
SURVEY AND ARCHAEOLOGICAL
WATCHING BRIEF AT 9, SPRING LANE,
GLASTON, RUTLAND**

**A report for
L. Burdett and G. Willson**

OS Grid Ref. SK 8604 0095 (centred)
TPA Project Code: GSW.1
November 2011

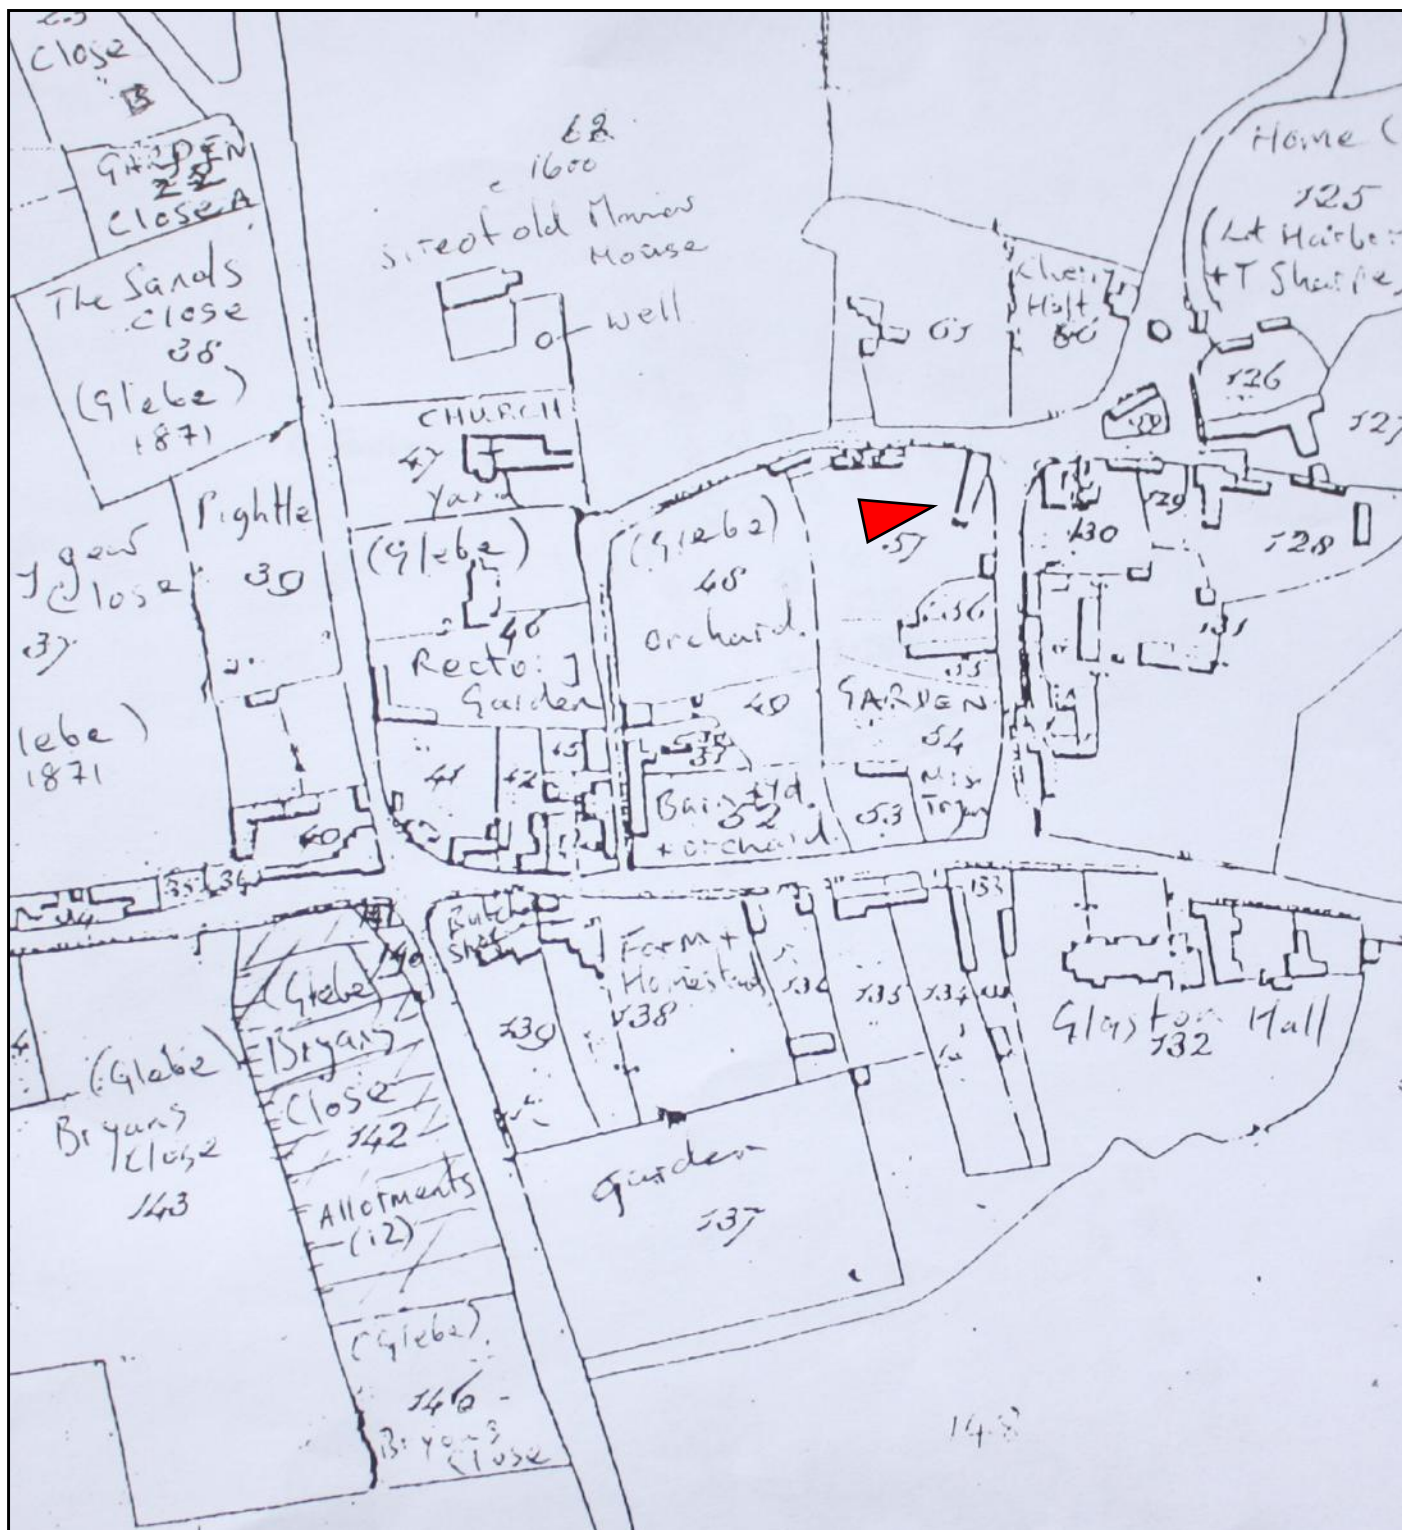
Figure 2: No. 9 Spring Lane (highlighted by arrow) as shown on the central part of the 1841 tithe map of the parish of Glaston, Rutland (with later notes added). Not to regular scale. Map supplied by client.

At the time of the tithe map in 1841 the row of 9, 11 Spring Lane was a single building occupied by John Buck. Documents and deeds within the Fineshade Estate Records collection at Northampton Record Office seen by the current owners of No. 9 strongly suggest that the house was partly used as a bakehouse in the first half of the 19th century. The building shown on the tithe map (Fig. 2) is approximately the same length as it is now, suggesting that a south extension then existed where the present one stands today - the latter now appears to be of more modern construction. This extension may have been the bakery. By the time of the First Edition Ordnance Survey large scale maps of the 1880s the extension is clearly distinguished, together with a subdivision of the main house into two parts (Fig. 3).

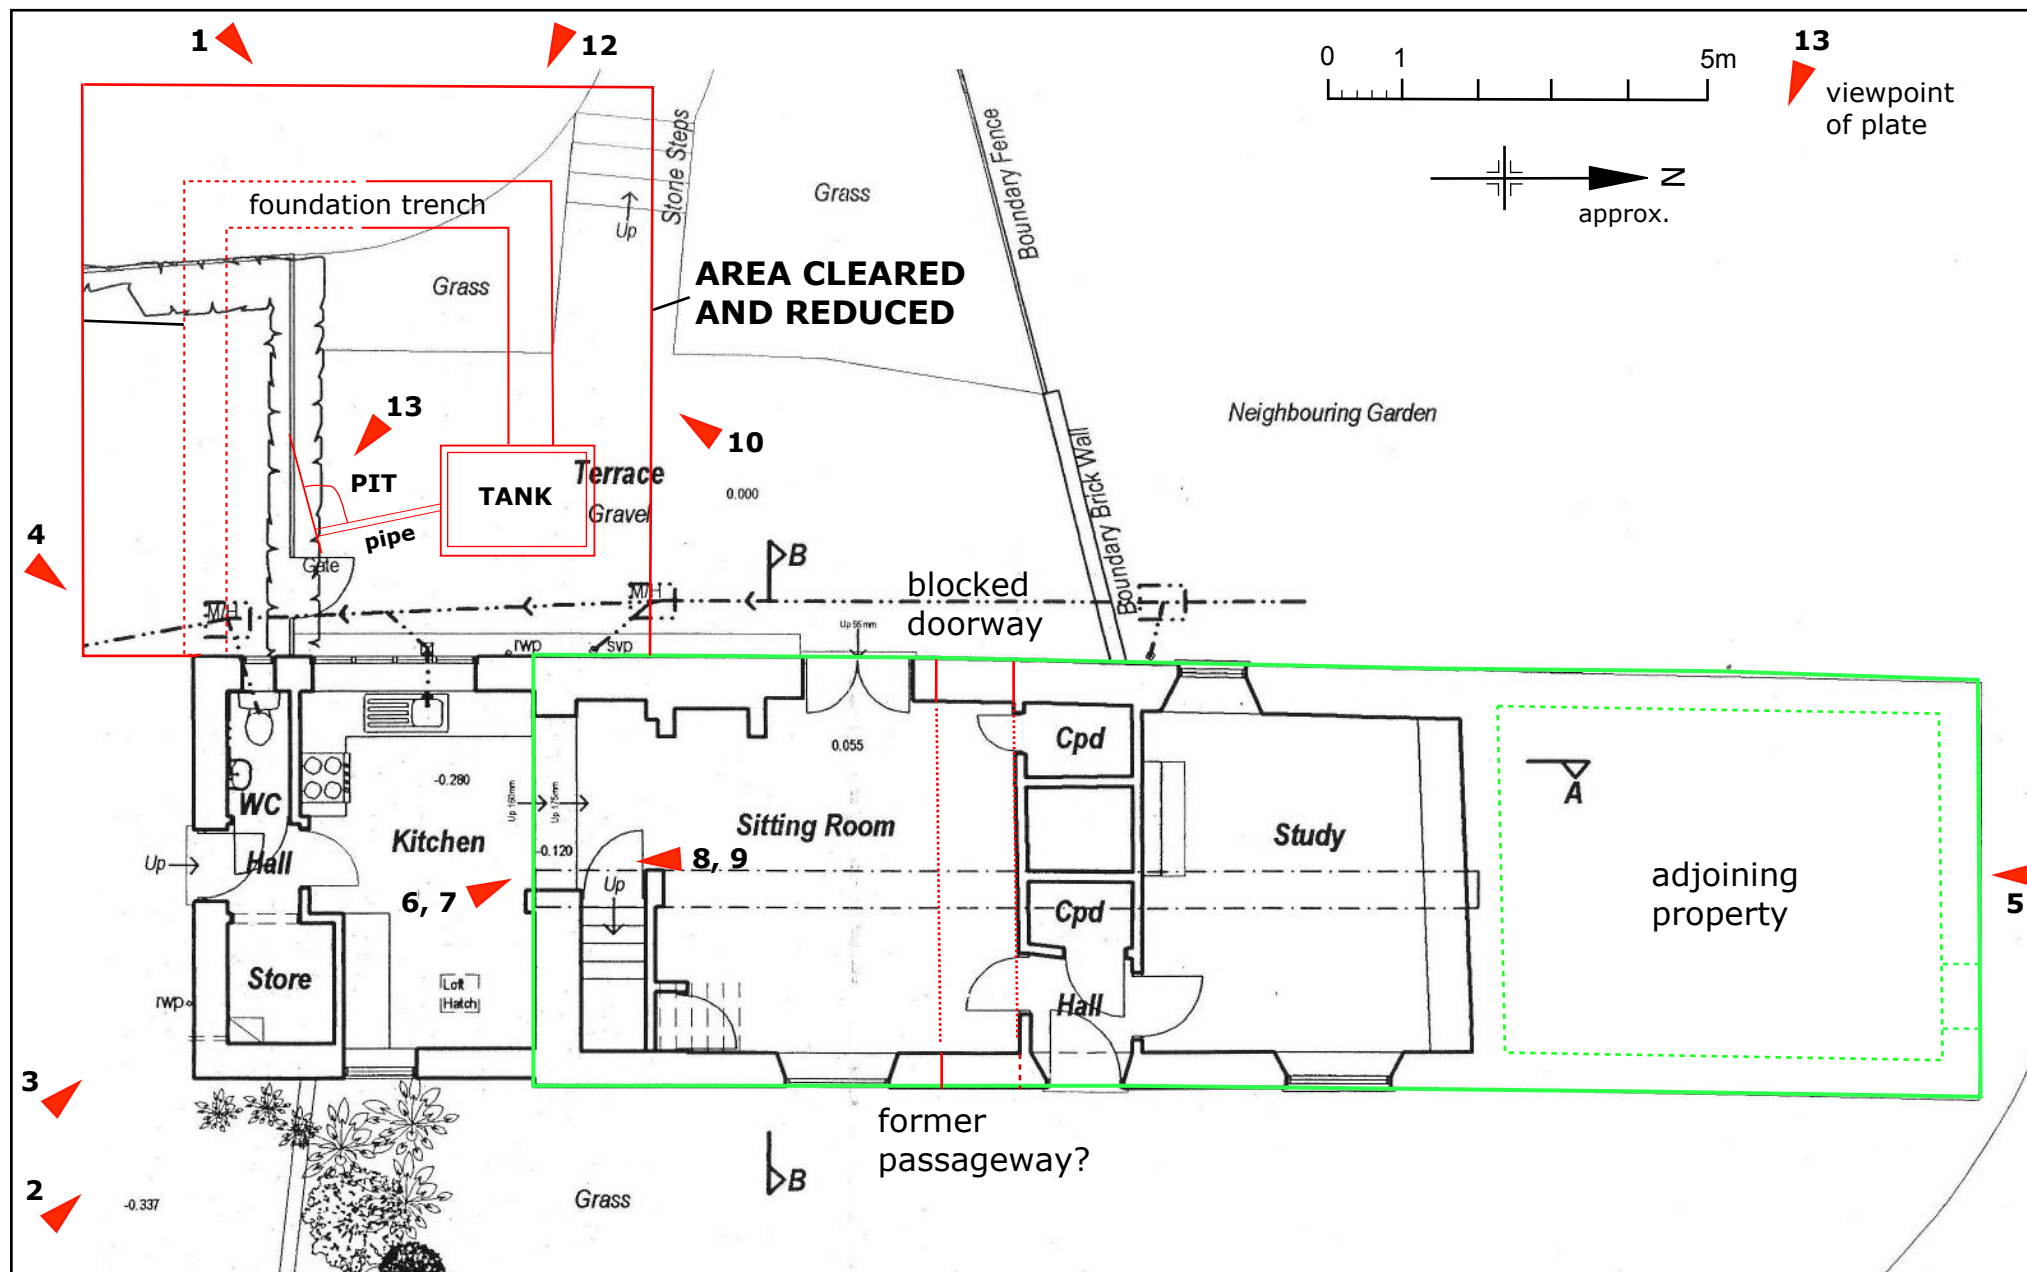
Figure 4: Ground plan of 9 Spring Lane, Glaston showing the full extent of the original building (green outline), the south extension and area cleared by machine for the new extension (red). Scale 1:100. Plan supplied by architect.

within No. 9 and the other in No. 11. The front entrances to both 9 and 11 are not original as the building originally had a through-passage between cells 1 and 2, with opposing doorways in the front and back walls, now blocked up – these are indicated on Figure 4. Another blocked doorway shows in the north gable wall, near the north-east corner (Plate 5) into cell 3; this part may originally have been a service room. The rear of No 11 is now largely obscured by a modern extension, although enough upper walling shows to prove that the building was one single entity.

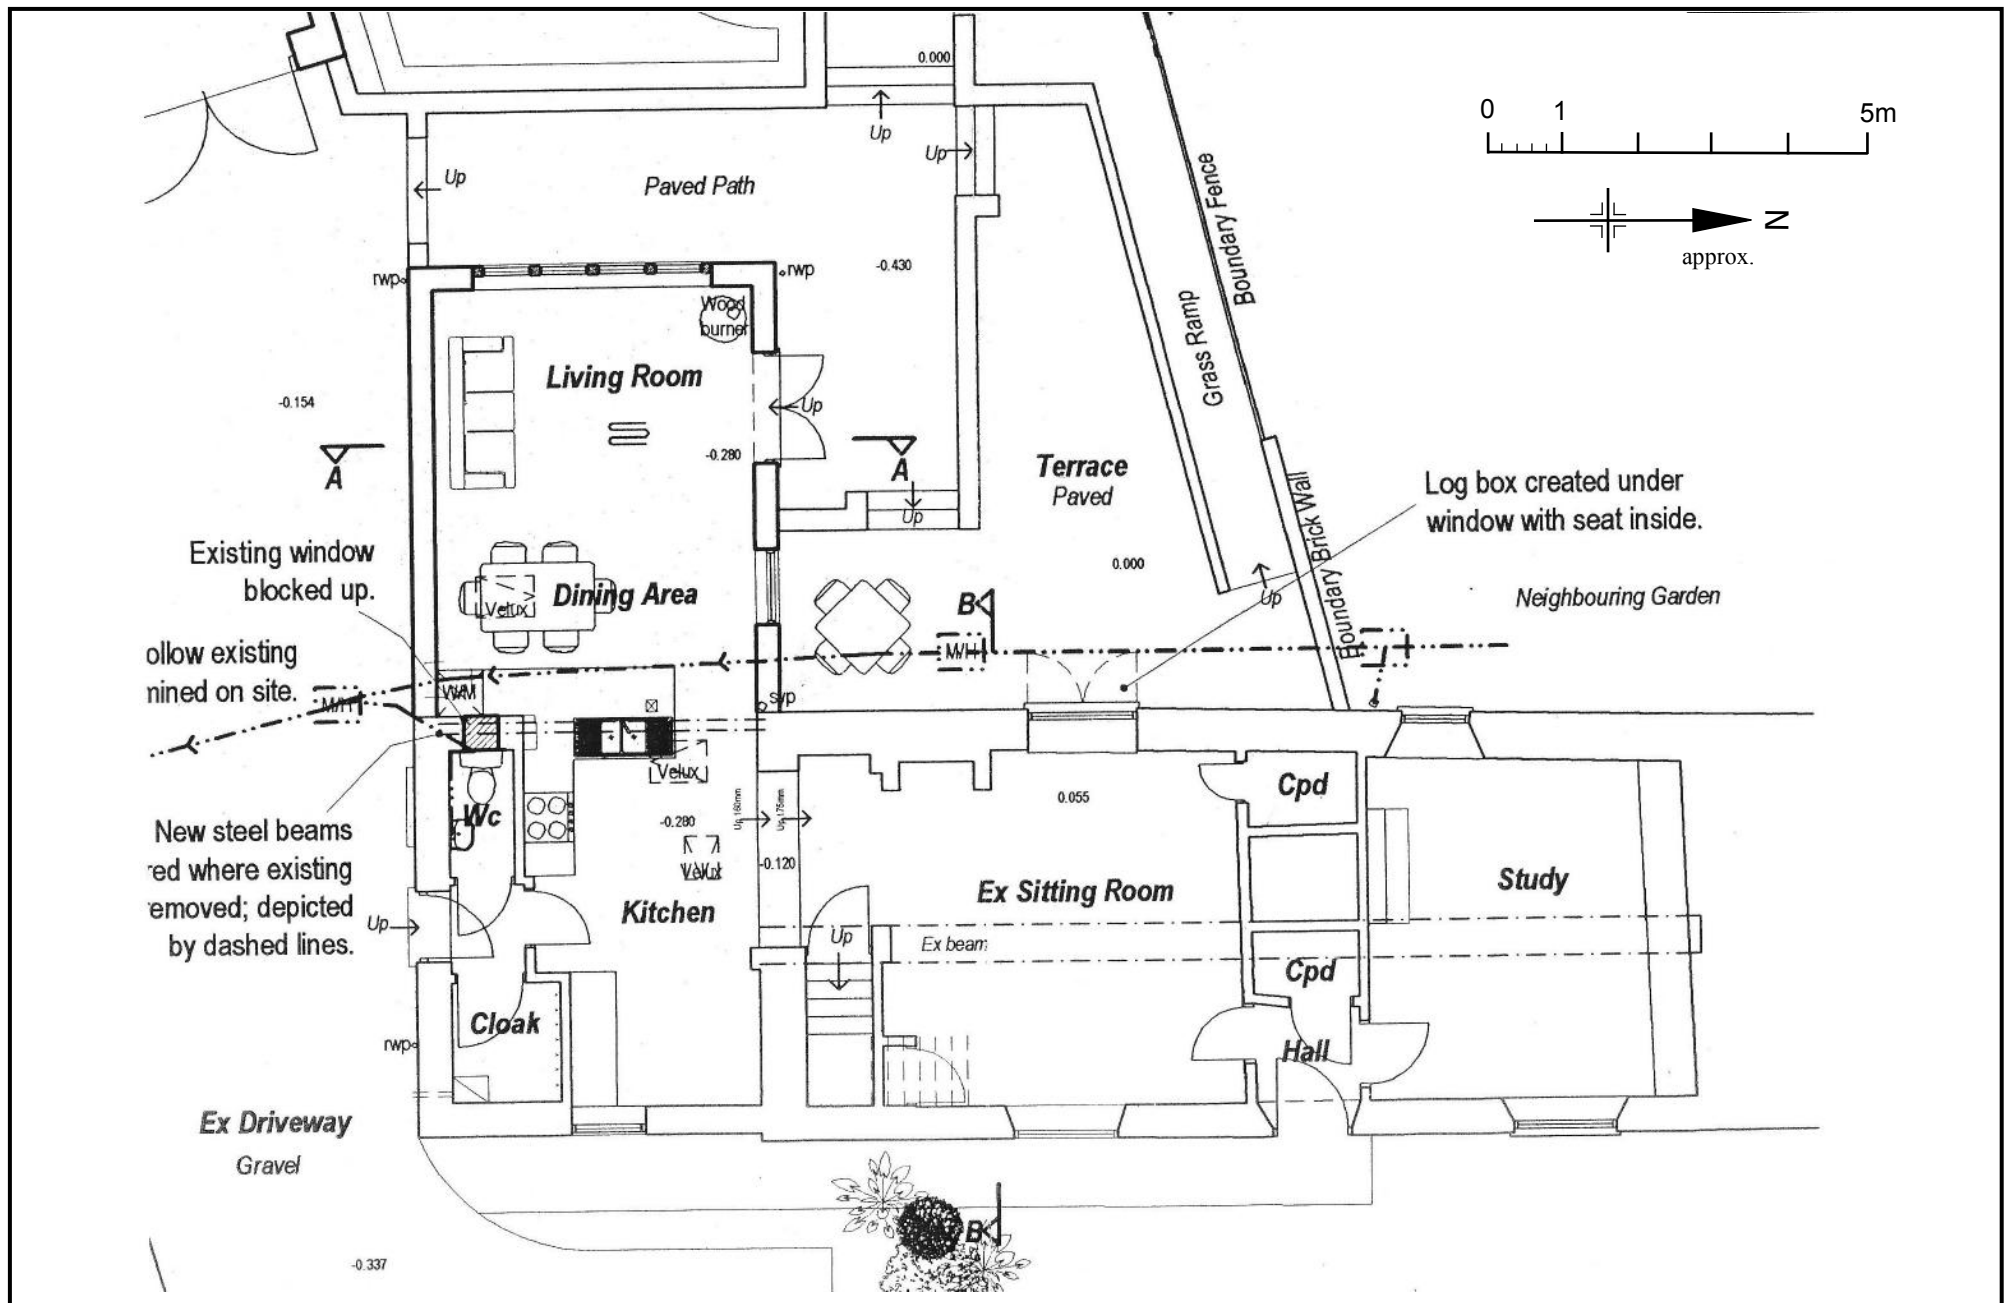
Figure 5: Ground plan of 9 Spring Lane, Glaston showing the proposed extension. Scale 1:100. *Plan supplied by architect.*

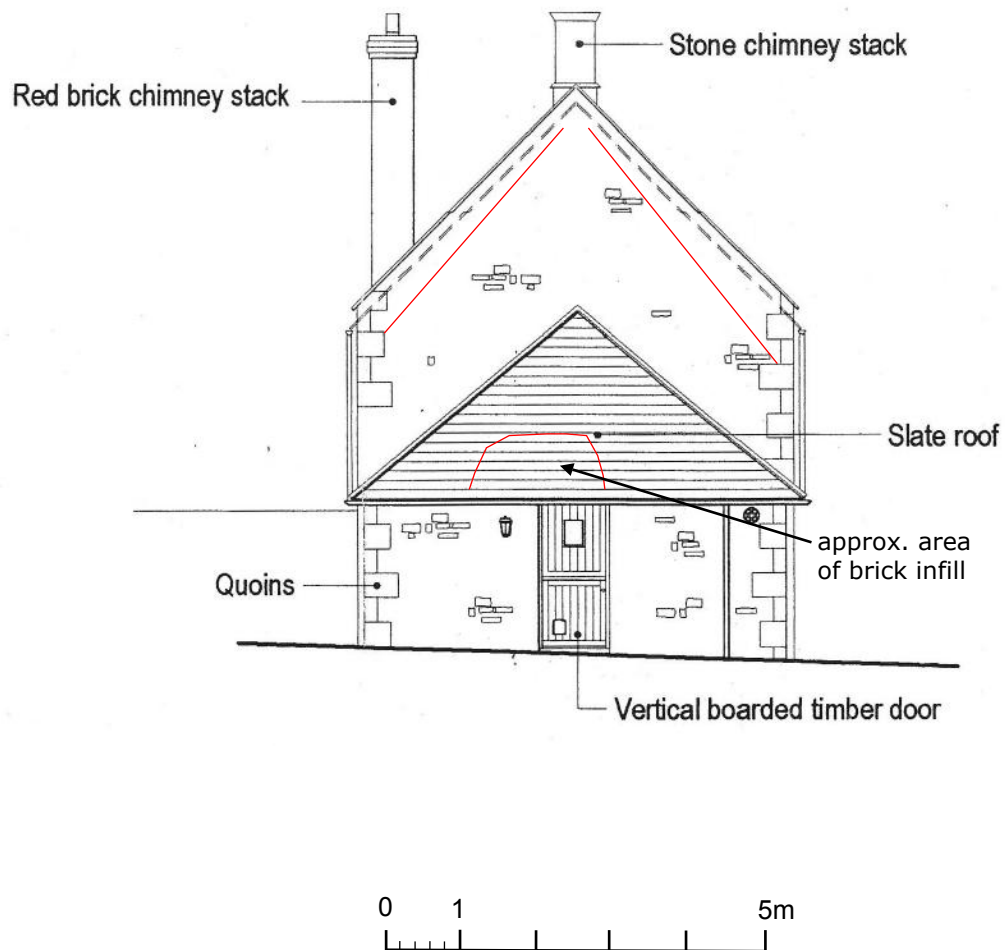
Figure 6: Architect's plan of south gable wall of 9 Spring Lane, Glaston showing existing extension, brick infill showing in its attic and lines indicating re-roofing. Scale 1:100.

At a lower level, the external face of the wall has been interfered with as there is an area of brick infill showing in the centre of the wall above the ceiling level of the existing extension (Plates 6, 7; Fig. 6). This might be evidence for a former fireplace / oven having been situated within the area of the extension. Its flue may have been cut through the end wall to join an existing one within it. This may conceivably have been a bread-oven built for or reused within a bakery.

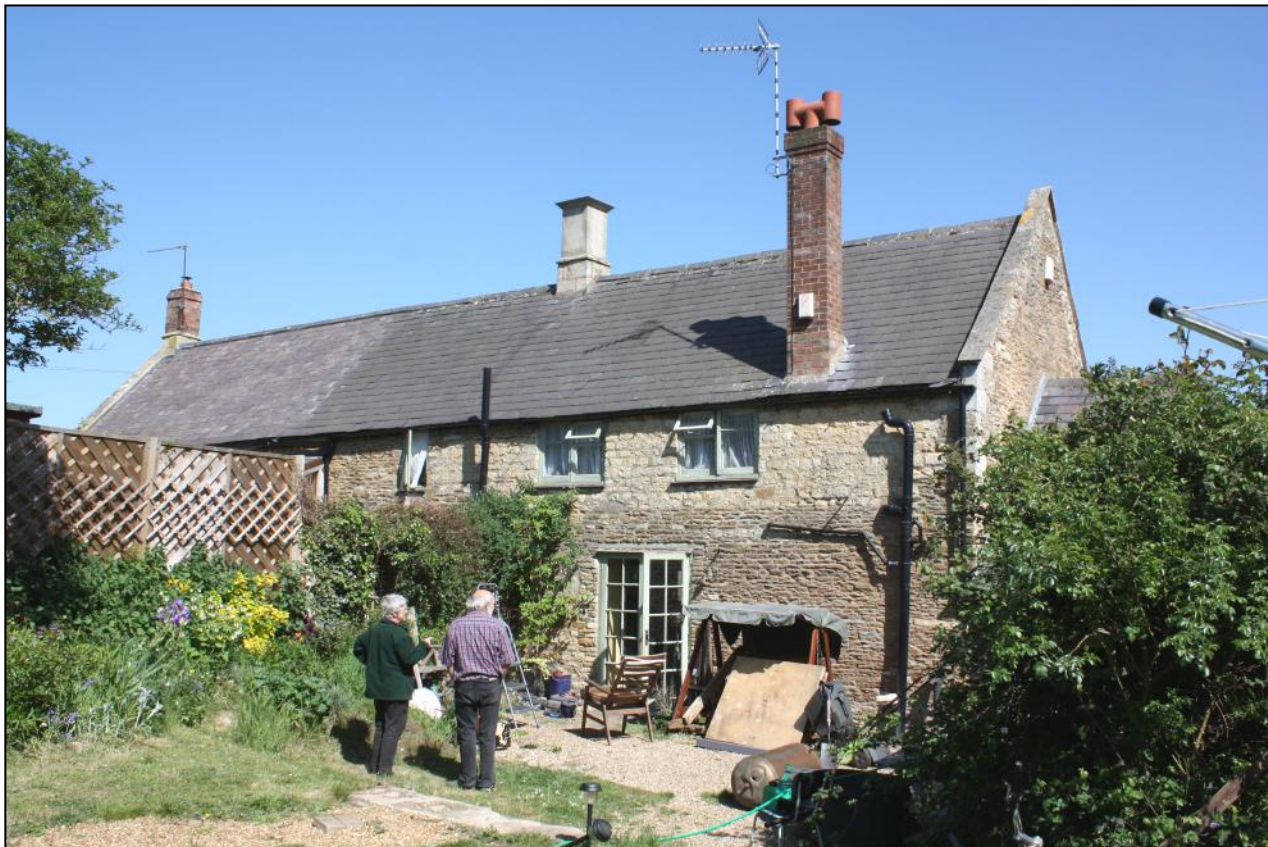
Plate 1: West, garden-facing elevation of the original part of 9 Spring Lane, Glaston. The existing single-storey extension is behind vegetation to right.

The planned west extension to the building's single-storey south end involved the clearance and reduction of an area approximately 7.5m square, extending back to roughly where a higher garden terrace started (showing in the foreground of Plate 1). Initial machine clearance by contractors removed 10-15cm of imported gravel close to the house and 25cm of topsoil further back, with up to 20cm depth of subsoil beneath this. The latter was above natural sand (Plate 10), with some bedded stone evident. About 1.2m in from the sides of the cleared area foundation trenches were excavated down through the natural.

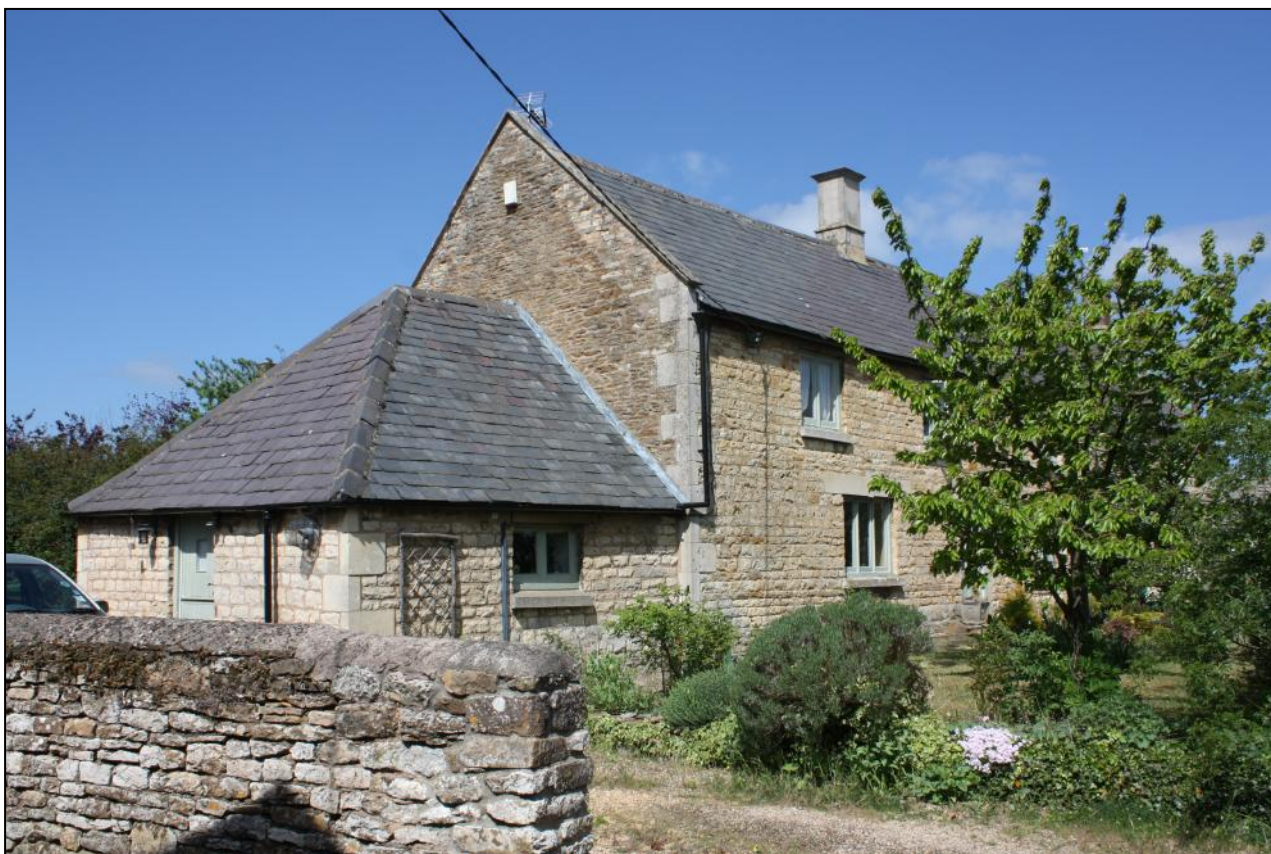
Plate 2: Single-storey extension at south end of 9 Spring Lane, Glaston, with part of the refaced street frontage of the original building also showing.

No 9 Spring Lane, Glaston is built largely from roughly coursed smallish oolitic limestone rubble on three sides and more regular coursed ashlar on its east side where it faces the road (cover photo). There is a little internal brickwork and a slate roof that may well have replaced an earlier thatched one of steeper pitch (Plate 1). There are dressed quoins, coped gables and both stone and brick chimney stacks. The single storey extension has a hipped roof and is composed on all three sides of coursed stone similar to that on the east side of the two storey building (Plate 2).

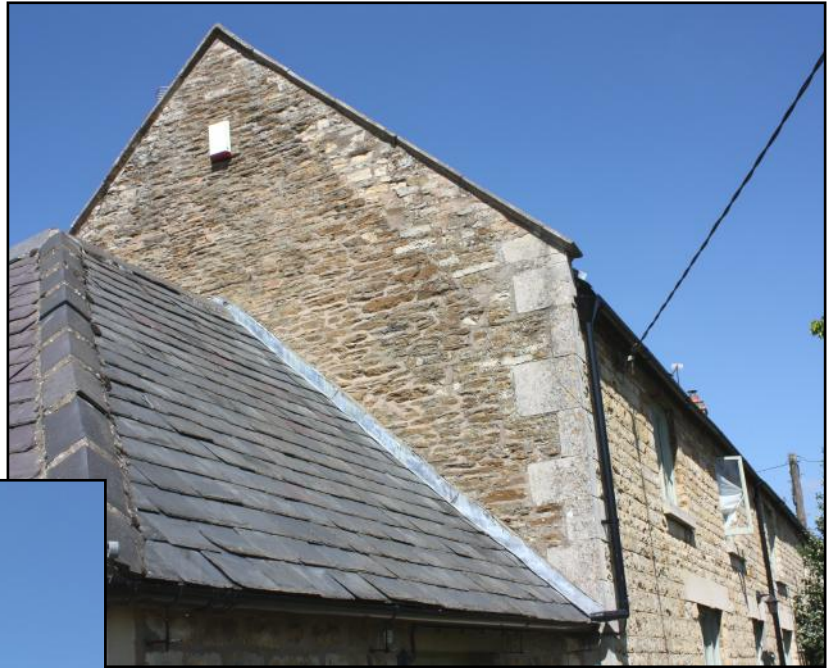
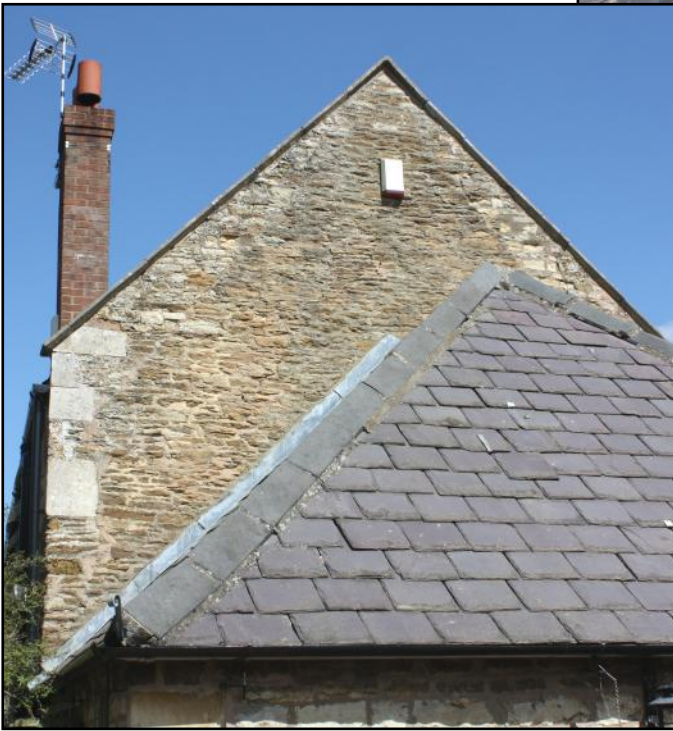
Plates 3-5: External views of the gable walls of 9 Spring Lane, Glaston. 3 and 4 show south end; 5: north end, with straight joints and raised roof line highlighted by lines to the side.

The refacing of the east side and possibly the present appearance of the south extension clearly belong to a major alteration. This probably included some rebuilding of the upper walling on the west side, and the re-roofing of the house on a broadened and heightened roof-line which shows in the two gable ends (Plates 3-5). This may all have occurred within the 19th century when the division of the building into two may have involved improvements that included the insertion of two new front entrances.

The lower wall of the south gable wall now has a wide internal opening between the sitting room and the kitchen within the existing extension and this has replaced any sign of any original entry point or former fireplace. Externally, the gable wall can be seen to have once been of a slightly lower and steeper pitch, although neither this or the north gable show signs of any former garret windows. The north gable rises to a chimney stack, the lower part of which may predate the roof change, and the south gable may have once have included a rise to a chimney too. Evidence for a former stack may show in the attic of the main building where a body of stone walling (edged on one side with bricks) extends out over 50cm from the main wall (Plate 8). Above this, the main wall has a slight depression for a flue (Plate 9). Viewed from the inside, evidence for the roof change is less clear but does show below the rafters from the mortar spread (far left in Plate 8).

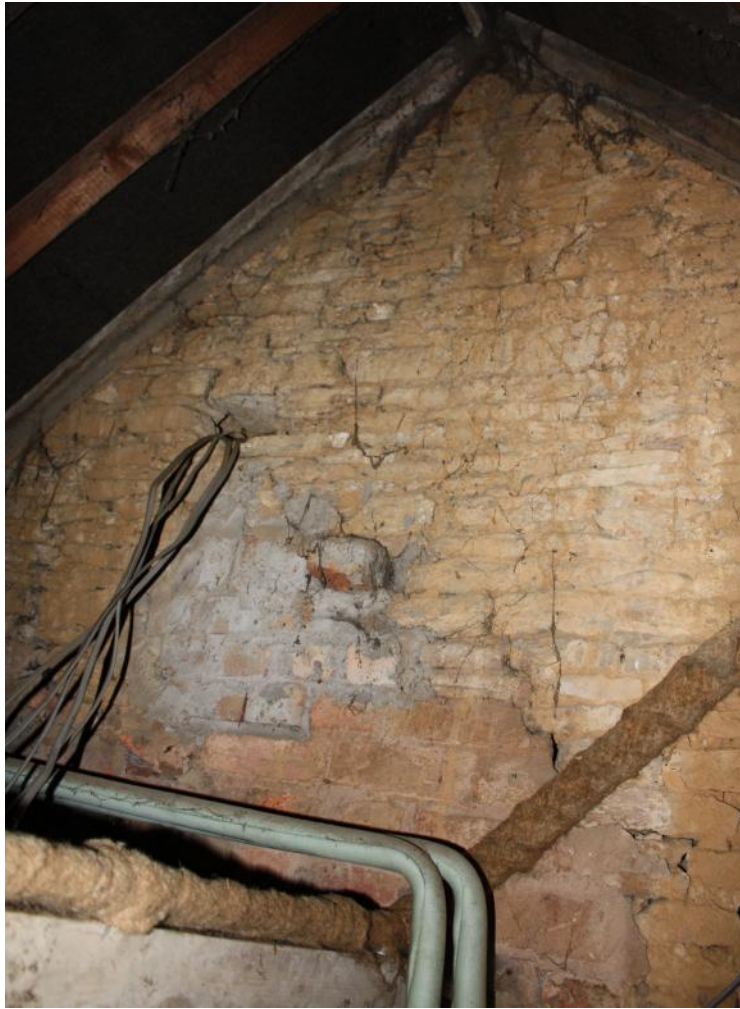
Plate 6: View of the lower external south gable wall of 9 Spring Lane, Glaston, here seen from the attic of the existing extension.

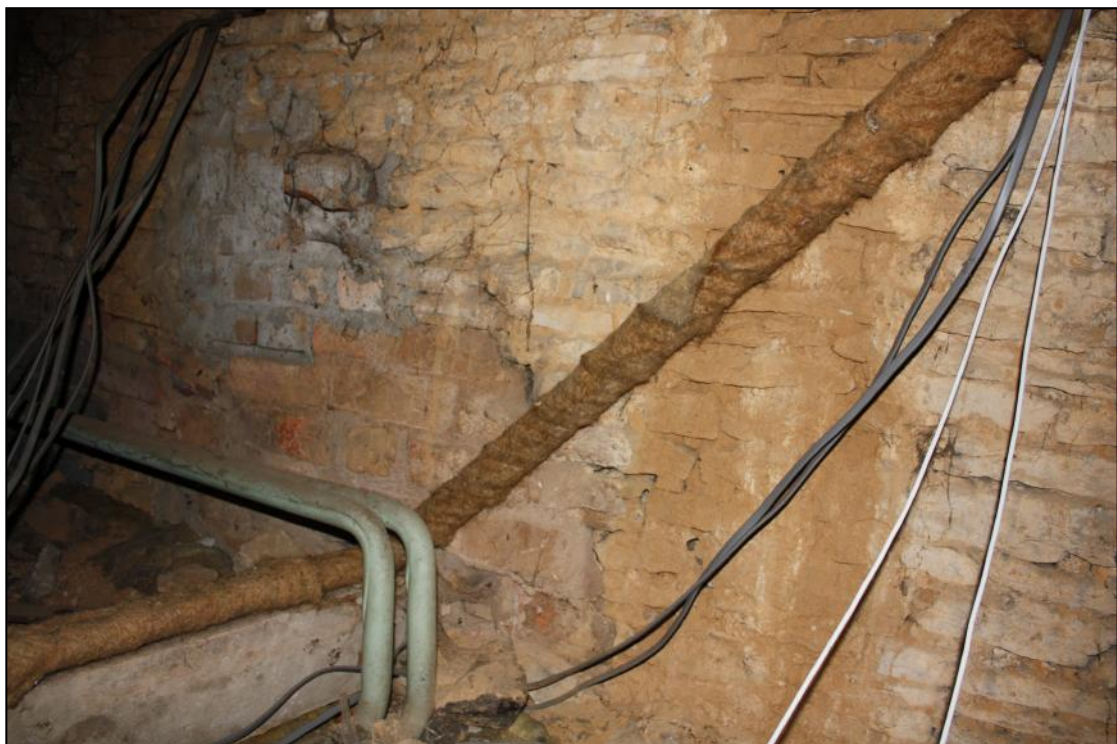
Plate 7: Closer view of the brick infill showing in the lower south gable wall (external side), seen from the attic of the extension.

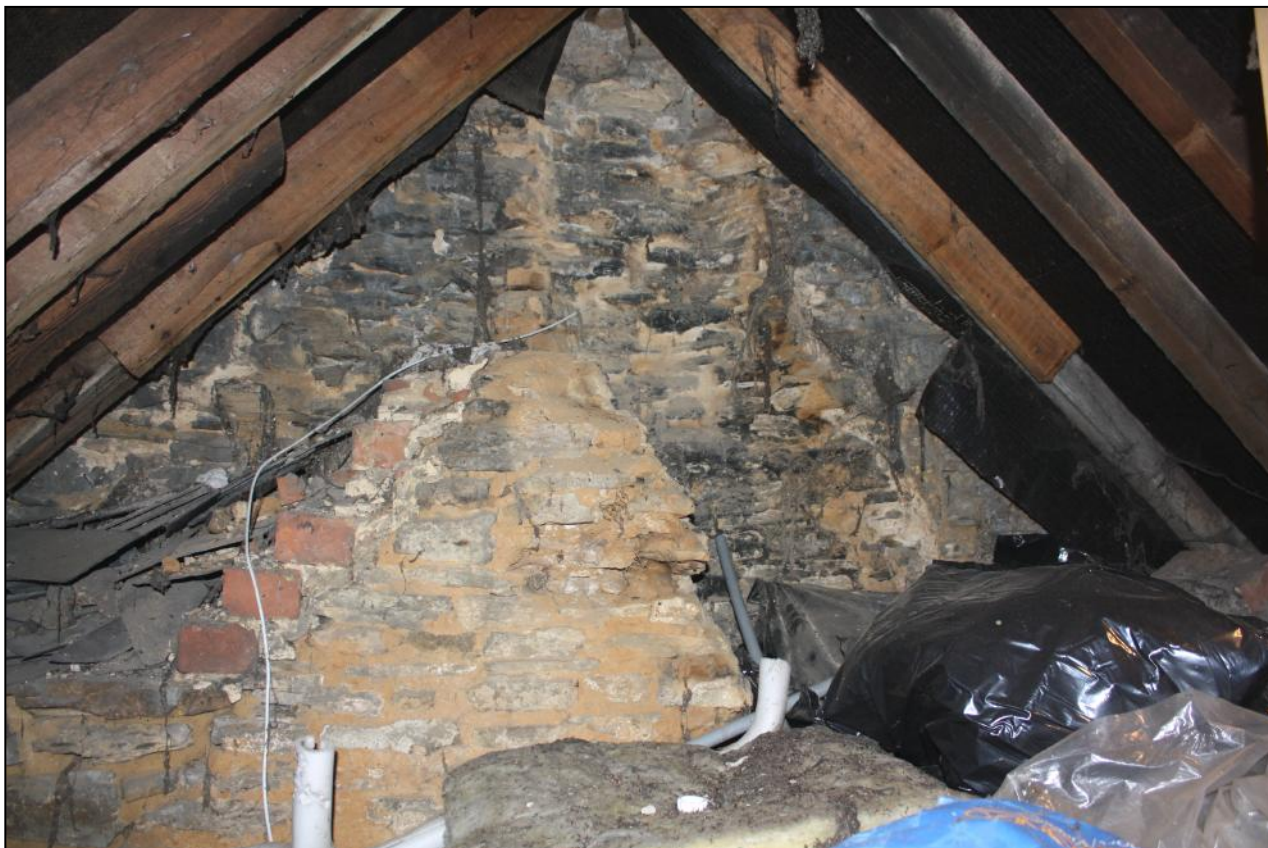
Plate 8: View of the internal side of the upper part of the south gable wall of the original part of 9 Spring Lane, Glaston, with two phases of stonework showing.

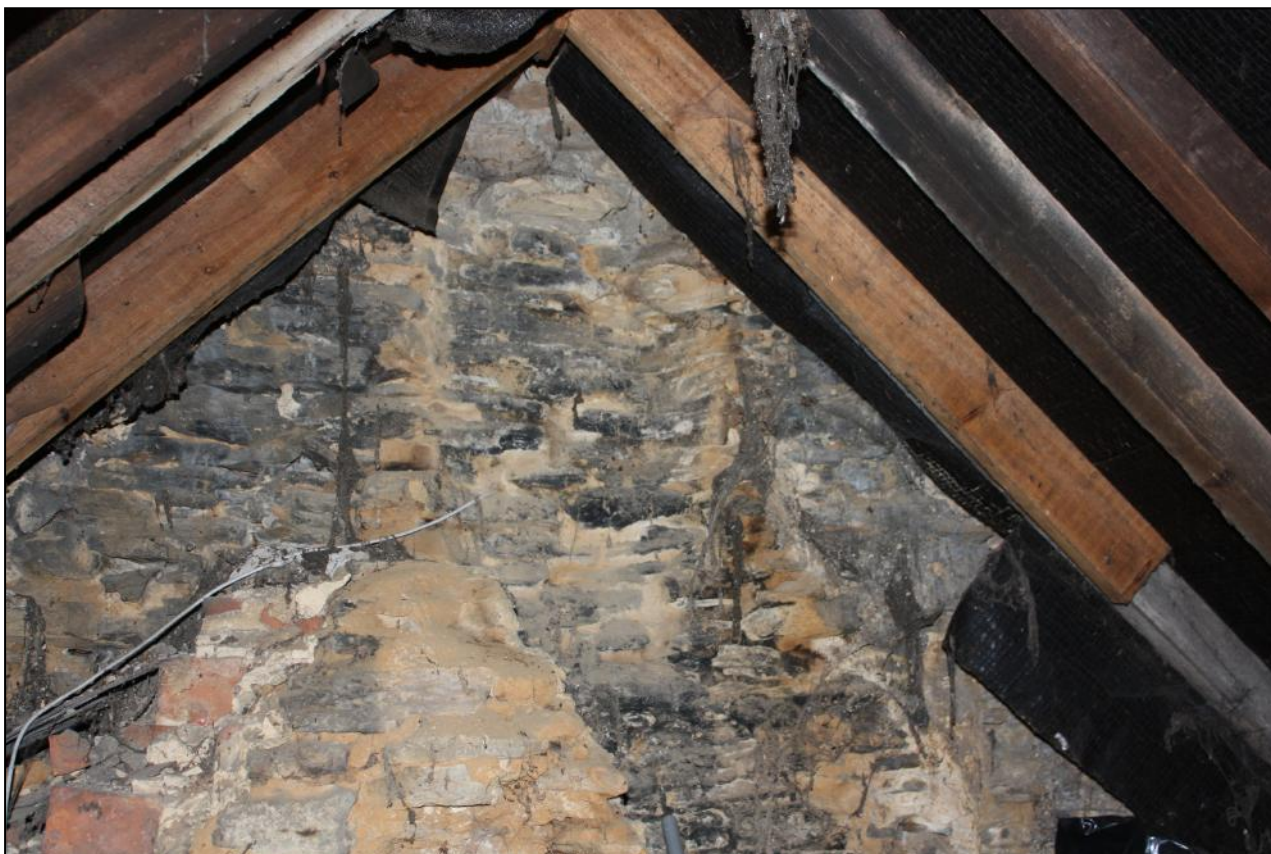
Plate 9: Depression showing in the upper part of the gable wall where a flue has previously been.

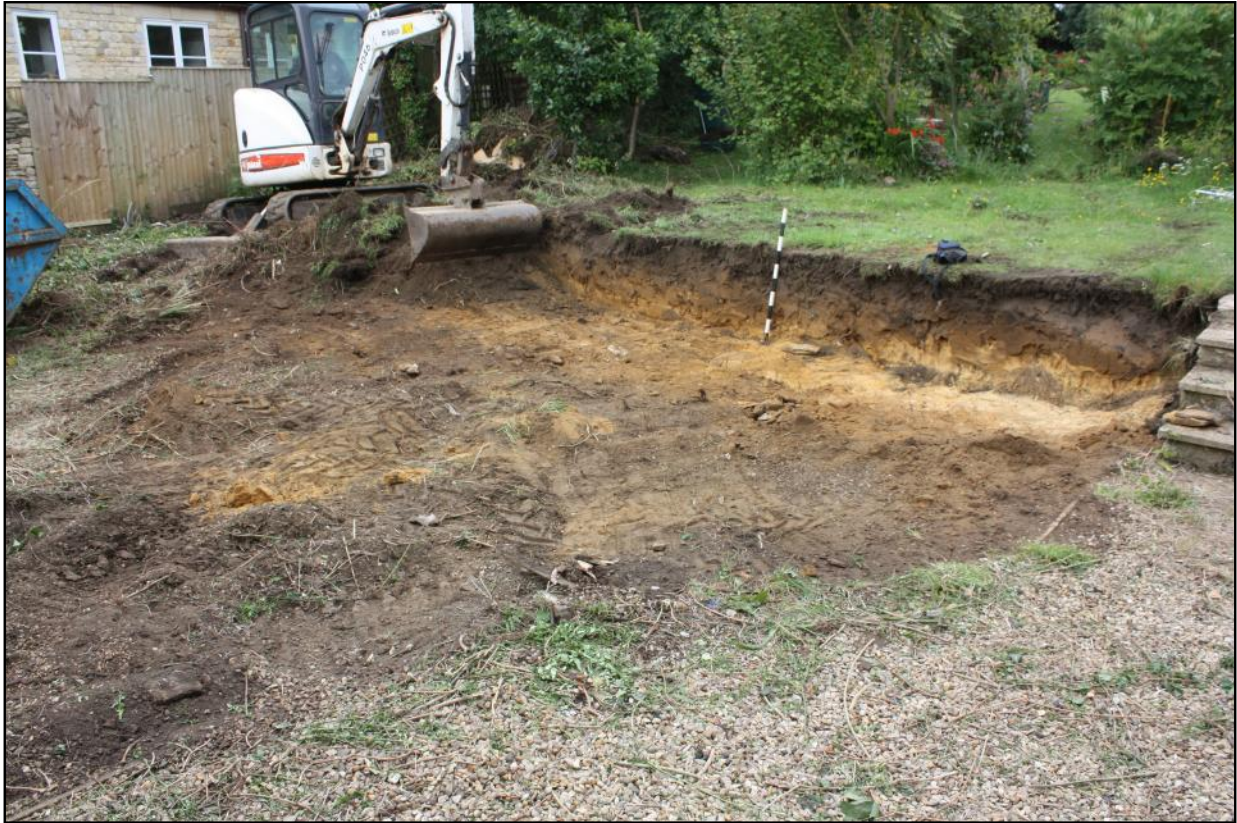
Plate 10: Area cleared at back of 9 Spring Lane, Glaston for new extension. View looking south-west.

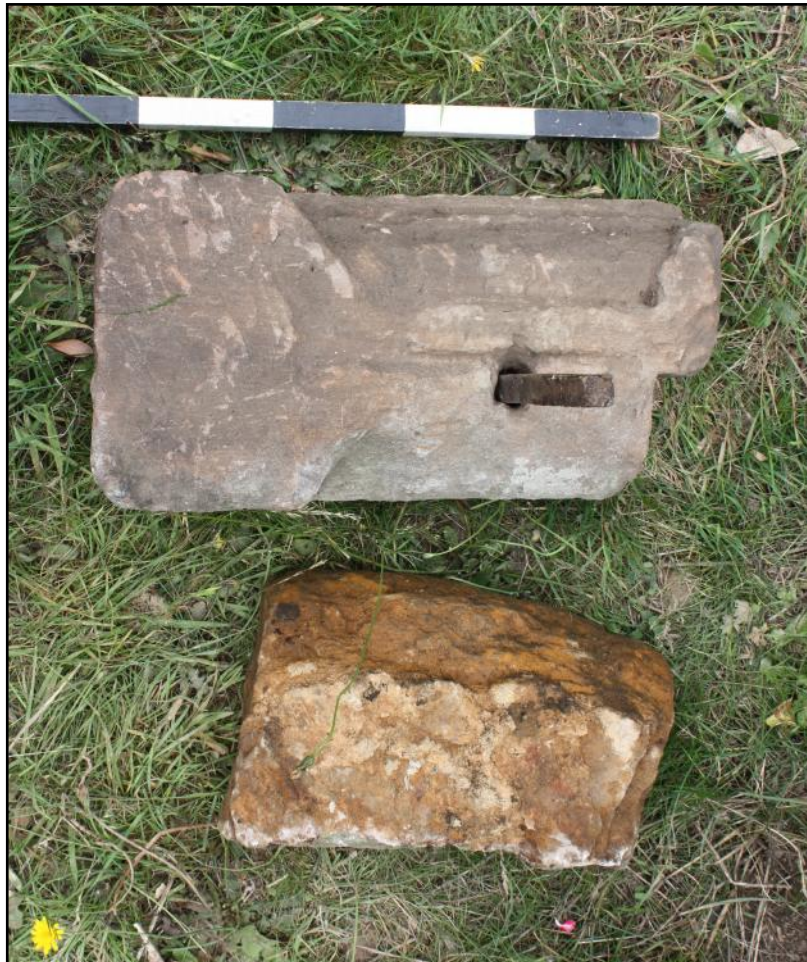
Plate 11: Two of several pieces of worked stones found during clearance at the back of 9 Spring Lane.

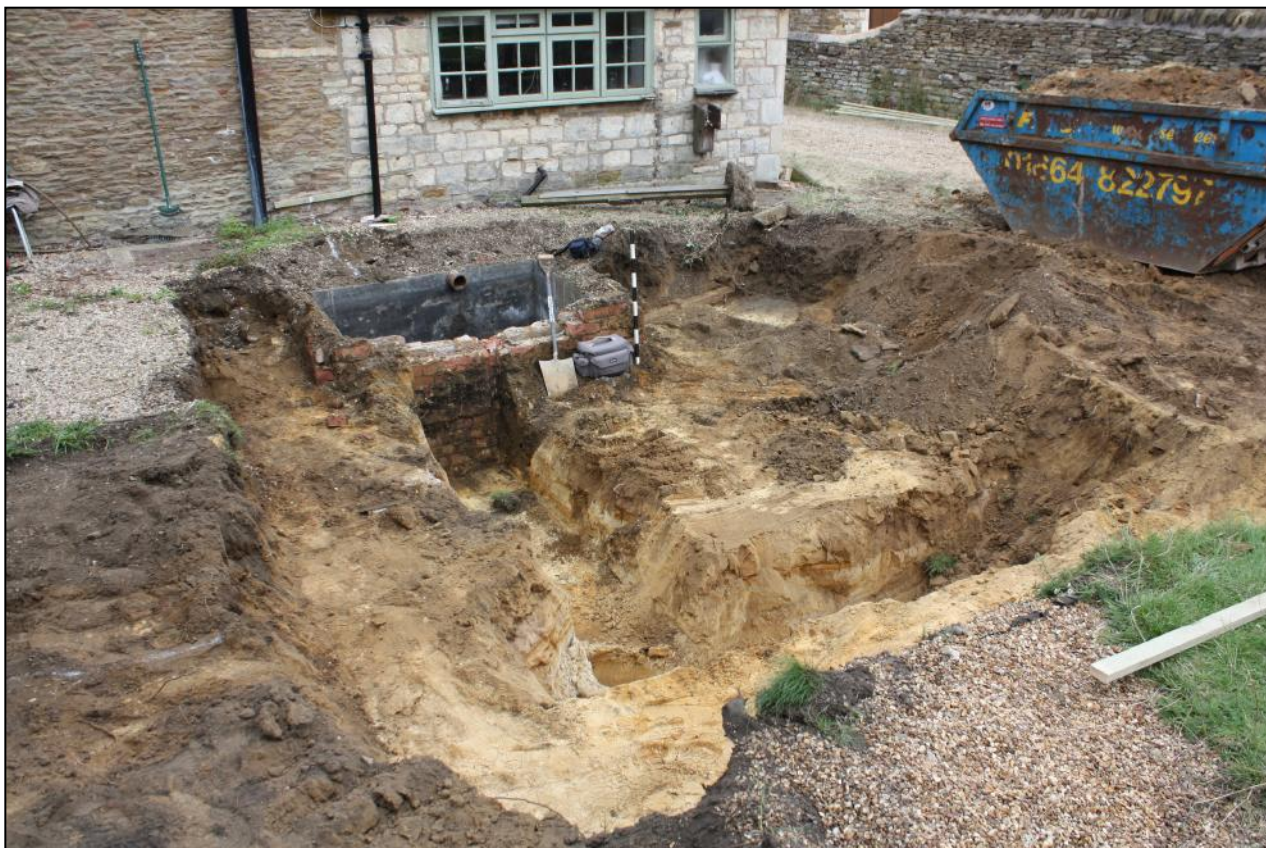
Plate 12: Exposed water tank and the first foundation trenches for the extension excavated through natural at the back of 9 Spring Lane, Glaston. View to south-east.

The clearance revealed a brick-lined water-tank with 9 inch (23cm) thick walls and two pipe inlets; water was still in situ at 1.65m depth. One of the pipes had cut through a small pit that showed below the gravel surface and had been cut through subsoil and natural (Plate 13). This went to a depth of 80cm from ground level and where cut by the pipe trench was 65cm wide. Its fill was very ashy and it contained an amount of animal bone. It also contained pieces of clay tobacco pipes, including four plain bowls with flat pedestal spurs and of a profile type of 18th century date (Ayto 1979). One stem piece had circle decoration.

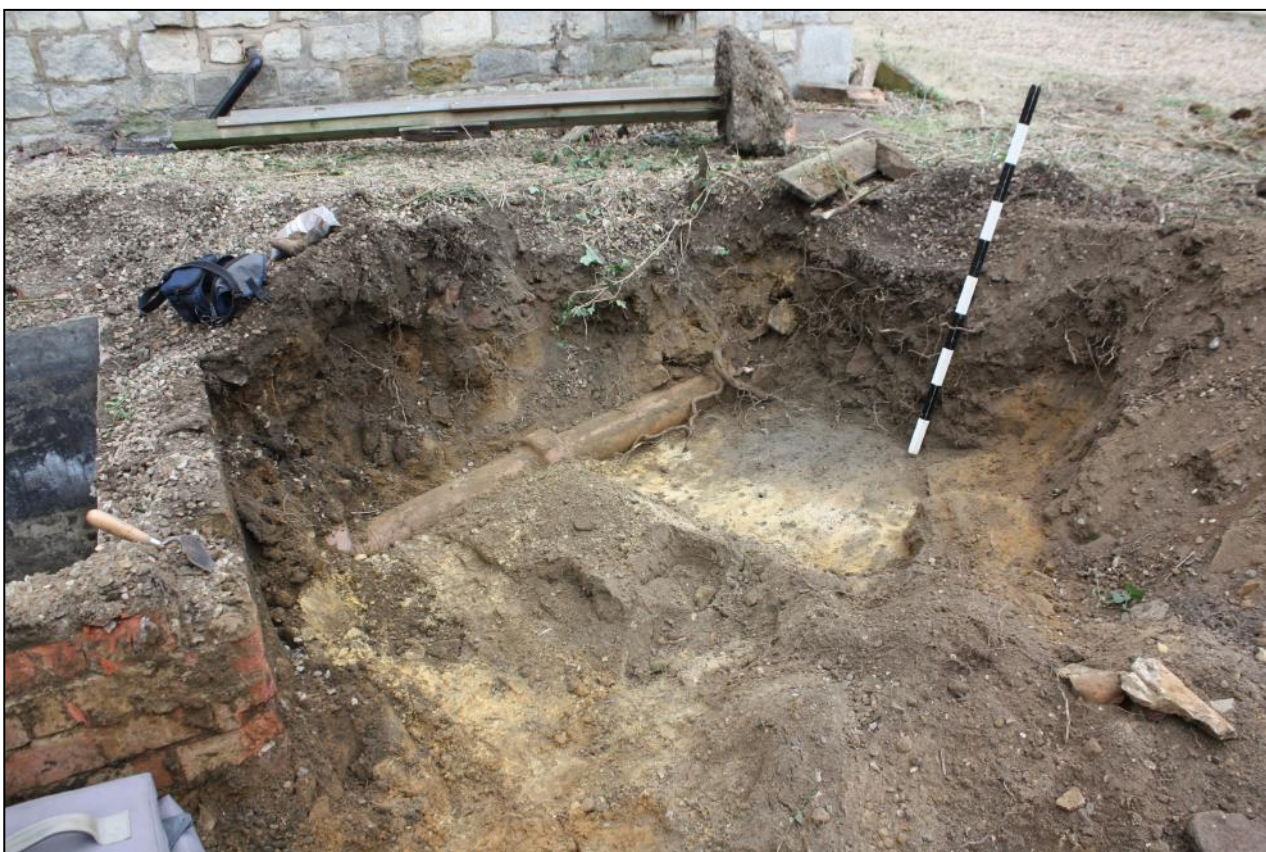
Plate 13: Water pipe and an earlier pit showing in section of reduced area behind the extension at 9 Spring Lane.
