**AN HISTORIC  
BUILDING SURVEY OF  
PARKFIELD HOUSE,  
BELTON-IN-RUTLAND**  
Including observations from  
a building watching brief

**A report for  
Mr and Mrs Leaf**

OS Grid Ref. SK 8180 0125 (centred)  
TPA Project Codes: PHB.1 and PHB.2  
January 2012

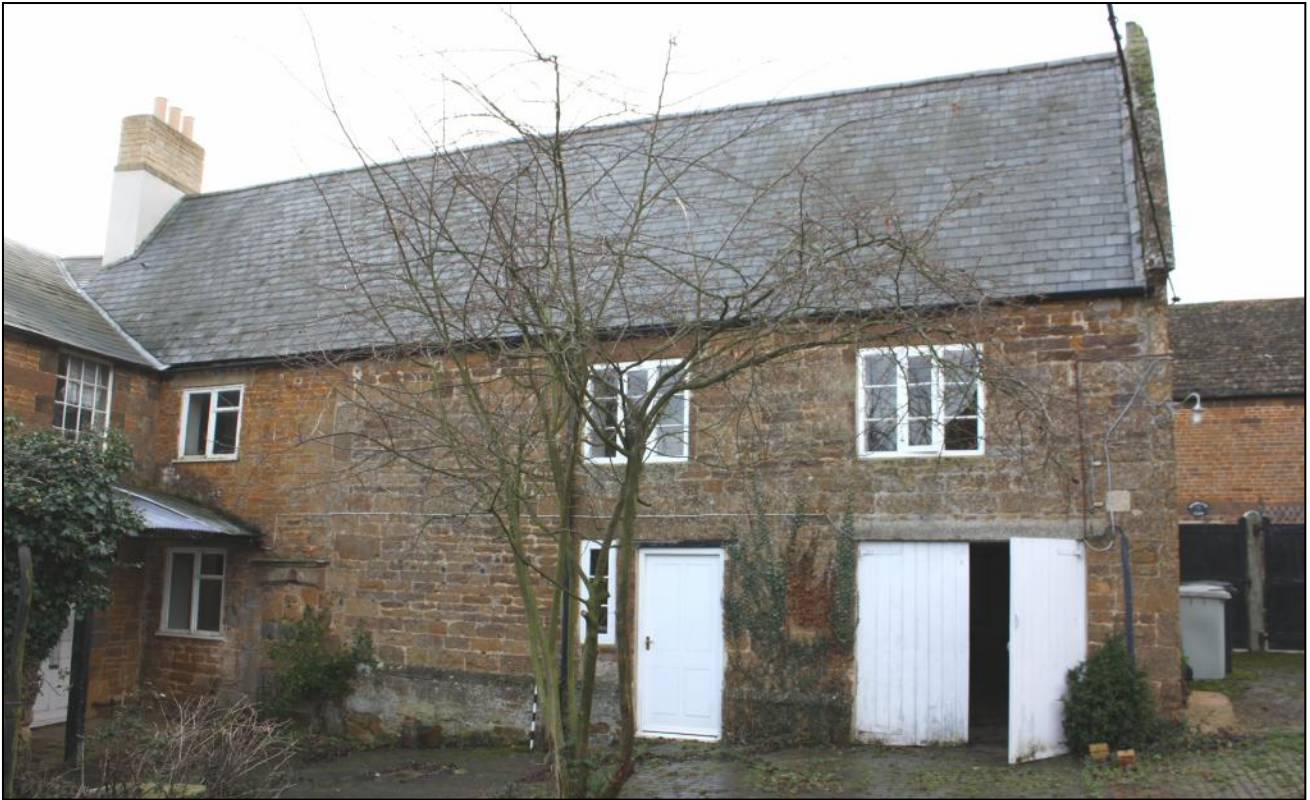
Plate 3: The east, rear frontage of the earlier part of Parkfield House, Belton-in-Rutland.

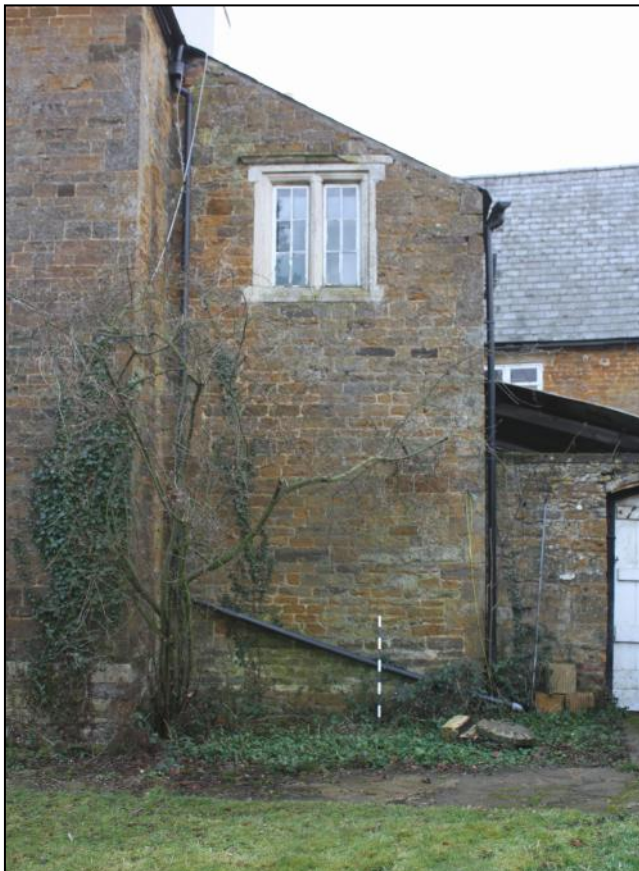
Plate 4: East side view of the lower service part of the Phase 3 wing, here showing a reused mullioned window.

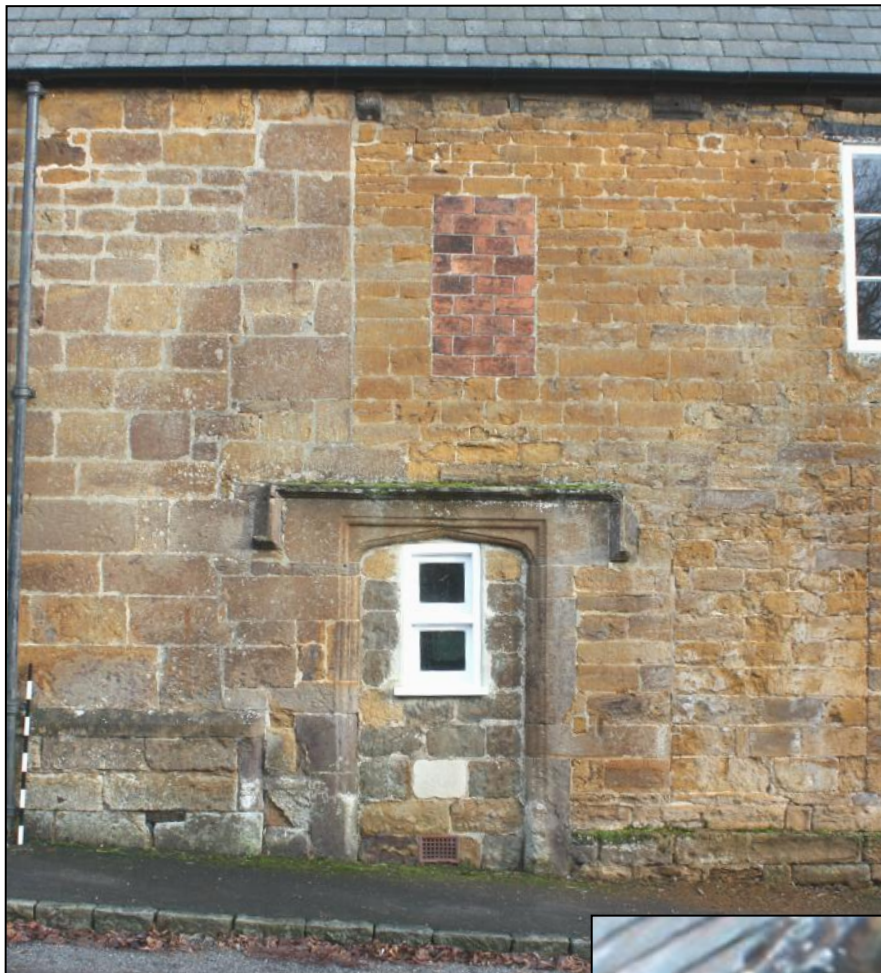
Plate 6: Infilled 17th century moulded doorway, stone plinths and straight joint above doorway on Nether Street frontage.

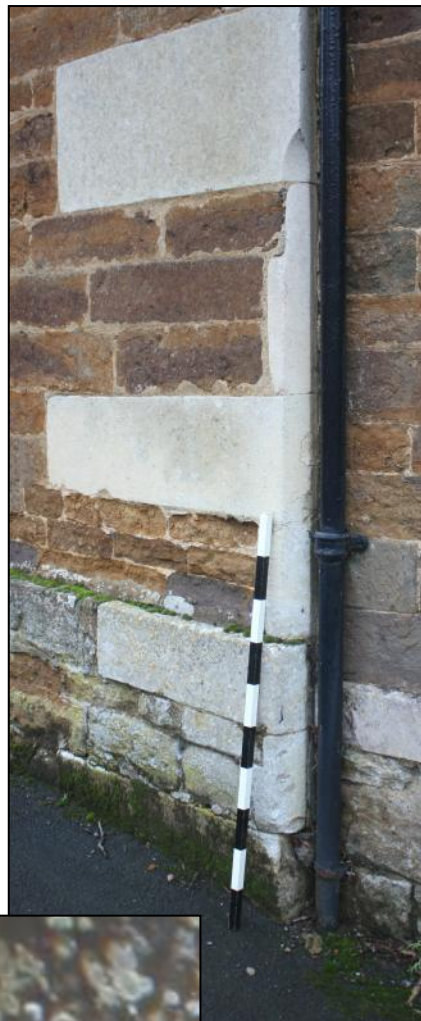
▲ Plate 8: Angled edge to arris and long and short quoins showing on the Nether Street frontage.

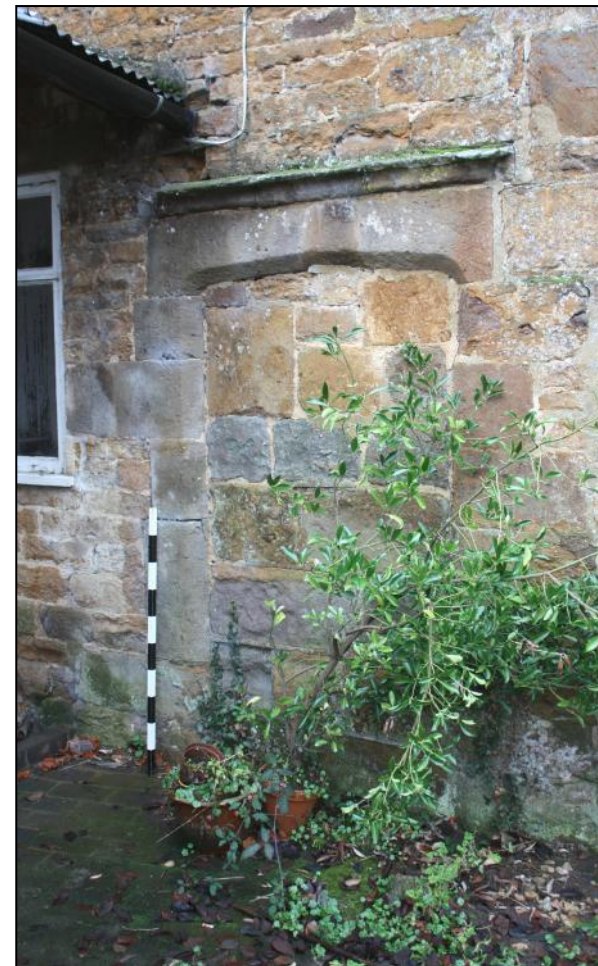
Plate 7: East side doorway to the through-passageway in the older part of Parkfield House.

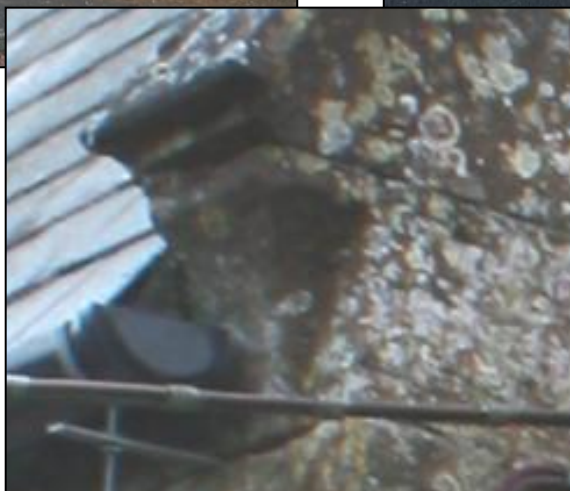
Plate 9: One of the two moulded kneeler stones at the north gable end.

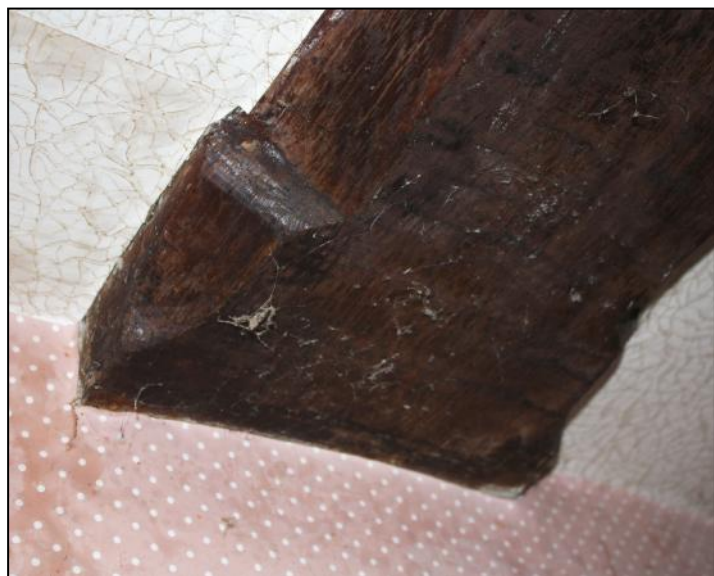
On the floor above the through passageway there was a small boxroom and the start of a new staircase up to the attic. This new phase created a three cell farmhouse, much in the style of the times and a plan shown in Figure 13. A cross-beam in the new bedroom has a heavy chamfer stop and notch of a type usually found in the late 17<sup>th</sup>-early 18<sup>th</sup> century (Plate 14).

Plate 14: Decorative chamfer stops on a ceiling beam in Bedroom 4.

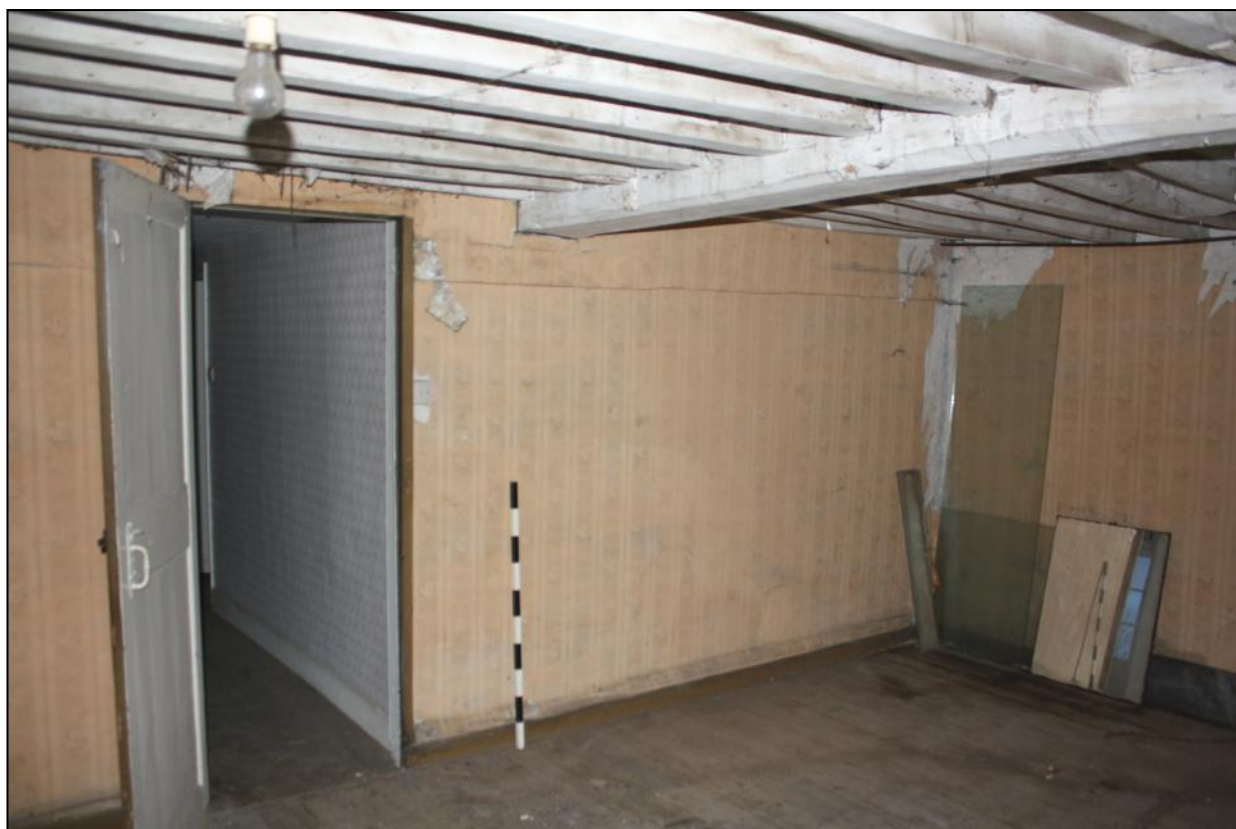
Plate 15: Timberwork in the ceiling and walling and a 2-panelled door in Bedroom 6.

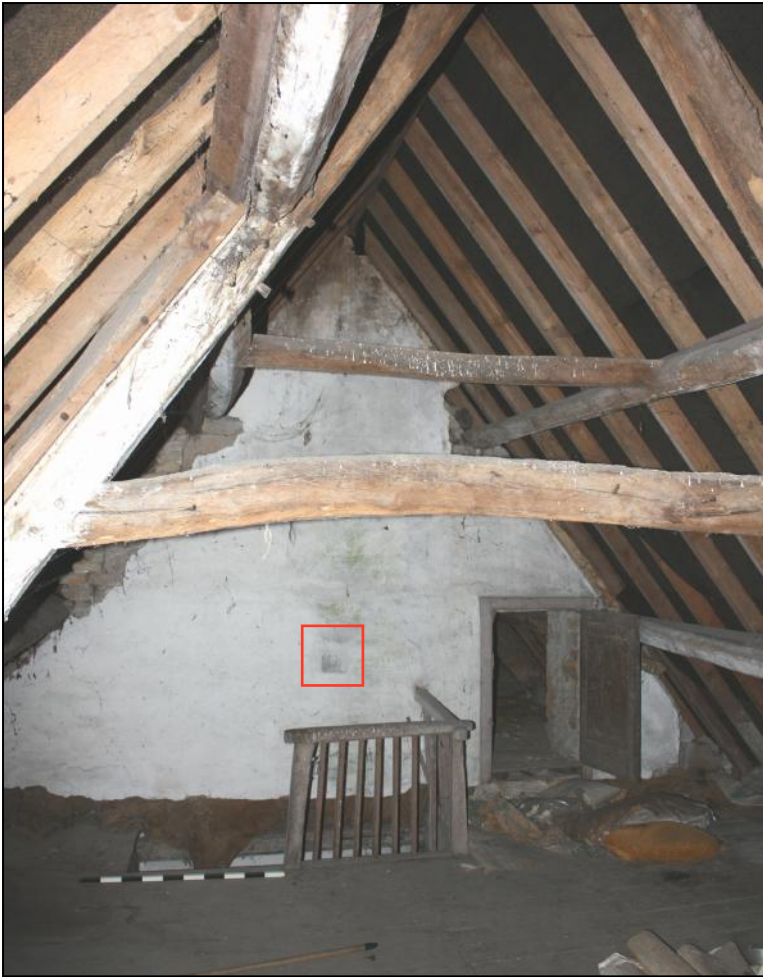
Plate 16: View inside Attic 1 looking towards the north wall with staircase and, highlighted, a timber showing in the walling, possibly a former ridge-plate.

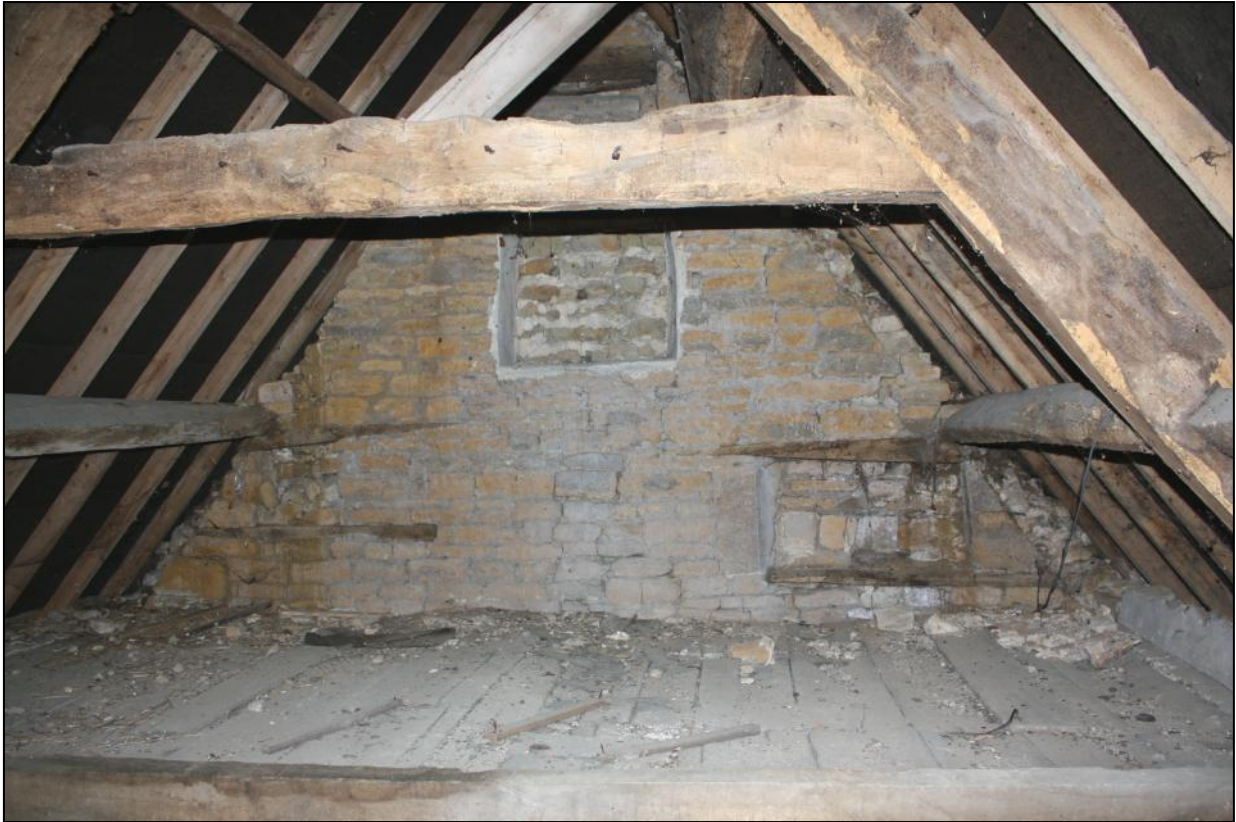
Plate 19: View towards north end gable wall in Attic 2 showing infilled garret window and two low cupboards.

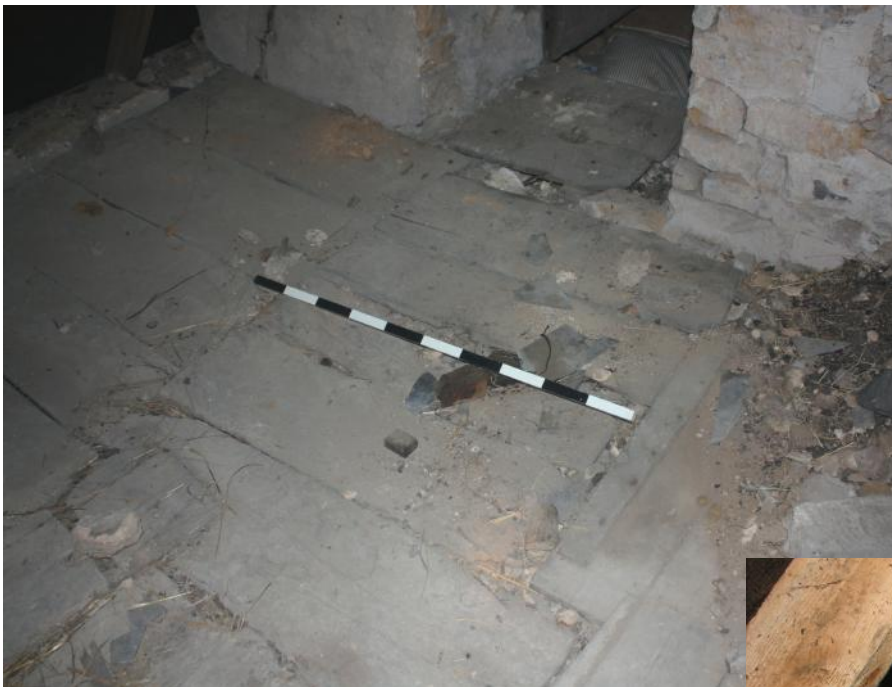
Plate 20: Possible former position of original stair(case) access into Attic 2 showing in floor near present entrance.

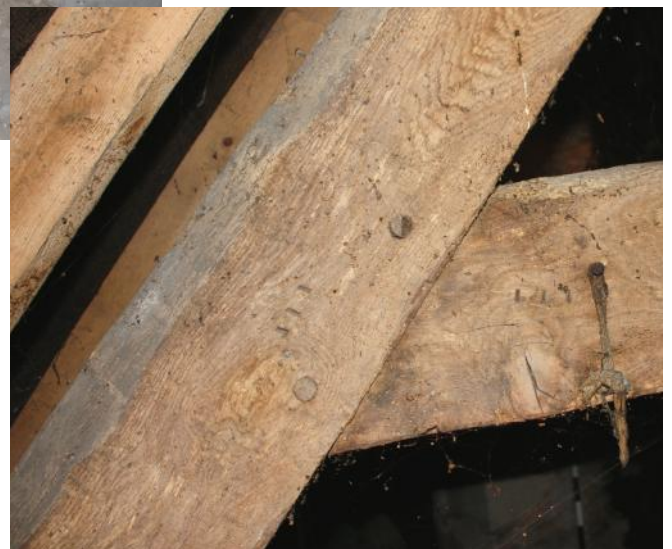
The attic space to the north part is three bays long with two simple original trusses with a tie beam and collar above. On the inner facing side of each truss there is a sequence I, II, III of matching carpenters' marks (Fig. 7, Plate 21), the positioning of each digit differing on either truss. The north end wall has a blocked high garret window and two low cupboards (Plate 19). The wide boards on the floor are laid in an irregular pattern and some have been disturbed where underlying joists have been replaced. Whilst the trusses are probably original the rafters are probably all replacements, dating from when the roof was changed from thatch to slates. There is no obvious evidence on the trusses or purlins for fire damage from the disastrous fire of 1776 that destroyed 27 houses in the village.

Plate 21: Matching carpenters' marks III showing on truss 2 in Attic 2.

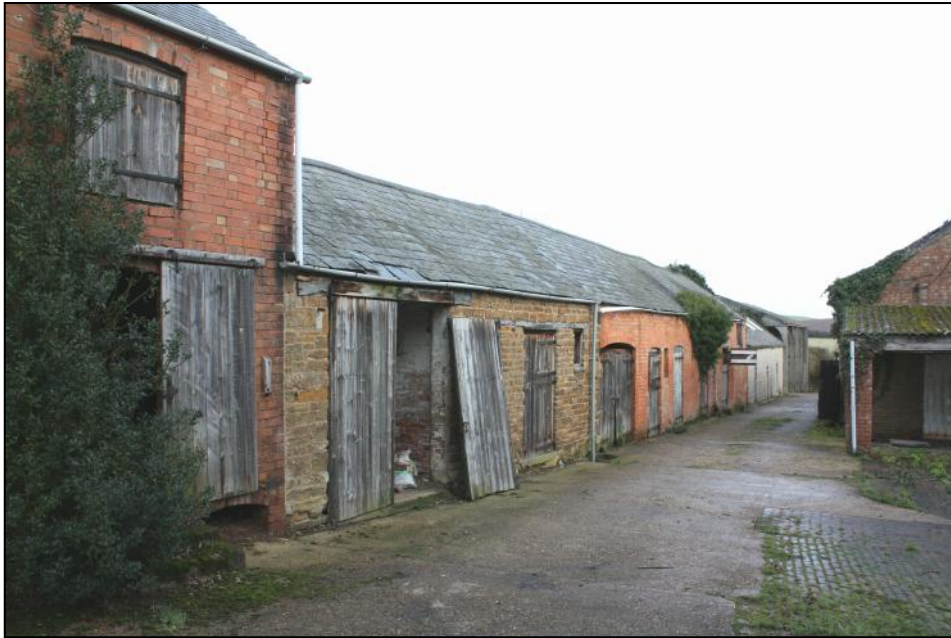
On the north side of the house there are two parallel ranges of outbuildings, built from an eclectic mixture of stone, brick and breeze-block and dating from the 19<sup>th</sup>-20<sup>th</sup> century period (Plates 33, 34). Most of these relate to the use of the accompanying land mainly as pasture for cattle, and the structures include use for sheltering animals, milking and dairying and latterly for their slaughter. Most of the structures within the south range are relatively modern and have replaced earlier buildings as stone and brick walling remains as a boundary to the garden (Plate 35). There is also a clear lower terrace in the garden with the hint from differences in the grass that another building may have stood here once (Plate 36).

Plate 33: North row of brick and stone-built outhouses / farm buildings.

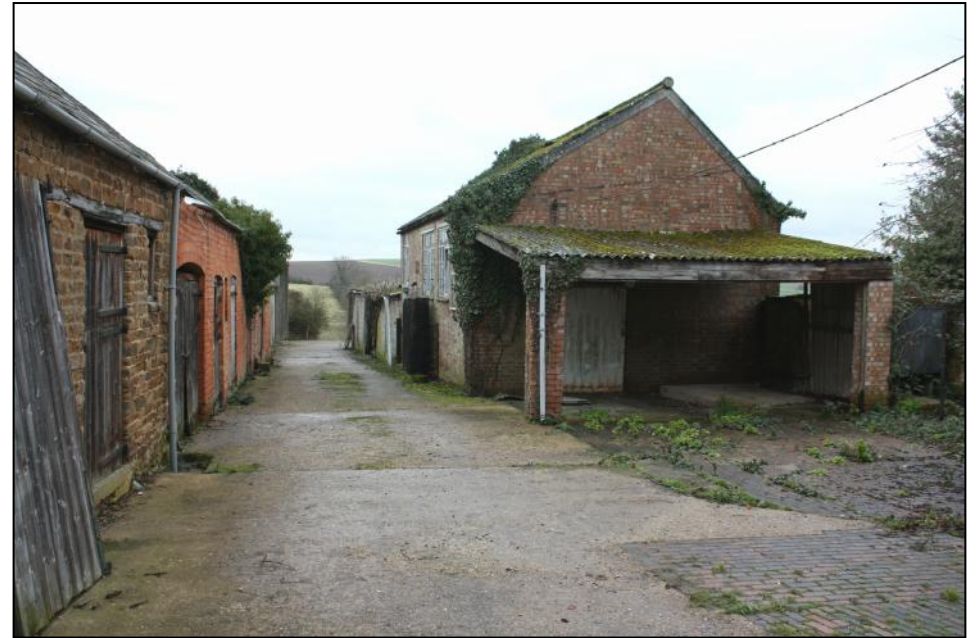
Plate 34: North and south rows of outhouses / farm buildings.

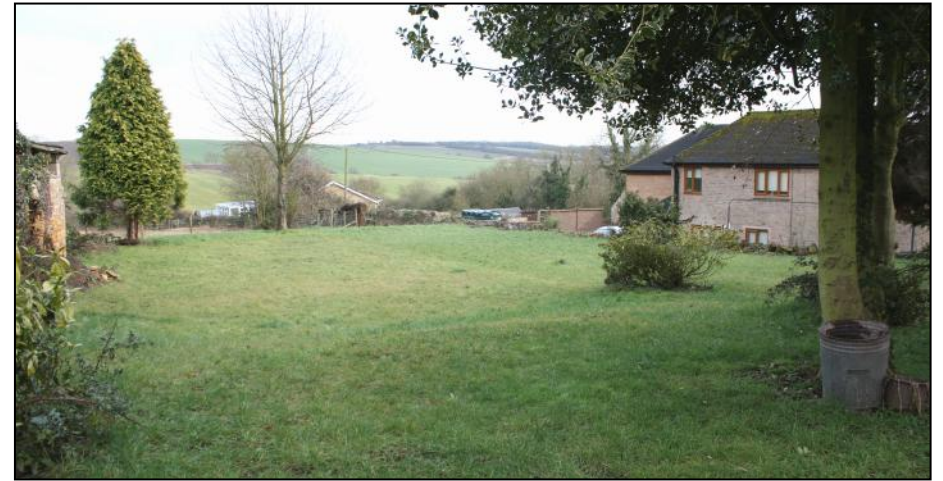
Plate 36: Lower terrace to the garden with the possible outline of a former building.

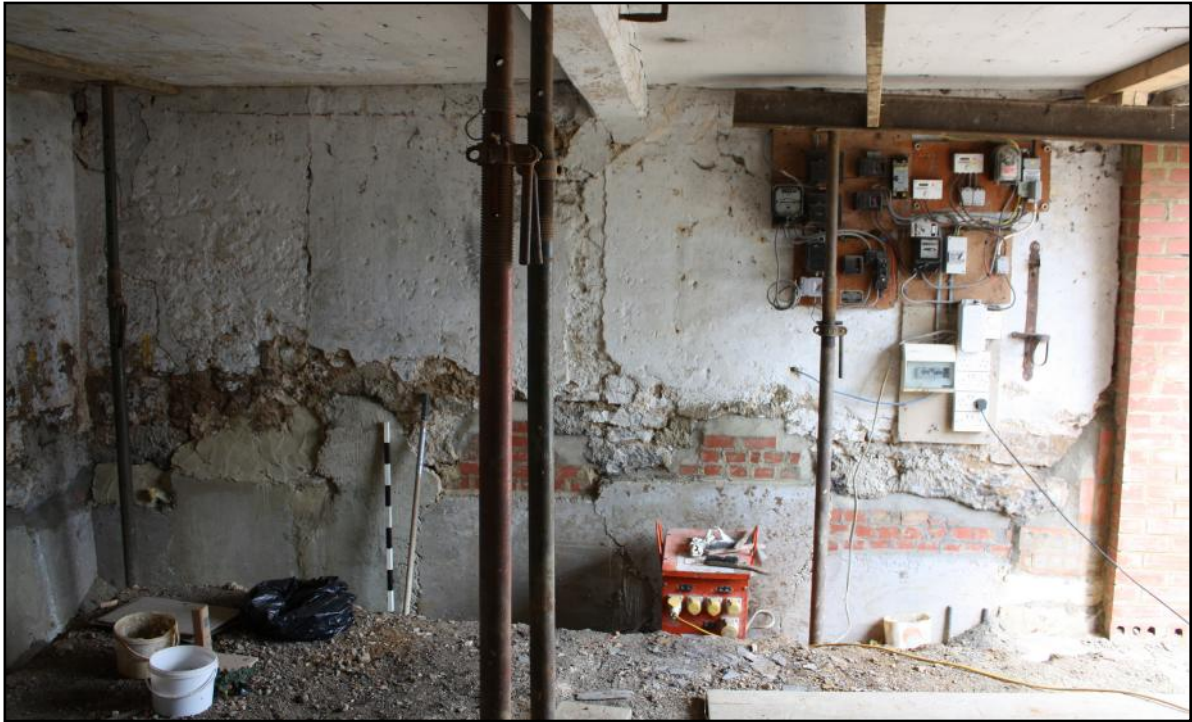
The north end wall was drilled through in a number of spots and the lower walling was found, in places, to have an outer skin of wall-stones with soil held within (Plate 37). The contractors also cut through the dividing wall between the former garage and washroom in a central position and dug a 2m rectangular pit for a new support pillar. The wall was one brick thick and made up of bricks mostly 2¼ inches (57mm) thick and 9-9¼ ins (229-235mm) long. Where a doorway had been situated in this wall the infill was a mixture of old and 3 inch bricks. The wall supported two cross-beams that traversed the two rooms and which were juxtaposed over the wall; another beam ran the top of the east length of the wall (Plate 38).

Plate 37: North end wall seen from the interior with new brick patching where the walling had deteriorated and in places found to contain soil.

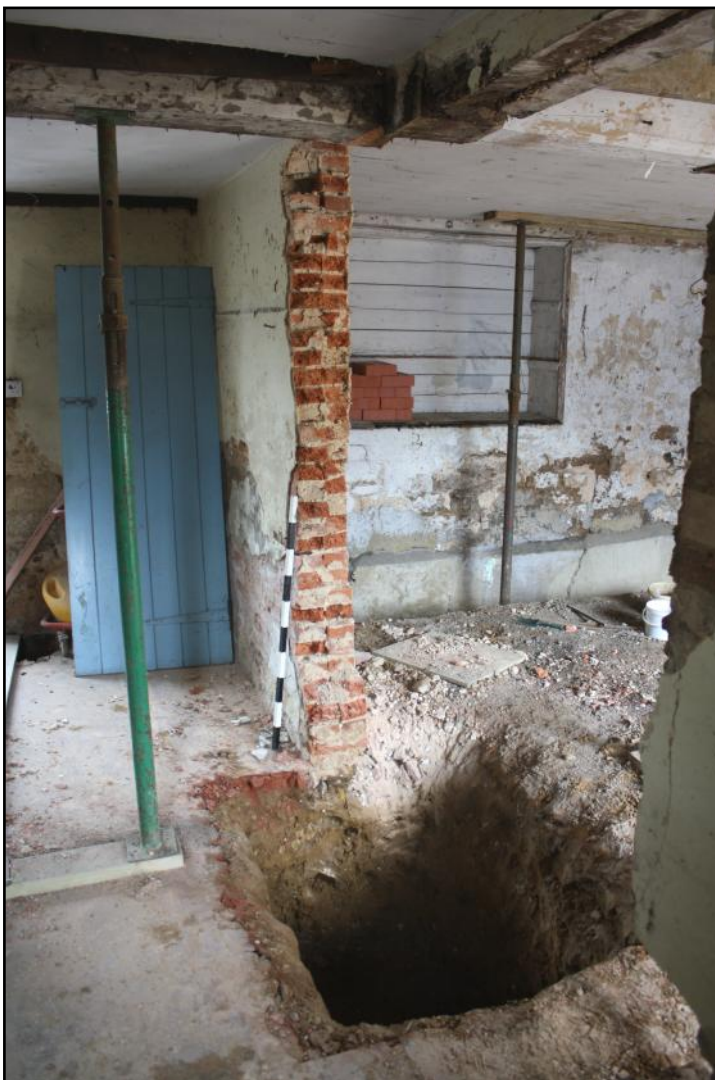
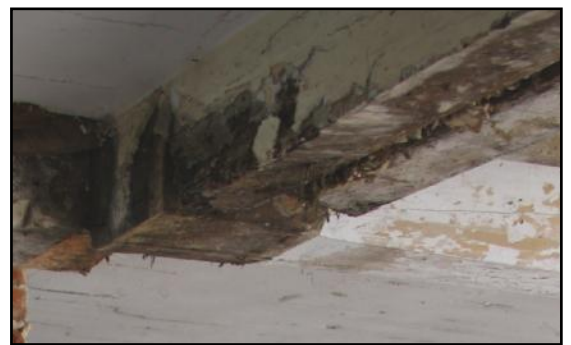
Plate 38: Brick internal dividing wall between former washroom and garage, showing adjoining ceiling beams (expanded in inset) and excavated base for new support pier.

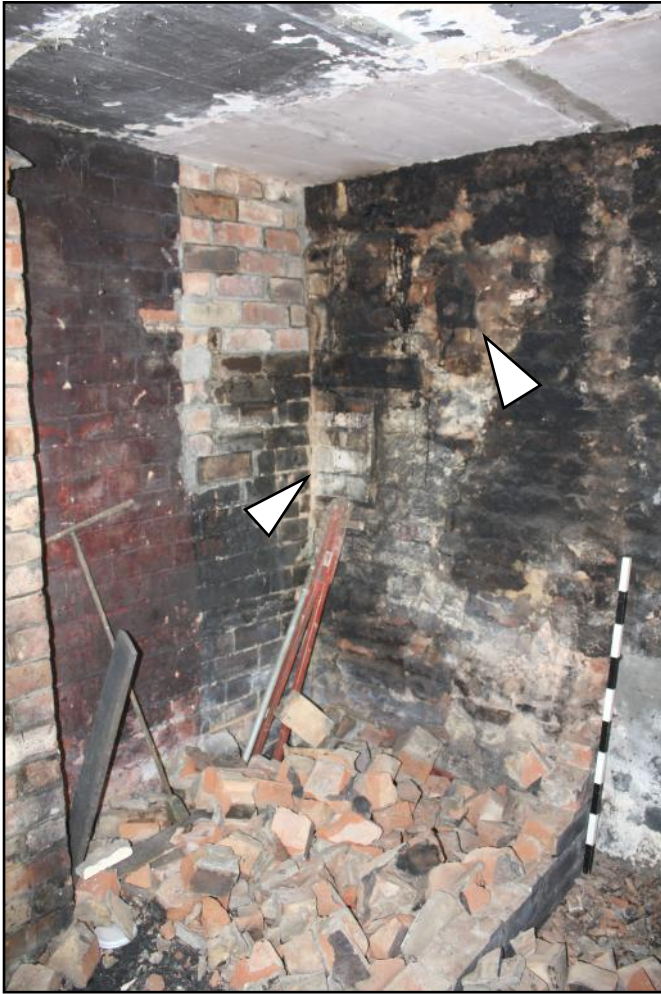
In the second room (the former washroom) a double-store-room was dismantled and a new doorway put through the back wall. This wall was well constructed and coursed on its south side and gave no direct structural indication of there having been a fireplace built into its north side. A dark stain showed where the

Plate 39: Removal of store doors and partitioning in former washroom revealing staining on the back wall from a former fireplace, an infilled cupboard and a wooden block (position highlighted by right arrow).

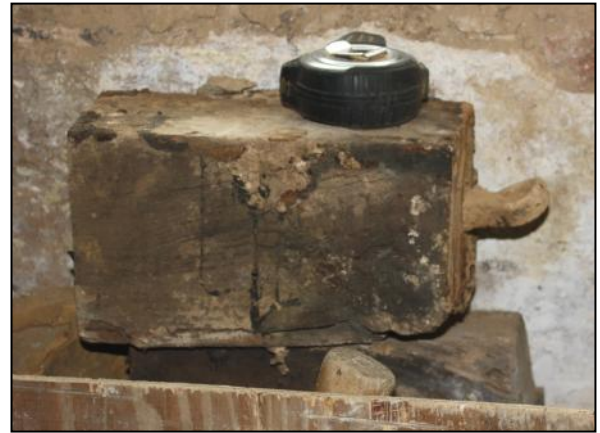
Plate 40: Wooden block removed from former fireplace walling prior to a new doorway being created.

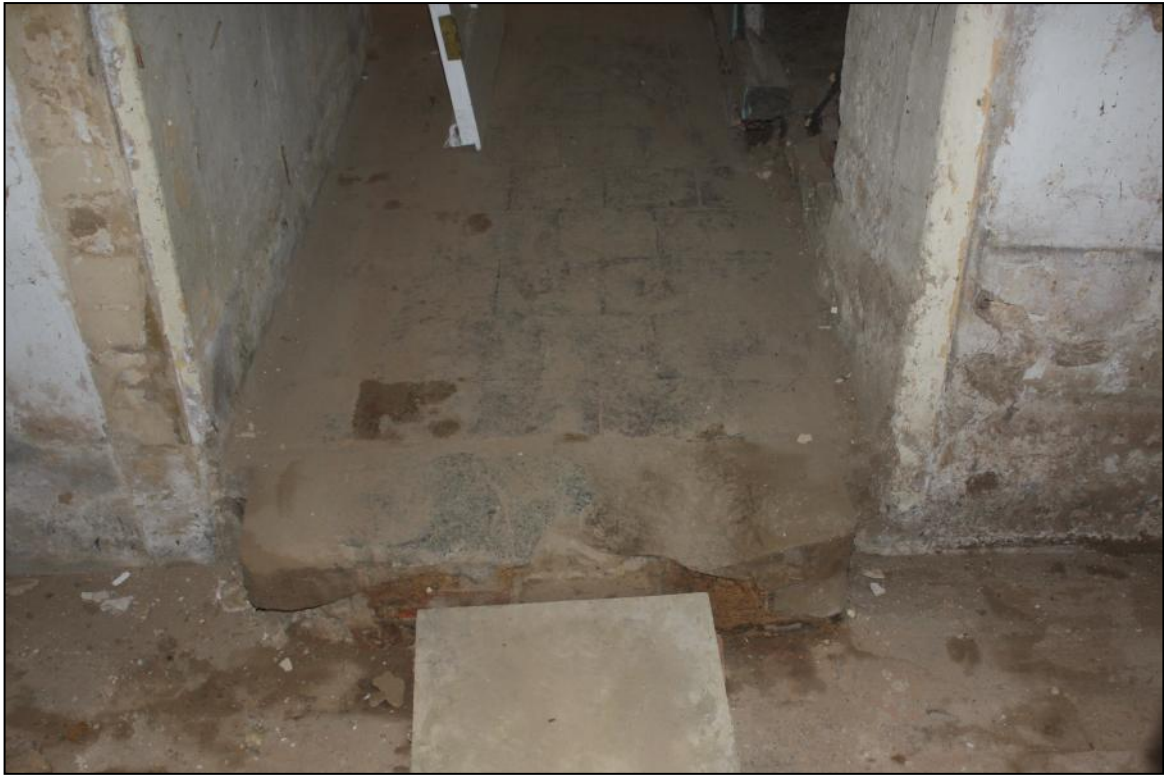
Plate 42: Possible threshold stone to what may have been an original south entrance into the Phase 2 building.

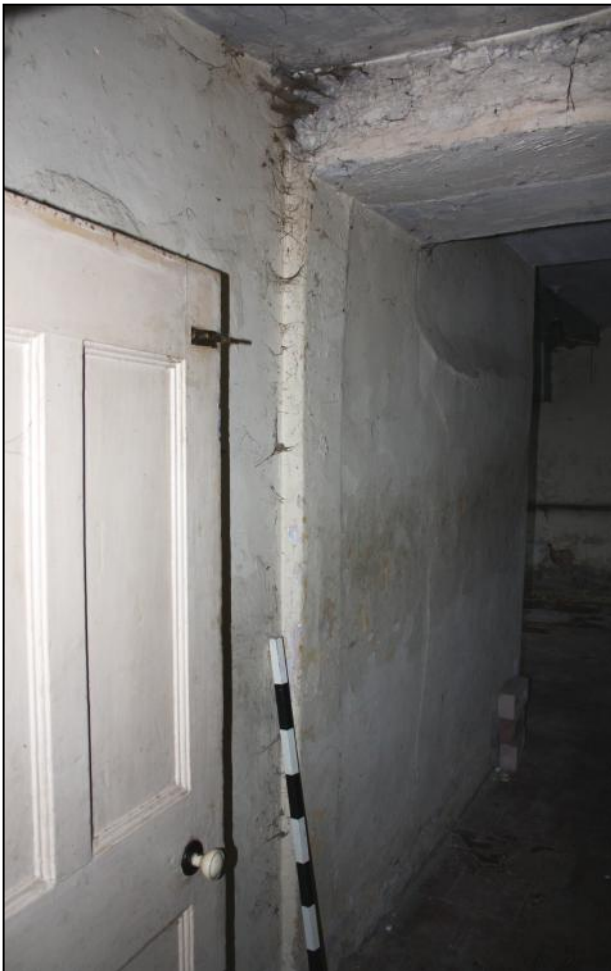
Plate 43: Timber post for doorway set into side walling above possible entrance threshold stone.

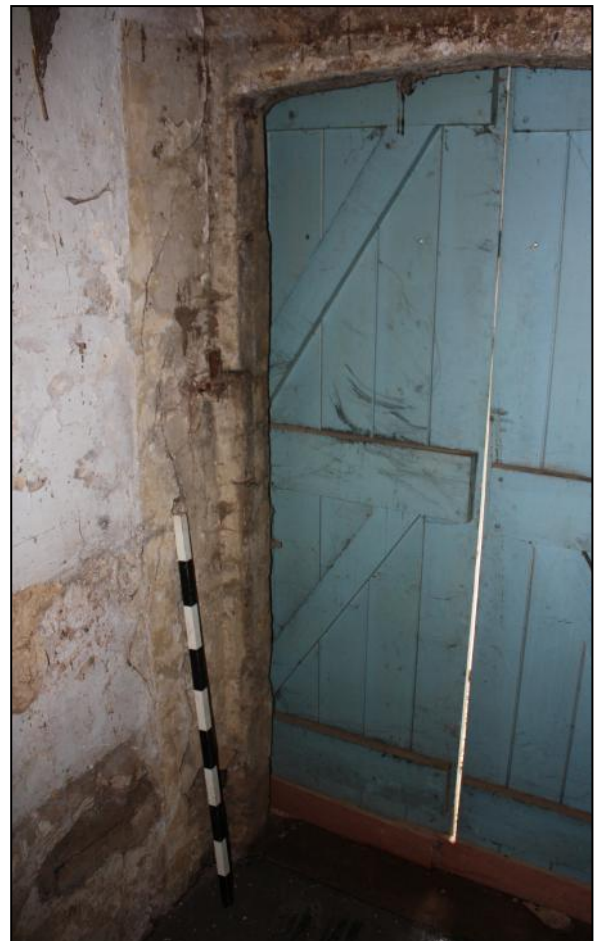
A thin partition wall forming the south side of the ground floor cross-passage included two entries into Room 3, the former kitchen. At either end the partition had been formed of vertical posts, fronted by horizontal slat covered by plaster. The middle length between the two entries had been replaced by brickwork when the west part had been divided off to form a pantry. The east entry was probably the position of the original kitchen entry. Opposite this was another entry to a short passage leading into Room 2. This featured a projecting and well worn threshold built of stone over bricks that fronted a raised tiled floor in Room 2 (Plate 42). What appeared to be slightly recessed timber jambs were set to either side of this entry, with stone and brickwork butting up behind them (Plate 43). No distinction between the stonework to the right of the entry and the east entry into the former passageway could be distinguished (Plate 44).

Plate 44: With infill removed from former east side entrance, no clear distinction showing between Phase 2 walling to left and Phase 3 entrance.

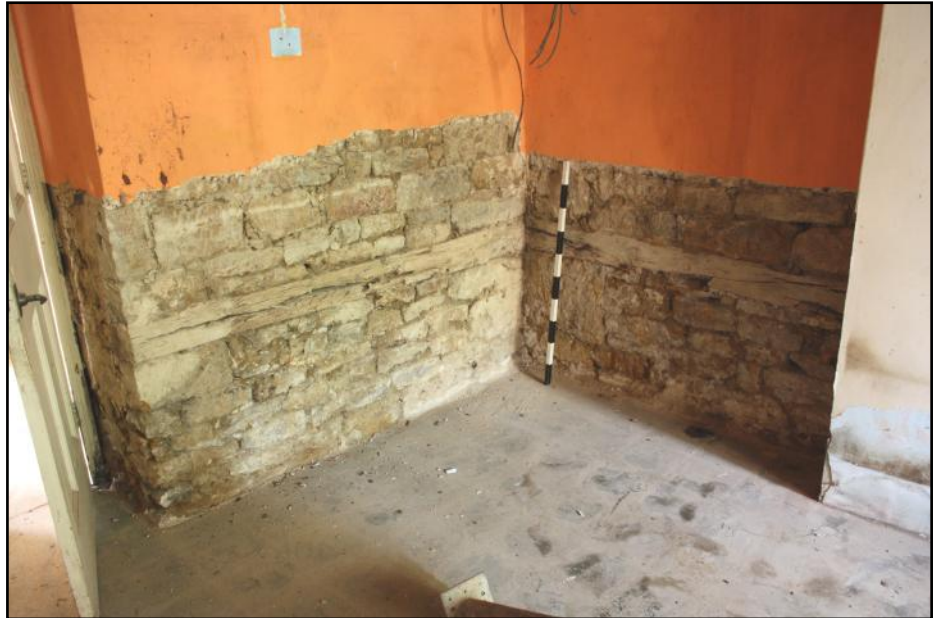
Horizontal timbers were found embedded in the lower walling in the south half of Room 3, the former kitchen (Plate 45). The blocking of a former window showed in the west wall with a low stone quoin also uncovered on its south side. A similar stone in the east wall next to the entry through to the south wing indicated that this too had probably been a window opening once. Ceiling joists ran north-south in this room and continued the full length of the room, suggesting that the building had extended to at least the furthest (south-west) corner before the walling was altered into an angled wall when the south wing was added. The joists' ends had tenons, angled at the top and with a right angle at the base, as typically found in 17<sup>th</sup> century construction. However, the timbers found in the lower walling would suggest some degree of inner refacing of the south ends of the existing side walls when the wing was added.

Plate 45: Timber plates showing in the south end walling of the Phase 3 former kitchen.

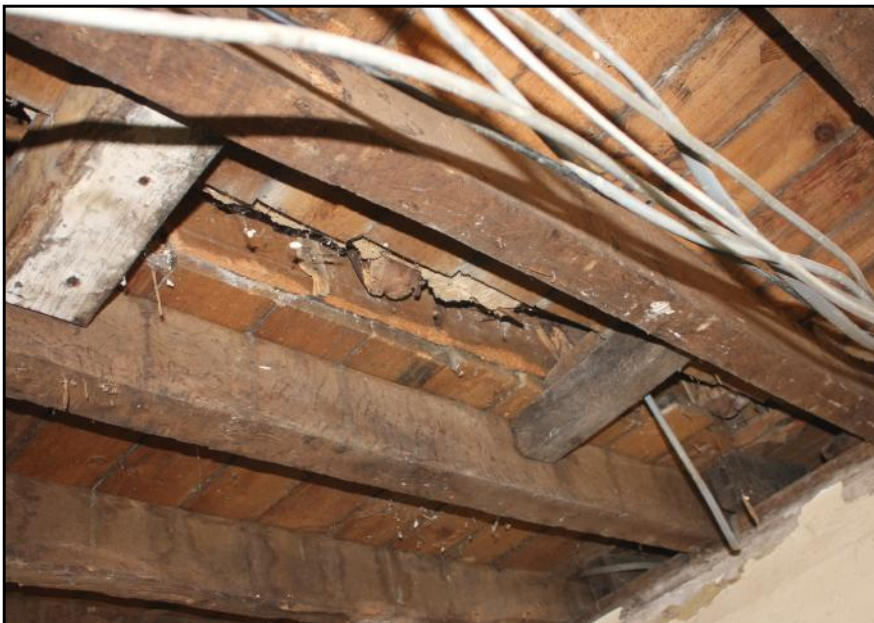
Plate 46: An irregular break between the floor planking showing where there is a first floor corridor partition above.

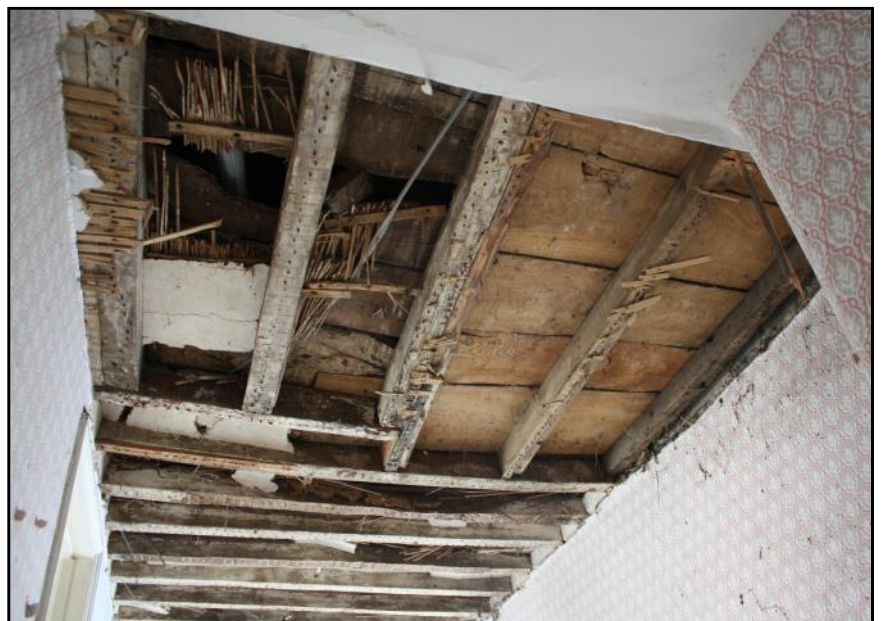
Plate 47: Change in direction of timber joists where a staircase may originally have risen to the garret of the Phase 2 building.

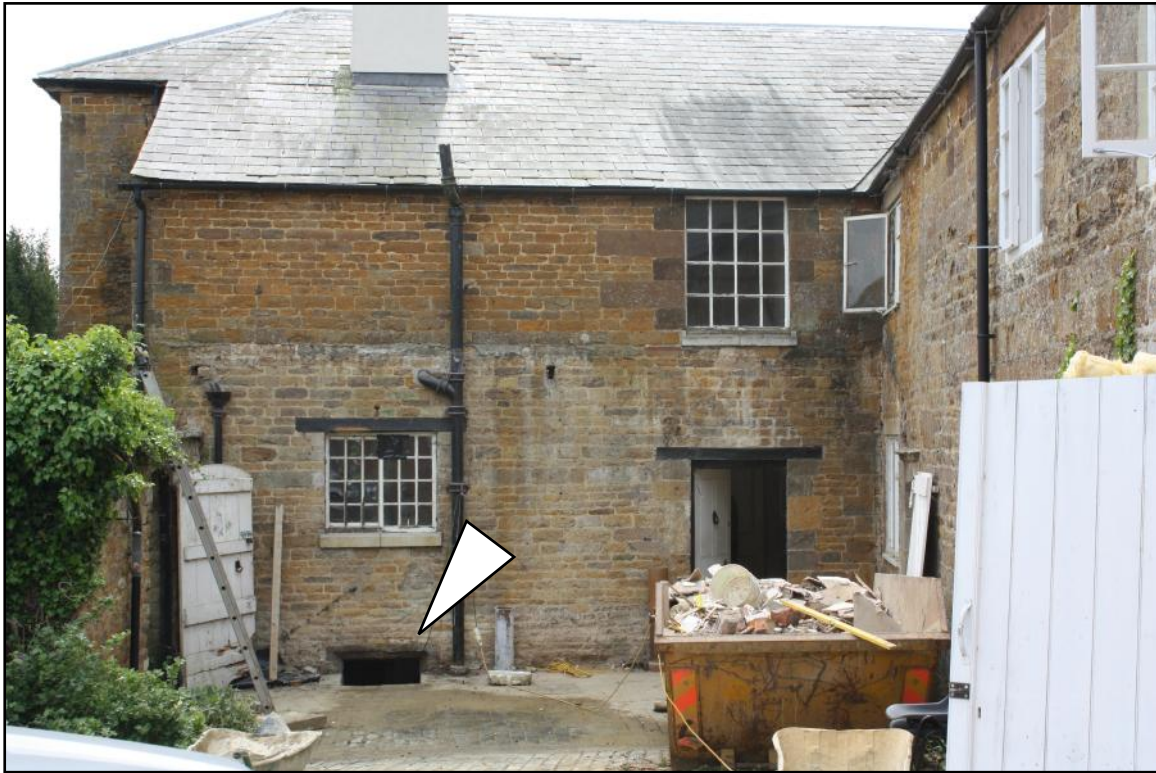
Plate 48: Back wall of the Phase 4 south wing service part, with former canopy removed and an arrow pointing to the position of a light-well to the cellar.

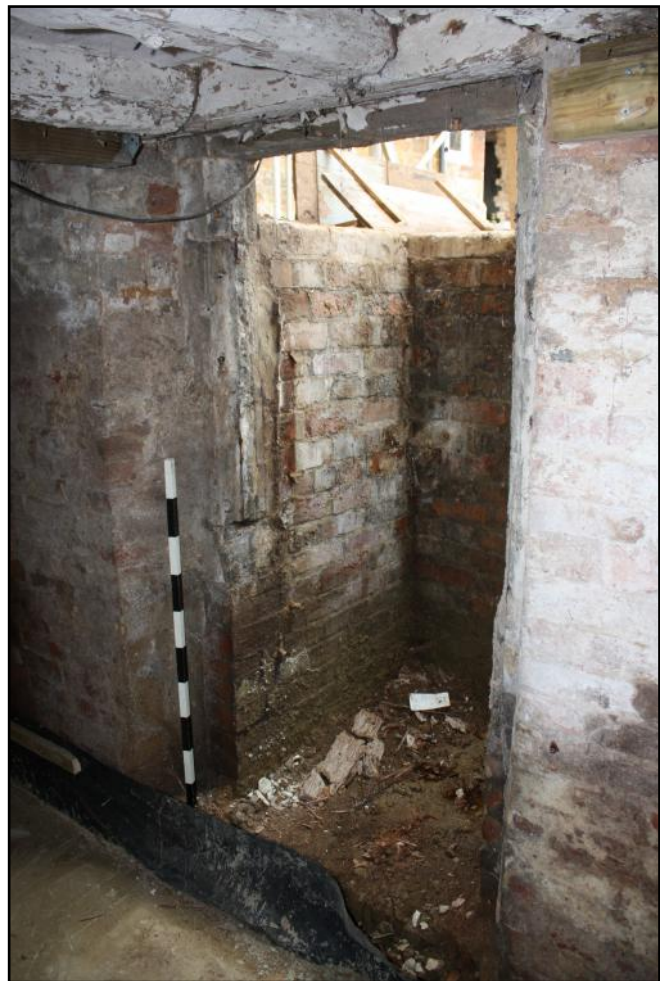
Plate 49: Light-well seen from inside the cellar, showing external brick surround and reused moulded stonework edging the window opening.

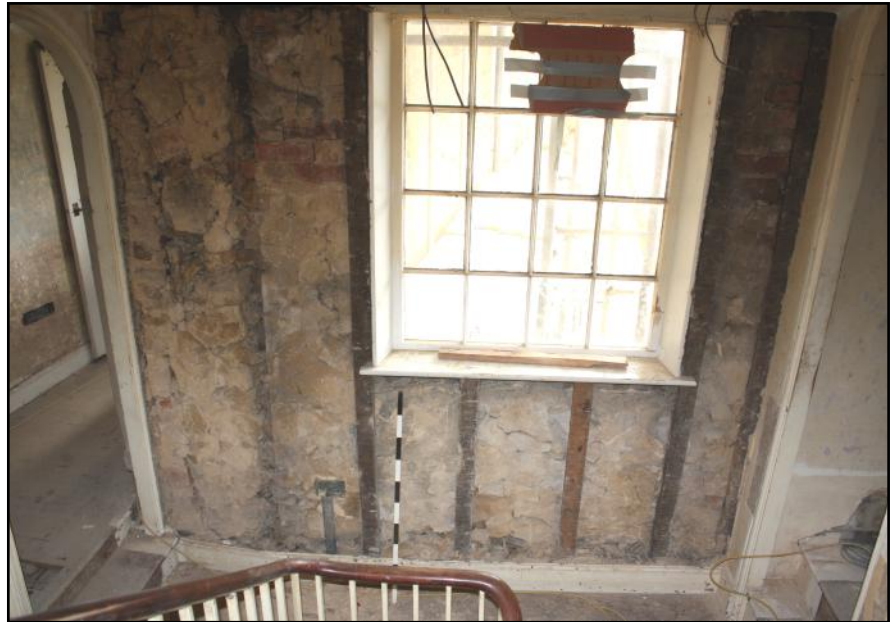
Plate 50: Exposed stone walling at the first floor back wall of the Phase 4 south wing service part showing rough stone finish and vertical studs for support of former plasterwork.

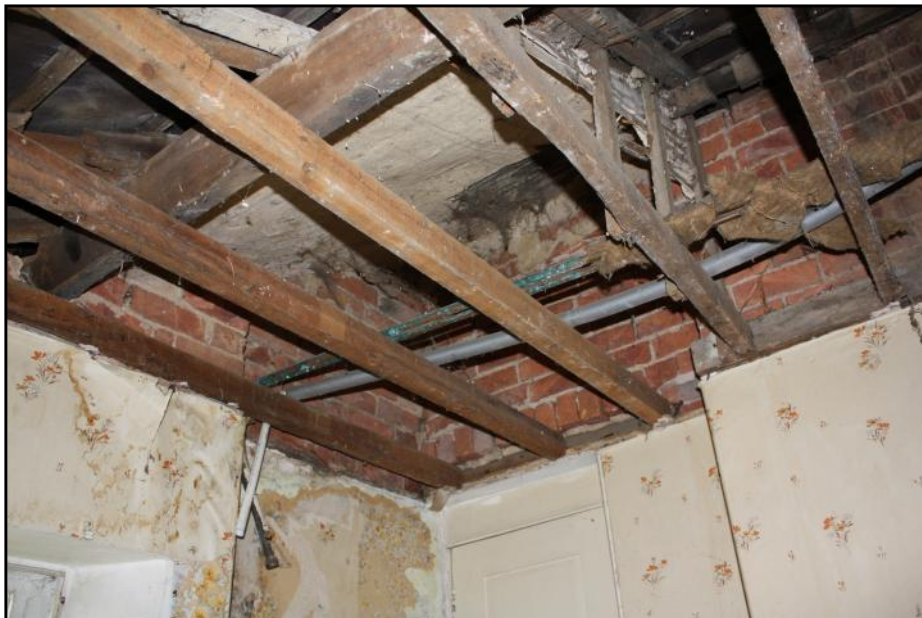
Plate 51: Internal brick walling showing in the Phase 4 south wing.

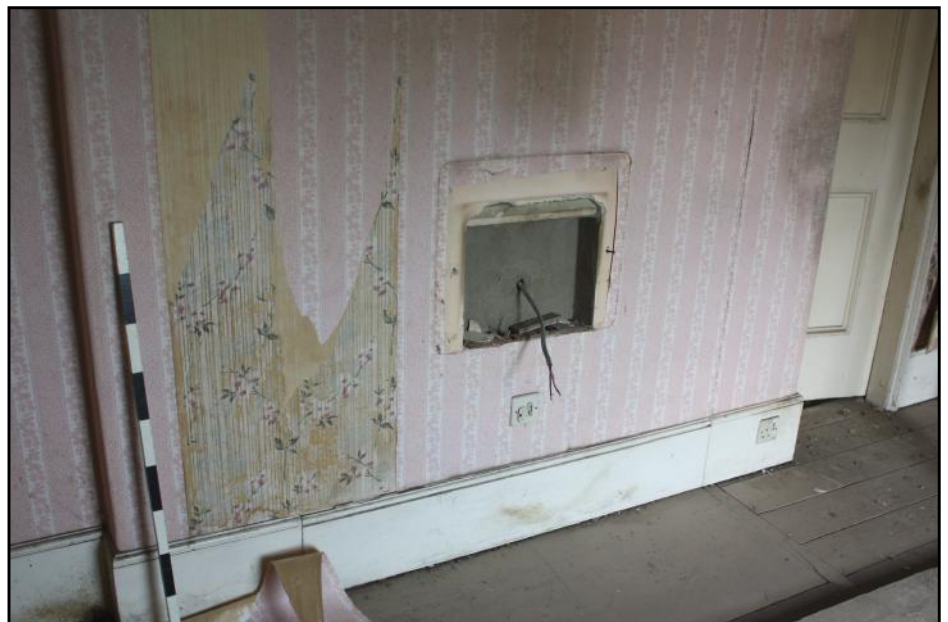
Plate 52: Possible surviving section of early 19th century wallpaper exposed in bedroom on first floor level of the Phase 4 south wing (to right of scale).
