COLDWELL STREET, WIRKSWORTH, DERBYSHIRE

A Report on an Archaeological Watching Brief

Project Code: CWI

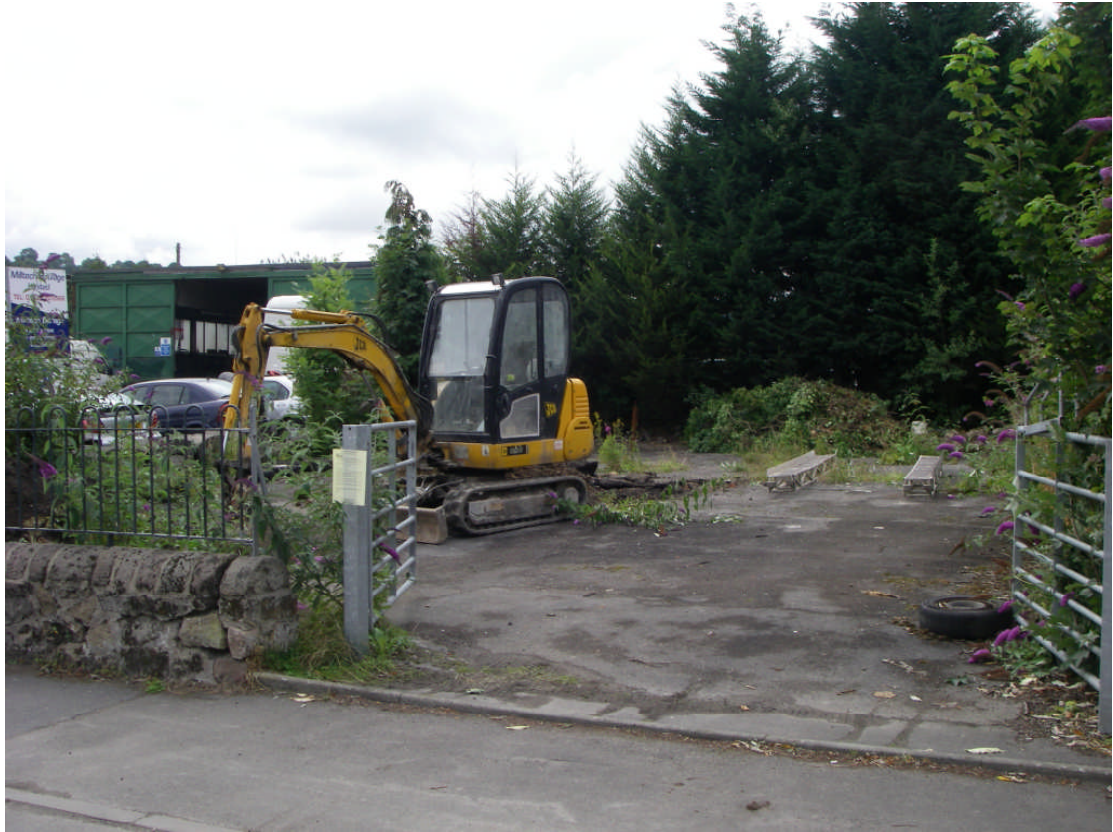
PLATE 1. Site prior to trial trenching. Looking south west.

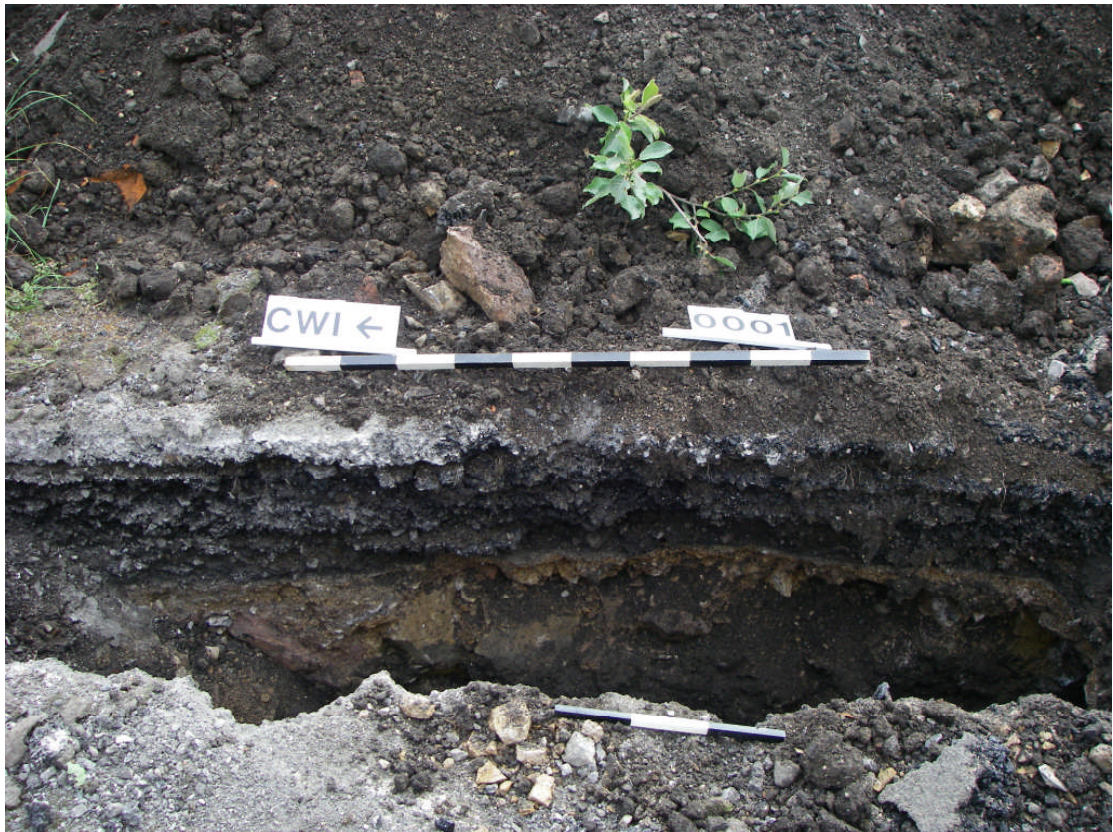
layers extending to the limits of excavation were recorded (Plate 2). The recorded stratigraphic sequence comprised:

PLATE 2. Area 01, west facing section. Looking east.

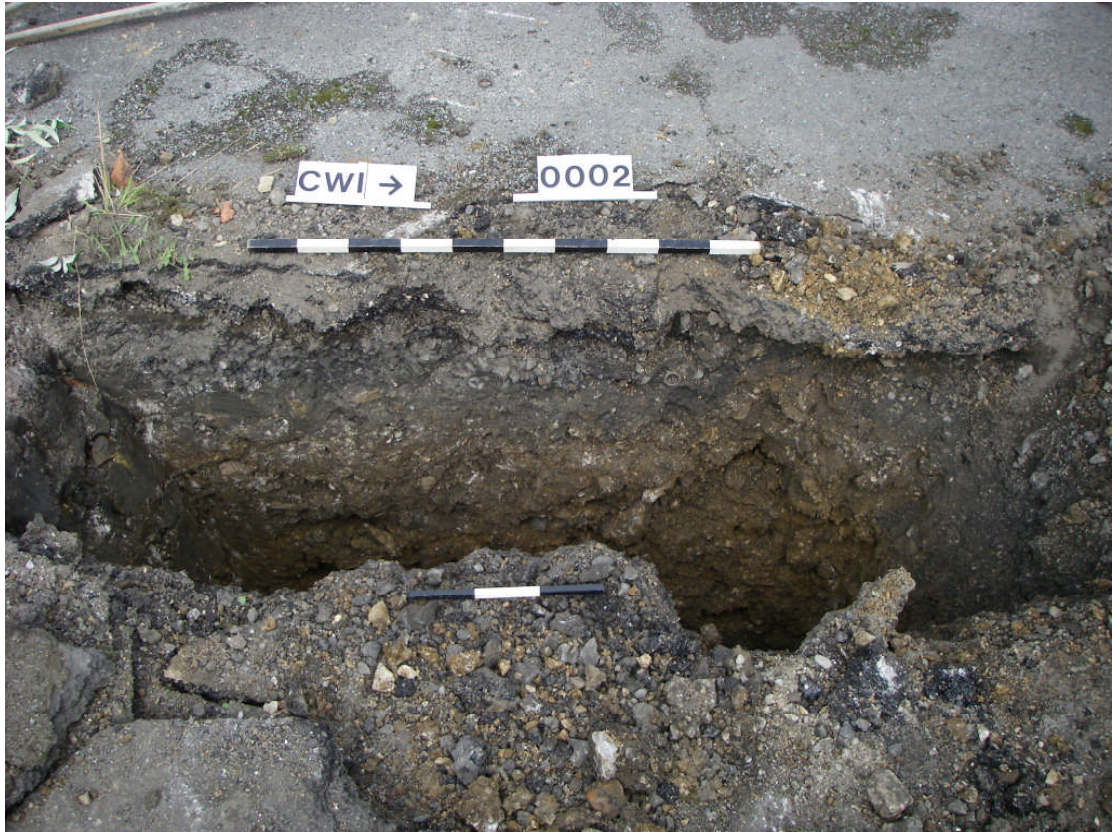
5.3 The middle trench in a line of three, aligned north-northeast by south-south-west was excavated. Following the removal of the tarmac surface, the trial trench was machine excavated to a depth of 1.9m (Plate 3). The recorded sequence was as follows:

PLATE 3. Area 02, east facing section. Looking west.

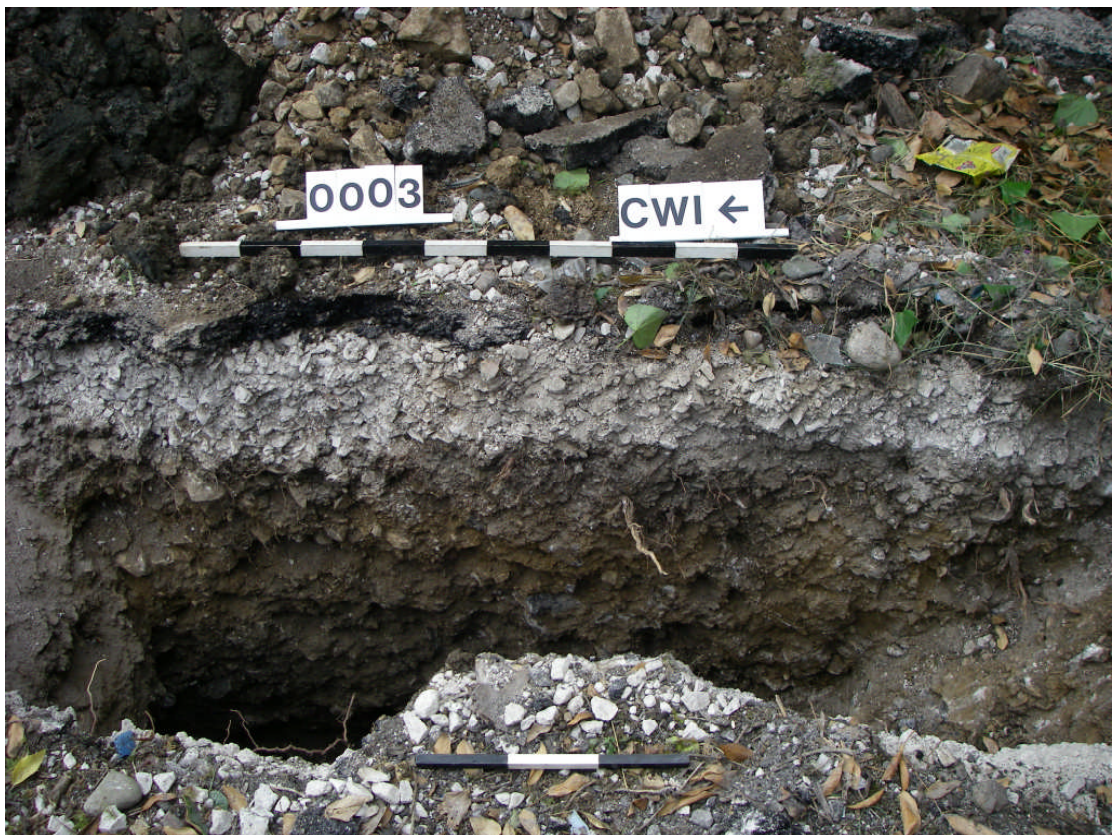
5.4 Trench 03, the most southerly of the trenches, aligned north-east by south-west, was excavated to a depth of 2.3m (Plate 4). Following removal of the tarmac surface, the trial trench was machine excavated to a depth of 2.3m. The recorded sequence was as follows:

PLATE 4. Area 03, west facing section. Looking east.

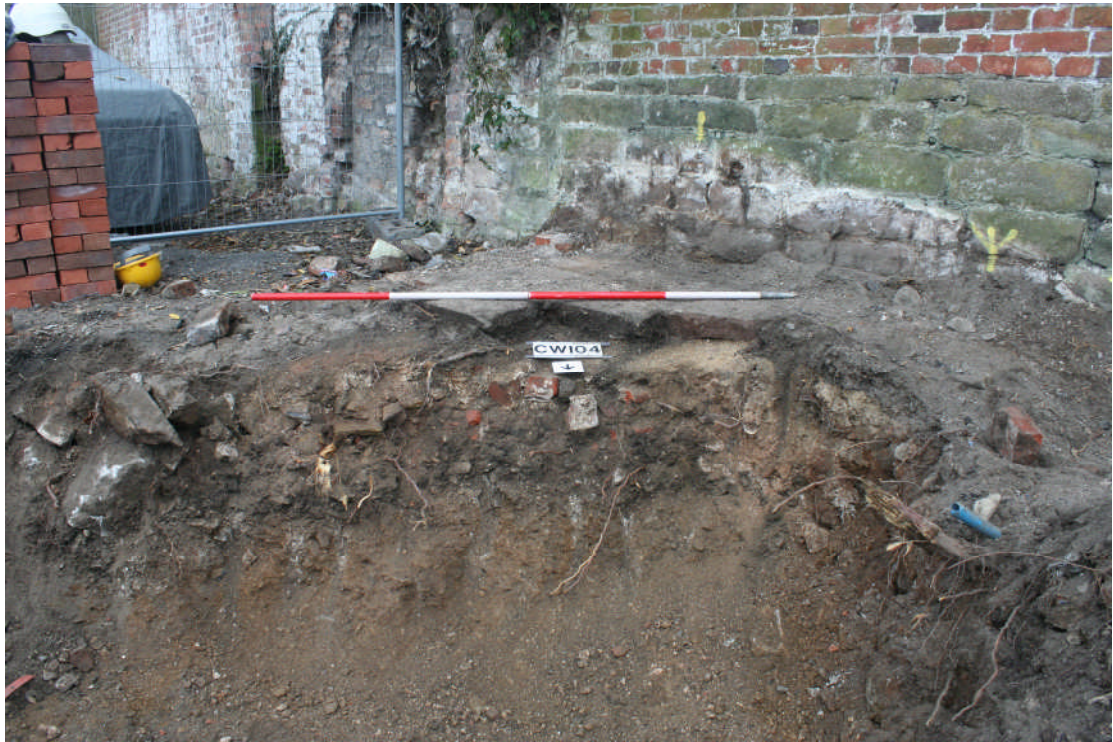
5.7 At the north-western end of the section a dump of large unworked angular stone blocks appeared to fill a shallow depression (0016), cut into the natural formation (Plate 8). On the surface of the topsoil layer (0013), immediately to the north west of 0016, the remains of a stone flagged surface were recorded, 0017 (Plate 5), which abutted the boundary wall. This was not disturbed during the ground works of the subsequent building.

PLATE 5. Flagged surface above north west end of Area 04. Looking south.

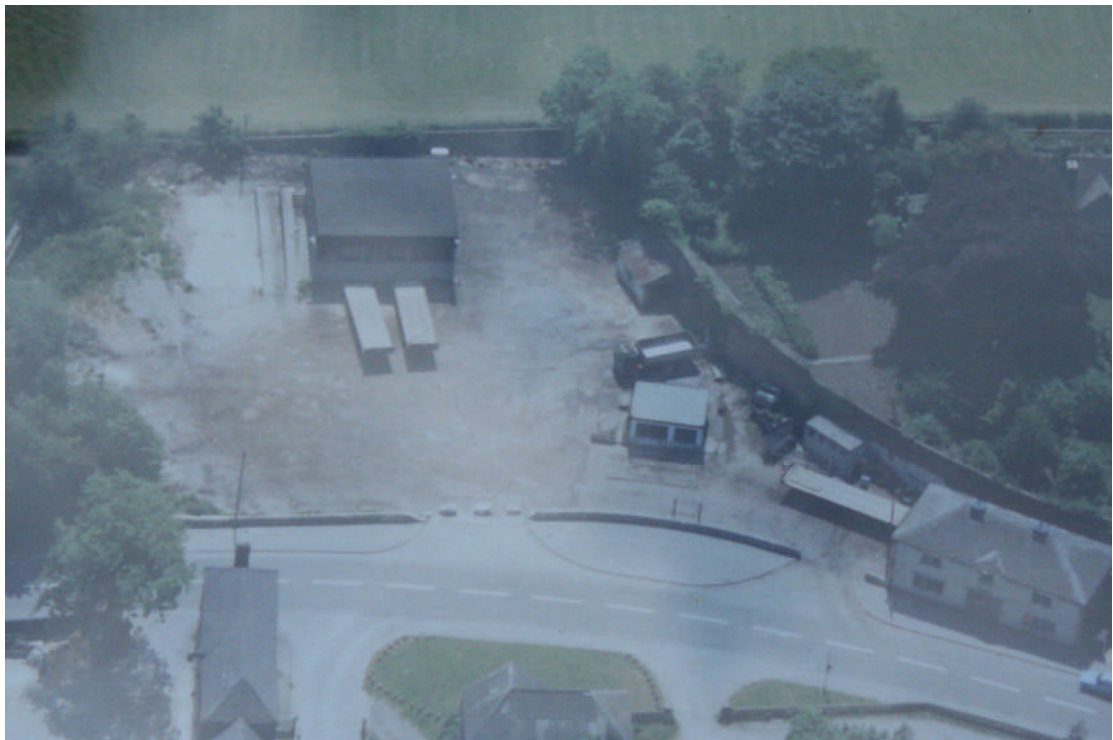
5.8 Layer 0014, comprising either a disturbed subsoil or made ground, extended across the site, occurring in sections recorded at the eastern limit of the site (Figure 7) and at the boundary of Areas 04 and 05 (Figure 9). The layer of topsoil (0013) recorded in section at the south-west edge of the site (Figure 6), did not extend in to Area 04 and is believed to be the vestigial remains of an earth bank that supported a line of small shrubs that marked an earlier boundary between the petrol filling station and the adjacent HGV park and garage. This had been removed as part of the vegetation clearance before the commencement of the watching brief. Its recent origin is supported by the ariel photographs one of which show an HGV vehicle parked where the bank would have been (Plate 6).

PLATE 6. Ariel photograph of site taken in c.1960 with HGV parked on the south west end of the site. Looking south.

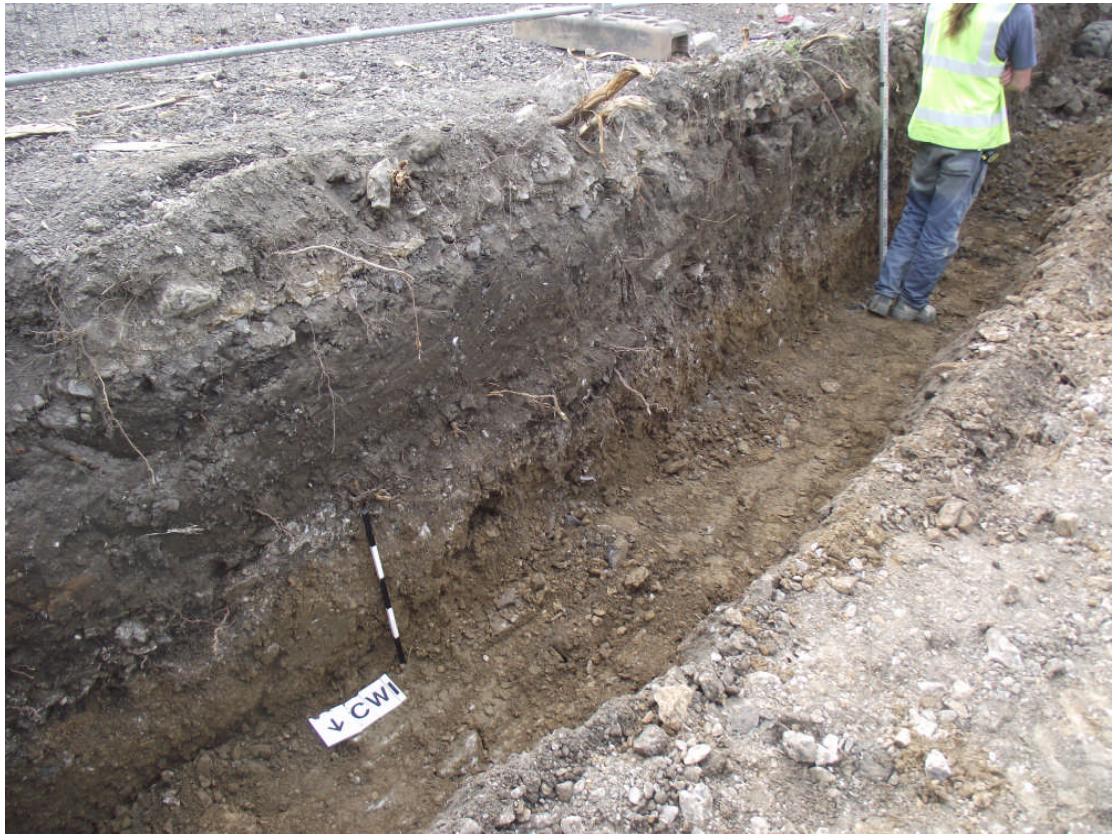
5.6 Positioned at the south-west end of the site, the whole of Area 04 was reduced by 1.20m using a tracked mini-digger. A section through the overburden at the south-west limit of the excavation was hand cleaned and recorded by photography and by scale drawing (Figure 6). This revealed a relatively simple stratigraphic sequence; below top soil (0013) a layer of possible made ground (0014) directly overlay natural deposits of clay (0015). At the eastern edge of the site no topsoil survived in section and layer 0014 was overlain by a graded aggregate topped by a tarmac surface (Figure 7). The following deposits were recorded:

PLATE 7. North east facing section of Area 04. Looking south west.

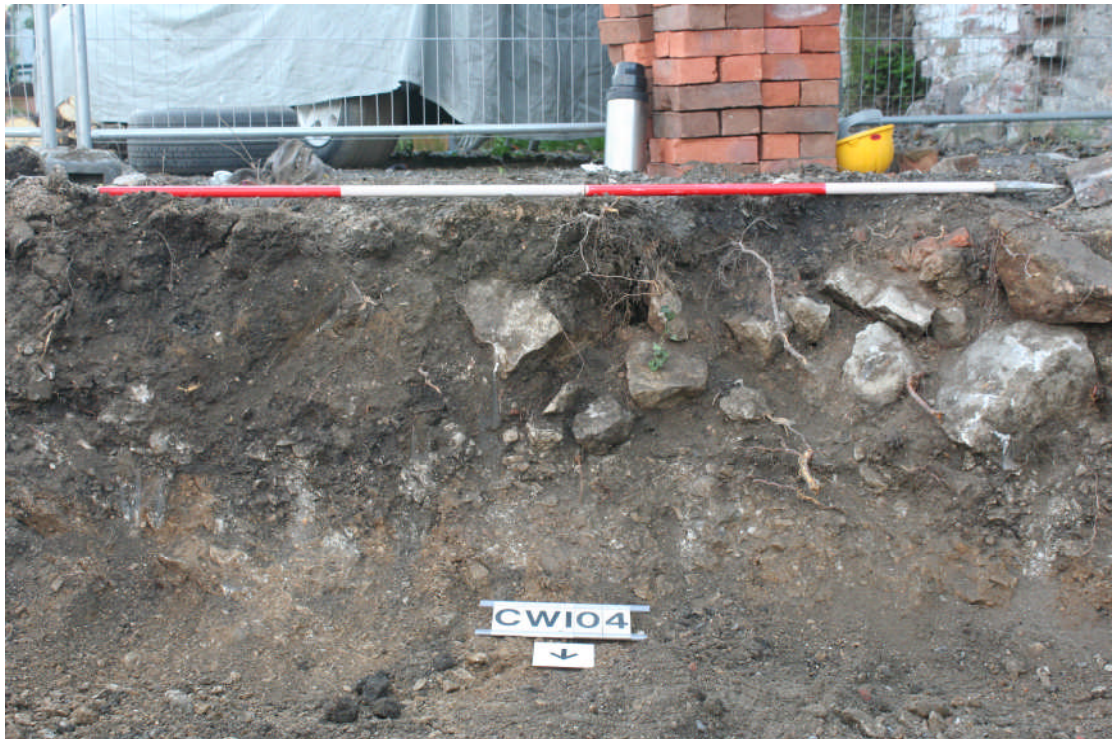
PLATE 8. 0016 looking south.

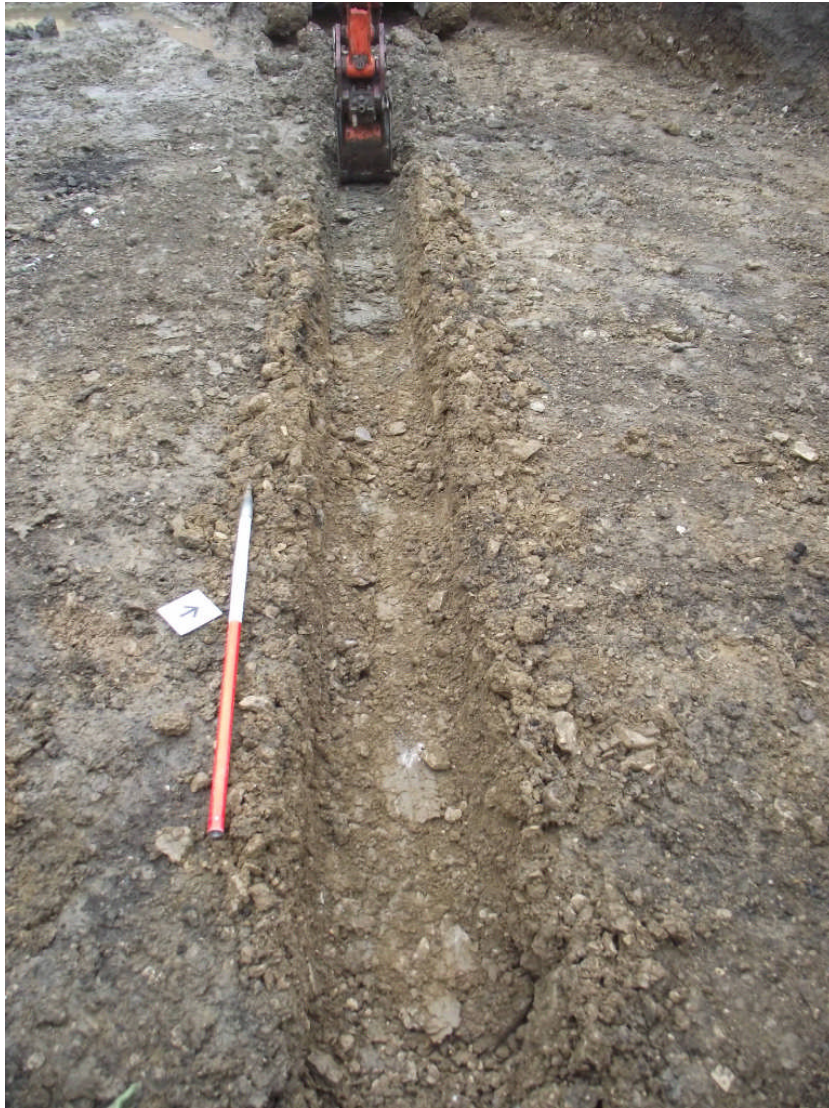
5.10 Four service trenches were cut into the base of the excavated area, 300mm wide to a depth of only 100mm. These did not penetrate below the base of the natural clay layer (0015) (Plate 9).

PLATE 9. Service trench cut into base of Area 04. Looking north west.

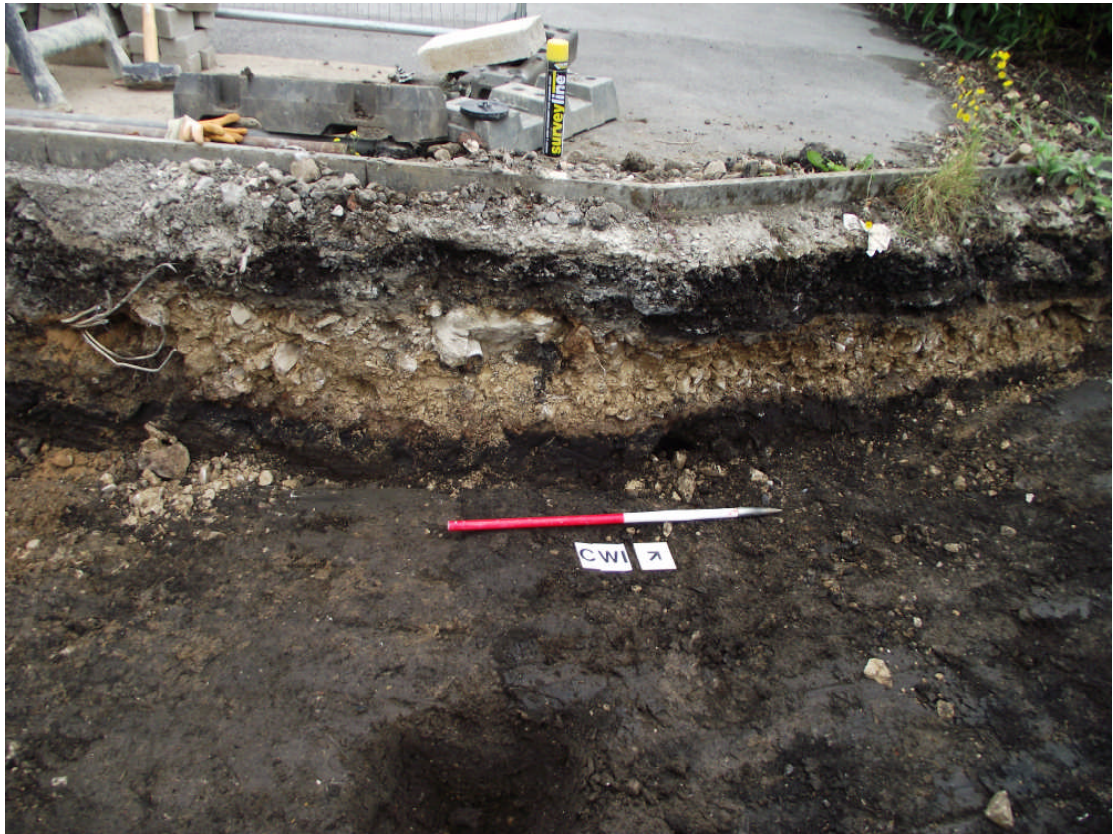
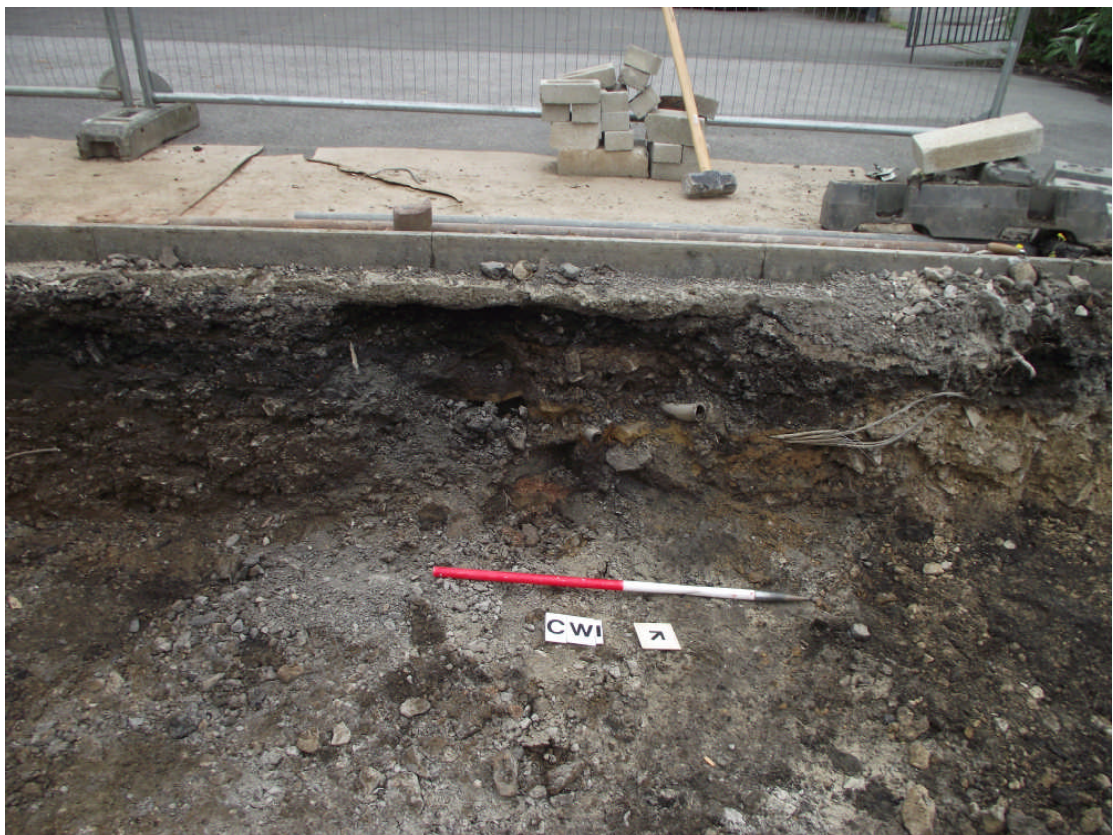
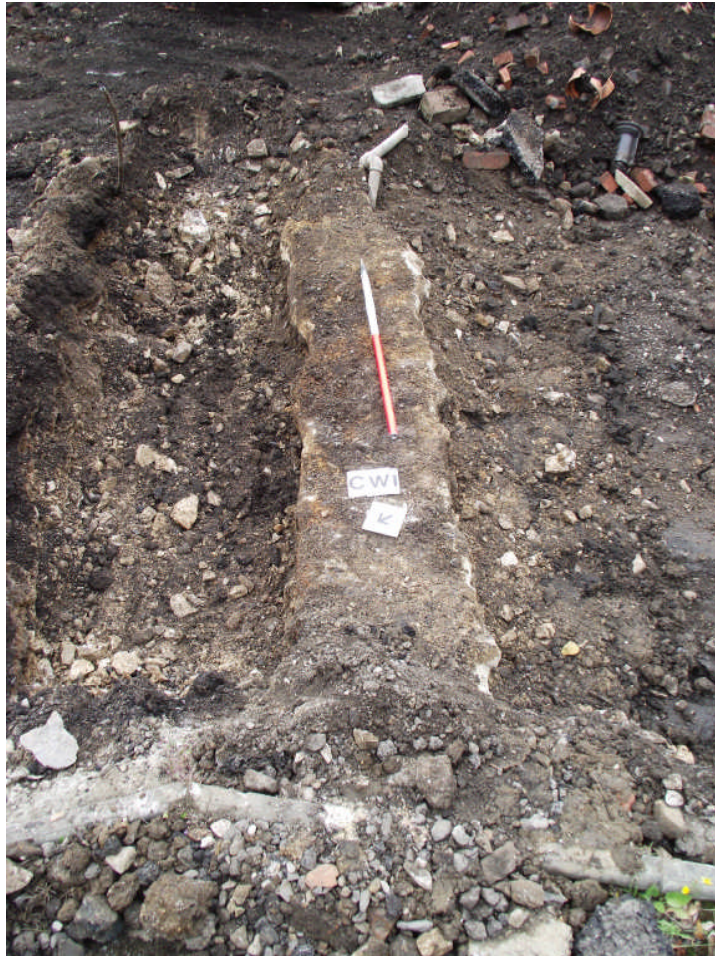
5.16 The recorded section revealed significant disturbance due to recent activity associated with the filling station (Figure 8). This included a number of earlier service trenches (0019, 0020, 0021, 0023 and 0024) running from the north-west into the site from the adjacent property. These contained either electric cables or pipes to carry fuel from the storage tanks to the pumps (Plates 10, 11, 12).

PLATE 10. Area 06. South east facing section with service trenches. Looking north west.

PLATE 11. Area 06. South east facing section. Looking north west.

Plate 12. Area 06, 0024. Concrete casing of vent pipe. Looking east.

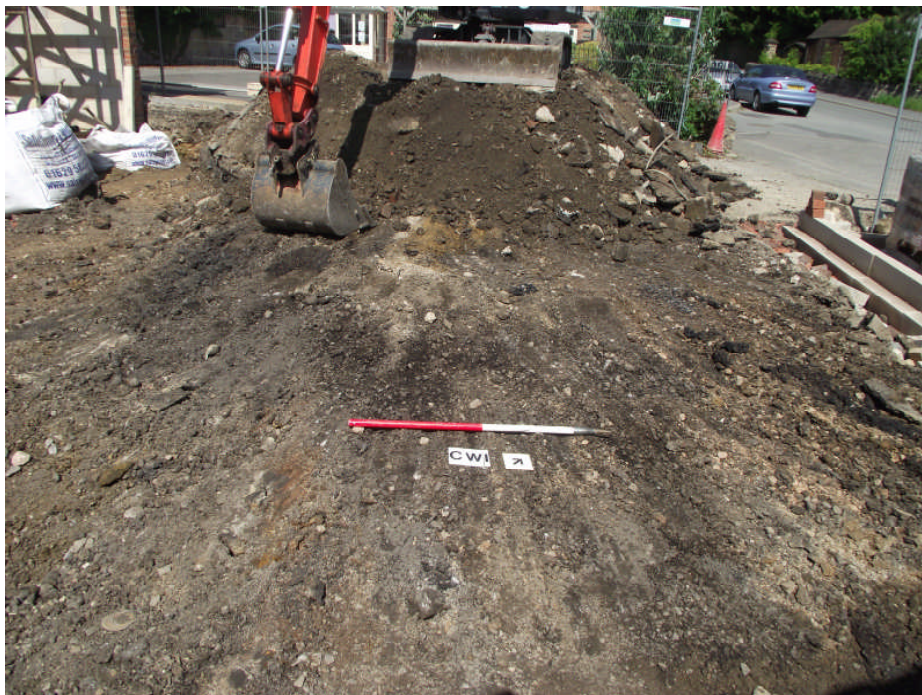
5.18 The intrusive ground work removed the topsoil (0001) but did not penetrate below the base of the layer of hardcore (0009/0022) underlying the tarmac surface (Plate 13).

PLATE 13. Area 07 with 0001 removed. Looking north west.

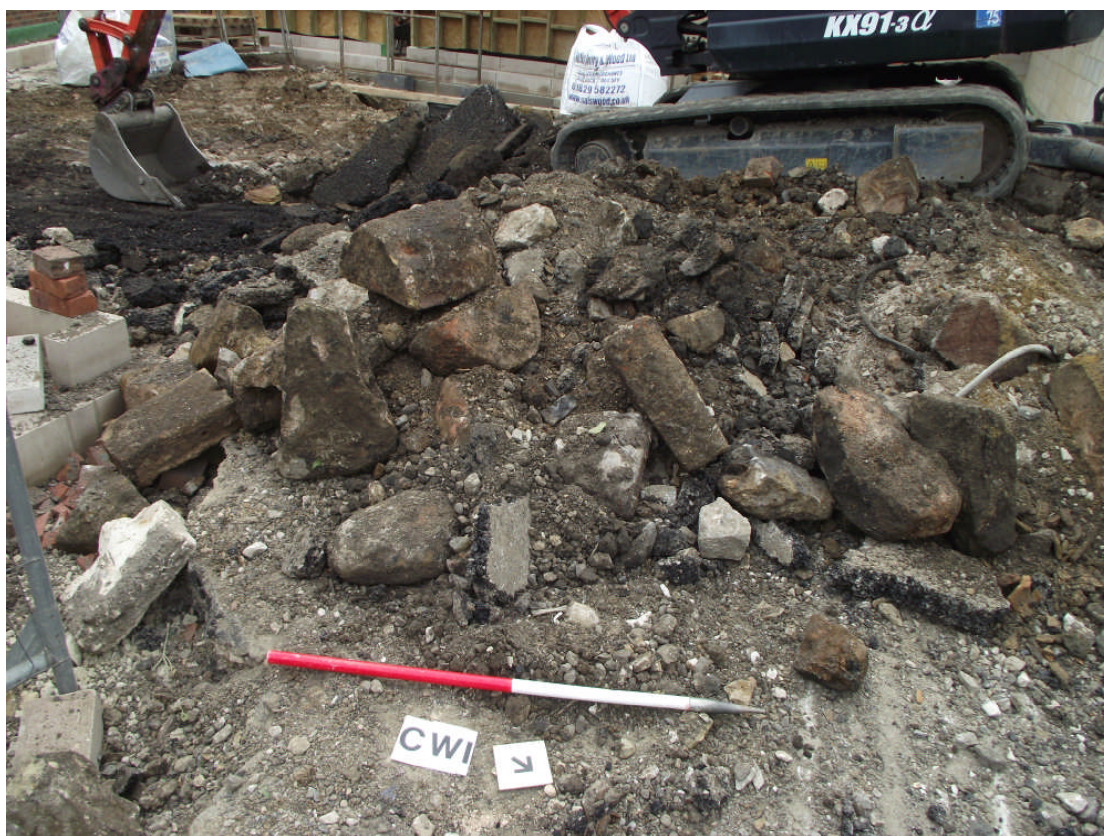
5.19 Within the hardcore a deposit of large stone building blocks (0029) was uncovered. These had come from the original boundary wall running between the property and Coldwell Street and were deposited on the site when the wall was pierced to create a separate entrance to the petrol filling station (Plate 6). The capstones shared the same dimensions, 300mm x 200mm as those in the surviving stretch of the wall (Plates 14 and 15). They were probably deposited during ground levelling prior to laying the tarmac surface.

PLATE 14. Area 07. Stones from demolished boundary wall in 0009. Looking west.

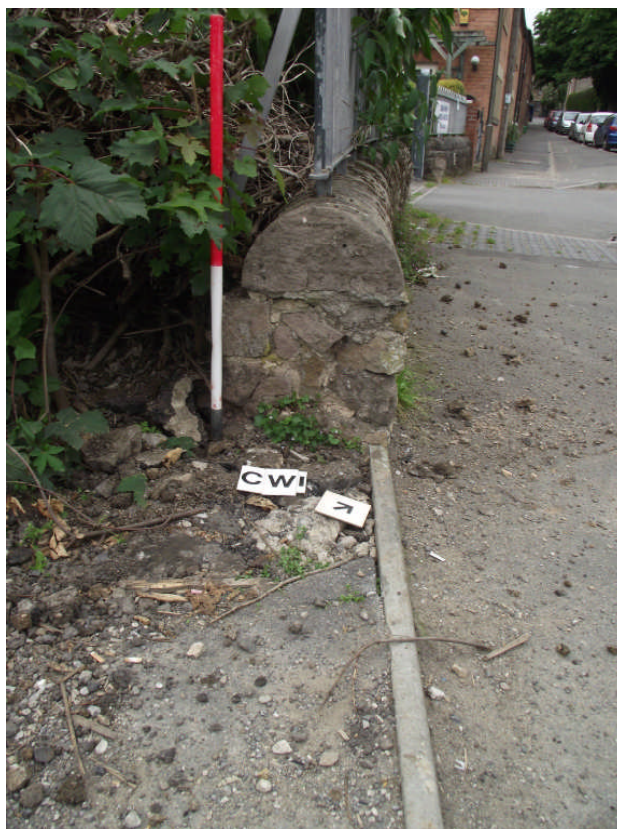
PLATE 15. Area 07. Existing boundary wall and entrance. Looking north west.
