MOUNT HOUSE FARM, SMISBY, DERBYSHIRE

Report on an Archaeological Watching Brief 2011.

Project Code: MFS

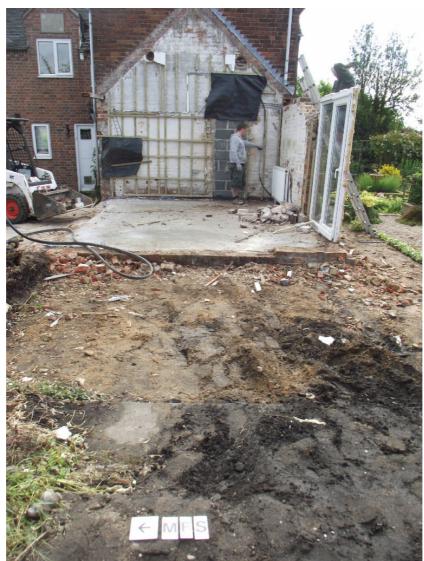
PLATE 1. Area 01 with modern extension in the process of demolition. The concrete slab, 0001 can be seen on the background and 0002 and 0003 in the mid and foreground respectively. Looking east.

- 4.1 The western extension of the existing building, itself a recent addition to the building, was taken down and a concrete slab (0001), which had formed the base for the floor was removed. Below the slab was a layer of modern rubble (0002) which overlay a mid orange/brown layer of silty loam (0003).
- 4.1.2 On the south side of Area 01 a section of the wall of the demolished extension nearest to the house itself was built of brick resting on a low stone foundation (0005) comprised of irregular angular blocks set in a greyish/yellow mortar butting up to the main wall of the house. This foundation which did not continue to the east below the house was removed during the course of the demolition of the extension and the subsequent ground works for the new built (Plate 5 and Figure 1).

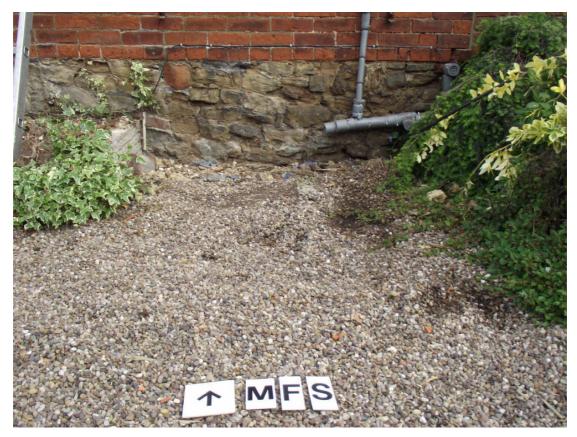
PLATE 2. The low stone foundation, 0005, in part of the south wall of the demolished extension. Looking north.

- 5.1 No features, finds or deposits or archaeological significance were exposed during the ground works associated with the extension to Mount House Farm.
- 5.2 Within Area 01 a low stone footing (0005) for the brick built south wall of the demolished modern extension, may have originated in an earlier structure. However there was no sign of its continuation to the west in either the stripped surface of Area 01 or in the foundation trench, Area 05.

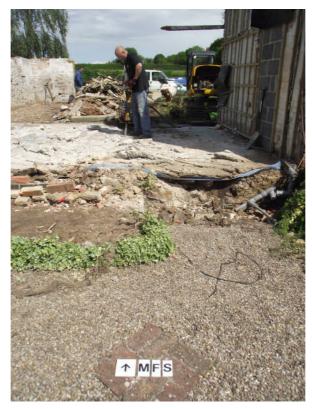
PLATE 3. 0001 being broken up prior to removal Looking north.

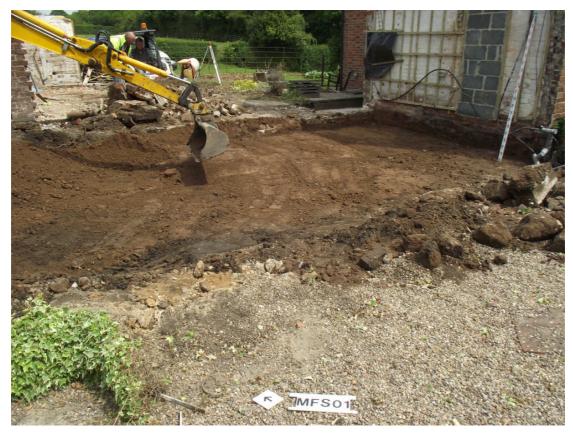
PLATE 4. Ground in Areas 01 and 02 being reduced to formation. Looking north east.

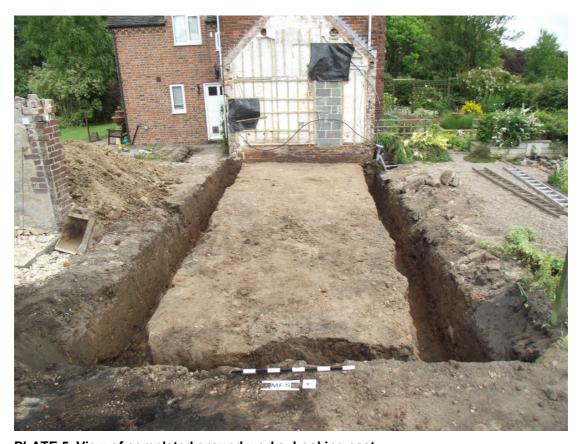
PLATE 5. View of completed ground works. Looking east.

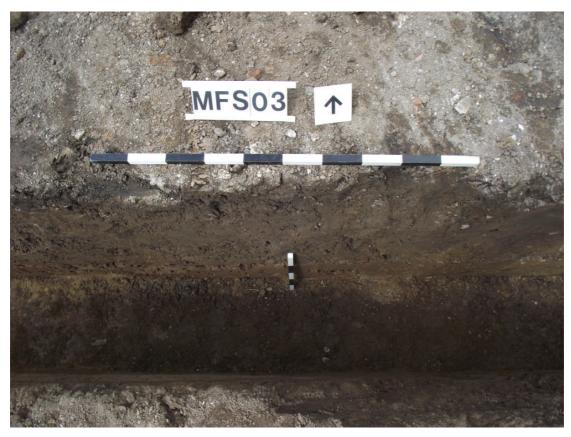
PLATE 6. South facing section of Area 03. This section is broadly representative of the footing trenches that were observed during the course of the watching brief.
