STENSON EGG FARM

DERBYSHIRE

Report on an Archaeological Watching Brief

Project Code: SEF

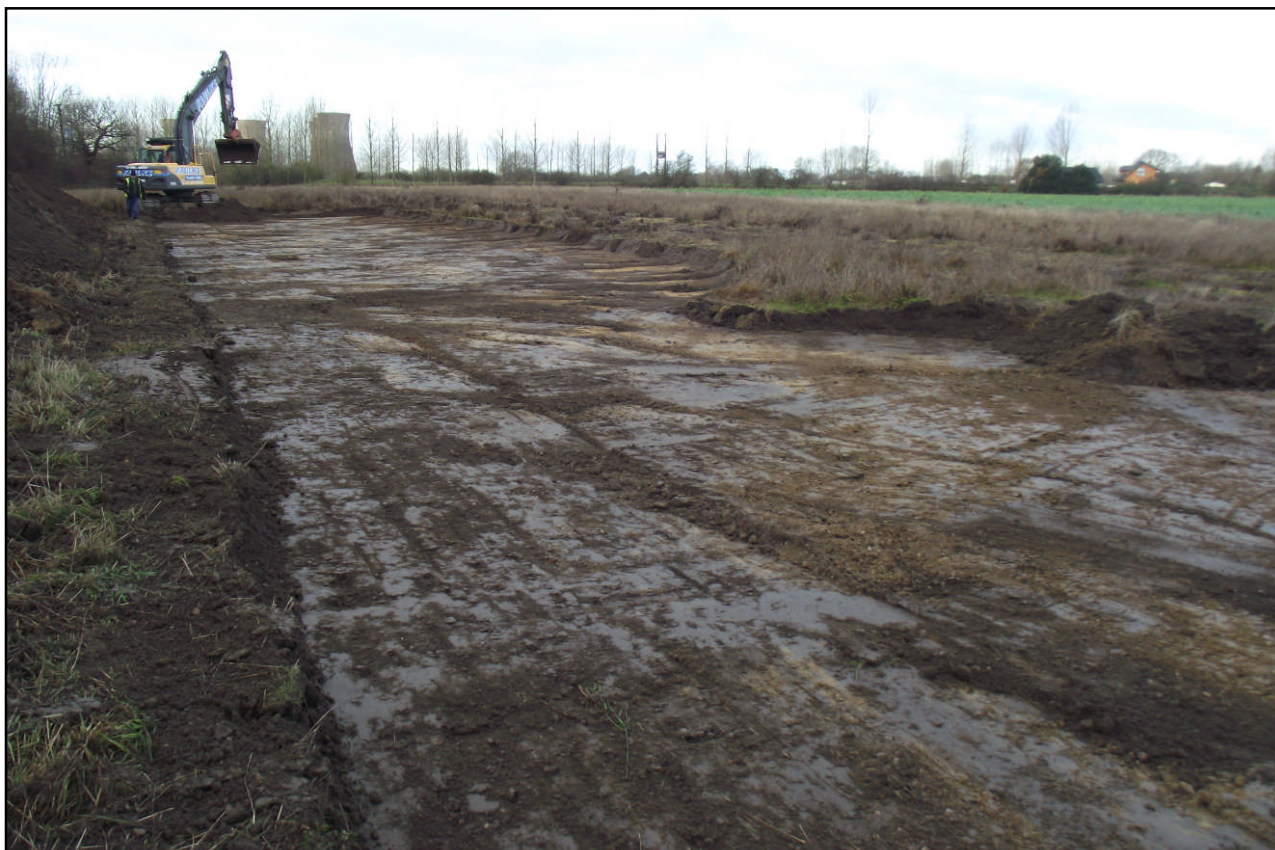
Plate 1: Working shot, topsoil strip of Area 04, looking North West

3.2 The topsoil was removed under archaeological supervision to expose the underlying natural formation (Plate 1). The surface was then examined to establish the presence or otherwise of any archaeological features or remains. The exposed surface was covered with a geo-textile layer to provide a barrier for the deposition of hardcore (recycled crushed brick). This was to form the base of the access road. The footprint of the pullet rearing building was not dressed with hardcore but left exposed until the start of construction.

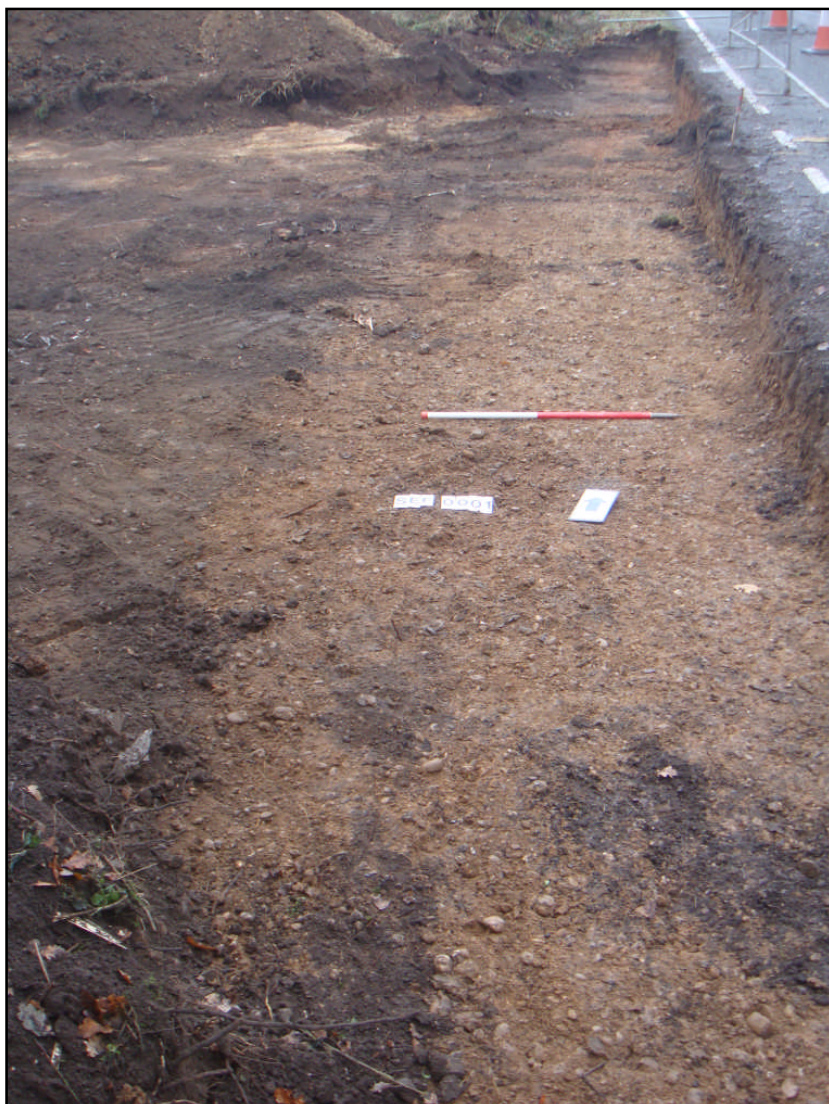
Plate 2: Area 01, Topsoil strip
for the new access road,
Looking North

4.1 Area 01 comprised the first 15m of the new access road (Plate 2) including the cutting of a new entrance to the site from Stenson Road. Area 01 was excavated to a depth of 500mm. Observation revealed layers and disturbance relating to the construction of the roadside pavement.

4.2. From to edge of Stenson Road, the ground was made up of compacted sand and gravel (0001) used as the aggregate base for the two metre wide pavement (Plate 2). A dump of modern debris (0002) measuring 12m x 5m, which cuts the natural yellowish sandy clay and gravels (0003), abutted the compacted aggregates. A modern oval void or rubbish pit measuring 4.5m x 2m was found within the 0002 debris, approximately 5m from the edge of the road. The natural sand and gravels continue to the end of area 01.

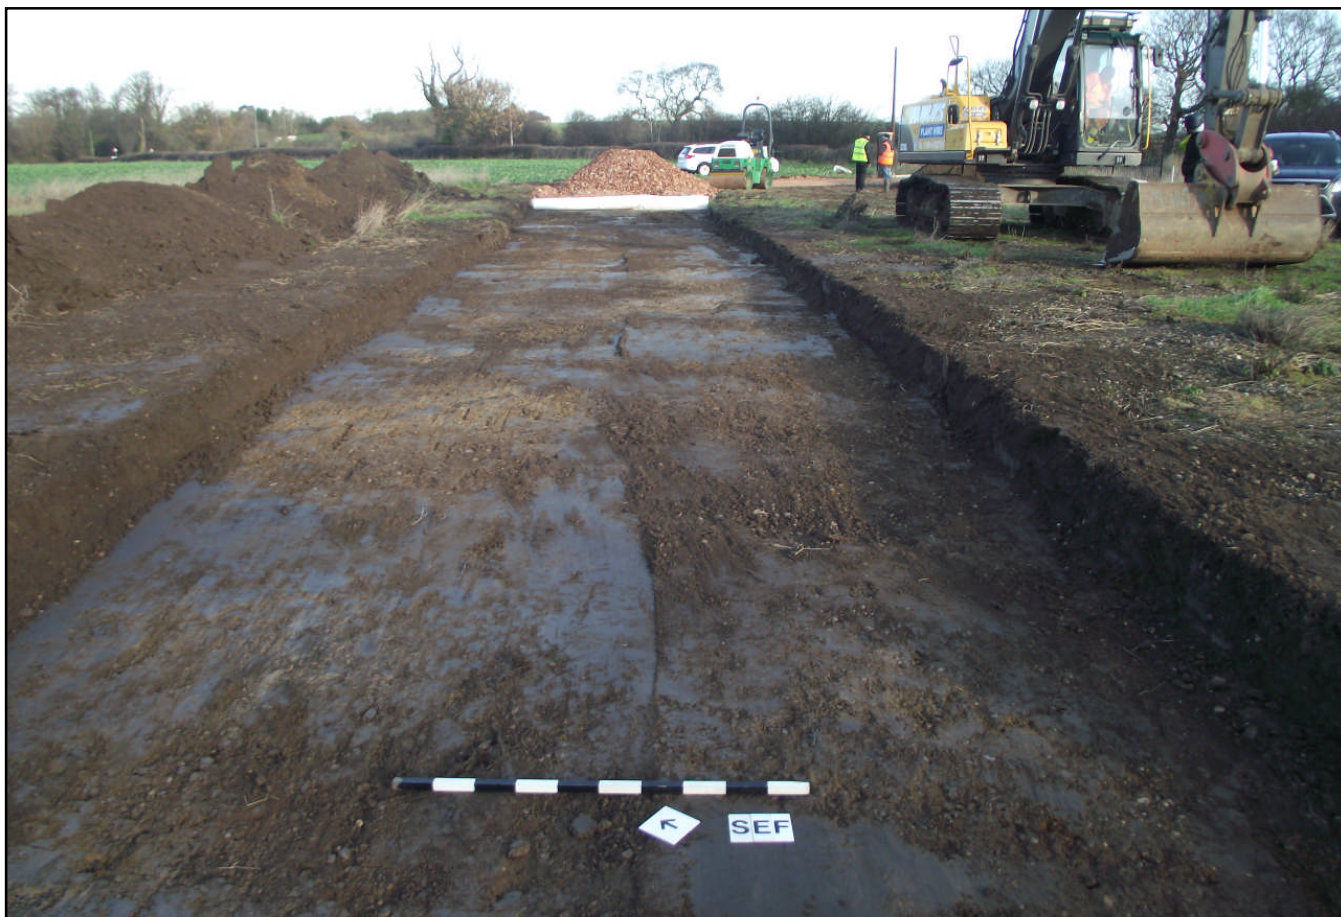
Plate 3: Area 02, Topsoil strip for the new access road, looking North East

4.2 Area 02 comprised the continuation of the new access road to the pullet rearing building. The mid brown sandy loam topsoil (0010) was stripped revealing patches of sandy clay and gravel (0011) which protruded through the base of the top soil. At the East end, the topsoil was excavated to a depth of between 250-300mm (Plate 3). At the western end of the access road, the depth of the top soil increased by up to 100mm. As with the eastern end of the area, extensive patches of 0011 were revealed.

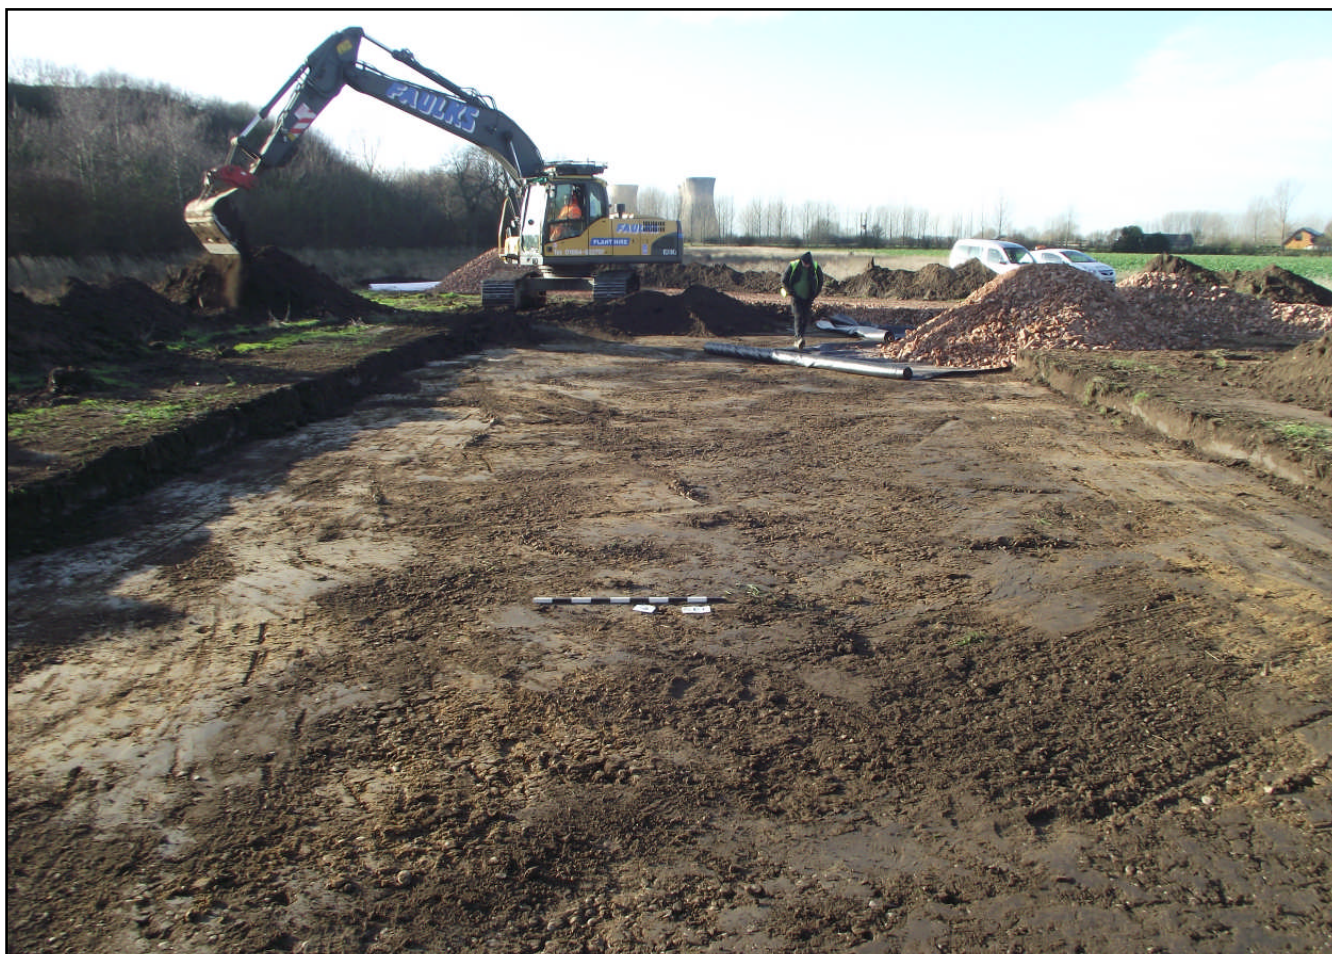
Plate 4: Area 03, Topsoil strip for the proposed construction of the mobile home platform, Looking West

4.3 Area 03 comprised the footprint for a platform on which a mobile home would stand (Plate 4). The mid brown sandy loam topsoil (0010) was stripped down 250-300mm until patches of sandy clay and gravel (0011) could be seen protruding through the exposed surface. (Plate 4.)

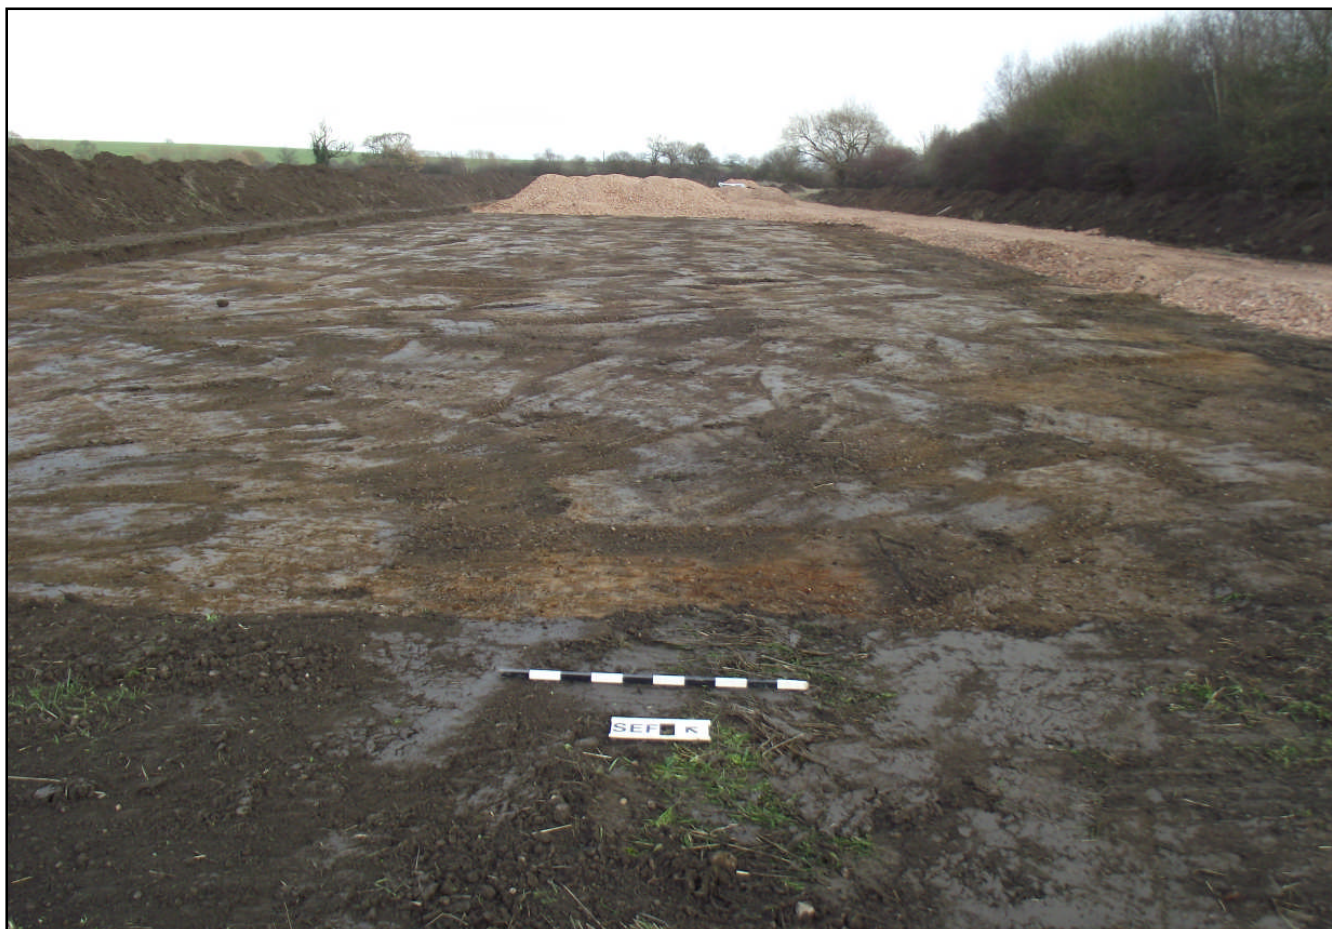
Plate 5: Area 04, Topsoil strip for the proposed construction of the pullet rearing Building, Looking East

4.4 Area 04 comprised the proposed building location and the lorry parking and turning area (Plate 5). The topsoil was excavated down to 400mm. Through the stripped surface extensive patches of 0011 were visible (Plates 1 and 4).
