IBSTOCK SEVERN TRENT A Report on an Archaeological Watching Brief

Project Code: IST

- Trent & Peak Archaeology was contracted by Severn Trent Water to conduct an archaeological watching brief on ground works associated with the construction of a pipe line at Ibstock, Leicestershire, between SK404094 and SK407096.

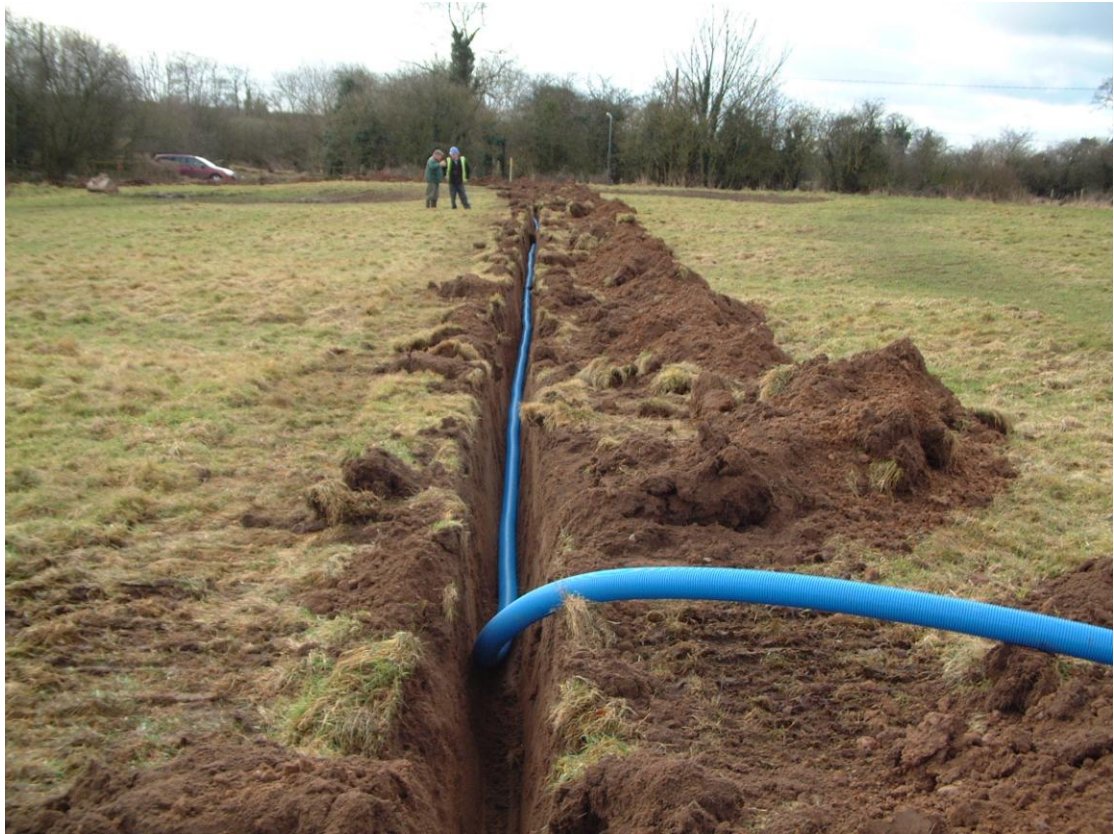
4.1 The ground work in preparation for the new sewer was carried out in two distinct phases. Firstly a 'pre drain' was constructed in order to ensure that surface water did not flood the main pipe trench when it was excavated. This consisted of excavating a narrow V shaped trench some 500mm wide at the surface and then the insertion of a plastic pipe. Plate 1.

PLATE 1. The pre-drainage pipe in Area 02. Looking north east.

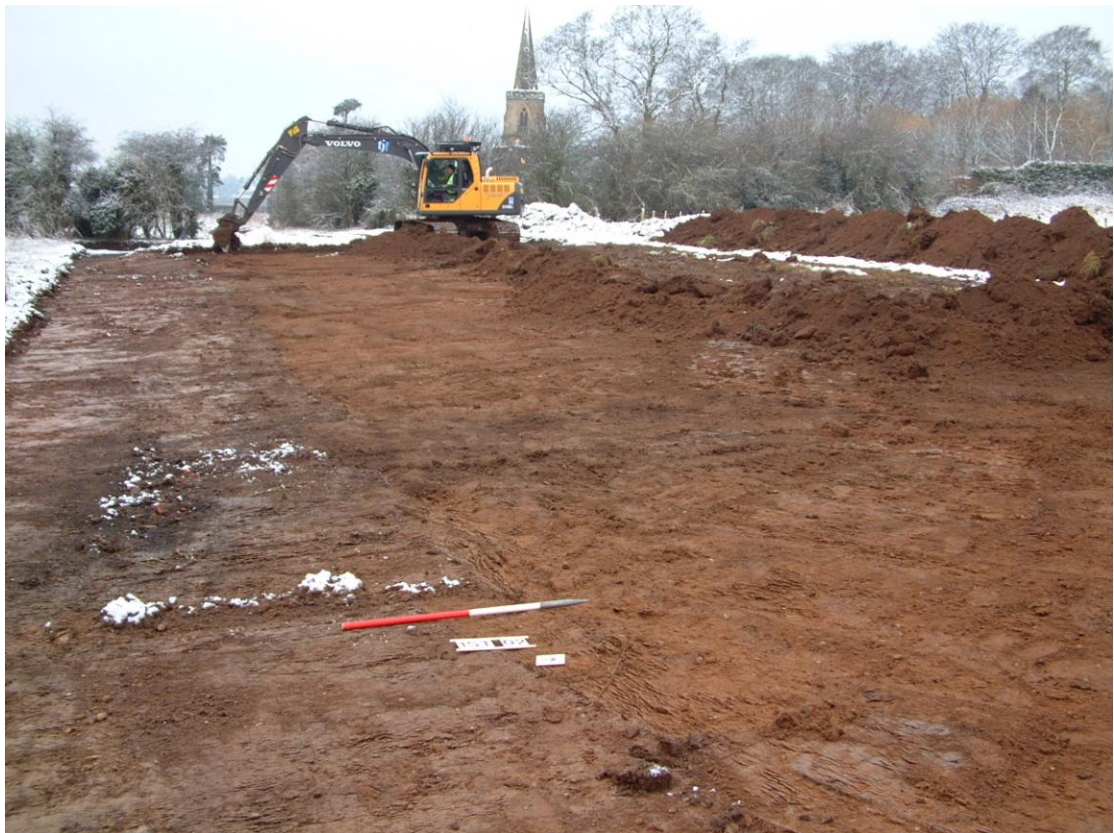
4.3 The easement was stripped by a tracked machine using a toothless ditching bucket, Plate 2, with the topsoil being stored within the twenty metre easement. The actual surface area that was seen was therefore on average fifteen metres wide in each area (Figure 2). The topsoil stripping was monitored along the entire length of the easement and a collection was made of pot and any other artefacts that were unearthed as a result of this.

PLATE 2. Machine stripping in Area 02. The fill of the original pipe trench is on the left Looking south west.

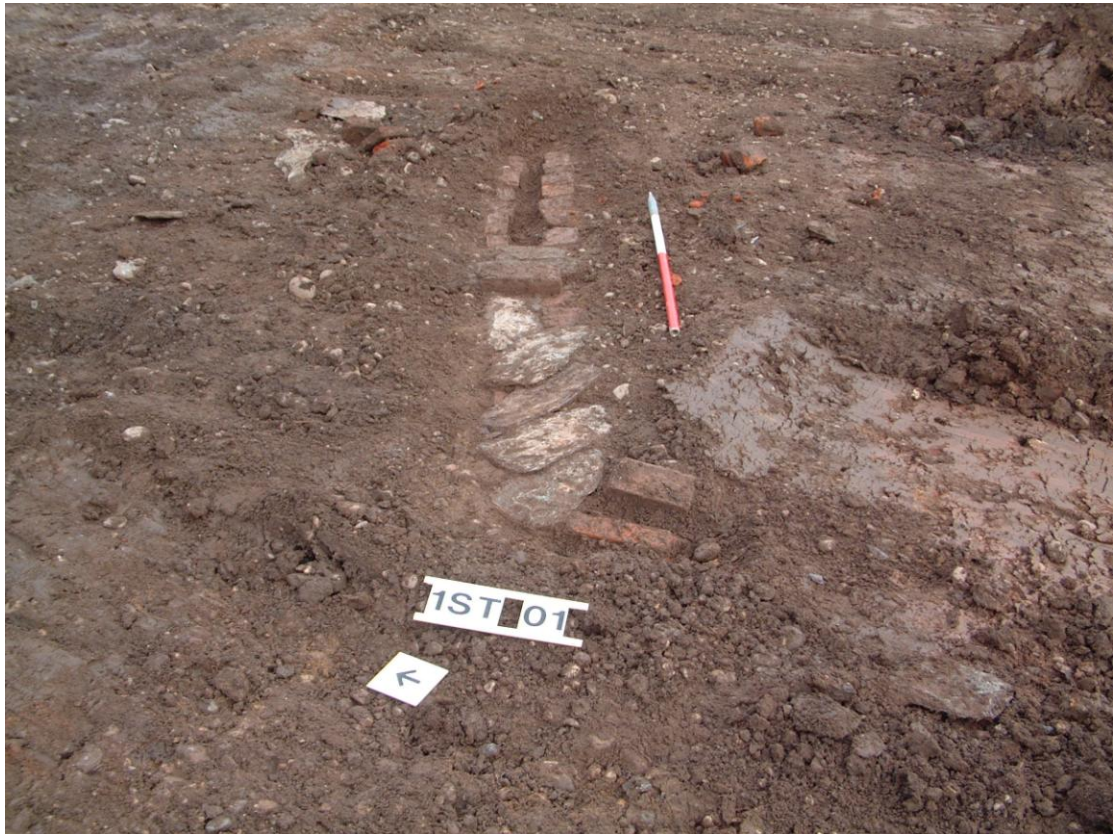
5.1 To the south of St Denys Church, this area revealed only one feature, the remains of a field drain, 0009, Plate 3, made up of bricks in places two courses deep topped off with slates. Figure 3. The bricks probably date to the late 18th / early 19th century. Their dimensions vary from 100x235x60cms to 110x245x50cms. Some incomplete bricks measure 35cms in depth and 100cms in width. All appear to be hand made and none have frogs. The slates when cleaned in post excavation have holes in them that suggest they were once part of the roof of a building. Very little of this drain survived but it is probable that the materials used in its construction have come from a building or buildings that had been demolished and subsequently re used. There were no artefacts recovered from the drain and it therefore remains undated.

6.1 The remains of the field drain in Area 01, 0009, were recorded. Only a small portion of this had survived. It was constructed of bricks and topped with slates. There was no dating evidence recovered from the excavation and recording of 0009. Whilst the bricks used in its construction appear to be hand made and date to the late 18th / early 19th century this does not securely date the feature since the materials it is constructed with could easily have been reused from another structure.

PLATE 3. 0009, brick and slate field drain in Area 01. Looking north west.

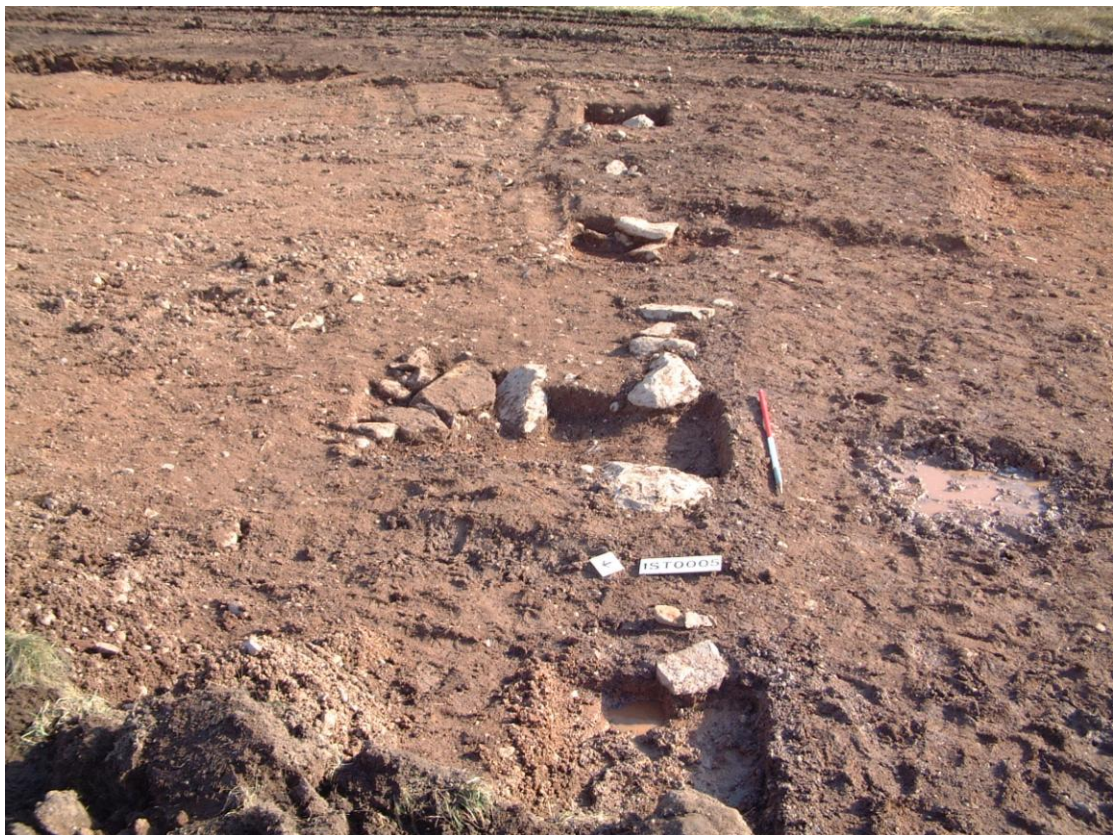
5.2.1 Thirty metres to the east of the boundary with Area 01 a line of large stones, 0005, was uncovered running north west to south east, Plate 4. This has been interpreted as the base of a wall. The stones were set deeply into the subsoil. (Plate 5). A quantity of medieval pottery was recovered from between and around the stones. All of these were

6.2 The base of a wall, 0005, was uncovered in Area 02. This was in the form of a line of stones, which run from north/west to south/east from the edge of the easement to the edge of the old pipe trench. There were no signs of a parallel wall and its interpretation is difficult. It could be the remains of a building or it could be a boundary wall. Its alignment does not correspond to any of the modern field boundaries. The stones show no signs of having been worked, rather they are rough blocks of varying sizes and there were no signs of any mortar. One course was all that remained. Individually the stones were set deeply in the subsoil, 0002, and covered by it. There was no evidence of a foundation trench.

PLATE 4. 0005, stone line, possible wall foundation in Area 02. Looking south east.

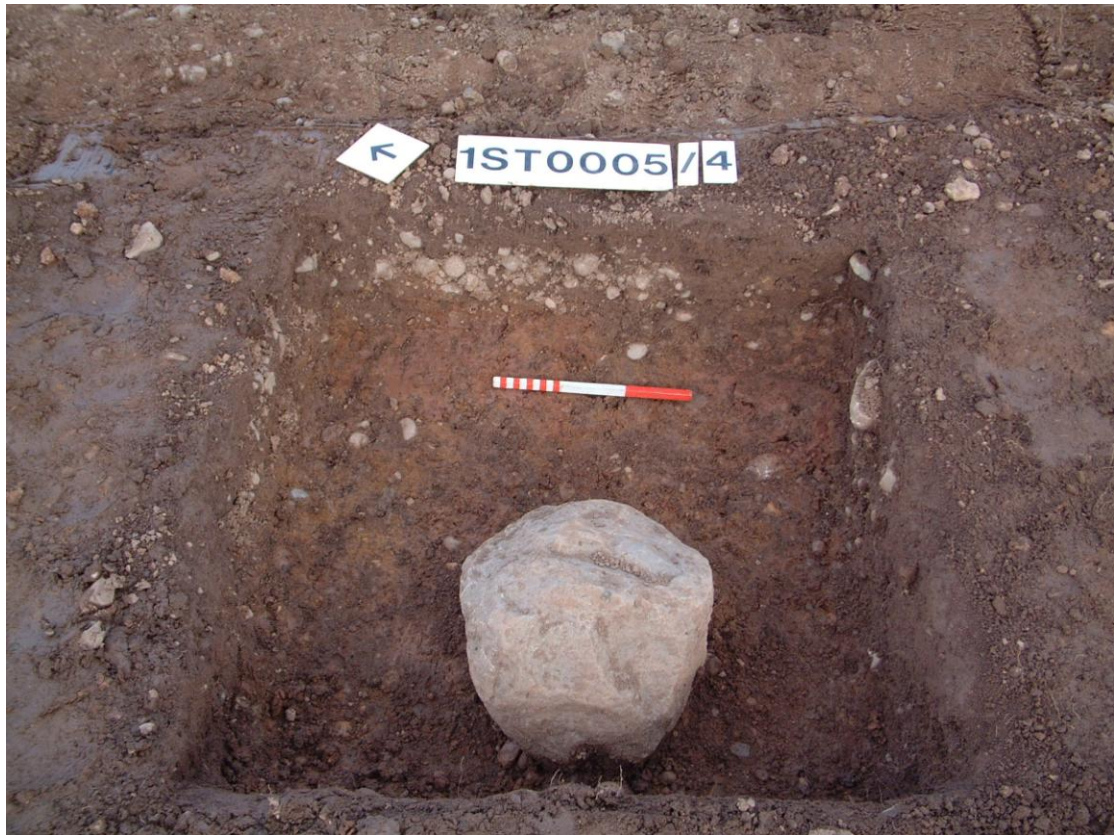
5.2.3 Four cuts were excavated across the line of 0005, to establish how much of it remained and whether or not it was possible to detect any evidence of a foundation cut (Figure 4). No foundation cut was visible. Excavation of 0005 was carried out in a manner that caused a minimum of intrusion and where sections were excavated across it this was done without removing any of the individual stones. It was agreed with the contractors that the area around 0005 would not be tracked over by plant or machinery when the new pipe is laid so that the feature can be preserved in situ.

PLATE 5. 0005, cut 4, showing stone set into subsoil, 0002, but no indication of a foundation trench. Looking east.
