# LUTTERWORTH SEWAGE TREATMENT WORKS LEICESTERSHIRE

## A Report on an Archaeological Watching Brief

2006

Project Code: LSW

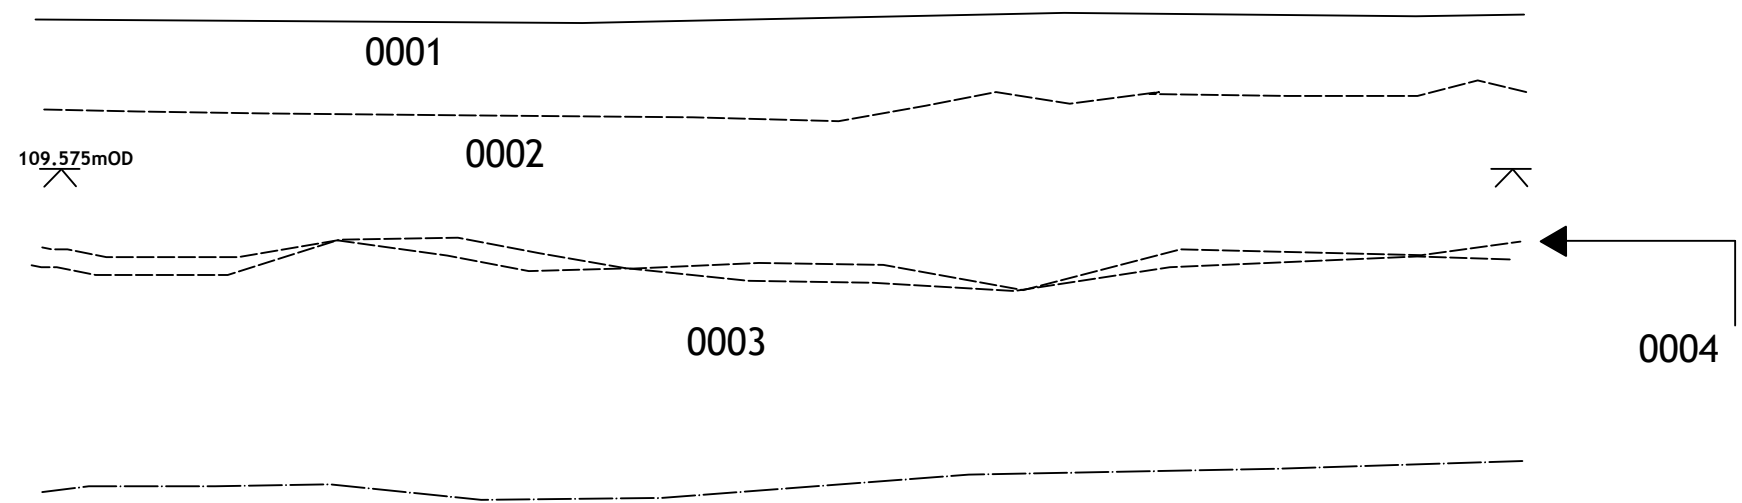
**Fig 2** Section of Area 03

- 0001 Topsoil, mid brown clayey loam
- 0002 Subsoil, made ground, mixed clay, silt and topsoil with modern rubble
- 0003 Natural, yellow clay
- 0004 Lens of grey silt, only partially surviving

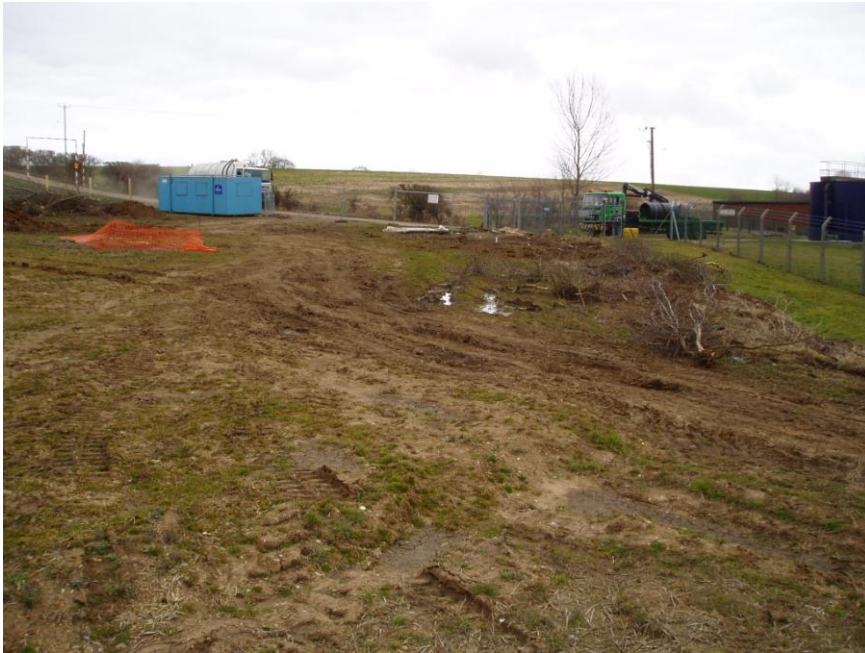
**Plate 1** View of Area 02 prior to stripping. Looking north east.

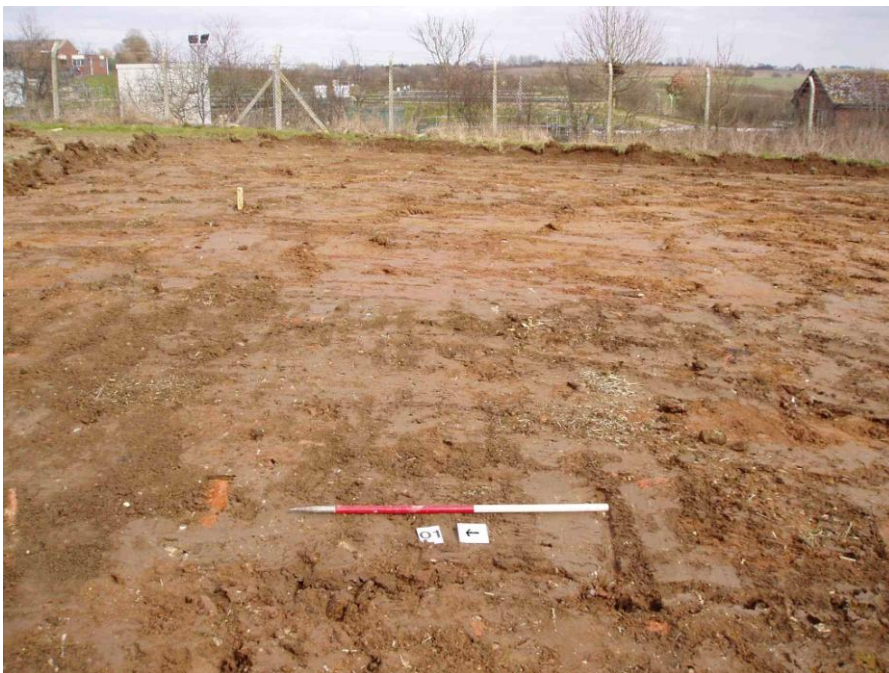
**Plate 2** North east corner of Area 01 after topsoil stripping showing brick rubble in the subsoil, 0002. Looking east.

5.1 Is the site for the permanent works and deeper excavations and comprises a total area of 4070sq metres. The topsoil (0001) was a brown clay loam, with a few inclusions of sub-rounded stones. During the topsoil strip there were a number of 20<sup>th</sup> century finds observed, mostly modern bricks, which were not retained. The underlying mixed silty clay (0002) was a made-up ground containing fairly frequent modern bricks, pieces of plastic, concrete, wood planks and boards (see Plates 2 and 3). The made up ground 0002 was an amalgam of yellow glacial boulder clays, grey colluvial silts and brown clay loam topsoil mixed together in a levelling out episode across the whole of Area 01 and much of Area 02. This material was likely to have been derived from the construction of the original sewage works in the 1970s.

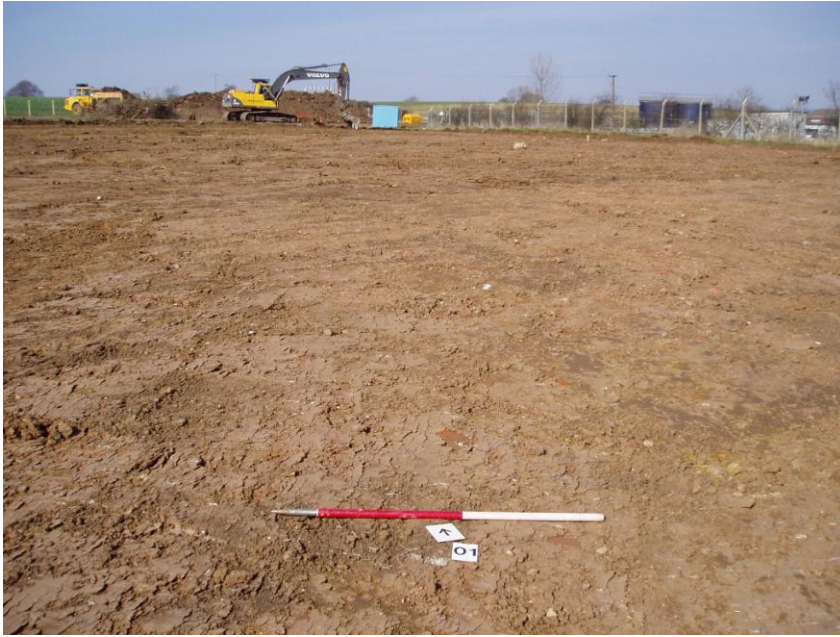
**Plate 3** Area 01 looking north north east towards the final part of the topsoil strip in Area 02.

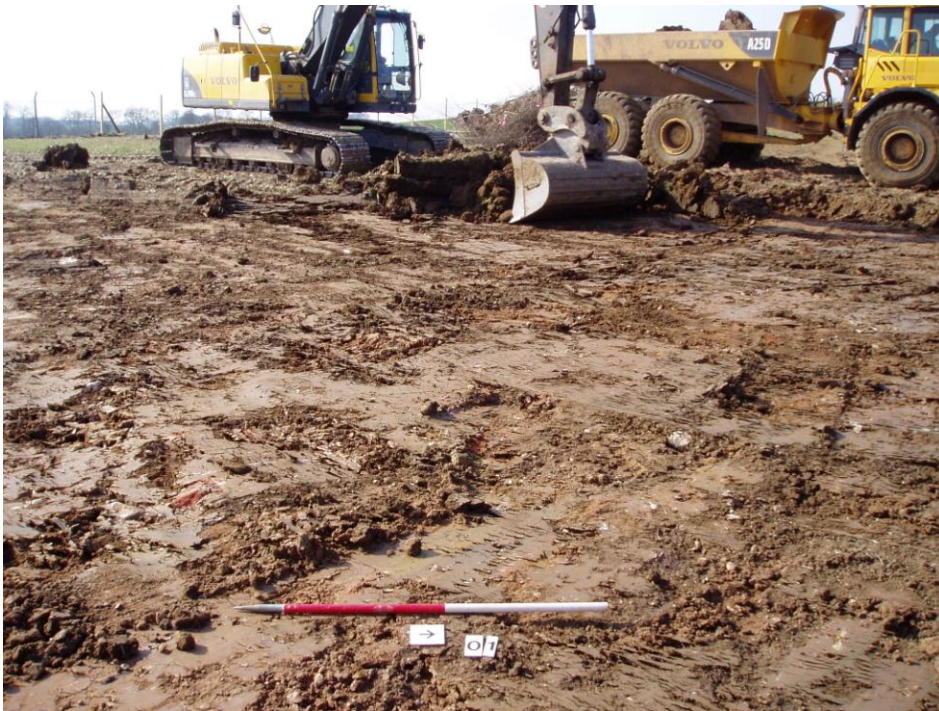
**Plate 4** Northern extent of Area 01 showing the continuation of 0002. Looking north.

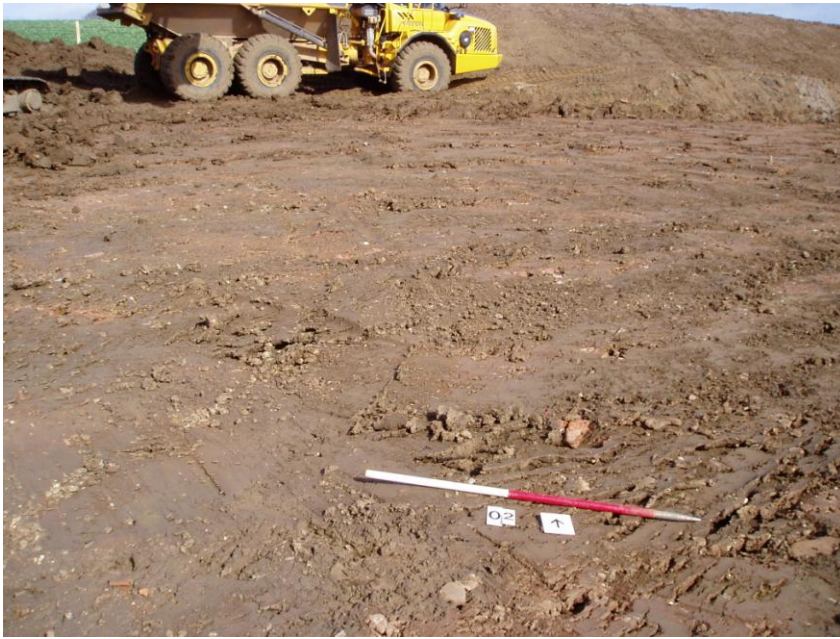
**Plate 5** In the northern most part of Area 02 the mixed clayey context of 0002. Topsoil bunds are in the background. Looking north

5.2.1 Only the topsoil, 0001, was removed from Area 02 exposing a continuation of 0002 as recorded in Area 01.

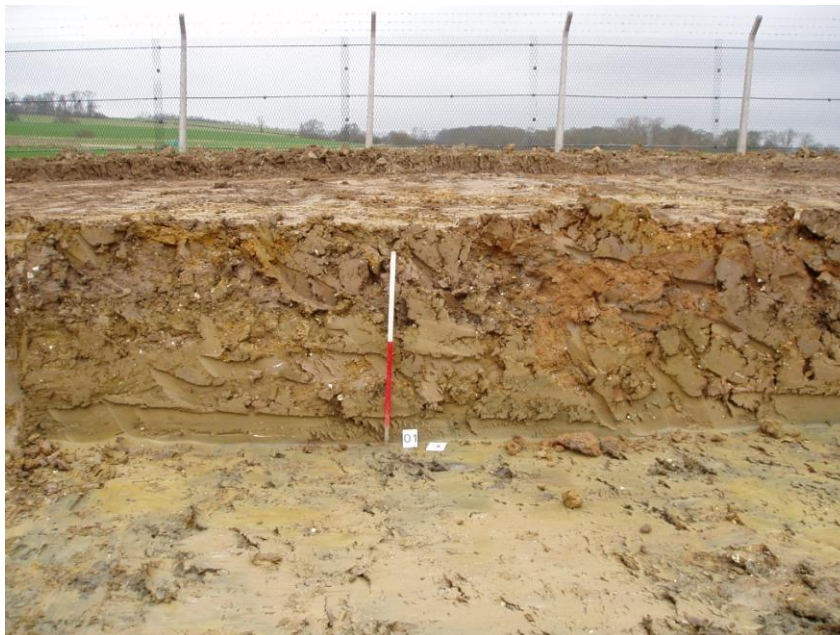
**Plate 6** Area 02 depth of overburden (0002) shown overlying the boulder clay natural and clearly demonstrates the depth of made ground.

5.1.2 The excavation of the deeper central area for the plant equipment for the new treatment works in Area 01 showed that there had also been considerable prior disturbance of the site, perhaps as part of landscaping for the earlier treatment works (plate 6). At a depth of

between 1m and 1.3m relative to the ground surface the boulder clay natural, 0003, was encountered. Intervening between this and 0002 was a disturbed c.0.04m thick lens of dark brown organic silts (0004). This layer appears to have been badly disturbed by the 1970s stripping and subsequent dumping of mixed clays and rubble and only survived intermittently. A single fragment of non diagnostic but probably post medieval tile was recovered at this depth at the interface between the heavily disturbed mixed clays and the natural although not in association with the silts. The only visible feature was in the very southern portion of Area 01 a ditch of a former boundary that cut layer 0002. This boundary ran in a slight arc east-west in the southwest corner of the site and was c.1.3m wide and filled with a rust mottled greyish brown silt (0005).
