ALL SAINTS CHURCH SAWLEY, DERBYSHIRE

A Report on the Archaeological Watching Brief conducted during the
Installation of a Lighting Scheme

TPA Project Code: SAC

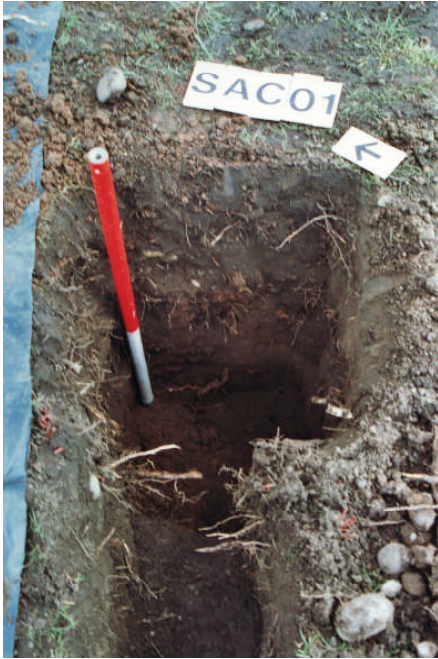
Plate 1: Light Position 1. Looking northeast.

5.1 Light position 1 (**Figure 2, Plate 1**) 0.45m square in plan, was excavated to a depth of 0.90m. It demonstrated the sites stratigraphy to comprise:

- 0001 a 0.20m thick dark yellowish brown sandy loam topsoil.
- 0002 a 0.35m thick mid-yellowish brown subsoil.
- 0003 a mid-reddish brown loamy sand, containing occasional pebbles.

5.2 The finds from layer 0002 indicate that this was a disturbed subsoil layer. Context 0003 is interpreted as an old burial soil or 'grave earth', due to its fairly mixed homogenous nature.

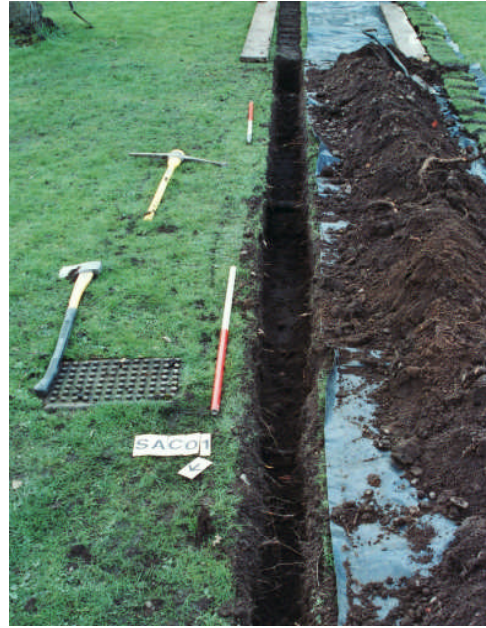
Plate 2: Area 01. Looking south.

5.2 The hand dug trench of 01 running from the light position continued for a distance of 25m, until reaching a tarmac footpath. It was excavated to maximum depth of 0.40m, never going below the level of context 0002 (**Plate 2**). Finds from 0001 and 0002 would appear to be broadly contemporary in date.

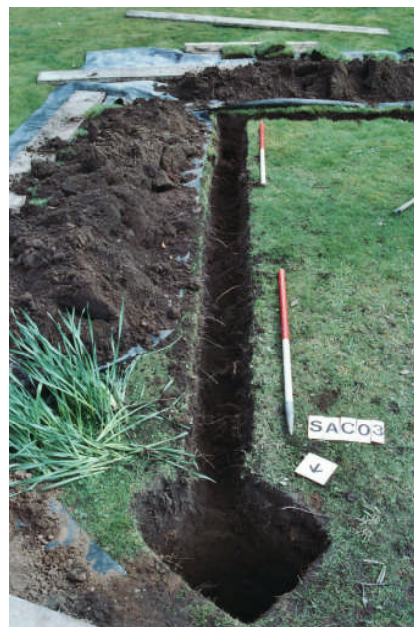
Plate 4: Light Position 2/area 03. Looking south.

5.8 From the light position the cable trench ran south for a short distance (**Plate 4**) then turned west (running northeast to southwest) and cut across the churchyard path leading to the northside of the church (**Plate 5**). Crossing this path the trench connected with a further section of trench that ran from Area 02 south to Area 04 (**Plate 6**). The cable trenches were excavated to the same depth (c.0.4m) as the others.

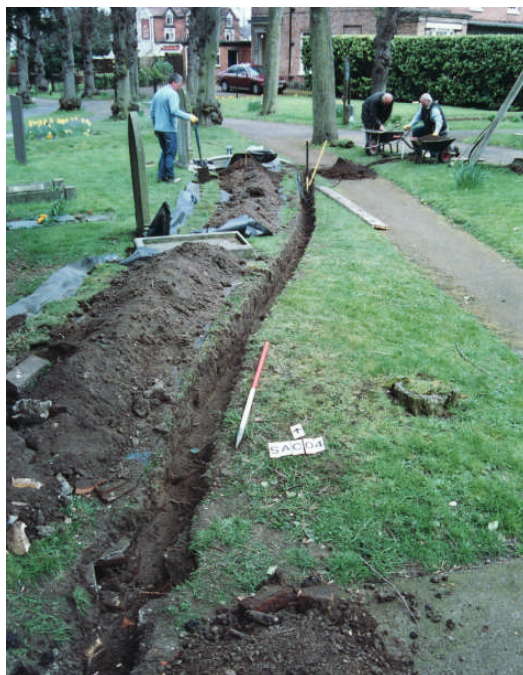
5.9 The south end of Area 03 on the west side of the churchyard path (**Figures 2, 3**) cut across the line of an old boundary visible as a grassed over earth bank (**Plate 7**). The trench

Plate 7: Area 03/04 showing the old boundary wall as a slight rise in the foreground. Looking north.

6.2 The most significant feature exposed by the groundwork was the old boundary wall found in area 03 (**Figures 2, 3, 5, Plates 7, 8**). On Sandersons map of 1836 an east west running boundary may coincide with that found during the watching brief, however this remains unclear with out significant documentary search. Although found to be of post-medieval date (c.18th /19th century) from the brick used, it is probably reflective of an older boundary feature.

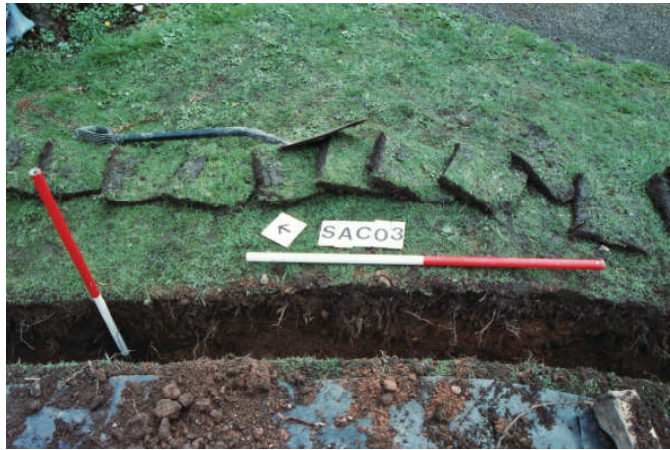
section (**Figure 5, Plate 8**) showed that the bank was probably constructed of brick in at least its later phase of use. The dismantling of the wall left only a disturbed bank 0004, possibly as a result of robbing out the footings. A sample of the bricks were retained for reference. These comprise a brick size of 225mm x 103mm by 60mm, while an incomplete brick voussoir was also present (56mm thick, narrowing from a width of 184mm to 150mm). These suggest the brick wall was constructed across the boundary sometime in the 18th century/19th century. There was however, due to the shallow nature of the excavation, no evidence to indicate any earlier phase to this boundary.

Plate 8: Area 03/04 showing the trench over the old boundary wall. Looking east.
