**AN HISTORIC BUILDING  
SURVEY OF THE FORMER  
RED LION PUBLIC HOUSE,  
HIGH STREET, GOLDENHILL,  
STAFFORDSHIRE**

OS Grid Ref. SJ 85189 53383  
TPA Project Code: RLG.1  
TPA Report No. 009/2013  
January 2013

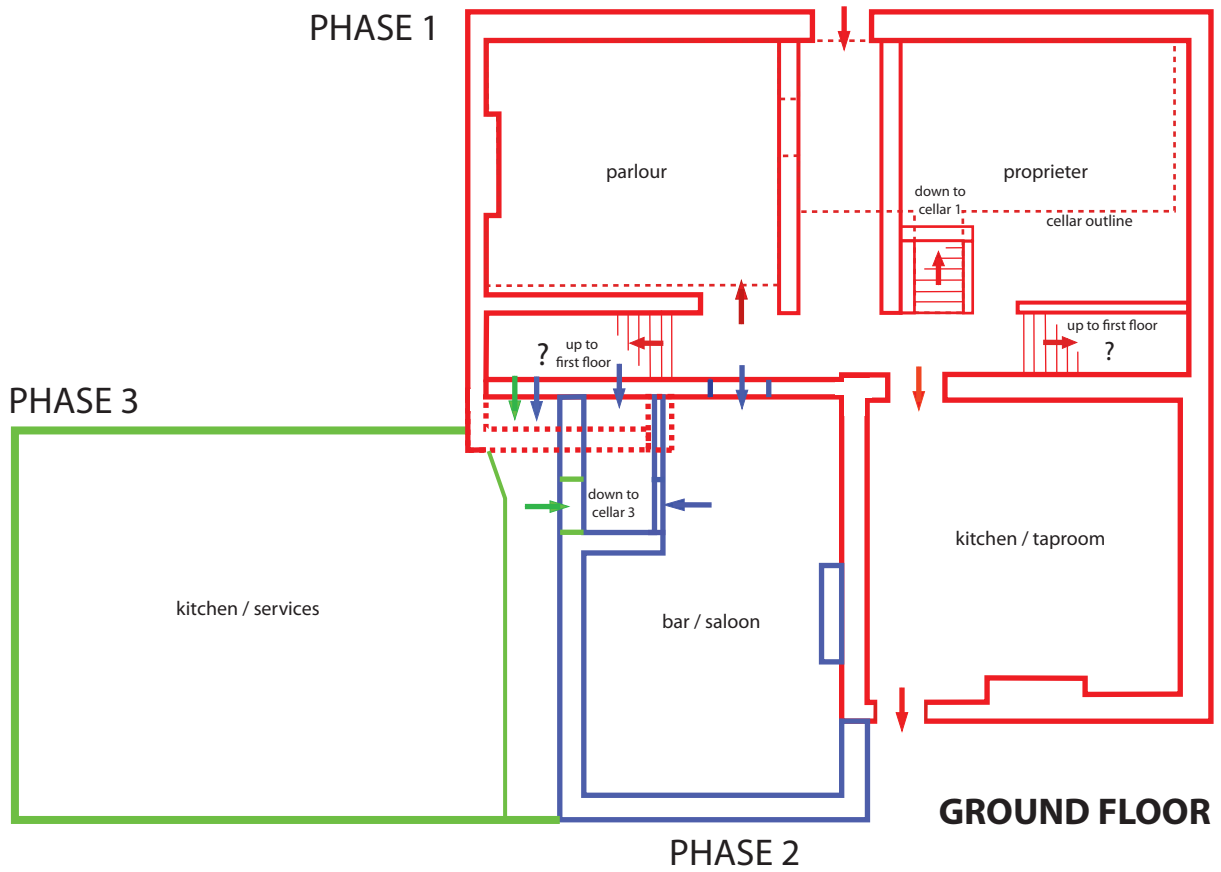
Figure 13: Suggested early phasing of the Red Lion Inn, Goldenhill. Scale 1:100.

Being not dissimilar to a normal domestic dwelling the Red Lion would have had private quarters for the proprietor and his family and a parlour that could be made available as a private room for guests who did not wish to mix socially with others frequenting the kitchen (*ibid.* 53). Figure 13 provides a suggestion of how the inn first operated, with one private room, one public room and the third that could be either. Where the original staircase stood remains unclear. Two options are shown in Figure 13, both close to what may have been a back

passage, lit by the middle window in the south wall. A position near the north-west corner of the north range is favoured here. At its lowest level in Cellar 3 the west wall has early brickwork; similar early brickwork shows in the wall between Rooms 16 and 17 on the first floor. The space here would allow for a dog-leg staircase between ground and first floor level.

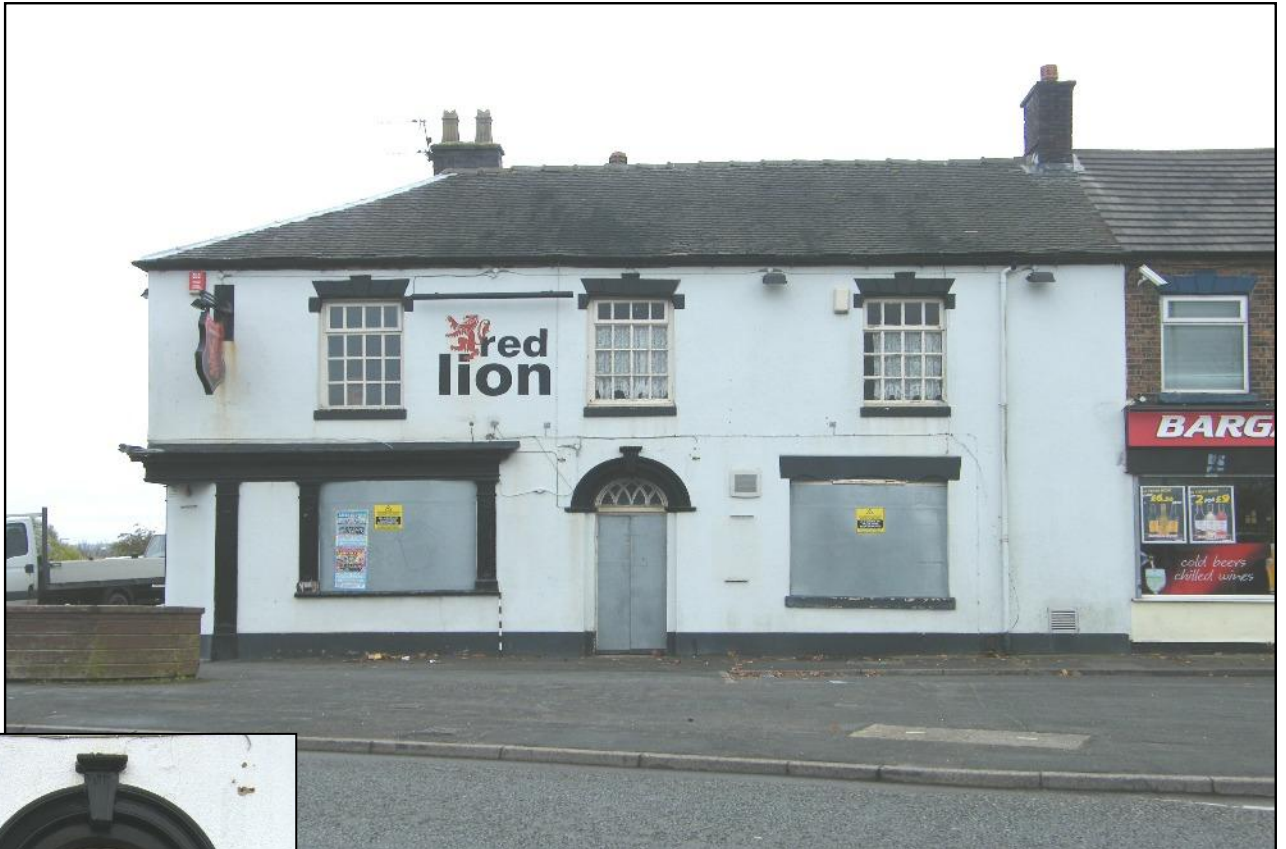
The east frontage shows a symmetrical arrangement of similar sized first floor window openings with straight lintels with flared ends and a keystone (Plate 3). These still contained sash windows until these were replaced sometime after 1967 (Plates 1, 2). The central doorway has a decorative rounded head with keystone and a Gothick-style fanlight (Plate 4). The lower windows are bigger and differ in size, but each has one side that aligns with a window above. Boarding currently hides windows that show internally as typical of public houses dating from the 1930s. The south elevation has a similar arrangement of openings that is less symmetrically accurate and lacks a central doorway. A corner doorway at the junction of the two ranges is a later addition. The rear of the building is more complicated, with a series of additions to the original

Plate 3: Symmetrical arrangement of door and window openings on the east frontage.

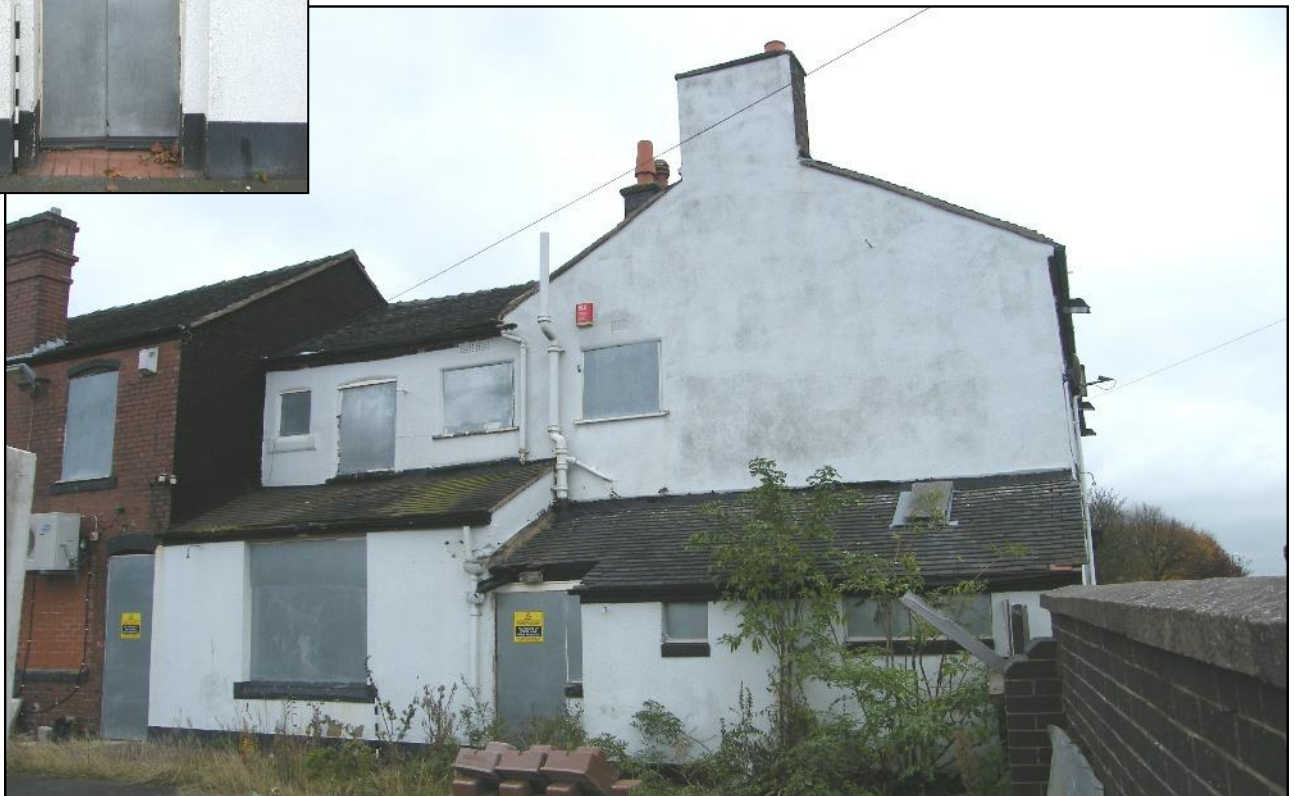
structure, both single and two storey in height (Plate 5). The north-west block and two adjoining outhouses still have their original brickwork free of render.

Plate 5: Rear view of the Red Lion public house showing the added middle range (in centre) and its extended lower room, a toilet block (lower right) and part of the function room block (brick showing, far left).

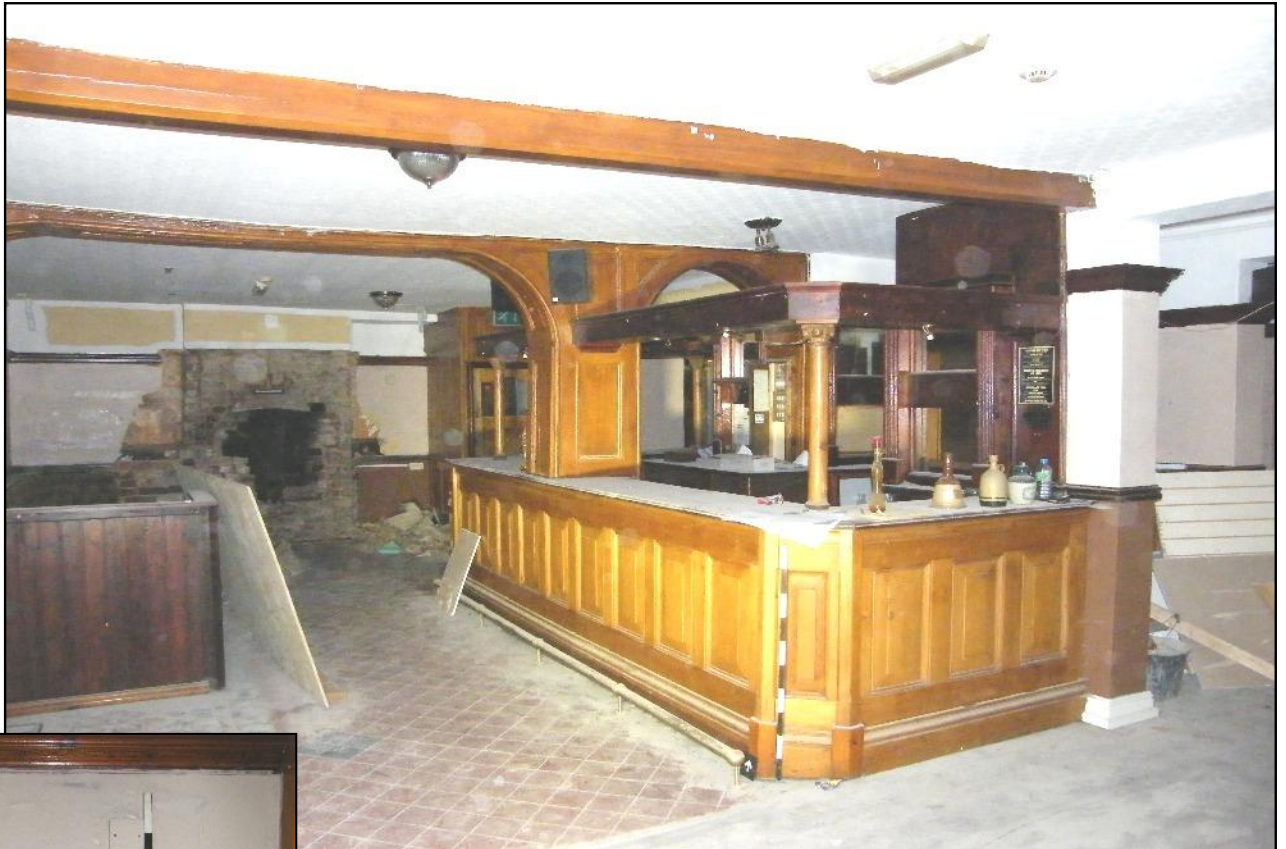
Plate 6: View of bar in Room 2, with position of removed kitchen range of former Room 3 showing in background.

The room arrangement, numbered 1-8 is shown on Figure 8. Four of these were until recently public drinking areas: a long open public bar (formerly separate Rooms 2 and 3; Plates 6-8); a bar parlour (Room 1; Plate 11) and a likely smoke room (Room 4, Plates 9, 10), with an added partition to stage a dart board (Area 4a). The latter room lacks seating and may have housed a billiard table. An inner door at the central entrance off High Street reads 'Smoke Room' and this has probably been moved from another position. This entrance also faced a slightly recessed part of the bar where off-licence sales may have taken place.

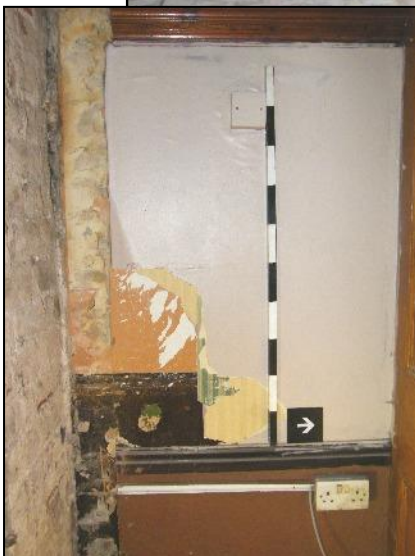
Three of the rooms had fireplaces. Room 1 has a colourful marble fireplace with tiles (Plate 11), Room 4 has a cast iron surround with rounded top and tiles in the hearth (Plates 9, 10) and Room 3 had a kitchen range, recently removed. These all appear to have been of late 19<sup>th</sup> century date. Part of an earlier dark brown and orange decorative scheme is also exposed next to the fireplace in Room 3 (Plate 7).

Plate 7: Evidence of a former decorative scheme revealed next to where the kitchen range used to be.

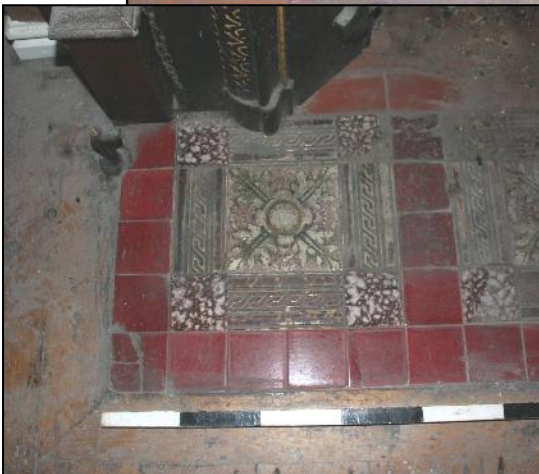
Plate 10: One of the decorative tiles at foot of the fireplace in Room 4.

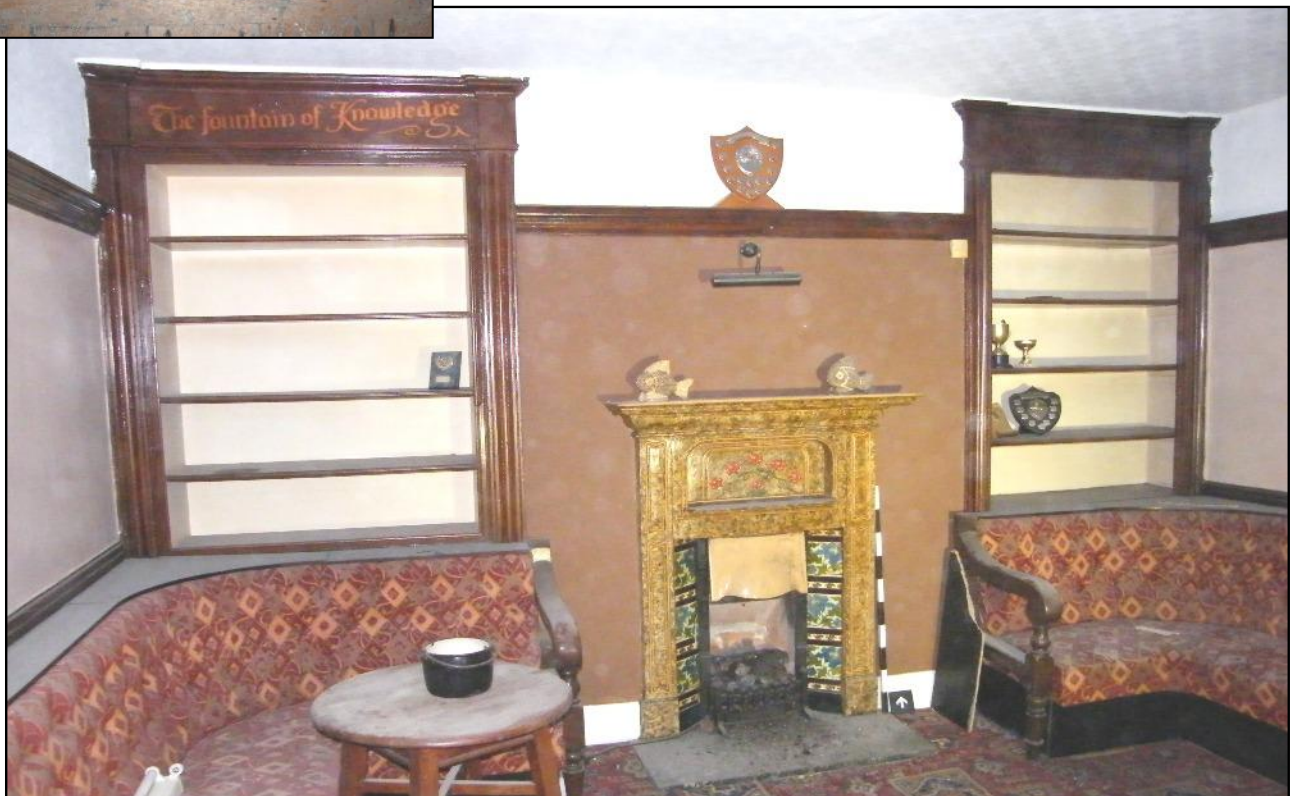
Plate 11: North end of Room 1 showing shelving and decorative Victorian marble fireplace.

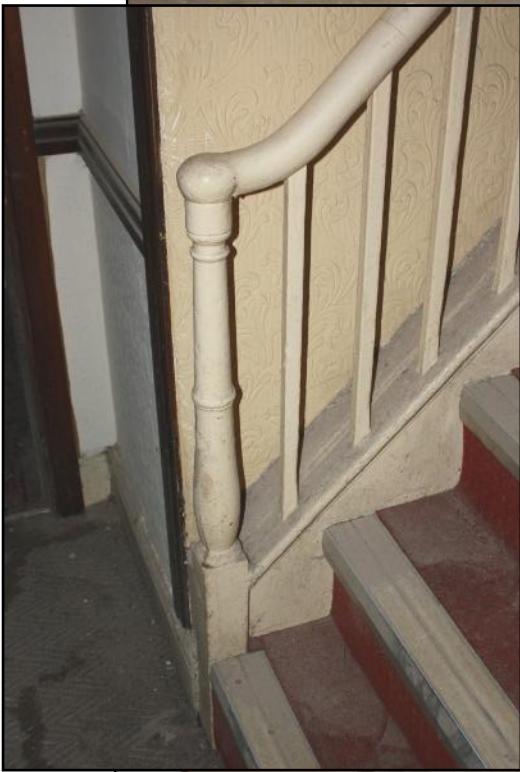
The upper floor (Rooms 9-17; Figure 9) is reached up a straight flight of steps, again of likely late 19<sup>th</sup> century date (Plate 13), that leads to a landing and to two parallel passageways. The upper rooms are separated mainly by thin half-brick and wood paneled partition walls. All windows are of likely 20<sup>th</sup> century date (Plate 12) and, as below, three rooms appear to have been heated at one time. The north-west room at 3-bay length is the largest room and was clearly used for functions. It had a small fireplace at the north end and a doorway leading to fire-escape in the west wall (Plate 14). Few details of any historical significance remain on this upper level.

Plate 13: Newel post of staircase.

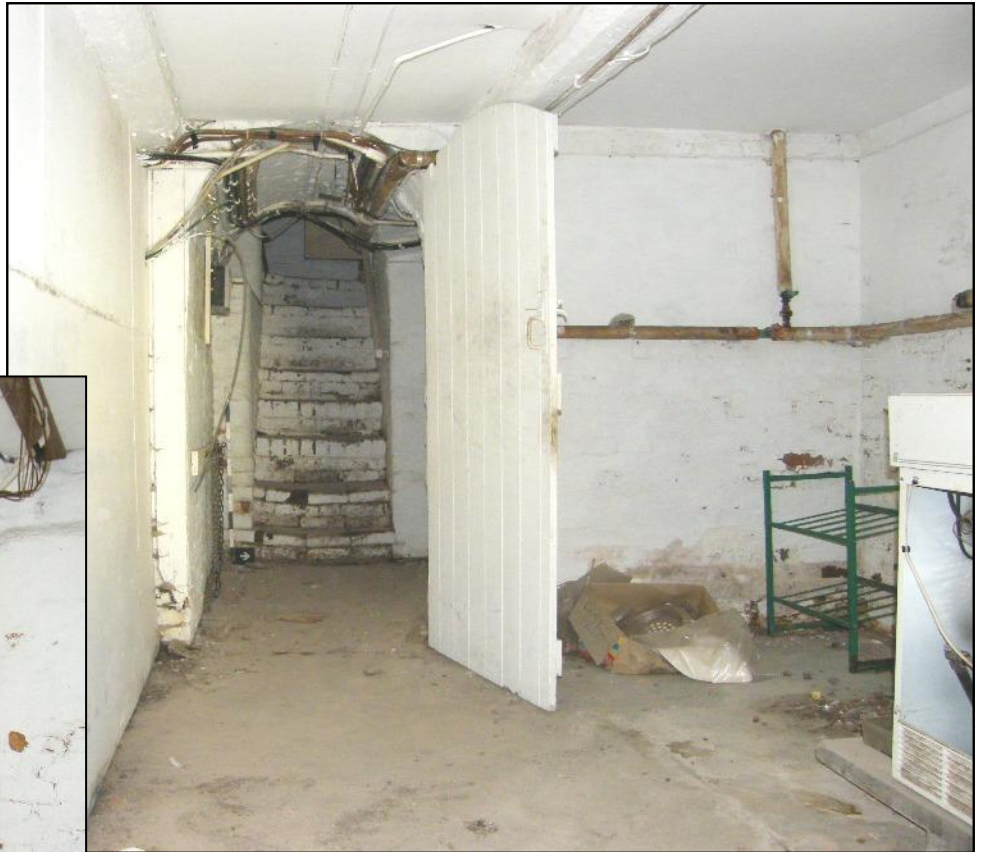
Plate 15: View of the Cellar 2 looking towards current staircase, and showing ceiling beams.

two larger cellars that run beneath the east range of the building, but are very different in appearance. Cellar 1 has a barrel-shaped brick ceiling and low thralls (Plate 17). On the south side there is an earlier flight of steps which originally descended from a position now under the bar-counter. Barrels and stock were delivered through a hatch and down a chute at the south end. Cellar 2, in contrast, has a higher flat ceiling supported by three irregular shaped beams, two of which have a similar end curve suggestive of being two halves of a split timber (Plate 15). It has no thralls but has an added thin partition that now divides it into two spaces, 2a and 2b. There are no obvious signs that these cellars differ in date, apart from the likely introduction of walling associated with the present entry steps.

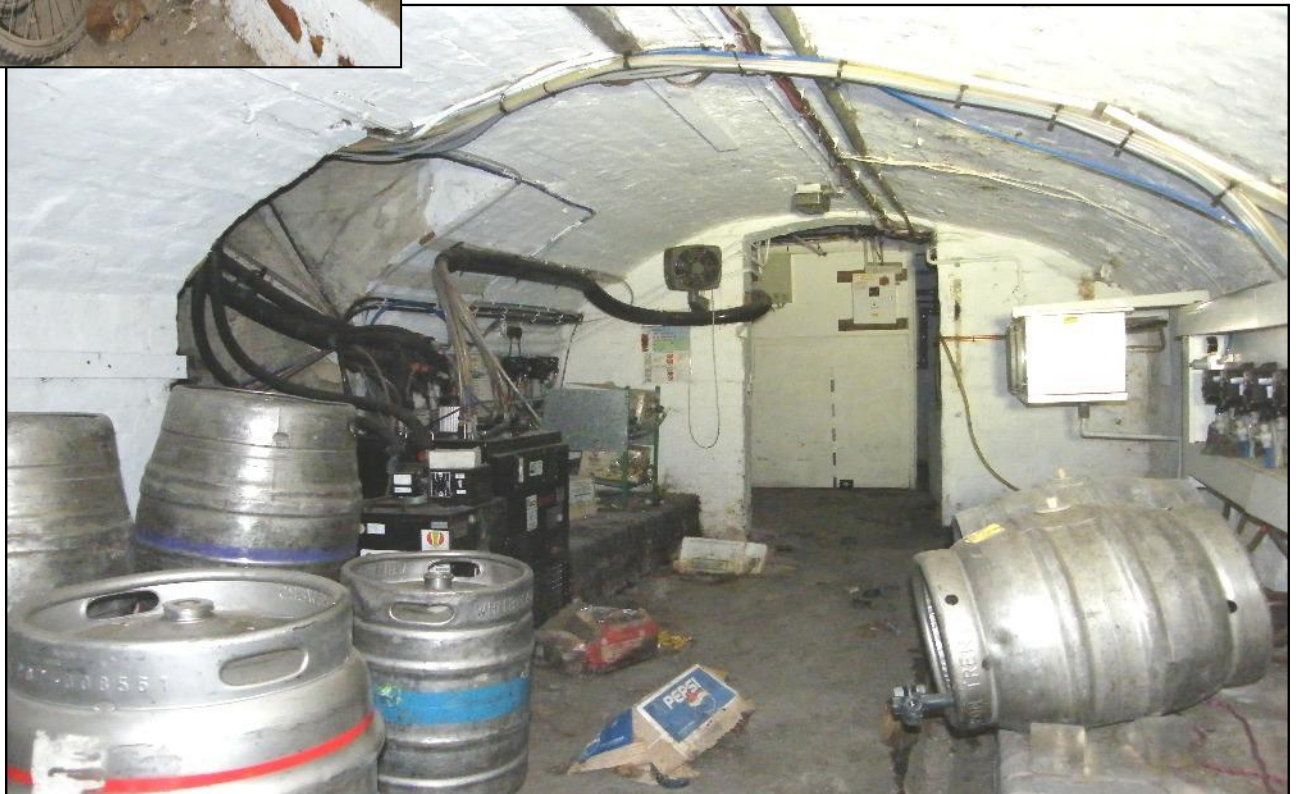
Plate 17: View of Cellar 1, looking towards Cellar 2, with former entrance showing to left, behind barrels.

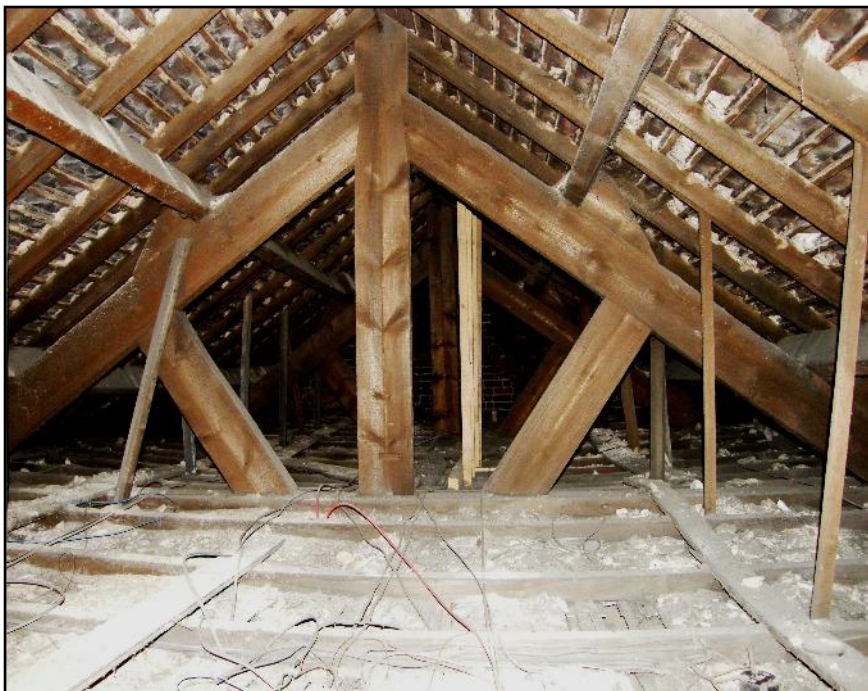
The North-west roof comprises two king post trusses forming three bays. It has a plank ridge and back purlins resting on cleats. Struts rise from the tiebeam to the principal rafters on each truss (Plate 18). All the timbers are machine sawn softwood. The roof is of a single phase and of modern date.

Plate 18: North-west Roof, Truss 1, viewed looking north.

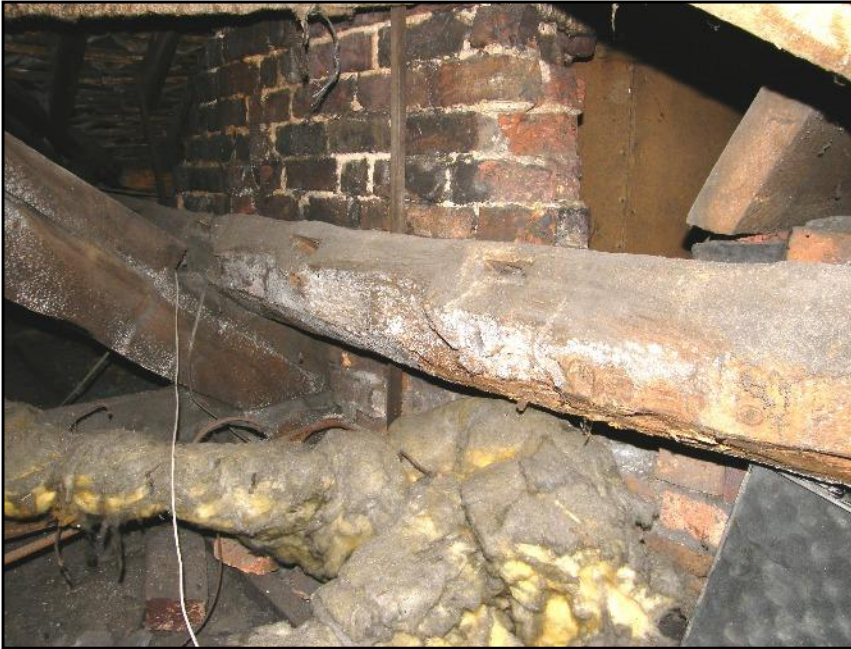
Plate 21: South Roof, north lower purlin with empty mortice holes indicating it is a reused timber, viewed looking north-west.

It appears likely that the roof of the early building, comprising the south and east elements of the property, was replaced in the late 19<sup>th</sup> century. It is tempting to suggest that the reused oak timbers forming the South Roof originated from this early building. The North Roof also utilises much reused material, although consisting of softwood rather than oak. The North-west roof is relatively modern and contemporary with the brickwork.

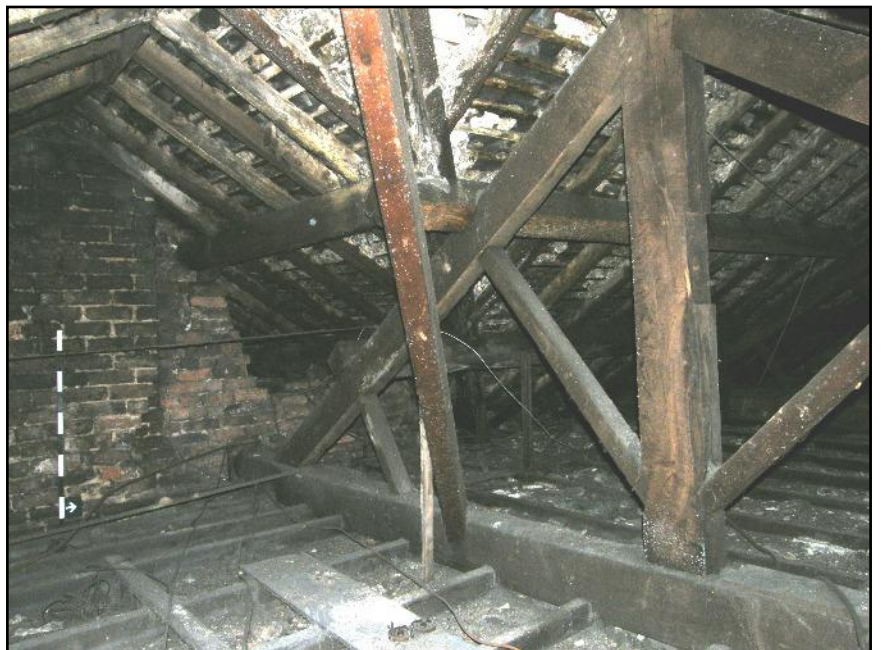
The East roof comprises two king post roof trusses forming three bays. It has a plank ridge and trenched purlins. Struts extend from the king post and tiebeam to the principal rafters (Plate 22). The south east corner of the roof is hipped using a hip rafter extending from the wall plate to the ridge which is supported by a further timber which is trenched into the tiebeam of Truss 2 and placed beneath the ridge where it joins with the hip rafter (Plate 23). The roof is constructed of machine sawn softwood timber and is of probable dates to the late 19<sup>th</sup> century.

Plate 22: East Roof, Truss 2, viewed looking north-west.

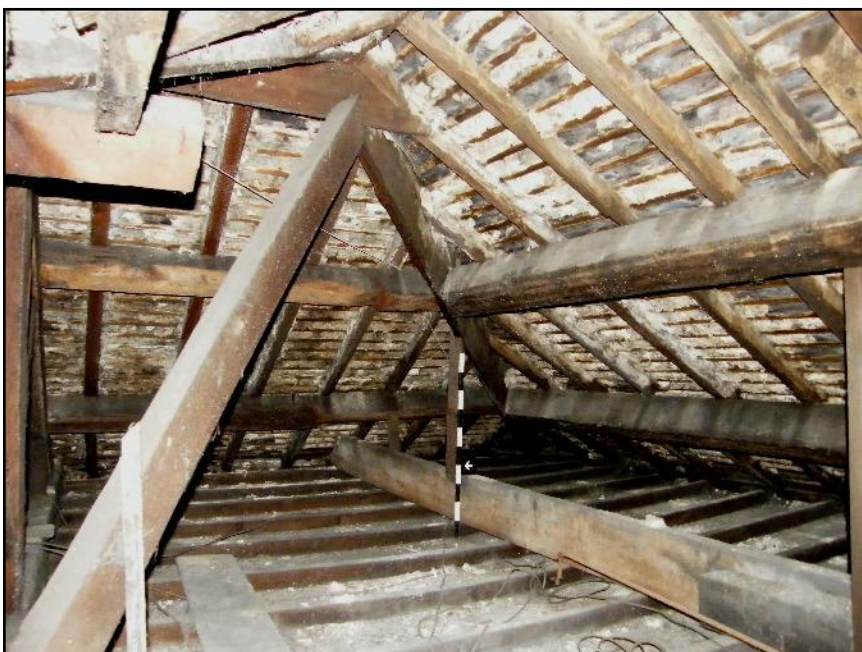
Plate 23: East Roof, with the hip rafter in the background and the timber support for the ridge and hip rafter in the foreground, viewed looking south-east.
