# TEN WARDS LANE, BREASTON DERBYSHIRE.

## Report of an Archaeological Watching Brief

Project Code - TWL

TPA Report No. 101/2013

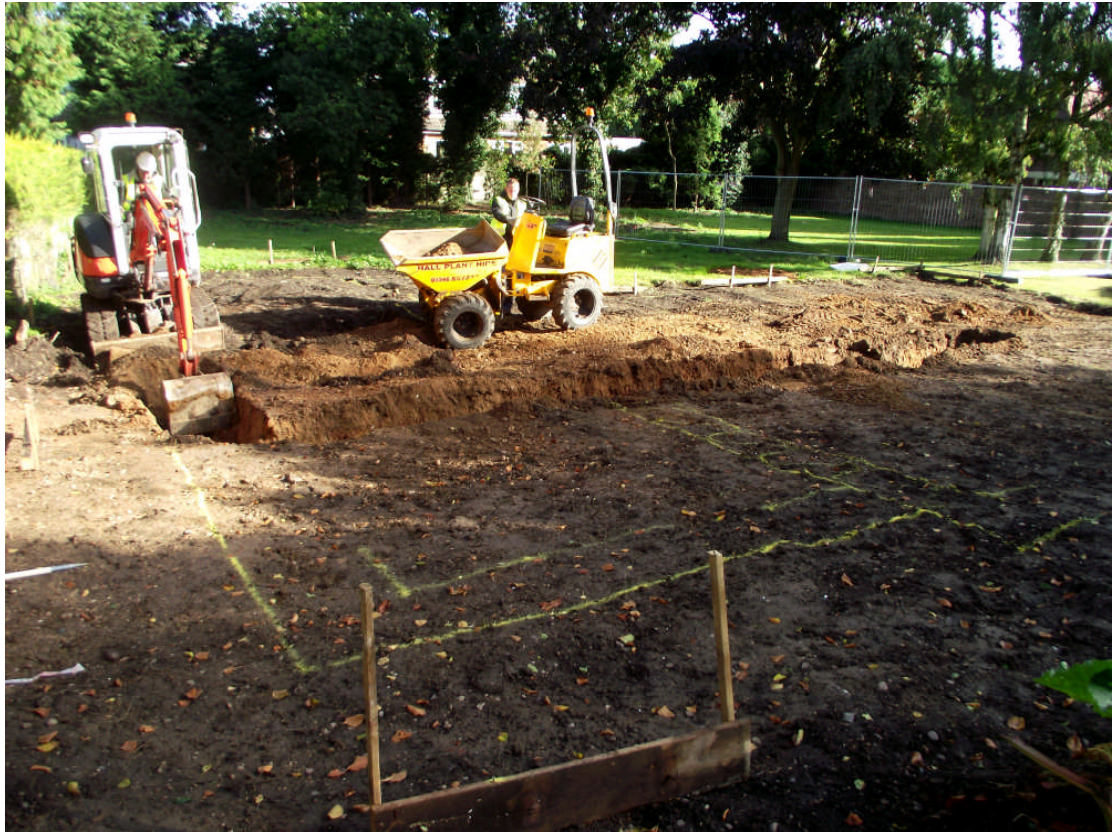
Plate 1. Trenching on site. Looking north east.

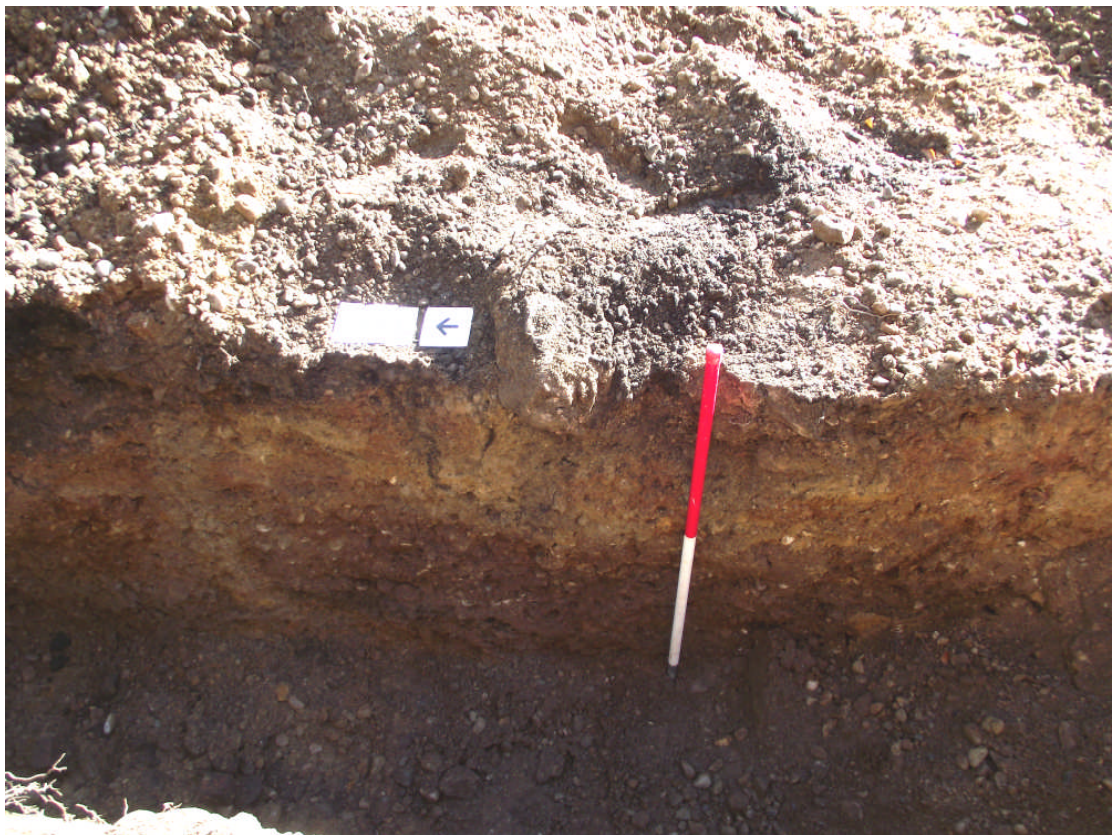
Plate 2. West facing section of Area 02. Looking east.

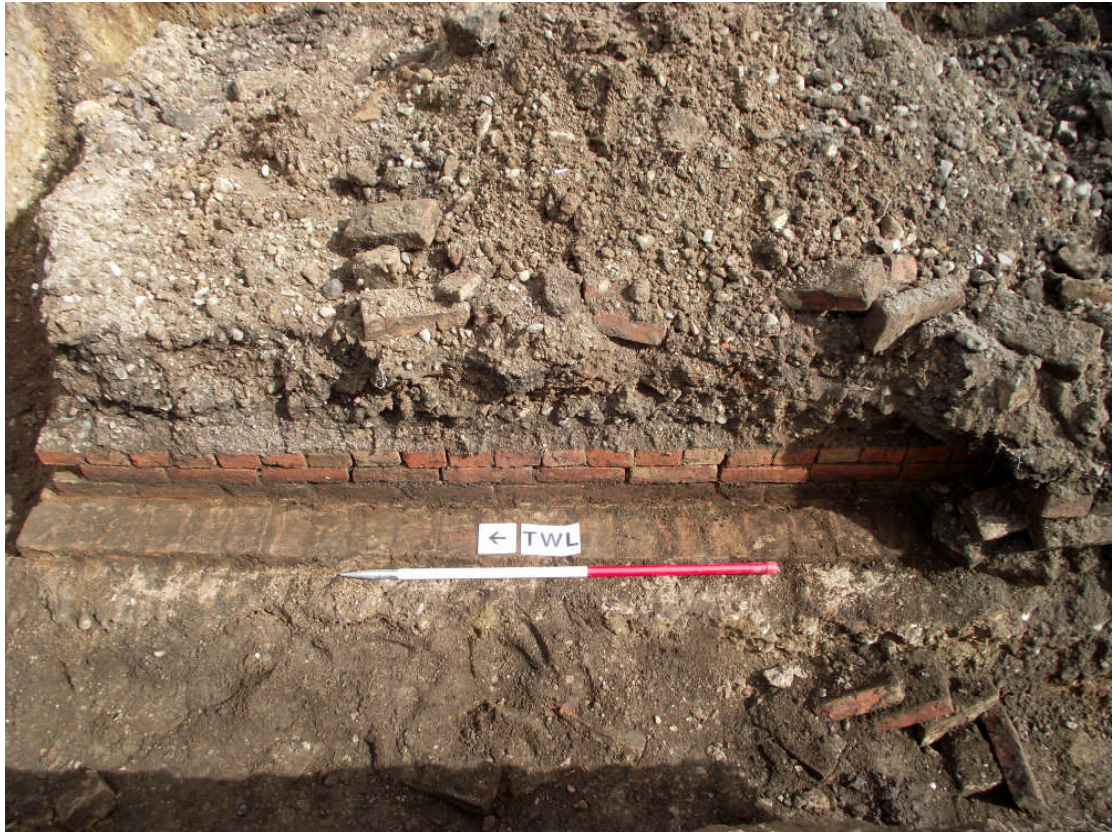
Plate 3. Brick culvert, 0006, Area 08. Looking east.

6.3 Area 08, Area 13. The trenching in these areas revealed a brick culvert, (0006), that ran across the front of the demolished barn.(Figure 4d, Figure 4e, Plate 3, Plate 4, Plate 5).The culvert connected to a salt glazed pipe with threaded ends, a type common in the late 19<sup>th</sup> early 20<sup>th</sup> century, (Lee Elliott, pers.com.). A similar arrangement was observed at the southern end of the culvert.

6.4 The culvert has been interpreted as part of the barn structure and may have functioned as a means of effectively disposing of detritus built up inside the barn whilst in use. The drain system appears to connect with drains in Wards Lane immediately beyond the property's southern boundary.

6.5 The bricks that the culvert was constructed from appear to be much older than the structure itself. Measuring 9½" (23.5cms) x 4¾" (11.5cms) x 2¾" (7cms) they are of a type that are usually found in buildings dating to the 17<sup>th</sup> century or early 18<sup>th</sup> century (Richard Sheppard, pers.com). The barn itself is not present on historic OS mapping and it is reasonable to conclude that its construction occurred sometime in the early 20<sup>th</sup> century. The bricks used to build the culvert have almost certainly been obtained from a nearby demolished structure and then re used.

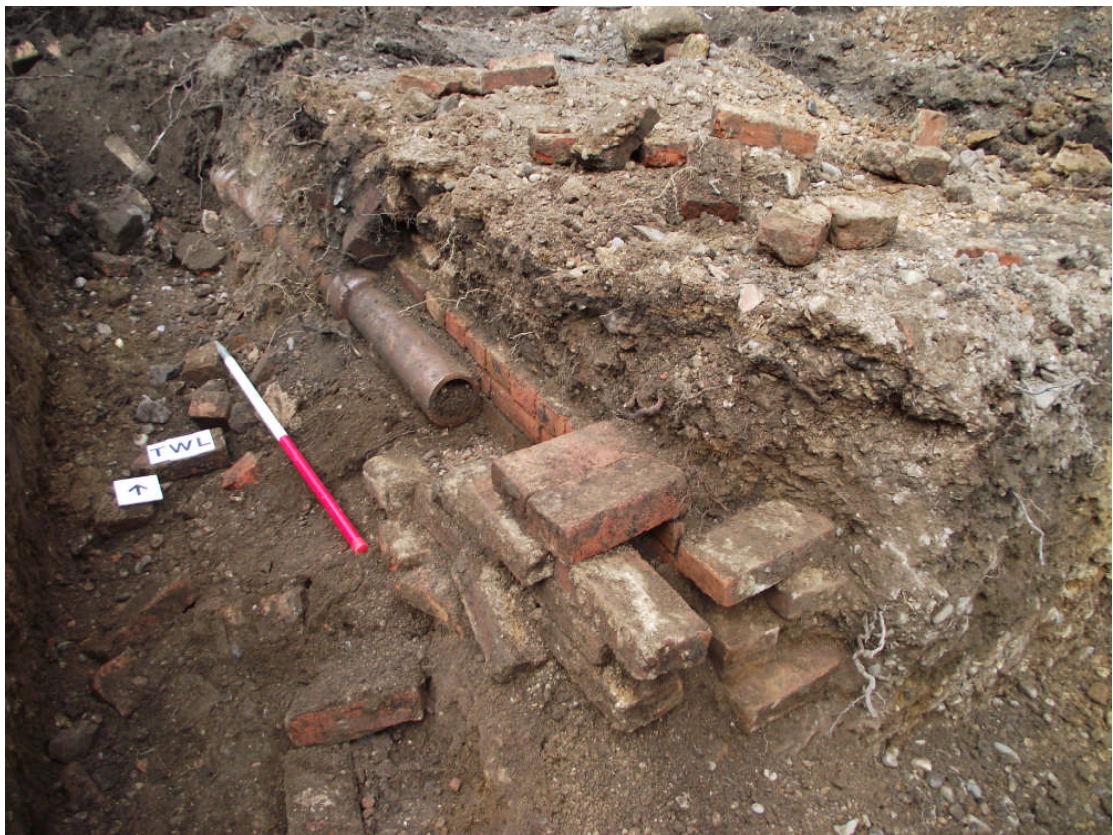
Plate 4. Brick culvert, 0006, with salt glazed pipe in situ in Area 13. Looking north east.

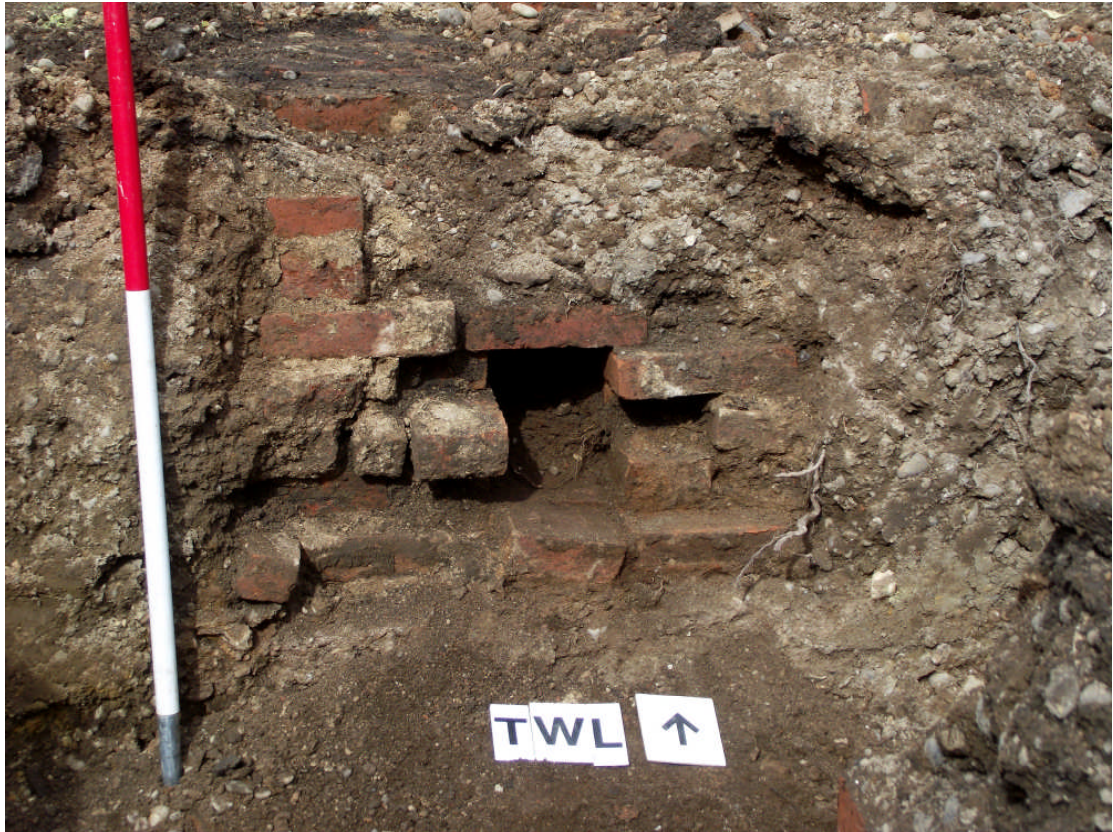
Plate 5. South facing section of brick culvert, 0006, at the junction of Area 01 and Area 13. Looking north.

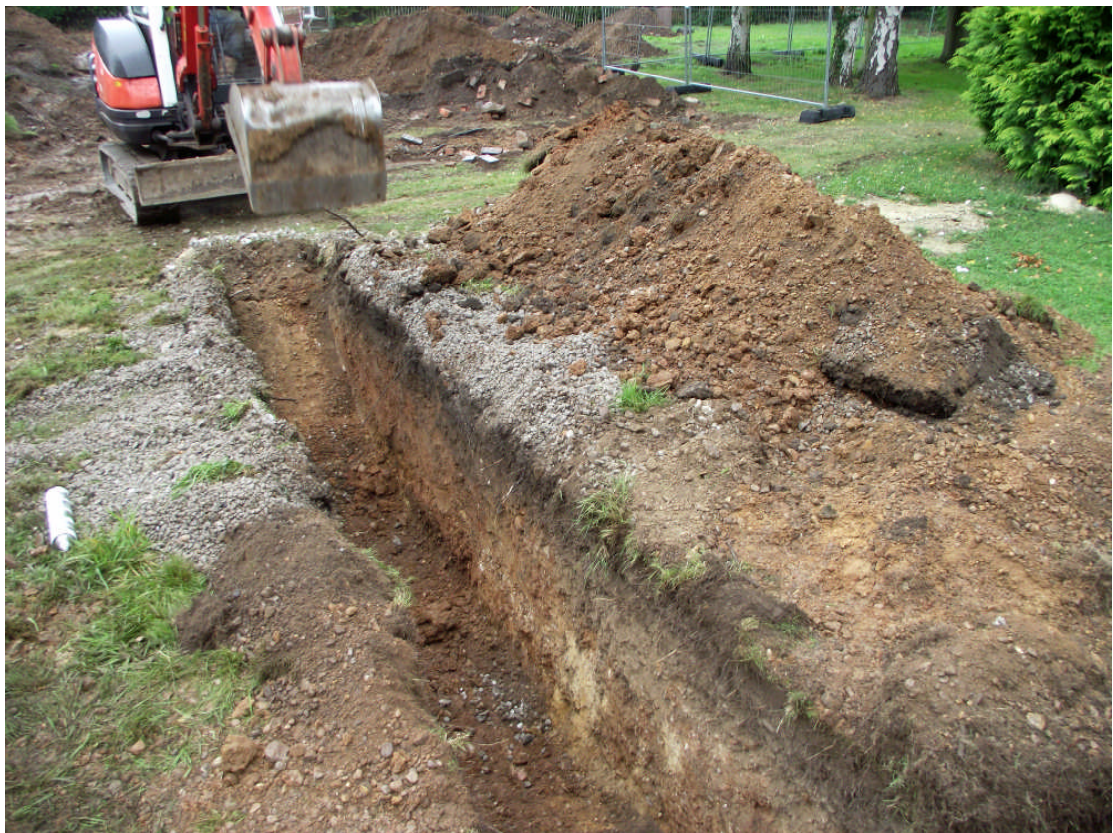
Plate 6. South facing section of Area 12 with top soil, 0001, lying directly over the natural sand and gravel, 0002 and 0003. Looking north west.

6.1 Area 01, (Figure 3a), Area 02, (Figure 3b) Area 03, (Figure 3c), Area 04, (Figure 3d), Area 06, (figure 4b) Area 07, (Figure 4c) Area 09, (figure 4f) Area 10, (Figure 4g) Area 11, Area 12 (Plate 6) and Area 14 revealed the same stratigraphy but with varying depth of top soil, (0001). In area 03 and Area 04 a rubble layer, 0005, was interposed between the top soil, 0001, and the natural sand and gravel, 0002. The rubble layer, 0005, comprised broken bricks and lumps of stone mixed with gravel. This layer may be associated with ground levelling.

7.1 The topsoil across the site sits directly above the natural sands and gravels with no intervening sub soil layers. This suggests that there has been an element of landscaping over the site prior to the present development.
