**COLWICK COUNTRY PARK, COLWICK,
NOTTINGHAM,**

FLOOD ALLEVIATION WORKS,

Report on an archaeological watching brief 2011

TPA Report No. 024/2012

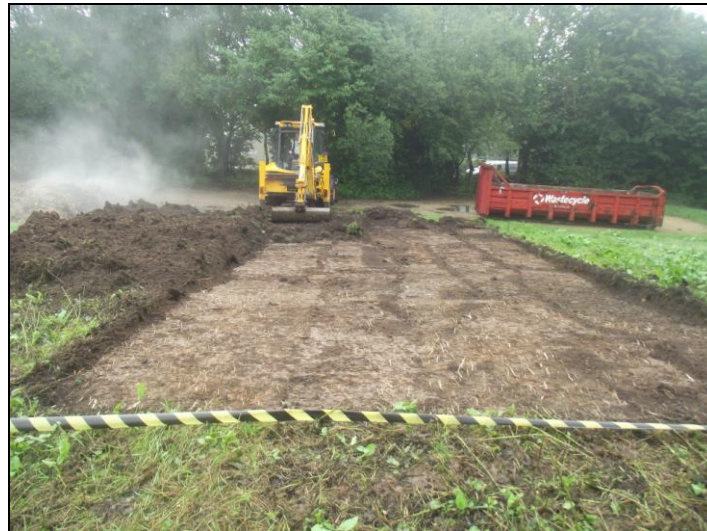
Evaluating mound, 0007. Looking east

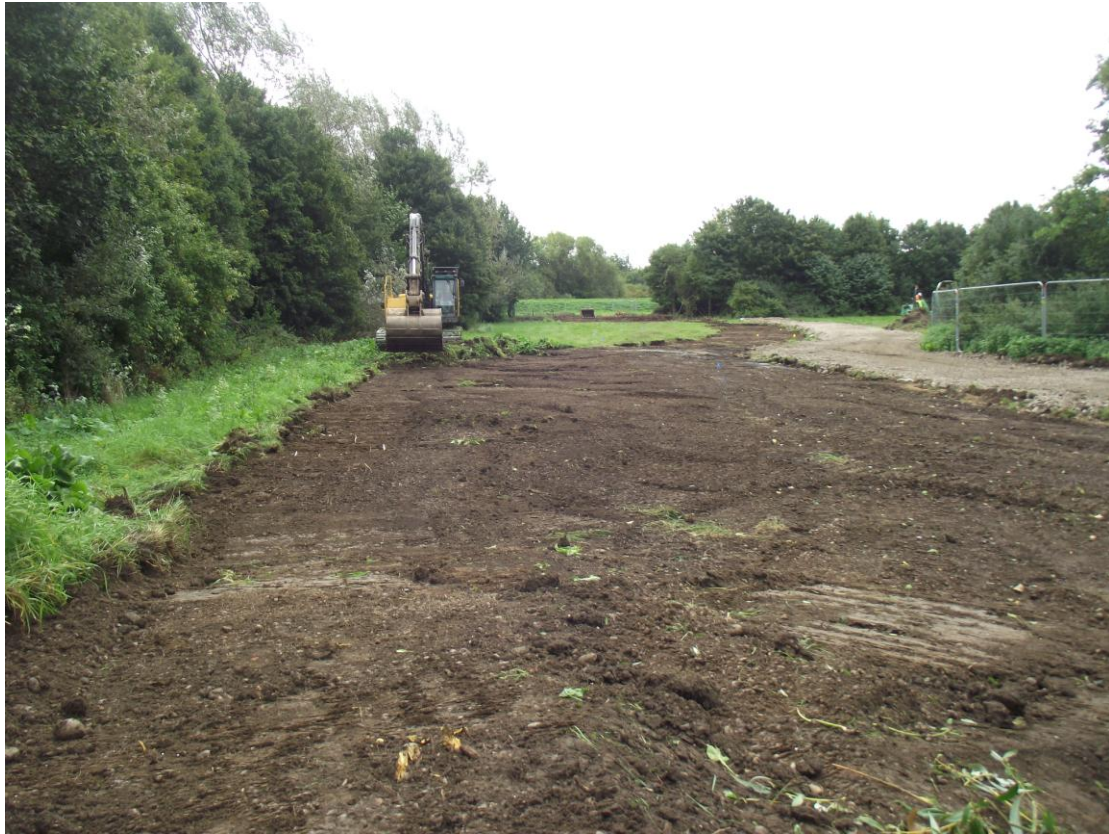
4.1.1 The top soil, 0001, was removed by a tracked machine using a bladed ditching bucket to an average depth of 300mm. This revealed a light brown sandy loam sub soil, 0002. There were no archaeological features or artefacts revealed as a result of the soil stripping. Plate 1

PLATE 1. Top soil stripping in Area 01. Looking east.

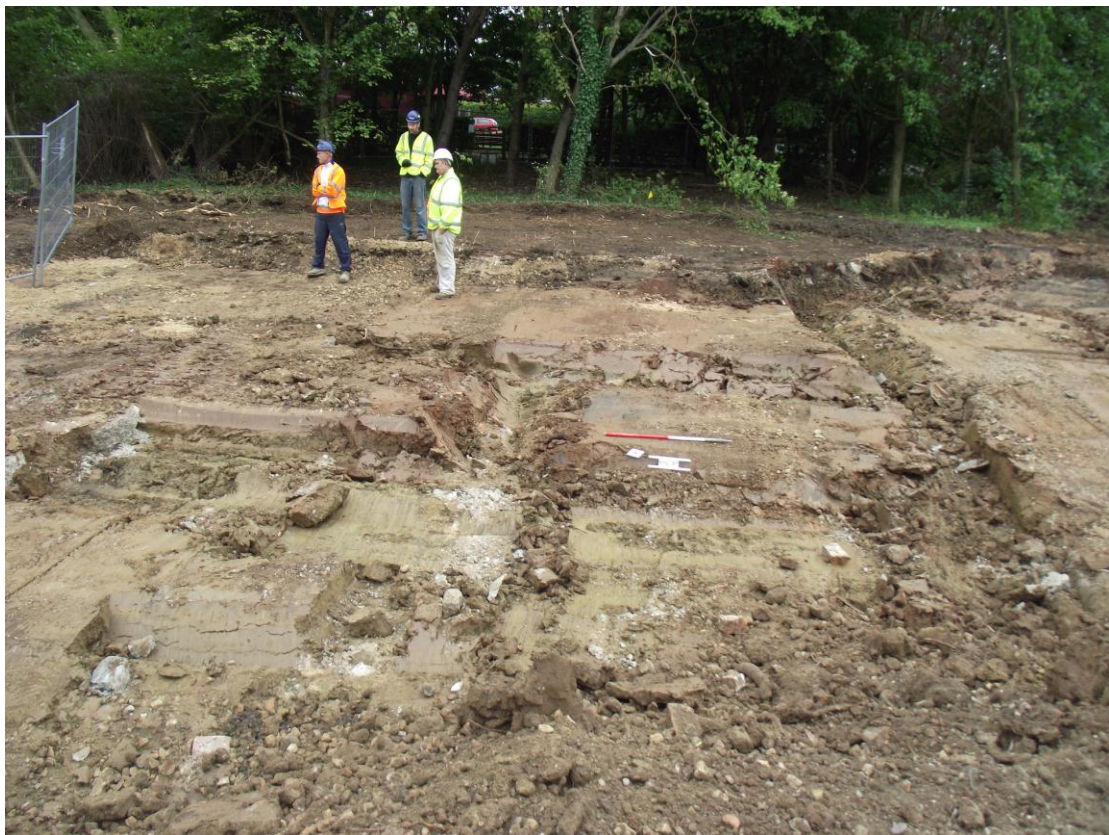
6.2.2 After the removal of the top soil the foundations of a modern structure, 0008 were revealed. This took the form of brick foundations built on a concrete base. The structural remains have been identified by Officers of Nottinghamshire County Council as the foundations of a now demolished information centre that had been situated in the Country Park. The structure had been demolished some time in the 1980's. Plate 2.

PLATE 2. Area 02, 0008. Footprint of demolished modern building.

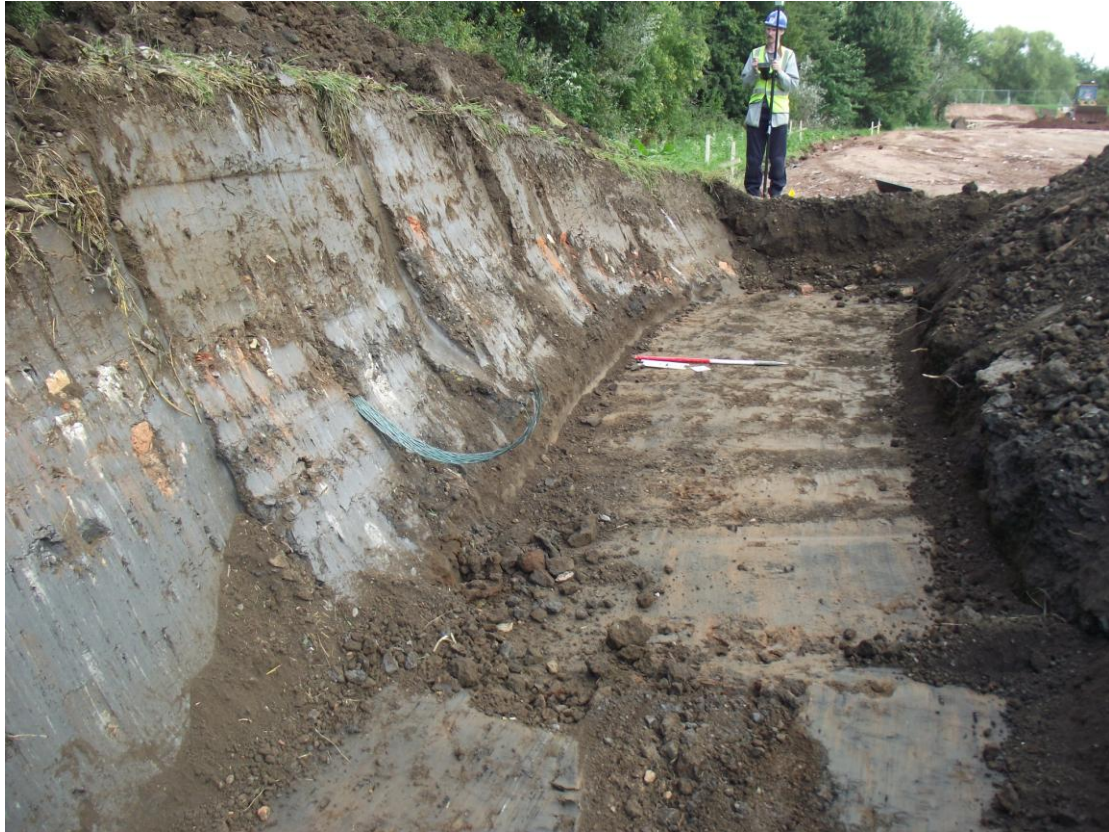
6.2.3 Immediately north east of Area 02 was a mound, 0004. The edge of the easement cut through the south western edge of 0004 and the revealed section was recorded. Figure 5, Plates 3 and 4.

6.2.4 After investigation 0004 has been interpreted as a modern deposit. The bulk of its make up was grey clay with brick and other building rubble. The base of the clay was immediately above a soil layer very similar to 0001 which has been interpreted as the original ground surface. It is likely that the mound is comprised of left over material from either the erection of earlier flood defences or from the building of the modern housing estate to the north east of the site. In both cases the mound would not pre date the mid to late 20th century.

PLATE 3. Exposed section of 0004. Looking east.

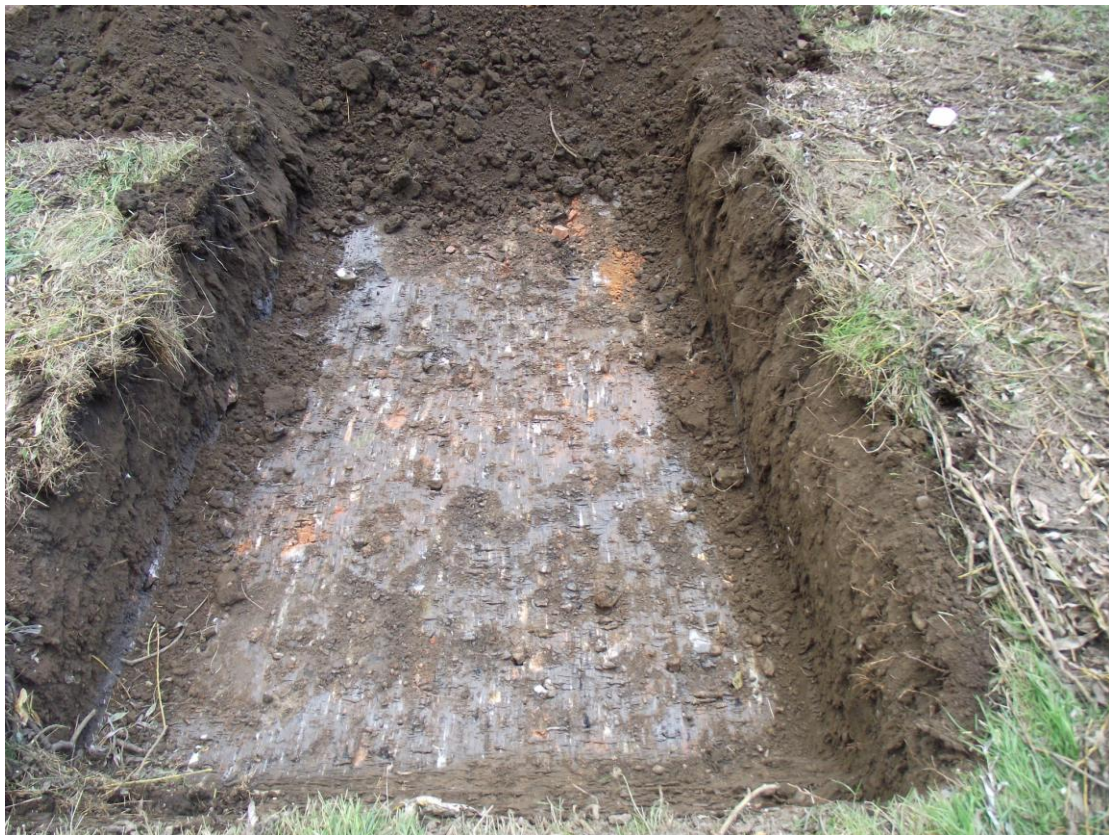
PLATE 4. Detail of excavation of 0004 showing modern bricks in the grey clay matrix. Looking north.

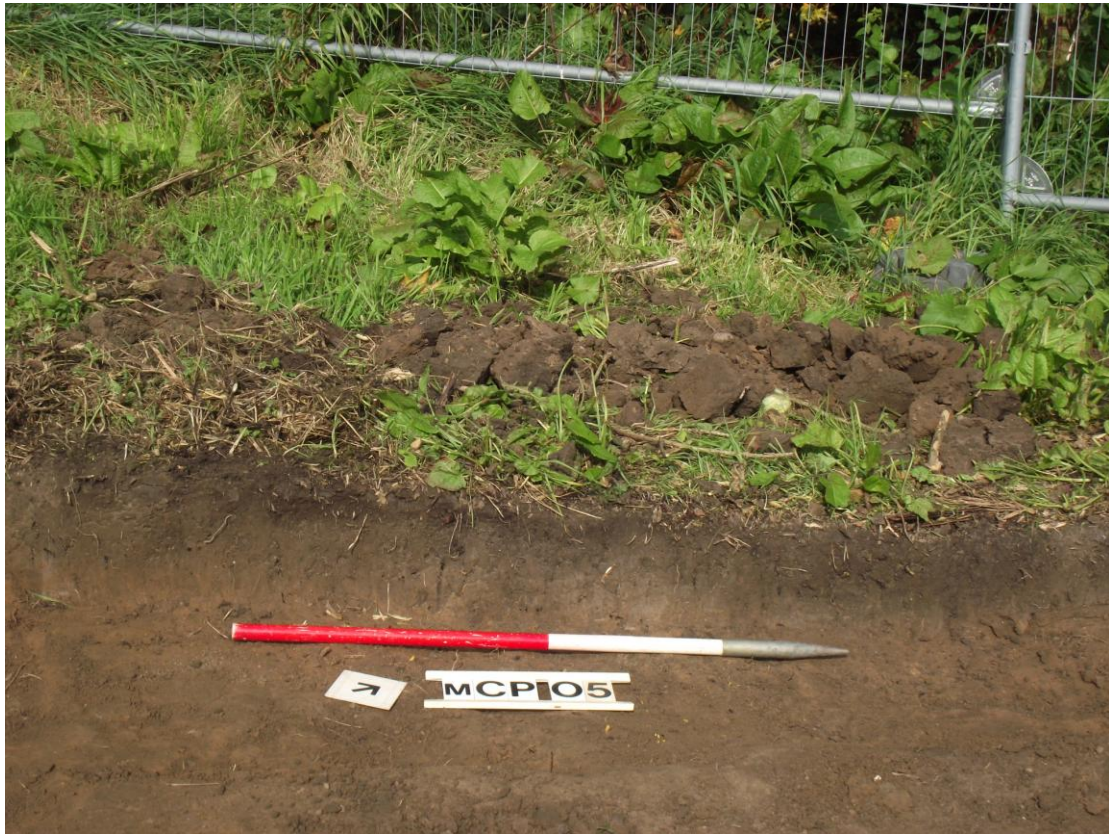
6.3.3 It was apparent once 0001 had been removed that the ridges had been made up largely of the top soil. The surviving furrows, 0003, 0005 and 0006 were excavated, and recorded by photograph and drawing, Figure 4 and plates 5, and 6. No dating evidence was recovered as a result of the excavations.

PLATE 5. Furrow base, 0005. looking north west.

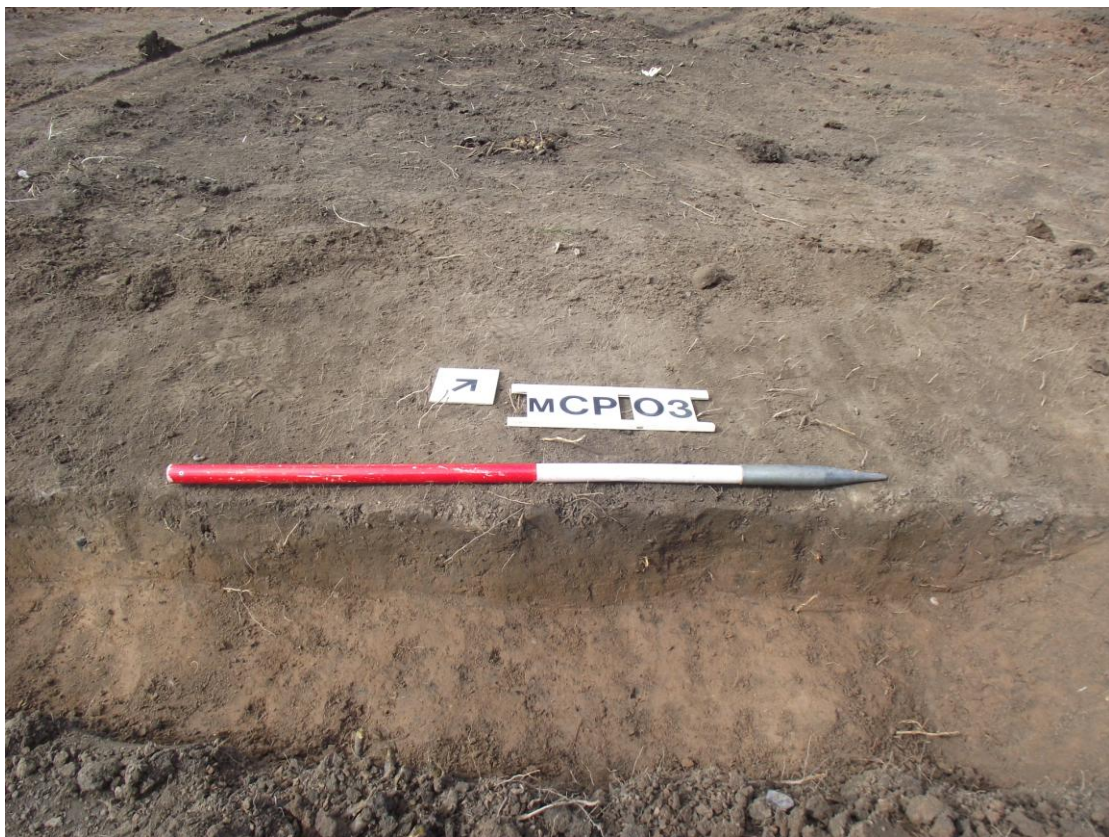
PLATE 6. Furrow base 0003. Looking north west.

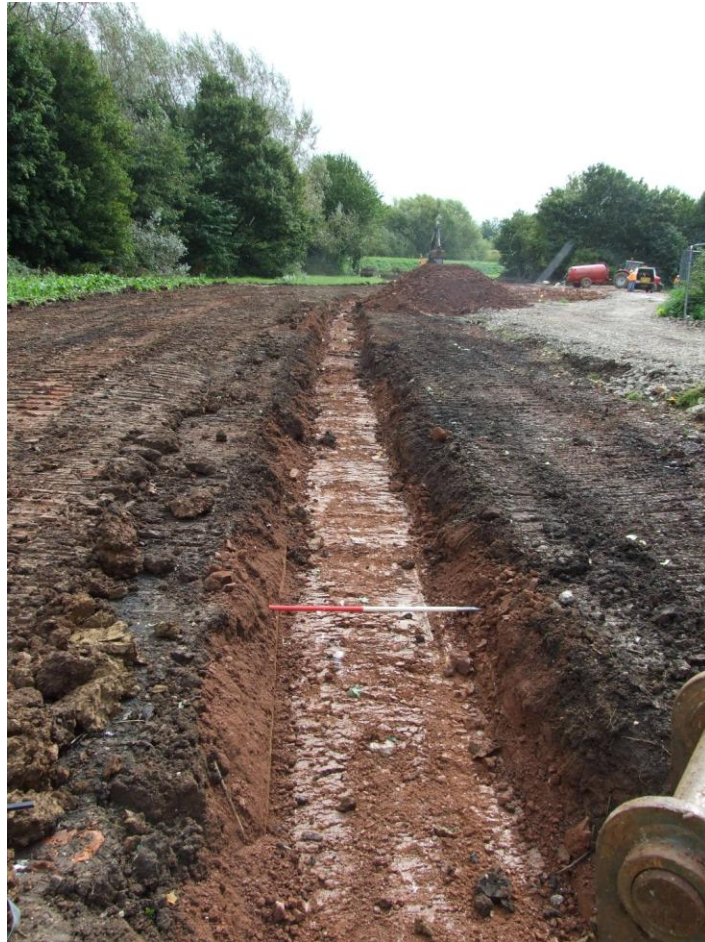
6.4.1 A key trench was cut along the entire length of the stripped surface in Areas 01, 02 and 03. Plate 7. This was then backfilled with clay to provide an impermeable base for the new flood defence.

6.4.3 The exposed sections of Area 04 revealed undisturbed red clay, 0009 which in area 03 overlay a deposit of grey/green stiff clay, 0010. Both of these layers form part of the alluvium which overlies the sandstone bedrock on the site.

Plate 7. Area 04, Key Trench cut through Area 01. Looking east.

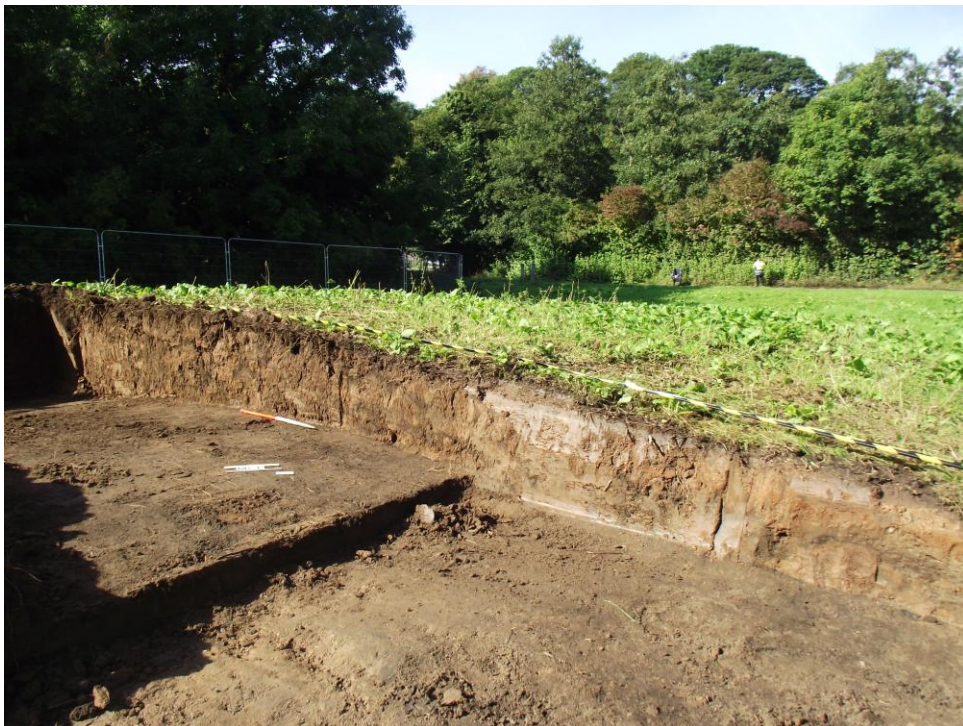
6.5.5 An examination of the sections and the observation of the stripping that revealed them demonstrated that 0007 was of recent origin. The make up of the mound being a yellowish/orange sandy silt with blocks of red clay giving the appearance of recently deposited material. Within this there were laminations of a similar material to the top soil, 0001, recorded elsewhere on the site. These have been interpreted as tip lines produced during the construction of 0007. There were occasional pieces of modern brick observed in the exposed sections of 0007.

PLATE 8. South east facing section of 0007. Looking north west.

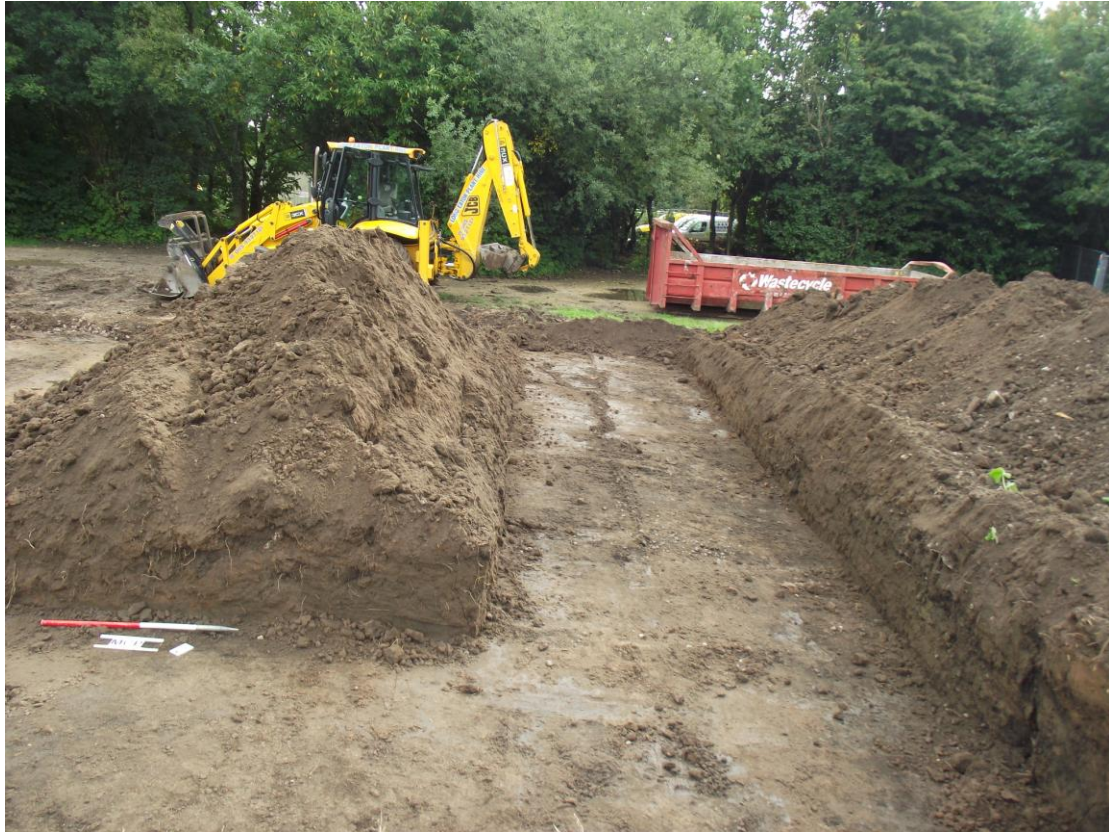
PLATE 9. North west facing section of 0007. Looking south.

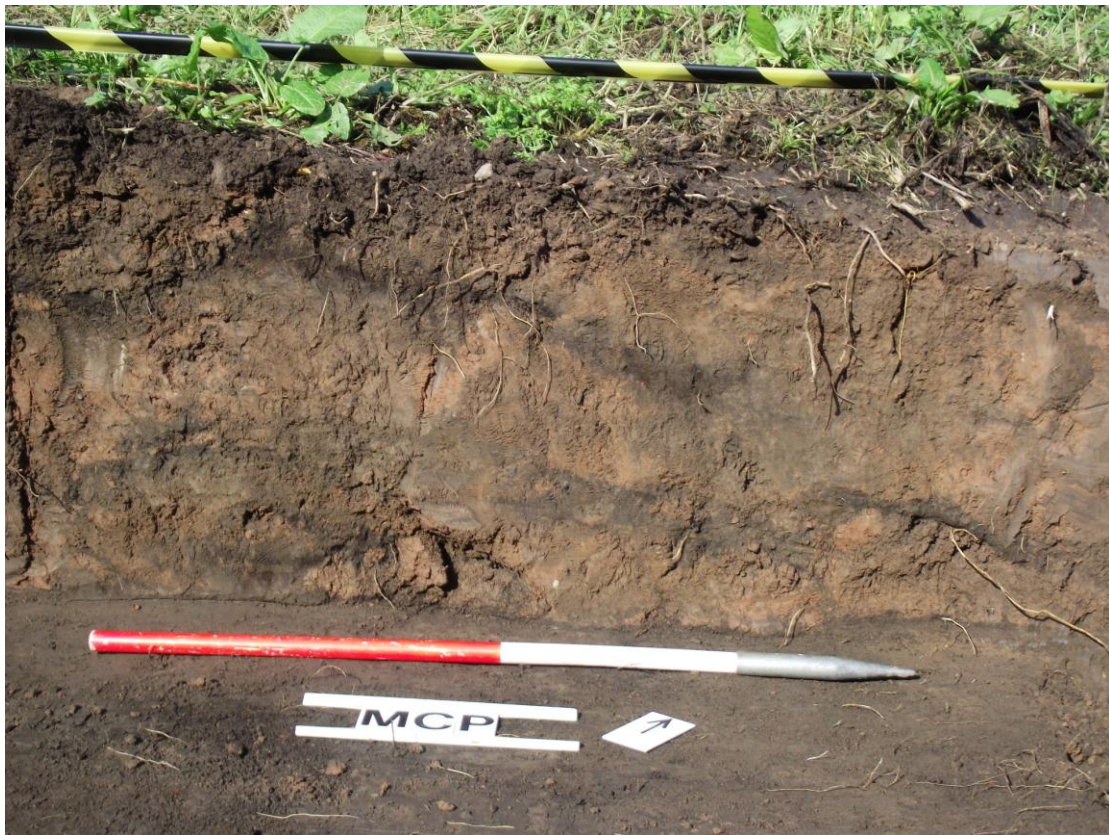
6.5.6 The whole mound appears to have been made up of modern deposits probably as a result of landscaping associated with the development of the country park.

PLATE 10. Detail of south east facing section of 0007 showing lenses of top soil within the matrix of the mound. Looking north west.
