ATTENBOROUGH FISH PONDS

Report of an Archaeological Watching Brief in Advance of New Flood Defences

TPA Report No. 074/2013

A Report on an Archaeological Watching Brief 2011

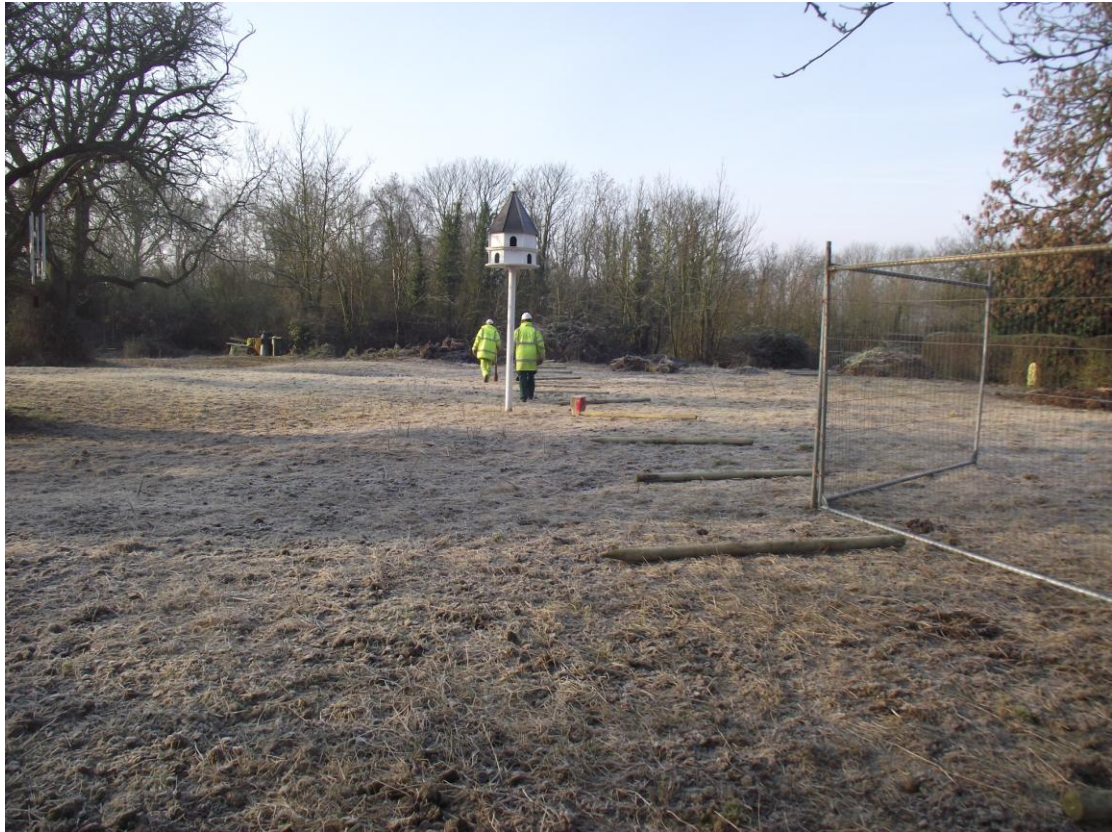
Plate 1. The Scheduled Area prior to the start of groundworks. Looking west.

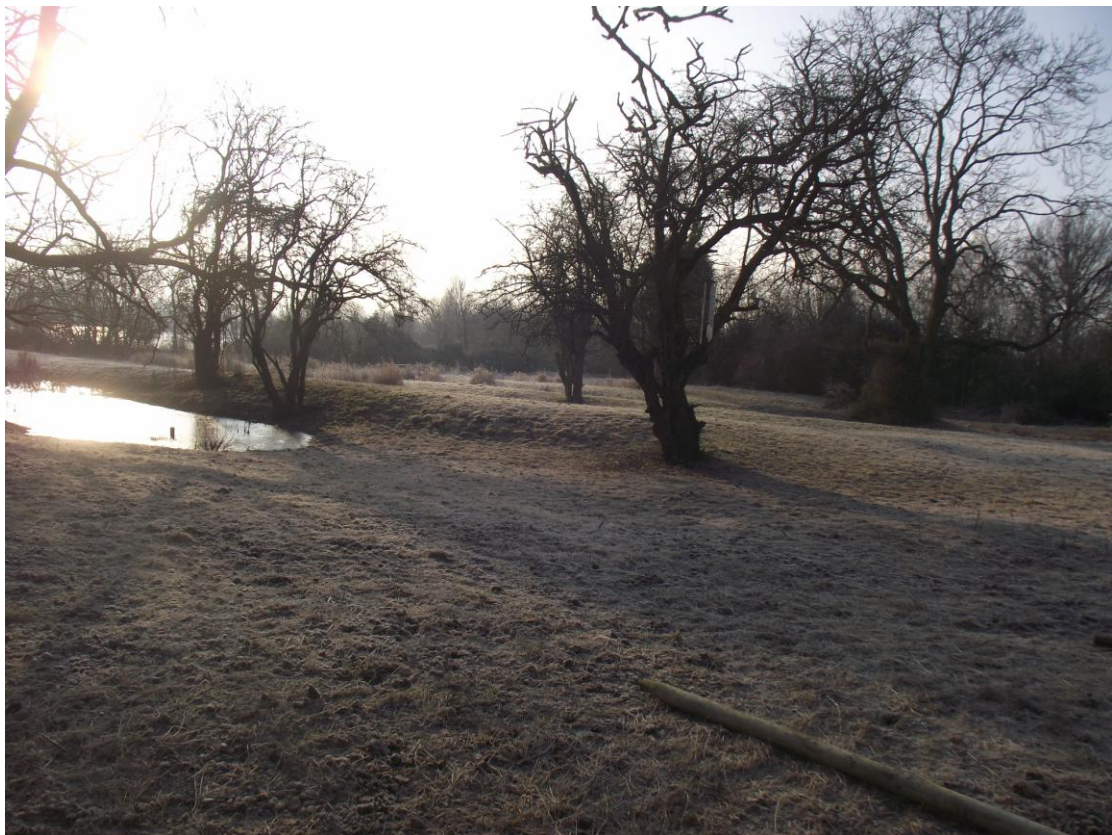
Plate 2. The Scheduled Area showing one of the fish ponds. Looking south west.

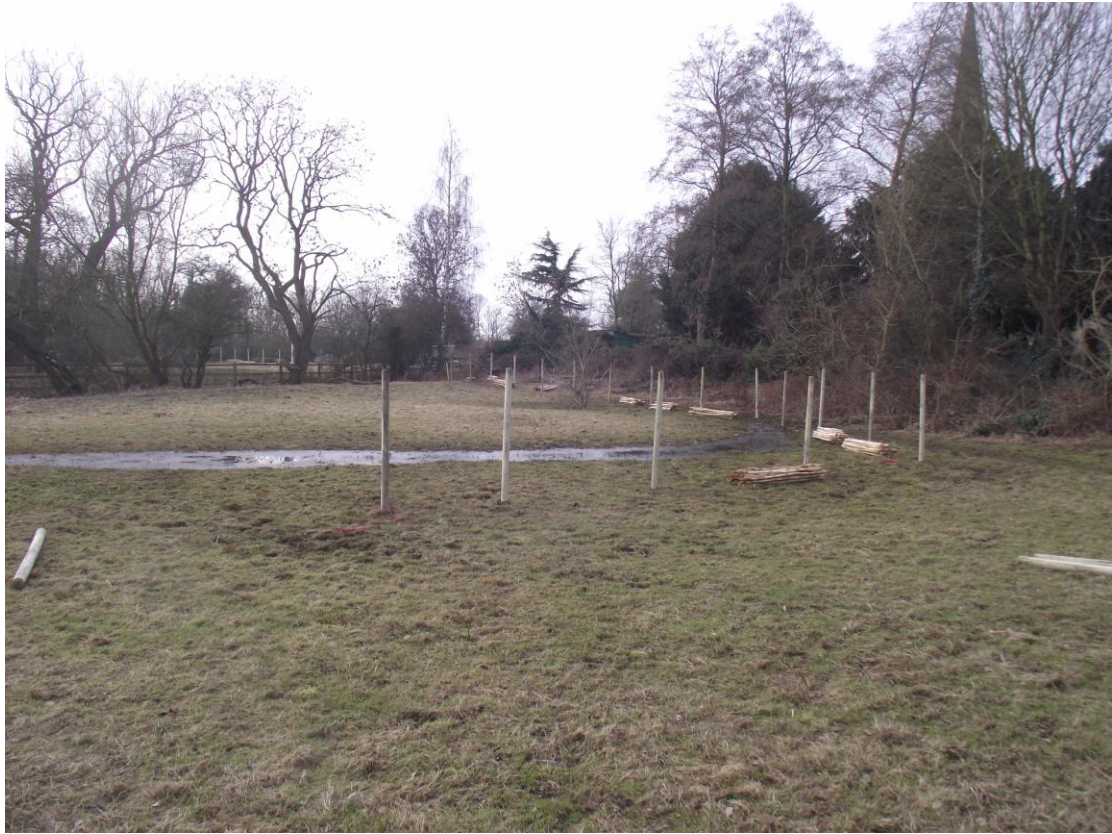
Plate 3. Fence marking the limit of ground work. The leat can be seen in the centre of the plate.
Looking west across Area 02 prior to stripping.

5.1.4 The leat, (0019), designed to circulate fresh water from the Erewash Stream into the ponds, is visible in the field immediately south of the churchyard. A 5m length of the leat, (0019), was exposed in Area 01 sealed below the top soil, (0001), and cut into the sub soil, (0021). The exposed length of the leat, (0019), was cut by the back fill of an evaluation trench (Tr-A3 excavated in 2005). The leat was not observed joining the field boundary/fishpond (0013). It was sealed beneath the subsoil washed down the slope from the potential bank of (0013). The remainder of the leat that runs southwards through the field to the east of 0013 lay outside the area of the groundworks and was not disturbed.

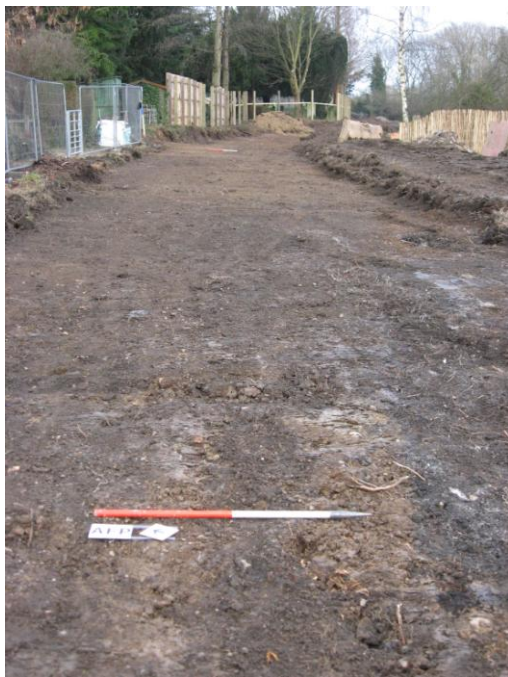
Plate 4. Stripped surface in Area 01.
Looking east.

5.1 Immediately north of the fishponds the stripped surface revealed interleaved layers of light to mid orange brown silty clay alluvium (0004) and mid brown to mid orange brown silty loam to silty clay loam subsoil (0002), the latter probably derived from the higher ground immediately to the north of the working area. There were no archaeological features present that may be related to the medieval fish ponds. Modern material comprising blue and

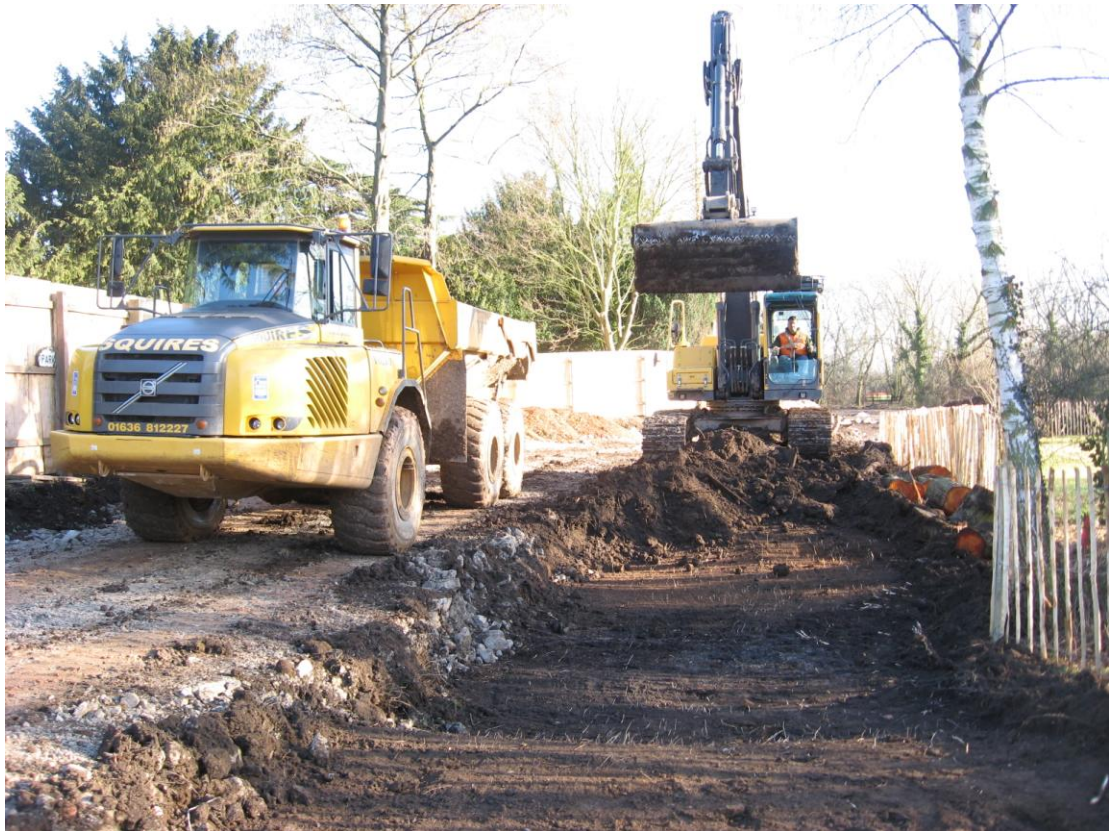
Plate 5. Stripping the southern half of Area 01 with dumper running on protected ground and the digger running on the top soil bund excavated from the northern side of the area. looking east.

4.2 The topsoil of Areas 01-03 was stripped using a 360° tracked excavator and the spoil temporarily stored as a bund to one side. The machine was then sited on the bund and geo-textile laid over the stripped surface. Crushed stone to a depth of 600mm was laid over the geo-textile creating a protective layer on which plant and equipment could travel without damaging the exposed surface. There was no machine tracking over exposed surfaces. An area up to 2.5m in width extending along the entire length of the proposed flood defence wall was excavated through the hardcore surface and geo-textile to the underlying deposits to facilitate the sheet piling. Once the sheet piling was in position trenching was undertaken adjacent to the sheet piles to the south-east, Area 04 and to the north-west, Area 05, for concrete foundations designed to further stabilize the piles. A further trench, Area 06, located to the north-west of the sheet piling and extending to the north-east for 23m from the south-west corner of the SAM, was excavated for the insertion of a drain.

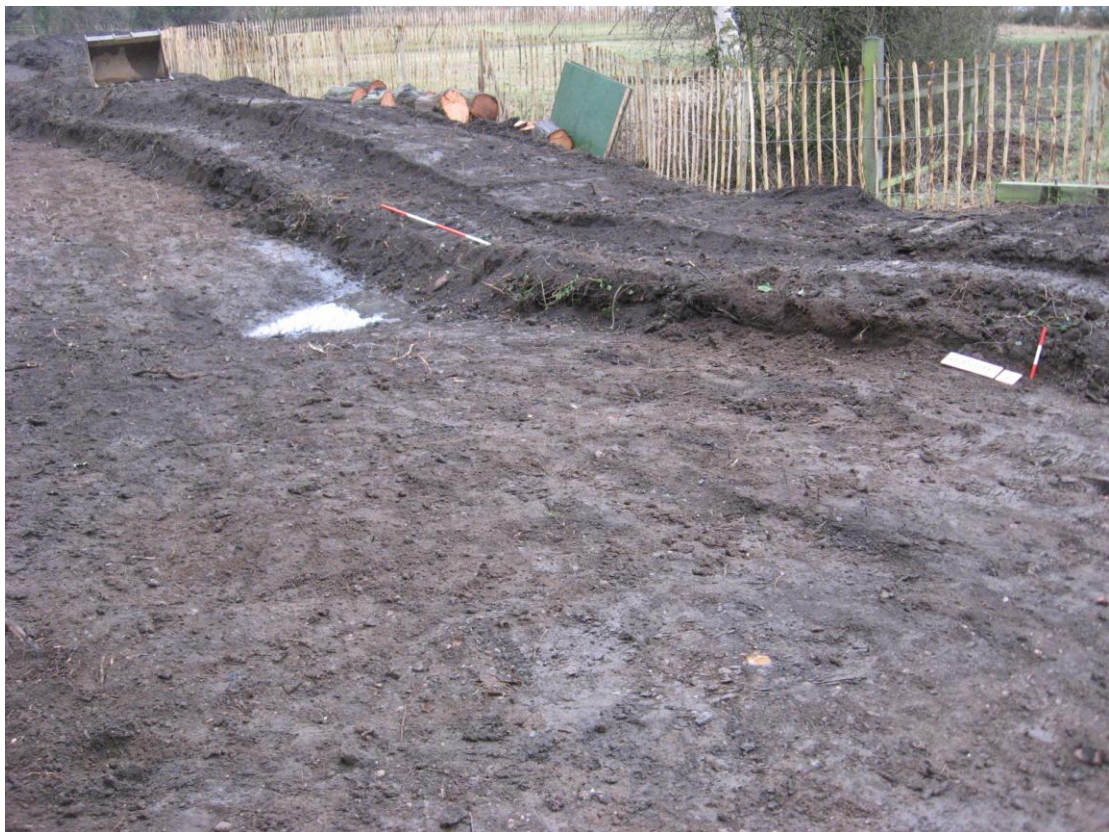
Plate 6. Field boundary/fish pond, 0013, after top soil has been removed. Looking south east.

5.1.2 The SAM is bisected by a north-west to south-east aligned field boundary (0013), believed to be a sixth fishpond. It measured between 9m and 14m in width and was machine excavated to a maximum depth of 0.60m. There was a rise in the level of the subsoil to the east of the linear suggesting the presence of a possible bank, presumably created by material up-cast during the re-cutting of the pond as a field boundary, or any subsequent re-cutting necessitated by its infilling of alluvium or subsoil. As it was within the SAM it was not fully excavated. Two silty clay layers containing modern material, (brown glass Marmite type jars), were revealed during machining and a mid orange brown silty clay subsoil layer from which a single fragment of tile (AAJ) was recovered.

6.2 Elements of the medieval fishpond complex within the SAM were encountered comprising the eastern most fishpond (0013) and a small portion of the leat (0019) used to circulate fresh water into the ponds. This pond, (0013), is now a modern field boundary and the infill may relate to later activity rather than the medieval fish pond itself. Although included in the National Monument description of the fish ponds in the absence of any detailed excavation of the site (which has not taken place) the existence of the sixth fish pond remains speculative. That part of the boundary, (0013), observed during the groundworks is likely to be an extension of the possible fish pond and may date to no earlier than the enclosure of the area in the 19th century.

The field boundary/fish pond, (0013), contained modern material comprising two 'Marmite type' brown glass jars and a single jar of the same material but stamped with Bovril. These jars clearly relate to the recent past whilst 0013 had become a field boundary. Located within the SAM no excavation took place and the feature was preserved in situ without further

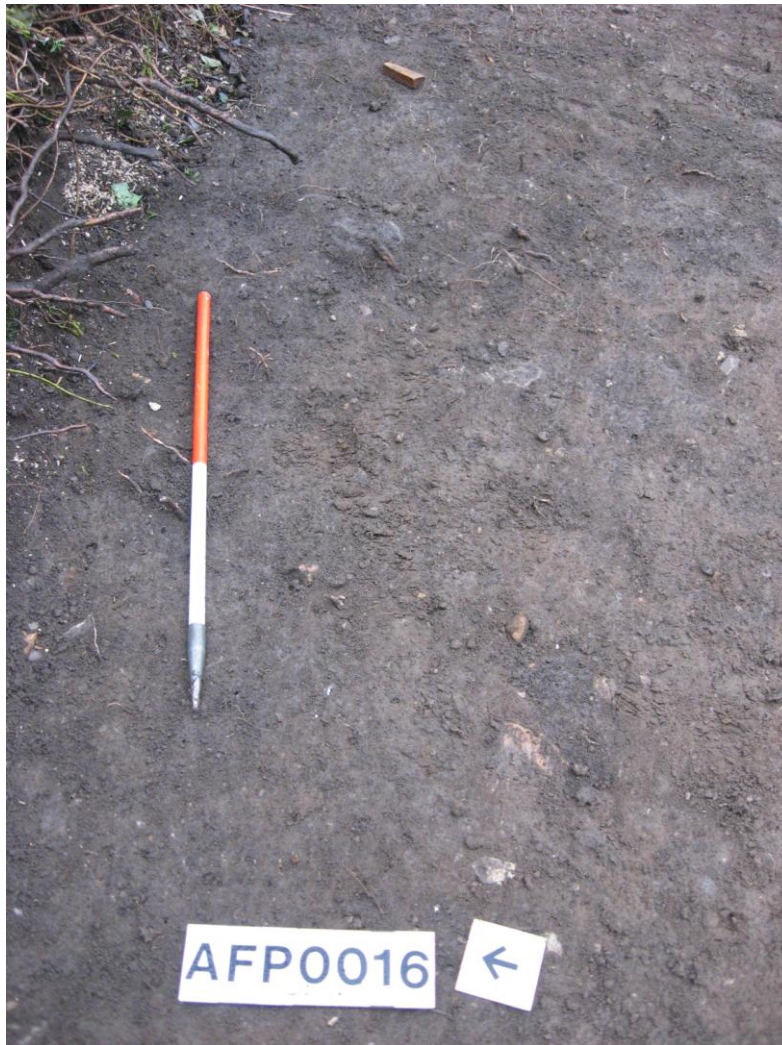
Plate 7. 0016, Area 01. Looking east.

5.1.3 East of (0013) three discreet deposits were encountered, (0014), (0015) and (0016). Context (0014) and (0015) both had 15% rounded stones in a matrix of mid grey brown silty loam that contained modern pottery. (0016) contained a very similar fill to the other deposits, 15% rounded stones in a matrix of dark grey brown to reddish brown silty clay loam. It measured 2.90m by 0.90m and appeared sub-rectangular in shape though its edges merged with the surrounding deposit and it may have extended beneath the baulk. A single sherd of medieval pottery, two pieces of lead and a glass fragment were recovered from its surface. Though the finds suggest the possibility of a medieval date for the feature the similarity of its fill to deposits (0014) and (0015) indicate that it too could be modern and the medieval pot re deposited. All three features were preserved in situ without further disturbance.

6.4 A further potential medieval deposit (0016), containing pottery finds, was located within the SAM adjacent to the churchyard. The deposit comprised a thin spread of rounded stones and gravel, and may constitute the remains of up-cast from the nearby fish ponds. This spread, (0016) was only partially uncovered by the groundworks and its full extent remains currently unknown. Located within the boundary of the SAM the deposit, (0016), was preserved 'in situ' without any further disturbance.

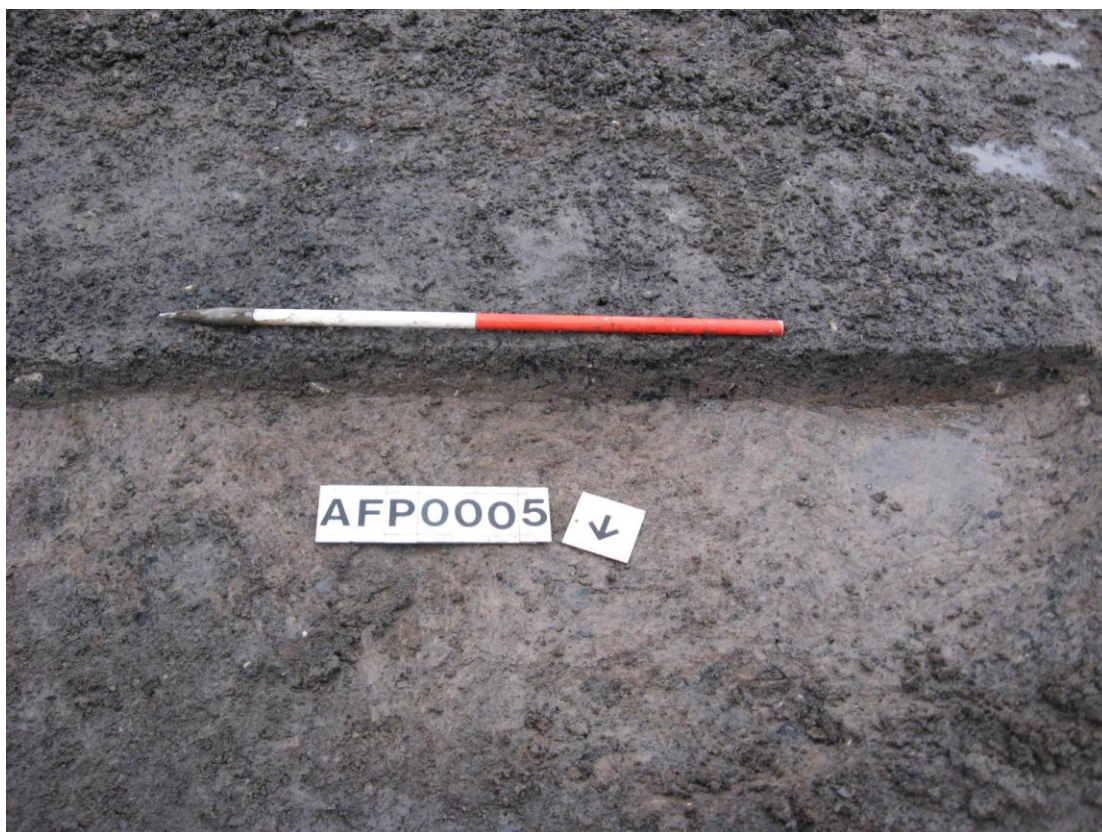
Plate 8. Pit/dump, 0005, half sectioned. Looking south.

5.3.1 A single archaeological deposit, (0005), (Figure 4; Plate 8), was observed in the eastern most part of the area. It was irregular in shape and measured up to 2.40m in width and 2.90m in length and 0.13m in depth. Its southern extent merged with the alluvial clays and no clear edge was visible. The deposit comprised an upper layer of dark grey silt with 50% coal fragments and a lower layer of greyish brown silt with 15% coal fragments. Both layers contained medieval pottery. Three pieces of corroded iron were recovered from the surface of the upper layer and within the lower layer. Tile was also present in the lower layer. Medieval pot was recovered from both layers of 0005.

6.3 A medieval deposit (0005) interleaved with alluvial clays was encountered adjacent to Church Field which contained finds dating to the medieval period. Although appearing to lie in a shallow depression, 0005, is probably a dump rather than a cut feature, its edges on excavation being unclear and the overall depth of the feature being less than 130mm. As significant assemblage of pot (35 shards), was recovered from the excavation of 0005 which includes tile, (3 shards), as well as shards from domestic vessels. Three pieces of slag, presumably indicating metal working somewhere in the vicinity were also recovered from the excavation of the feature.

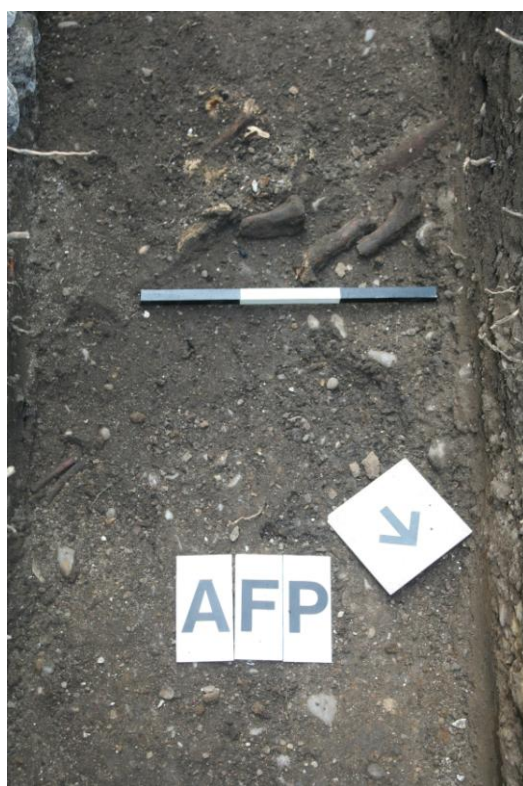
Plate 9. Dog burial in Area 06. Looking south east.

5.5 Area 06 two pits 0023 and 0047 were encountered cutting the alluvial layers. Pit 0023 contained 19th century pottery. This has been interpreted as a refuse pit associated with Ireton House. Pit 0047 was filled with concrete rubble and has been interpreted as a modern post hole for gate or boundary fence. In the base of Area 06 and immediately below 0047 were the remains of a dog burial, ADM, (Plate 9). This was left in situ. There were no finds associated with the burial and no evidence of a cut in the section. The pit which had been excavated for the dog burial had probably been destroyed when the post hole (0047) was excavated. The dog skeleton remains undated but the condition of the bones would suggest that it is relatively recent.

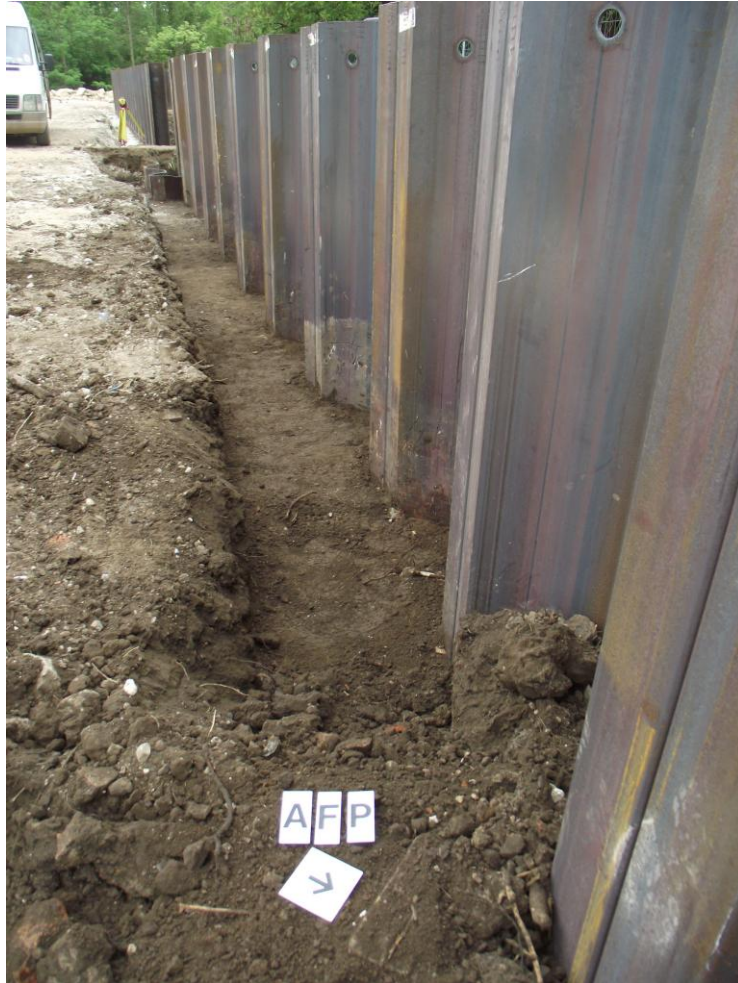
Plate 10. Area 04, shallow trench in front of sheet piles. Looking north west.

5.4 The trenching in Areas 04-06 confirmed the interleaved nature of the subsoil and alluvial deposits. In places the subsoil exceeded 0.8m in depth from ground level. The groundworks have also established that alluvial gravel deposits exceeding 0.70m thick are present in places almost directly beneath the topsoil. Modern pottery was recovered in Area 05 but no archaeologically significant material was present.
