# ENVIRONMENT AGENCY ATTENBOROUGH AND NORTH CONNERIES.

## Report on groundworks in advance of the construction of new flood defences and associated environmental enhancement.

Project Code – EAA/NCO

TPA Report No. 079/2013

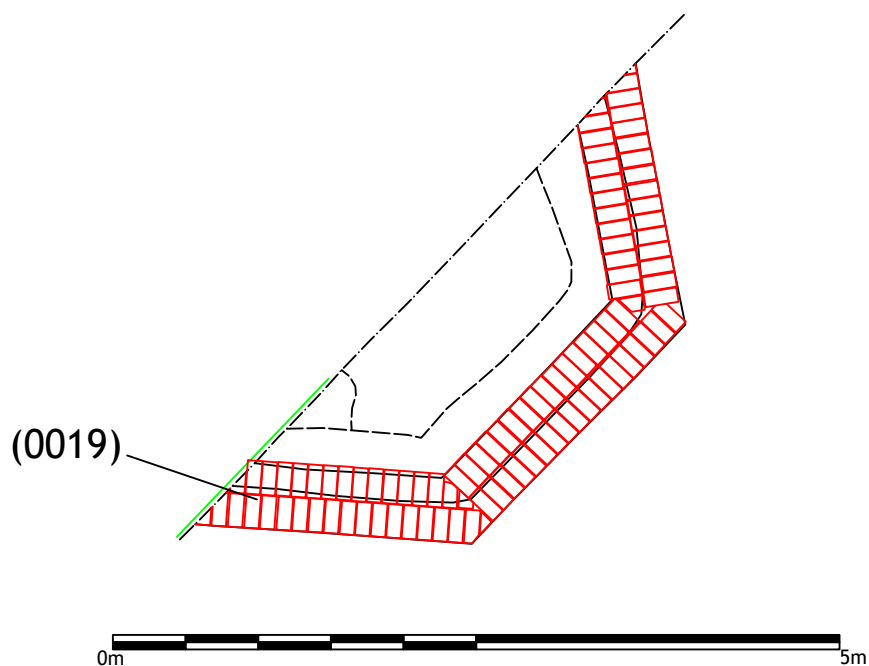
EAA/NCO  
Figure 2. Plan of 0019  
Scale at A4 1:50

6.1.2 The foundation of a modern brick structure, (0019), was recorded at 23m from the start of the excavation. (Figure 2 and Figure 3, Plate 3). This has been interpreted as being part of a now demolished railway infrastructure. It was only partially exposed and its full dimensions and shape could not be observed. Similarly, its function currently remains unknown.

- 0001 Angular stone 10-40mm with 10% coal fragments and 20% dark brown silt loam
- 0002 Dark brown gritty loam with 40% angular stone 10-20mm
- 0003 Dark brown gritty loam
- 0004 Rounded stone 10-30mm within 20% light brown silt
- 0006 Dark brown gritty loam with 20% angular stone 10-20mm
- 0019 Brick feature - mix of red and yellow bricks measuring 80mm x 230mm bonded by yellowish white lime mortar

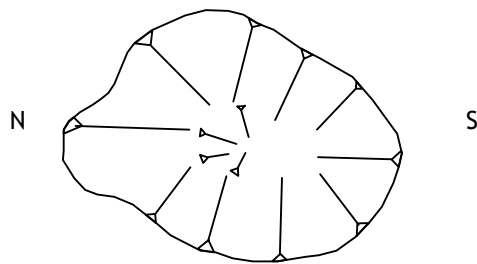
6.3.2 A single pit, (0008), was present 23m north east of Cemex Yard, (Plate 6). This was excavated but there were no finds present and no other dating material, (Figure 4, Plate 7). The pit, (0008), was an isolated feature and currently both its date and function remain unknown.

a burned material in orange/brown clay  
b mid brown loamy sand

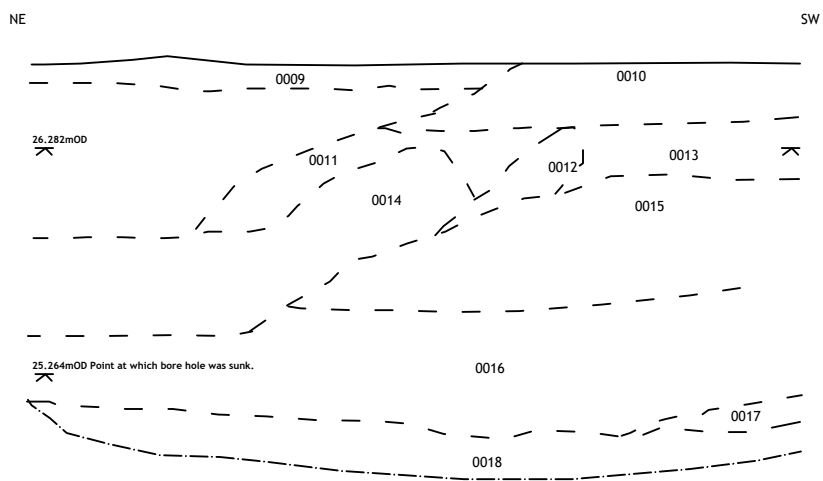
6.4.4 The remaining layers of alluvial silts and clays were then removed down to the existing water level to provide the correct environment for seeding the reed bed. The upper layers revealed in the section, (0010, 0011, 0012, 0013, 0014), are made ground associated with successive layers built up against the interface of the dry ground and the water's edge. Below these, (0015, 0016, 0017, 0018) appear to be undisturbed alluvial layers laid down as a result of flooding. There were no artefacts in any of these lower layers that would enable a date to be established for the probable inundations. A section of this was recorded to preserve a record of the stratigraphy, (Figure 5, Plate 11).

- 0009 ground surface, modern deposits, brown silty loam mixed with yellow clays
- 0010 Yellowish/brown silty clay
- 0011 dump of lime and broken concrete fragments
- 0012 dump of lime and broken concrete fragments, similar to 0011
- 0013 greyish yellow silty clay
- 0014 greyish yellow silty clay, same as 0013
- 0015 yellow clay
- 0016 greyish yellow clay
- 0017 grey clay
- 0018 mid yellow clay

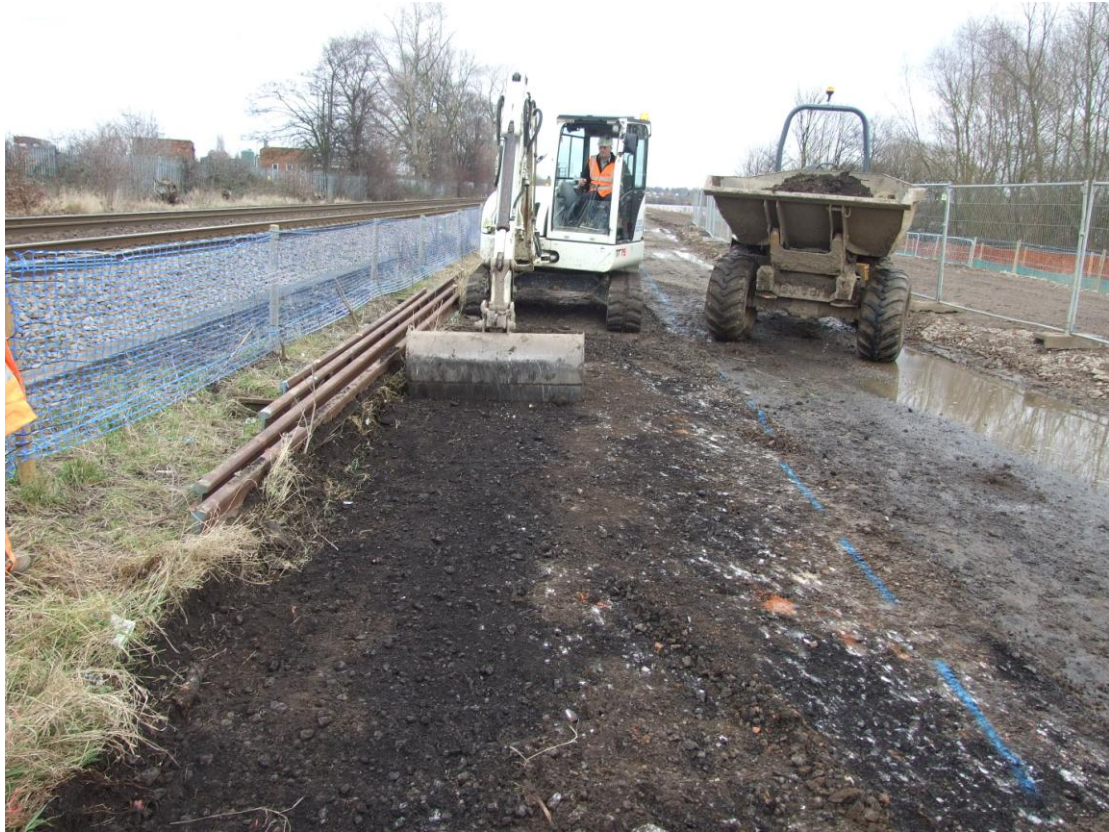
6.1.1 Only the upper surface, (0001), of the existing ground was removed to an average depth of 200mm. This exposed a black heavily compacted ashy layer, (0002), (Plate 1), which as the excavation progressed alternated with an orange/brown layer of compacted silty clay with abundant brick rubble inclusions, (0003), (Plate 2 and Plate 4). Only the surface of the underlying layers was exposed and it was not possible to ascertain their respective depths. These layers have been interpreted as the make up of a once existing quarry haul road with material from the railway slumping on to it.

Plate 1. Stripping at the start of Area 01. Looking north east.

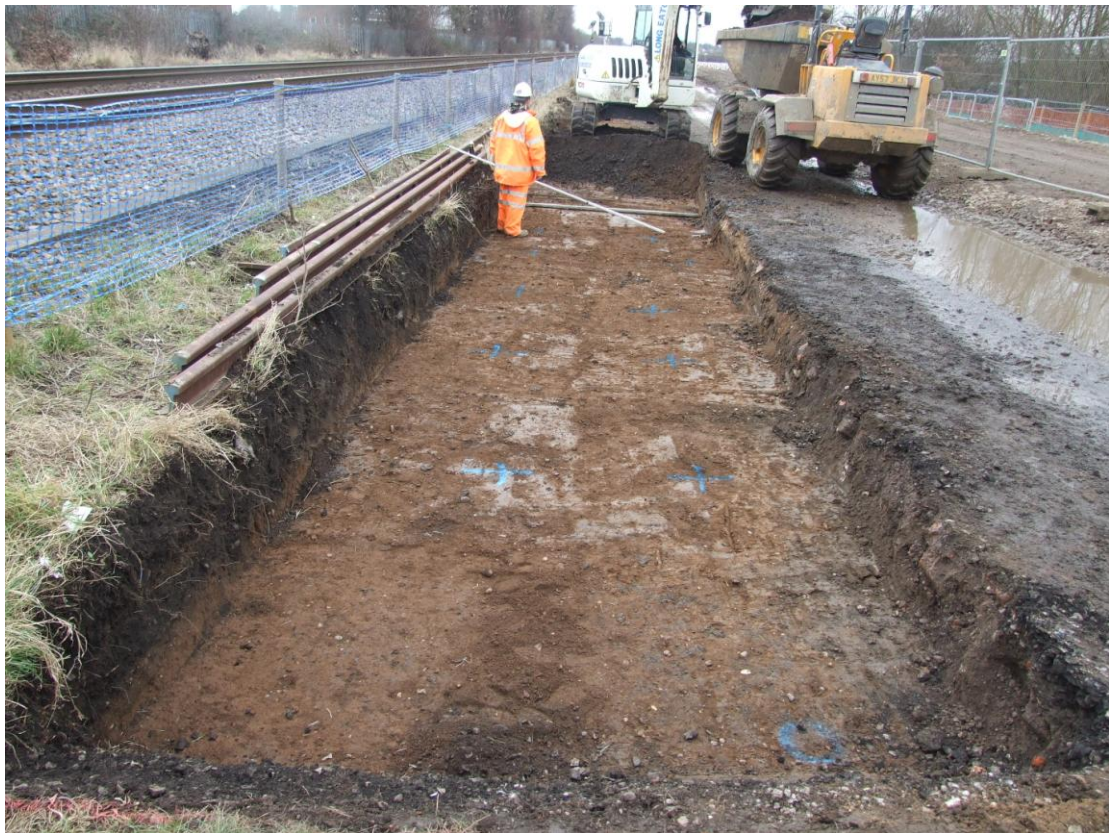
Plate 2. Stripping in the centre of Area 01. Looking north east.

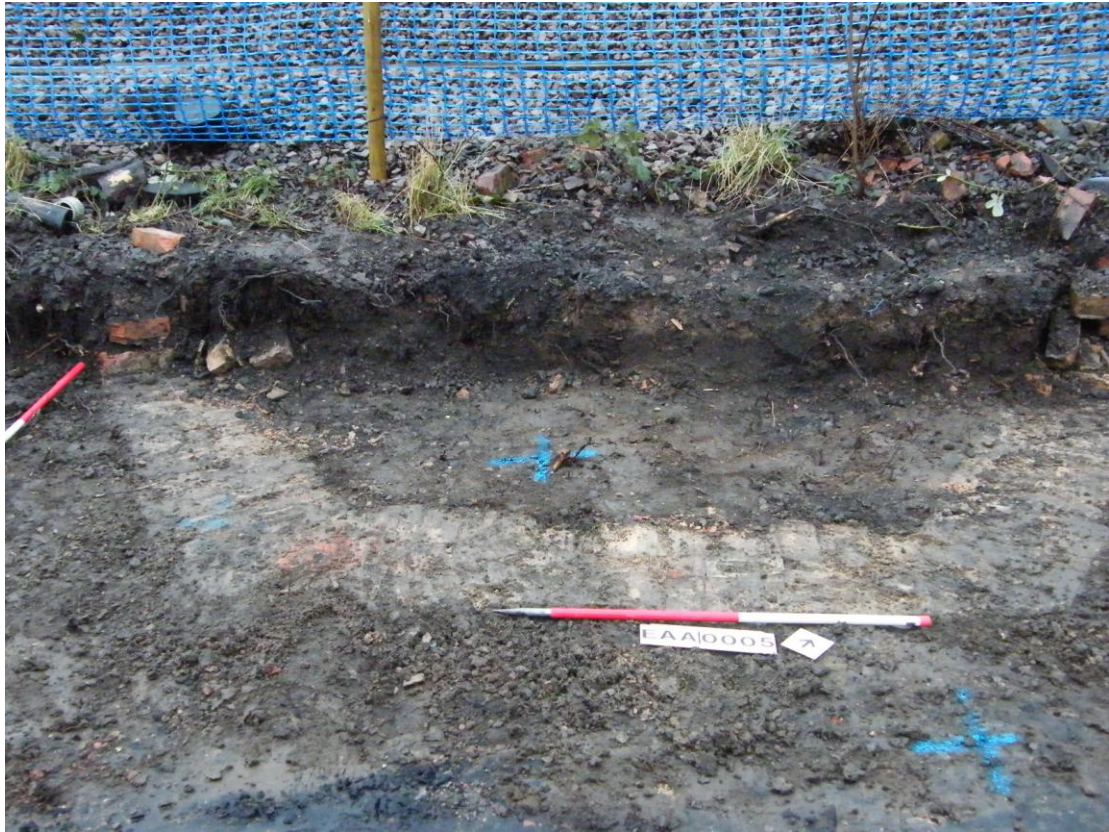
Plate 3. Brick foundation, 0019, Area 01. Looking north west.

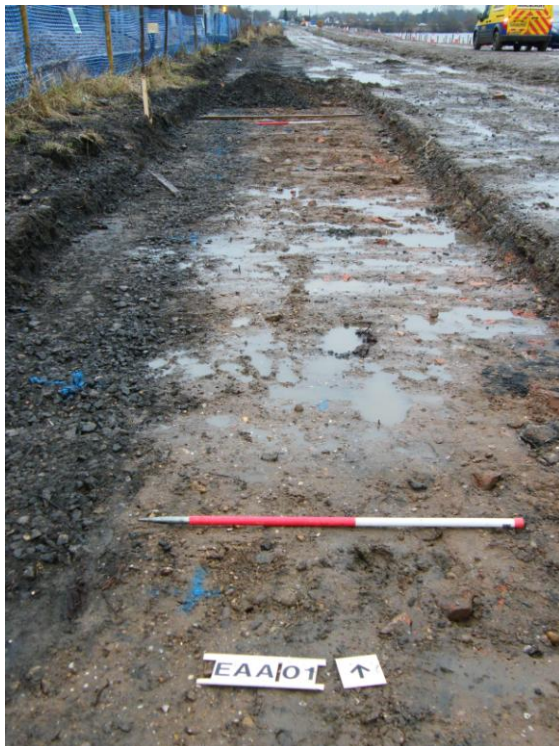
Plate 4. Area 01 showing slumped material from railway abutting the compacted silty clay of the former quarry haul road. Looking north east.

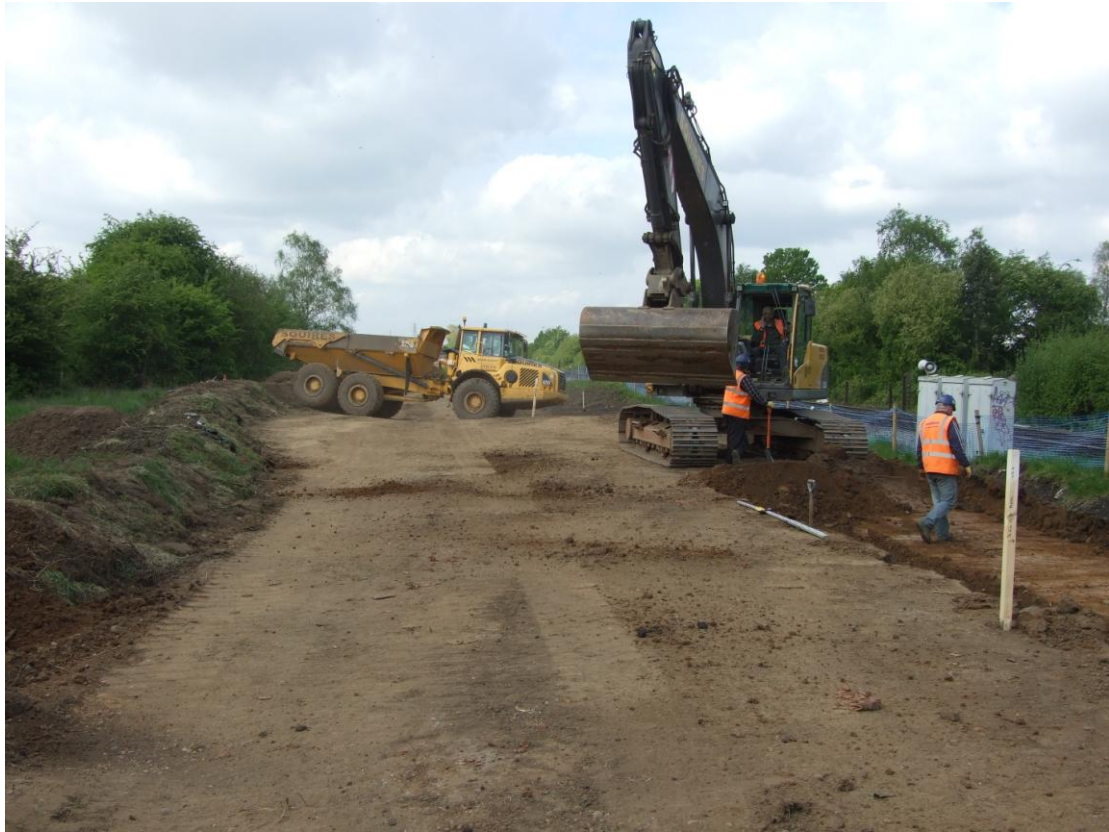
6.2.1 Only the upper surface, (0004), of the existing ground was removed to an average depth of 200mm, (Plate 5). This exposed a uniform orange/brown silty clay, (0005) which extended the entire length of Area 02. Random blocks of modern concrete were embedded in 0005 indicating a high level of modern disturbance having taken place in the recent past.

Plate 5. Soil stripping in Area 02. Looking north east.

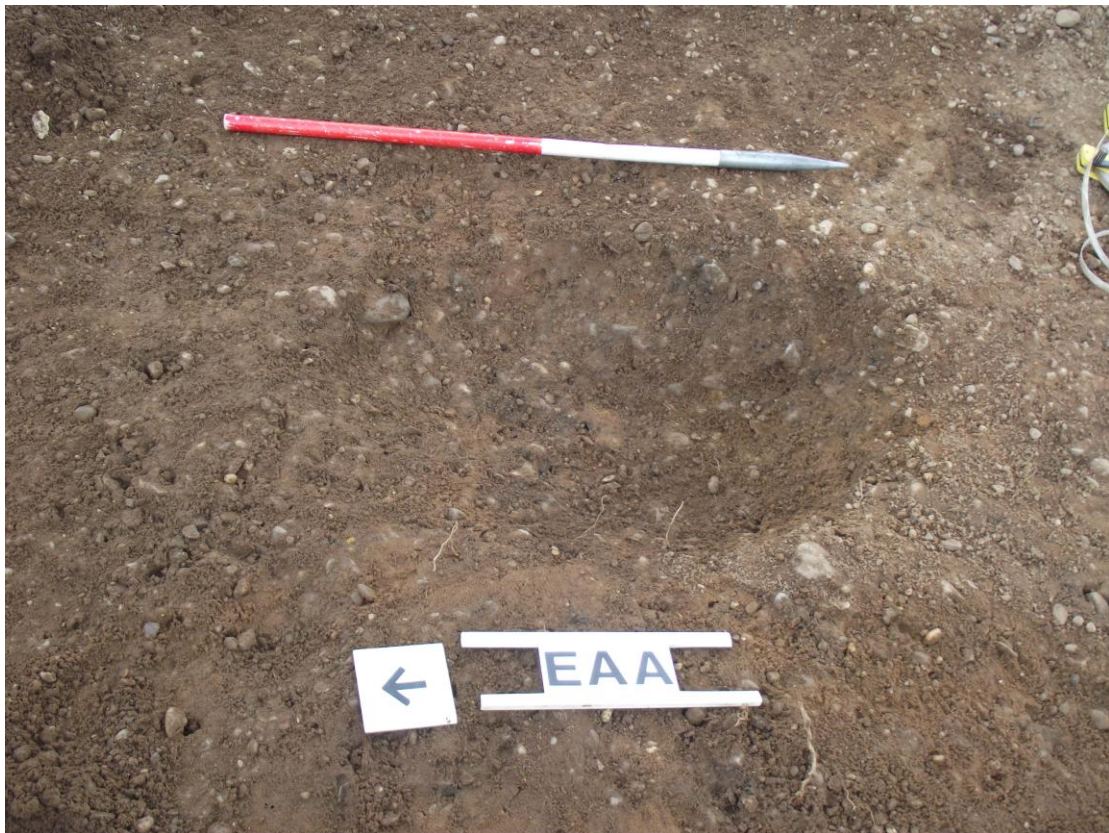
Plate 6. Small pit, 0008, in Area 03 pre excavation. Looking west.

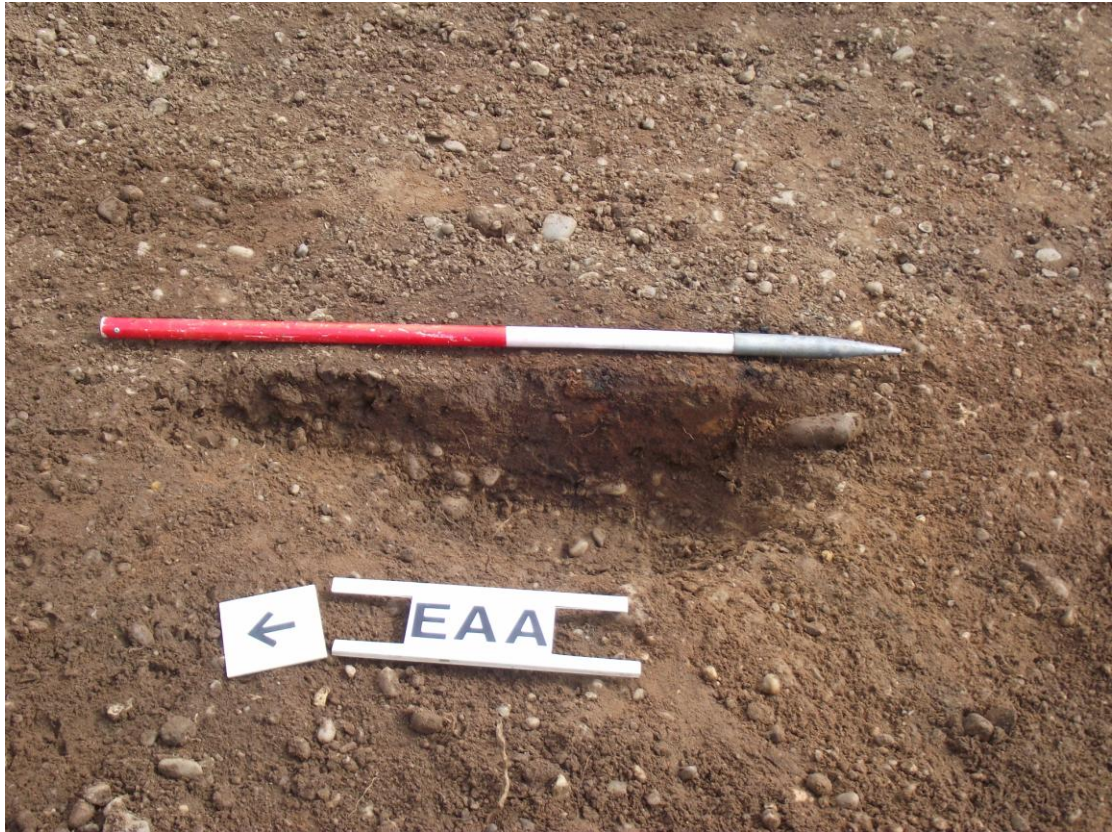
Plate 7. Pit, 0008, west facing section. Looking east.

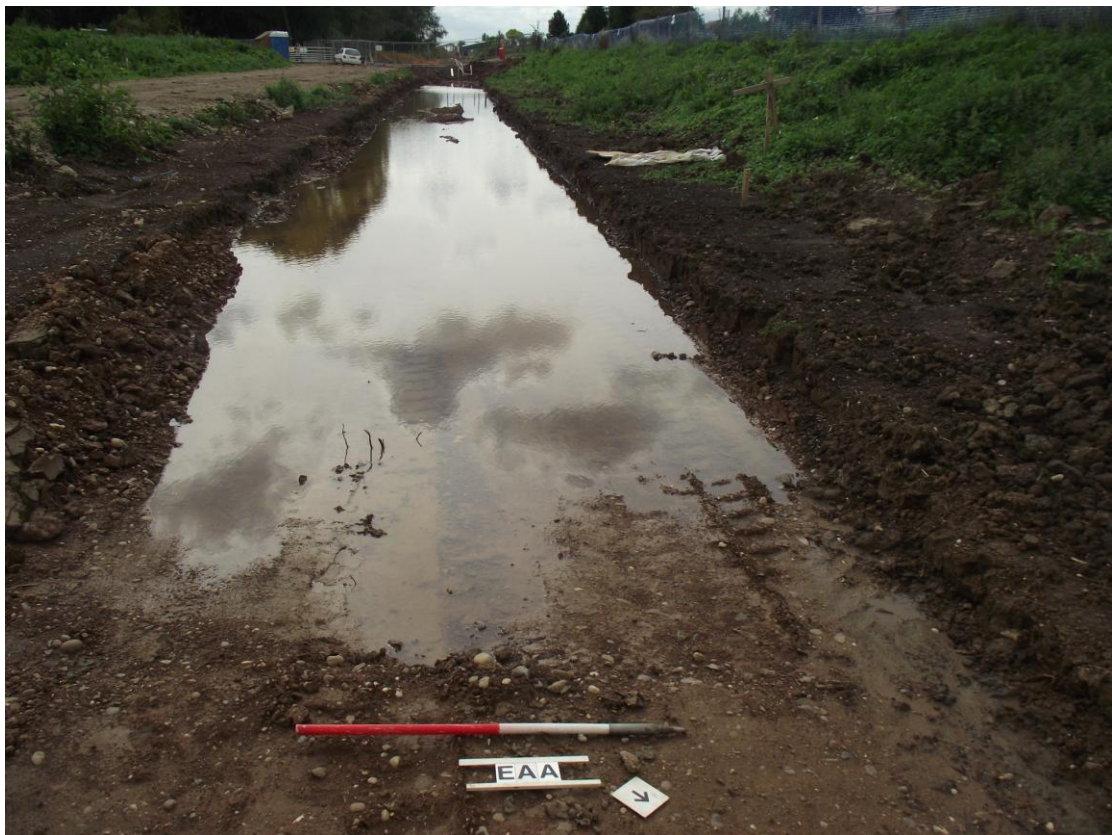
6.3.4 At the south western extent of Area 03 flooding of the excavated trench prevented any accurate observation of either the stripped surface or the presence of archaeological features, (Plate 8).

Plate 8. Area 03 flooding after topsoil strip. Looking north east.

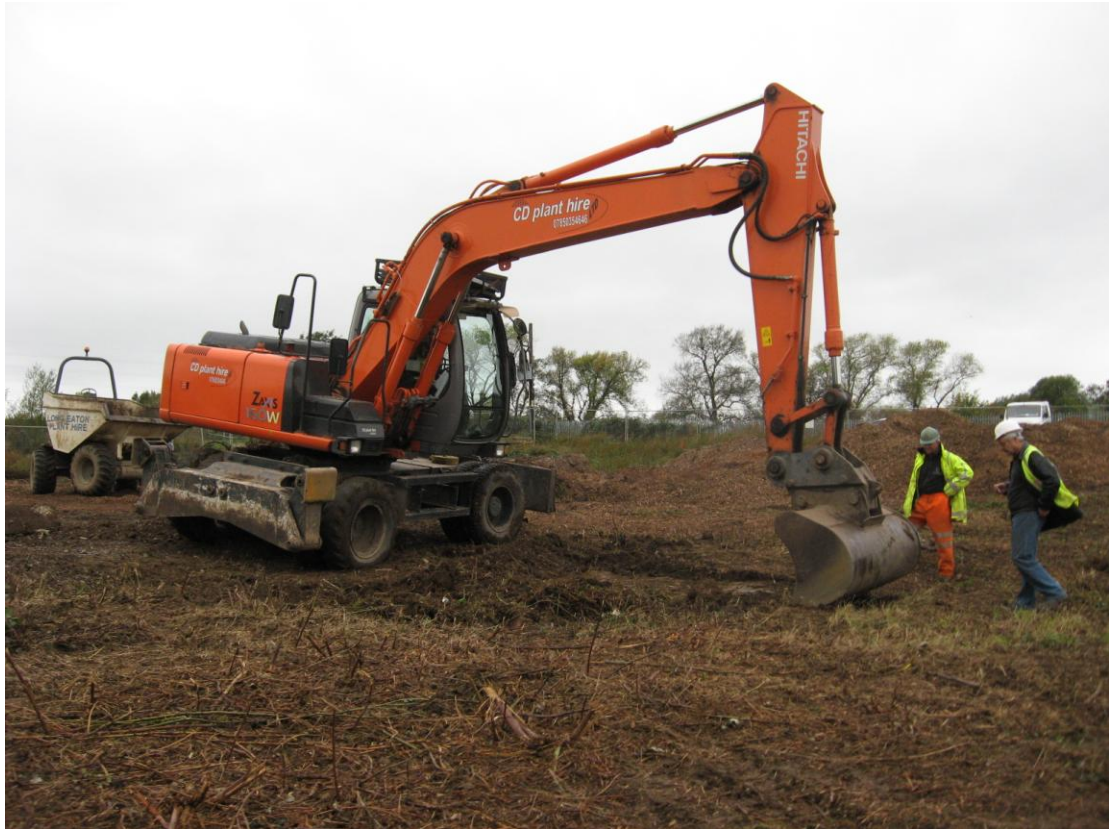
6.4.3 The upper surface of Area 04, (0009), was removed by a tracked machine using a bladed ditching bucket, (Plate 9 and Plate 10), and the exposed surface, (0010), monitored for any archaeological remains or deposits. There were none present.

Plate 9. Start of soil stripping in Area 04. Looking west.

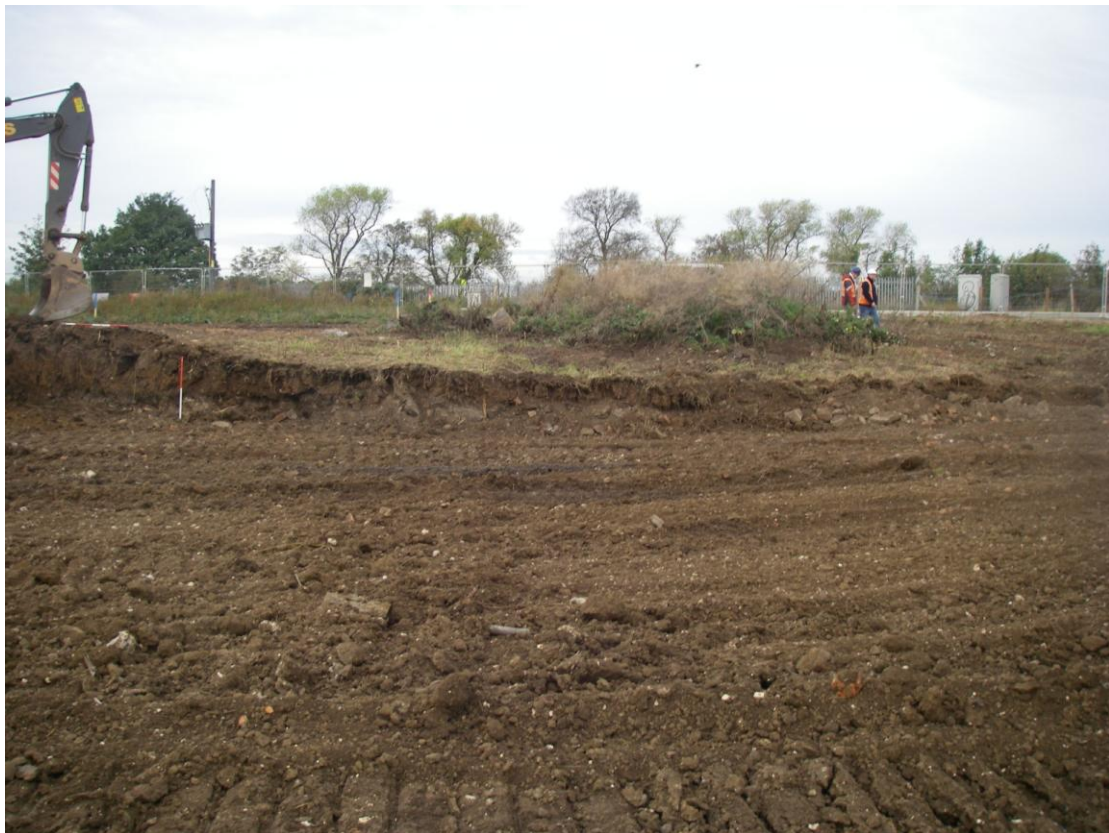
Plate 10. The surface after the upper layer has been removed. Looking west.

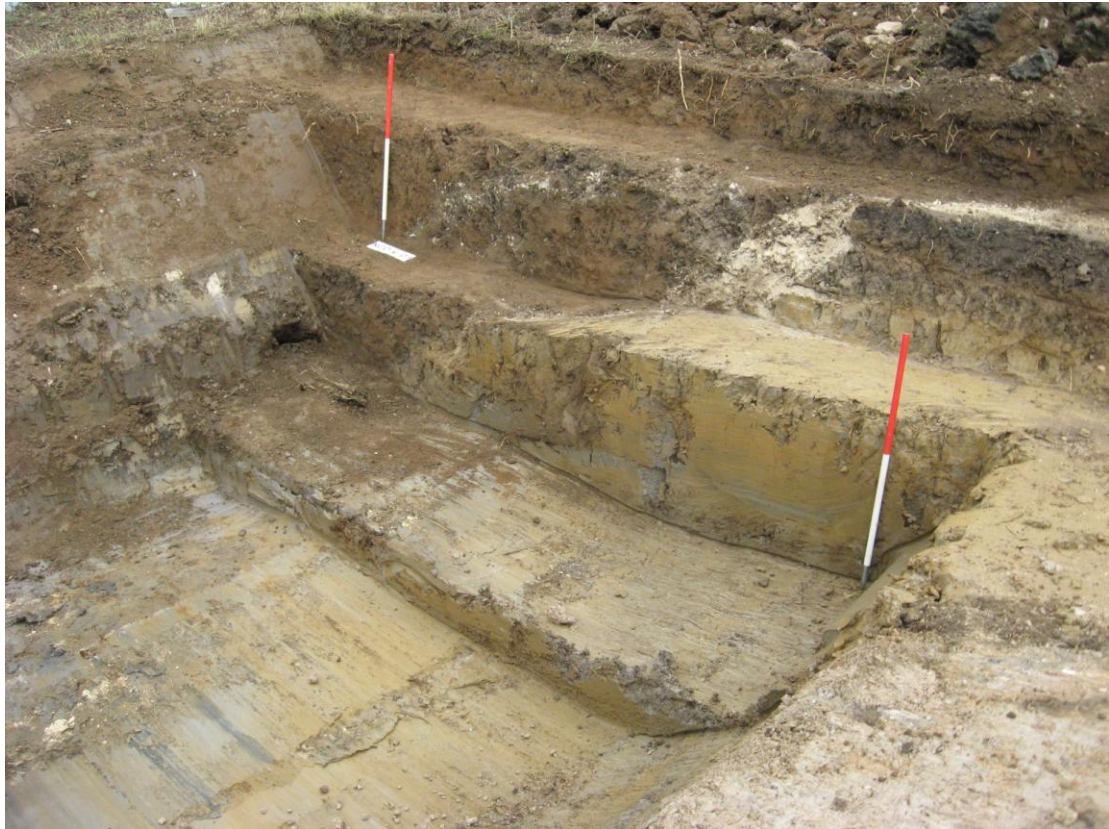
Plate 11. Stratigraphic sequence in Area 04. Looking south east.
