# **EREWASH FLOOD DEFENCES**

**A report of an archaeological watching brief 2010/11.**

**Project code: EFD**

**EREWASH FLOOD DEFENCES, TOTON , NOTTINGHAMSHIRE.  
Report of an archaeological watching brief.**

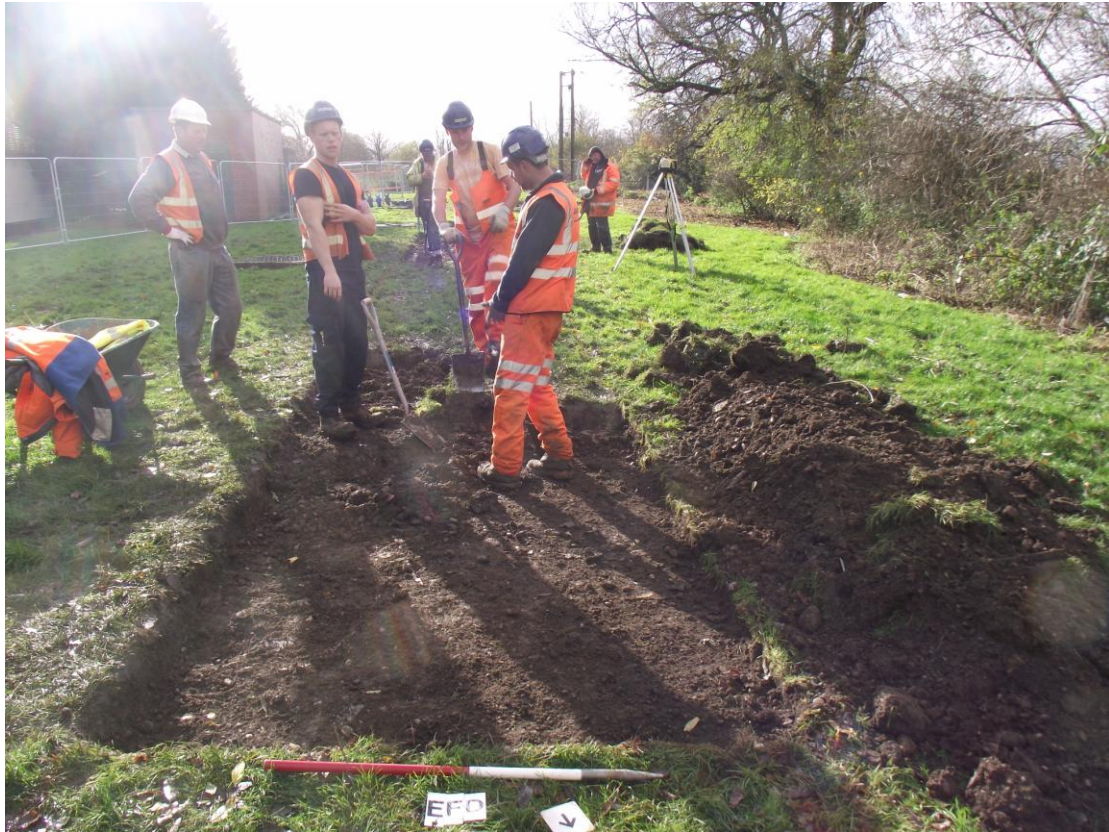
4.2 **Area 02**. A hand excavated trench 2m wide by 300mm deep extending the length of Area 01. Plate 1.

**PLATE 1. Area 02, hand excavated trench. Looking south west.**

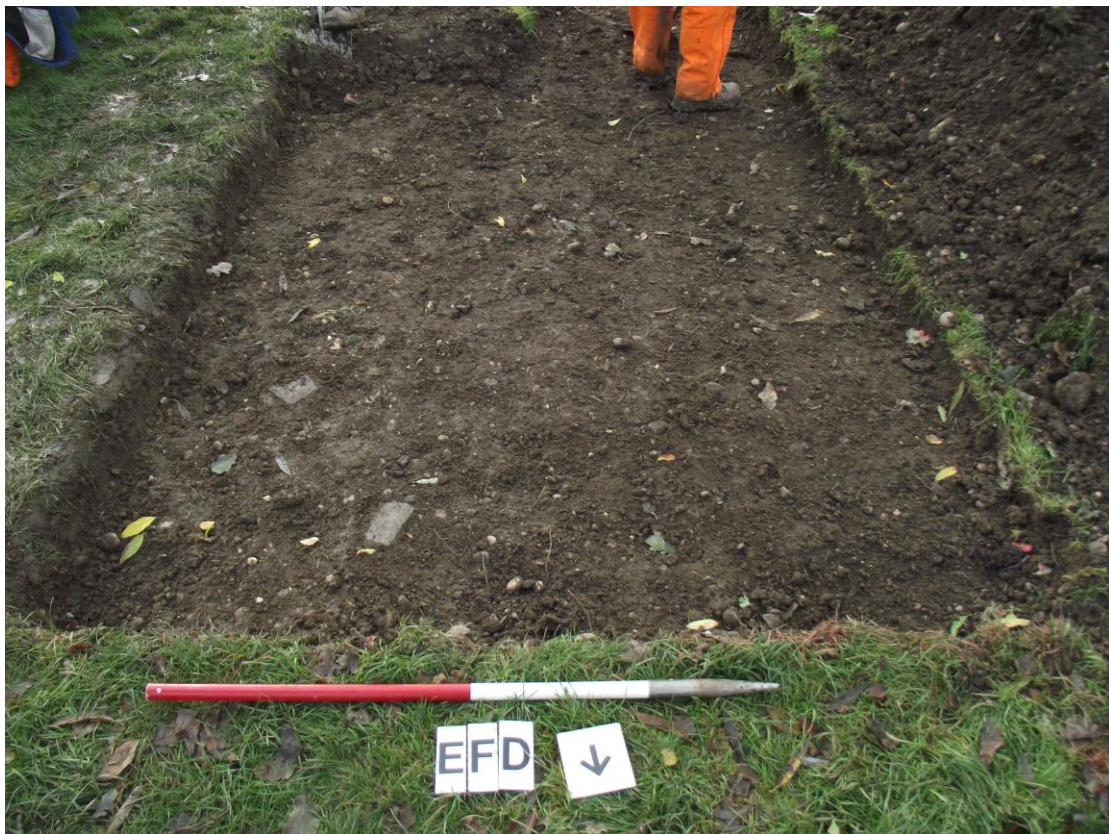
4.2.1 Topsoil, 0001, was removed by hand exposing 0002, a mid to light brown silty loam with 40% small stone inclusions and modern brick rubble. 0002 was consistent throughout the area. No archaeological features or artefacts were revealed. Plate 2

**PLATE 2. Brick rubble in base of Area 02. Looking south.**

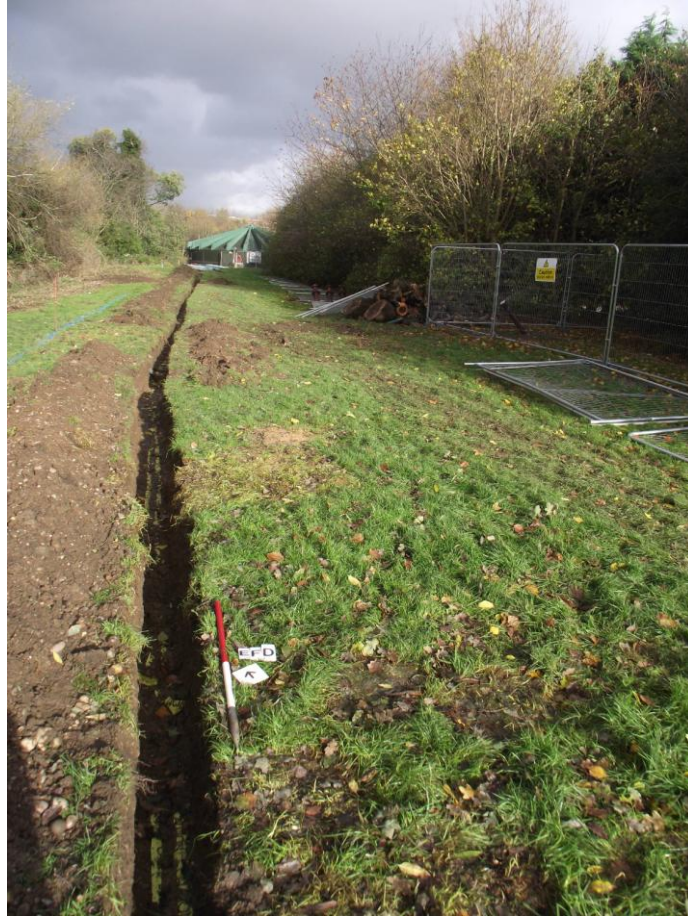
4.3 **Area 03**. A narrow slit trench, hand excavated, along the side of Area 02 in order to expose a service cable so as to avoid damage when the main trench was excavated. Area 03 was incorporated into Area 02 as the latter was advanced. Plate 3.

4.3.1 The hand excavation of Area 03 did not extend below the level of Area 02, i.e. 300mm. No archaeological features or artefacts revealed

**Plate 3. Area 03, narrow slit trench incorporated into Area 02.  
Looking north.**

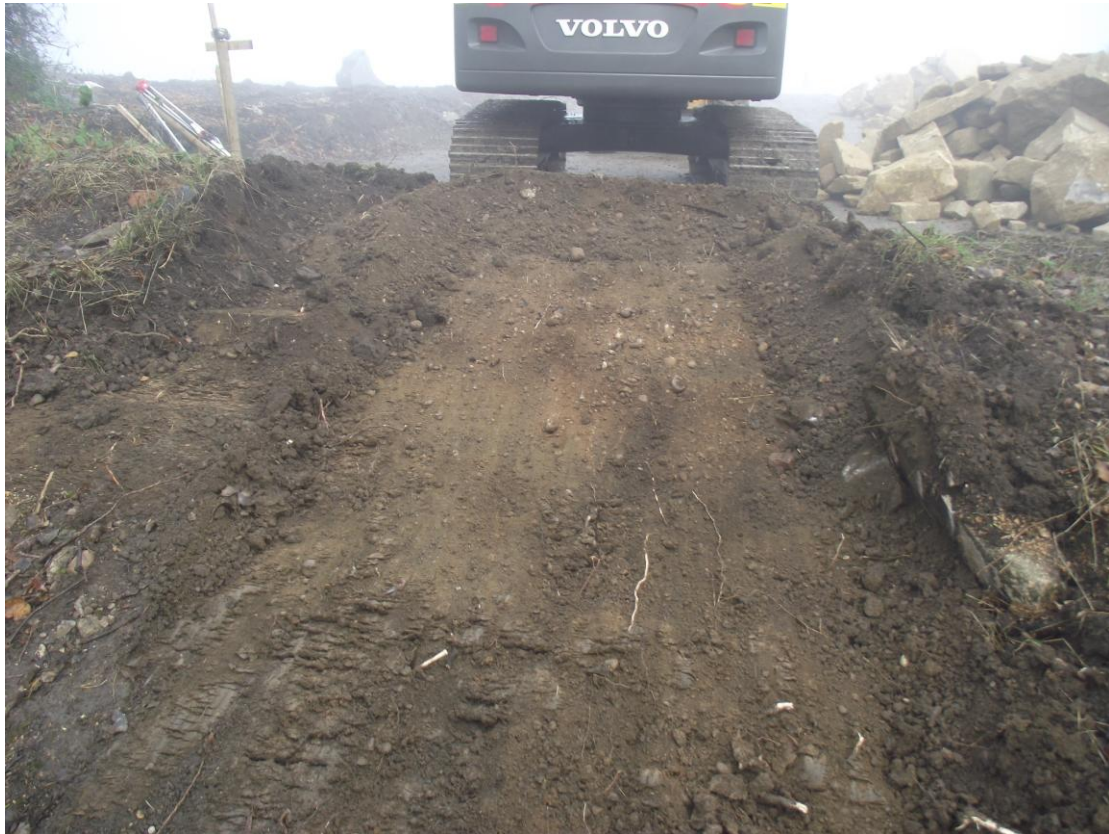
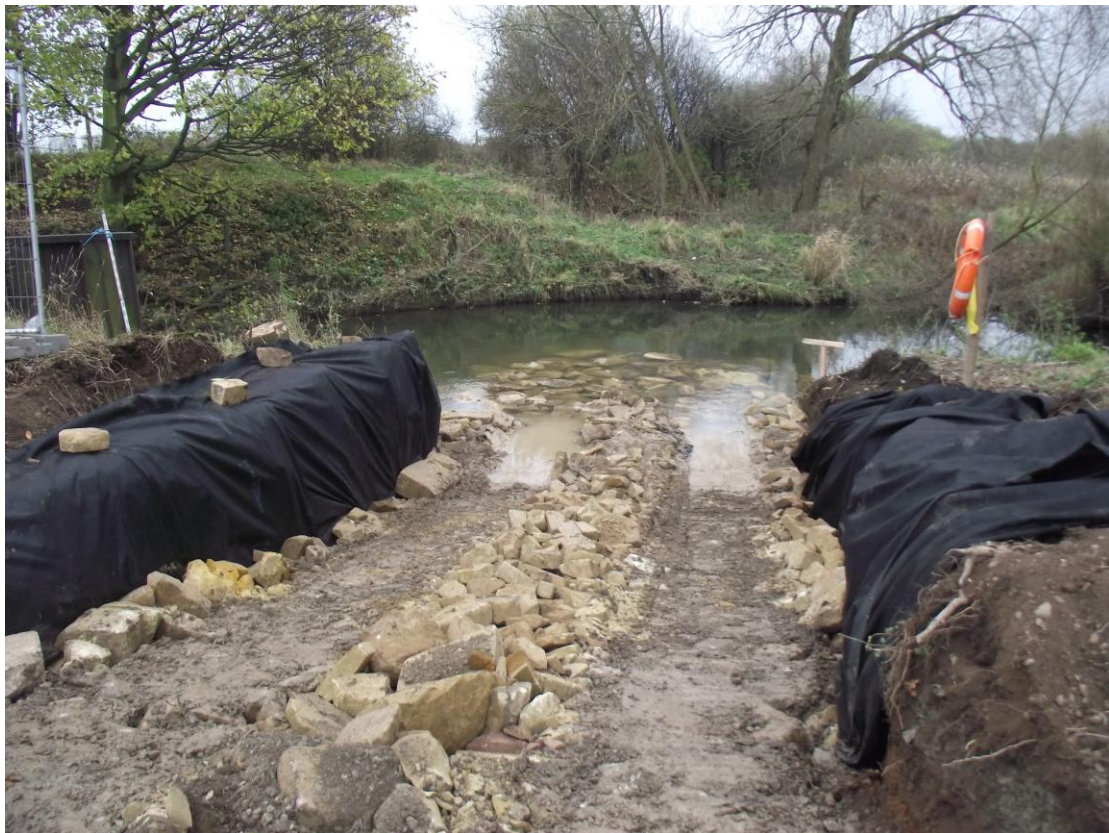
4.6.2 The bank of the river was cut through to provide an even sloped surface to give access to a crossing point over the river. This was stoned up to provide a firm surface for the passage of plant and machinery to the opposite bank. Stone was also used to provide a stable surface across the river bed. Plates 4 and 5.

**PLATE 4. Excavating through the river bank to provide a smooth surface. Looking north east.**

**PLATE 5. Stone laid over the surface and into the river to construct a ford. Looking south west.**

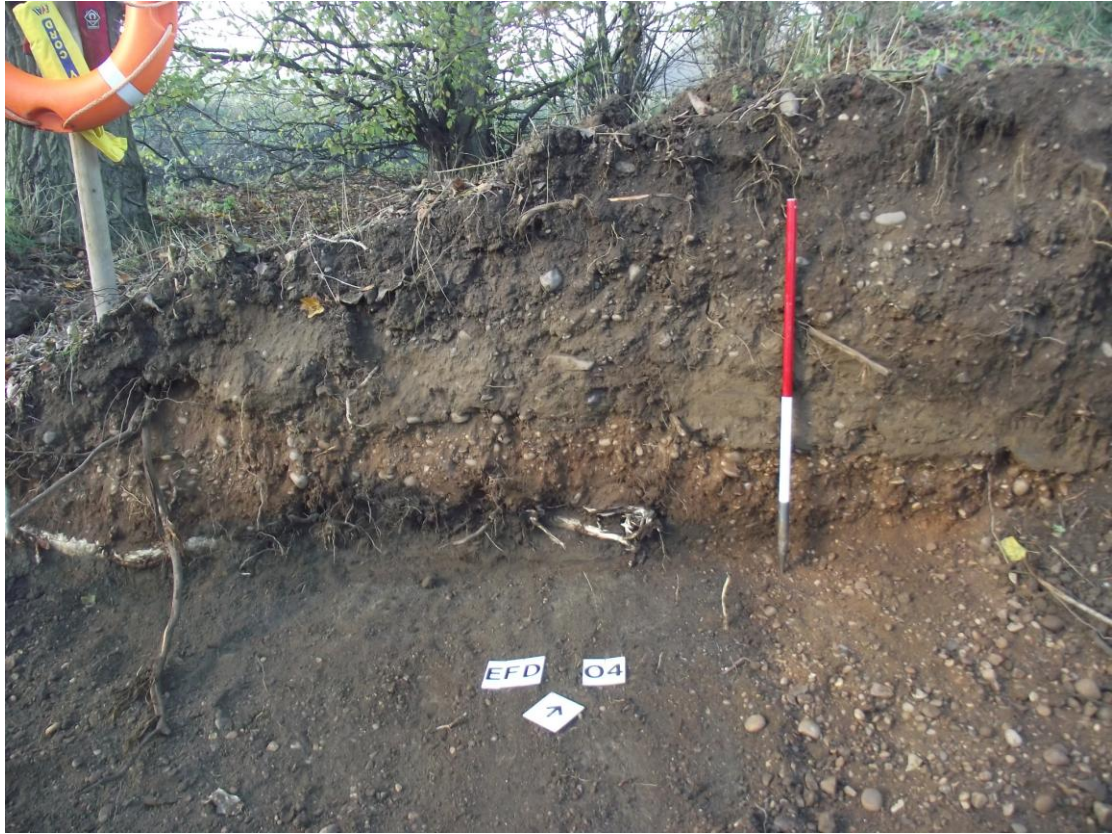
4.6.3 A section of the bank exposed by the machining was recorded by photograph and drawing, Figure 3 and Plate 6.

<b><i>Context</i></b>	<b><i>Thickness</i></b>	<b><i>Description</i></b>
0001	250mm	Mid brown loam
0003	280mm	Mid to light brown silty loam with less than 40% small rounded stones.
0004	460mm	Mid to light brown silty loam with Inclusions.
0005	280 mm	Gravel in orange sand matrix.

4.6.4 There were no archaeological features or artefacts revealed as a result of the ground intrusion in Area 04.

**PLATE 6. Area 04, section through the river bank. Looking north west.**
