# COLWICK FLOOD DEFENCES NOTTINGHAM.

## Watching Brief Report

TPA Report No. 010/2013

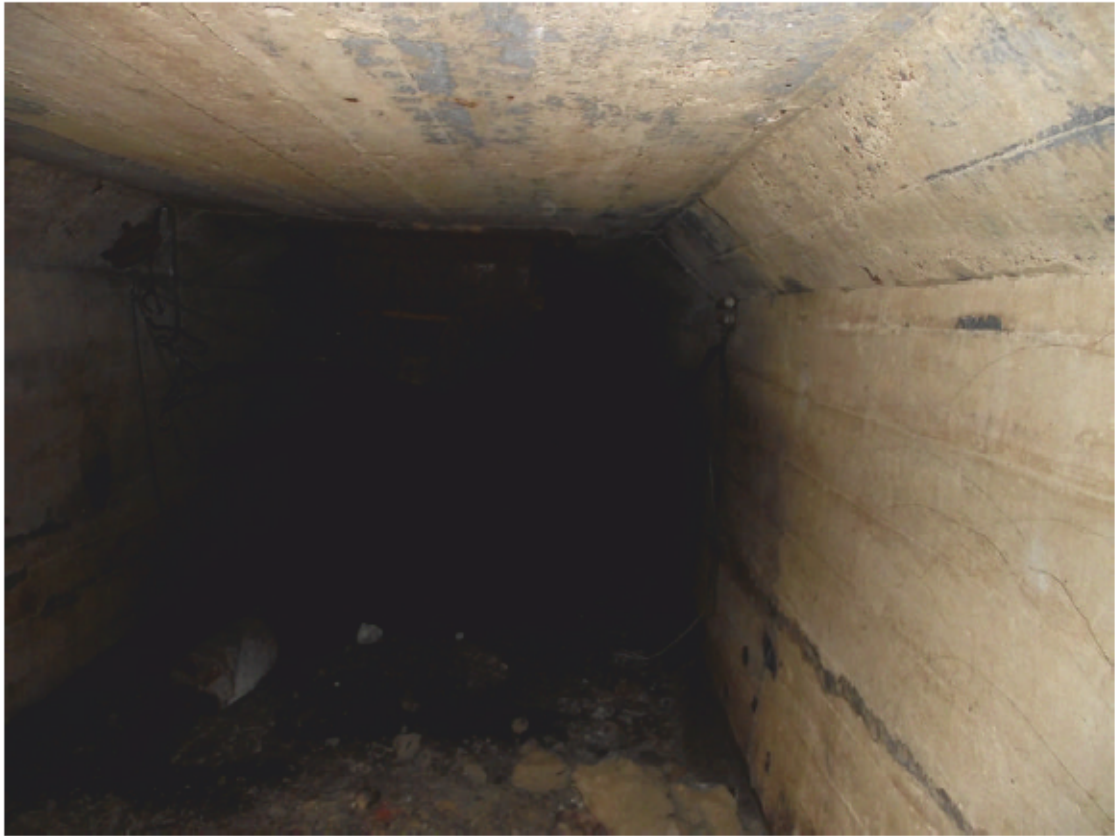
**PLATE 1. Looking down the chamber from the entrance. Looking south.**

3.2 From such visual inspection as was possible (entry into the chamber was not allowed) would appear to have been shuttered concrete. What appears to be hoppers set into the roof would have given access to the chamber from above. Plate 1.

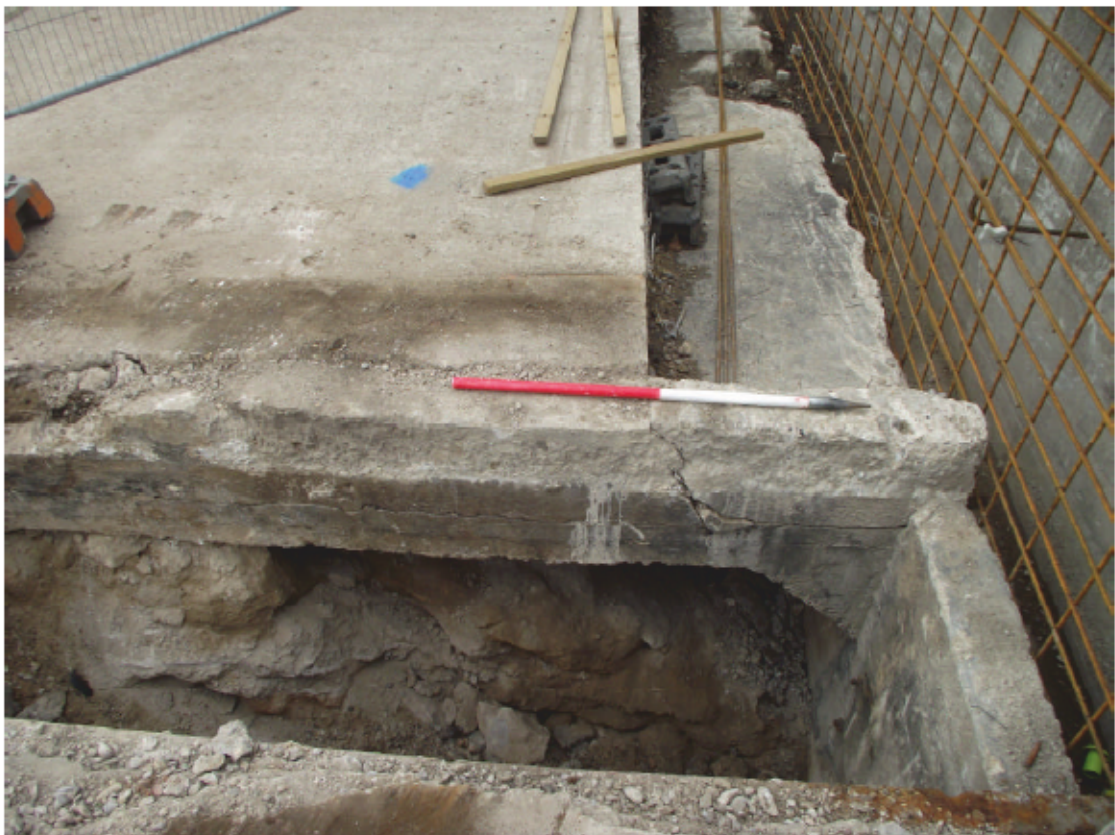
**PLATE 2. Partially exposed entrance to the chamber. The original upper surface is immediately below the scale with the newer surface above.**

3.3 When the chamber went out of use a further concrete layer was laid over the top thus sealing the hoppers and closing off the entire structure. Plate 2

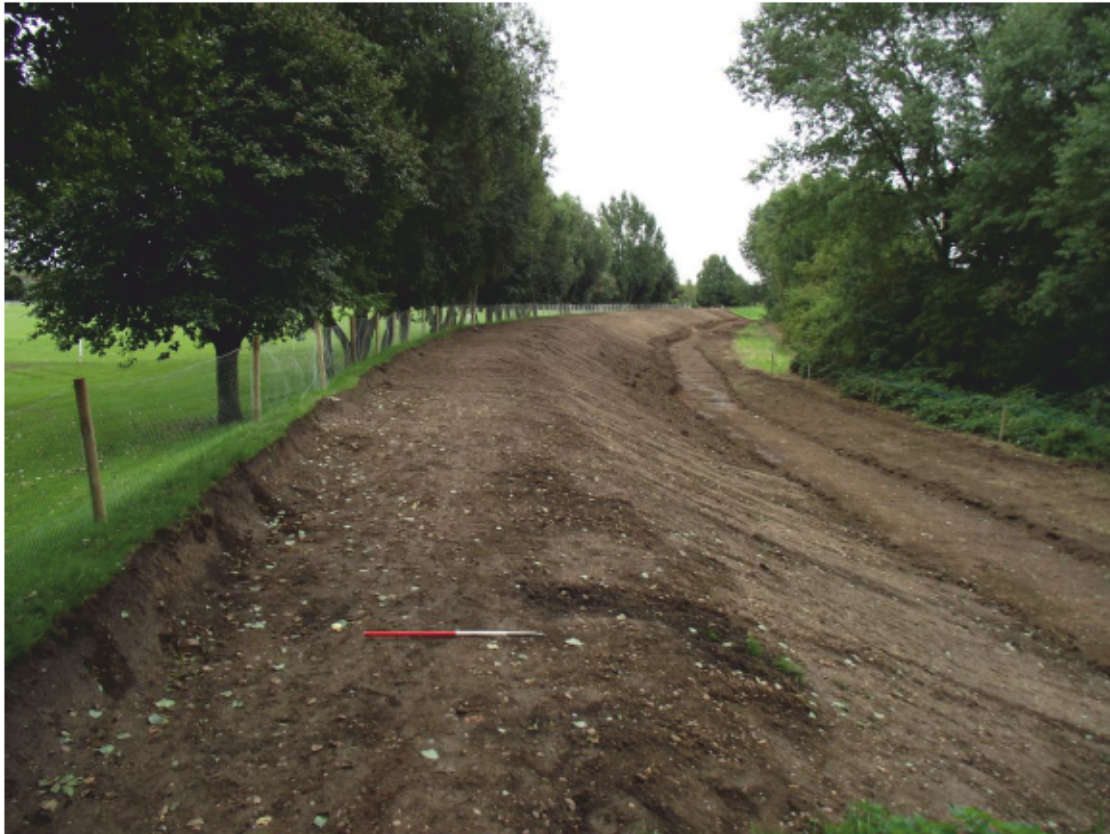
PLATE 1. Stripped flood bank, Area 01, looking south-east from River Road.

6.1 Along the whole length of Area 01, Figure 2, the south west facing edge of the existing bank was stripped to the level of its base. (Plate 1) This exposed an area of undisturbed ground c. 3m wide. There were no archaeological features or deposits uncovered during this process and no artefacts revealed.

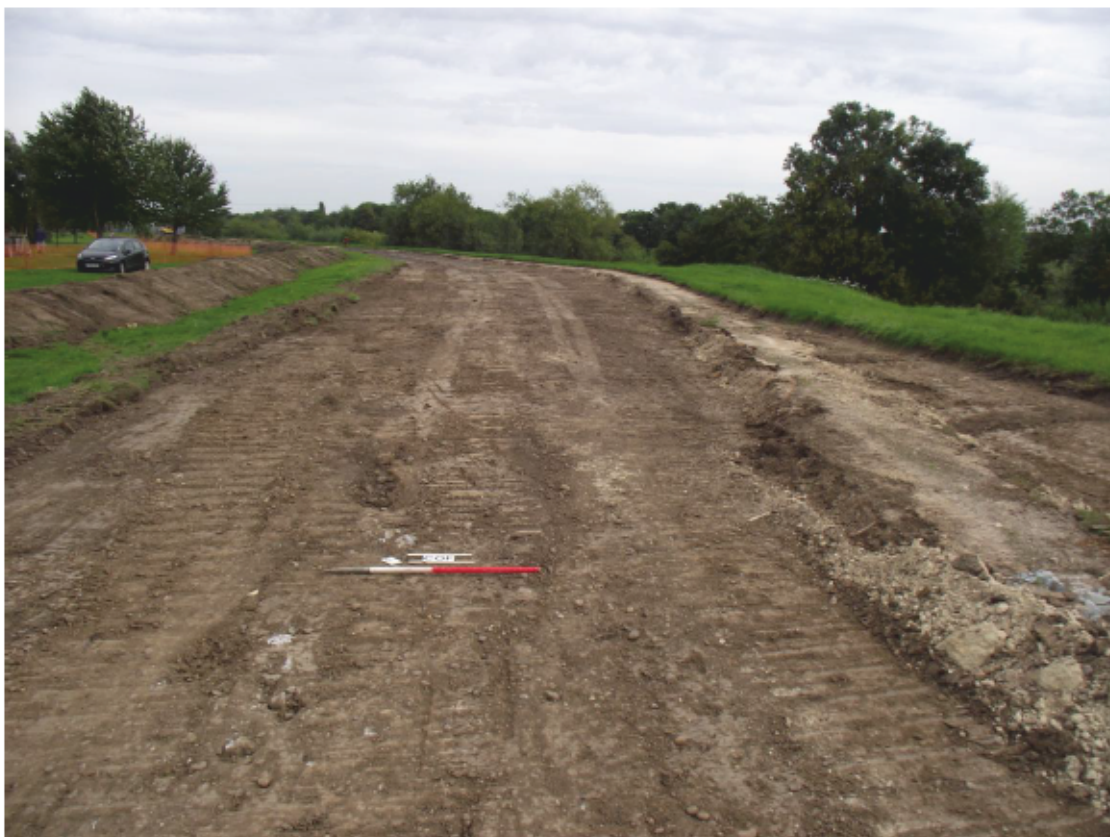
PLATE 2. Stripped flood bank, Area 02, looking north-east.

6.2 The top of the existing bank, Figure 2, was stripped to an average depth of 200mm. Stripping exposed the modern material that had gone into the construction of the existing flood bank. (Plat 2, Plate 3) This was primarily made up of rubble set in a matrix of red clay similar to the material that was used to raise the height of the flood bank as part of the current work (Plate 4).

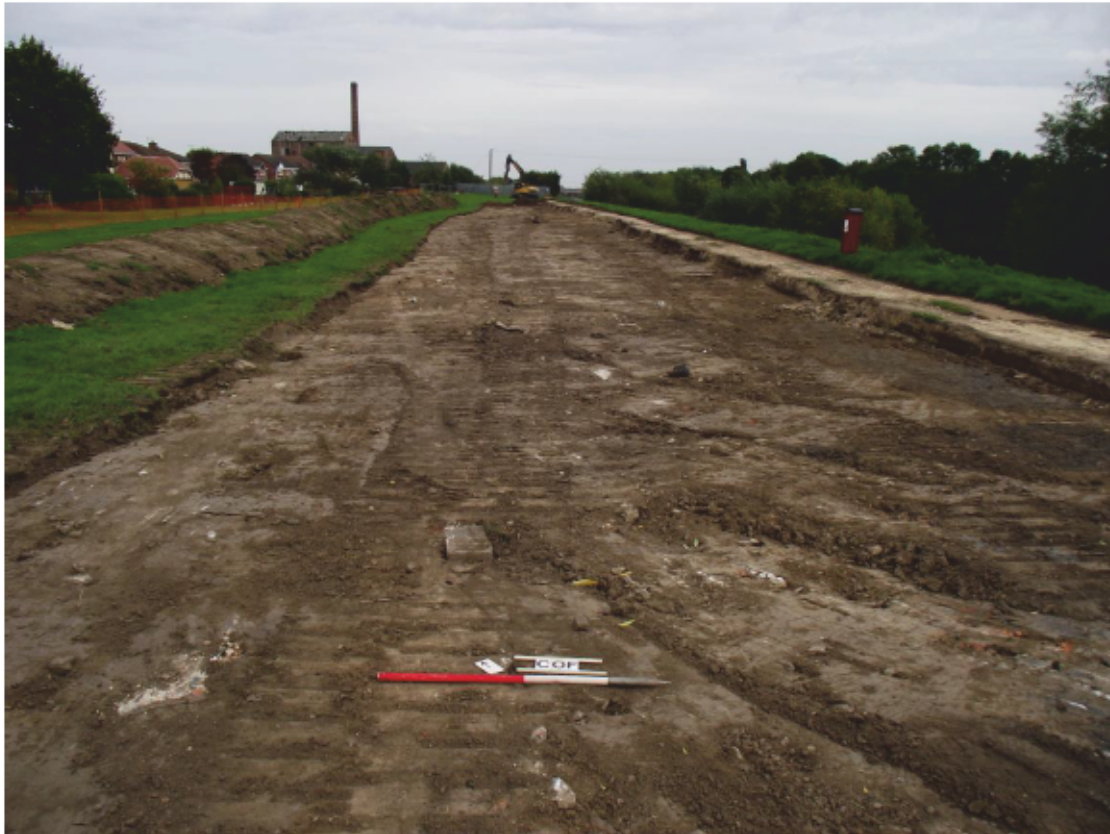
PLATE 3. Stripped flood bank, Area 02, looking south-east.

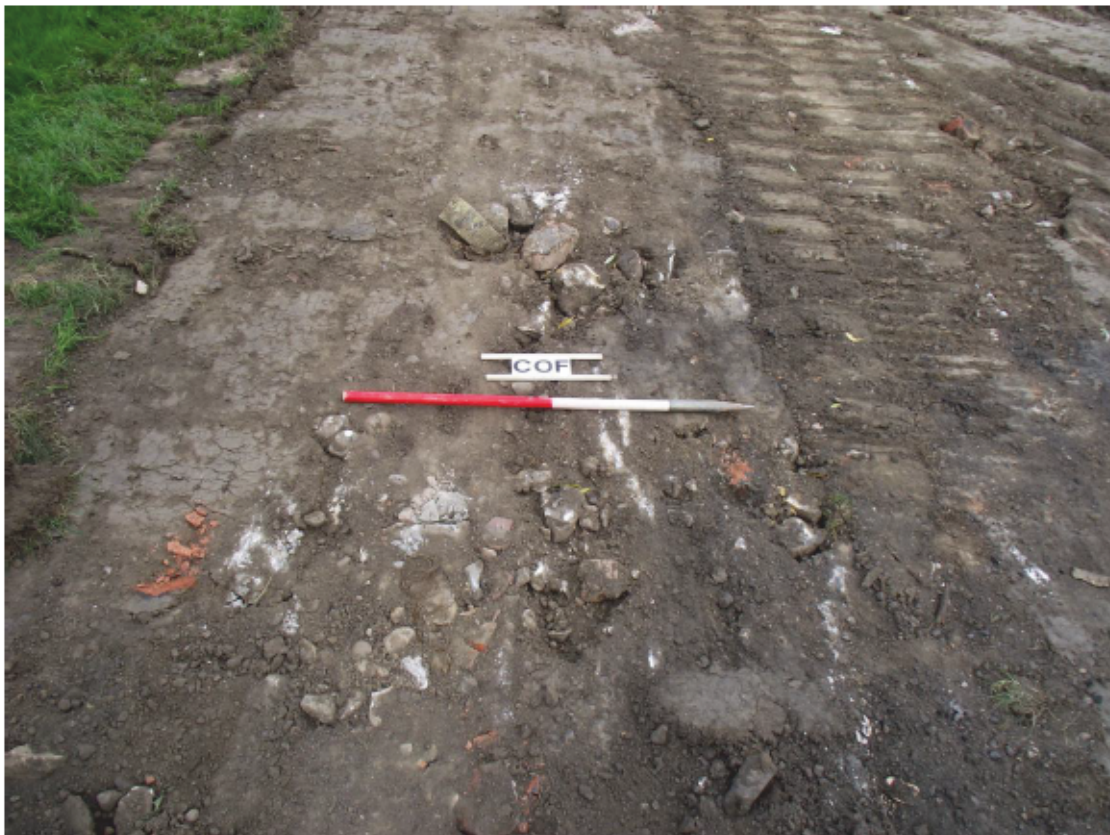
PLATE 4. detail of rubble directly beneath the topsoil on the flood defence in Area 02.

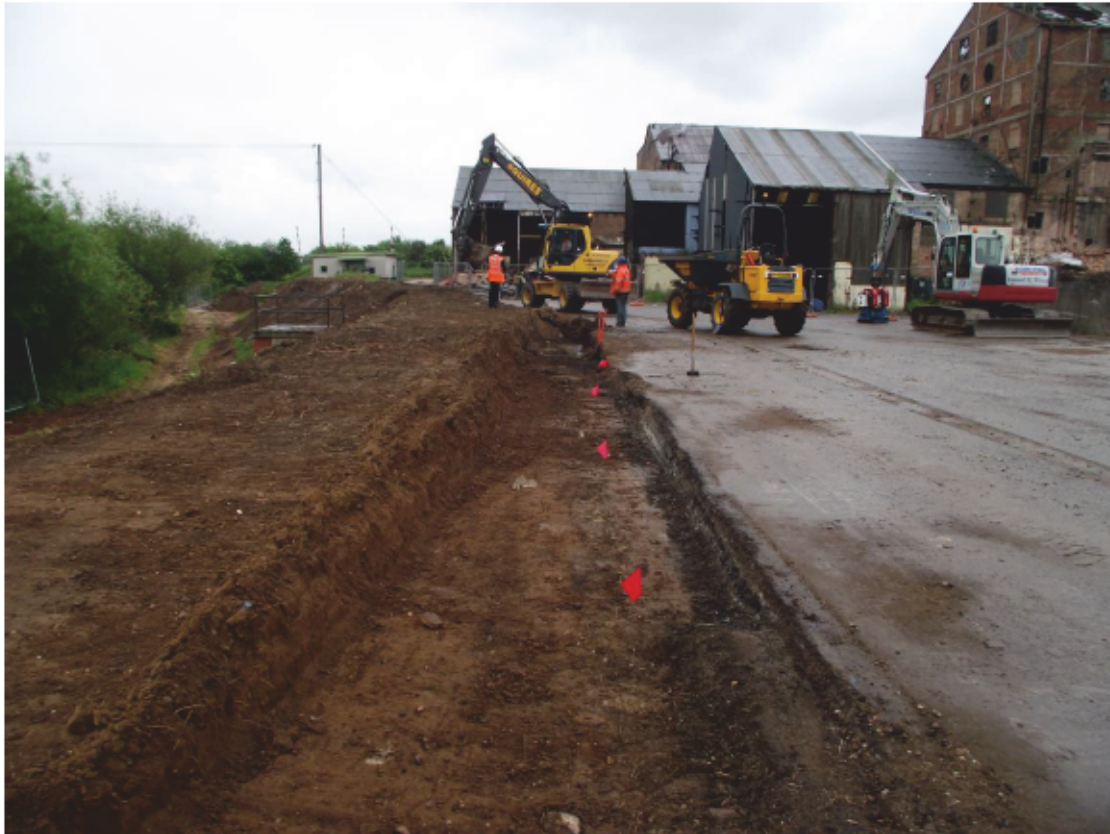
PLATE 5. Topsoil stripping on the edge of the existing flood defence in Area 03. Looking south-east.

6.3.1 The lead trench was initially excavated to a depth of 400mm (Plate 5). A deeper trench was then excavated through the centre of this to a further depth of 600mm giving an overall excavation of 1m (Figure\*\*) Sheet piles inserted at 2.5m intervals (Plate 6).

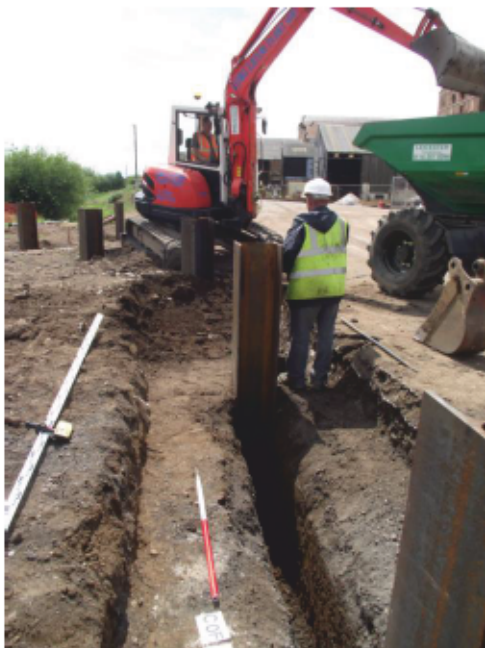
PLATE 6. Inserting sheet piles in Area 03. Looking south-east.

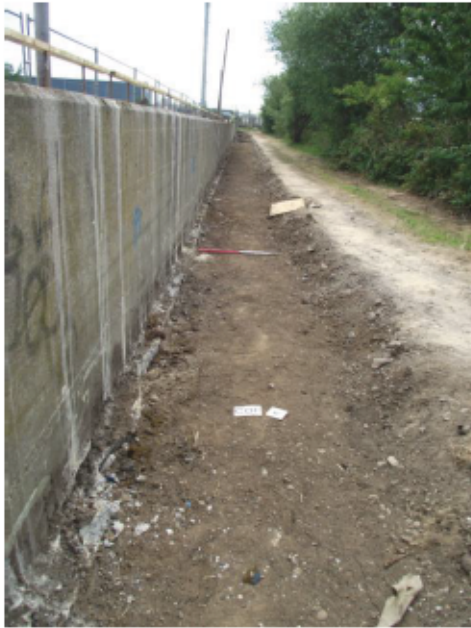
PLATE 7. Area 06 after top of flood defence stripped. Looking north-east.

6.6.1 Only minimal intrusion took place in Area 06 comprising a shallow scrape along the top of the existing flood defence extending to a maximum depth of 100mm (Plate 7).

6.6.2 The groundwork exposed the upper strata of the existing flood defence. There were no archaeological features or deposits revealed and no artefacts uncovered.

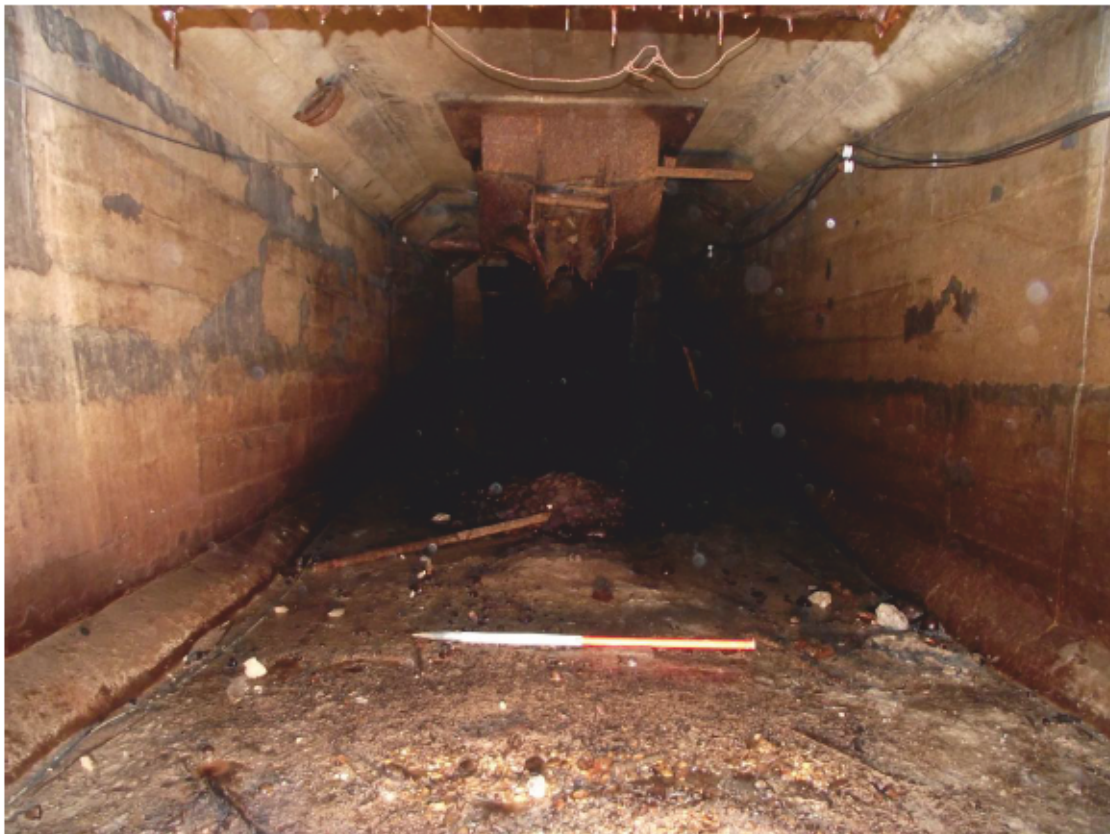
PLATE 8. Interior of concrete chamber, Area 04. Looking south-east.

6.4.1 The feature comprised a concrete tunnel running north to south. It sloped towards the south (Plate 8).

7.5 In Area 04 a subterranean chamber was uncovered during the groundworks. This took the form of a rectangular concrete tunnel running parallel to the Trent. No record of the structure appears to exist according to the contractors, Jackson's Civils but the likelihood is that it relates to the site at a time when river transport was still an important aspect of industrial activity at Colwick. Although there is no precise dating for the structure it probably dates to the mid 20<sup>th</sup> century.

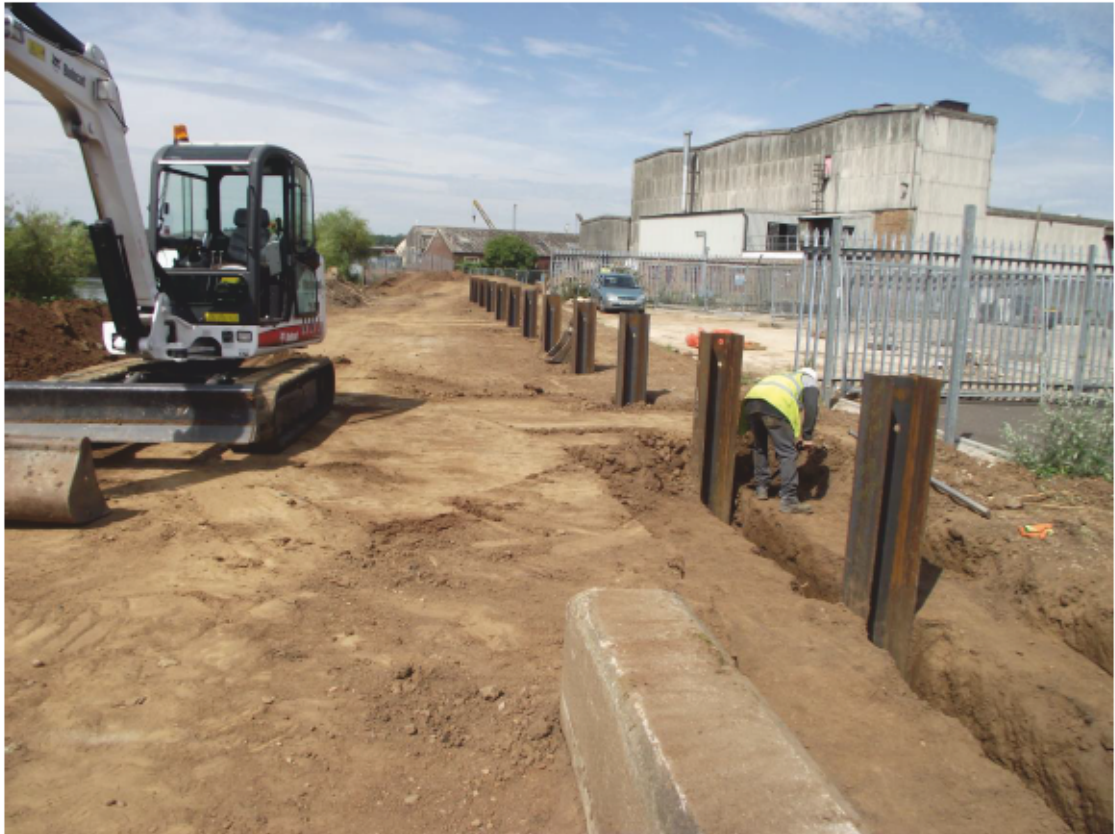
PLATE 9. Area 05, sheet piles inserted in lead trench. Looking south-east.

6.5.2 The lead trench was excavated to a depth of 1m x 400mm wide. Sheet piles were inserted at an average distance of 2.5m (Plate 9).

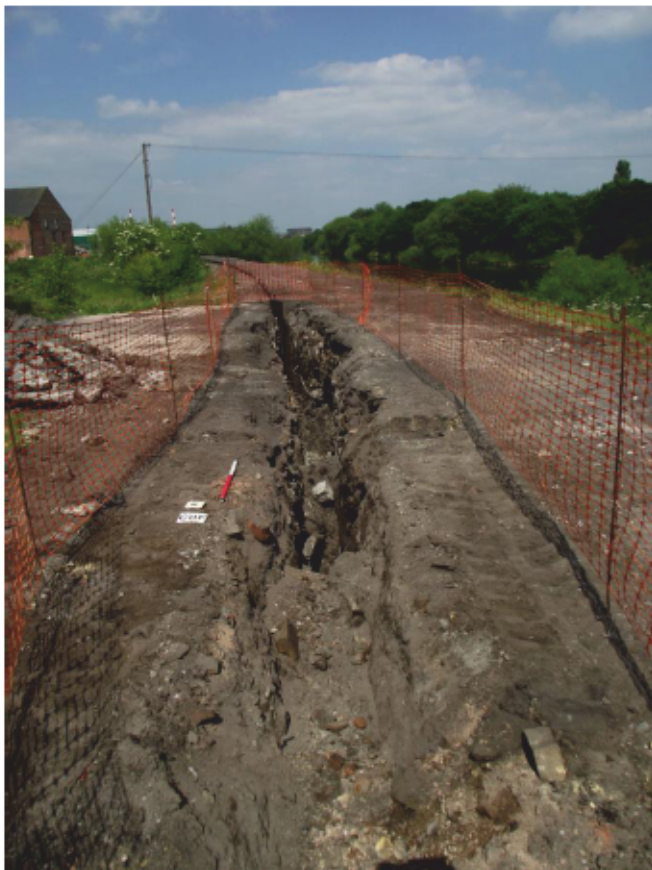
Plate 10. Deep excavation at the eastern extent of Area 02.

6.2.4 The depth of this excavation precluded entry in order to examine the exposed sections but a photographic record was made. The excavation cut through made ground which formed

the underlay of the existing bank including large blocks of concrete, and rubble in a dark grey ashy matrix, (Plate 10)
