# Glenbery House, Walton Street, Long Eaton, Derbyshire

Historic Building Record

Report Number: 002/2014

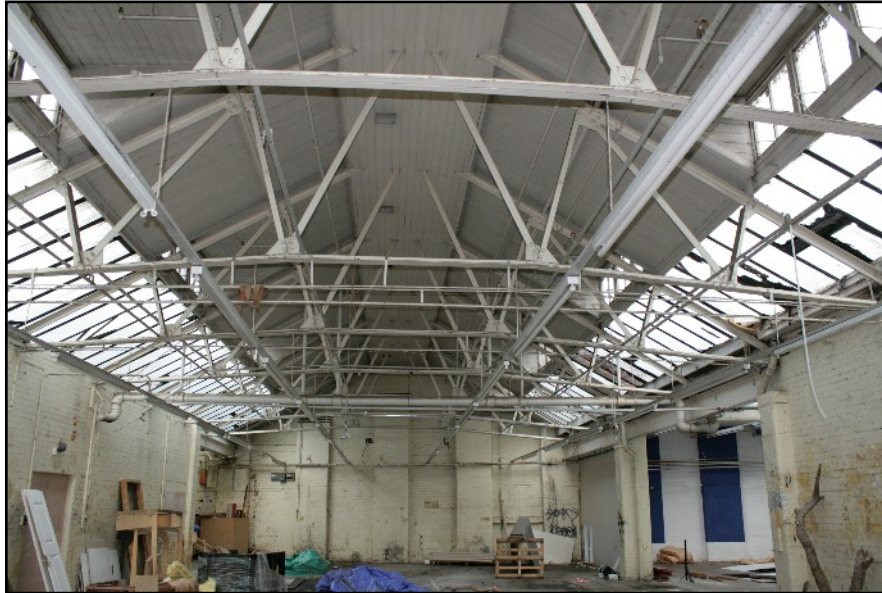
Plate 1: General view down the western bay of Phase F1 with the north wall of the original factory in the background, viewed looking north

This phase is located to the south of, and is contemporary with, Phase F and infills the gap between the buildings fronting Cranmer Street and Walton Street. Its western range is a single storey glass-roofed range identical to the eastern single storey range in Phase F. Originally it had been subdivided into four units, subsequently further divided in recent years.

The south wall of the most northern unit contained a blocked opening and may relate to the earliest phase of the factory. To the east are two large single storey ranges utilising the same construction techniques as in Phase F which functioned as manufacturing areas.

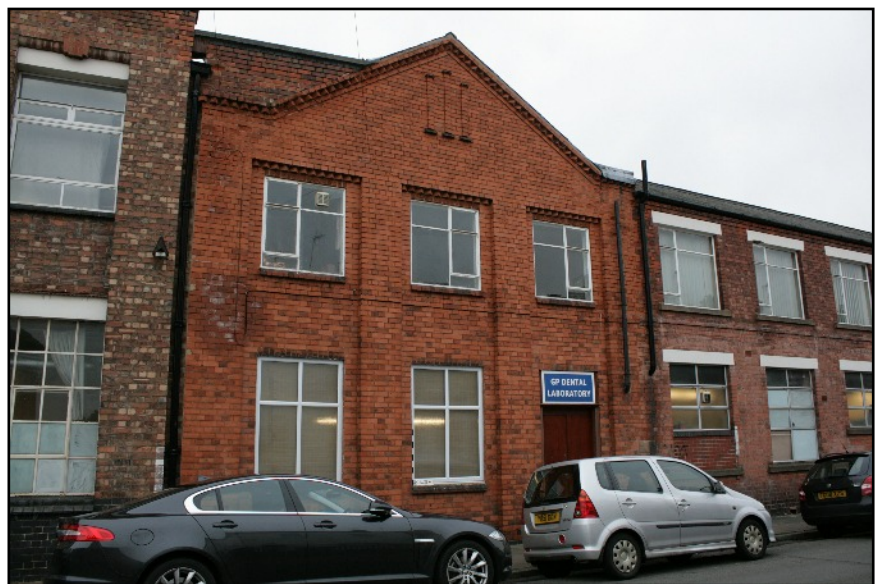
Plate 3: Post 1928 office building fronting Walton Street (Phase B), viewed looking south-east.

At some point after 1928 a new office was built at the Walton Street end. It is a two storey, two bay brick building. The gable wall fronting the road is constructed in Flemish Bond using orange bricks. Dentil ornamentation has been used beneath the roof line and along the tops of the first floor windows. The internal walls are constructed of breeze blocks with the ceiling supported on steel girders. The first floor has been recently converted into offices with a modern ceiling preventing an examination of the roof.

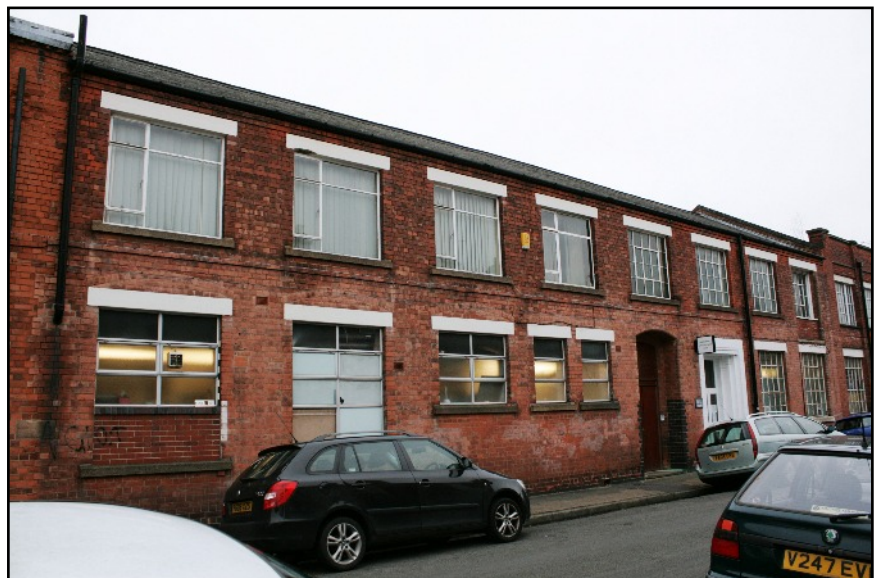
Plate 4: General view of the showrooms fronting Walton Street (Phase C), viewed looking south-east.

A new range abutting Phase B and extending to the south was constructed shortly after. It is a two storey building constructed in Flemish bond with a gabled roof. The Walton Street frontage has undergone some alterations since its construction. To the north of the entrances the ground and upper floor windows have been replaced (as had the rear upper floor windows) and to the south of the entrances the southern most upper floor doorway partially blocked and a window inserted. The two entrances are likely to be original, each providing access into a different functioning half of the factory, the southern entrance being more decorative suggesting that it led into a non-manufacturing part of the factory, possibly a

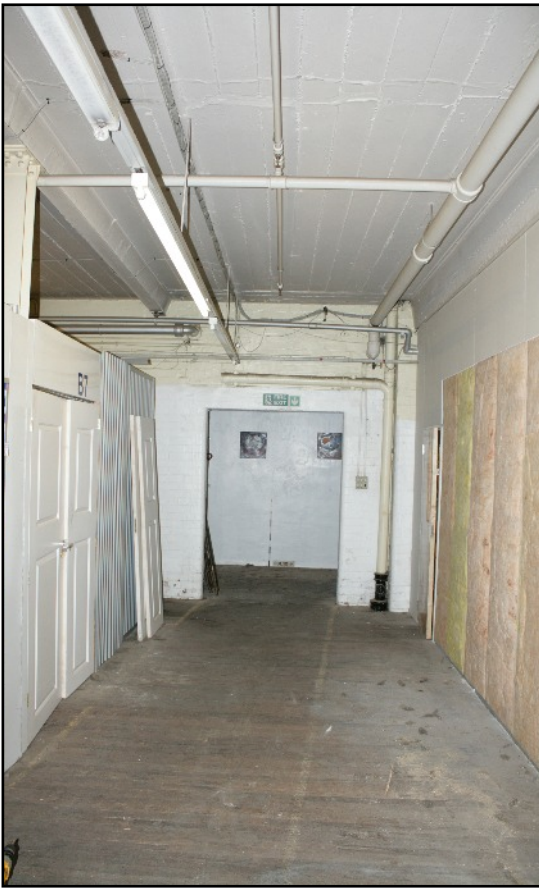
Plate 5: The interior of the showrooms in Phase C. Note the timber floor and concrete plank ceiling, viewed looking north.

showroom. Internally on the ground floor the northern entrance retained its original door, door frame and window frame above. In contrast the fixtures and fittings of the southern entrance had been replaced and the stairway appears modern. The flooring in both rooms was of timber. As the ceiling was of concrete plank construction supported on steel girders it was designed to withstand considerable weight indicating that it was originally used to store materials or finished goods. On the first floor the building had been subdivided into modern offices obscuring any early features. The roof above could be partially viewed revealing that it is of timber construction possibly forming an M shaped truss.

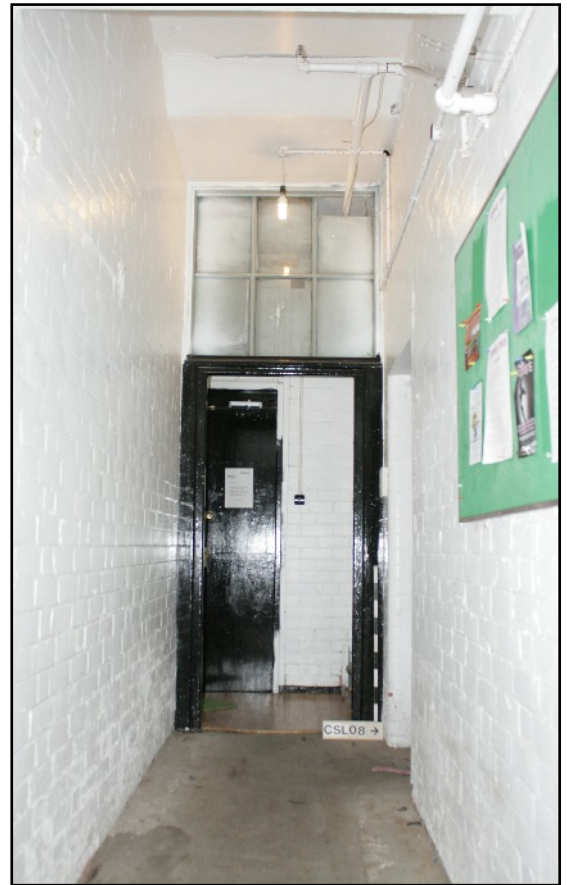
Plate 6: Original door and window in Phase C, viewed looking west.

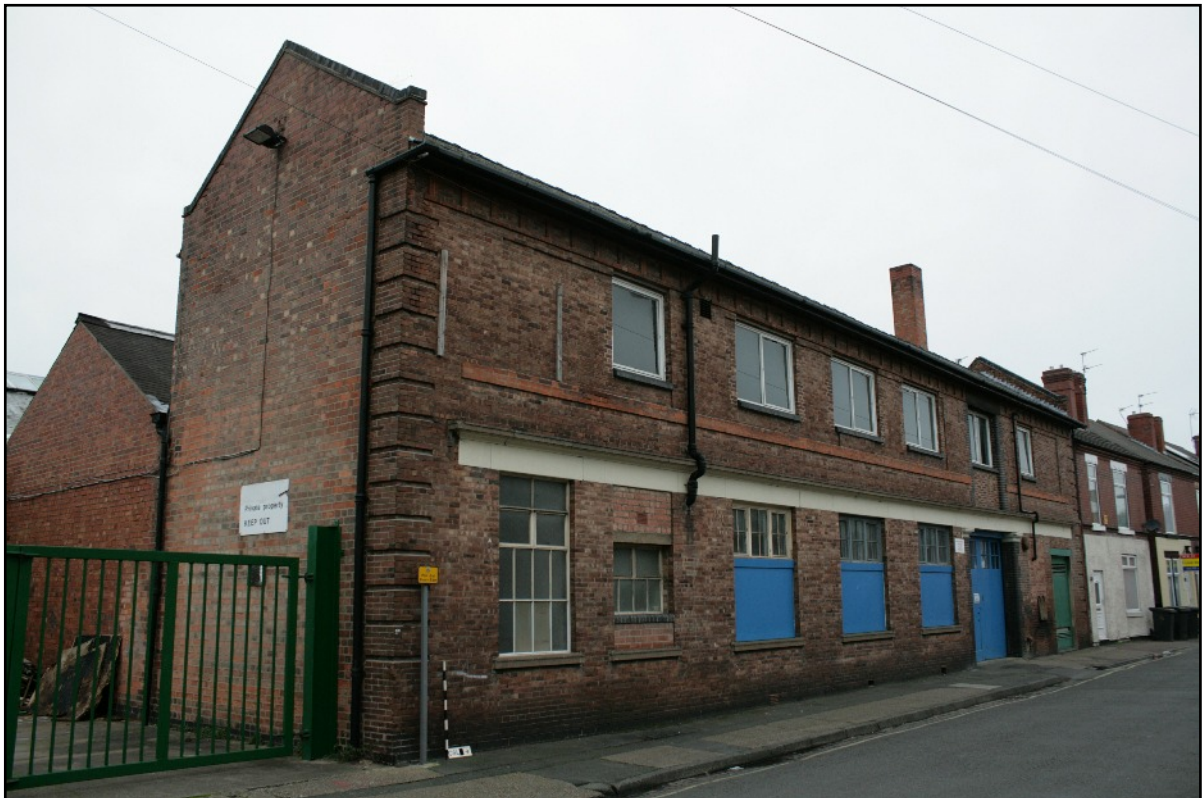
Plate 7: The building range fronting Cranmer Street (Phase D), viewed looking north-west.

Around the same time that Phase C was constructed a further building, Phase D was built fronting Cranmer Street. It is a two storey brick building constructed in Flemish bond with a gabled roof. Brick ornamentation is present beneath the cornice with imitation quoining in a similar style. It has a string course and a continuous hood and utilises blue bricks for a number of the window cills. There is a double-door entrance and reduced delivery doorway providing access to the generator. The upper floor was used as a canteen. The original upper floor window openings have been altered for the insertion of modern windows. The floor level on the ground floor is 0.20m higher than the rest of the factory complex. In contrast to the first floor which was refurbished in the latter half of the 20<sup>th</sup> century as a canteen the ground floor is largely original with the majority of its few fixtures and fittings surviving.

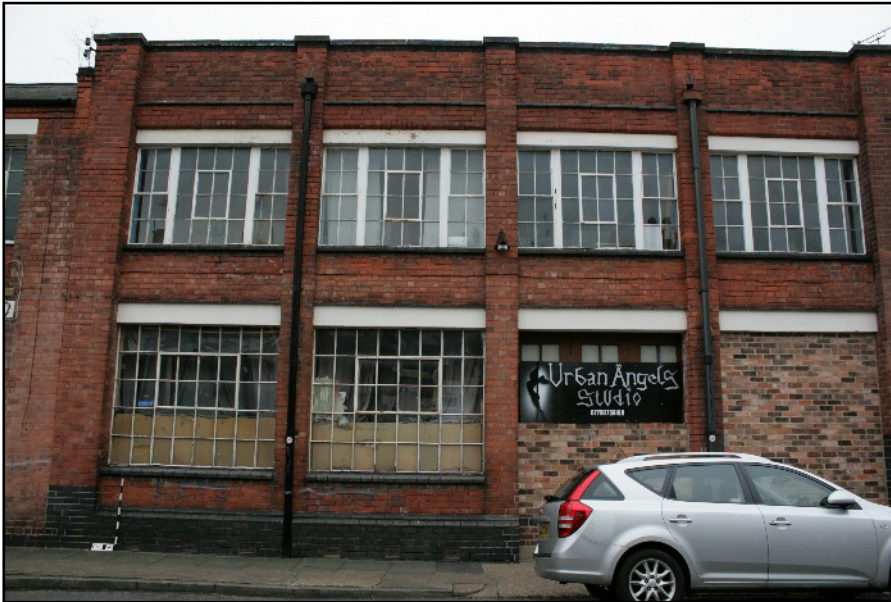
Plate 8: General view of the dispatch building fronting Walton Street (Phase E), viewed looking east.

A major expansion of the factory was undertaken in the 1930s. This began with an extension southwards to the Walton Street frontage of a brick built building with a gabled roof. It is constructed in Flemish bond with blue bricks used for the window cills and lower courses. It has two original windows and two large double doors fronting Walton Street which have been filled in though the doors survive behind the brickwork. Internally the heavy timber ceiling is supported on steel girders suggesting goods were stored on the floor above and dispatched below, though there is no surviving evidence for a lift system in this part of the building. The upper floor walls and ceiling have timber panelling and early radiators, possibly original to the build, present along the northern wall.

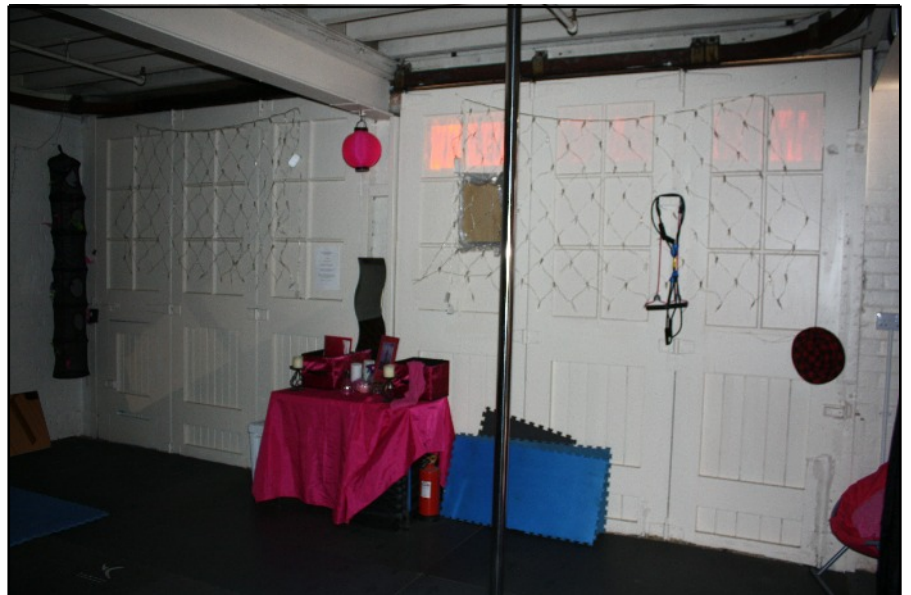
Plate 9: Interior of the dispatch building (Phase E) showing the original doors behind the bricked in entrances of the west wall, viewed looking south-west.

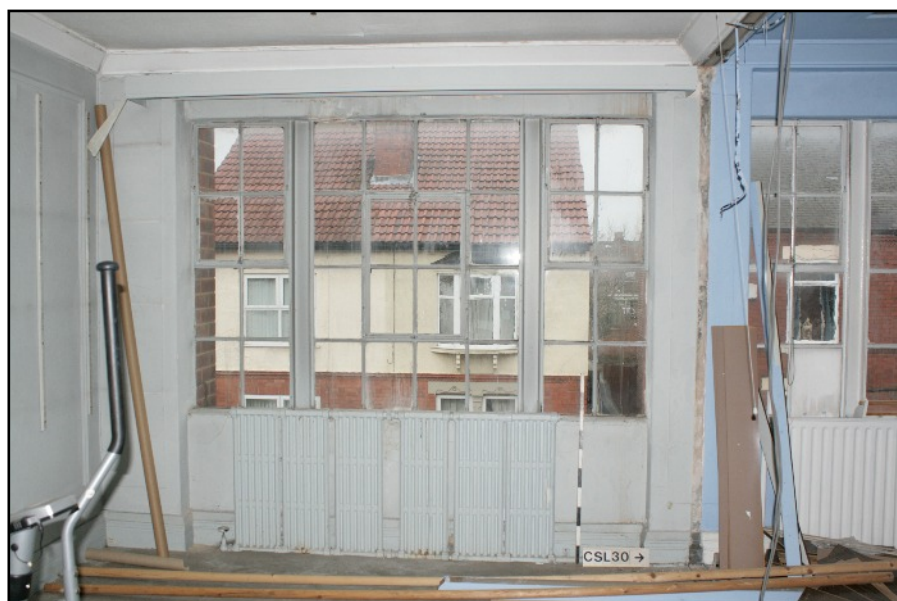
Plate 10: Original radiator and window, including tiled cill, on the north wall of the first floor of the dispatch building (Phase E), viewed looking west.

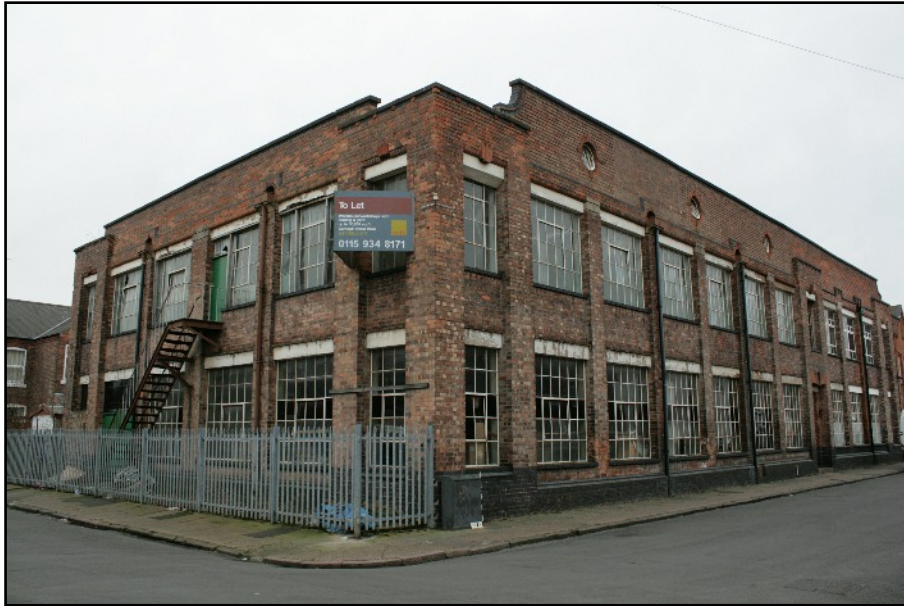
Plate 11: General view of of the north-west corner of Phase F, viewed looking south-east.

The factory was expanded at the north end of Walton Street with a two storey brick building typical of the 1930s. It is constructed in Flemish bond and lit with large metal frame windows beneath concrete lintels along the north and west walls. On the Walton Street elevation there is some decorative detailing including a pediment with port-holes, keystones and miniature arches above drainpipe hoppers. Blue bricks are used on the lower courses.

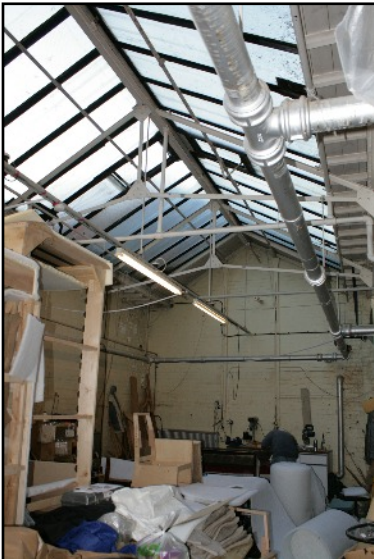
Plate 12: The single storey glass range in Phase F range viewed looking south-east.

4.7.2 The southern half of the building is narrower. No bases for heavy machinery were present on the ground floor. The upper floor is likely to be the former sewing room on account of being very well lit by windows in both the west and east walls and the skylights in the roof. A contemporary single storey glass-roofed range to the east, built using the same type of roof truss as that in the rest of the phase.

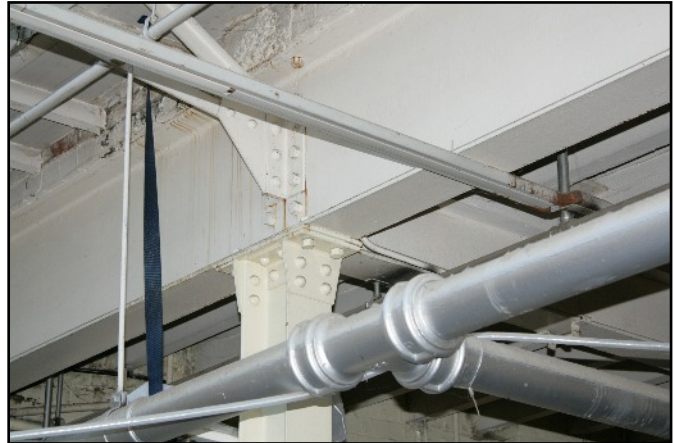
Plate 13: Detail of the roof truss, steel post and plate in the single storey range in Phase F.

4.7.1 The building consists of two units of unequal size separated by a staircase which is lit from an open well near the centre of the building. The northern part of the building is larger with windows present on both floors along the north and west walls with a delivery door where materials arrived at the north end. Concrete bases are set in the ground floor for heavy machinery indicating that the room was used for the initial processing of the raw materials. The first floor is well lit by the windows in the two walls and by skylights in the roof. Trap doors in the northern and southern end of the room facilitated the movement of goods between the two floors. The nature of the room would suggest that it was the former cutting room. The roof is carried on five light metal trusses supported on steel girders.

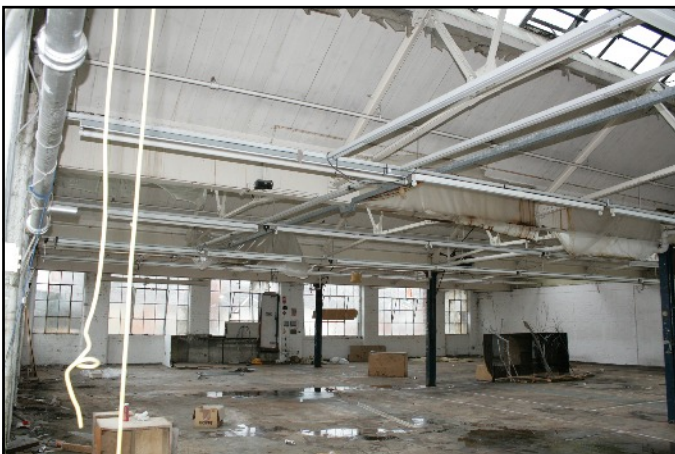
Plate 14: The first floor of Phase F, viewed looking north-east.

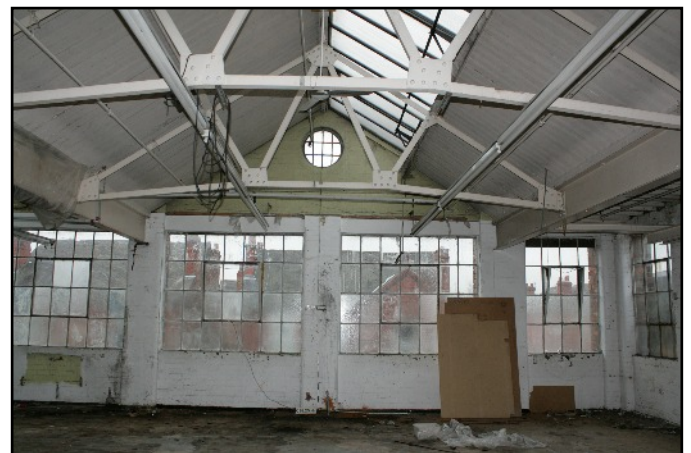
Plate 15: The roof trusses used on the first floor of Phase F, viewed looking west.

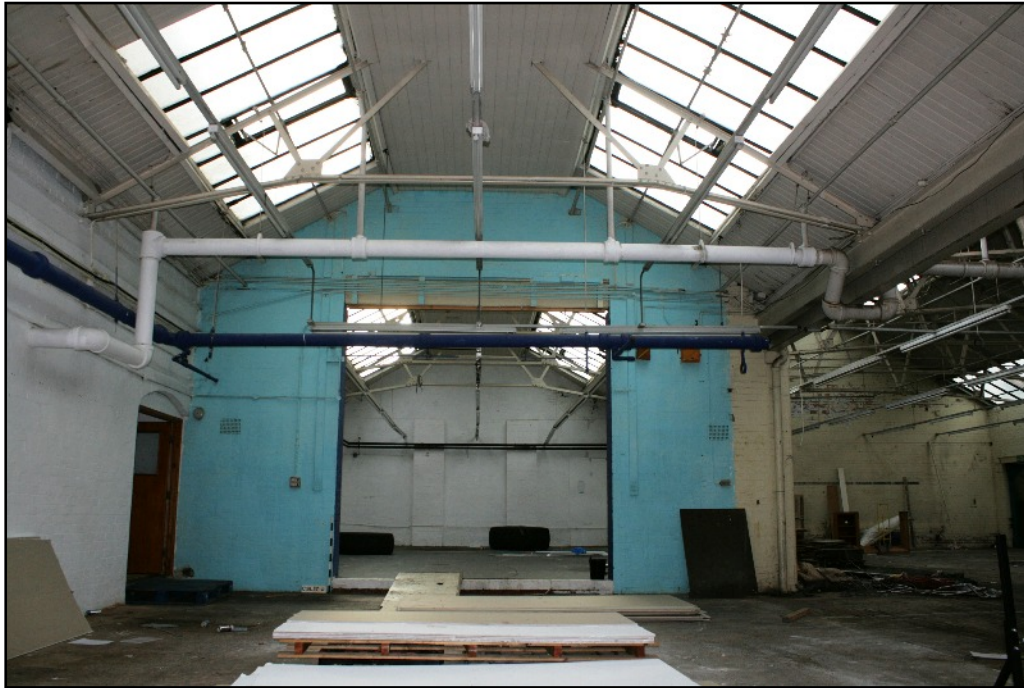
Plate 16: General view of the eastern most range of Phase F1, viewed looking south.

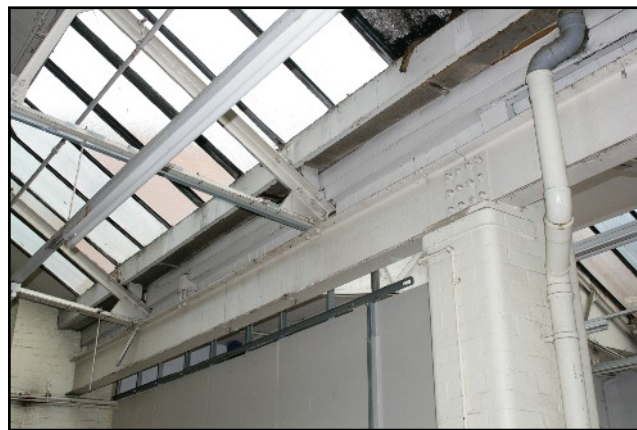
Plate 17: Detail of the roof truss, steel plate and brick posts in the eastern range of Phase F1.

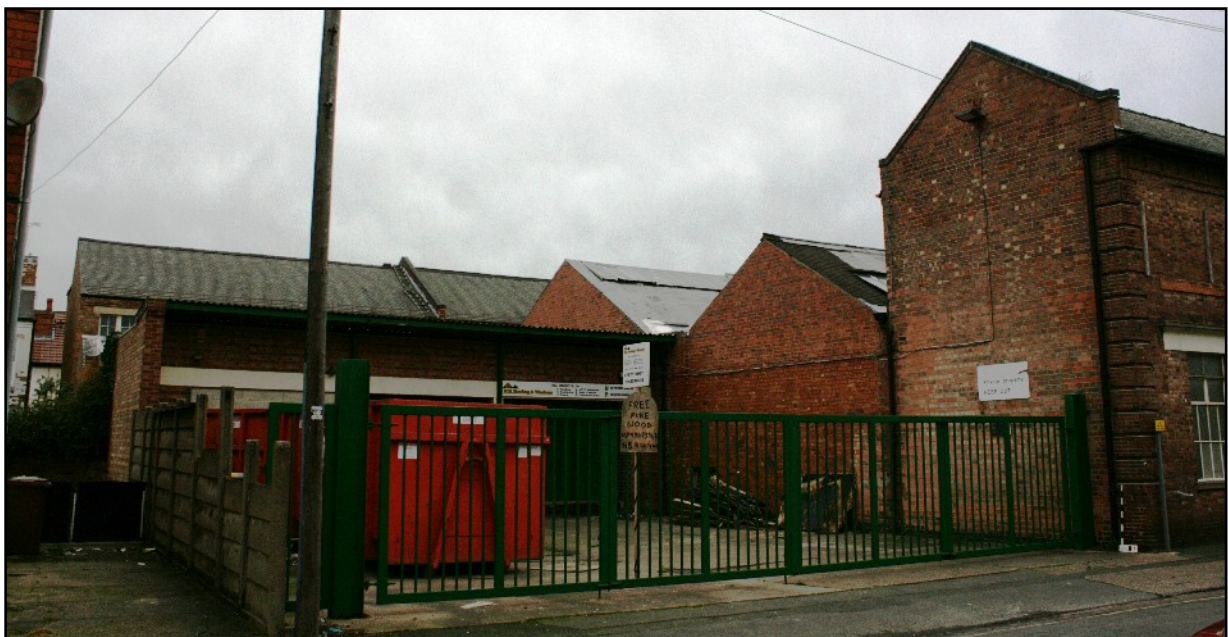
Plate 18: General view of the factory gables with Phase G to the left, viewed looking north-west.

At some point after 1958 two houses behind Phase E were demolished to allow the expansion of the dispatch department eastwards. It is a single storey brick built building with three large doors facing Cranmer Street and two internal ones providing access into Phase E behind. It has a flat corrugated roof supported on two girders.

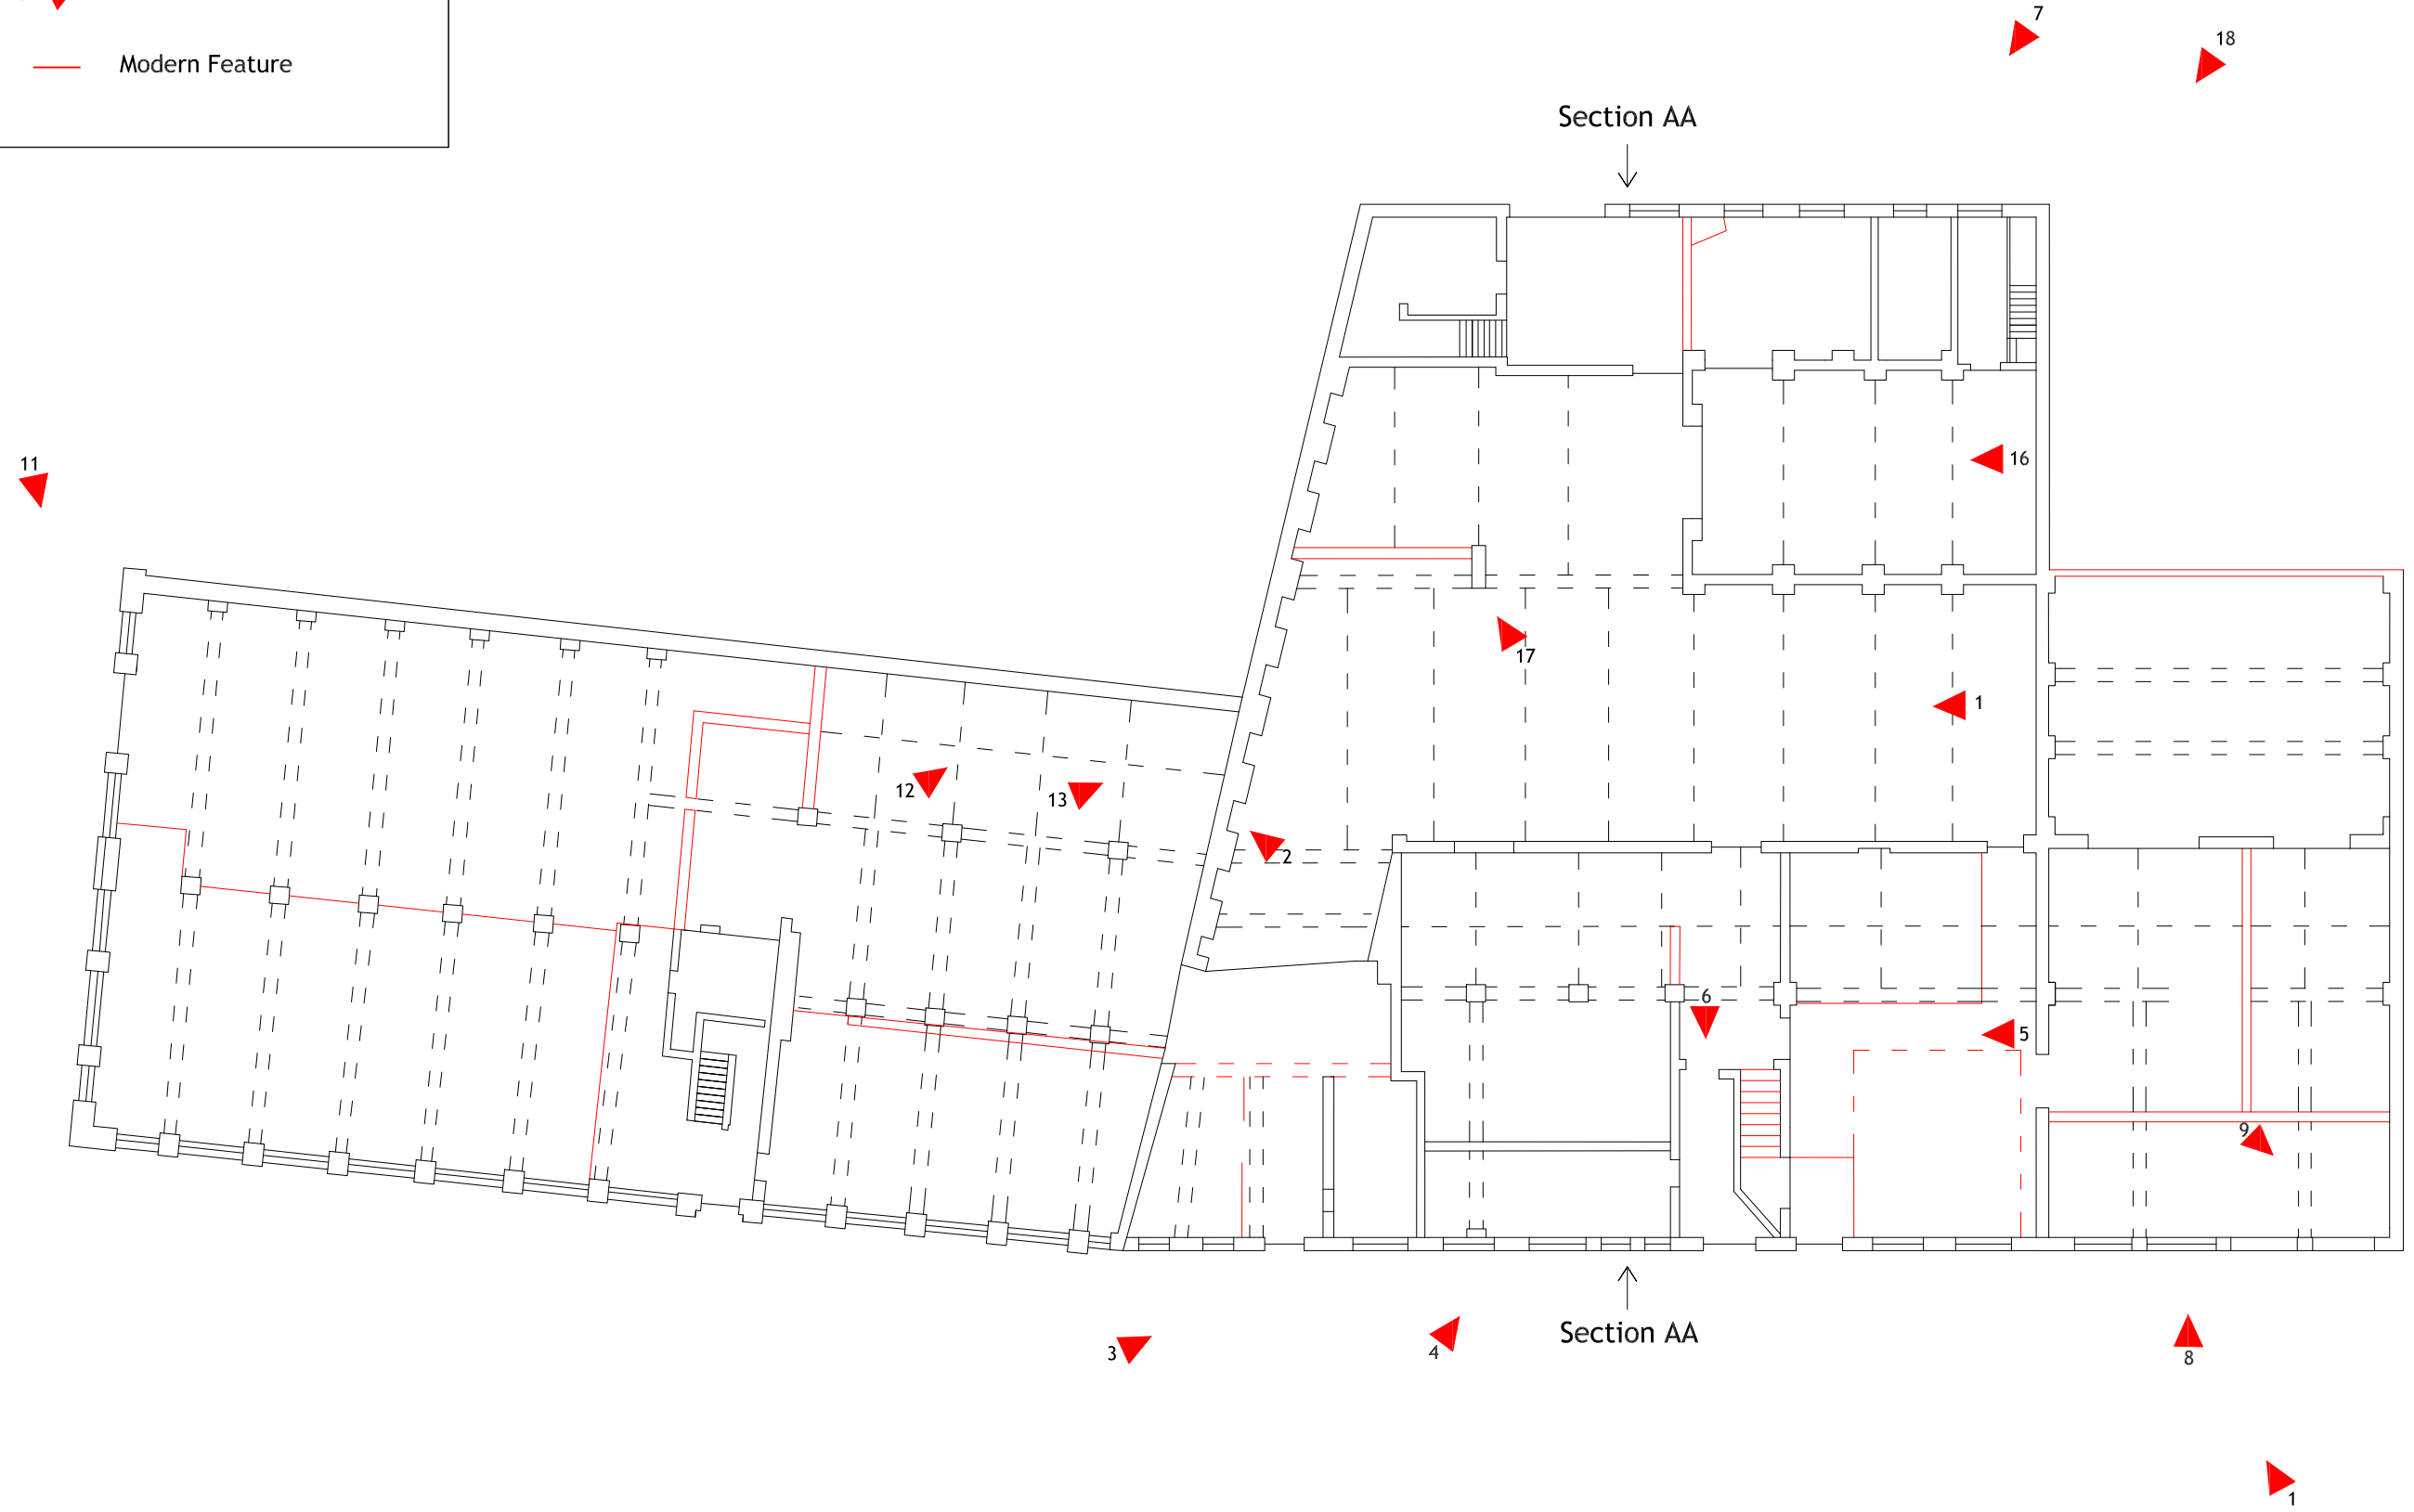
Figure 6: Plan of the ground floor with plate viewpoints indicated. Scale 1:250
