Bolsover Castle Play Area

Report on an Archaeological Watching Brief

Project Code – BPA2

TPA Report No. 019/2014

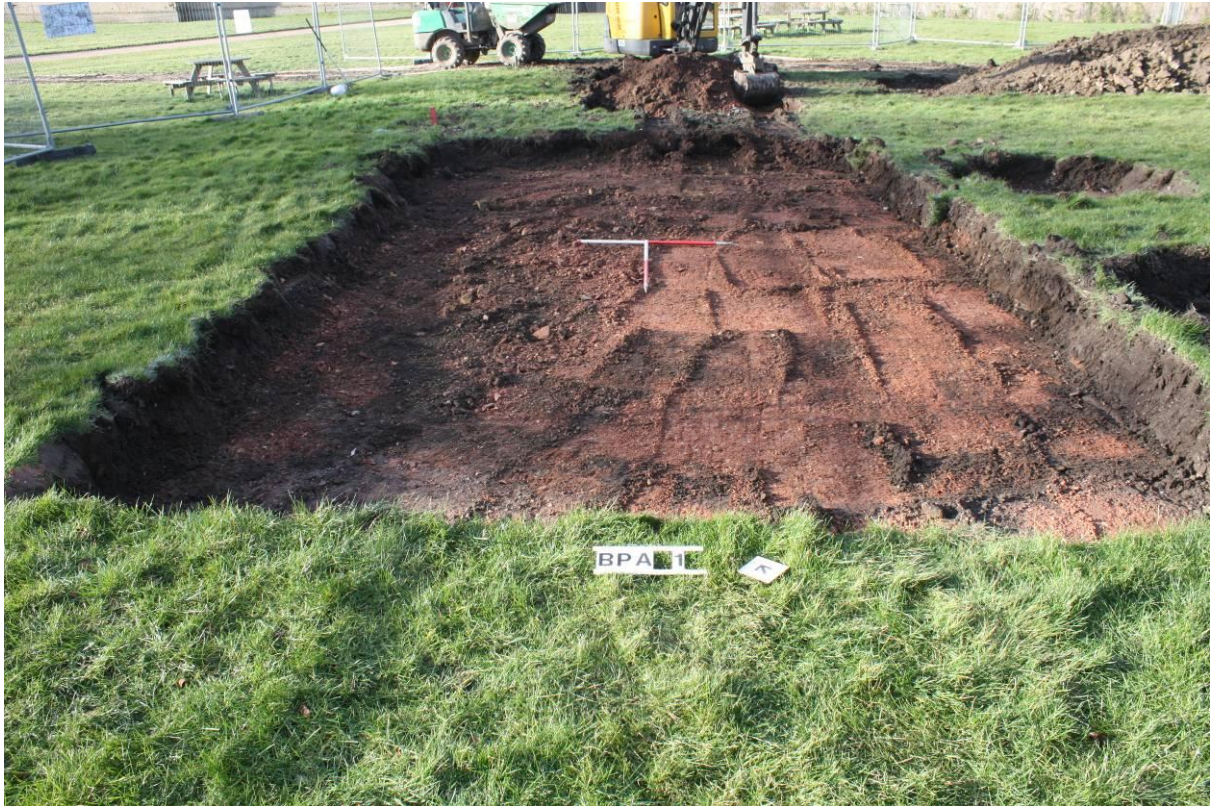
6.2 Trench 1 (7m x 3.2m). Rectangular trench aligned north-west/south-east, located towards the south edge of the proposed development site. Trench 1 contained two subsidiary trenches (1a, 1b) for the foundations of the play equipment, measuring approximately 1m by 0.5m. The main trench was stripped of topsoil (001) to a depth of 0.3m, at which the remains of the early 20th century tennis court (003) were found (Plate 1). This consisted of a thin layer of compacted hard red clay fragments with a maximum depth of 0.15m. Excavation of Trenches 1a and 1b were excavated through this layer to a depth of c.0.3m, exposing the underlying deposit (005), comprising broken limestone chunks and chips within a dark brown silty soil matrix which averaged 0.18m in depth (Plate 2). This deposit is known locally as "ratchel". The bedrock (006) was encountered at the base of this deposit. No archaeologically significant finds or features were identified within Trenches 1, 1a, 1b, although a single metal plate connected to a concrete base (009) was identified as a marquee anchor point (see section 3.7).

Plate 1: Trench 1 after stripping showing the tennis court layer (003). Scales = 1m

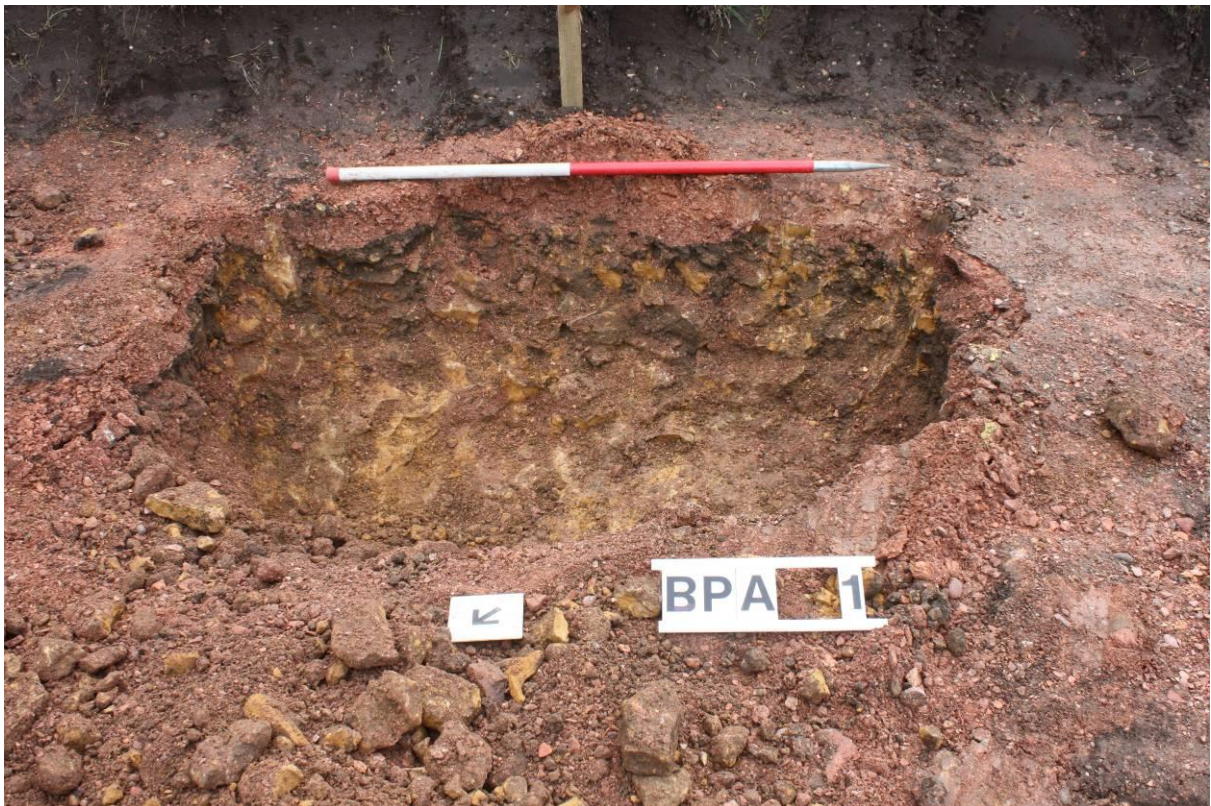
Plate 2: Trench 1a. Scale = 1m

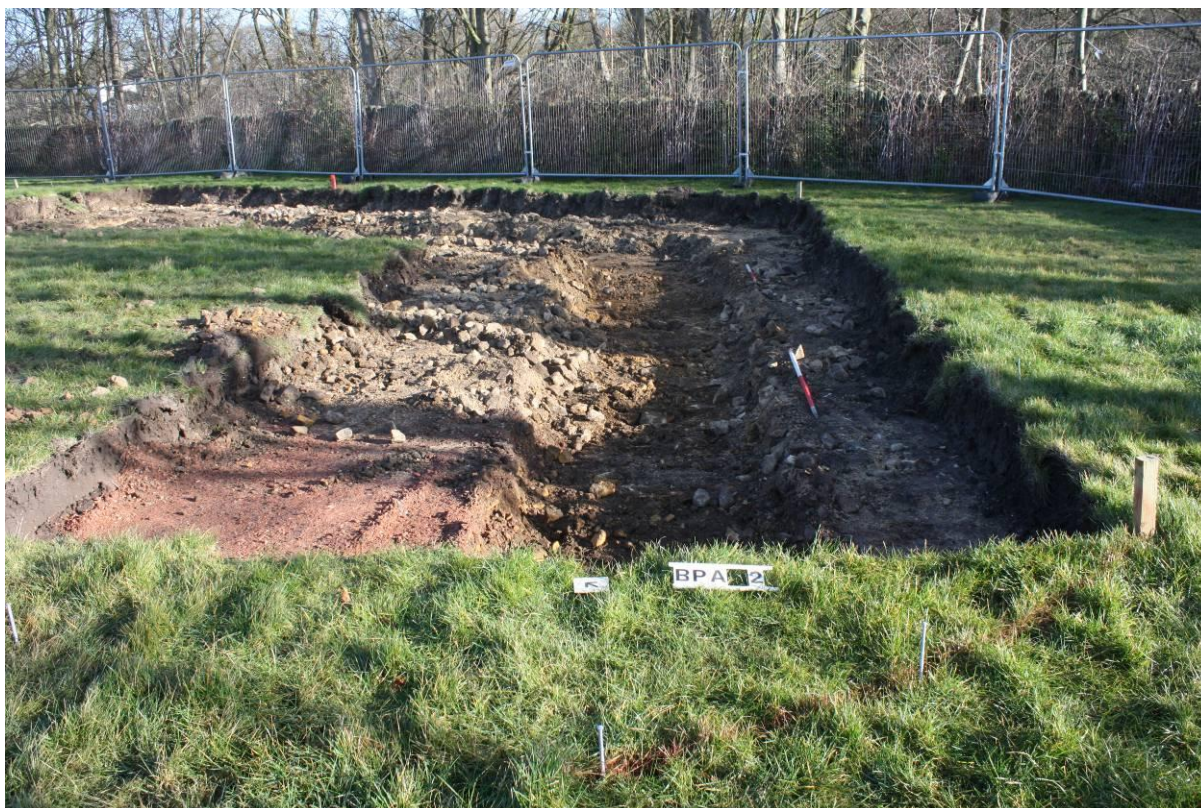
6.3 Trench 2 (21.2m x 4.4m). L-shaped trench, positioned on the eastern edge of the proposed play area. The stratigraphic sequence was similar to that of Trench 1; however, the red clay layer of the former tennis court surface did not extend further than 2m from the south-west end of the trench. Past this point the surface changed to pale yellow compacted gravel 0.25m deep (004) which appeared to be imported hardcore. It is likely that this was the surface material used as pathways around the outside of the tennis court. After removal of topsoil a continuous shallow foundation slot was cut following the midpoint of Trench 2 to an additional depth of 0.2m (Plate 3). This demonstrated that below the compacted gravel surface (004) the stratigraphy was almost identical to that of Trench 1, with a layer of 'ratchel' covering the bedrock.

Plate 3: Trench 2. Scales = 1m

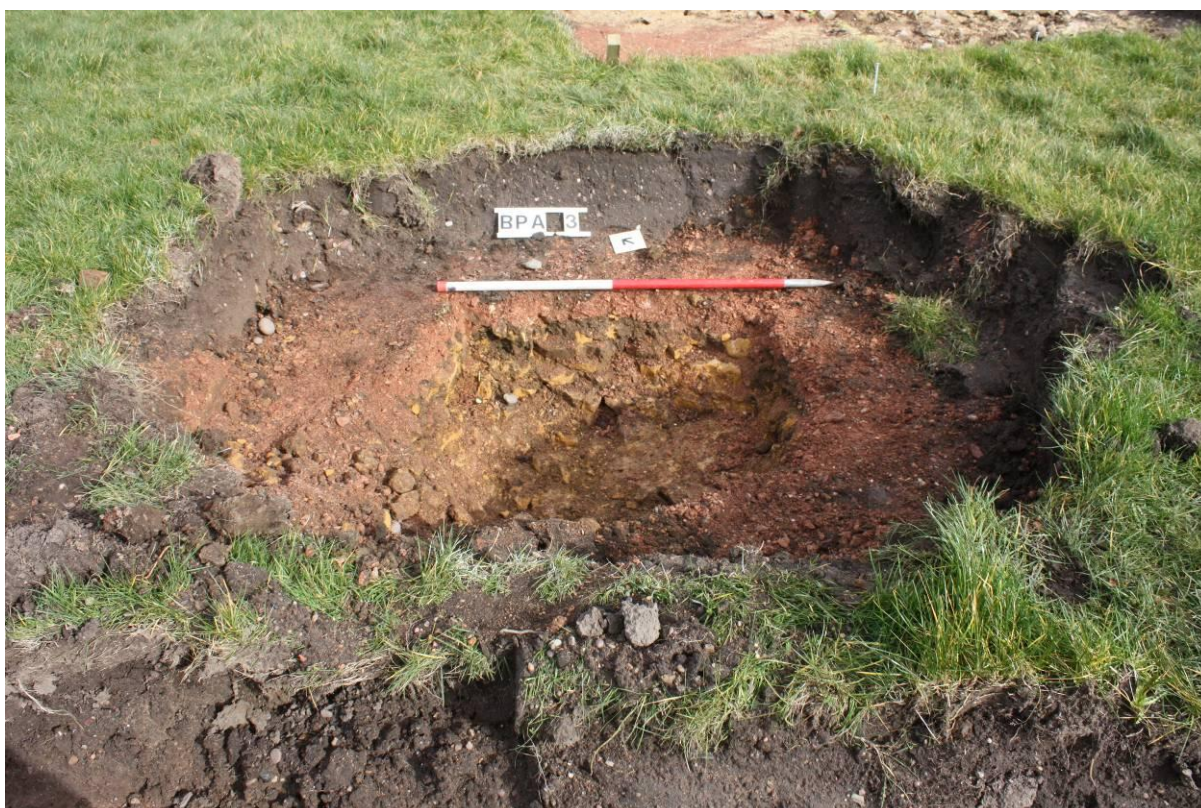
6.4 Trench 3 (x2m). Circular trench 2m in diameter, located in the space between the south-west end of Trench 2 and the south-east end of Trench 1. Following the removal of topsoil from Trench 3, a deeper (c.300mm) excavation was made of a 1m² area within Trench 3. This gave a maximum excavated depth for Trench 3 of c.600mm. The stratigraphy was almost identical to that in Trench 1, with topsoil 0.3m deep covering the red tennis court clay. A layer of 'ratchel' approximately 0.2m deep was present below the clay surface, which in turn rested above bedrock (Plate 4).

Plate 4: Trench 3. Scale = 1m.

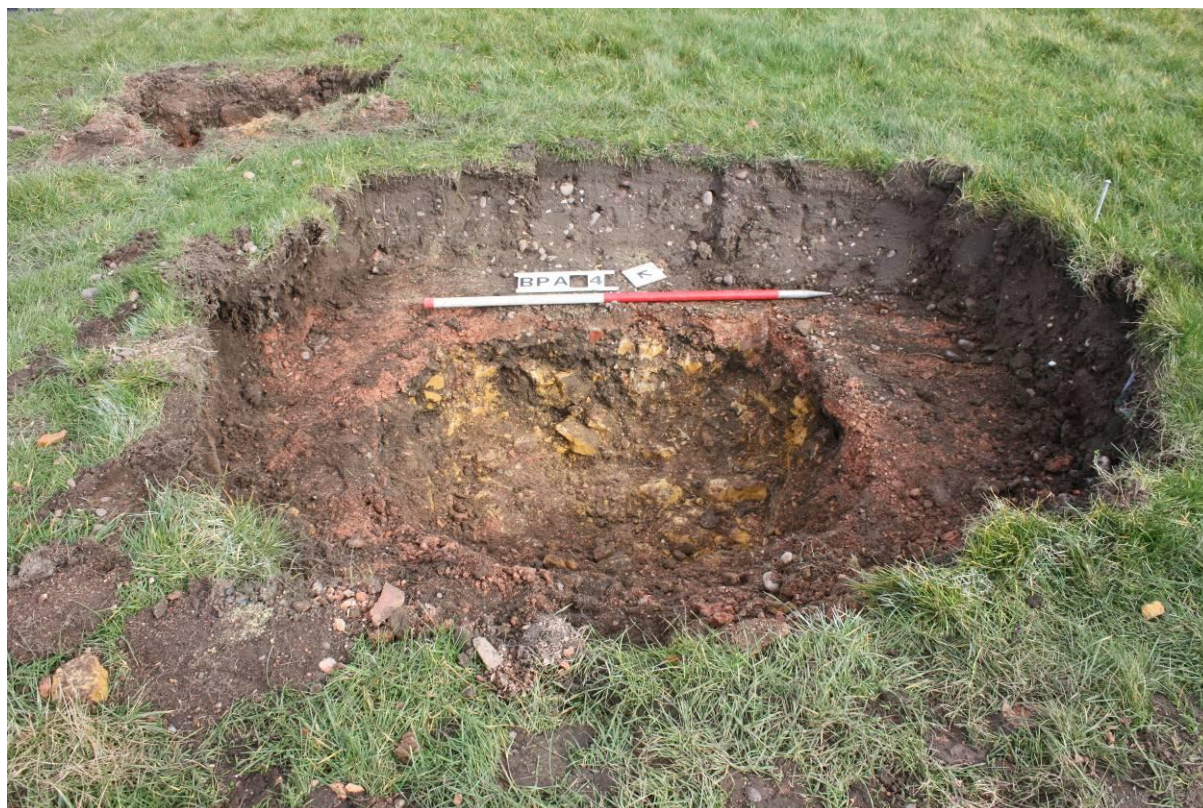
6.5 Trench 4 (x2m). Circular trench 2m in diameter, situated c.2m north-west of Trench 3. Following removal of c.300mm of topsoil the level was reduced by a further 300mm within a central 1m² area, this established an identical stratigraphic sequence to that recorded in Trench 3, with topsoil overlying the red clay of the tennis court beneath which was a layer of "ratchel" to a thickness of c.200mm over rock head (Plate 5).

Plate 5: Trench 4. Scale = 1m.

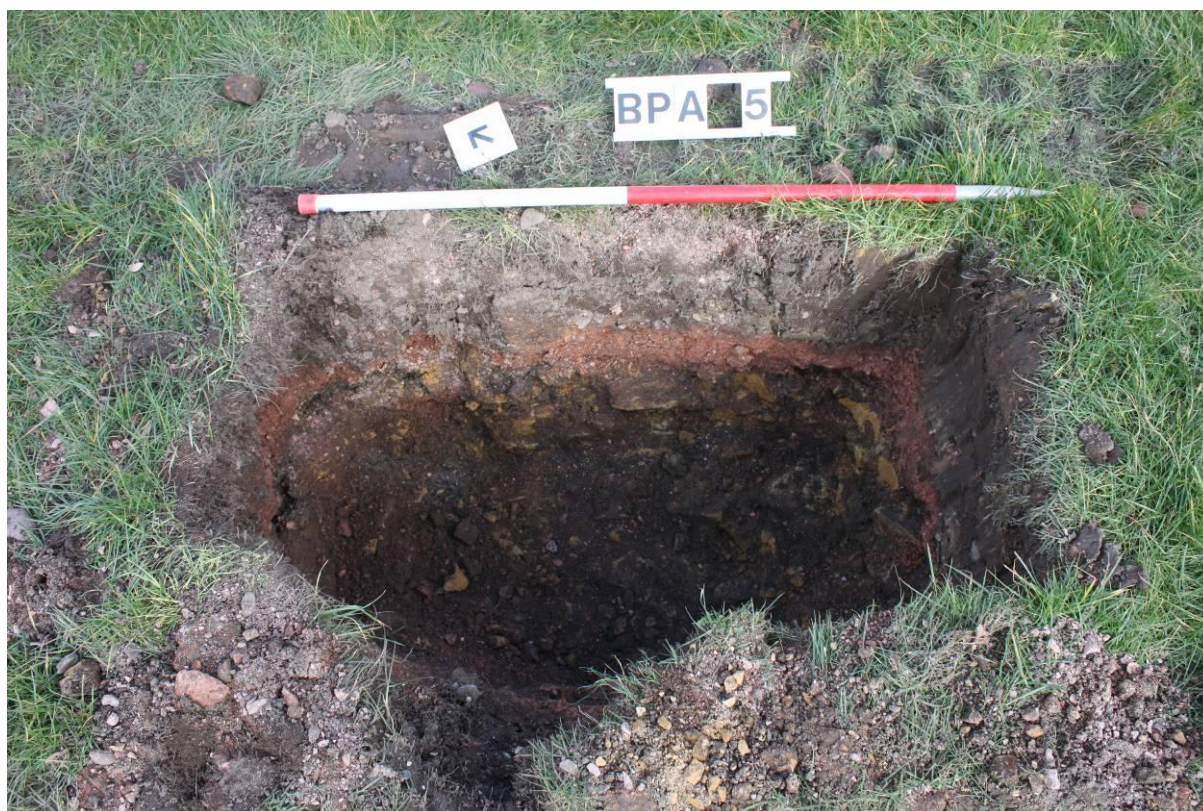
6.5 Trench 5 (1m x 0.5m). Rectangular trench aligned north-west/south-east and located c.1m north of Trench 4. The small trench was excavated in its entirety to a depth of 0.5m. As with Trenches 1, 3 and 4 the red clay layer of the former tennis court surface was encountered at a depth of c. 0.3m deep (Plate 6). This layer had a maximum thickness of 0.15m and directly overlies the "ratchel" deposit. Bedrock was revealed at approximately 0.6m.

Plate 6: Trench 5. Scale = 1m

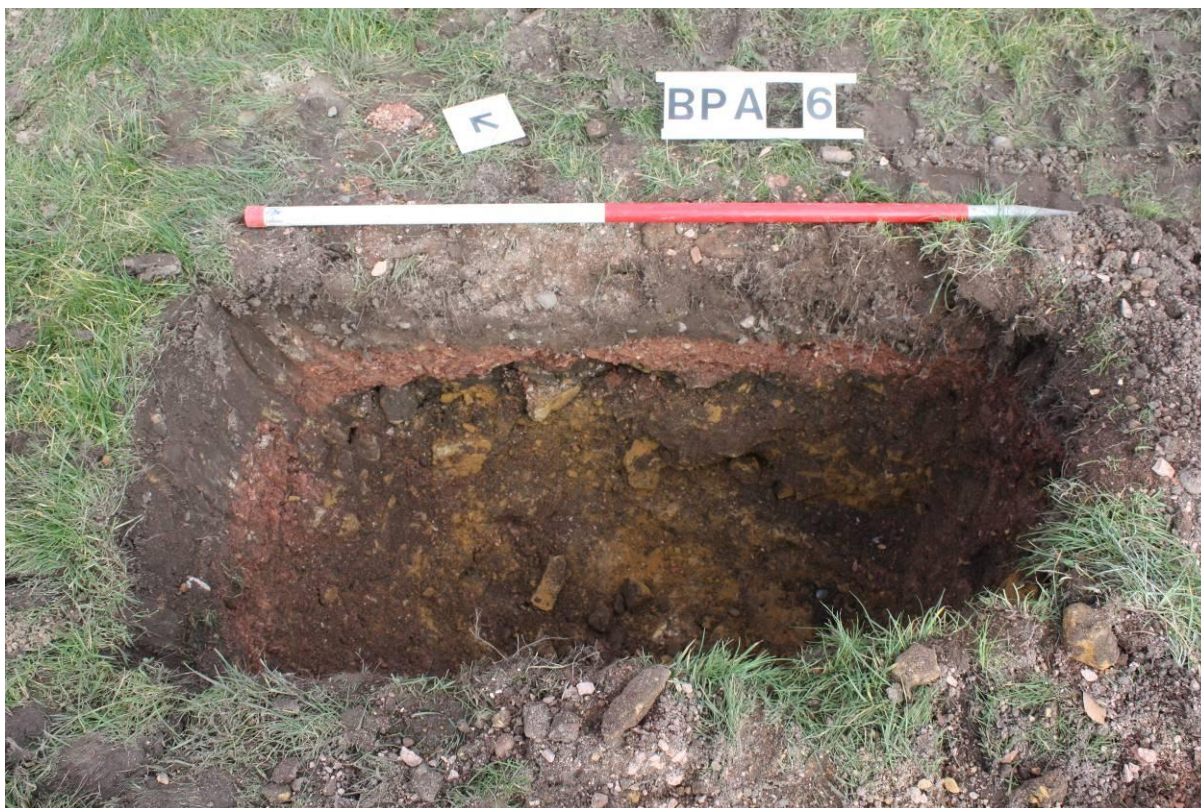
6.6 Trench 6 (1m x 0.5m). Rectangular trench aligned north-west/south-east and positioned c.2.5m north-west of Trench 6. Excavation to a depth of 0.5m revealed an identical stratigraphic sequence (Plate 7) to that recorded for Trench 5.

Plate 7: Trench 6. Scale = 1m

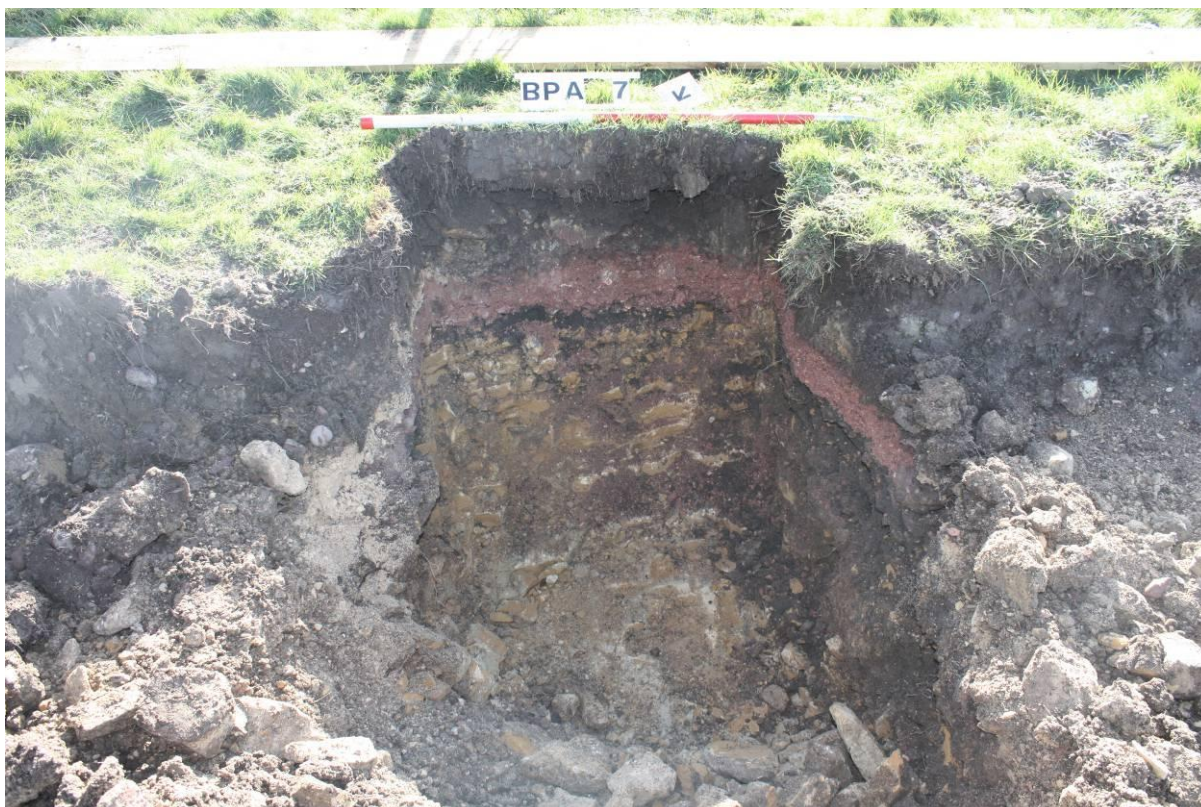
6.7 Trench 7 (7.75m x 3.5m). Rectangular trench aligned north-east/south-west. The main trench contained subsidiary foundation trenches (Figure 2, 7a-d), each measuring c. 1m x 1m and excavated to a maximum depth of 0.8m. As with trench 2, the trench contained a mixture of red tennis court clay and imported hardcore approximately 0.15m deep below the topsoil, which covered a layer of 'rachel' (Plate 8). The bedrock was encountered at approximately 0.5m. A second marquee anchor point (010) was uncovered below the topsoil in this trench, which extended through all layers into the natural bedrock. A disused modern water pipe was found in subsidiary trench 7d within the rachel (005) at approximately 0.45m deep.

Plate 8: Trench 7a. Scale = 1m

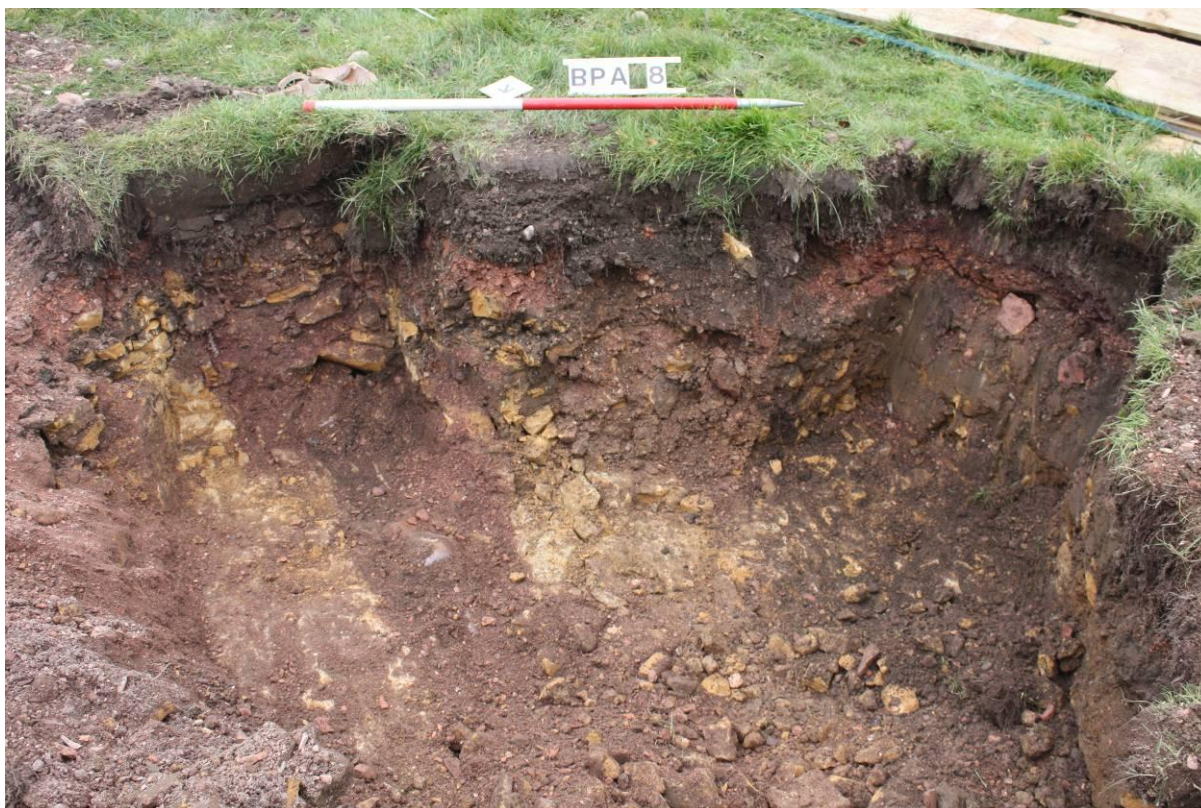
6.8 Trench 8 (7m x 3m). Rectangular trench aligned north-west/south-east positioned within the south-west corner of the playground area (Figure 2). Two deeper triangular extensions were excavated on the north-east and south-west sides of the main trench (Figure 2), each accommodating two foundations and cut to a depth of 0.8m. The excavations revealed the red clay layer (003) of the former tennis court at a depth of 0.3m, directly below the topsoil. The clay layer was again c. 0.15m in thickness and was located above the "rachel" layer (005) which was approximately 0.2m deep. This was situated directly above the bedrock (006). A disused modern drainage pipe (007) was found at the base of Trench 8, with its trench cut through the bedrock to a depth of approximately 0.8m and filled by (008), consisting of redeposited topsoil and 'rachel' with crushed patches of red clay, indicating that it was later in date than the tennis court (Plate 9).

Plate 9: Trench 8b, showing pipe trench [007]. Scale = 1m

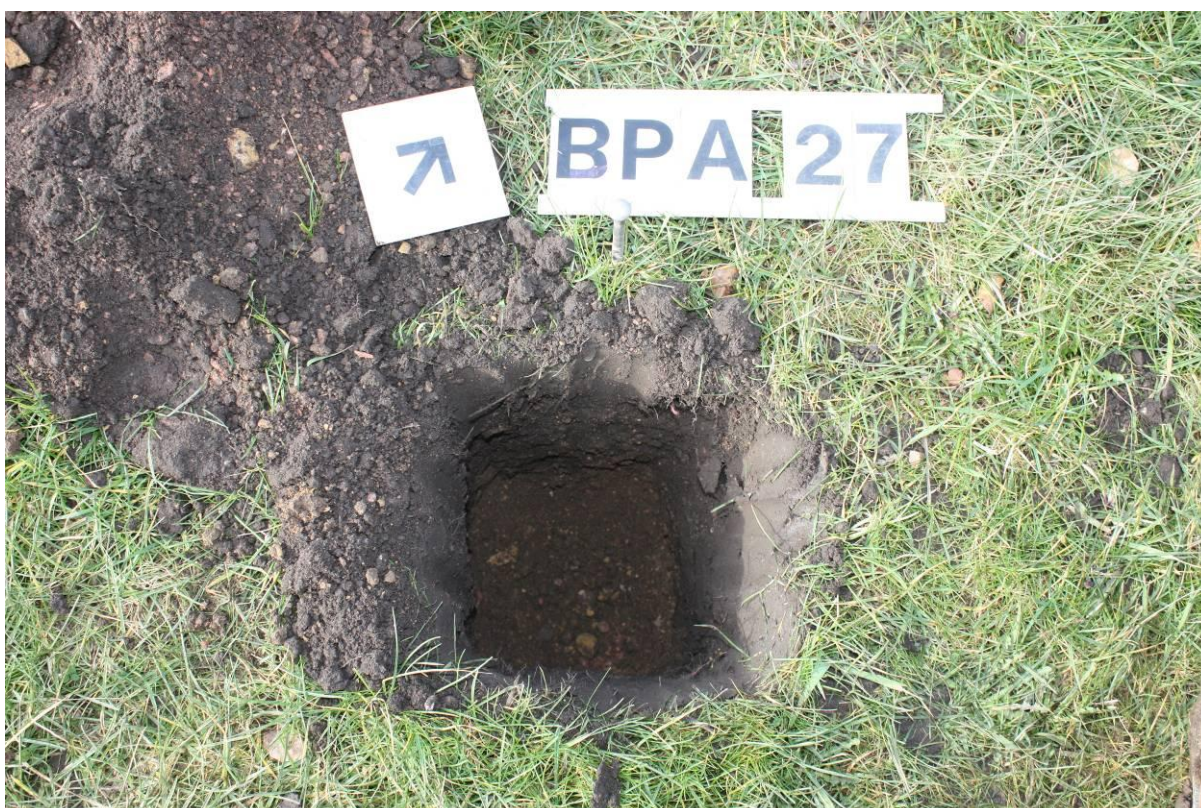
6.9 Fence Holes (0.2m diam. x 0.5m deep). A total of 28 fence holes were excavated around the limits of the play area (Figure 2). The holes were excavated with a boreholer down to the 'rachel' layer, and thereafter with a small breaker. Due to the small diameter of the holes it was not possible to observe the base of the holes during excavation, but the upcast was monitored for finds and photographs of the completed holes were taken (Plate 10).

Plate 10: Post-hole, showing the typical stratigraphy along the fence line.
