The Former Rainbow Depot, Burgage Green, Southwell, Nottinghamshire

Report on an Archaeological Evaluation

Project Code – RSS2
TPA Report No. 170/2014

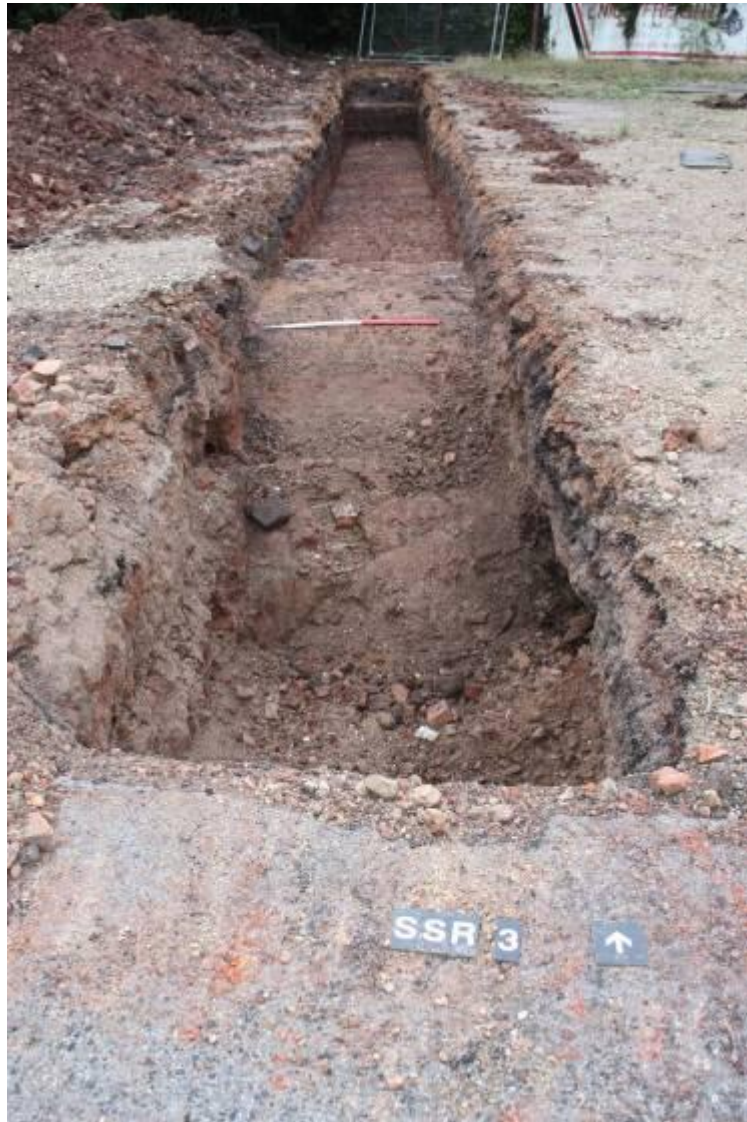
Plate 1: Trench 3 looking north. Scale = 1m

Trench 3 was 30m in length and was located at the northern corner of the site on a north-south alignment. The trench was mostly sealed by (3000), a mid to light yellowish brown crushed stone with a maximum depth of 0.1m, imported as a surfacing material. A small area (less than 0.5m) at the southern end was covered by tarmac (3016). These surfacing materials are situated directly above a levelling layer of crushed, heat-affected ceramic building material (3001) averaging 0.2m in depth but deeper towards the northern edge of the site indicating that the previous land surface sloped towards the north. Directly below (3001) was a thin layer of mid to dark greyish brown ashy silt (3002) containing moderately frequent fragments of brick. This layer was a maximum of 0.1m deep across the whole trench.

At the southern end of the trench, below (3002), was [3017], a large pit or, more likely, a backfilled cellar, filled by (3003) and (3004), both comprised brick rubble mixed with large amount of mortar and worked stone. There was no clear horizon between the two deposits, with the only difference being that the upper fill, (3003), contained a higher amount of silt mixed in with the rubble. It is probable that they were part of the same backfill event, but that one area of the backfill material contained a larger amount of topsoil. The dressed stone recovered from the deposits was undiagnostic limestone that had been sawn. The largest piece, measuring 0.42m x 0.39m x 0.19m in size is possibly a gatepost pivot, although the piece is too damaged to be certain.

Directly below (3002) across the remainder of the trench not affected by [3017] was a layer of redeposited clay mixed with topsoil (3007) with a depth of between 0.25m and 0.75m (deeper at the north). Cut through this layer and a short way into the layer below was pit [3006], approximately 2m wide by 0.5m deep and only visible in section. It was a wide V-shape in profile with a slightly rounded base, and was filled by (3005), a loose dark blackish grey silt containing moderately frequent inclusions of brick fragments and charcoal.

Below (3007) was layer (3011), a levelling layer consisting of a cleaner redeposited clay material mid orangey-red in colour excavated to 0.75m deep (the base was not found at this depth) and containing moderately frequent fragments of brick and mortar. A layer of slightly darker redeposited clay, (3015) was spread over the trench towards the north but appears to be part of the same levelling event.

Cut into (3011) was narrow linear [3013] which was 0.75m wide and approximately 0.3m deep. The profile was an irregular flared V-shape with a slightly rounded base. It was filled by (3012), a mid to dark greyish black patchy silty clay containing frequent fragments of brick and charcoal. The linear was parallel to the original boundary wall and to that of the former house of correction building, suggesting they may be related.

Close to the northern end of the trench a section of brick wall (3009) was visible in the western side of the trench. There were three courses of double skinned wall present with a brick size of 0.08m by 0.25m in profile, although the length of the bricks could not be seen without dismantling the edge of the trench. The bricks were mortared with pale yellowish-grey mortar, and were within a narrow foundation cut [3010]. Where the bricks had been removed from the foundation cut, it was filled by (3008), a loose mid to dark grey silt demolition deposit containing frequent inclusions of brick rubble and charcoal. The wall appeared to run roughly parallel to the current western boundary wall.

A second fragment of brick wall was seen within (3011) in the side of [3017], consisting of three courses of double skinned wall constructed from mid reddish orange bricks. The wall was at such a depth it could not be fully investigated for safety reasons and so the bricks themselves were not measured. The wall appeared to be aligned north west to south east and no clear cut was visible.

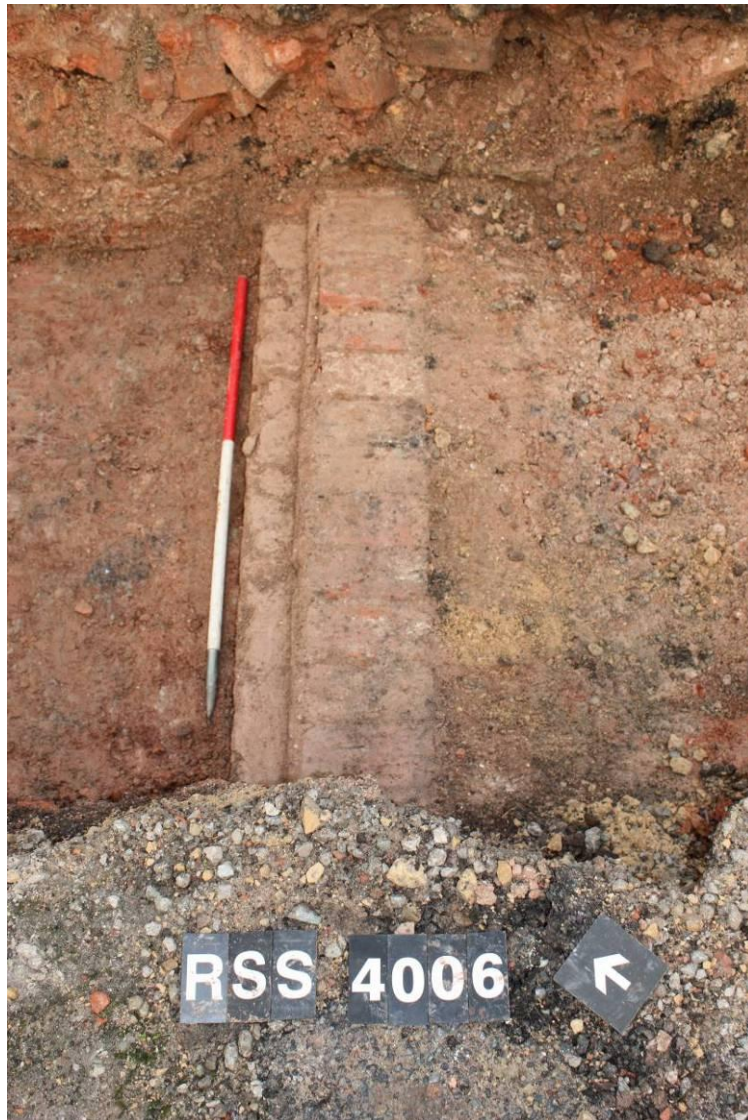
Plate 2: Wall (4006), Trench 4 looking north east. Scale=1m

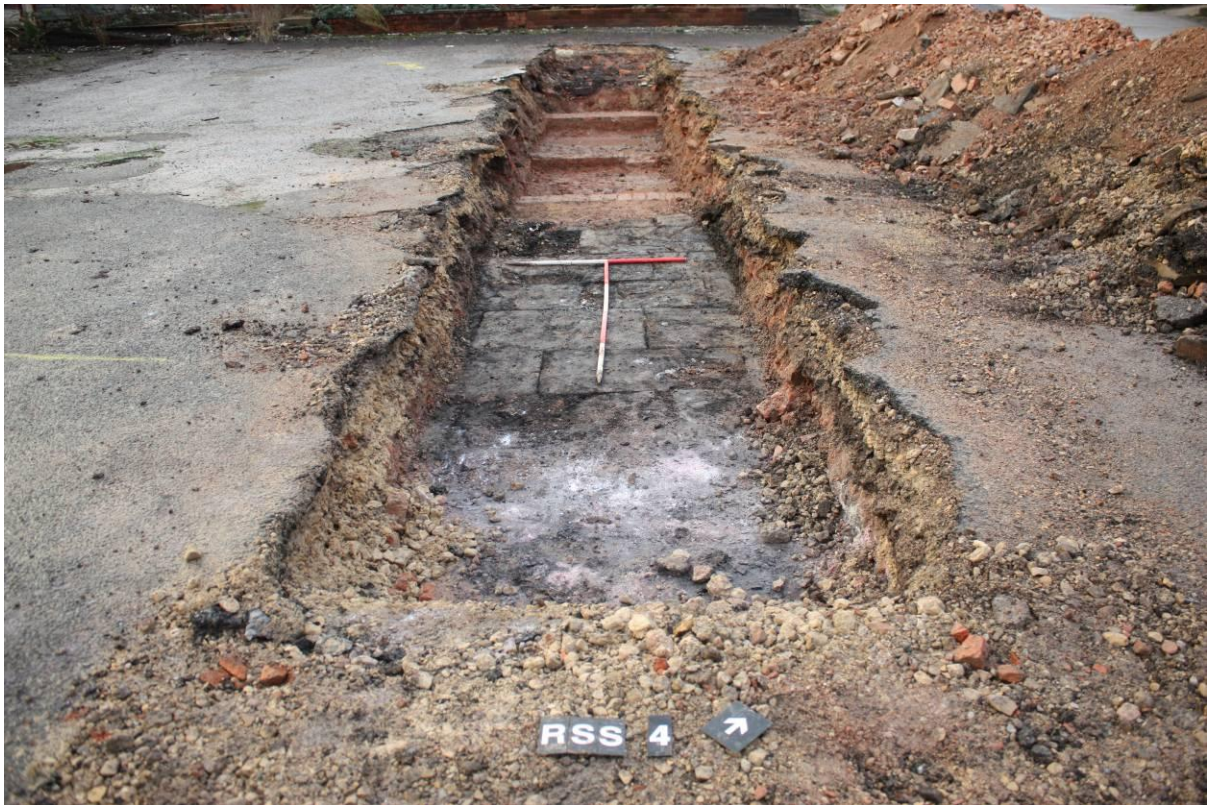
Plate 3: Trench 4 looking north west. Scales=1m and 2m

Trench 4 was located at the centre of the site, aligned north-west to south-east. The trench was originally intended to be 30m in length, but due to an extant building and the presence of a possible cellar the trench was shortened to 13m. The trench was sealed by a layer of modern tarmac (4000) which was a maximum of 0.2m deep. This was situated directly above (4001), a moderately compact layer of crushed yellow stone, probably imported as a bedding layer. It was no more than 0.1m deep and was situated directly above (4009), a deposit of compact, mid to dark greyish-black burnt brick, ash and cinders. This was probably related to a fire at the depot during the 1970s which destroyed the building. The layer was no more than 0.12m deep and was probably spread and levelled prior to the laying of the tarmac. Directly below (4009) was (4002), a layer of unburned brick and mortar rubble no more than 0.4m deep.

Directly below (4002) and only present at the south eastern end of the trench was a layer of paved flooring (4003). The floor was constructed of rectangular flagstones averaging 1.3 x 0.6m in size and had probably originally extended further north-west due to the presence of loose flagstones within (4002) in this area. The floor was not removed for further excavation due to the presence of possible contamination within the surrounding deposits. To the north west of the trench, where the flagstones were not present, three metal pipes were in place within (4009). As it was unknown whether the pipes were still in use they were left undisturbed.

Below (4002) in the area between the pipes and the flagstone flooring (4003) was a layer of finely crushed brick and mortar mixed with redeposited clay, mid to light reddish-grey in colour and no more than 0.1m deep. It appears to have been deposited as a bedding for the flagstones (4003). Below this layer were three parallel north-east to south-west walls 2.2m apart (4004), (4005), and (4006). All of the walls were of identical construction (Dearne's bond), with only two courses visible. They appeared to match up with buttresses present running down the length of the extant south western wall of the warehouse building (still in use as a retaining wall), and it is likely that, unless a cellar was present, they would have continued below the flagstone floor (4003) as a support. The bricks used were likely to be of mid 18th century to early 19th century date. These walls appeared to have been built into the natural clay (0001) and the wall foundation cuts backfilled with redeposited natural, making the cuts extremely difficult to see.

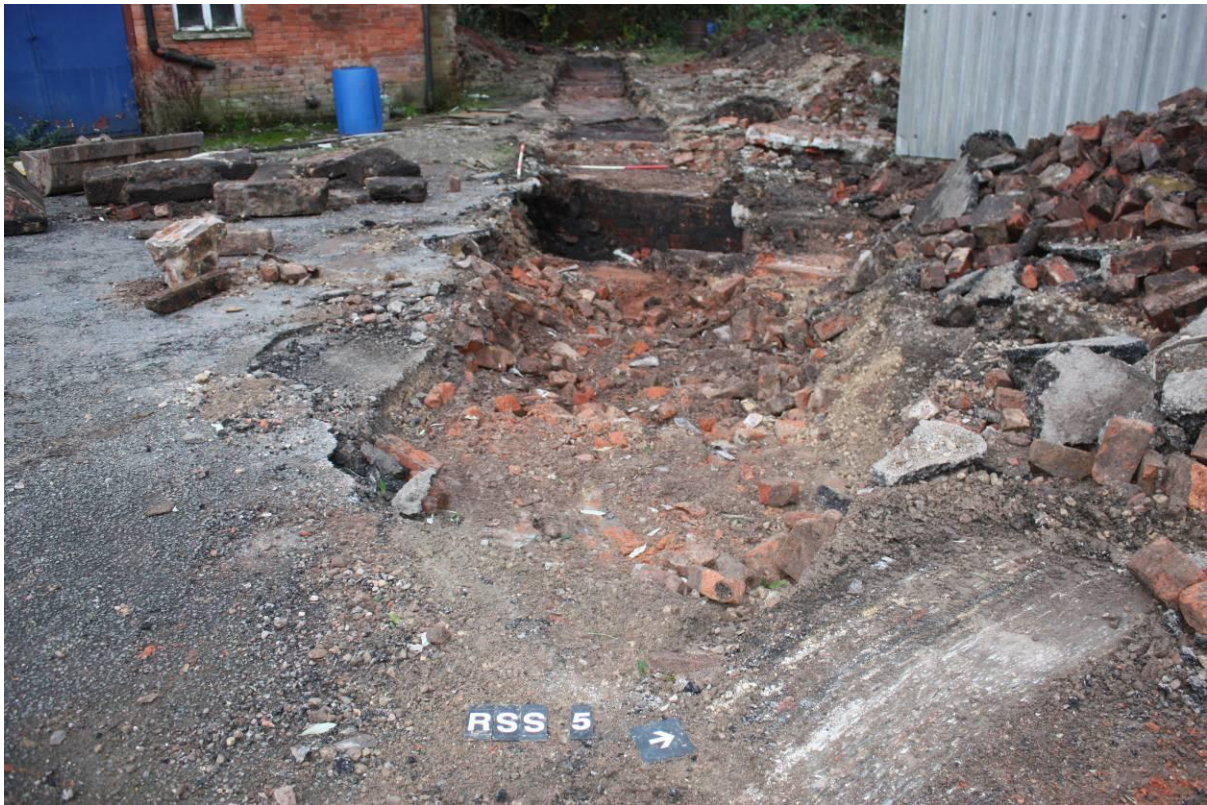
Plate 4: Trench 5 looking east north east. Scales=1m and 2m

Trench 5 was located to the south-west of Trench 1, between two extant prison buildings and was aligned west-north-west to east-south-east. The trench was shortened slightly to 25m to allow for access. Structural remains were present towards the east and centre of the trench, but were not fully excavated due to the presence of asbestos.

It was sealed by a modern layer of clean, yellowish-brown gravel (5012) which was no more than 0.15m deep at this end of the trench and was probably imported as a surfacing layer. Below this was a layer of topsoil (5011) 0.4m deep, which contained a small amount of animal bone and pottery. This topsoil was situated directly above the natural clay substratum (0001). An area of (5011) 2.1m in width was left in situ at this end of the trench due to an extant drain. Towards the middle of the trench a second surface deposit of concrete (5015) was present above (5012), and was a maximum of 0.15m deep.

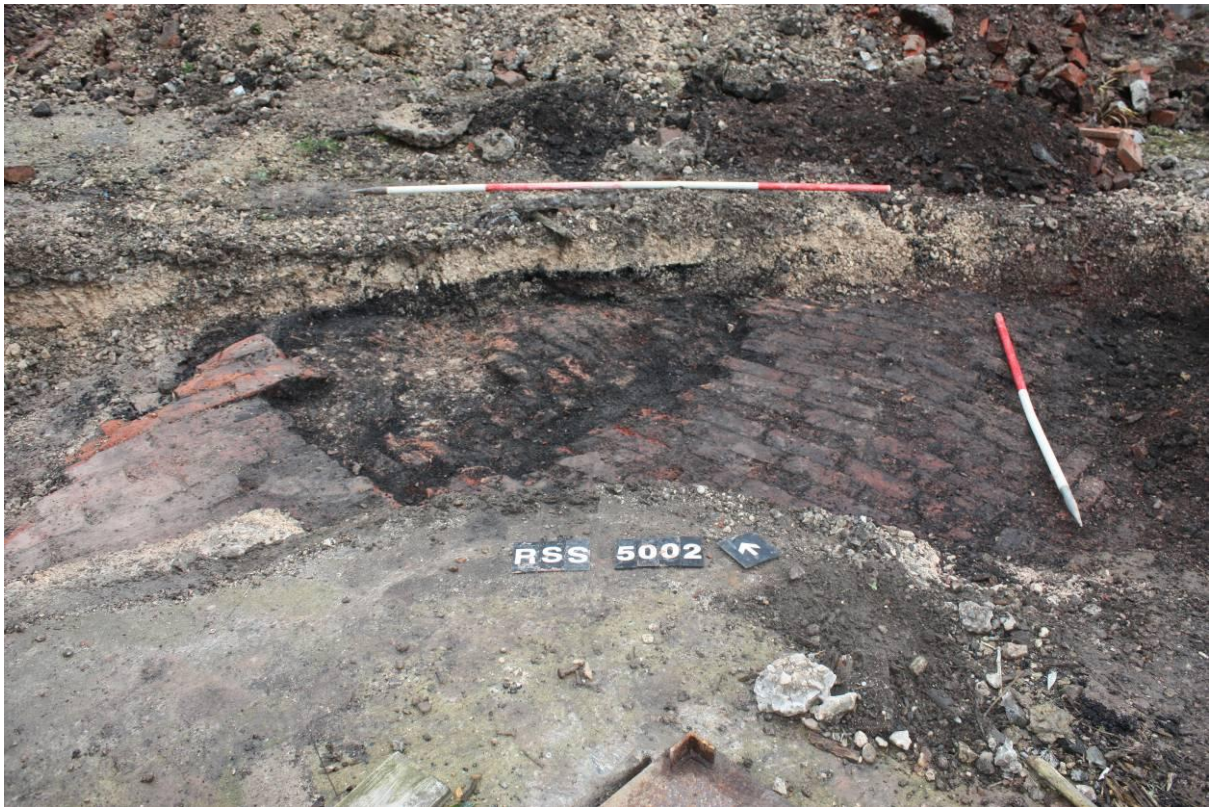
Plate 5: Brick floor (5005) and (5006) looking north east. Scales=1m and 2m

Approximately 13m from the eastern end of the trench a brick surface was uncovered. It was covered by a layer of old tarmac (5018) no more than 0.1m deep, which was in turn sealed by (5012). The

brick floor was 2.2m wide and consisted of what appeared to be two phases of construction, although it was not possible to positively determine which was the older phase. The less well-preserved phase of flooring (5005) was constructed of rectangular, dark orangey-red bricks laid edge-face up without bonding, the dimensions of which suggest a mid 19th century - 20th century date. The inclusions within the brick suggest that the date is more likely to be from within the earlier part of this estimate than the later. Many of the bricks were slightly worn or damaged and misaligned in places. An area in the middle had been significantly damaged, with some bricks missing entirely and the remainder damaged. It is not clear if this area was a different phase of construction, or it had been disturbed, separating it from the main body of the floor. The better preserved area of the floor (5006) was constructed of slightly paler orangey-red bricks laid face-up without bonding but more skilfully laid than those of (5005), resulting in a more regular, stable surface. The brick dimensions again suggest a mid 19th century to 20th century date (again more likely to be the earlier part of this range), although the dimensions are slightly different. Both phases of flooring were set into (5014), a compacted layer of ashy sand and gravel containing a high amount of clinker, ash and brick fragments. This layer was obviously intended as a bedding layer, and it has also been compacted into the gaps between the bricks. (5014) is situated directly above the natural clay (0001).

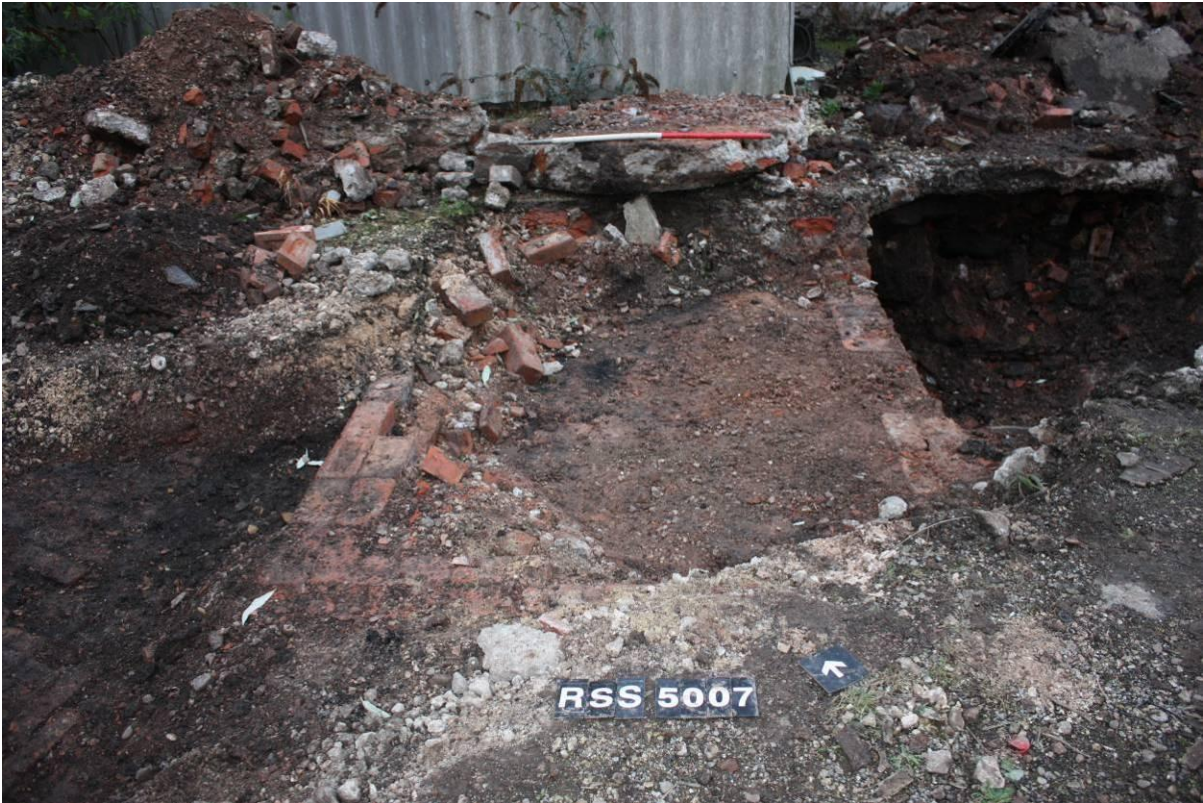
Plate 6: Brick structure (5007) looking north east. Scale=1m

Immediately west of (5005) and (5006) there was a rectangular brick structure (5007), 3.4m wide, of which the southern wall was exposed and the eastern and western walls partially exposed. It was constructed of frogged, mid reddish-orange bricks bonded with cement, two skins thick and a minimum of 13 courses high. The form and dimensions of the bricks suggest a date of post-1914. The interior of the building was not fully excavated due to the presence of asbestos. At a depth of 1.2m immediately to the east of (5007) a paved floor (5010) was found. It was 2.9m wide with slabs of varying sizes between one and two metres wide. Directly above the slabs was a demolition deposit (5019) containing a high amount of brick and mortar rubble, and also a high percentage of large limestone blocks, many of them dressed. It is probable that these have come from one of the demolished House of Correction buildings. At the eastern extent of the paving slabs was a second brick wall (5009) aligned parallel to (5007) but without a visible return. Its construction was identical to that of (5007), with a minimum of 12 courses of brick present.

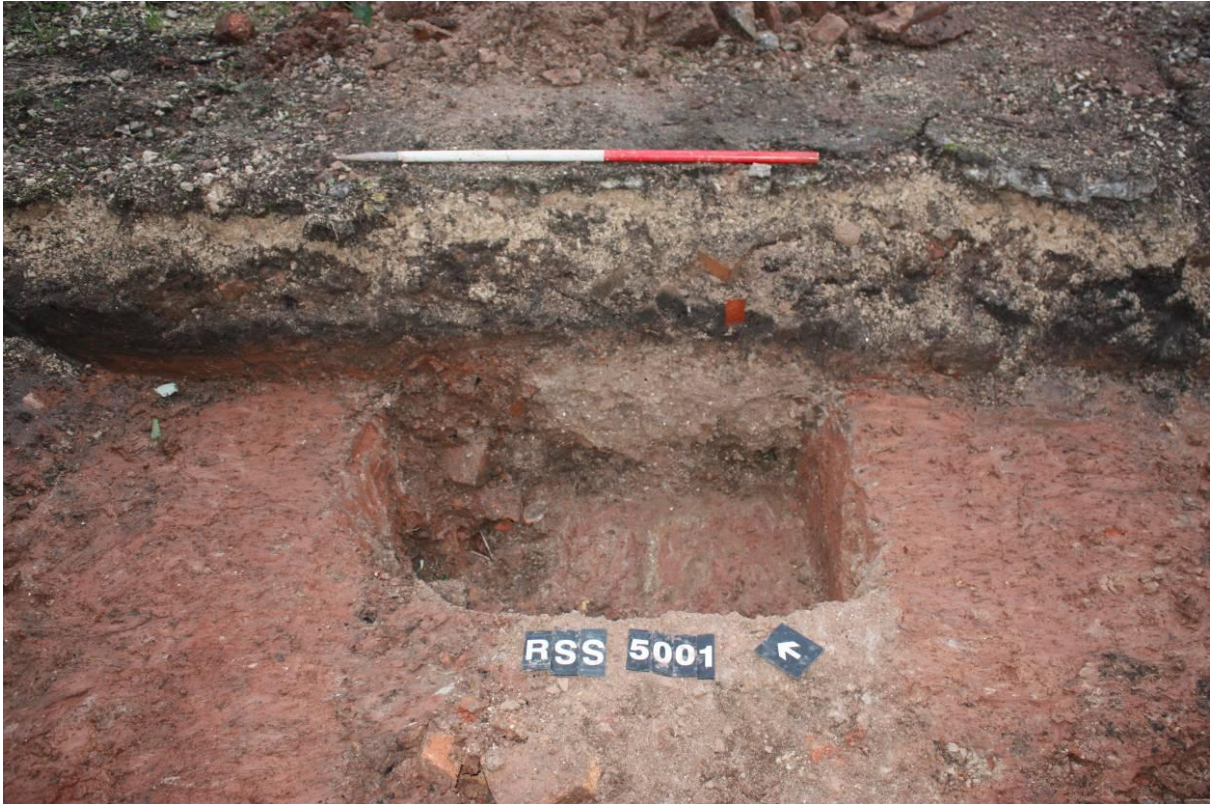
Plate 7: Foundation trench (5001) looking north east. Scale=1m

Cut into the natural clay below (5011) was a north-south aligned linear feature [5001] with straight sides and a flat base through which a modern drain [5016] had been inserted. The alignment of this linear, along with its shape, suggests that it may be a robbed out wall trench relating to a former house of correction building which once stood in this location. The fill of the trench (5020) was a loose, pale yellowish-grey gravelly sand containing a high amount of stone, mortar and brick rubble.

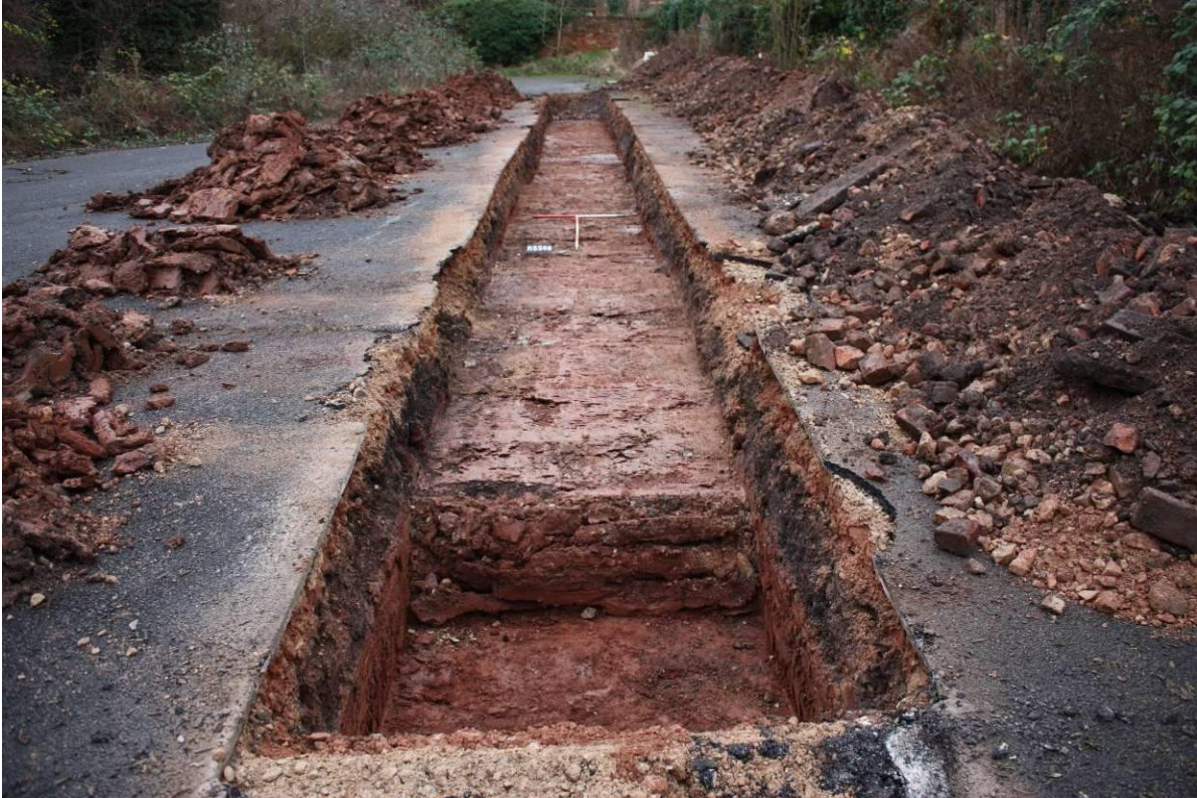
Plate 8: Trench 6 looking north west. Scale=1m and 2m

Trench 6 was located at the south-western limit of the site, outside the perimeter wall of the house of correction. It was aligned north-west to south east and was 30m in length. It was sealed by a layer of modern tarmac (6000) 0.3m deep which was directly above a layer of mid to light brown crushed stone: an imported bedding layer for the tarmac. This was a maximum of 0.29m deep. (6001) was directly above (6002), a mid grey deposit composed of brick rubble, ash and redeposited topsoil probably related to demolition. This layer was slightly compacted and was a maximum of 0.3m deep.

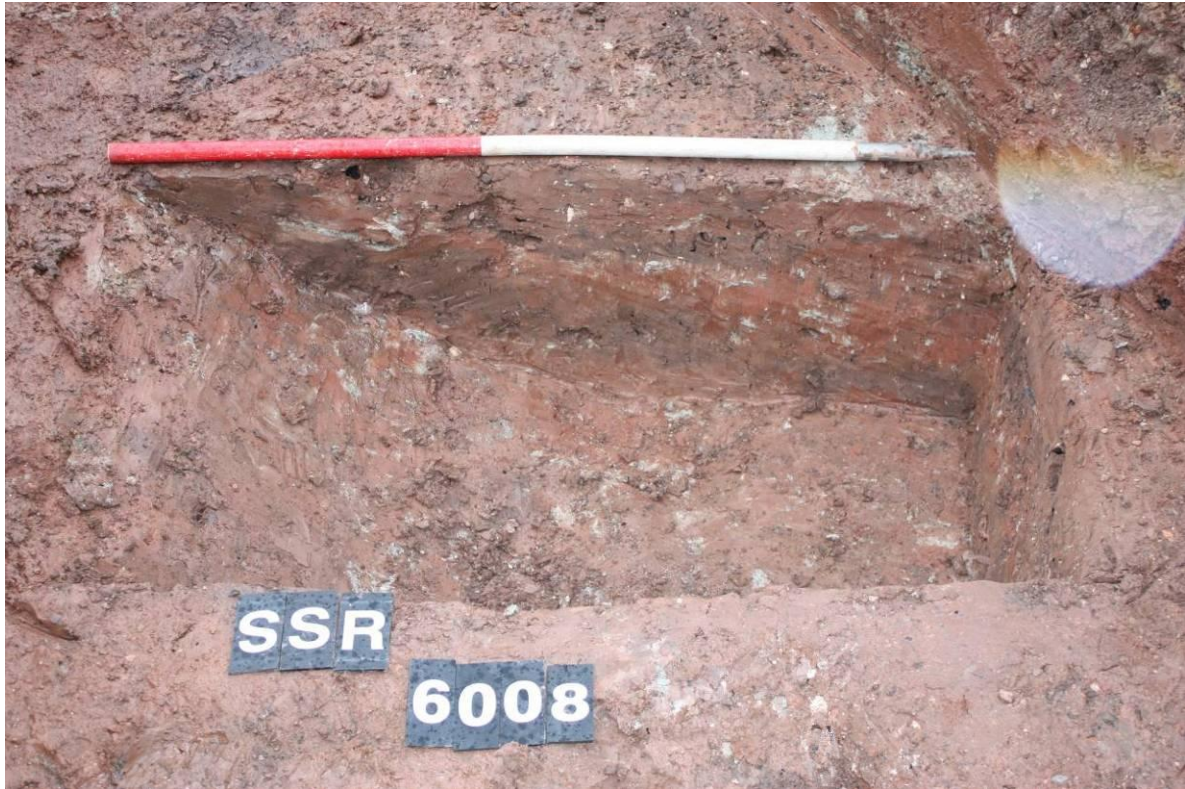
Plate 9: Linear feature (6008) looking north. Scale=1m

the natural substratum. This was probably the result of an episode of backfilling, again similar to [6005]. The upper fill (6006) was a mid to light grey silty-clay 0.15m deep which contained occasional charcoal flecks and was probably the result of a final period of silting, resulting in the ditch being completely filled. No further features were uncovered within Trench 6.

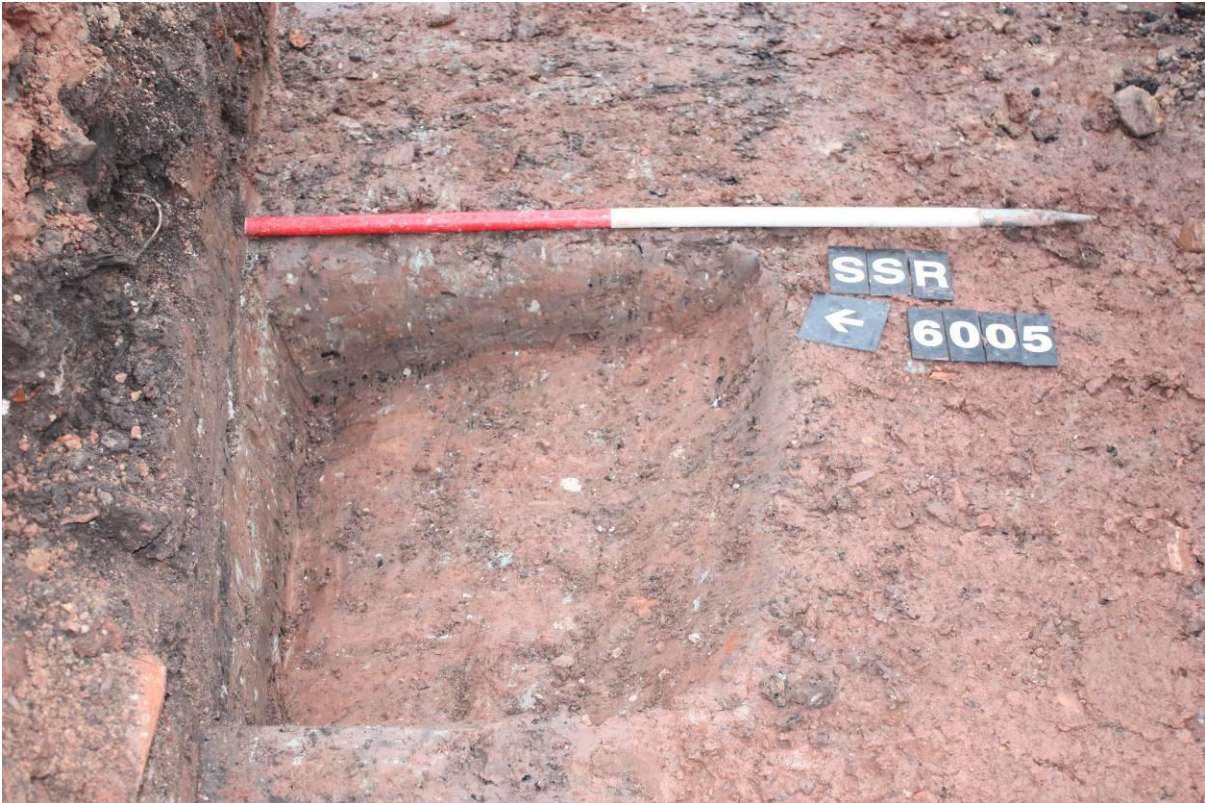
Plate 10: Linear feature (6005) looking south east. Scale=1m

Two linear features were found cutting the natural clay substratum (0001). The first, [6005] was located at the south-eastern end of the trench and was 0.7m wide and 0.3m deep. It was north-north-west to south-south-east aligned and the profile showed sloping, concave sides with a slightly uneven, rounded base. Two fills were present: the primary fill (6011) appeared to be the result of an episode of primary silting and was composed of a dark grey clayish silt material containing flecks of charcoal and was 0.08m deep, and the secondary fill (6004) was a mid to light orangey-brown silty clay similar in colour to the natural substratum probably created through backfilling. The second linear feature [6008] was located 7.75m south-east of the north-western end of the trench and was aligned roughly north to south. it was a maximum of 0.3m deep and had a wide V-shaped profile with straight, sloping sides. It had three separate fills: the primary fill (6009) was a maximum of 0.12m deep and was composed of a mid to light grey clayish-silt containing moderately frequent flecks of charcoal. This was probably the result of primary silting, similar to that within [6005]. Above this was the secondary fill (6007), a mid to light orangey-brown silty clay deposit 0.12m deep and very similar to

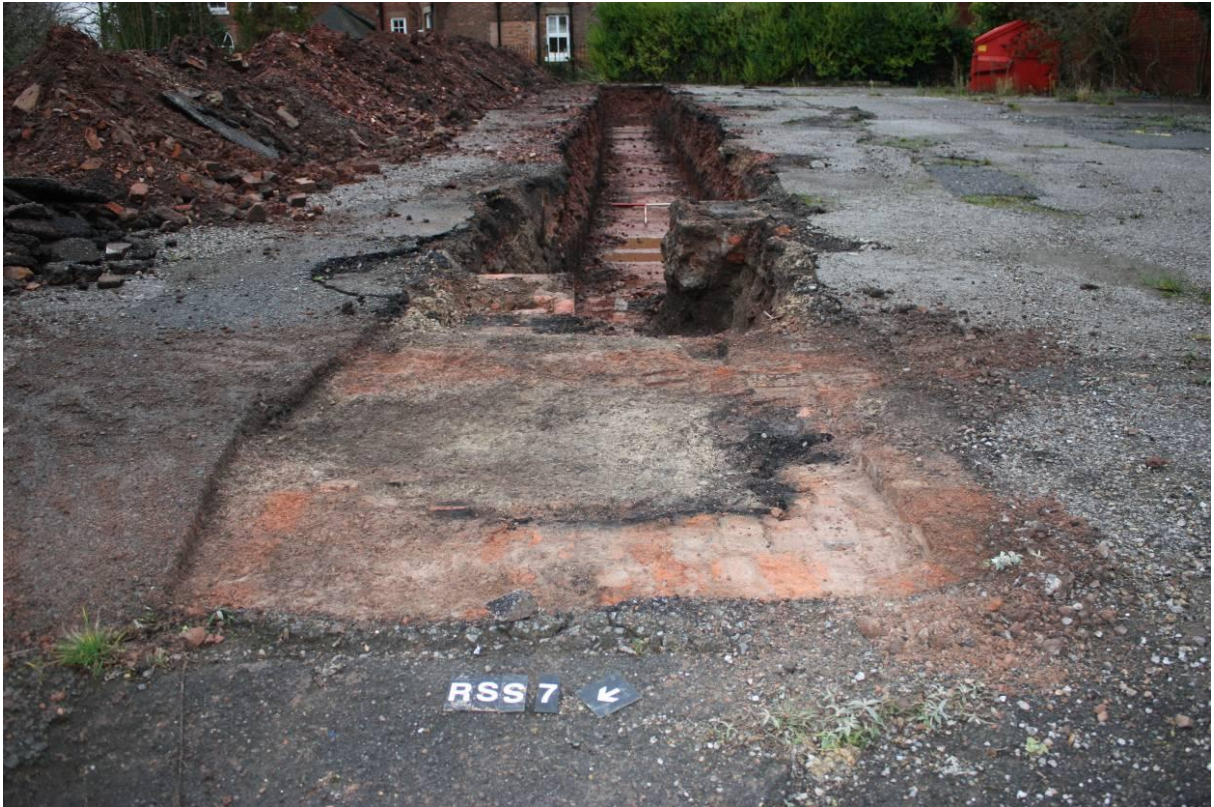
Plate 11: Trench 7 looking south east. Scales=1m and 2m

Trench 7 was located south of Trench 4 and south-west of Trench 5. It was 30m long and aligned north-west to south-east. The majority of this trench was devoid of archaeological features, however structural remains were present at the north-western end.

The trench was sealed by patched tarmac (7001) which varied in depth over the trench. It was particularly shallow over the structural remains at the north-western end (around 0.04m deep), and averaged approximately 0.15m over the rest of the trench. A levelling layer of crushed, fire-hardened brick (7004) was present below the tarmac except for at the north-western end, which had been laid down to increase the level of the area in order to match the height of the retaining wall. The deposit was approximately 0.65m deep and was very loose, collapsing frequently during excavation. Below this layer was (7005), a layer of blackish-grey clayish silt material containing infrequent inclusions of small fragments of brick and tile but no other finds. It is possible that this is the original topsoil that was present prior to the increase of the level of this area, however the horizon between this and the natural substratum (0001) below is very sharp, indicating instead that it had been imported after the original surface had been removed, perhaps during a previous landscaping event.

At the north-western end of the trench three manholes were uncovered: (7007), (7008) and (7009). (7007) was constructed from modern red brick and concrete, indicating that it was later than the other structures within this trench. (7008) was situated directly below (7007), with much of its height removed. This was probably so that the newer manhole (7007) could replace it. (7009) was situated 2.15m north-west of (7008), and both it and (7008) were of almost identical construction. They were both constructed of a double skin of plain orangey-red brick and were 0.8m by 0.8m in size. As (7008) had been partially demolished it was much deeper below the tarmac than (7009) which had a minimum of 14 courses of brick present. The bricks used in the construction of these manholes suggest a date of post-1914.

0.6m north-west of (7009), at the very north-western edge of the trench, was (7000), a large, square, brick structure 2.43m wide constructed of a double skin of mid orangey-red bricks bonded with hard mortar, the dimensions and form of which suggest a date of the mid 18th to early 19th century. The height of the structure was not ascertained. It was filled by (7010), a deposit of highly-compacted pale yellow gravel slightly darkened with soot around the edges. Infrequent inclusions of brick fragments are present. The location of this structure along with its form indicates that it may be the chimney shown on the 1919/1967 Ordnance Survey maps. Abutting the exterior of this structure is (7011), a layer of redeposited natural clay and mudstone mixed with demolition debris which was probably used as a backfilling material for the voids around the chimney structure during the landscaping process.
