# The Rainbow Depot, The Burgage, Southwell, Nottinghamshire

Historic Building Record

Report Number: 089/2016

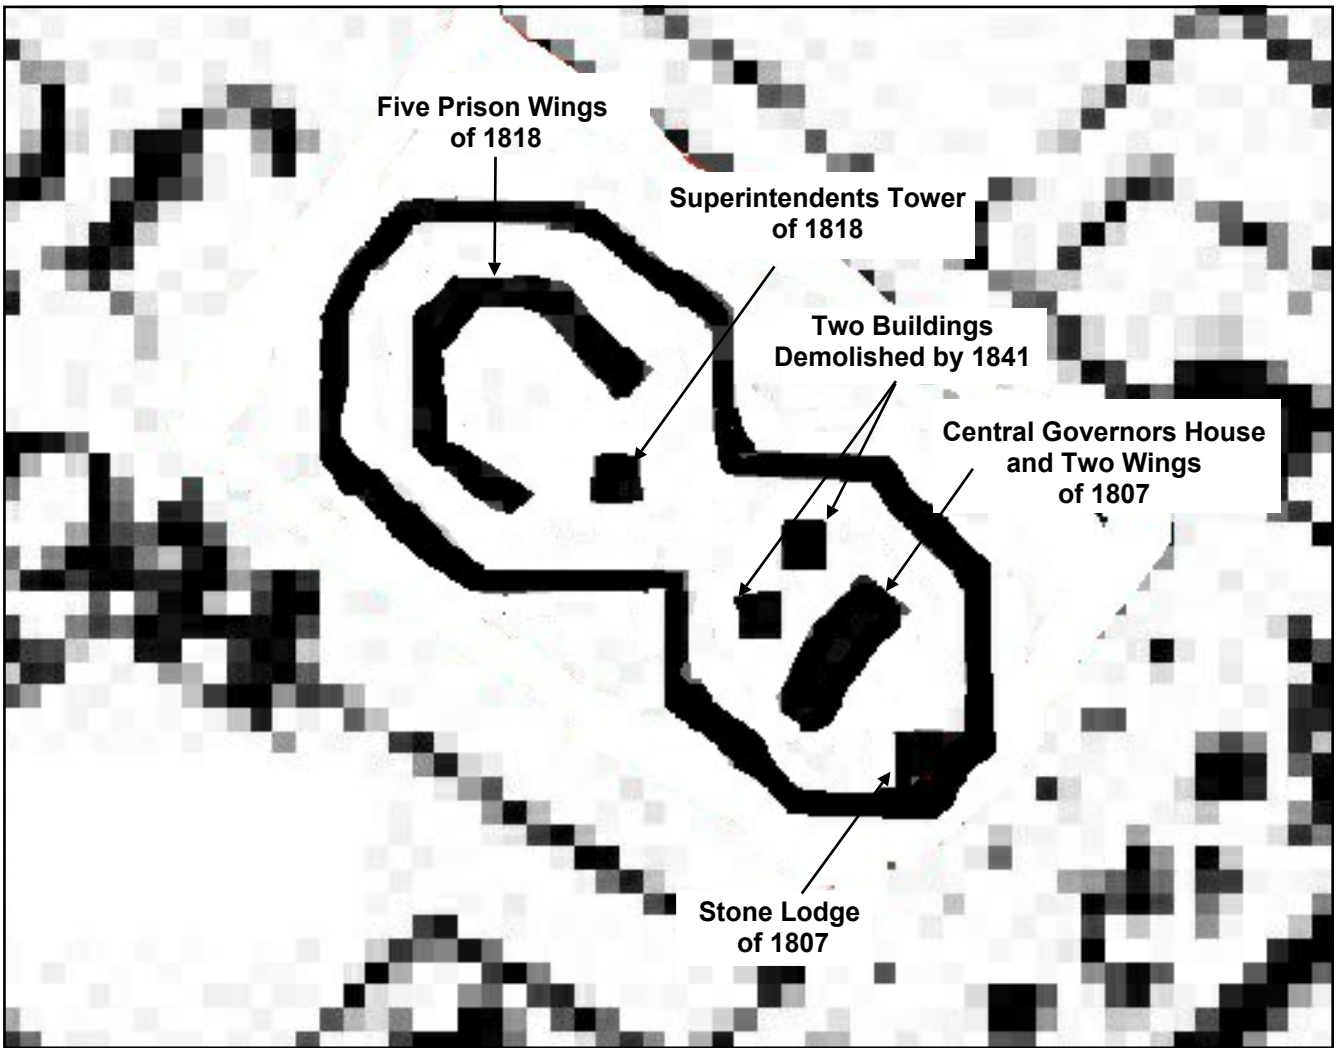
**Figure 3:** The House of Correction depicted on Sanderson's map of 1835.

3.1.3 Local architect Richard Ingleman began work on the new House of Correction in 1807. Documentary evidence, combined with the earliest visual depiction of this phase of the prison on Sanderson's map of 1835 (Figure 3), indicates that there were originally two wings radiating to the north-east and south-west from a central governor's house reached via a pathway extending from the reception lodge fronting Burgage Green. To the north-west two small buildings possibly relate to this phase that were replaced by the time that the 1841 Tithe map (Figure 4) had been published, by a rectangular block of similar dimensions to those flanking the governor's house thus creating the classic radial format or windmill plan prison design of the era. Southwell was one of the earliest radial prisons in the country not to be built by the architect George Byfield whose first radial prison was Cambridge County Goal built in 1801 (Brodie *et al* 2002, 67). The prison was built using materials from the 17<sup>th</sup> century one, including bricks and stone. Surrounding the prison was a 17ft boundary wall. Of note the stone built lodge is the only building surviving from this phase of the prison.

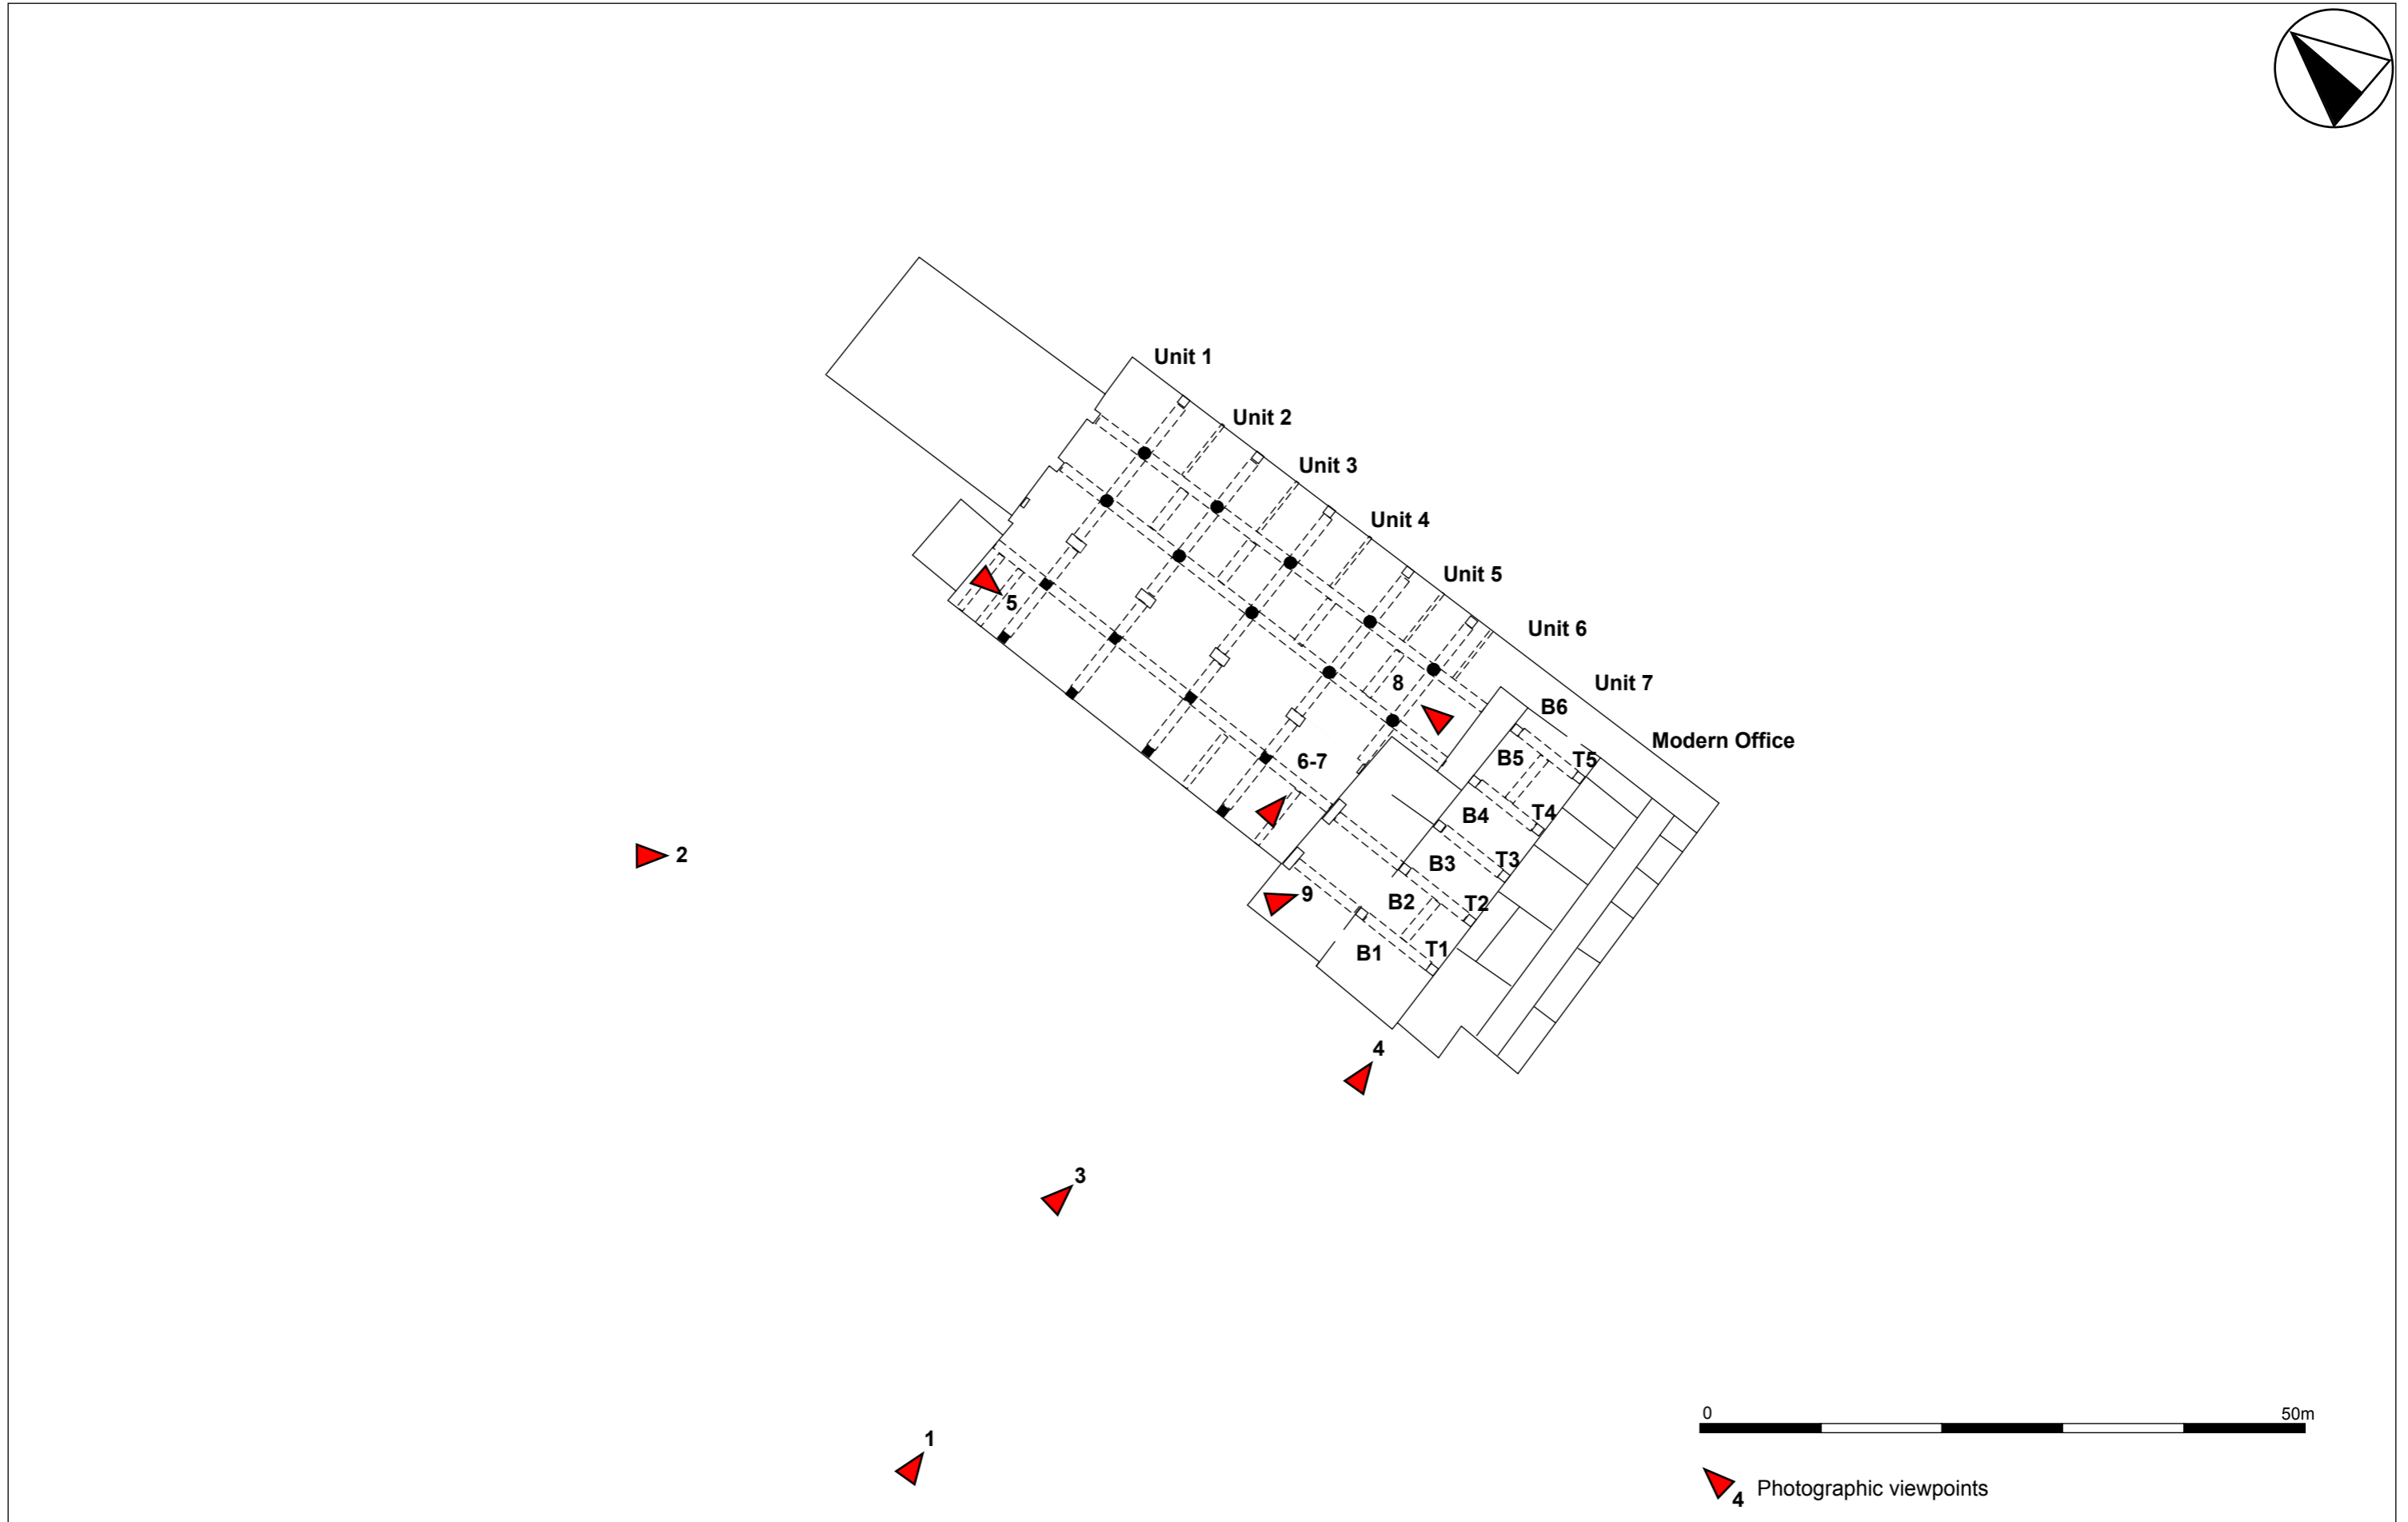
**Figure 11:** Sketch plan of the lace factory with the photographic viewpoints of the plates within the report indicated.  
Scale 1:500 at A3.

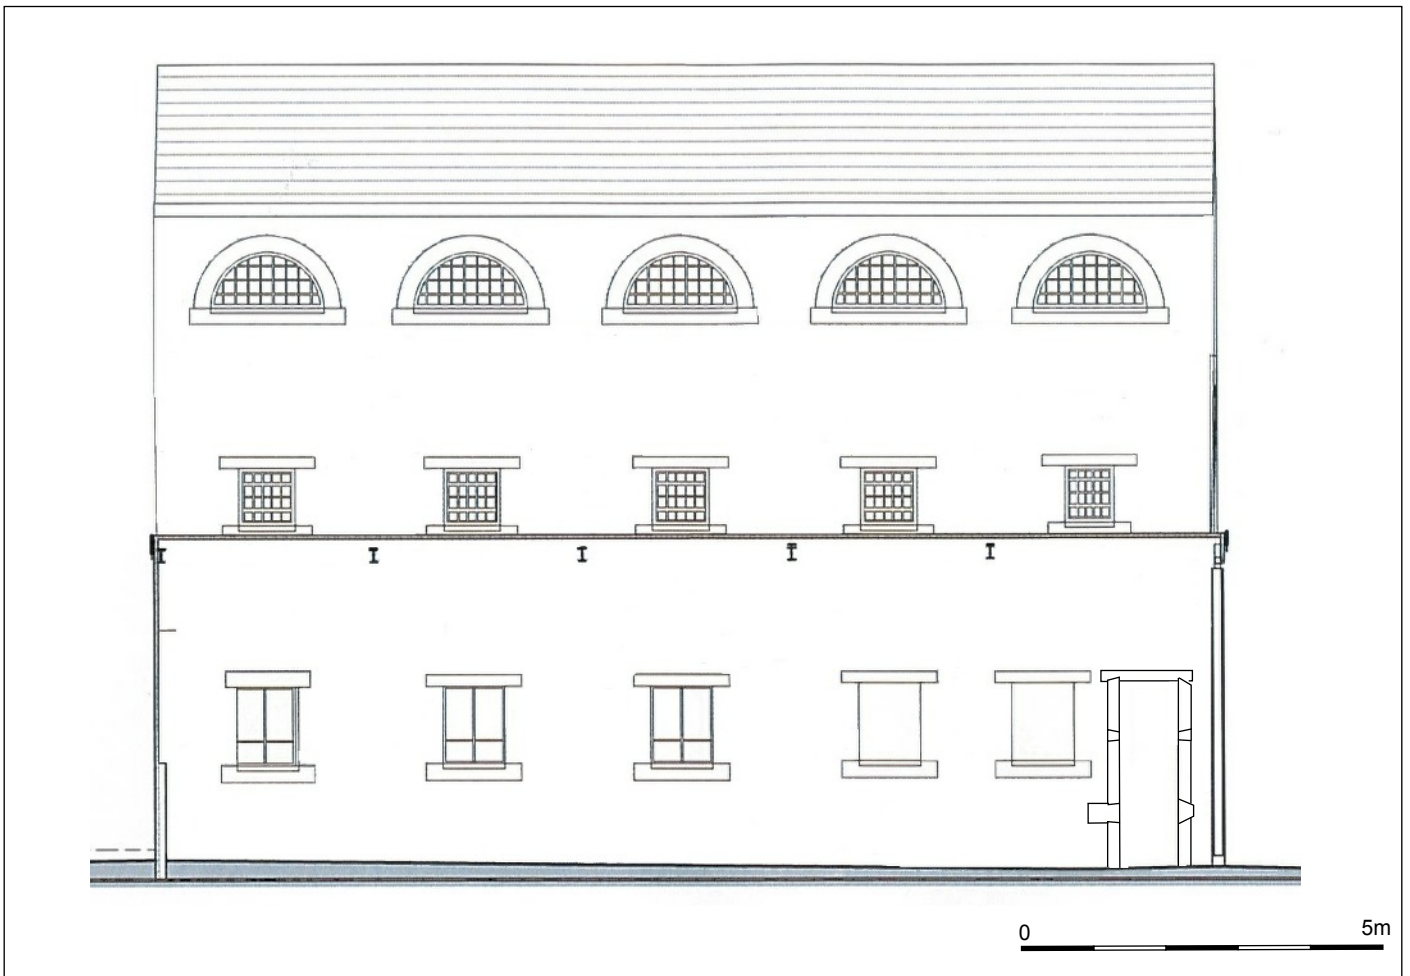
**Figure 19:** South elevation of the north wing, based on a drawing provided by the client.  
Scale 1:100 at A4.

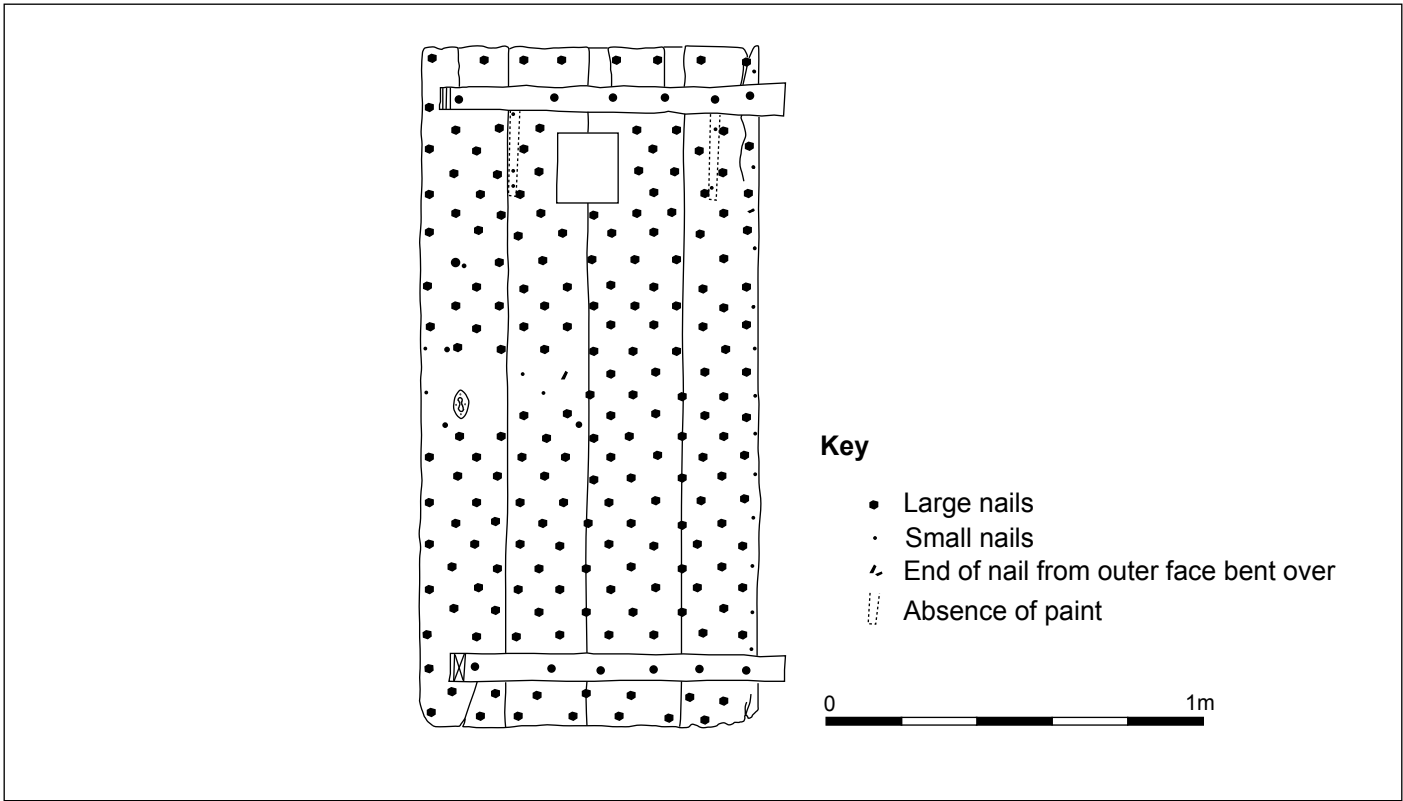
**Figure 31:** The inner face of the prison door.  
Scale 1:20 at A4

4.6.6 Unfortunately the edges around the door had suffered badly from rot thus limiting the investigation of the inner core. Nevertheless it appears to have been made of seven horizontal oak timbers up to 0.26m in width and 0.04m thick.

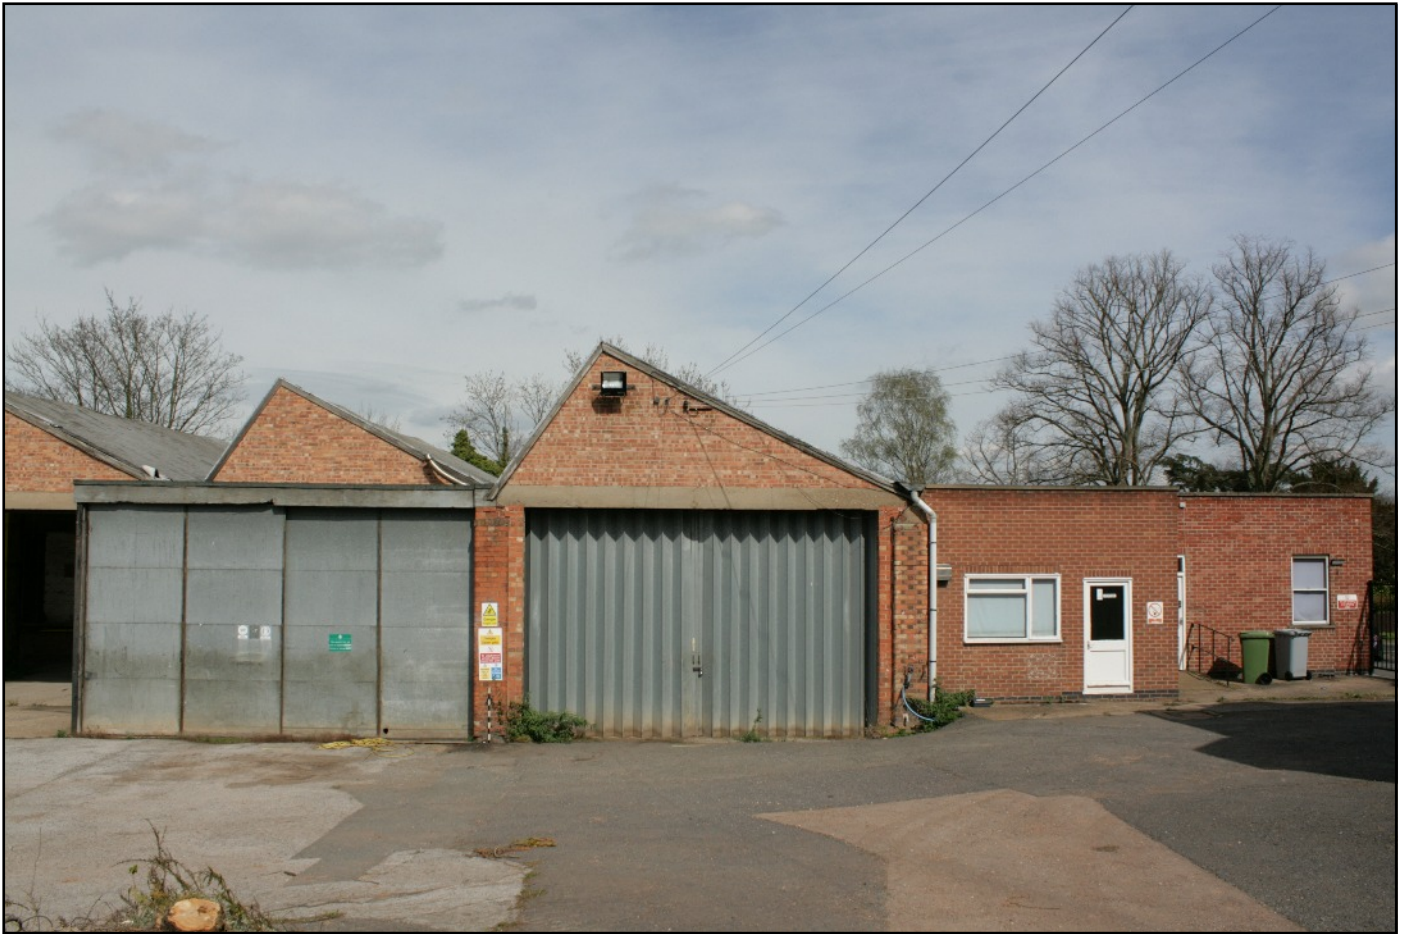
**Plate 3:** The south end of the former lace factory with the only surviving complete western bay dating to between 1884 and 1900 flanked by the late 20th century office to the south and garage extension to the north, viewed looking east.

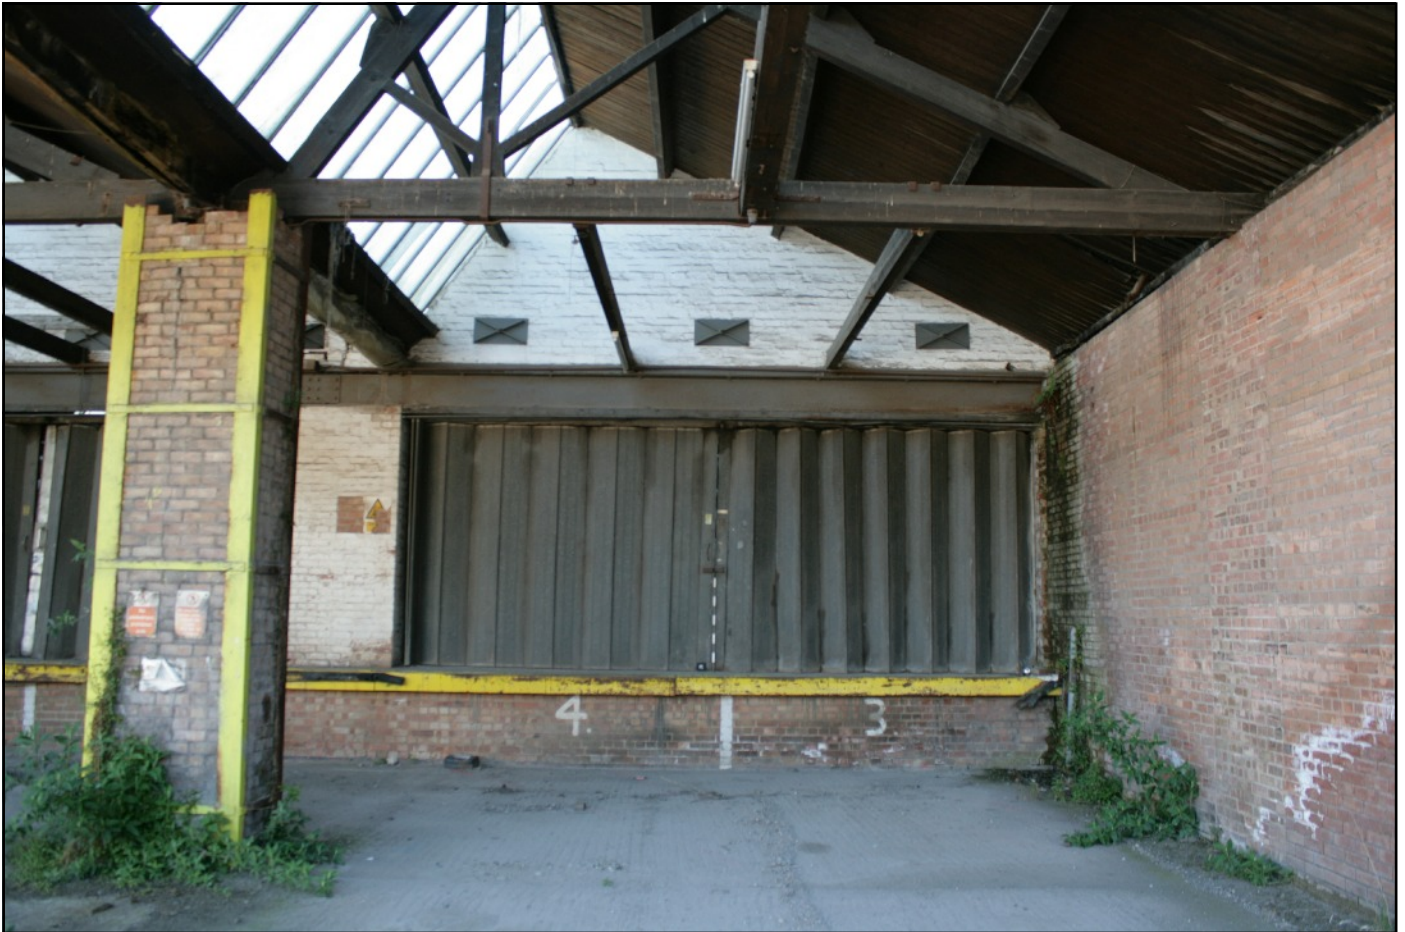
**Plate 6:** Bay 2 Unit 5, viewed looking east. The doorway was inserted and the floor raised when the former lace factory became a depot. The wall to the right, which is part of the garage, is also a modern build. The brick pillar was rebuilt following the fire in the 1970s. The metal ties above the doorway are probable insertions designed to provide additional structural integrity to the building.

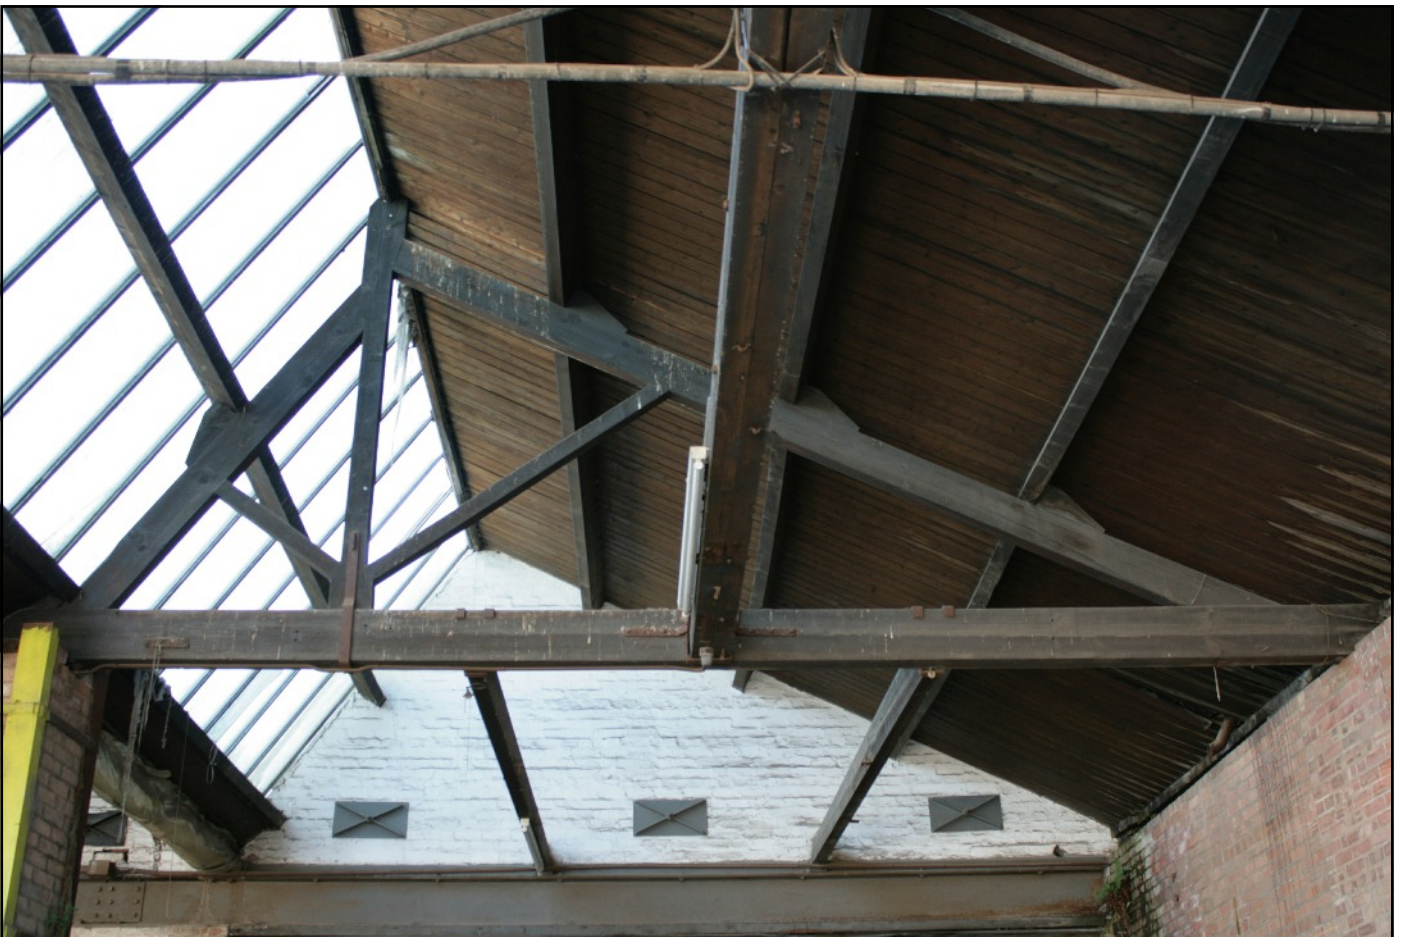
**Plate 7:** Truss 2, Bay 2 Unit 5, viewed looking east.

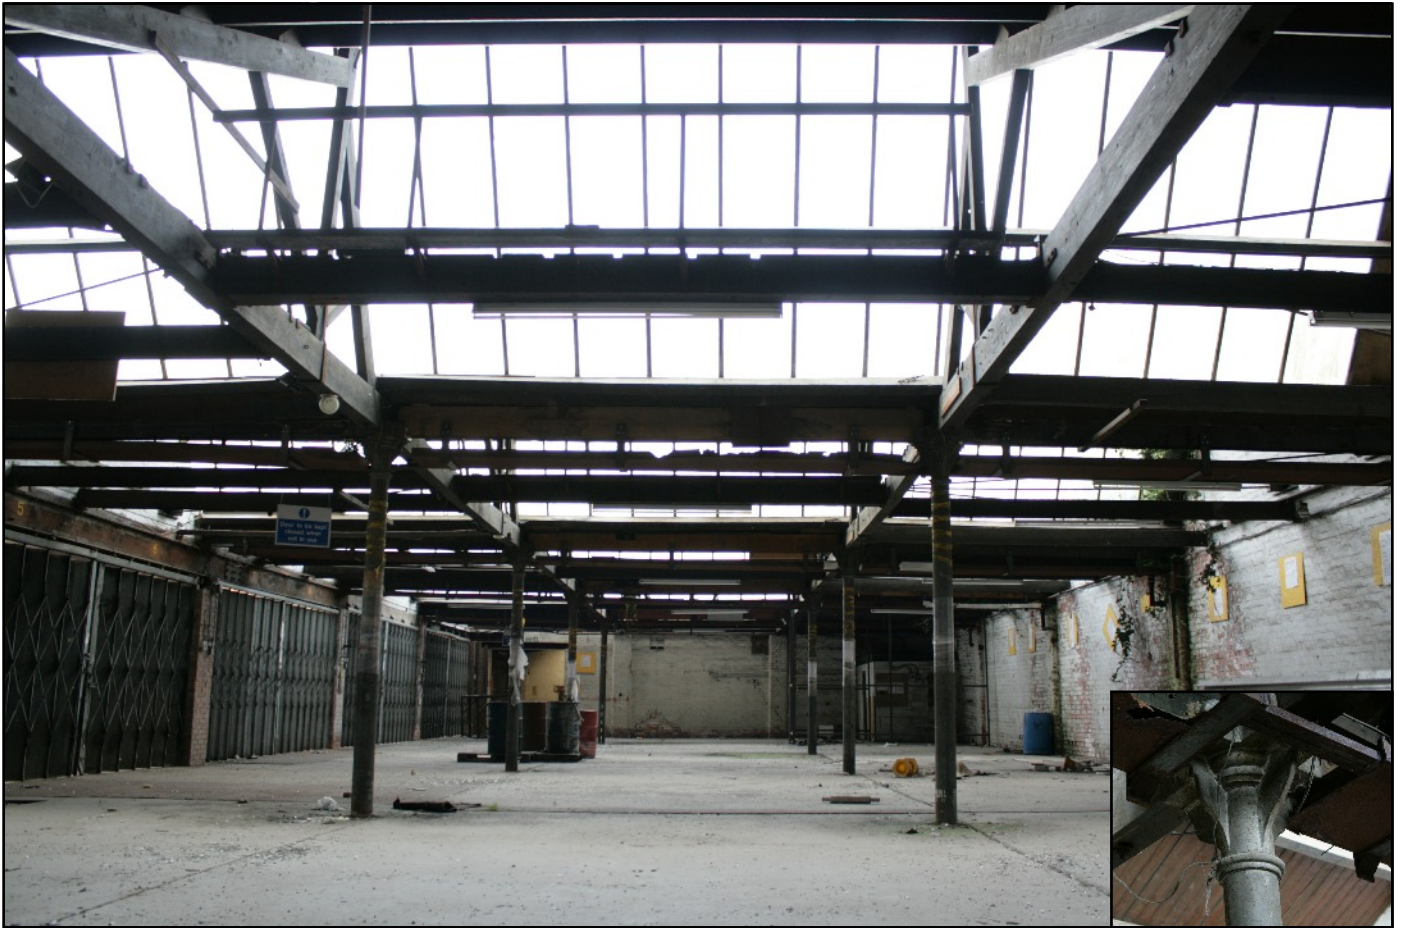
**Plate 8:** The interior of the former lace factory viewed looking north from Bay 4 Unit 7. The insert depicts the column capital supporting the trusses.

4.1.6 The brick piers supporting the trusses replace the original cast iron columns, an alteration presumably undertaken following the fire in the 1970s that reduced the size of the 1884-1900 phase of the building.

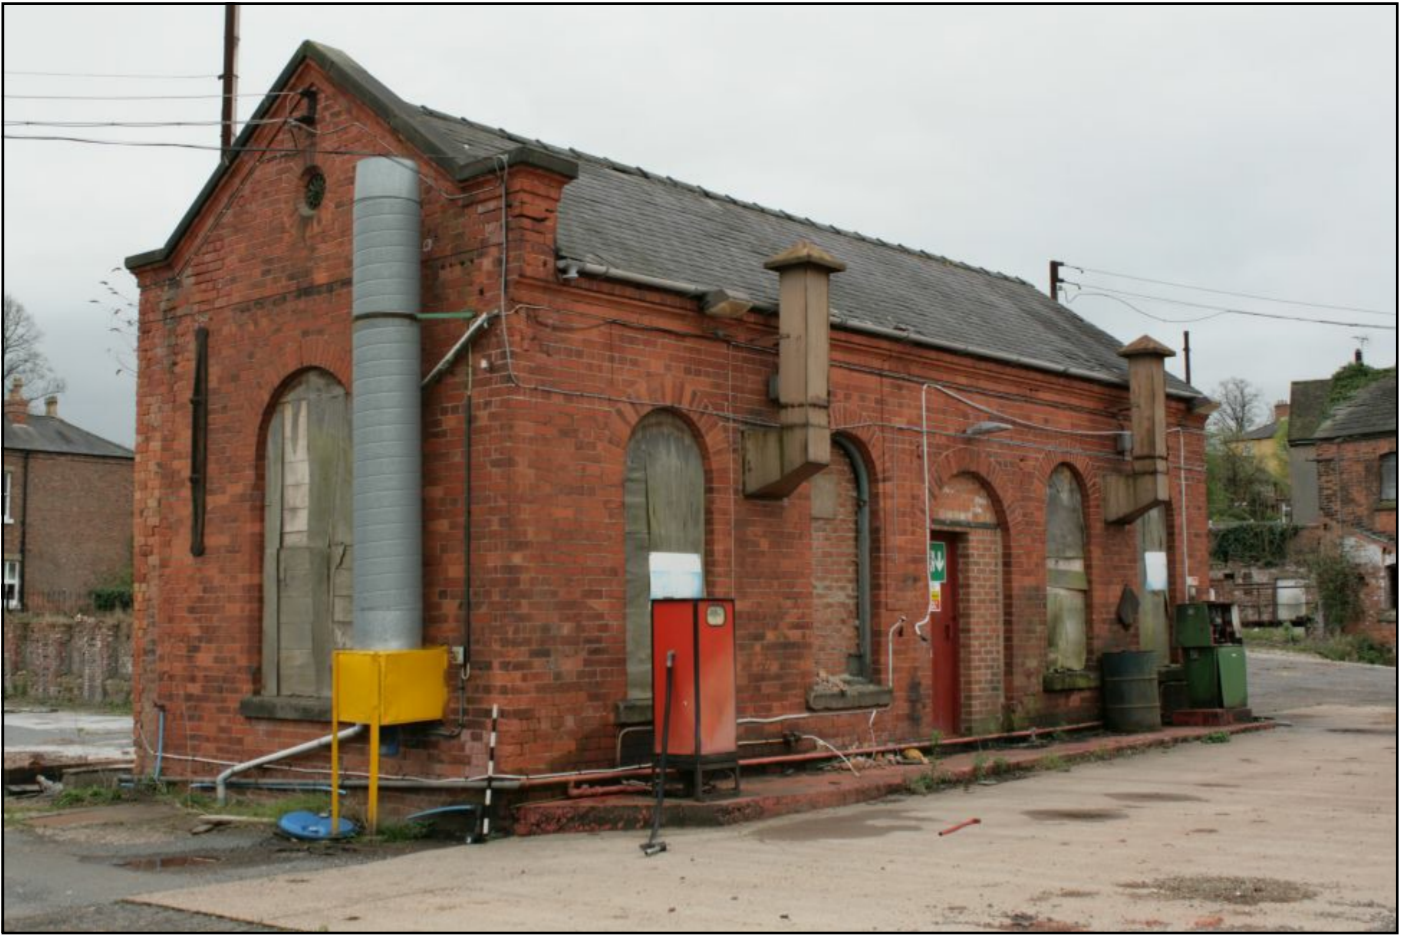
**Plate 10:** East gable and north elevation of the engine house, viewed looking south-west.

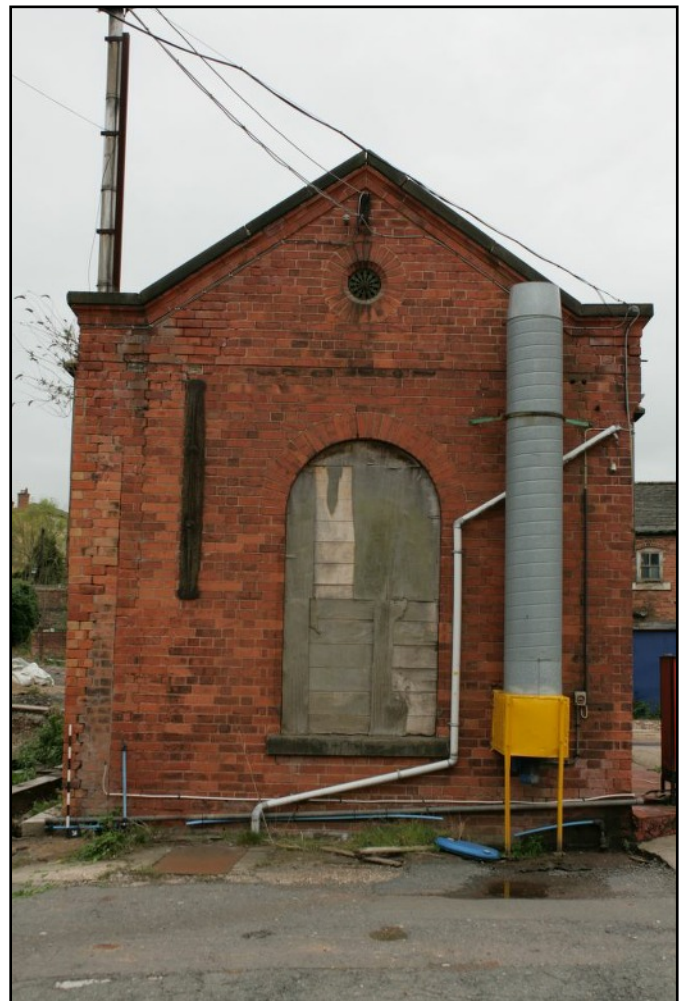
**Plate 12:** East gable of the engine house, viewed looking north-east.

4.2.4 The east gable is constructed of superior quality bricks measuring 9 inches x 4¼ inches x 3 inches with a stone coping and kneelers with ornate moulded bricks beneath. There is a large blocked central round headed window with stone cill and a circular brick opening above for a cast iron vent. Straight joints in the brickwork the southern part of the gable indicate repair to this part of the building probably due to the demolition of the lace factory in the 1970s. Additional structural support is provided by a long cast iron tie.

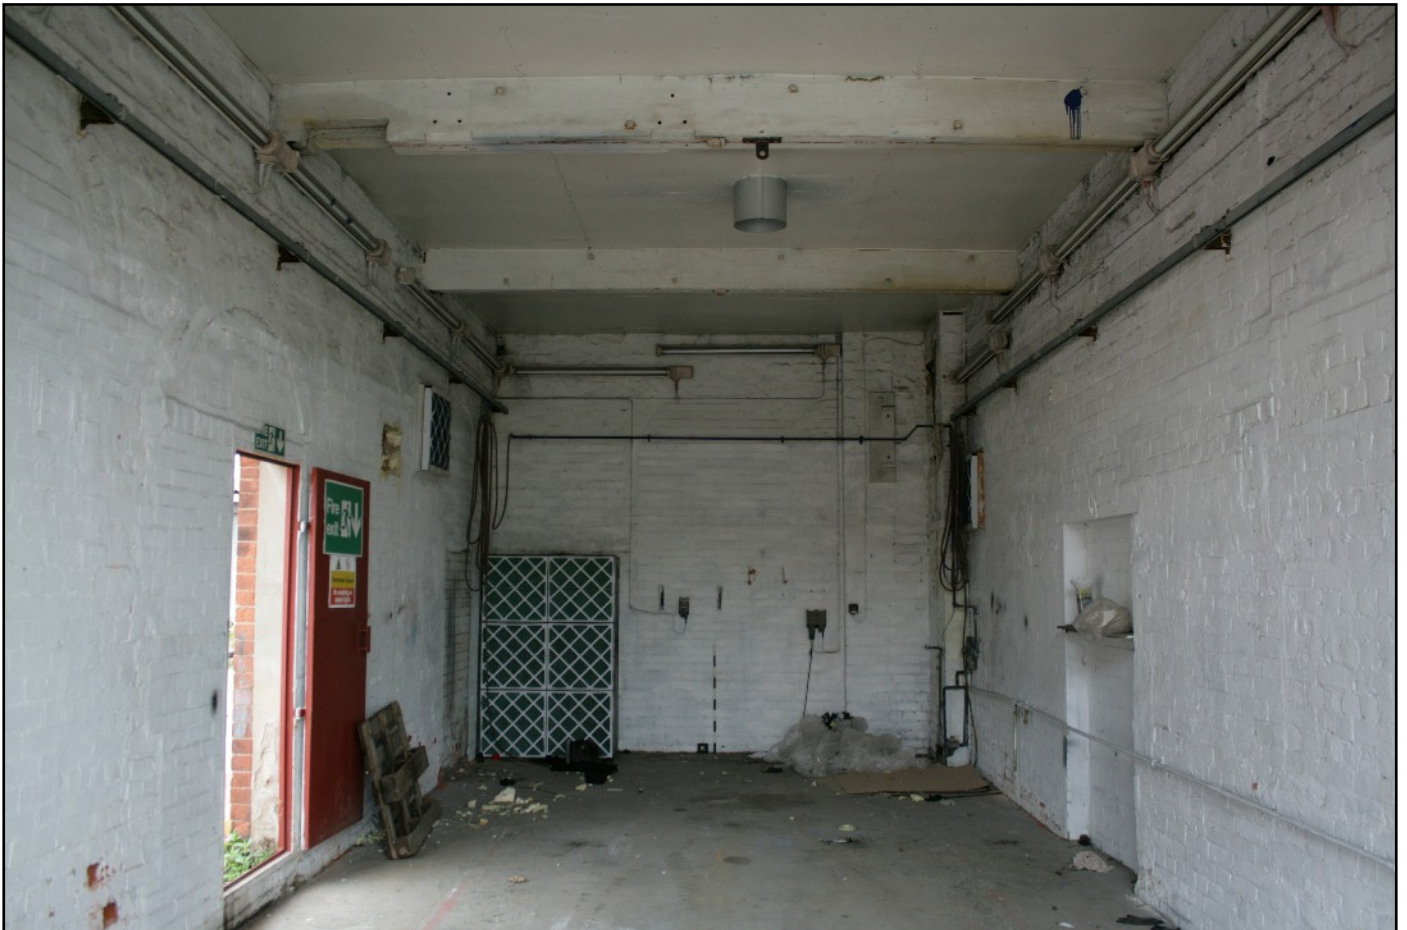
**Plate 16:** The interior of the engine house, viewed looking east.

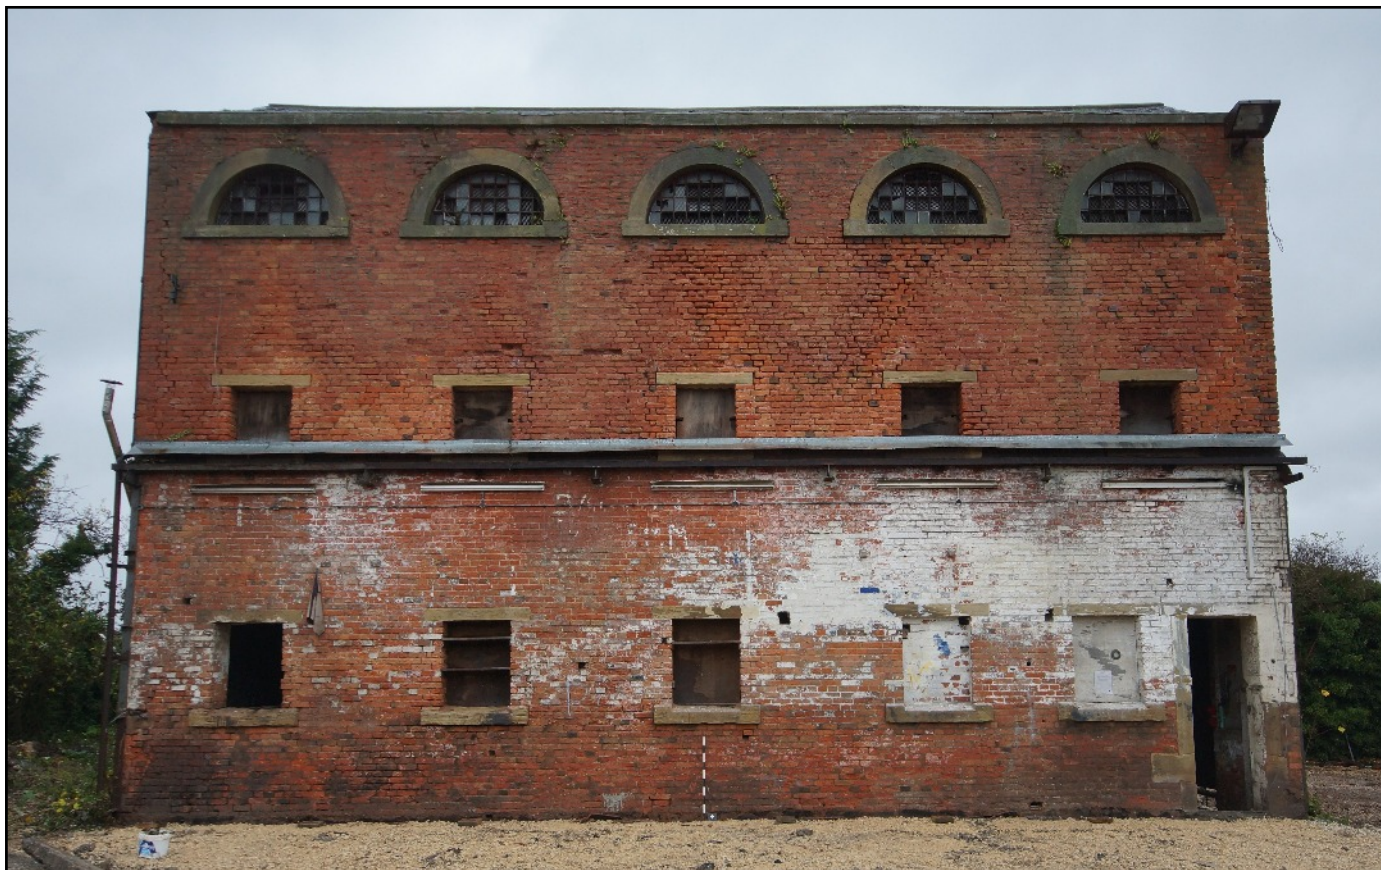
**Plate 17:** South elevation of the north wing of the penitentiary, viewed looking north.

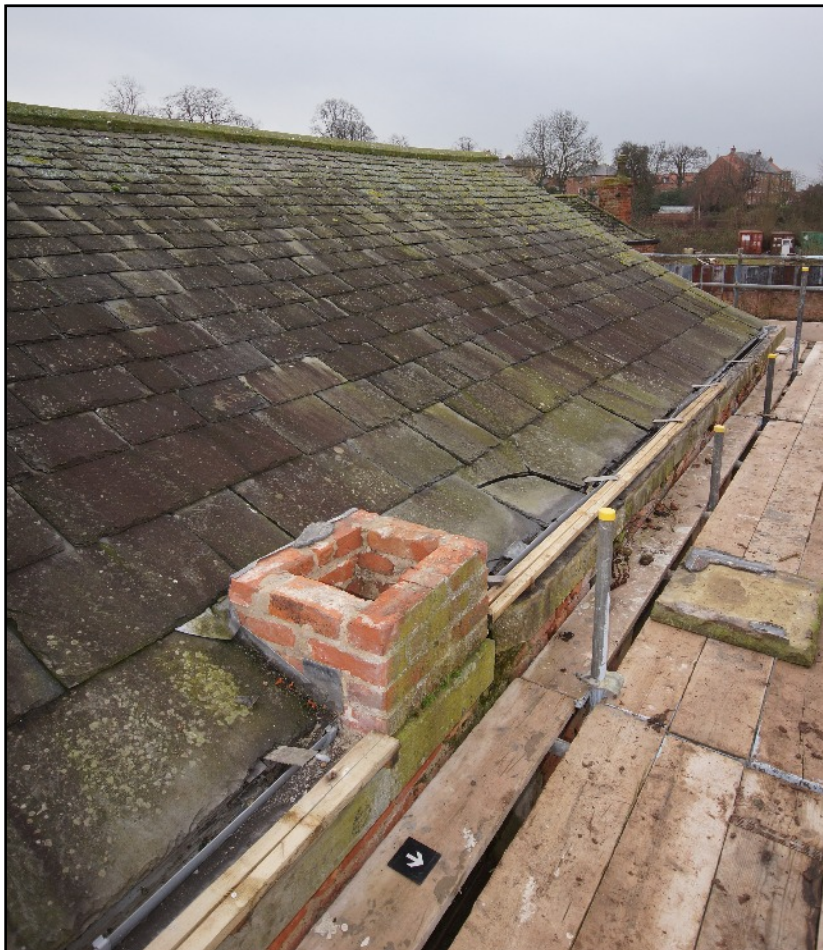
**Plate 28:** North face of the roof and the inserted chimney, viewed looking south-west.

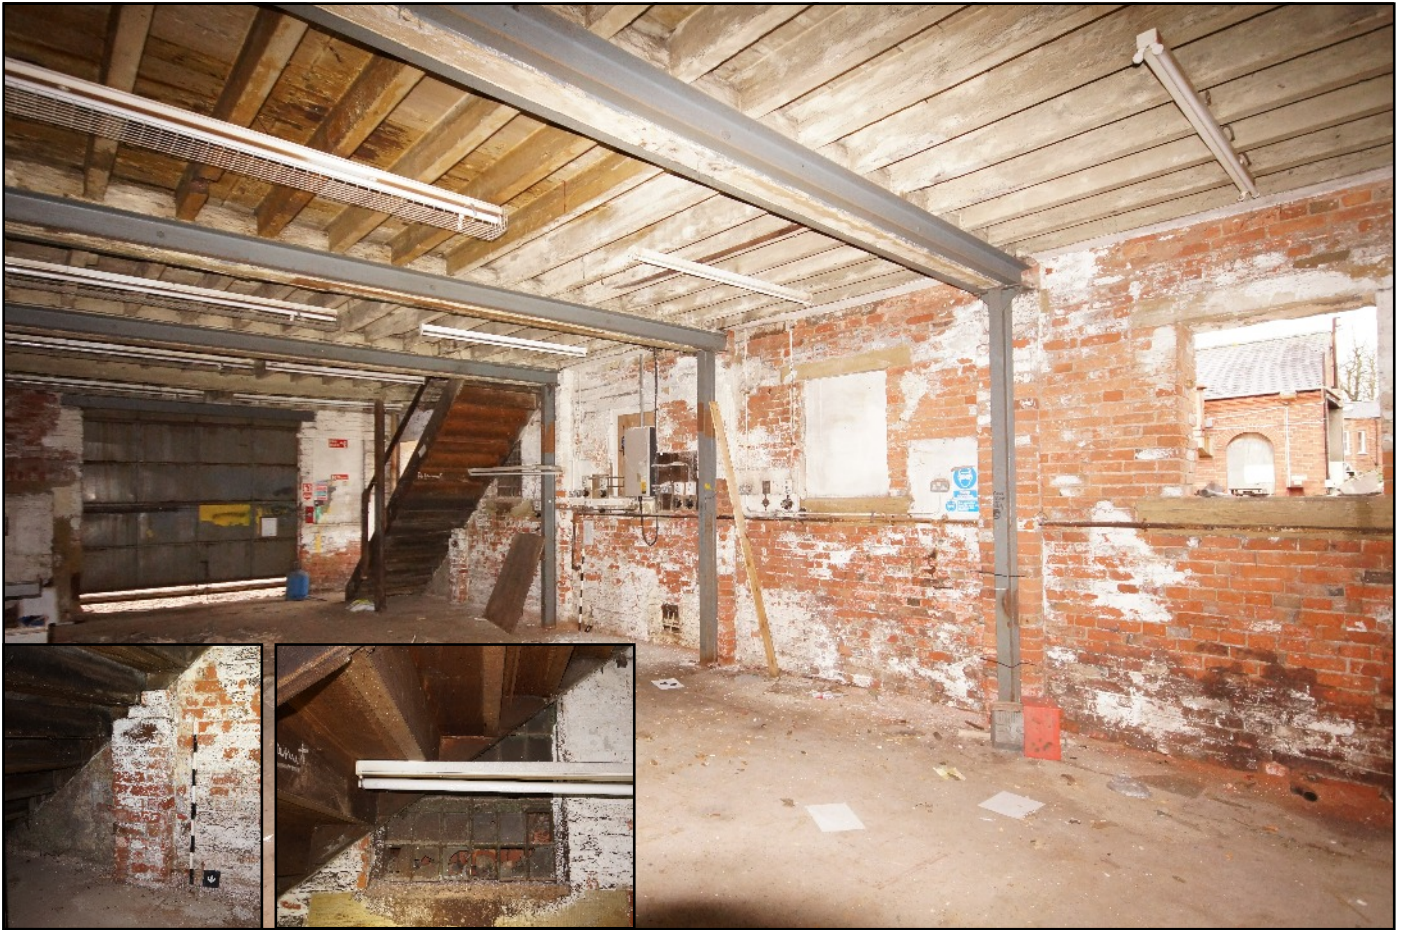
**Plate 29:** Ground floor of the west wing, viewed looking south-east. The inserts depict the staircase truncating the pillar supporting the ceiling beam and partially blocking the window.

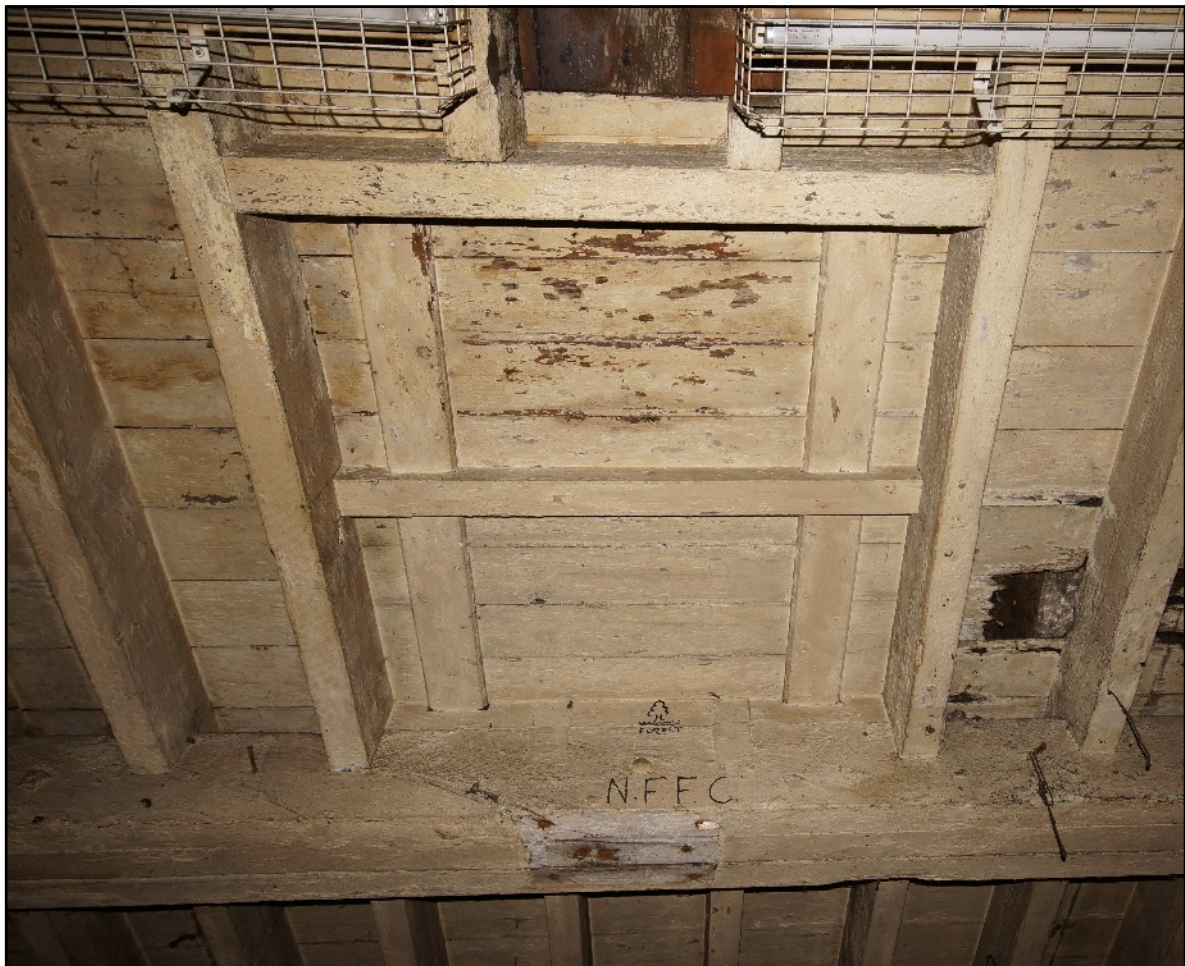
**Plate 30:** Hatch, or original access, between the ground and first floors, viewed looking east.

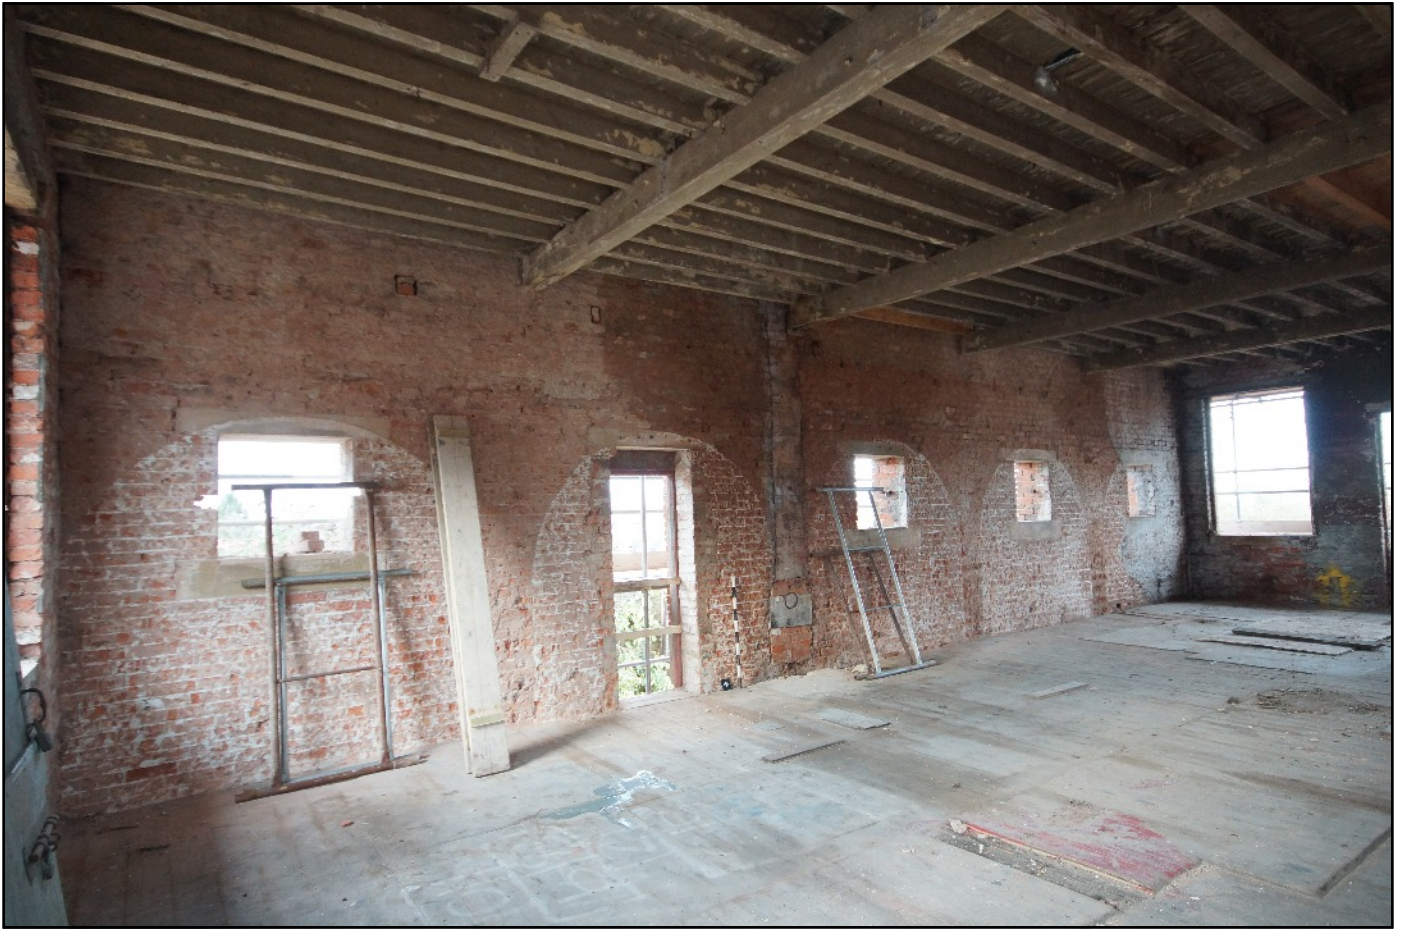
**Plate 31:** The north wall of the first floor of the west wing with the former cells outlined in the brickwork, viewed looking north-east.
