# The Rainbow Depot, The Burgage, Southwell, Nottinghamshire

Historic Building Record

Report Number: 089/2016

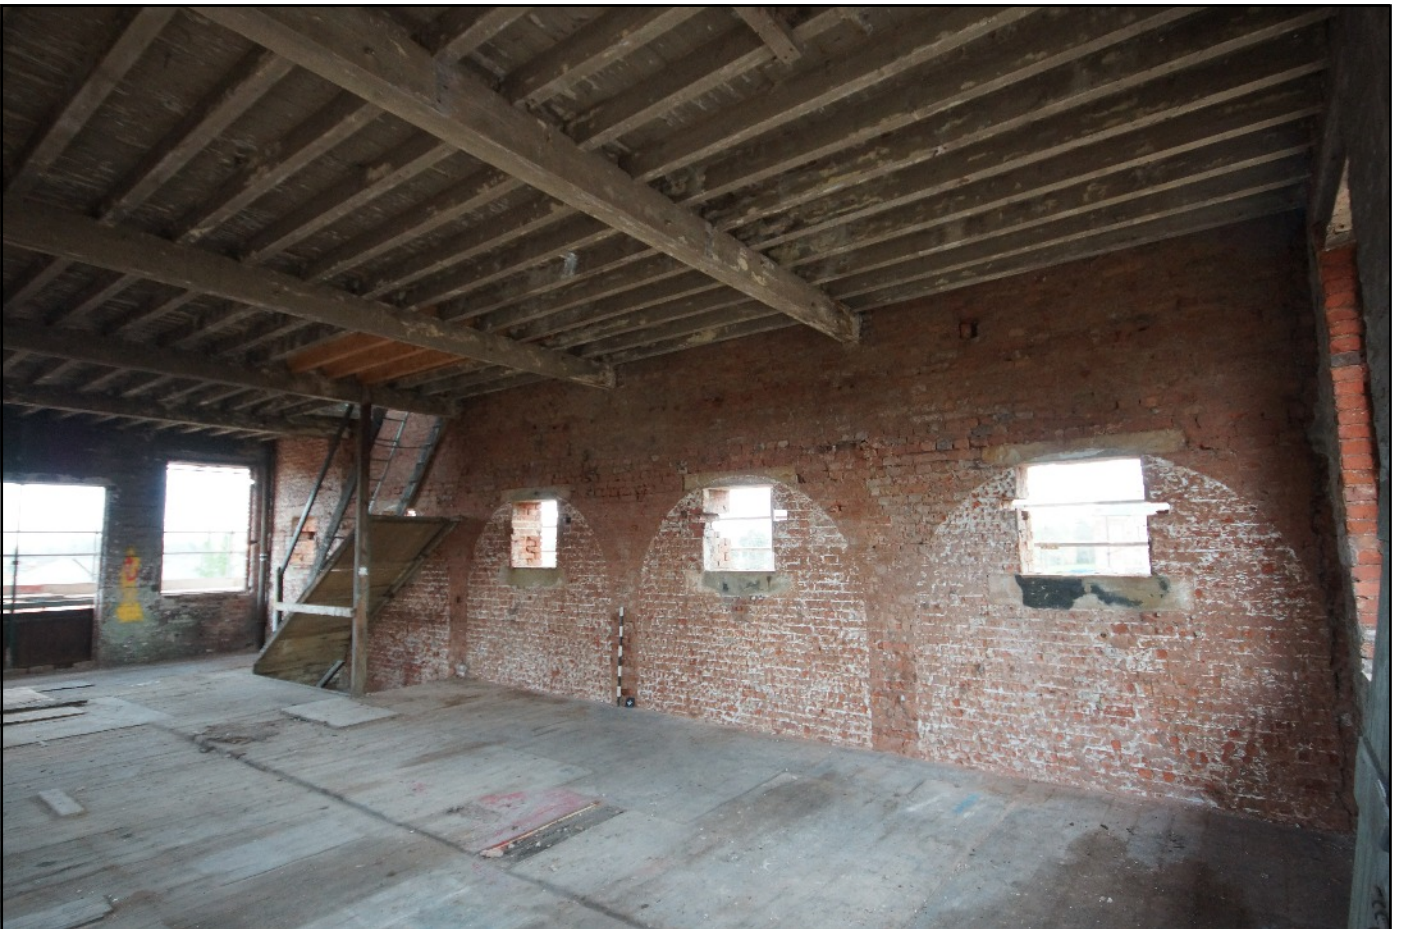
**Plate 32:** The south wall of the first floor of the west wing with the former cells outlined in the brickwork, viewed looking south-east. Note how the staircase truncates the cell.

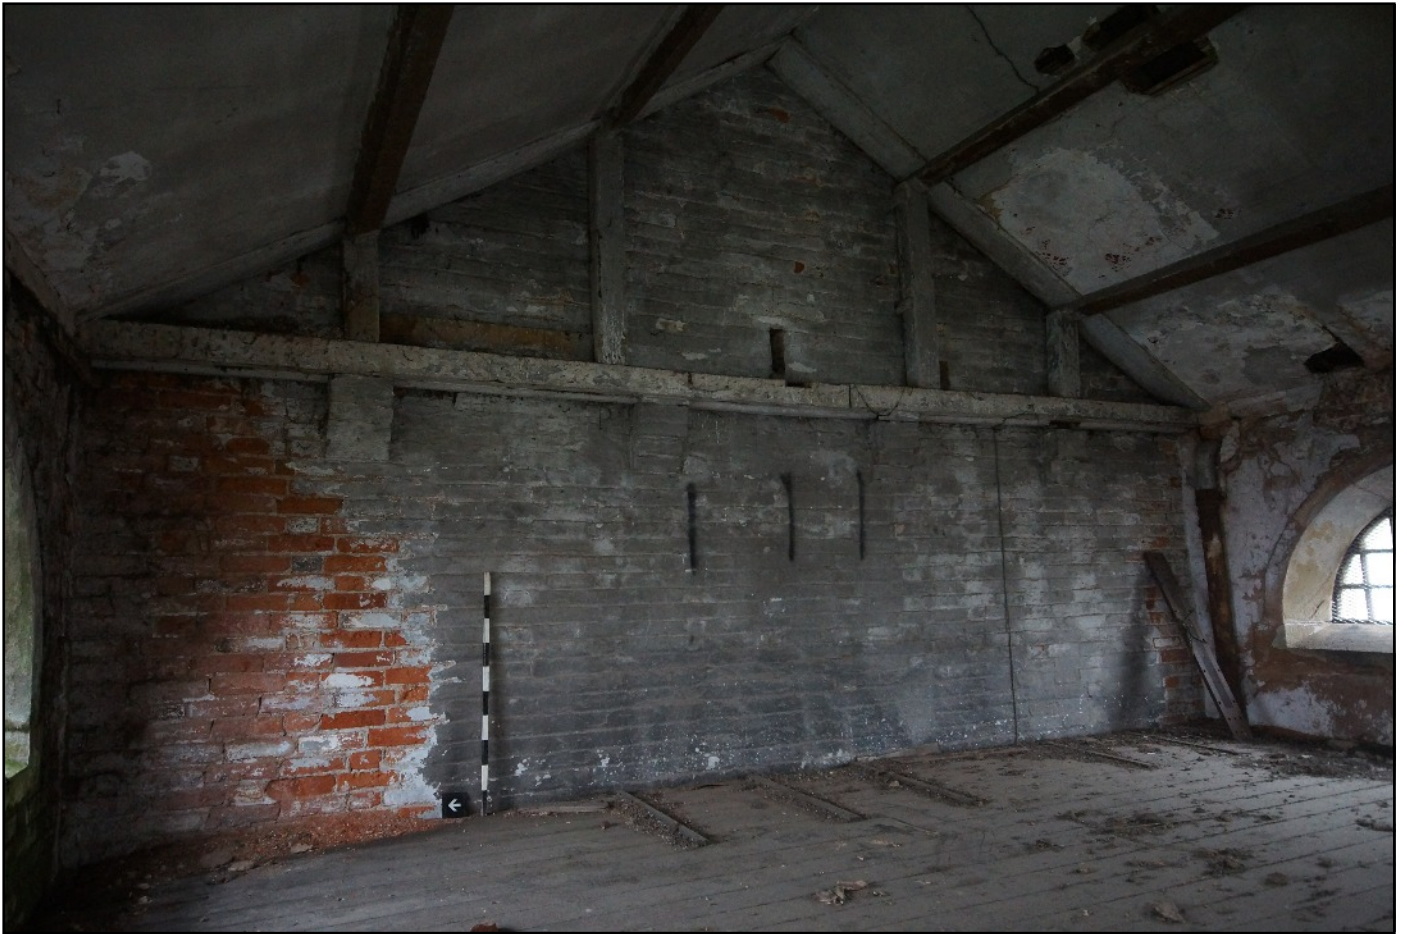
**Plate 37:** Truss 5 of the west wing, viewed looking south-east.

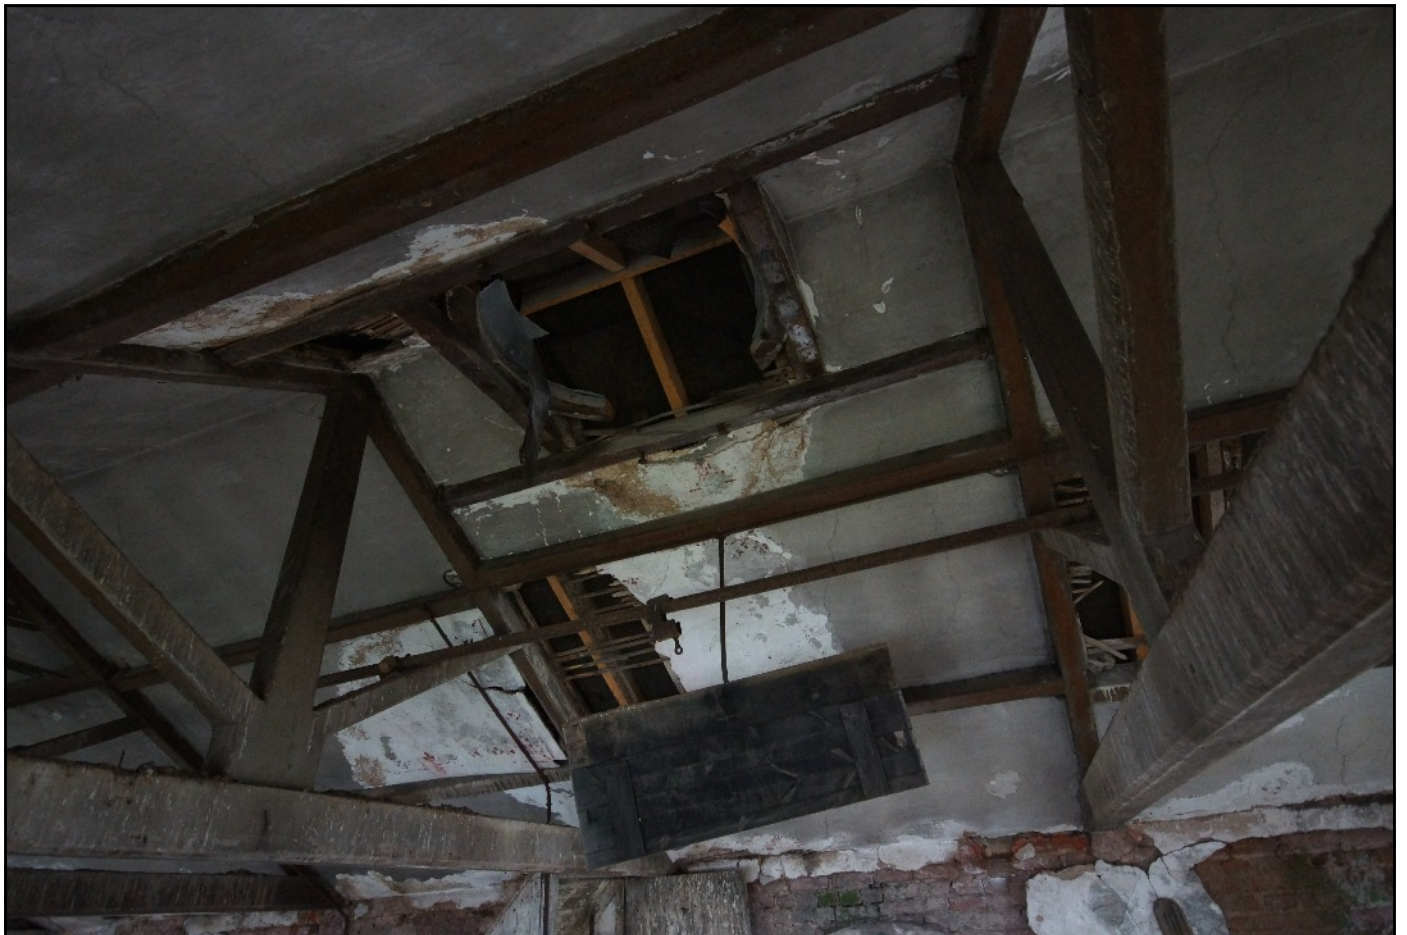
**Plate 38:** Ventilator and iron bar for the no longer extant winch in Bay 3, viewed looking south-east.

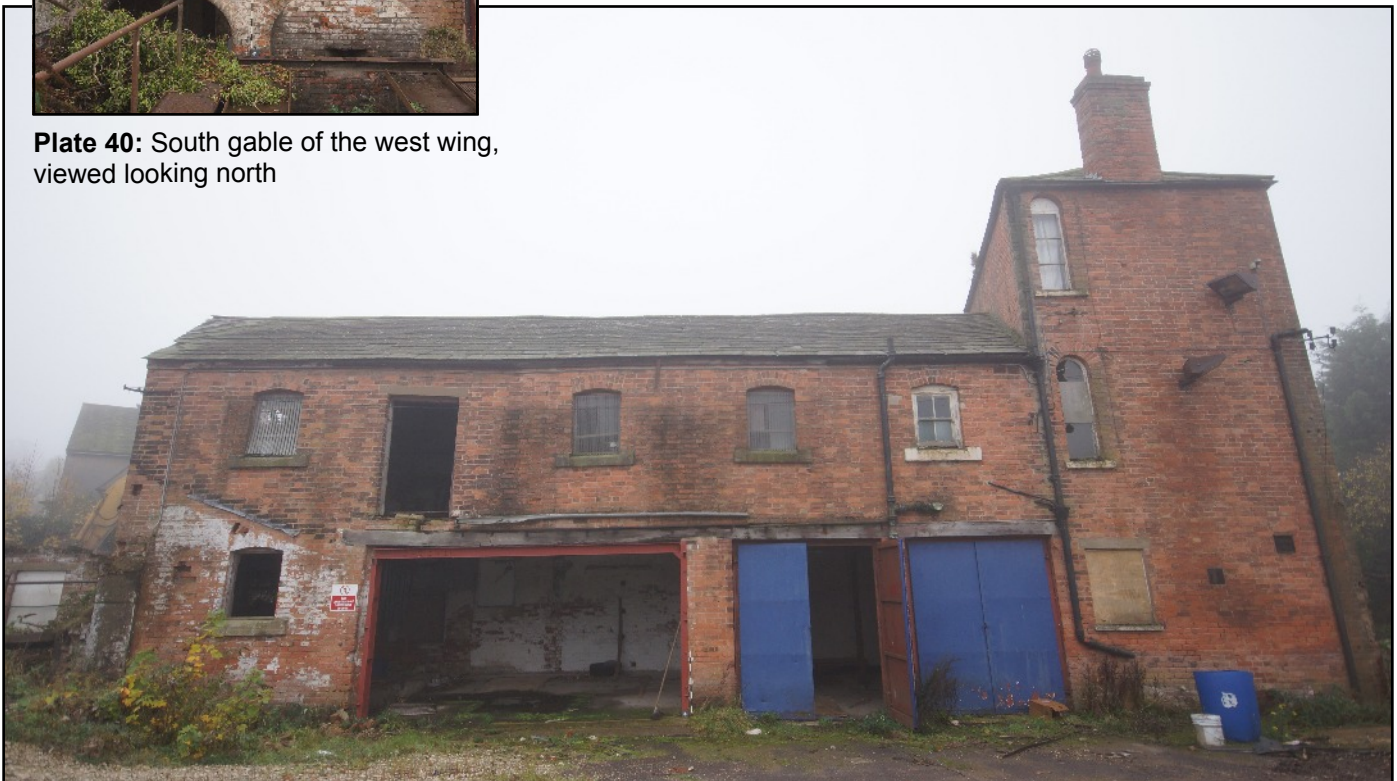
**Plate 41:** East elevation of the west wing and the east gable of the house, viewed looking west. Note that there is no building join between the two buildings indicating that they are contemporary.

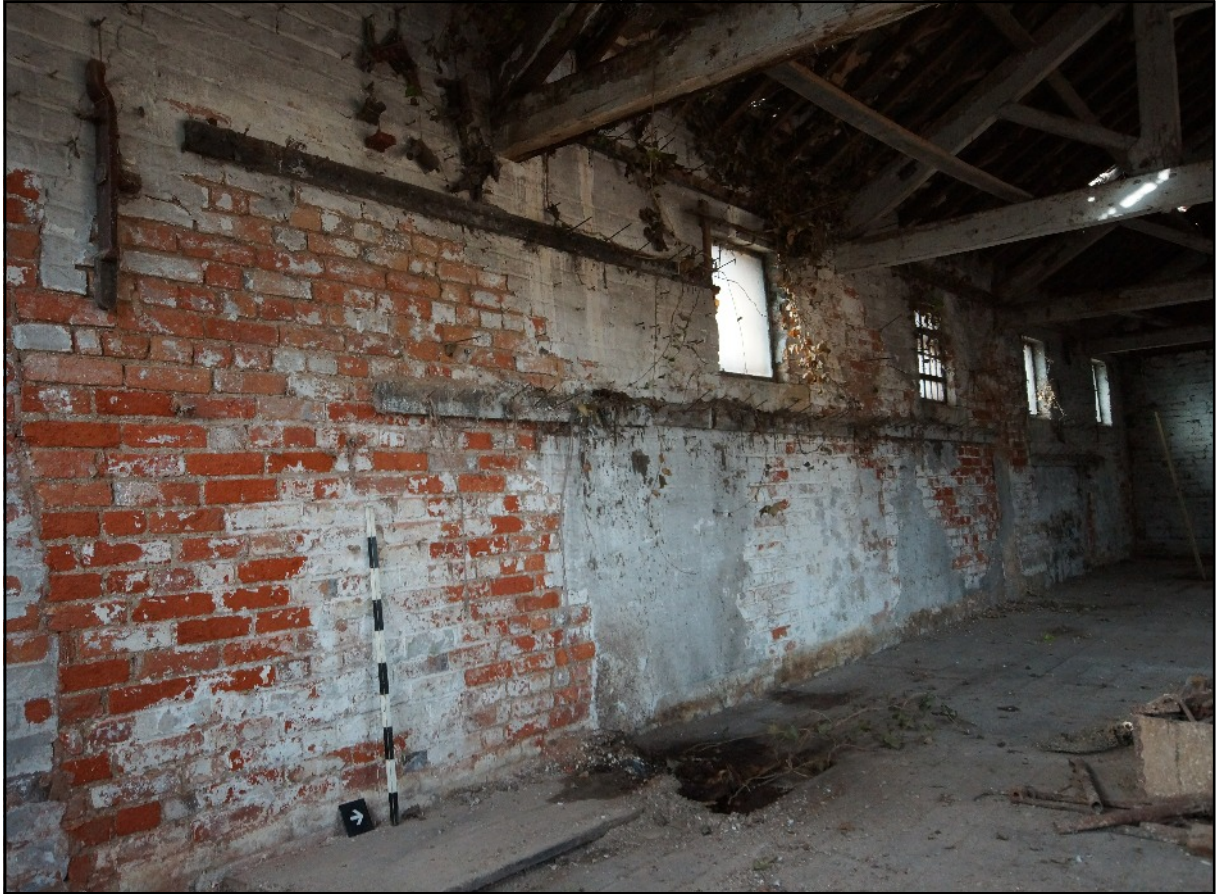
**Plate 48:** The bobbin racks extending down the west wall of the first floor of the west wing, viewed looking north-west.

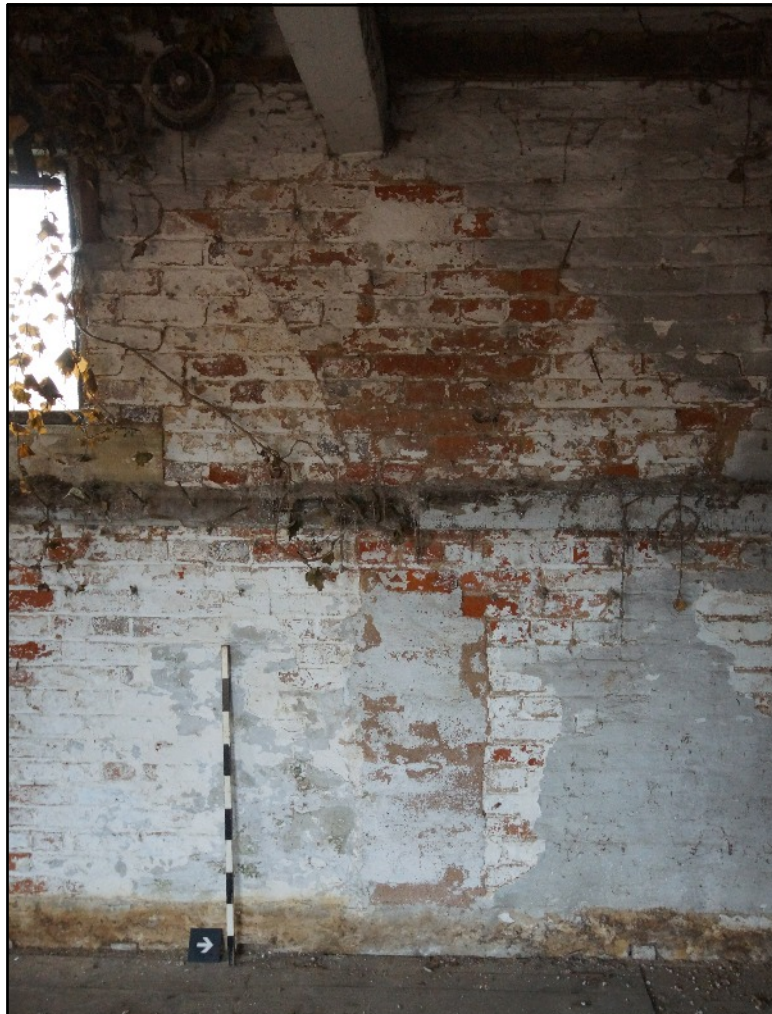
**Plate 49:** Outline of two prison cells on the first floor of the west wing, Bay 4 on the west wall, viewed looking west.

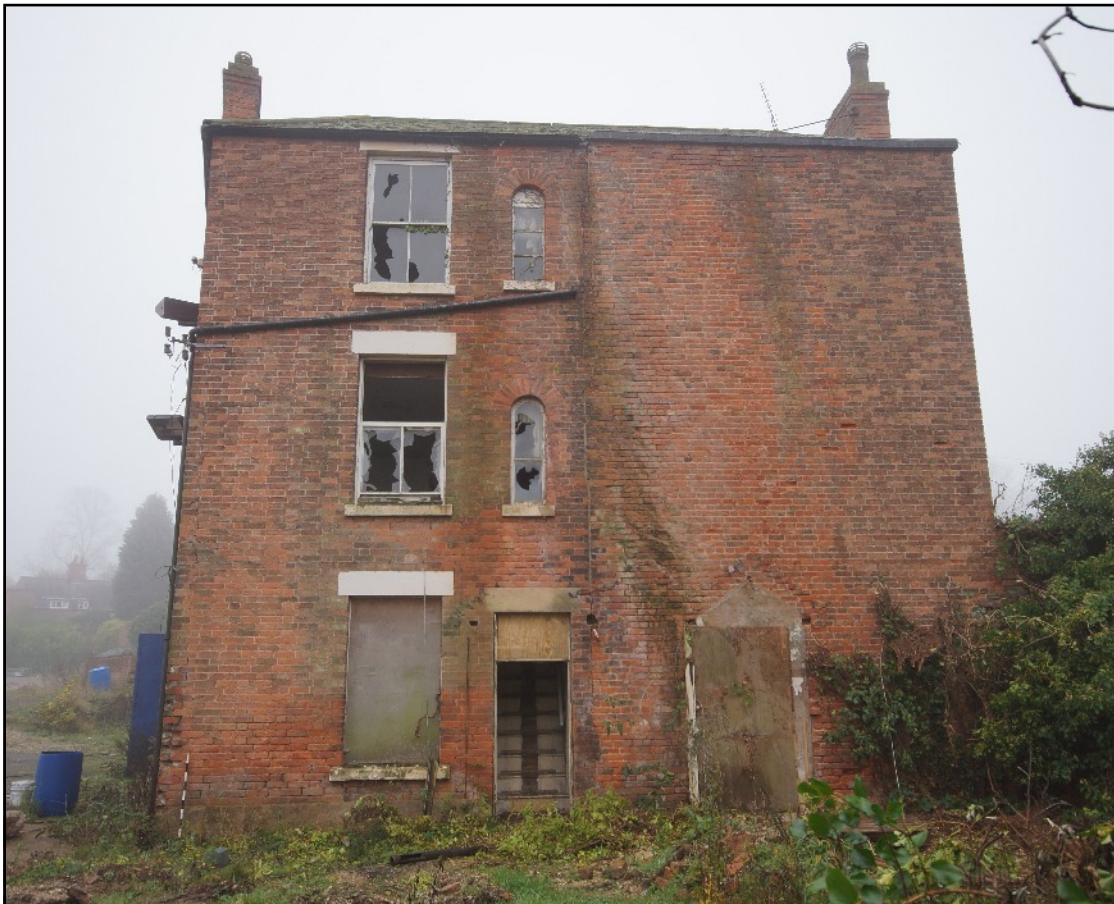
**Plate 51:** North elevation of the house with the building join between the east and west unit clearly visible, viewed looking south.

4.5.4 Essentially the house is of two phases, the first being the west unit that post dates the west elevation of the west wing of the penitentiary with cartographic evidence suggesting that it was built after 1841. The east unit most likely replaced, an earlier building and is contemporary with the remodelling of the west wing that probably took place between 1841 and 1867. The bars in the cill of the west unit attest to it being a former prison building though it was a dwelling by 1921.

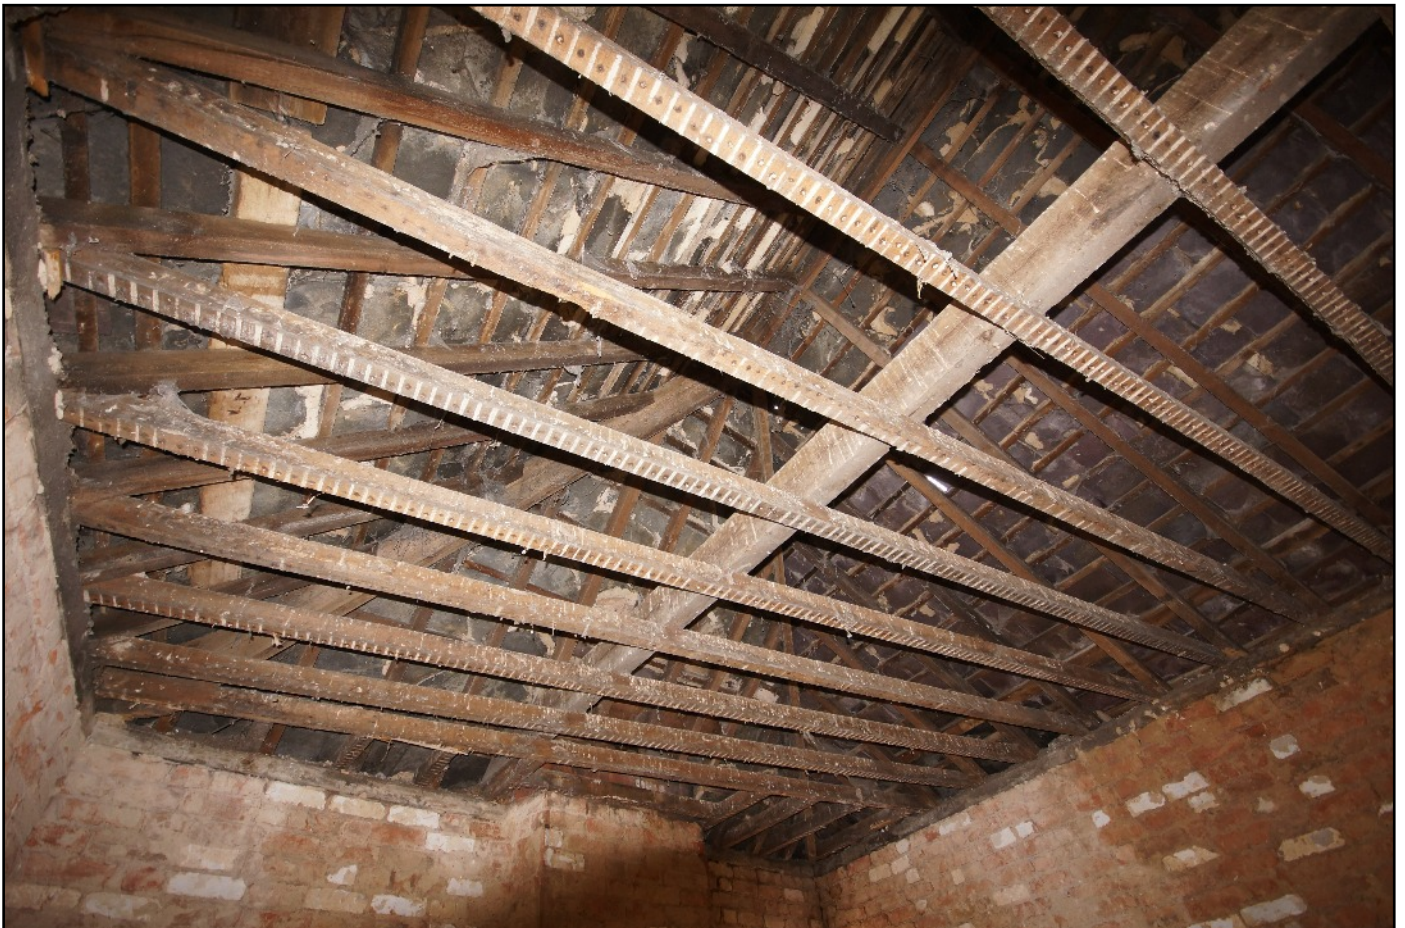
**Plate 55:** The roof of the house viewed looking south-east from the first floor of the east unit.

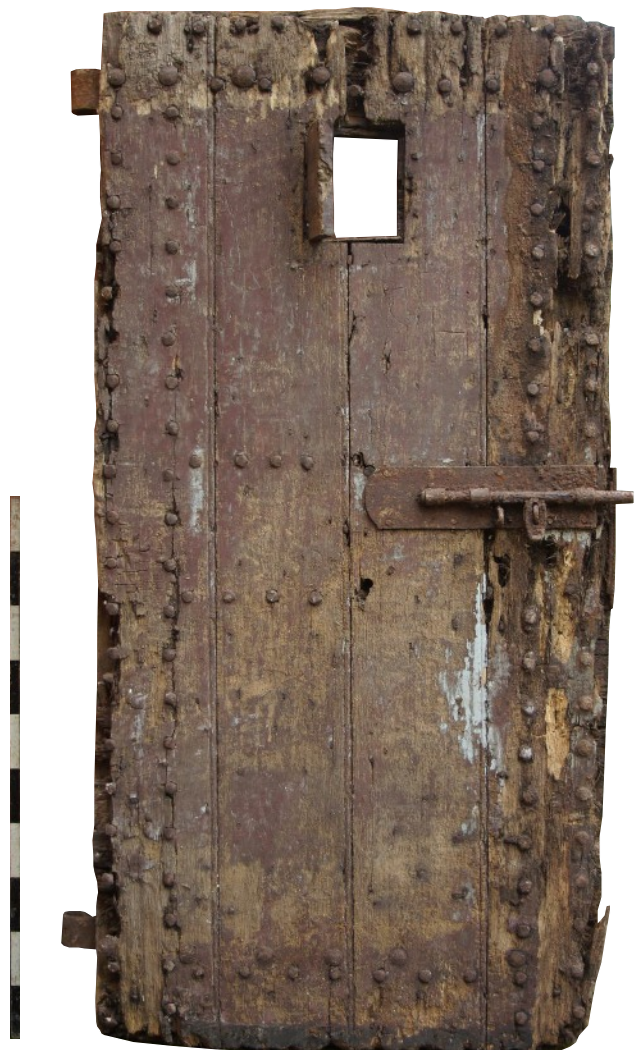
**Plate 57:** The outer face of the prison door.
