# The Former Rainbow Depot, Burgage Green, Southwell, Nottinghamshire

**For Burgage Homes Ltd**

Report Number: 013/2016

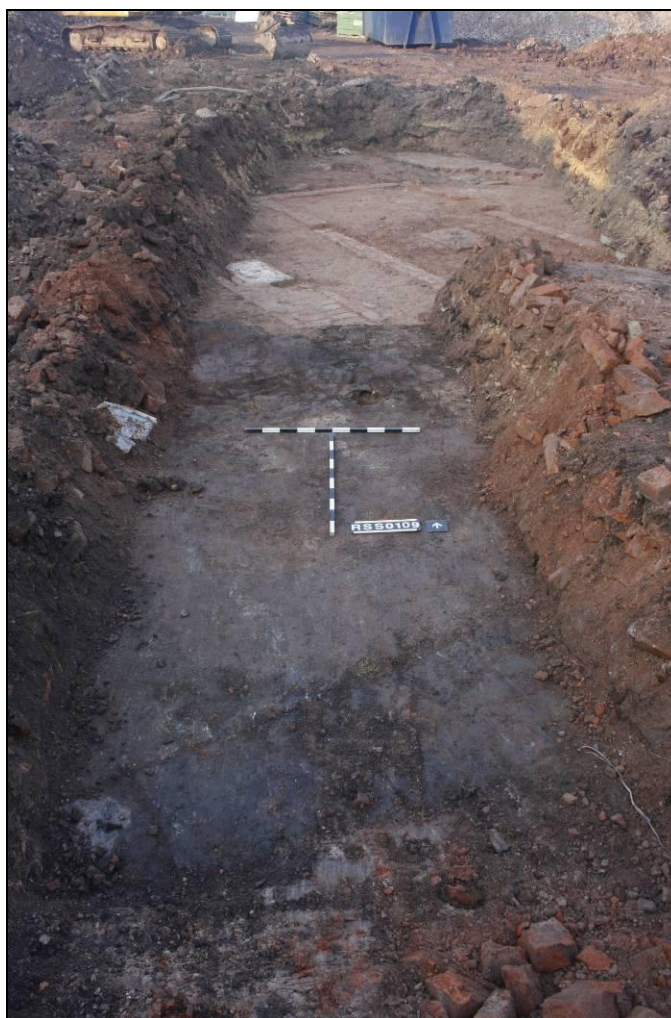
Plate 1: Trench 1, looking North

6.1.1 Trench 1 was 15m in length and was located at the centre of the site on a north-south alignment. The trench was mostly sealed by a mixed layer consisting of mid yellowish brown crushed stone, brown clayey-silt and black klinker with a maximum depth of 0.6m (0118), imported as a surfacing material (Fig 6, 6c). This surfacing material was situated directly above a layer of heat-affected yorkstone slabs (0109) averaging 0.13m in thickness. This layer of stone was removed in the northern part of the trench and left in-situ across the southern part of the trench. Directly below (0109) was a layer of cream and red-brown mortar and silt (0104) containing frequent fragments of brick. This layer was a maximum of 0.18m deep and extended across the entire trench.

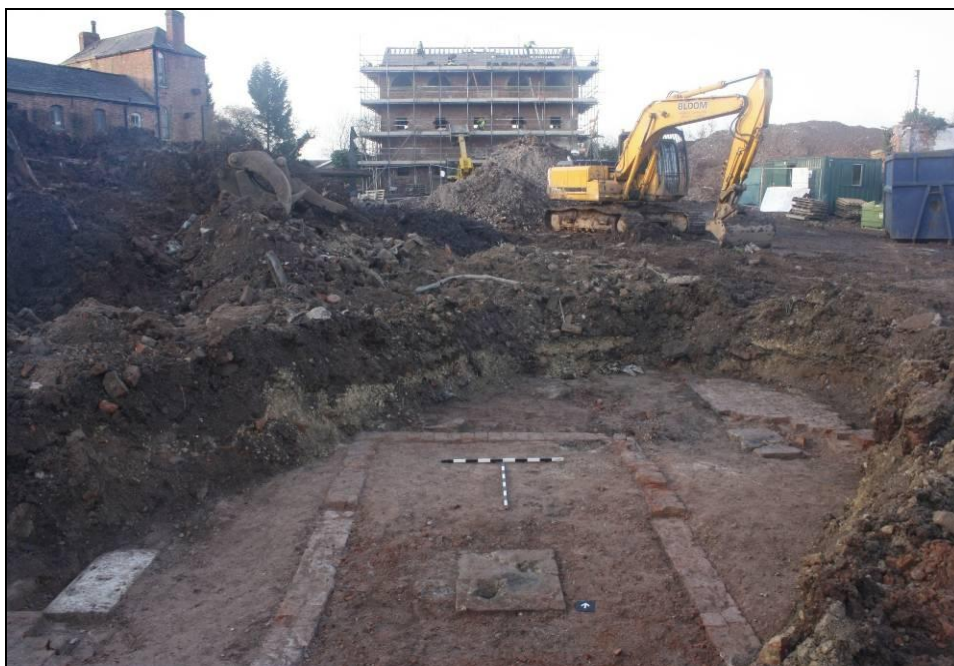
Plate 2: Structure 0120 and Machine Bases (0108, 0113 & 0114), looking North-West

6.1.2 Below this layer were two parallel north-west to south-east walls 2.1m apart (0101) and (0103). Wall (0101) was shown to survive to a height of 6 courses, though only a single course was exposed of (0103). Both were 2 courses wide. The bricks were laid as headers and stretchers in alternate courses. These walls were connected at their north western extent by a third wall (0102), with bricks laid as headers along the entire length.

6.1.7 Three potential machine bases (all disturbed) were also observed within this trench, (0108), (0113) and (0114) (Plate 2). These were sealed by (0104). Upon excavation of a sondage against (0114), it was established that this base was sat upon the redeposited natural/made ground (0115, Plate 6).

- 7.1.1 The stratigraphic sequence within Trench 1, suggested that the brickwork (0120, 0108, 0110 & 0112) could have supported a wooden floor within the large central prison block. The infilling of the areas between the brick walls with the same material that sealed them, suggested that the floor was later replaced by the flag stone floor (0109) perhaps during the conversion of the building to a lace factory in the late 19th century.

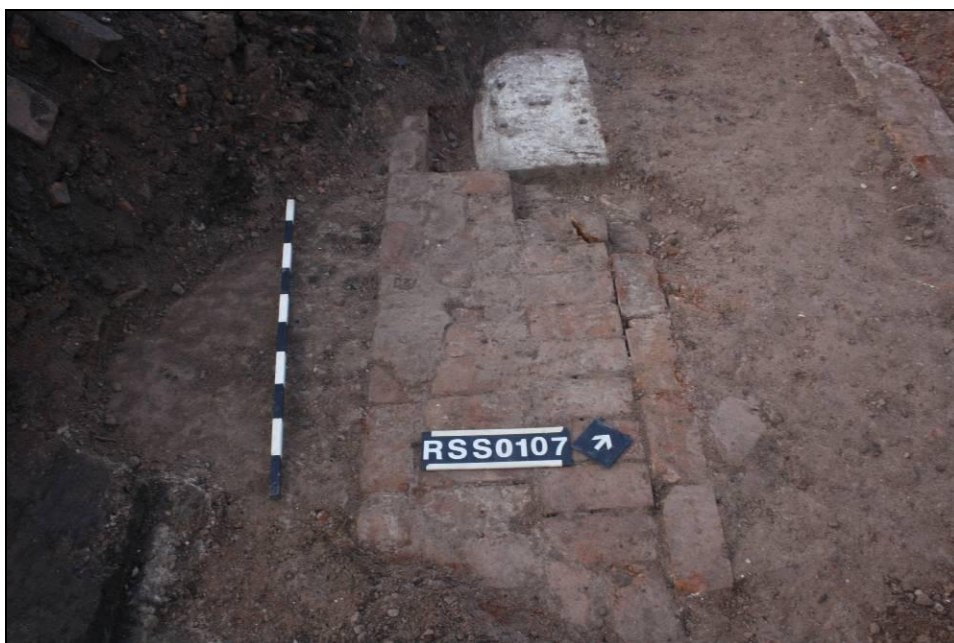
Plate 3: Wall (0107), looking North-West

6.1.5 To the north-west and south of walls (0103) and (0101) there were two parallel walls, (0107) and (0110) (Plates 3 and 4) which were up to 0.76m thick. Running at right angles to (0110) was a further north-east south-west aligned wall (0112); this was similar in construction to (0102) and was similarly aligned.

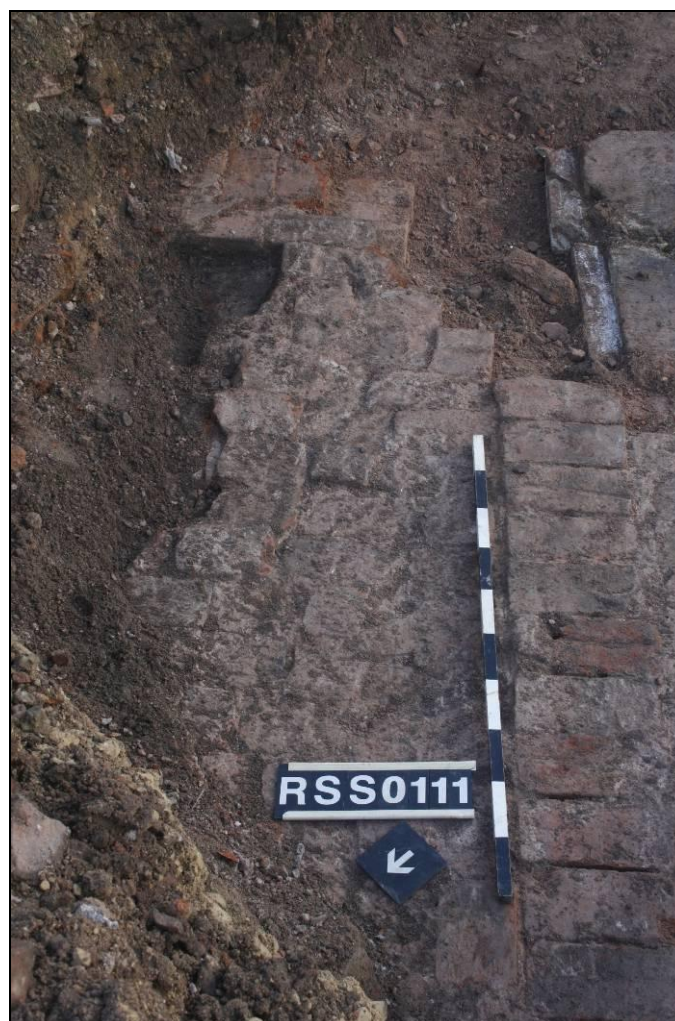
Plate 5: Surface (0111), looking South-East

6.1.6 A rough brick surface, with the bricks laid in no clear pattern (0111), was observed within the space between the walls (0110) and (0112) (Plate 5).

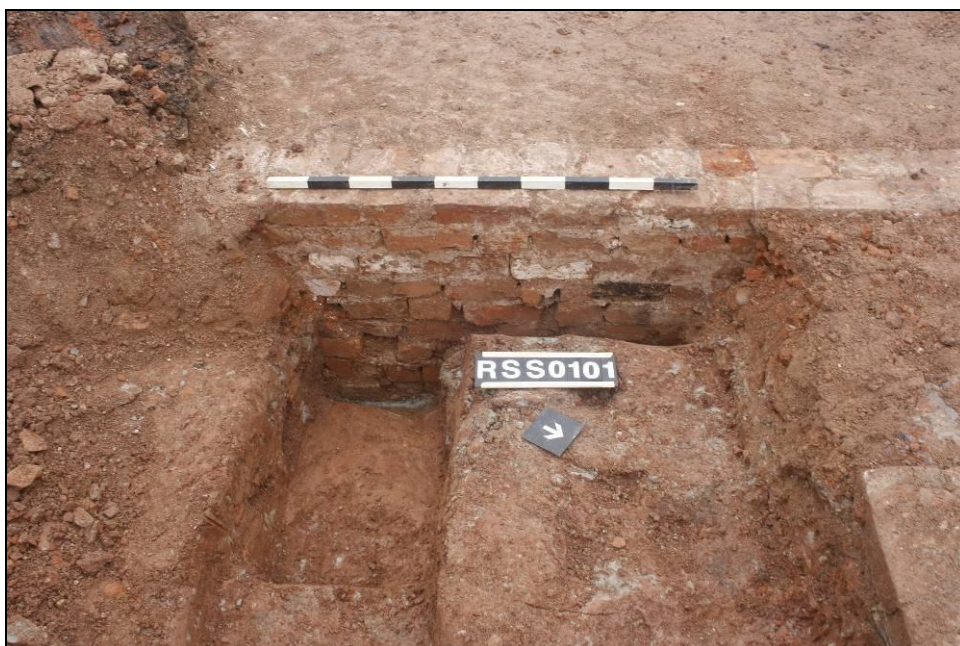
Plate 6: Wall (0101) Sondage within Trench1, looking South-West

6.1.3 The bricks were likely to be of mid 19th century to early 20th century date. Following excavation of a sondage against the eastern side of (0101), it was established that this wall was cut into the natural clay (0119) and redeposited natural containing occasional brick rubble (0115) and the foundation cut [0117] backfilled with redeposited natural with inclusions of brick and mortar (0116) (Fig 6, 6d).

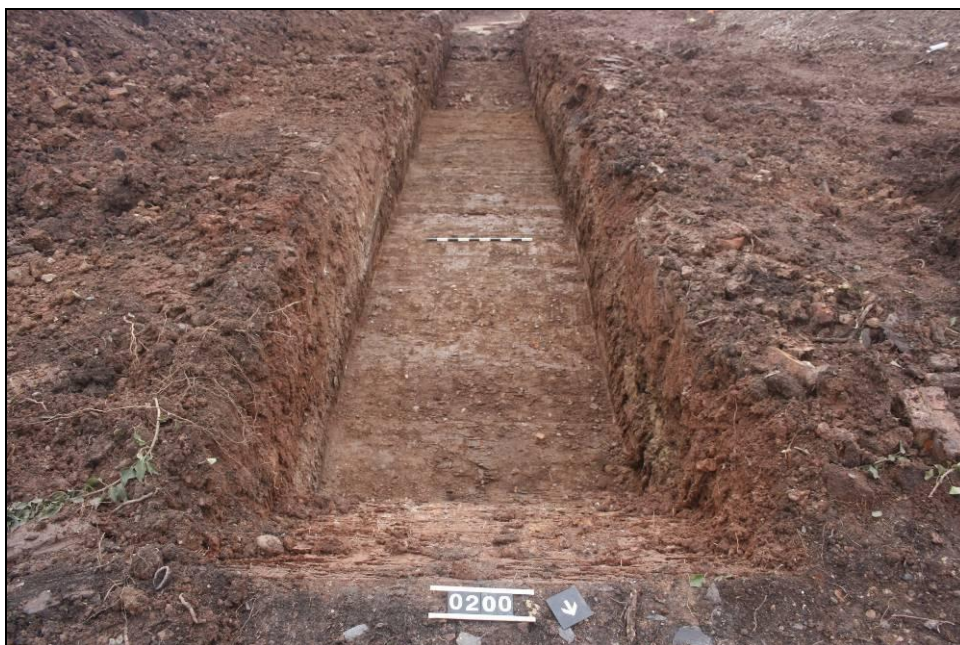
Plate 7: Trench 2, looking South-West

- 6.2.1 Trench 2 was located to the east of Trench 8 and to the north of Trench 1 and was 25m long, on a north-east south-west alignment. The trench was sealed by friable reddish-brown clay (0201), with moderate inclusions of brick rubble with a maximum depth of 0.58m. Beneath this a compact reddish-brown clay (0202) with brick rubble inclusions, probably redeposited natural, was observed.

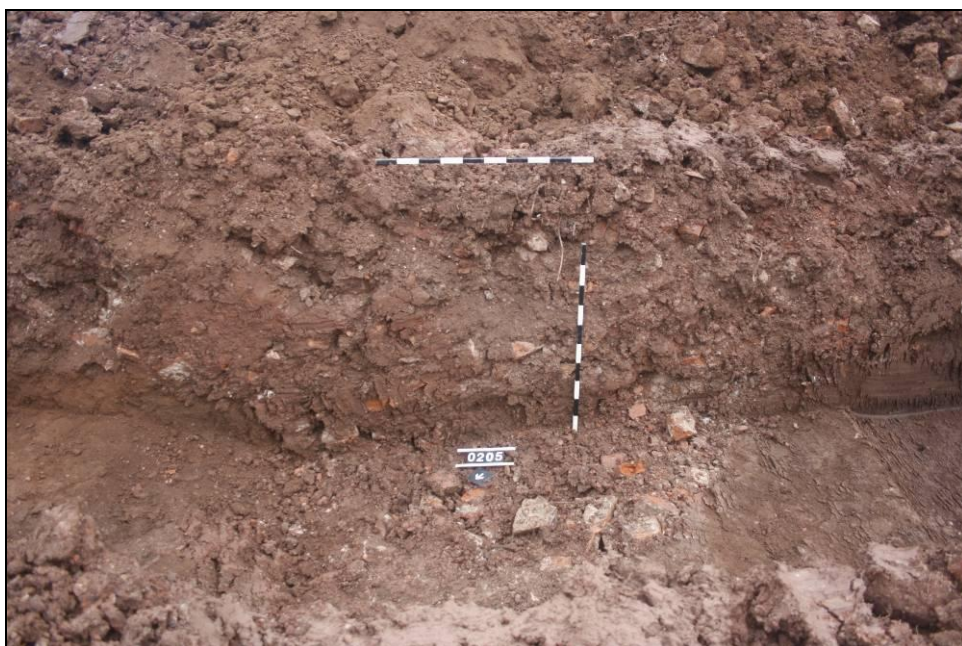
Plate 8: Robber Cut of House of Correction Boundary Wall [0205], looking South-East

- 6.2.2 These materials sealed a compacted brown-grey clayey-silt (0803), at least 0.86m thick, possibly a buried post-medieval soil horizon. This material was cut by a north-west south-east aligned linear feature [0205], which was filled by a brown-grey sandy-silt (0206) with frequent inclusions of brick rubble (Fig 6, 6a). Due to its location and alignment, this feature could represent the robbing trench of the boundary wall of the 19<sup>th</sup> century house of correction (Plate 8).

- 7.1.3 Cartographic analysis of the 1840 tithe map, indicated that the linear feature observed within Trench 2 [0205], lay along the same alignment and location as the boundary wall of the 19<sup>th</sup> century house of correction. The wall is known to have been over 5m in height with the top six courses left unbonded to help prevent escape (Smith 2015).

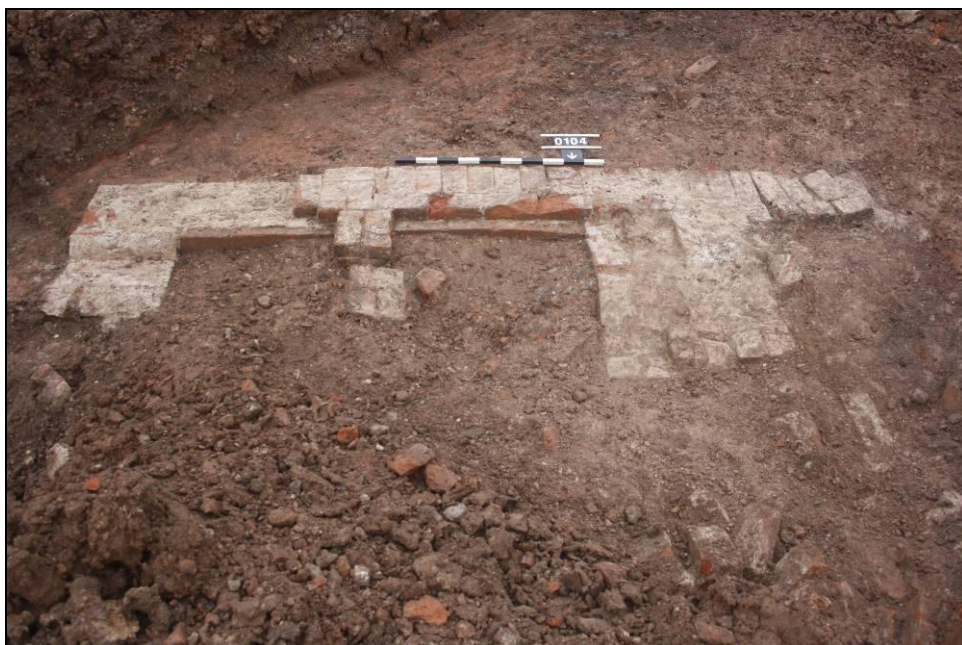
Plate 9: Wall 0204, looking South

- 6.2.3 At the south-western end of the trench, a heavily truncated east-north-east to west-south-west aligned brick wall (0204, Plate 9) was observed, its construction cutting into the made-ground/redeposited natural (0202).

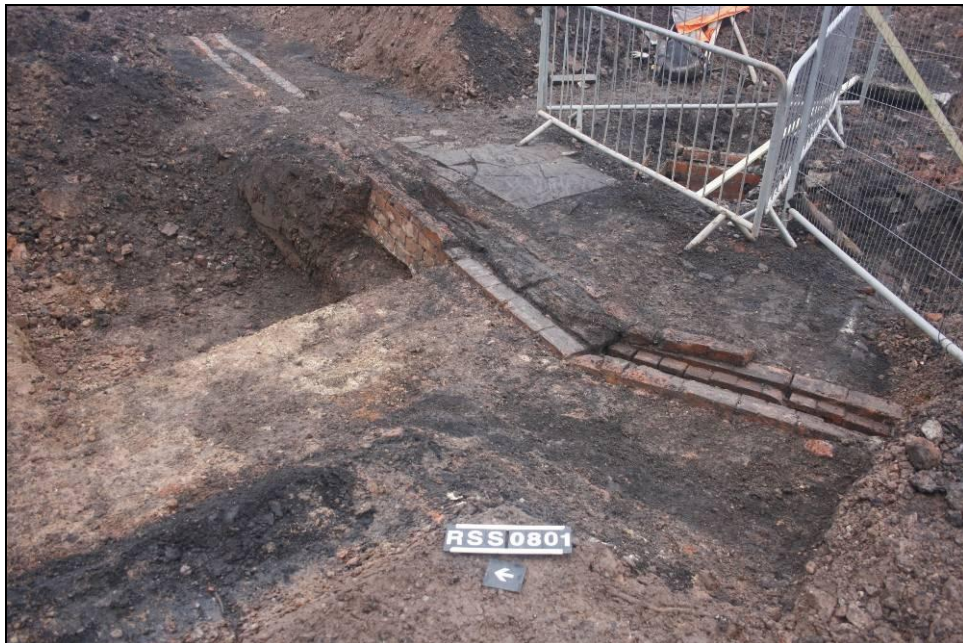
Plate 10: Trench 8a and Culvert (0801), looking East

- 6.3.4 Cutting into a possible demolition deposit (0812), was the construction cut [0807] of a brick built culvert (0801) & (0802), which contained an insulated copper pipe (0806). The outer course of bricks (0801) survived to a height of 4 courses, and was 1 course wide; the bricks were laid flat as stretchers. The inner course (0802) survived one course high, with the ricks laid on edge as headers. Within the central void of the culvert a copper pipe (0806), with fibre glass insulation was laid.

- 6.3.5 The entire structure was backfilled with friable greyish brown silty clay (0809), which also contained timbers in some parts to cap the inner course of bricks (0802) and copper pipe (0807).

- 7.1.4 The brickwork within Trench 8b, was unfortunately too truncated to draw any meaningful conclusion. The culvert and surface observed within Trench 8a, are probably related to the use of the site as a Lace factory. Unfortunately the culvert (0801) does not match up with any services depicted on the 1921 map of the lace factory (Fig. 7).

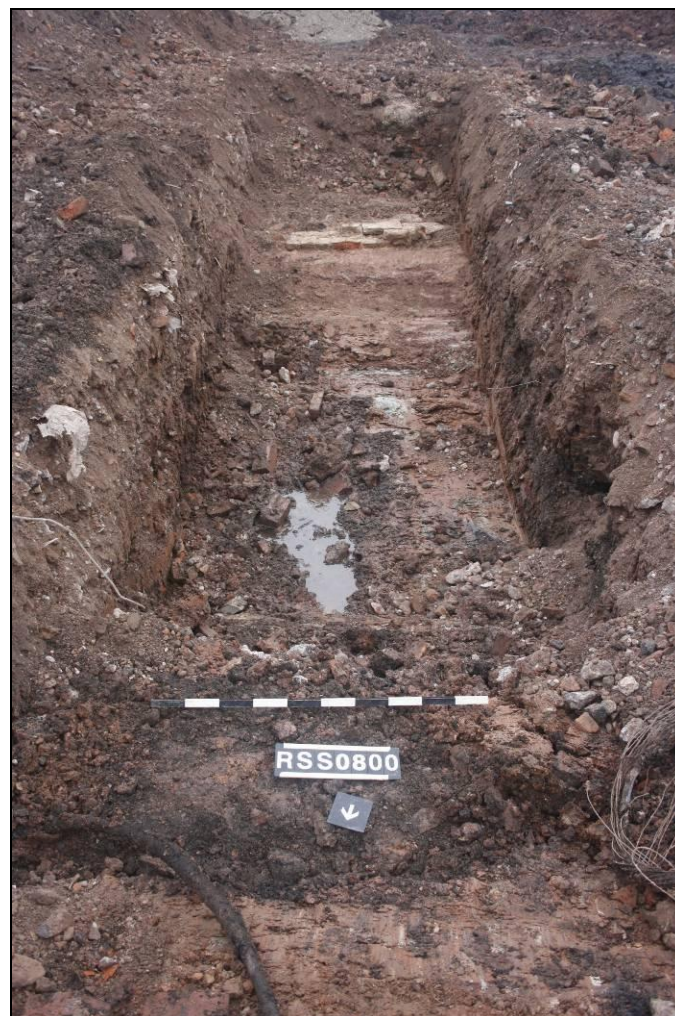
Plate 11: Trench 8b, looking South

- 6.3.8 Cutting (0811) was a large trench or possible pit, [0815, Plate 11, Fig 6, 6b]. The feature correlates well with the alignment of a gas service shown on the 1921 plan of the site (Fig 7, courtesy of Gusto Construction). Due to the depth and loose nature of the overlying deposits this feature was not fully investigated.

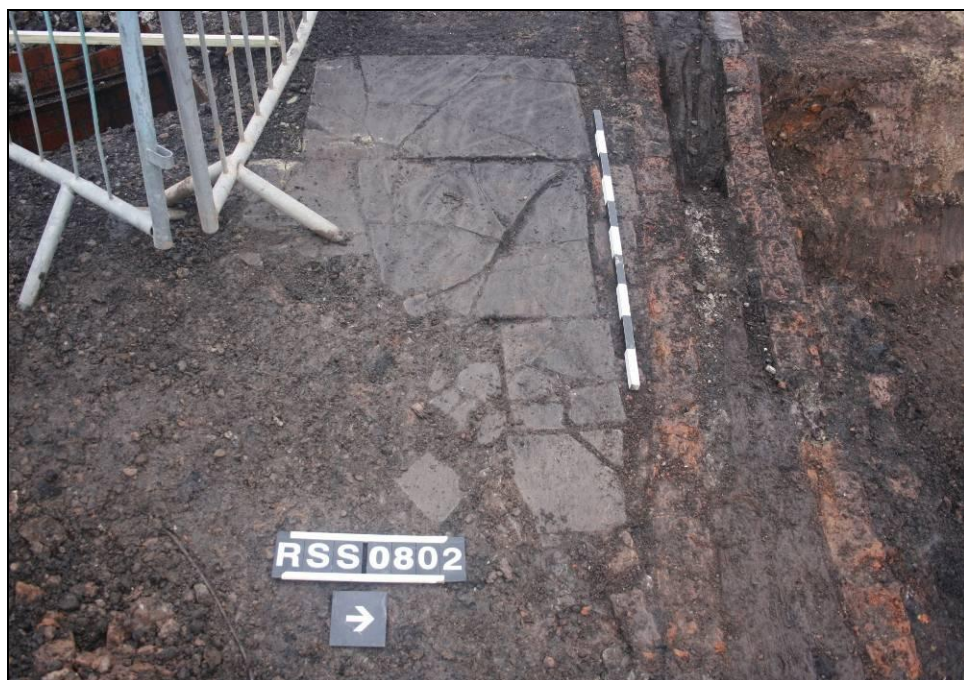
Plate 12: Surface (0802), looking West, Manhole in background

- 6.3.6 Abutting the above structure was a layer of paved flooring (0808, Plate 12). The floor was constructed of rectangular flagstones averaging 1.3 x 0.6m in size, a modern brick built manhole truncated the floor to the south.

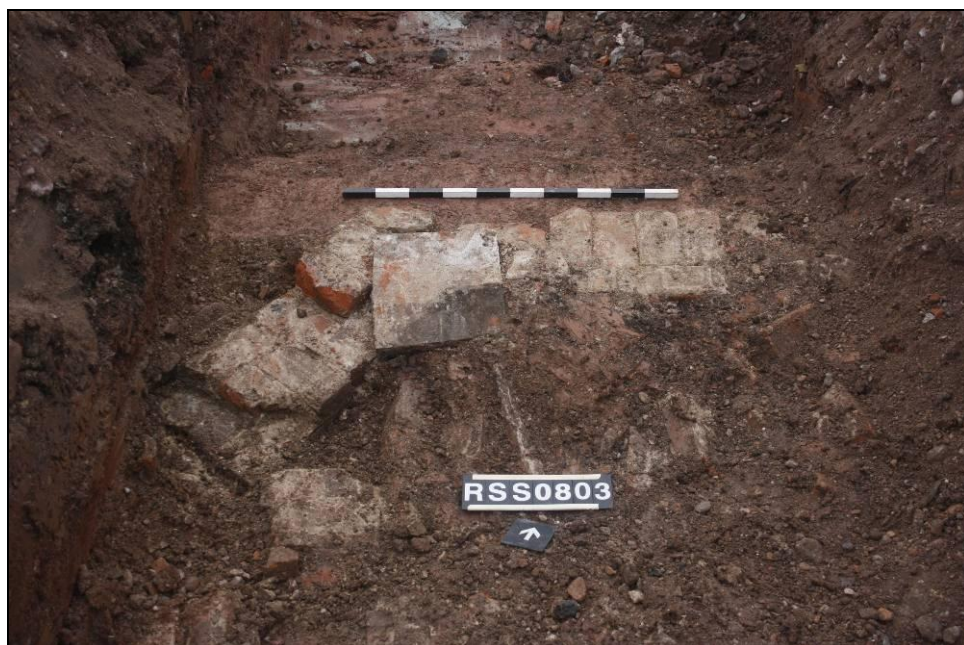
Plate 13: Wall (0803), looking North-West

- 6.3.9 Deposit (0811) sealed the heavily truncated remains of a north-east south-west aligned brick wall (0803, Plate 13). The surviving section of wall was too heavily disturbed and truncated to draw any further conclusion, except that the bricks were probably 19<sup>th</sup>/20<sup>th</sup> century in date and as such the structure was most likely related to the lace factory. The construction cut [0804], clearly cut into the underlying natural clay (0805).

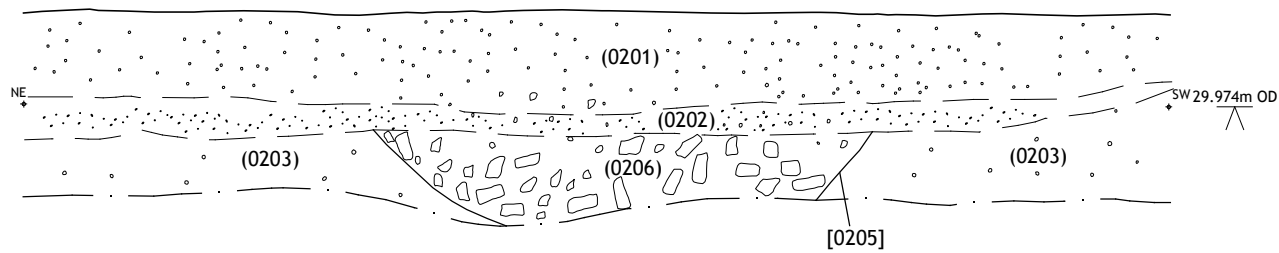
Fig 6a  
North-West facing section of Trench 2 showing robber trench of 19th century House of Correction boundary wall

Fig 6b  
South-West facing Representative Section of Trench 8b

Fig 6c  
South facing Representative Section of Trench 1

Fig 6d  
South-East facing section of Sondage within Trench 1
