**Manor House Farm, Wilson's Lane, Longford, Coventry
Warwickshire**

An Archaeological Excavation

Report Number: 162/2014

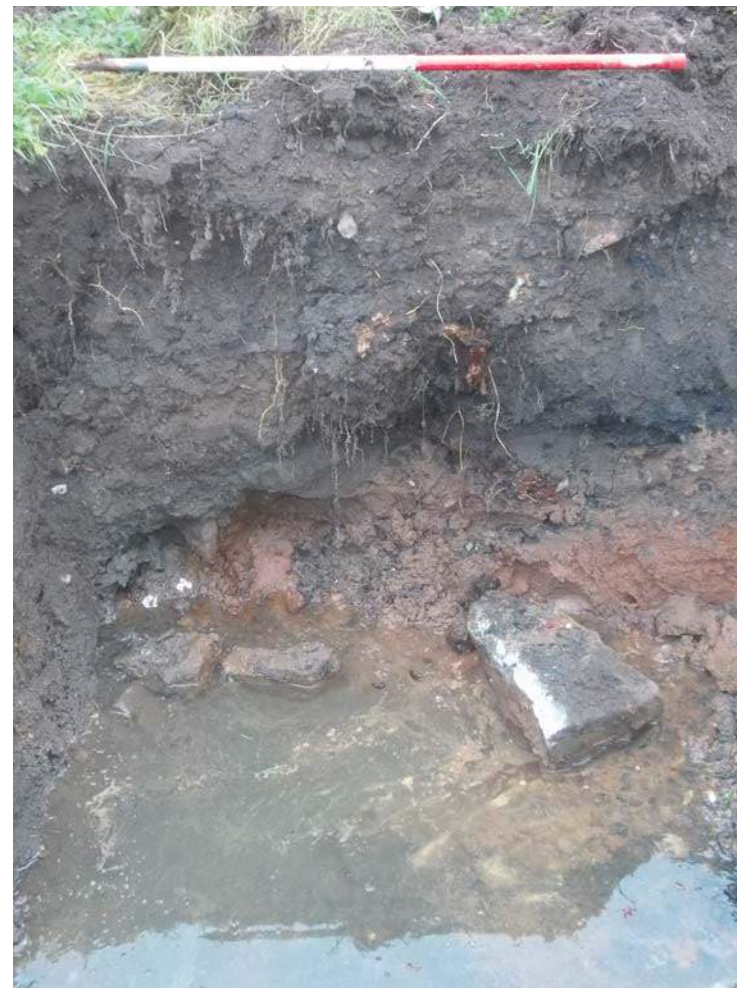
Trench 7, view of pit 707, looking south (scale 1m)

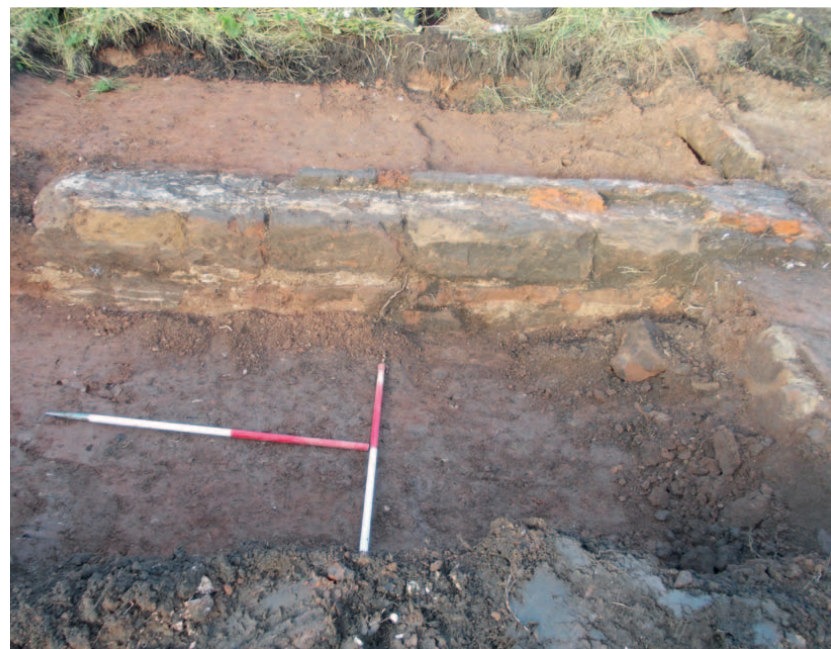
View of wall 9003, looking north (scales 1m)

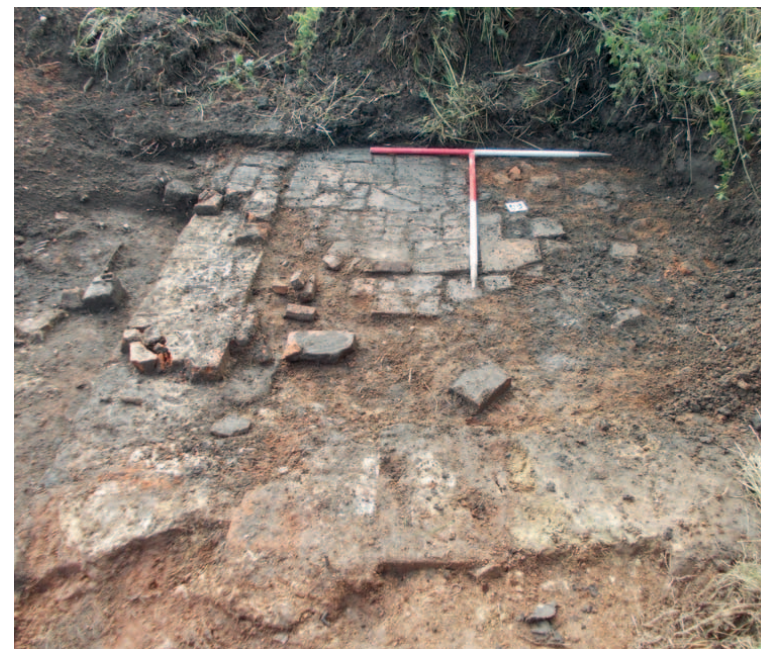
View of brick floor 9019, looking south-west (scales 1m)

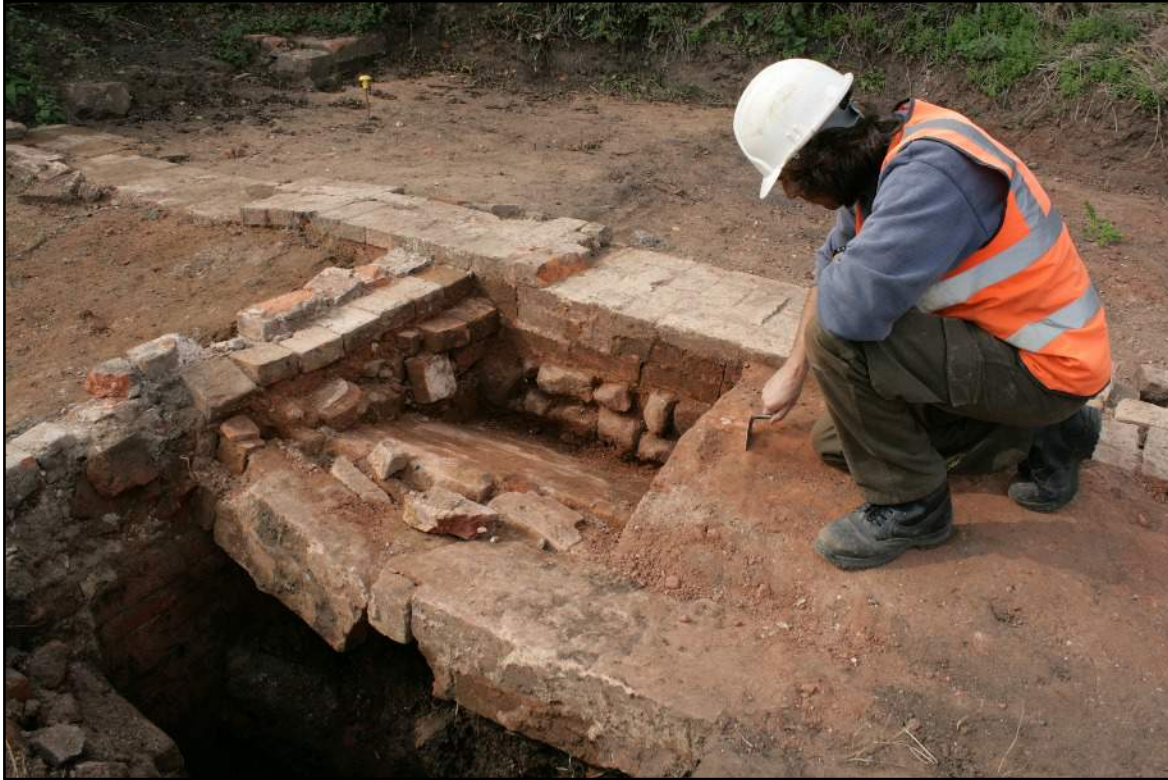
Plate 3: The cellar during excavation, viewed looking south-west.

The cellar is brick built with a vaulted roof [1219] and [1220] which had been broken during the demolition of the farmhouse in the late 20th century. It exceeded 0.88m in depth, 3.5m in width and 3m in length; it could feasibly extend beneath the entire of Room G. Well compacted red sand (1222) was dumped over the vault creating a level surface for the floor above which comprised quarry tile floor [1245], the tiles measuring 5½ inches x 5 inches set in mortar. However, it is probable that the floor relates to the re-building programme of the 18th century discussed below rather than to the 17th century.

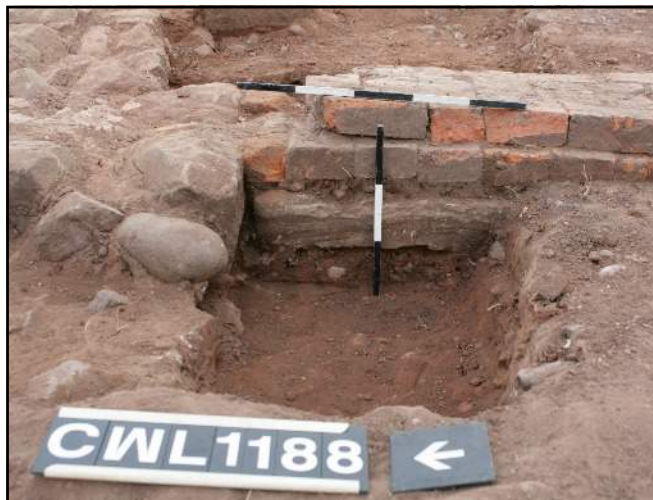
Plate 4: The 17th century wall 1188 abutted by the 18th century wall 1230, viewed looking east.

The west exterior wall [1188]/[1241] is the frontage mentioned in the Victoria County History as being of 17th century date (Salzman 1951, 87). It comprises a shallow sandstone foundation of up to two courses, bonded with light reddish brown clay, upon which the brick courses are laid. The bricks are hand-made, measure 8 inches x 4 inches x 2 inches and are bonded with a pinkish white mortar. The wall is not tied into the principal walls [1230] and [1187] which extend to the east forming the north and south walls respectively of the farmhouse. However, the west wall is tied into the southern cellar wall [1189] indicating that the cellar is also of 17th century date. The cellar wall [1189] extended above floor level, becoming wall [1192] to the east thus dividing the principal room of the main range.

| 1188/1241 | West front of the farmhouse, north to south orientated, 13.50m long, 0.52m wide, 2 brick courses survive to a depth of 0.17m which rest upon a single rough stone course 0.08m deep. Bricks 205mm x 100mm x 50mm mortar 7.5YR 8/2 pinkish white, abutted by 1187 and not tied in properly to 1230 | Exterior wall pre-dating rest of walls ie 17th house rebuilt but retained the west front if the Victoria County History is to be believed. Certainly has different foundations and bricks and is poorly tied into the rest of the house | 17th century |

| 1230 | Room H north exterior wall, west to east orientated, 1 course of sandstone foundations | Stone footing | 18th century |

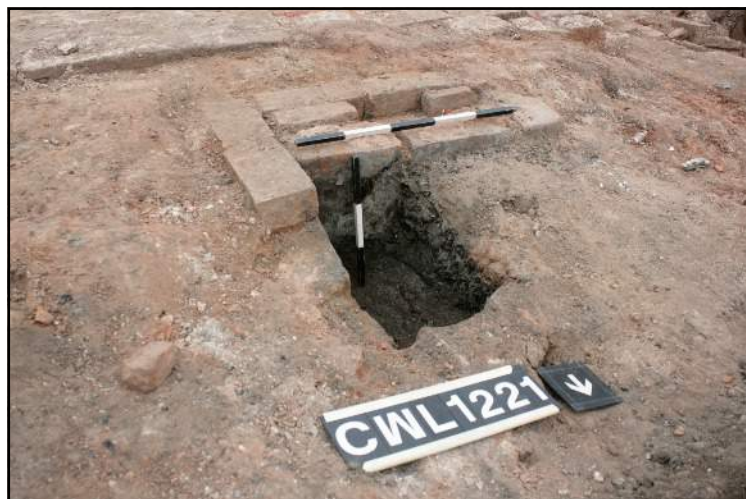
Plate 5: Ash pit 1221 after excavation, viewed looking south-west.

| 1246 | Loose ash 2.5YR 3/1 dark reddish grey | Fill of ash pit 1221 | 17th century |

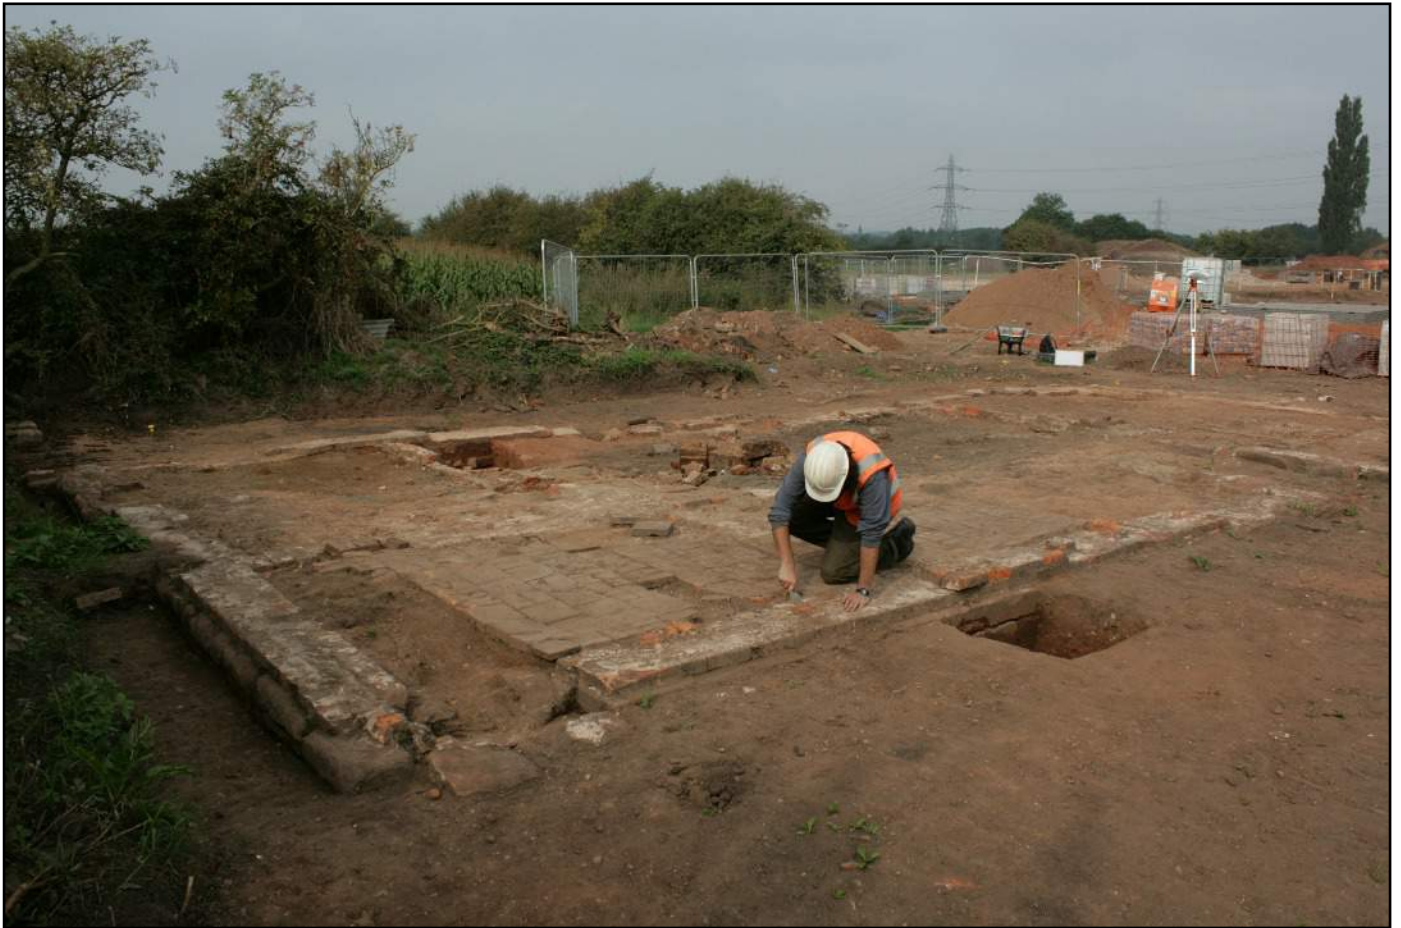
Plate 6: General view of the main range with 18th century wall 1187 and the later quarry tile floor 1193 in the foreground. Note how both have been truncated by an electric cable trench, viewed looking north-west.

| 1187 | U-shaped linear, 2.10m x 7.6m x 7m, 0.45m in width and 0.48m deep comprising 2 sandstone courses, lower course made up of roughly shaped blocks c. 0.20m wide and c. 0.35m long and the upper course of blocks c. 0.15m wide and c 0.65m long bonded with reddish brown clay., broken tile used to keep sandstone courses level. Brick wall, 2 courses surviving, on top of foundation, bricks 240mm x 120mm x 55mm mortared with strong lime mortar 5YR 8/2 pinkish white <5% charcoal flecks. Abuts 1241, in foundation trench 1199. Abutted by 1200 and 1193 and cut by electric cable trench | Exterior wall Room F and E | 18th century |

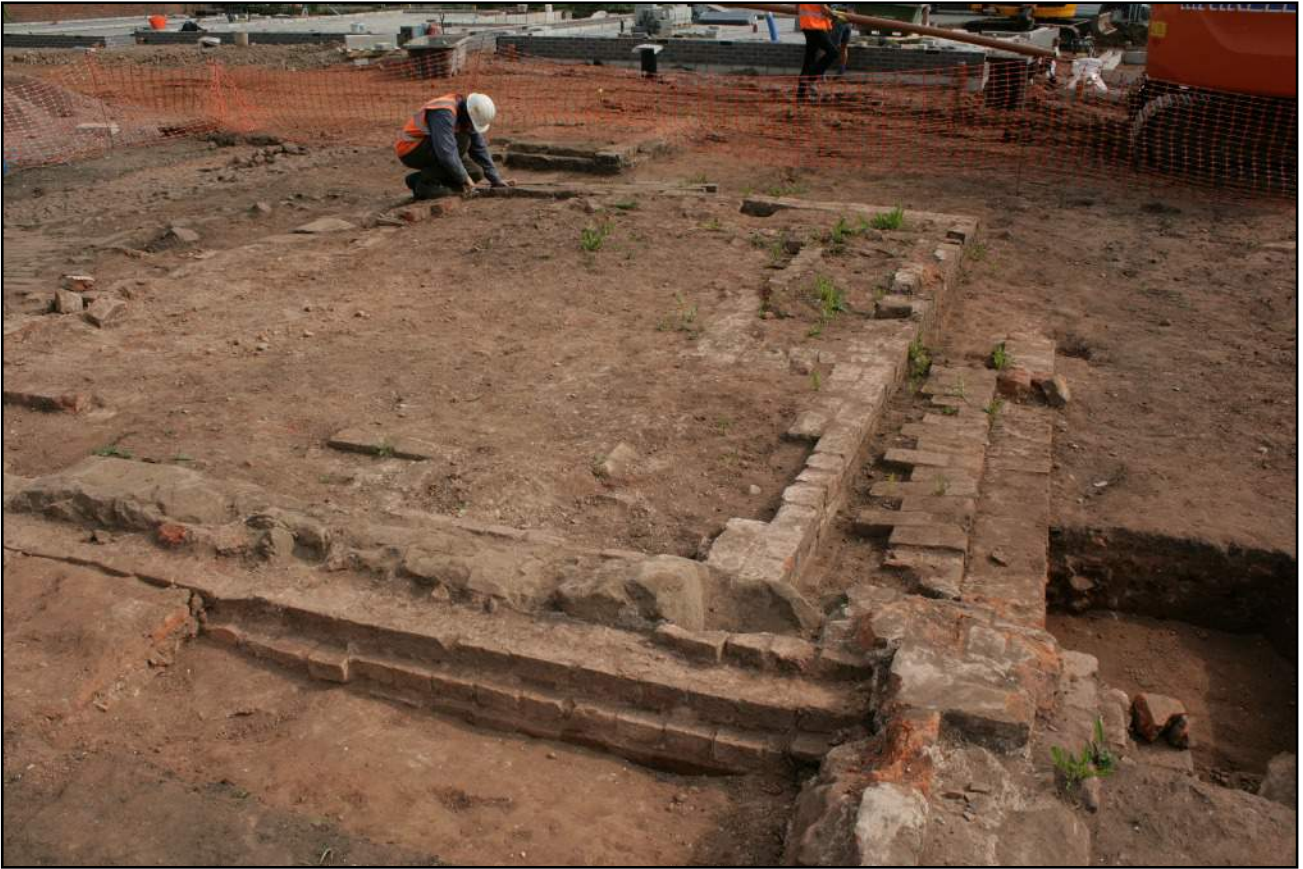
Plate 8: Room B under excavation, viewed looking north-east.

Room B1 was subsequently demolished and replaced with a slightly larger building Room B2 comprising a south and east wall [1143] constructed using bricks 2¾ inches in size, and a north wall [1146], which used the same size bricks on a sandstone foundation, and the wall of Room C [1174] which [1143] abuts. The northern wall [1146] is on the same alignment and uses the same type of footings as wall [1115] to the east raising the possibility that the north wall [1146] reuses earlier wall foundations. Smooth sandstone blocks [1145] forming part of the northern wall are likely to be the threshold of the former doorway into this part of the building. Within the room beneath modern demolition layer (1159) are the fragmentary remains of a brick floor [1151]/[1152] comprising bricks which have been halved and pressed end-on into the underlying sandy silt loam deposits (1158) and (1168). Brick features [1148] and [1149] are also likely to relate to this phase of the building.

It is likely that Room B was the dairy, a building considered an essential part of the house, and usually located at the rear of the property beyond the kitchen with easy access to the farmyard (Brown 1985, 83-4). The insubstantial foundations of both phases suggest a single storey structure.

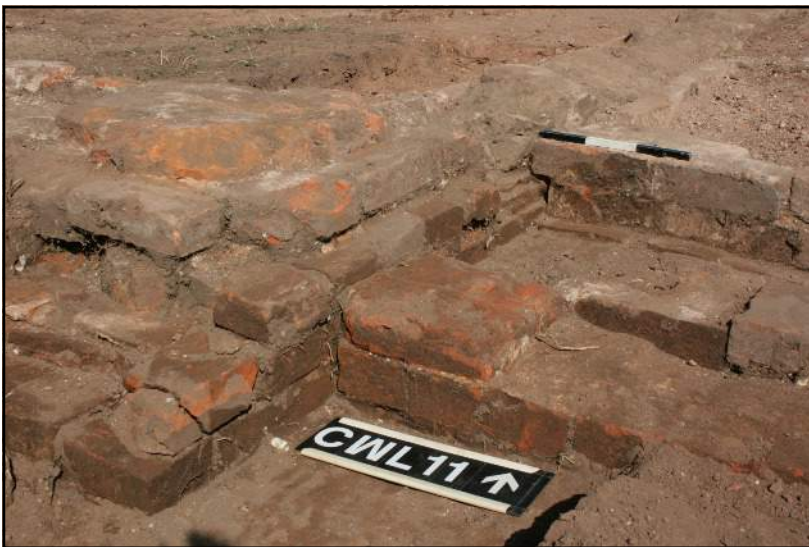
Plate 9: Walls 1161 in the foreground and 1143 in the background abutting wall 1174, viewed looking north-west.

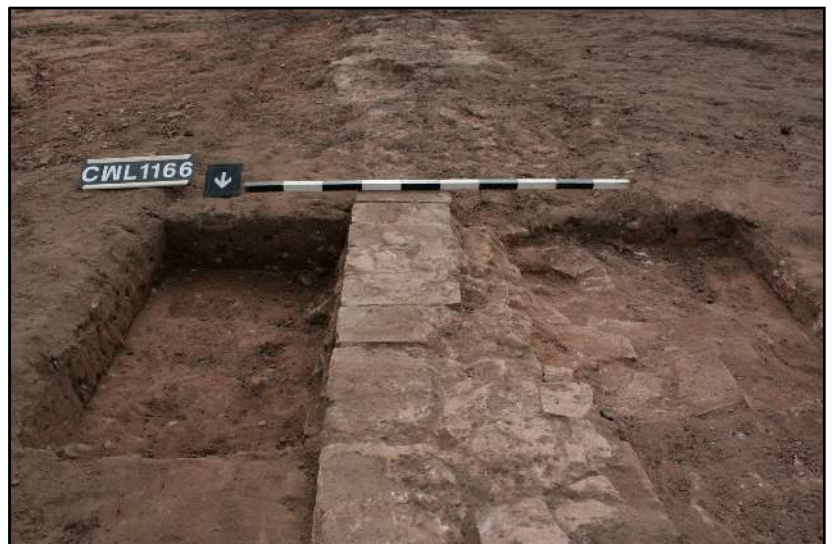
Plate 10: Wall 1166 after a slot was excavated through the feature, viewed looking south.

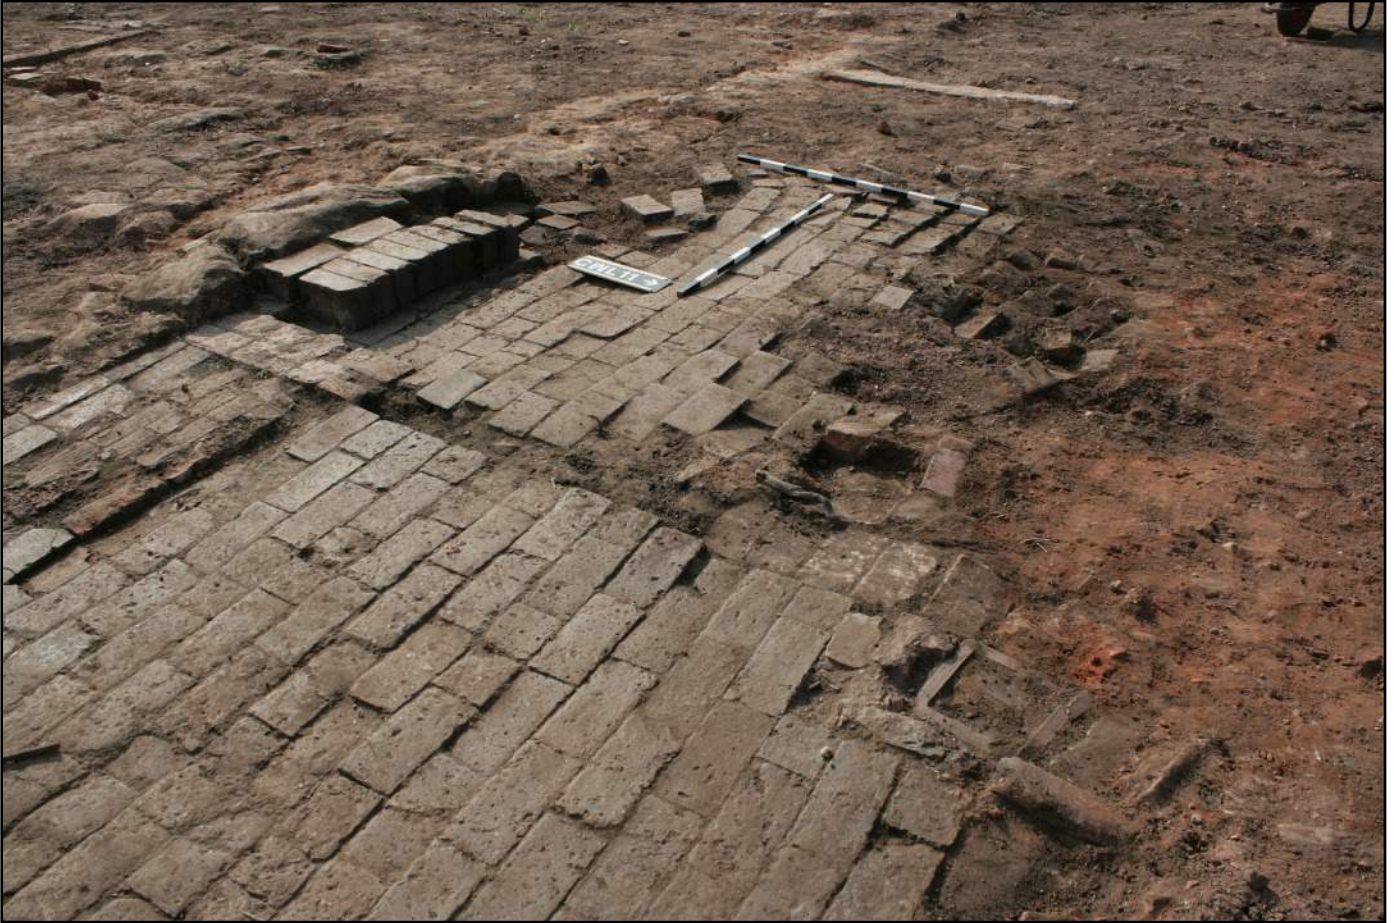
Plate 11: Eastern end of yard surface 1156 with Room D in the background, viewed looking south-west.

| 1156 | Brick surface extending from Room B west to the, and including, Room D the wash house, northern extent not established. Bricks 230mm x 111mm x 73mm bonded with loose dark brown silt loam, 1 brick thick laid flat. Abuts all north walls of farmhouse, cut by walls for Room D 1205 and 1206 | Exterior yard surface | Pre-1880 |

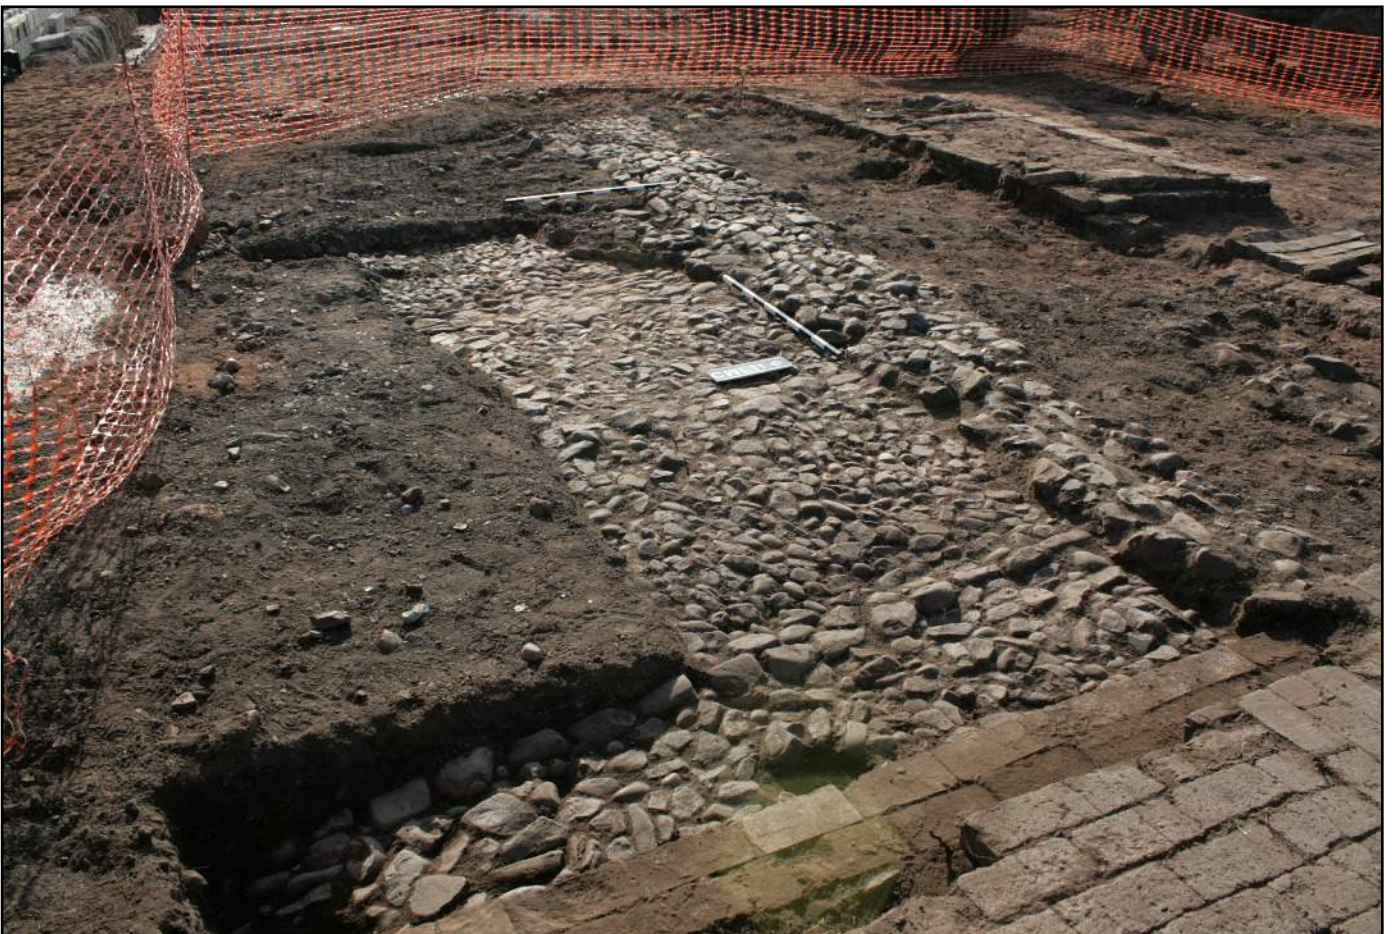
Plate 12: Cobbled surfaces 1140 and 1141, viewed looking south-east.

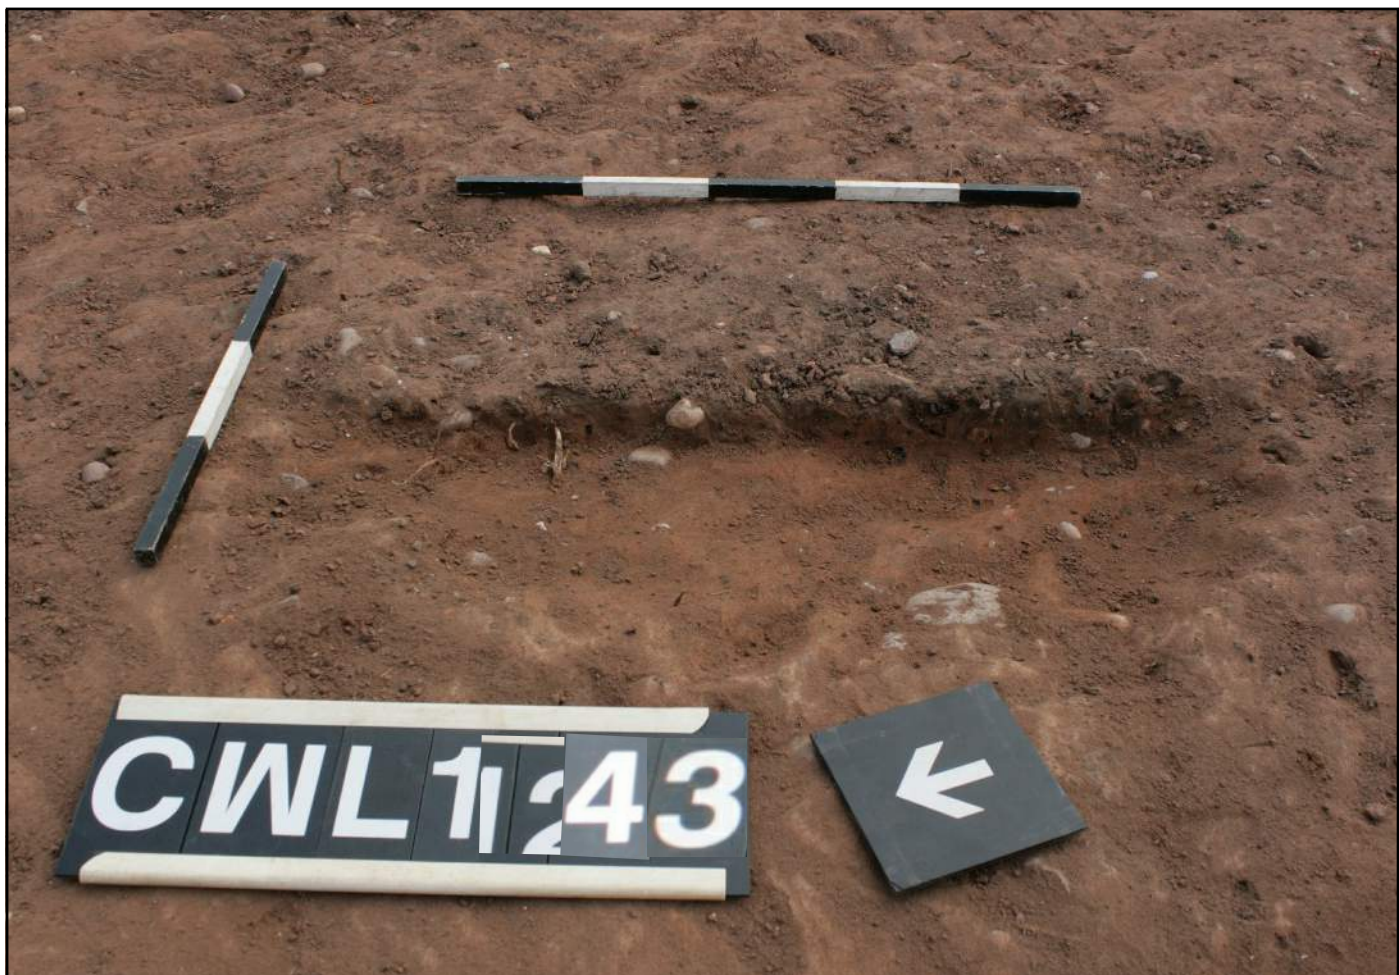
Plate 13: Pit 1243, after the excavation of its north western half, viewed looking south-east.

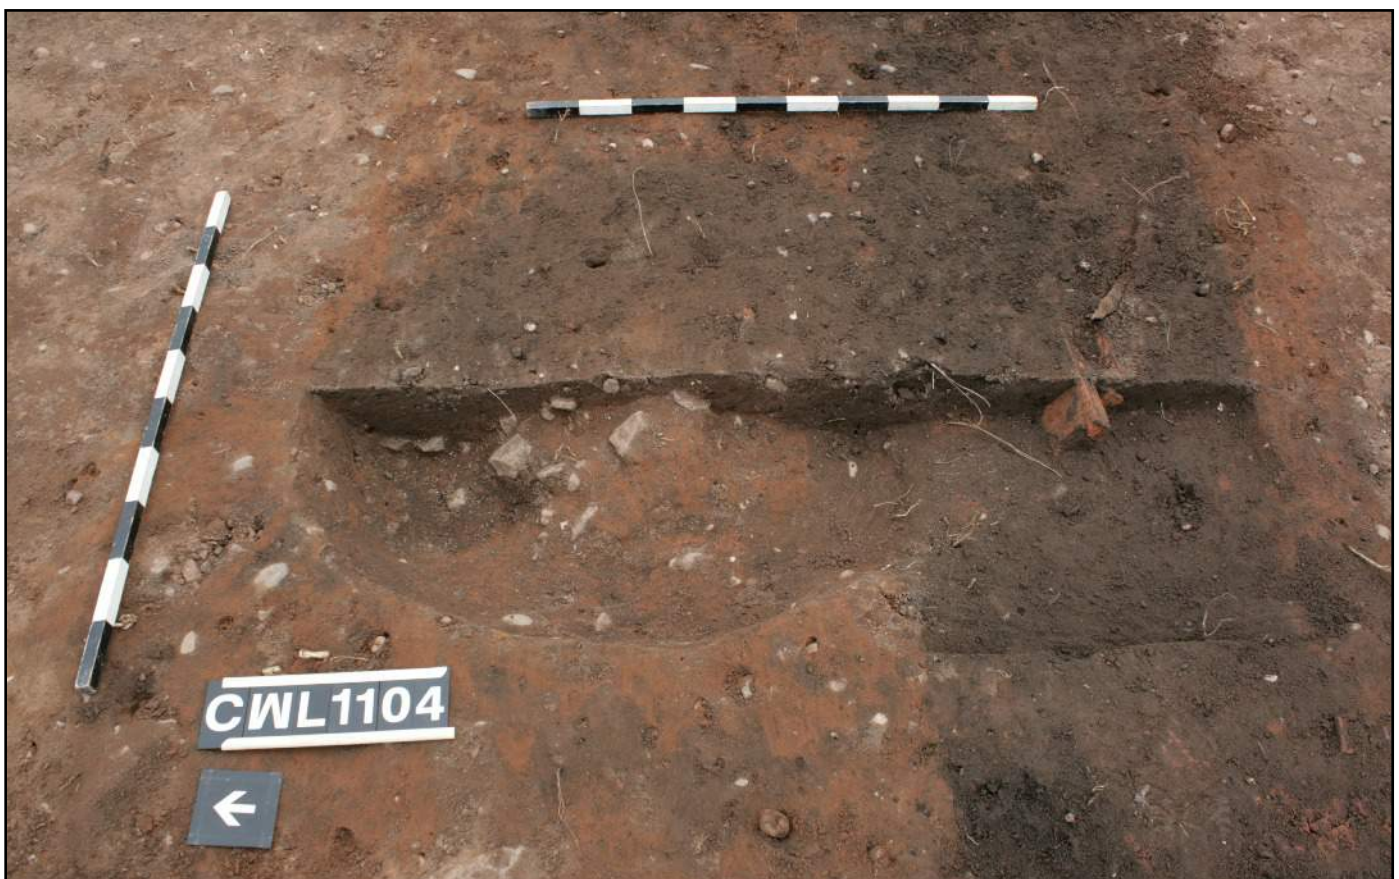
Plate 14: Pit 1104, and electric cable trench truncating it to the south, after the excavation of their western halves, viewed looking east.
