**Northwich Town Centre Flood Risk Management Scheme
Archaeological Monitoring of Ground Investigation Works**

Project Code – NFS

TPA Report No. 146/2014

Report on the archaeological watching brief for the Northwich Flood Alleviation Scheme

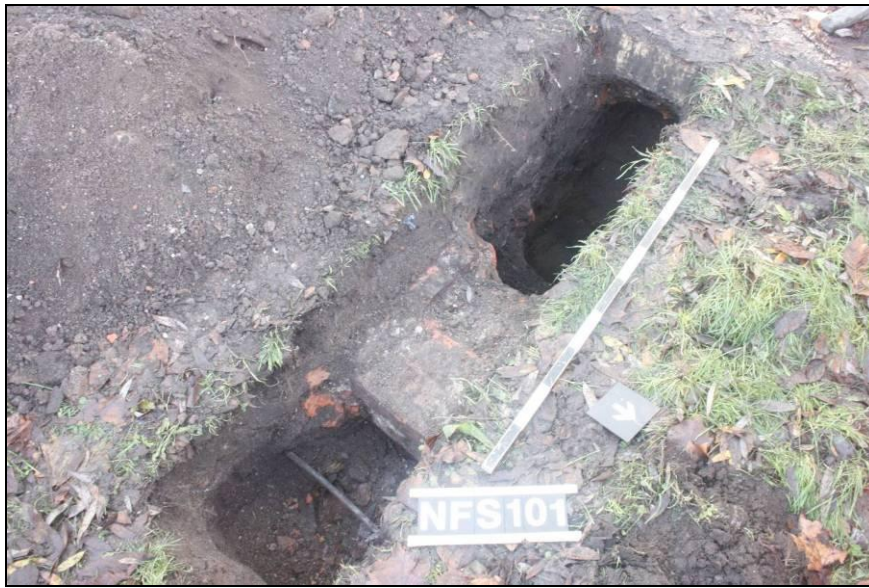
Trial pit 101 was located in Reach One, between the northern bank of the River Dane and Whalley Road. After the removal of the topsoil (Context Number 1011, see Appendix 1) to a depth of 0.2m BGL, a brick wall (1015) was observed along a northwest-southeast orientation. Due to the narrow width of the trench, it was not possible to determine the nature of the construction, or full depth. Only a single course was observed, formed from two bricks laid as stretchers. The bricks themselves were orangey-red, measuring 0.23 x 0.11x 0.09m. This appears to have been overlying, or built onto (1014), a deposit of firm dark grey-brown, clayey, silty-sand with inclusions of ceramic building material (CBM) throughout. This deposit was present to a depth of 0.4m BGL.

The area to the northeast of the wall was truncated by a cable trench [1013] for nearby streetlights. Whereas the area to the southeast contained a gas service trench [1017] which was observed cutting through deposit (1014) to a depth of 1m BGL.

Plate 1: TP 101, showing brick wall (1015)

The brick wall (1015) was interpreted as possibly being the remains of a garden wall related to the terrace houses constructed along Whalley Road in the late 19th century, as seen on both the 1877 and 1910 OS map of the area (see Figs. 5 and 6). These buildings were most likely constructed for the workers of the nearby Croft and Leftwich Salt Works and were demolished sometime during the first half of the 20th century.

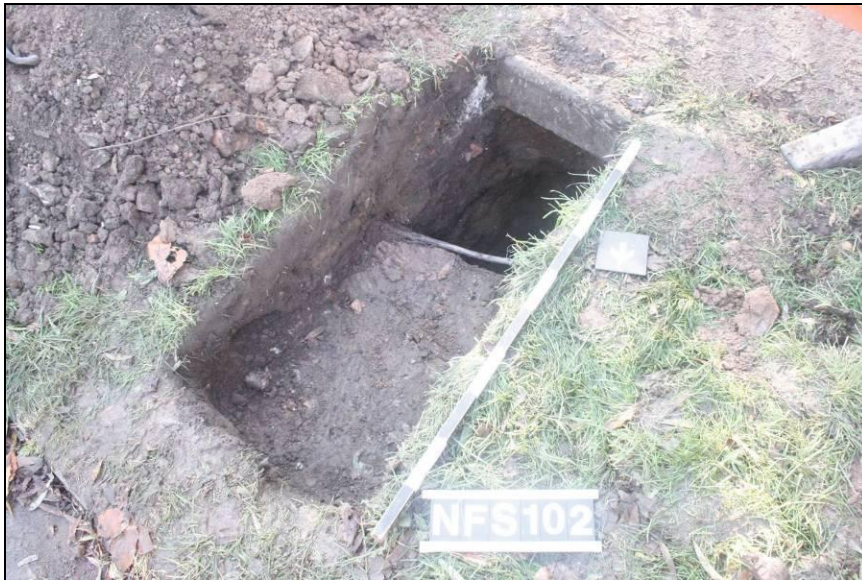
Plate 2: TP 102

Trial pit 102 measured 1.2m in length and 0.5m wide. It was located in Reach One, on the northern bank of the River Dane, in the verge of Whalley Road. After the removal of the topsoil (1021) to a depth of 0.2m BGL, two modern services were observed cutting a late 19th/early 20th century demolition deposit of firm dark-grey-brown clayey-silty-sand with inclusions of occasional brick fragments (1022). This deposit was present to a depth of 0.3m BGL. Cut [1023] was observed to a depth of 0.3m BGL, and related to the street lighting, the second was a gas service main [1025], which was present to a depth of 1.2m BGL.

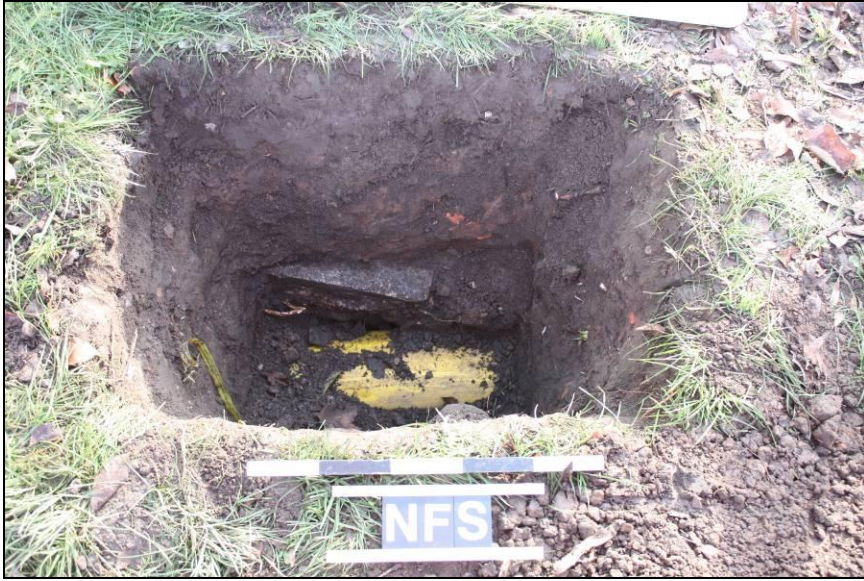
Plate 3: TP 103

Trial pit 103 was situated at the western end of Reach 1, upon a grass verge between the River Dane and Brockhurst Street. It measured 1m x 0.6m in plan, and was excavated to a depth of 0.75m BGL. A single deposit was observed within the trench, consisting of dark, grey brown, clay silt with containing fragments of concrete paving and CBM. At the base of the trench was a plastic gas pipe, indicating that the pit was located entirely within the construction trench for pipe.

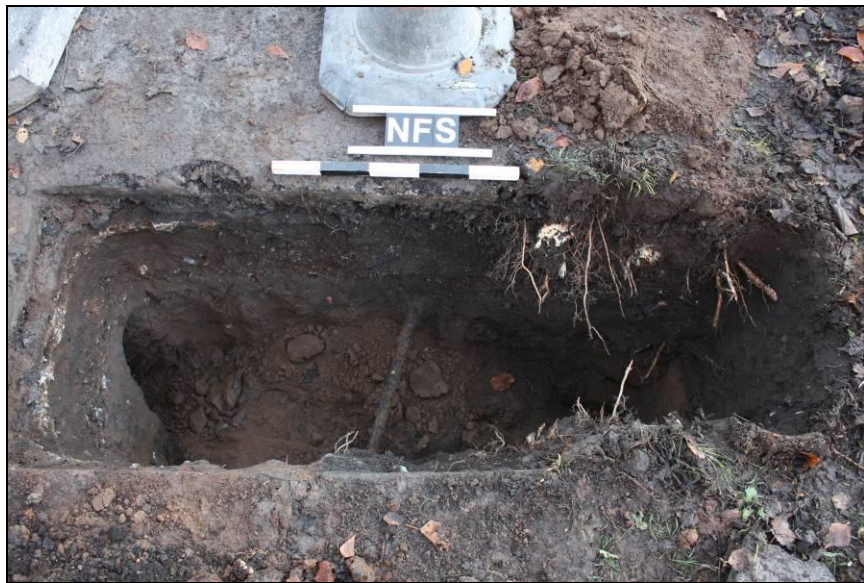
Plate4: TP 104

Trial pit 104 was excavated at the eastern end of Reach 1. Excavated in two stages, it covered a total area measuring 2m by 0.6m, with a maximum depth of 1m below ground level. Following removal of a tarmac layer, which formed the surface of a footpath and cycle path, a mixed deposit (1041) of made ground was observed with a thickness of 0.36m. Underlying the construction levels for the footpath, was mid to dark brown clay silt deposit, which varied in thickness from 0.2m at the west, deepening to 0.8m at the east. The base of this layer was

marked by a thin lens (0.05m) of coke/charcoal type material (1043). The underlying deposit was a mid to dark orange, clay silt, which is thought to represent undisturbed drift geology.

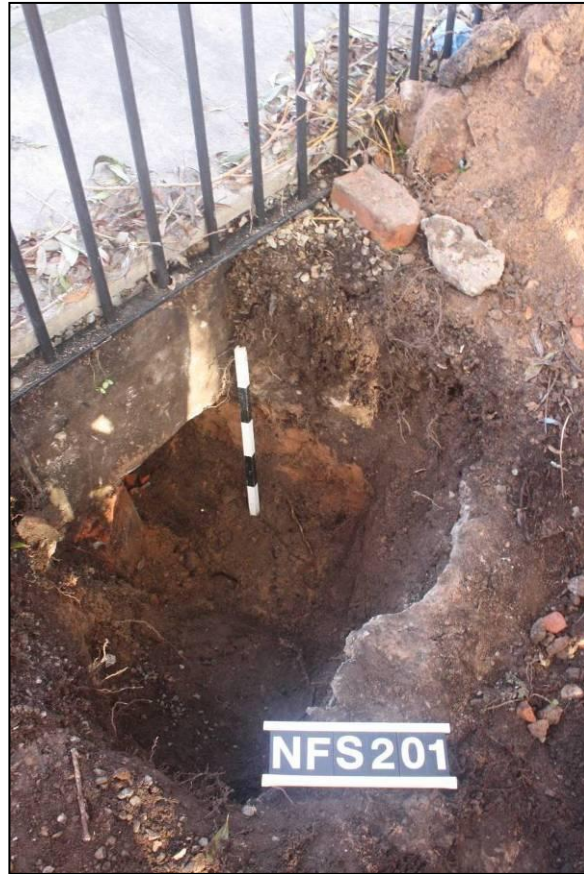
Plate 5: TP 201

Trial pit 201 measured 0.8m x 0.8m and was located in Reach Two on the north bank of the River Dane, between the Watling Street Medical Practice and the river itself. The aim of this trial hole was to investigate the nature of the foundations of the car park and fence of the medical practice car park. After the removal of the soft, dark-brown-grey sandy-silt topsoil (2011) to a depth of 0.45m BGL; Soft, light-red-brown sand with occasional brick fragments (2012) was revealed, this extended to the limit of the excavations at a depth of up to 0.75m BGL. This material was interpreted as bedding for the concrete car park foundation. No archaeology was observed.

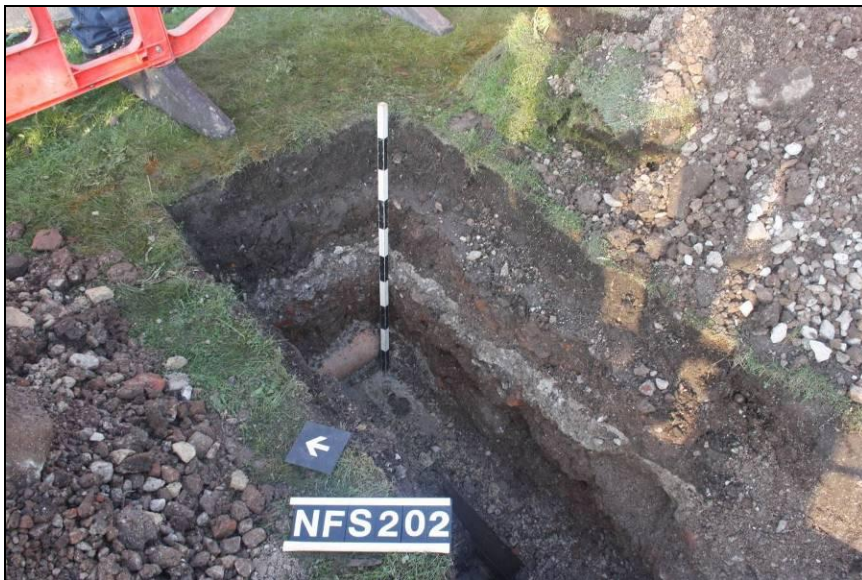
Plate 6: TP 202

Trial pit 202 was located in Reach Two on the north bank of the River Dane just to the east of the A533 bridge over the river. The aim of this trial hole was to investigate the nature of the concrete rafts of the existing river wall. After the removal of the soft, dark-grey sandy silt topsoil (2021) to a depth of 0.1m BGL; a soft dark-grey sandy-silt, with inclusions of occasional brick fragments subsoil (2022) was observed to a depth of 0.3m BGL. At this depth compacted angular stone up to 250mm across (from now on referred to as Type 1) (2023) was observed to a depth of 0.4m BGL, which was interpreted as covering/ weighting on top of the existing concrete raft of the river wall. Following this, a firm, dark-grey sandy-silt, with inclusions of frequent brick and concrete fragments (2024) was observed to a depth of 0.9m BGL, which sealed the concrete raft of the existing river wall (2025), which was observed at this point, which was also the limit of the excavation. The material was interpreted as 20th century made ground. No archaeology was observed.

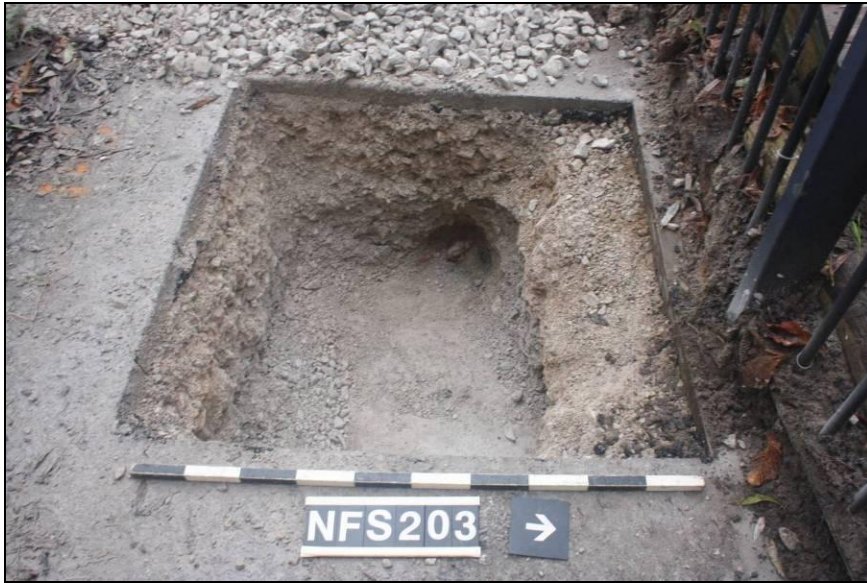
Plate 7: TP 203

Trial pit 203 was located in Reach Two on the north bank of the River Dane between the River Bank Day Nursery and the river. After the removal of the tarmac (2031) to a depth of 0.1m BGL, type 1 (2032) was observed to a depth of 0.75m BGL, which was interpreted as ballast above the concrete raft of the existing river wall (2033). The concrete raft was the limit of the excavation. No archaeology was observed.

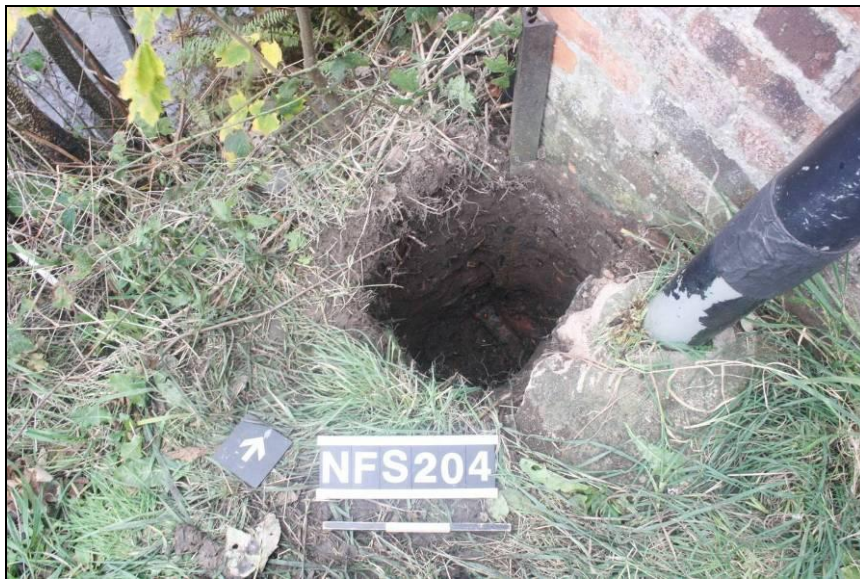
Plate 8: TP 204

Trial pit 204 was located in Reach Two on the east bank of the River Weaver, just to the south of the Town Bridge, up against an existing building. The aim of the trial hole was to investigate the nature of the foundations of the existing building. After the removal of the topsoil (2041) to a depth of 0.1m BGL; a soft, mid-grey-brown sandy-clayey-silt with inclusions of frequent brick and sand stone fragments and occasional fragments of slate (2042). This material extended to a depth of 0.95m BGL, which was the limit of the excavation and was interpreted as 20th century made ground associated with the construction of the buildings cellar or the “jacking-up” of the building in the 20th century. No archaeology was observed.

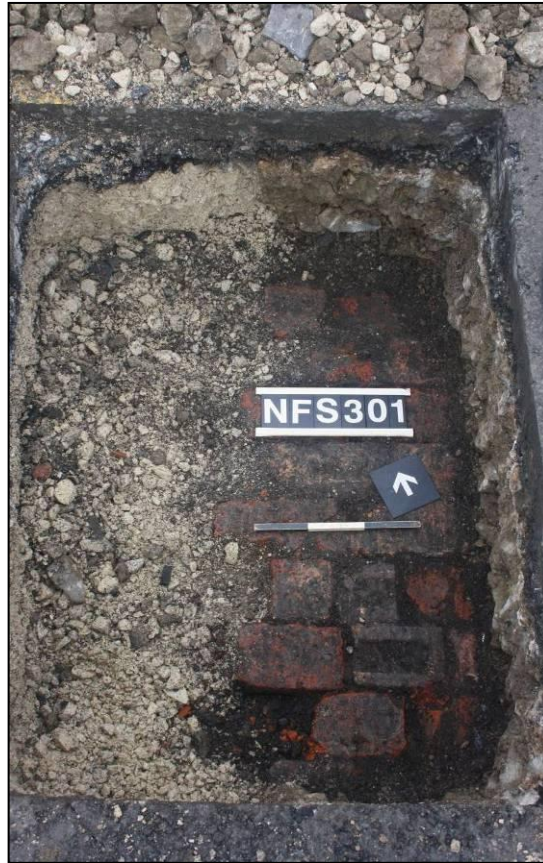
Trial pit 301 was located in Reach Three on the east bank of the River Weaver, at the northern extent of the existing quay on Weaver Way. After the removal of the tarmac (3011) and tarmac sub-base (3012) to a depth of 0.2m BGL, two distinct deposits were observed. At the western side of the trial hole, white type 1 gravel (3013) was observed, to a depth of 1m BGL, which was the backfill of the previous trial hole excavated in this location. On the eastern side of the trial hole, compacted angular limestone fragments between (0.02 and 0.2m across) (3014) was observed to a depth of 0.5m BGL. At this depth, a brick surface (3015) was observed, consisting of red bricks measuring 0.24 x 0.11 x 0.9m (some of which were frogged). This surface sealed a deposit of loose black clinker and ash (3017), which extended to the maximum depth of the trial hole, 1.35m BGL, and butted against the raft of

the existing quay wall (3018). The brick layer (3015) was interpreted as a 19th century feature surface, possibly related to the late 19th century Baronsquay Salt Works (see Fig. 7), or one of the houses that replaced said works by 1910 (see Fig 8). The black clinker (3017) was interpreted as 19th/20th century industrial waste, used to raise the ground level around the river during the late 19th/early 20th century.

Plate 9: TP 301, showing brick surface (3015)

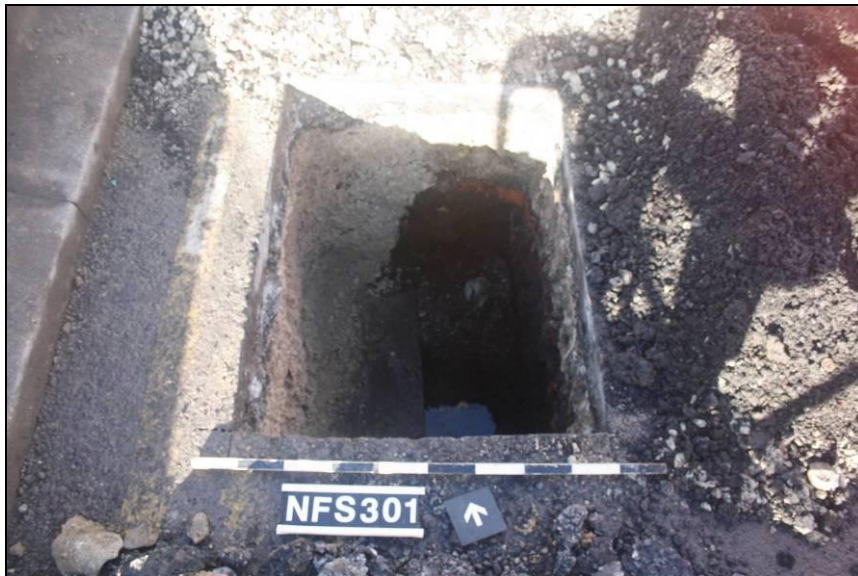
Plate 10: TP 301, fully excavated

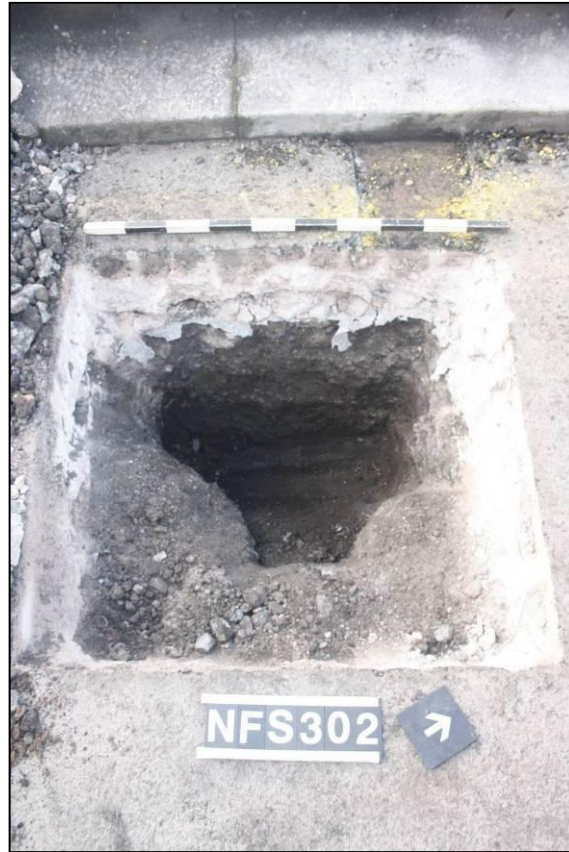
Plate 11: TP 302

Trial pit 302 was located in Reach Three on the east bank of the River Weaver, on the existing quay on Weaver Way. After the removal of the tarmac (3021) to a depth of 0.1m BGL, reinforced concrete (3022) was observed to a depth of 0.3m BGL. This material sealed a mixture of compacted tarmac and concrete fragments (3023) to a depth of 0.7m BGL, at which point, soft black silty-sand was observed, which extended to the limit of the trial hole, at a depth of 0.85m BGL. This sand sealed two high voltage electric services. No archaeology was observed.

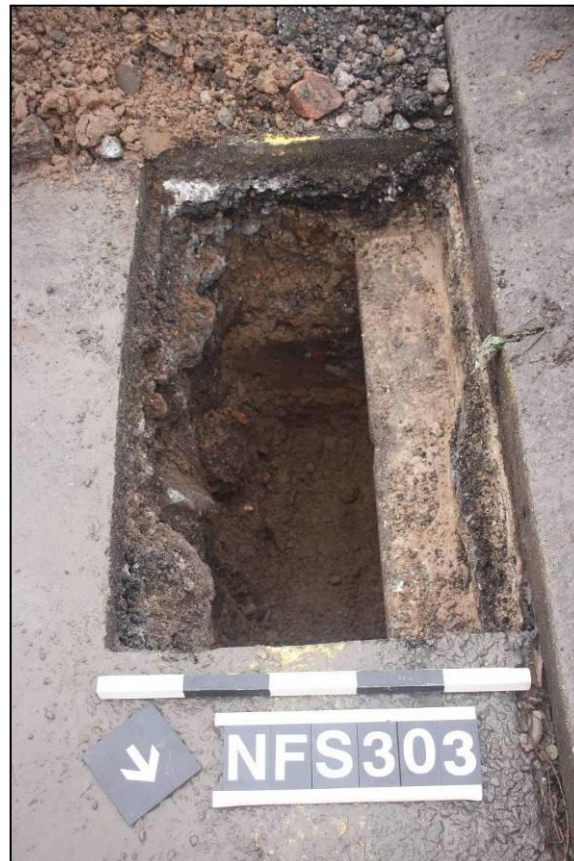
Plate 12: TP 303

Trial pit 303 was located in Reach Three on the east bank of the River Weaver, on the existing quay on Weaver Way. After the removal of the tarmac (3031), tarmac sub-base (3032) and type 1 (3033) to a depth of 0.4m BGL, a dark-grey sandy-silt with inclusions of fragments of brick and concrete was observed to a depth of up to 0.7m BGL. At this depth loose red-brown sand was observed, which sealed two high voltage electric services, at the limit of the Trialhole, at a depth of 0.8m BGL. Both (3035) and (3036) were interpreted as backfill of the high voltage cable trench. At a depth of 0.5m BGL, the concrete base of the existing wharf (3034) was also observed at the western limit of the trial hole. No archaeology was observed.

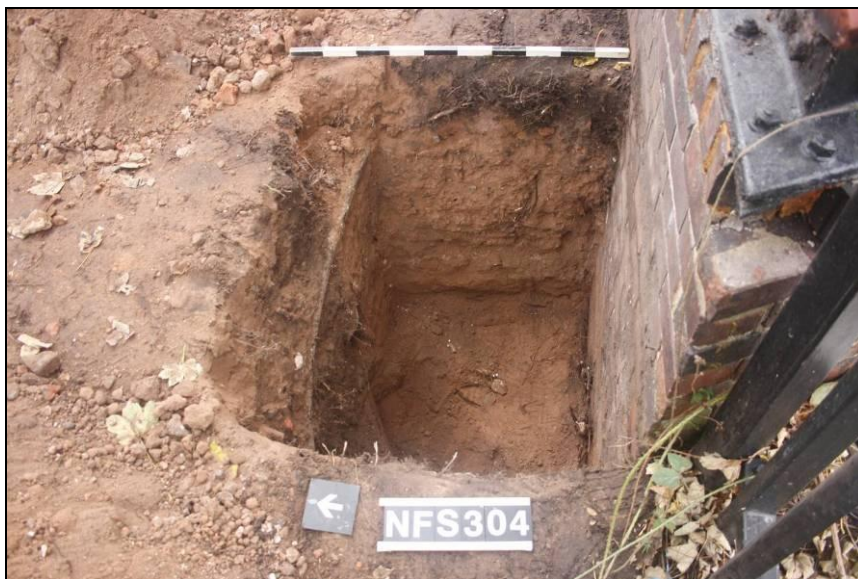
Plate 13: TP 304

Trial pit 304 was located in Reach 3 on the east bank of the River Weaver, just to the north of the Town Bridge, up against the northern wall of an existing building. After the removal of the topsoil (3041) to a depth of 0.1m BGL, loose light-red-brown sand with frequent inclusions of brick and concrete fragments (3042) was observed to a depth of 1.0m BGL, the limit of the excavation. This material was interpreted as 20th century made ground or fill associated with the construction of the buildings cellar, or associated with the “jacking up” of the building during the 20th century. No archaeology was observed.
