TOTON UNEARTHED, TOTON, NOTTINGHAMSHIRE

Report on an archaeological evaluation on the site of Toton Mill, Manor
Farm Recreation Ground, August to September 2014

TPA Project Code – TOF2

TPA Report No. 023/2015

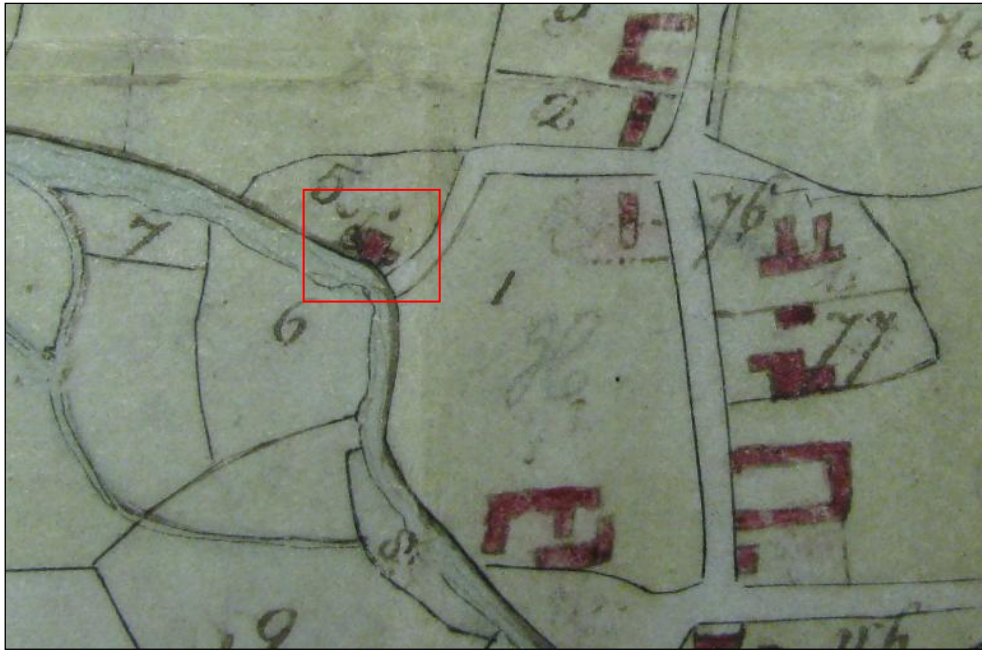
Plate 1: Extract from Sir John Borlase Warren's map of 1789; mill outlined in red

The earliest definite depiction of Toton Mill is on Sir John Borlase Warren's map of 1789 (Plate 1). This shows a single sub rectangular building. None of the buildings depicted are labelled. The depiction of the mill appears to be a stylised sketch rather than an accurate depiction.

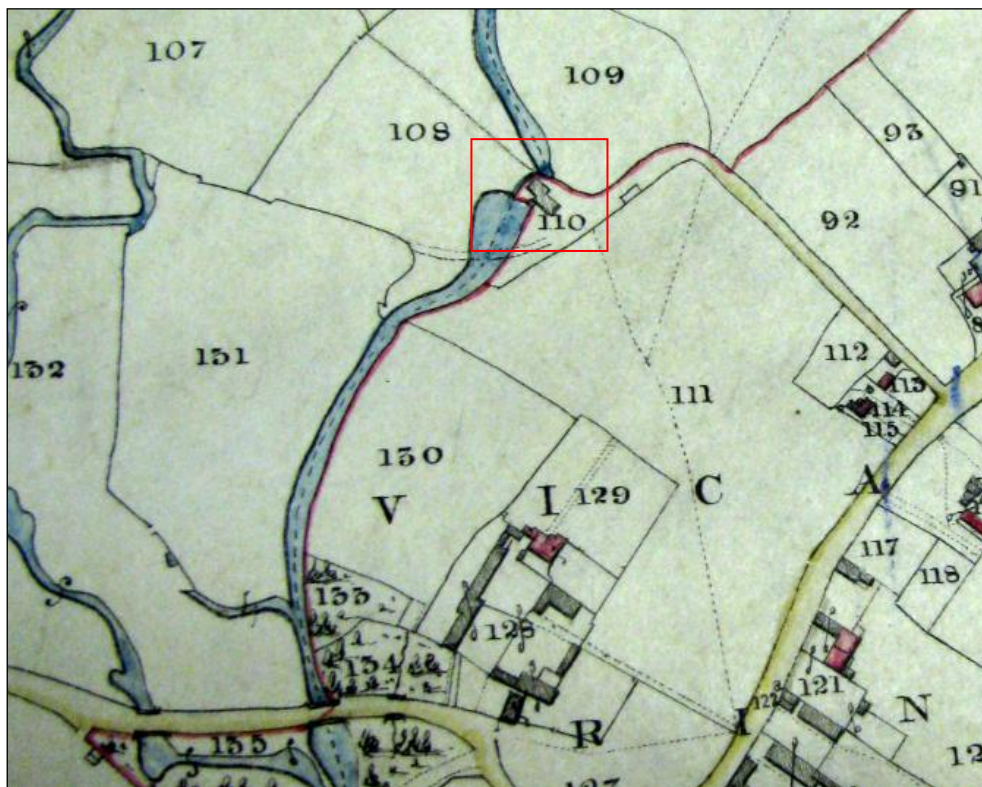
Plate 2: Extract from The Tithe Map of 1847; mill outlined in red

The Tithe Map of 1847 (Plate 2) shows the mill, which appears to be made up of two conjoined rectangular buildings. The general layout of the area has changed little since the maps from the 1780's. The building is not labelled and so its function at this stage is unclear.

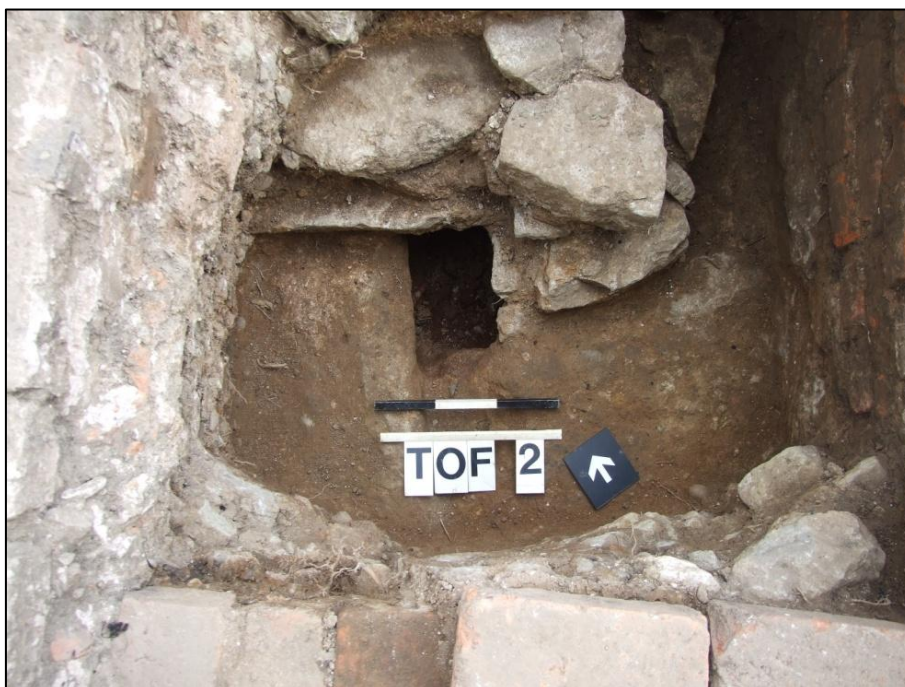
Possible Medieval activity was identified in Areas 08 and 10 in the form of rough stone foundations as well as a posthole and possible beam slot. In Area 10 the foundations (0525) were identified below made ground on top of which sat 18th century foundations (0520). Posthole [0529] was rectangular and located within the south of this stone foundation (Plate 5). A possible beam slot was identified below the foundations orientated north west - south east. Further possible medieval foundations were identified to the east and south east which were of similar unworked stone (0605) and seemed to be orientated north west – south east, running through the unexcavated section between Area 08 and Area 10. No artefacts were recovered to accurately date these features.

Plate 5: Area 08, posthole [0529] within foundation (0525) looking north east

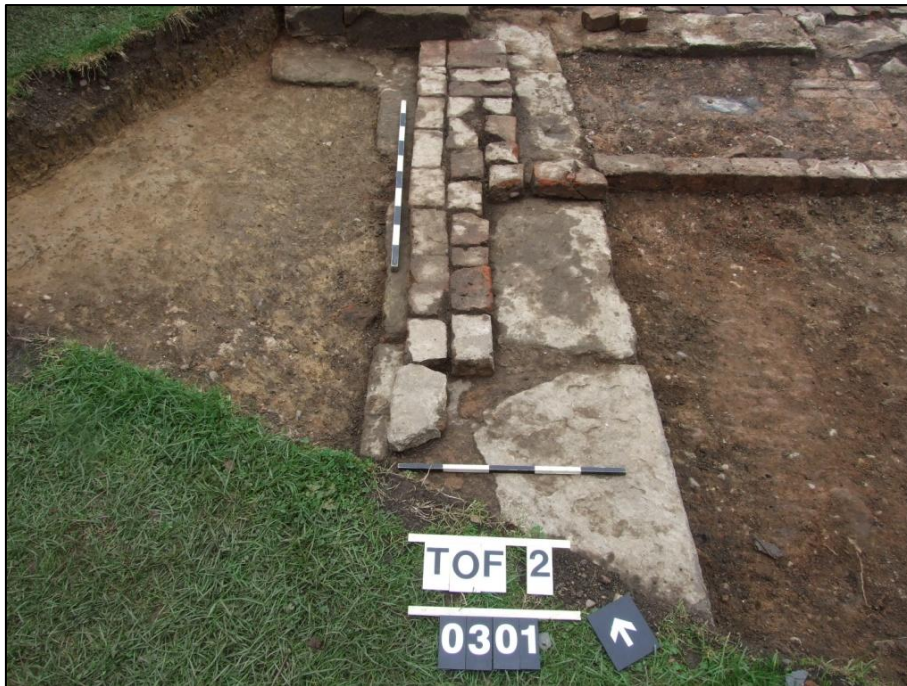
To the north west of wall (0308) a further cut stone foundation (0427) was observed which had the remnants of mid 18th century (R Sheppard, pers. com) brick foundation (0301) above it (Plate 8). The brick work forms an insubstantial foundation/wall base over what is a very substantial stone foundation. Constructed from white limestone this stone foundation was nicely faced on its southern side mirroring outer wall (0308) to the south east. Excavation of a sondage part way along (0427) revealed it was 0.8m deep (Plate 9). Given the location of this wall it is thought to form part of the structure associated with supporting the axle tree, which would have been located to the north and which would have required load bearing walls (Plate 10).

Plate 8: Area 08, stone foundation (0427) and brickwork (0301) looking north east

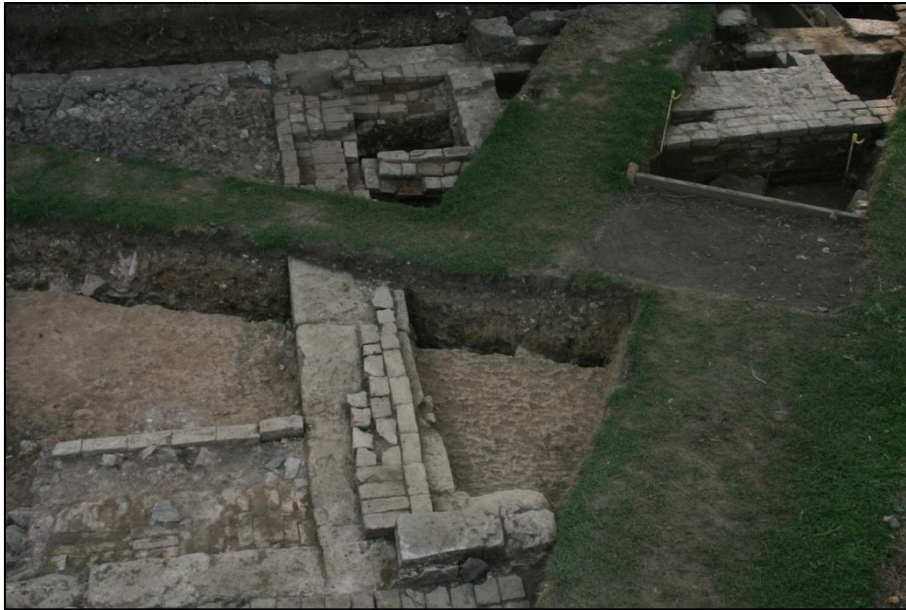
Plate 10: Junction Areas 08, 09 and 10 showing (0427) in foreground looking south west

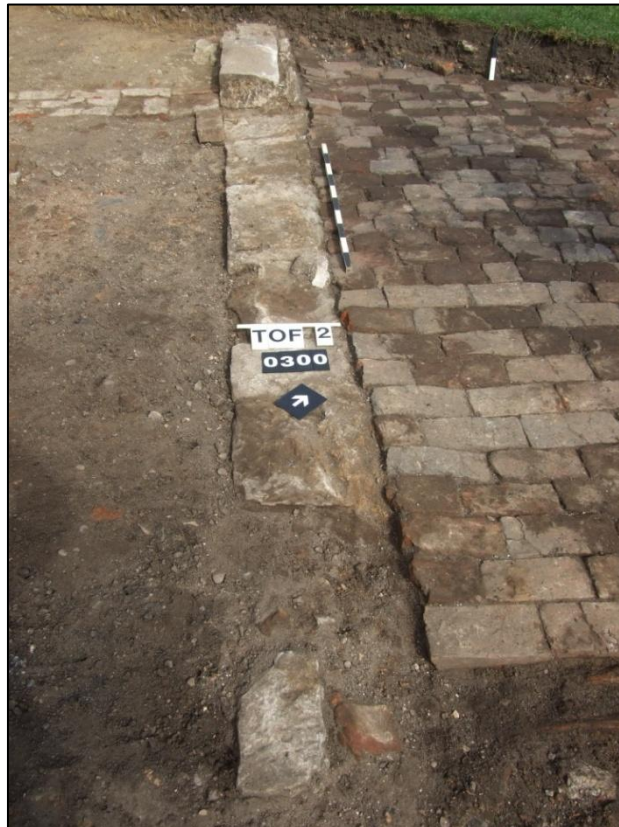
Abutting (0301/0427) at its east end a further stone wall foundation (0300), constructed out of white limestone was observed orientated north west – south east (Plate 11). This had the remnants of a floor level on its south west side and a large area of 18th century brick floor (0303) on its north east side, which remained intact to a good standard (Plate 12). This floor led to what must have been a doorway at the back of the mill, at the eastern end of (0308) which was indicated by wooden threshold (0313).

Plate 11: Area 8 stone wall (0300) abutting wall (0427) looking north west

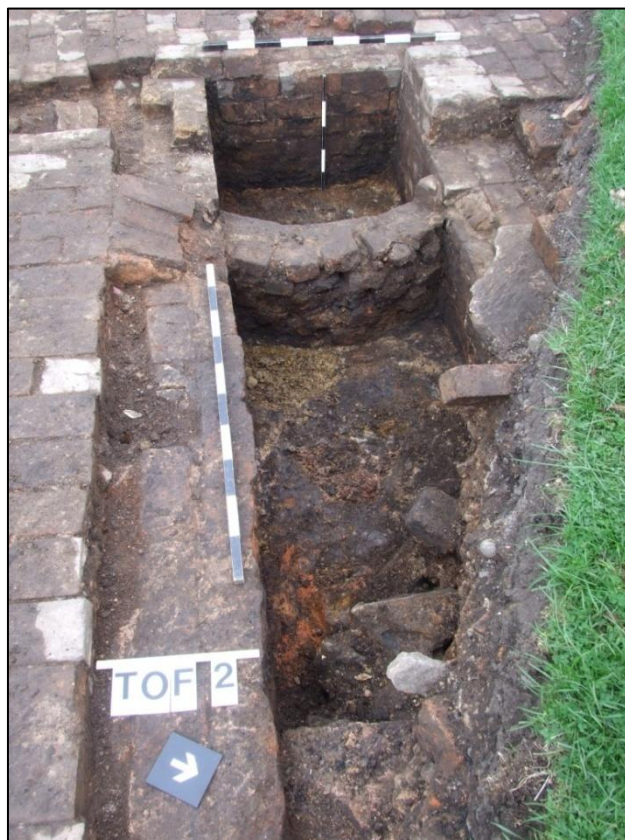
On the eastern side of brick floor (0303) and integrated within it, was a sunken trough feature (0610) approximately 0.7m x 2.5m in length. It was divided into two sections by a small curved brick wall (0430) (Plate 13). At its eastern end was a cast iron pipe (which is likely to have functioned as an overflow outlet pipe taking material out toward the tail race end of the mill (observed 0453). Excavation of this feature revealed that the bricks on the interior of this trough had been subjected to intense heat; furthermore the fill of this feature consisted of several large fragments of firebrick often used in environments requiring intense heat such as a furnace, kiln or hearth. It is unclear at present what this feature may represent. It may have been used to dry grain or the mill may have had a secondary purpose such as acting as a distillery.

Plate 13: Area 08 trough (0610) with curved wall (0430) looking south west

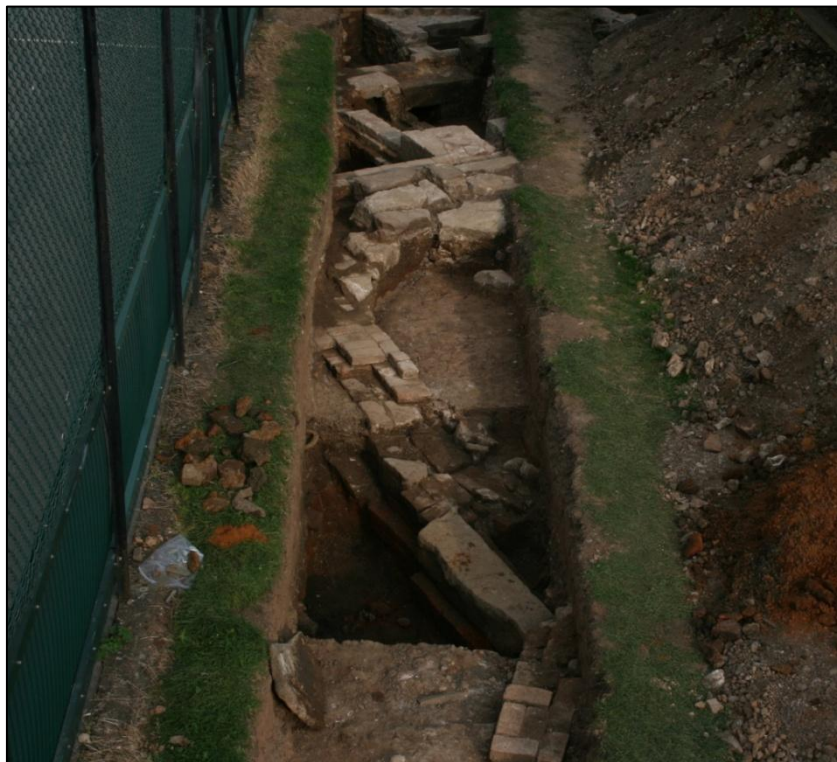
Abutting (0369), a brick wall structure constructed with mid 18th brickwork and orientated roughly east - west was observed; this appeared to have an opening which had subsequently been patched up at a later date using a large stone doorway threshold measuring 1m in length (0579). The purpose of these alterations is unknown however the feature itself is likely to represent an overflow sluice running from the side of the dam (Plates 24 and 25).

Plate 24: Area 09 west end showing leat looking east

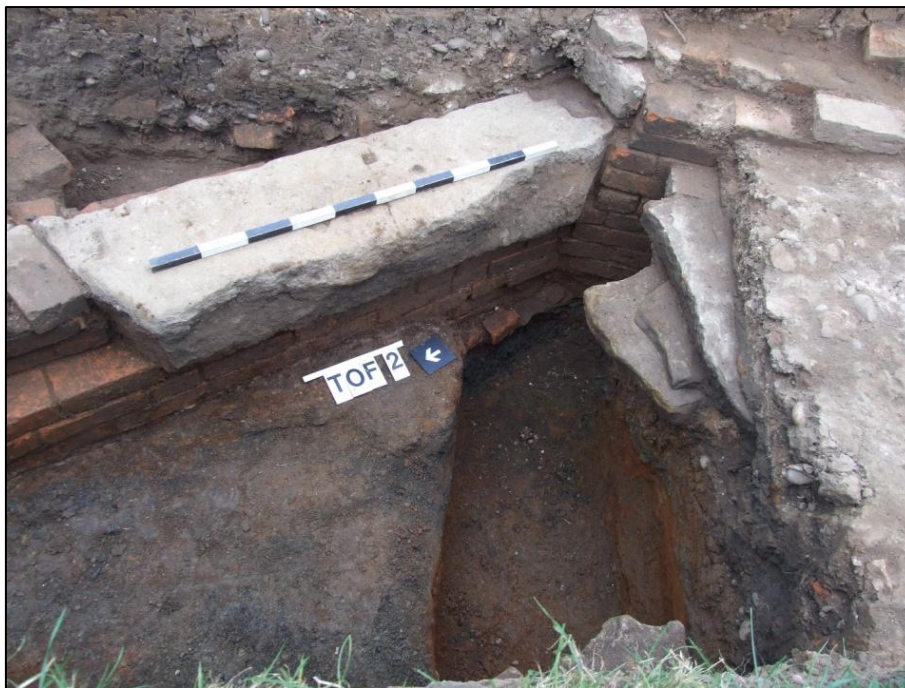
Plate 25: Area 09, (0579) repairing (577) and (0578) looking south east

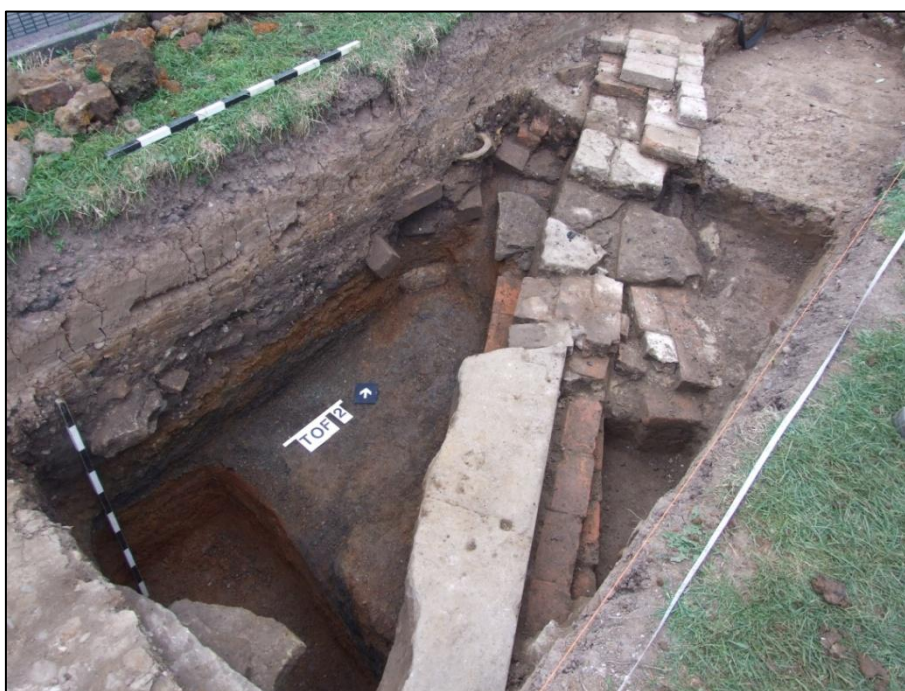
Excavation of a sondage in this area (Figure 6) showed that fine waterborne gravels had been deposited up against this wall consistent with the flow and settling of gravels along the periphery of the dam. Unusually these gravels had been cemented together presumably via a process of mineralisation caused by an iron rich water source. The iron may have been from industrial contamination of the river or perhaps by the presence of iron components and mechanisms in the water next to the mill which may have led to iron particles leaching into the water over time (Plates 26 and 27).

Plate 26: Area 09 wall threshold (0579) and walls (0577) and (0578) looking north east

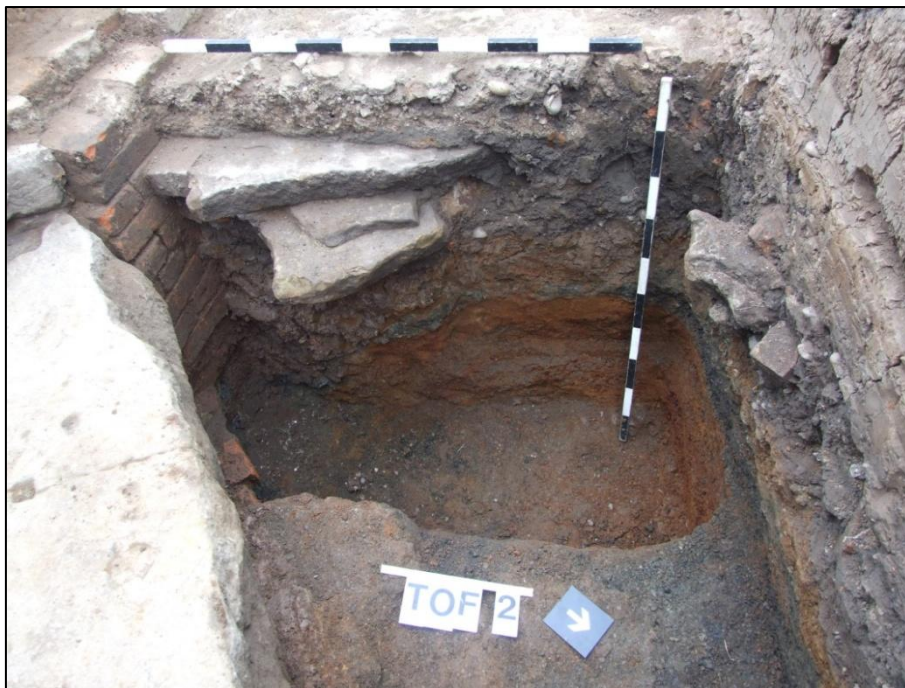
Plate 27: Area 09 west end showing iron effected gravels looking west

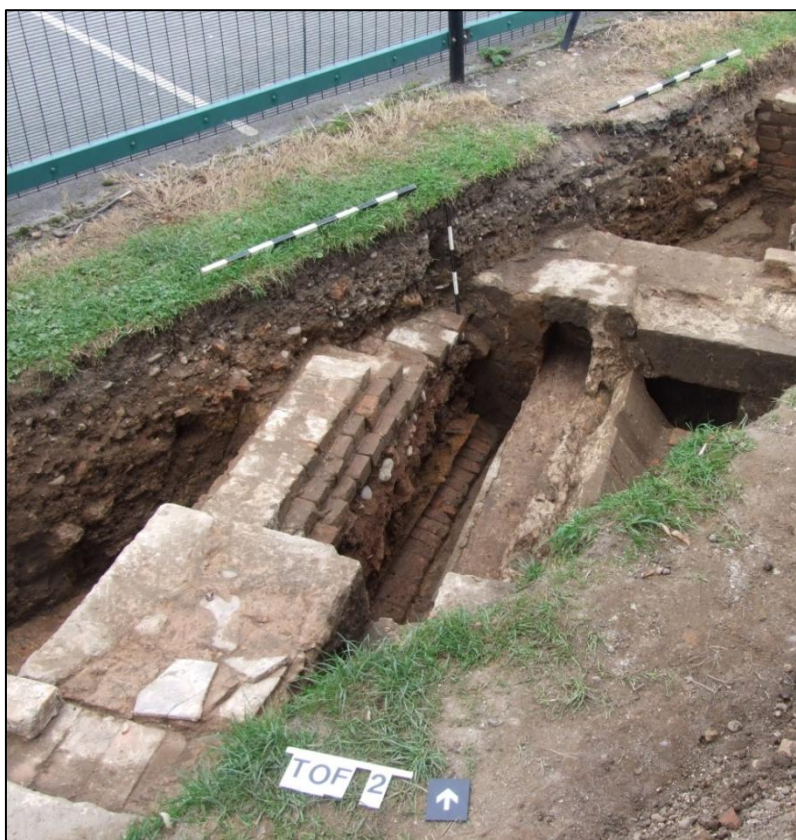
At the north end of the water wheel pit a large metal plate (0606) was noted resting on the brick surface now crushed by the debris above (Plate 28). This feature may represent the water wheel being modernised from the original 'Undershot' to the 'Poncelet' wheel type. The undershot wheel used a vertical blade in front of the wheel which slowed down the water before it passed through. The Poncelet design used an angled metal blade to funnel the water course resulting in the pressure of the water passing through the wheel being greater (Figure 4).

Plate 28: Area 9 feed channel (0496) showing Poncelet phase related plate (0606) looking north east

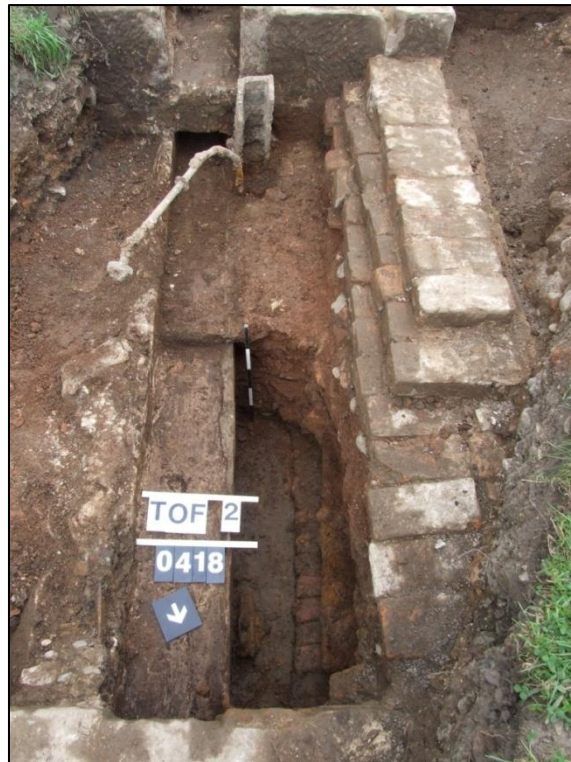
Located directly at the foot of (0496) and attached to the interior of the stone wall (0367) a bracket for holding a sluice gate was observed and the remnants of a further bracket were noted on the opposing side (Plate 29). This would have controlled water entering the water wheel pit from the dam above. This was abutted by a low mortar lined wall (0418) spanning the wheel pit east-west which had an angled stone plinth set against it. This plinth which also had downward grooves cut into it mirrored the angle of the wheel at its base and would allow the flow of water to run smoothly off the wheel in to the pit. Abutting these features is the floor of the water wheel pit which is made of machine engineered bricks (0528) datable to the later half of the 19th century suggesting further modifications in this area towards the end of the mills life (Plates 30 and 31).

Plate 29: Area 09 section of channel [0418] looking west

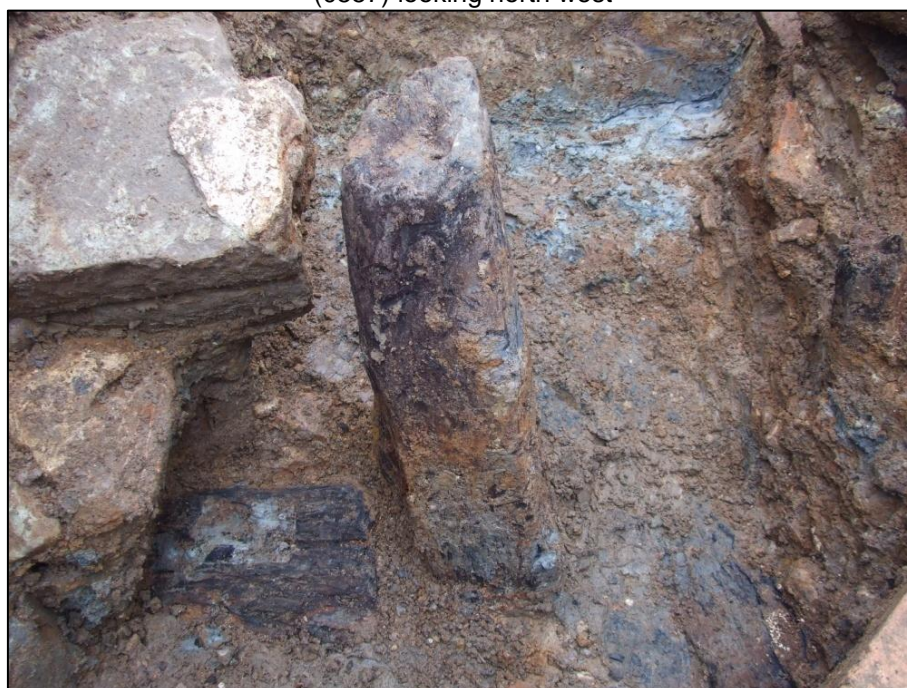
Further excavation revealed two large upright oak stake piles (0614 and 0615), also noted was a horizontal timber with a mortise (0616) (Plate 40). Excavation of these timbers revealed them to be very substantial with (0614) measuring 2m in length. Samples of the timbers were sent for dendrochronological dating. The dating revealed that the timbers had been cut between 1210 and 1231 AD (Arnold and Howard, Section 7.3). The alignment of this structure suggests a possible medieval timber revetment for the pond related to stones (0608). Excavation continued to the south of these stakes until the base of the pond was found at approximately 1.2m below ground level. Samples of primary fill (0604), which represents the silting up of the pond, were sent for Environmental Remains Analysis (Carson and Miller, Section 7.2). The date of these deposits is unclear. CBM and glass were recovered from (0604) but this may represent later material being introduced to this soft deposit when it has been disturbed. The samples of (0604) were found to contain a range of plant remains from plants typically found in scrub woodland and wetland. Remains of trees and bushes from mixed scrub woodland were also recorded in significant numbers as were a number of well preserved small branches which appeared to have been worked, some cut at one end and others at both ends. Arnold and Howard suggest that this may represent debitage from wattling, associated with the two large Medieval stakes, used to support the pond edges. Nine fig seeds (*Ficus carica*) were also recovered from this sample, these may have been introduced through human faeces while a hemp (*Cannabis sativa*) seed may have been introduced during retting (rotting) of stems for fibre. These seeds and environmental remains may all have been washed into the pond from further up stream.

Plate 40: Area 11 oak stake piles (0614) and (0615) with mortised beam (0616) and stone revetment (0608) looking north

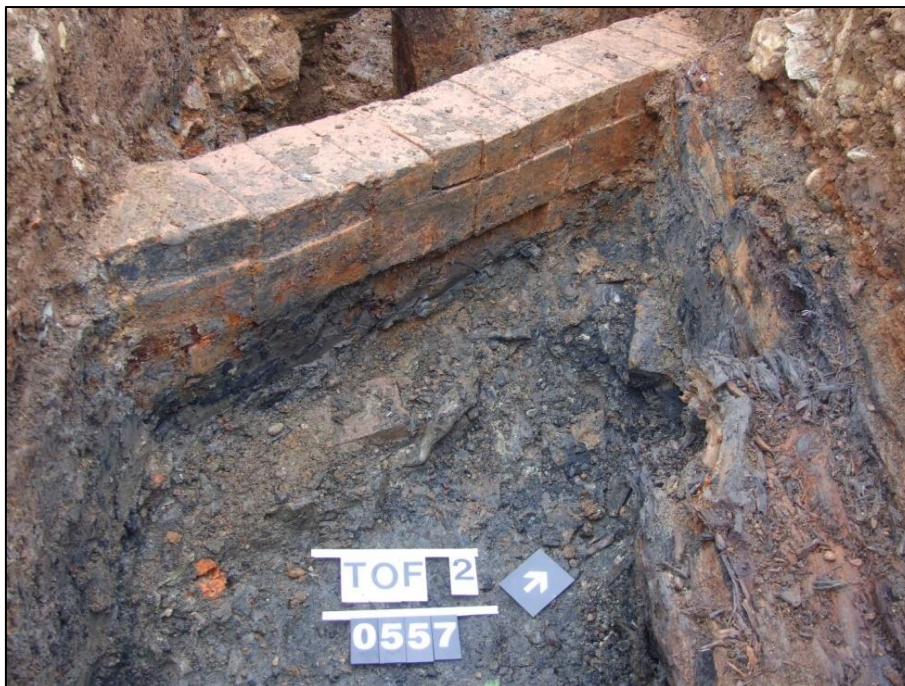
A prominent feature in this area was the presence of a brick box drain (0557) on a north to south alignment (Plate 41), this was constructed using late 19th bricks and may have served as a replacement after the former channel had become blocked.

Plate 41: Area 11 box drain (0557) looking north west

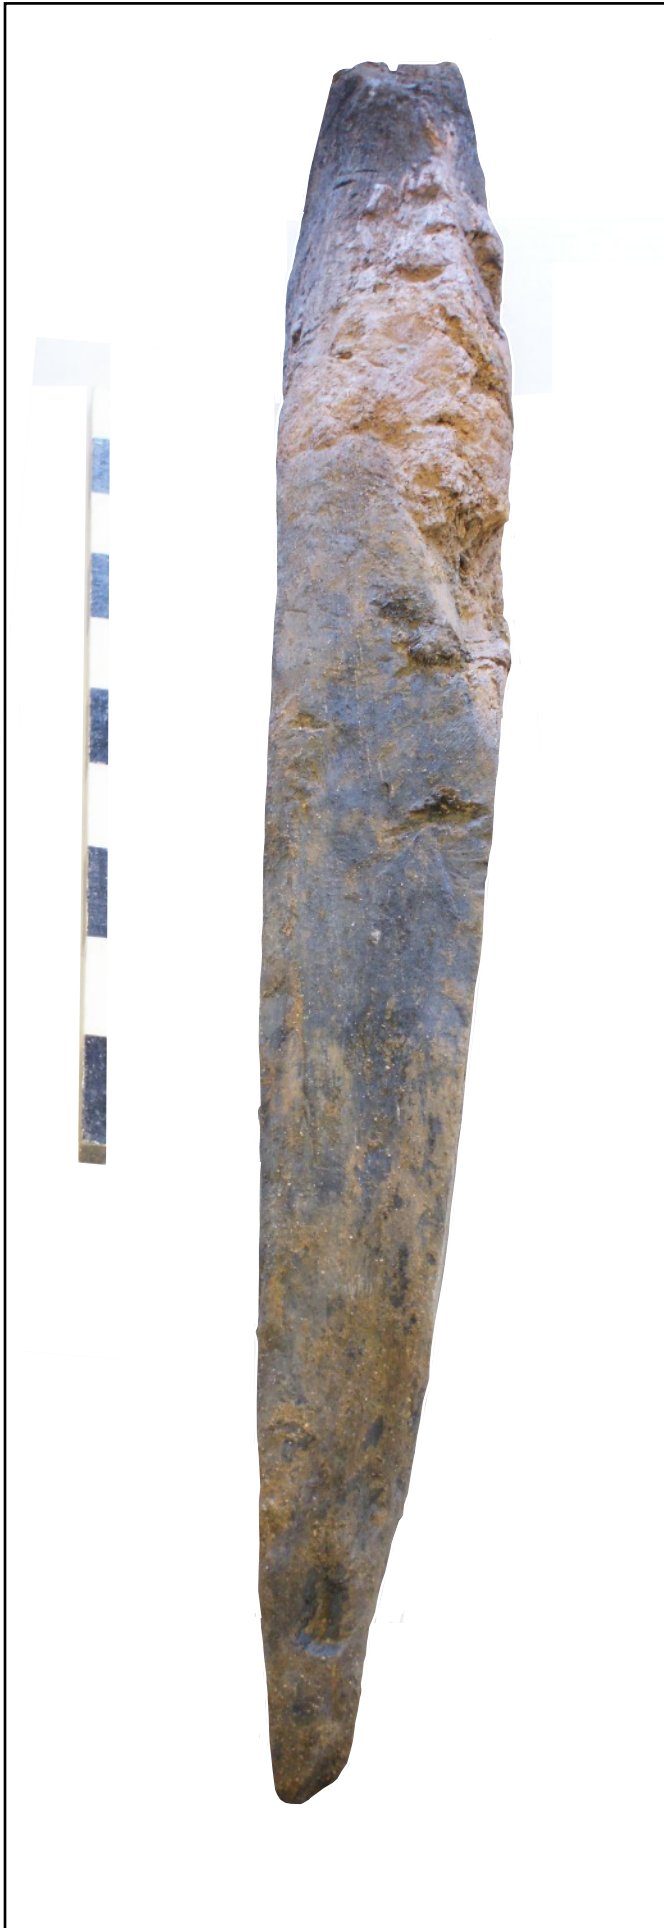
Plate 43: Timber pile DBO. Note the tool marks at the top of the timber.

Sample number	Sample location/identifier code	Total rings	Sapwood rings*	First measured ring date (AD)	Heart/sap boundary	Last ring date	Estimated felling date range**
TOT-M01	DPB	101	h/s	1116	1216	1216	1231–56
TOT-M02	DBO	136	h/s	1060	1195	1195	1210–35
*h/s = heartwood/sapwood boundary, i.e., only the sapwood rings are missing							
**Felling date range based on a minimum of 15 sapwood rings and a maximum of 40 sapwood rings

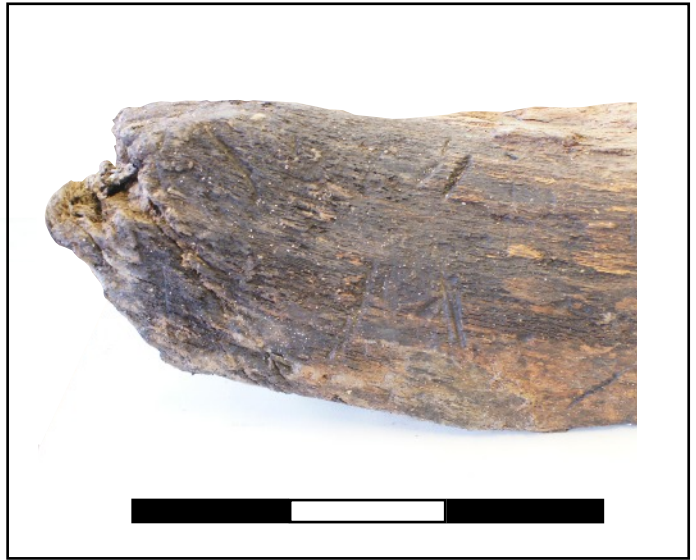
Plate 44: Detail of the tool marks at the top of timber pile DBO.

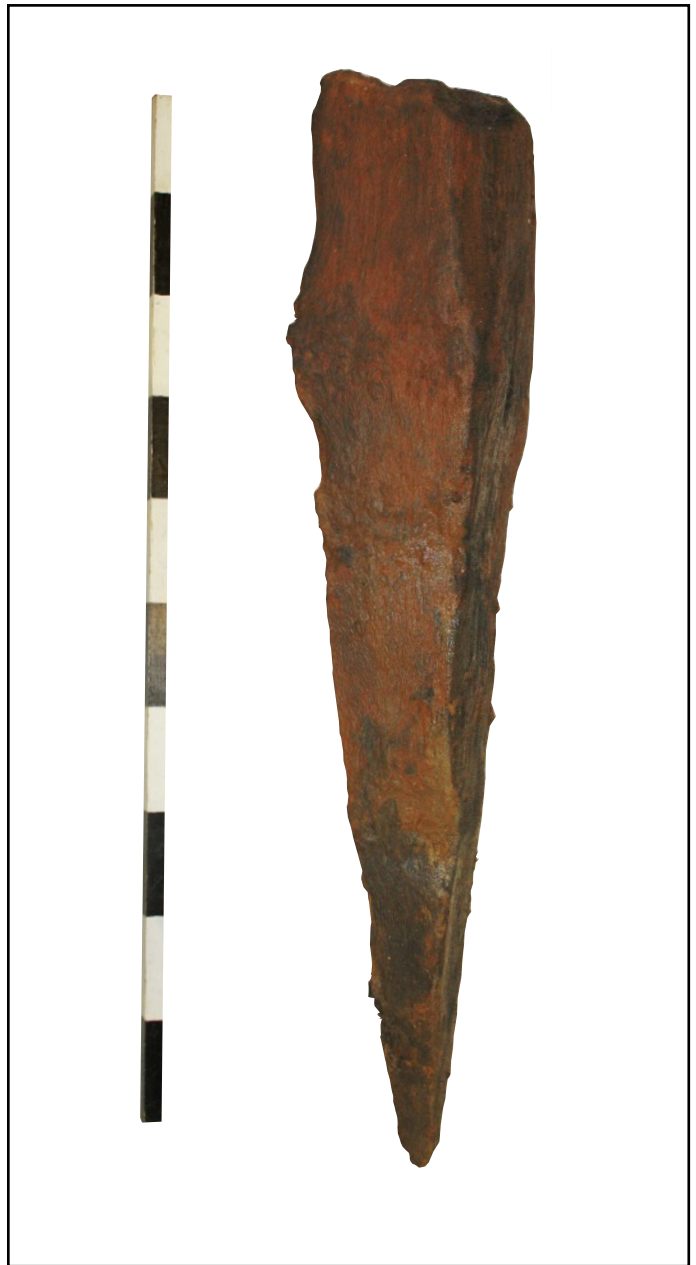
Plate 45: Timber pile DBP.

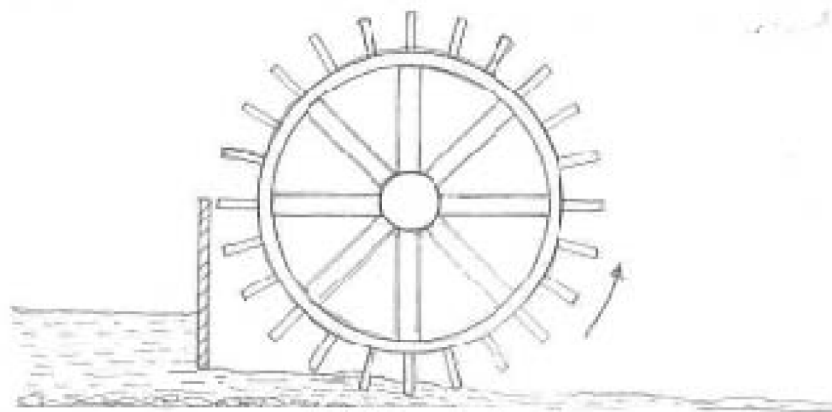
Fig 3 Undershot wheel

The water wheel pit was located to the west of the wheel/cog pit structure. It was defined on either side by large stone blocks. On the north east side this was (0365) which measured 0.2m x 6m (visible) x 0.4m and (0366/0367) on the south west side which measured 0.26m x 0.5m (visible) x 0.6m (Plates 18 and 19). Situated between these parallel stone walls, the base of the wheel pit was visible and surviving in good condition (Plate 20). From the northern edge of Area 09 this area would have been fed water via the dam head race inlet end of the water wheel pit, a finely made brick floor angled at 45° could be observed entering the water wheel pit area (0496) (Plates 21). The bricks have been identified as the same early to mid 18th type in keeping with the majority of this mill. This construction is almost certainly designed in this way to create maximum downward velocity forcing the water to hit the wheel at its optimum speed; this early 18th century wheel may have been an 'undershot' wheel as was common at the time.
