TOTON UNEARTHED, TOTON, NOTTINGHAMSHIRE

Report on an archaeological evaluation on the site of 'Manor Farm' at Toton Manor Farm Recreation Ground, June-July 2014

TPA Project Code – TOF2

TPA Report No. 143/2014

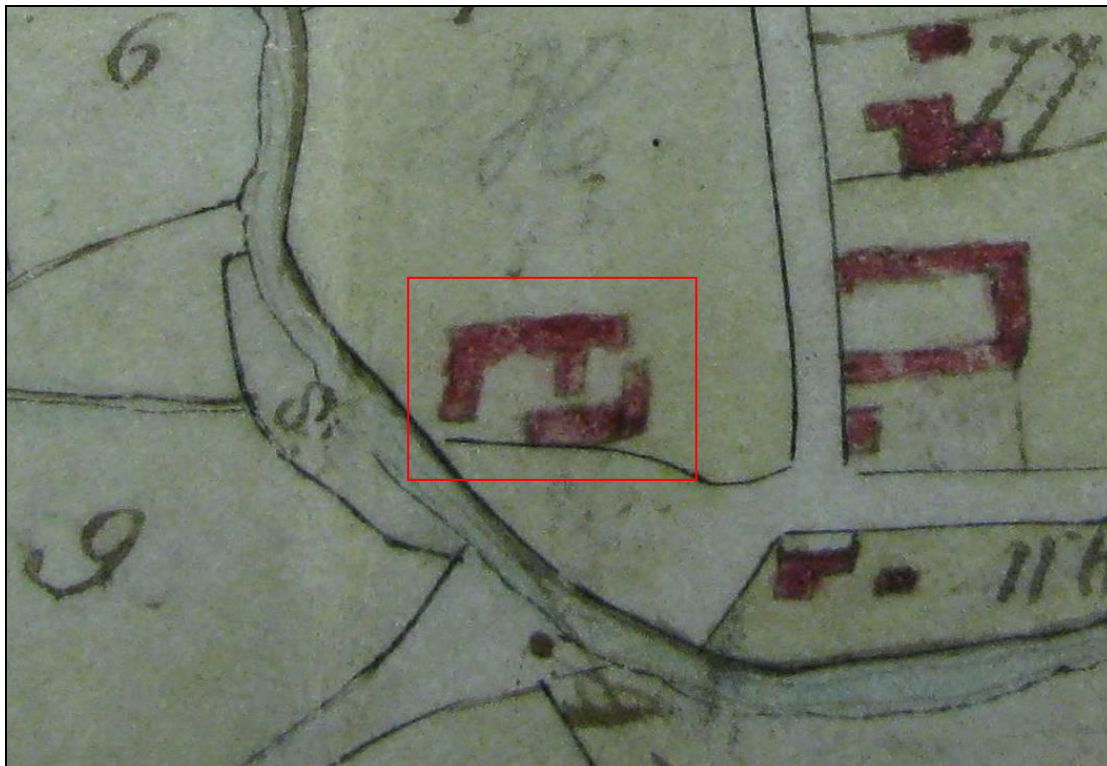
Plate 1: Warren's Toton Map of 1789 showing buildings on site outlined in red

The earliest definite depiction of the manor is on Sir John Borlase Warren's map of 1789 (Plate 1). This shows two groups of buildings, a northern F shaped block and a southern L shaped block. It is not clear from this map what the buildings are used for.

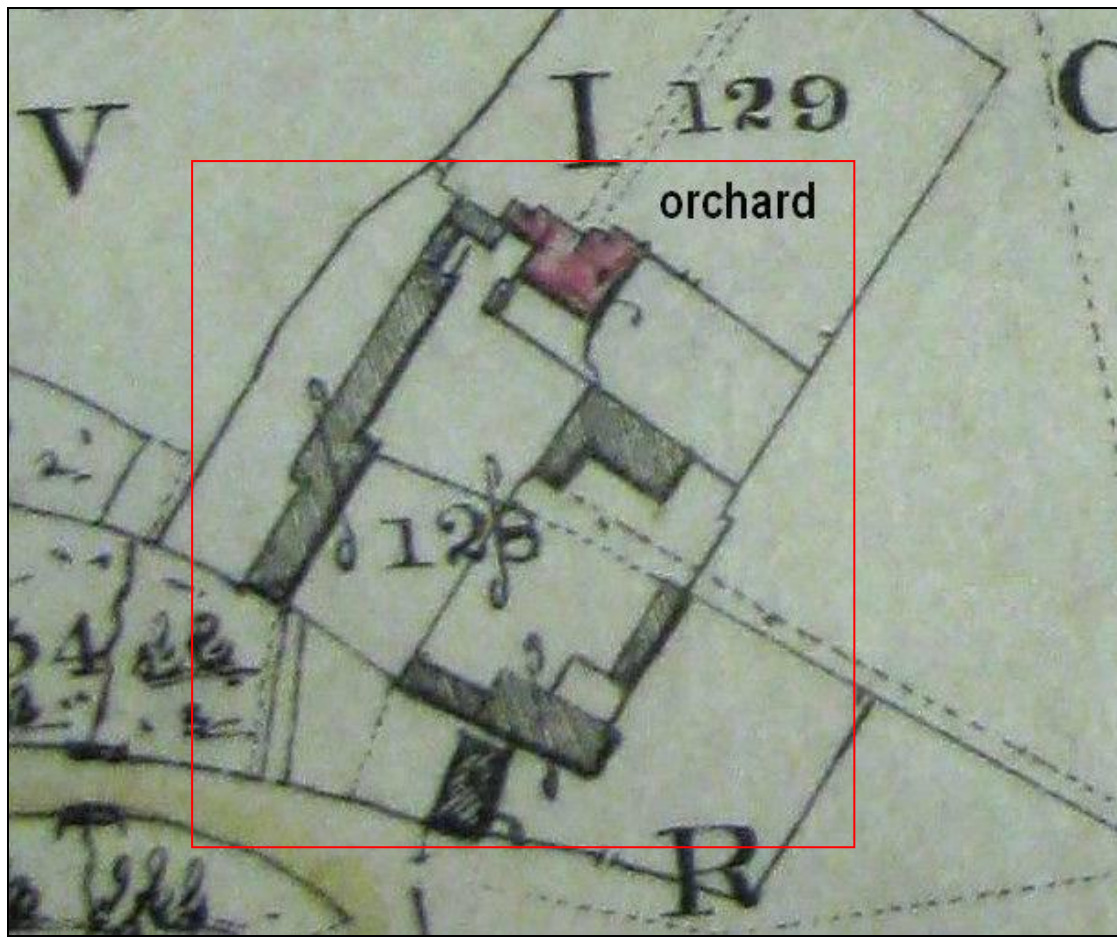
Plate 2: Tithe Map of 1847 showing buildings on site outlined in red

Sanderson's "Twenty Miles round Mansfield" map of 1835 (not depicted) does not show sufficient detail to give any idea of the layout of the site at this time. The Tithe Map of 1847 (Plate 2) shows the farm set out with the farmhouse at the north (shown in red) with what are thought to be barns and out buildings set out in a roughly rectangular shape to the south. The map does not show the house with an east and west wing as has been identified in the excavated trenches described below (Figure 2), rather as sub-rectangular. A temporary building or roofed area may have stood on this southern side of the house at this time or it may be that the map is incorrect. The site may have been set out in this way in 1789. Warren's map lacks detail and the buildings may be shown in a stylised manner.

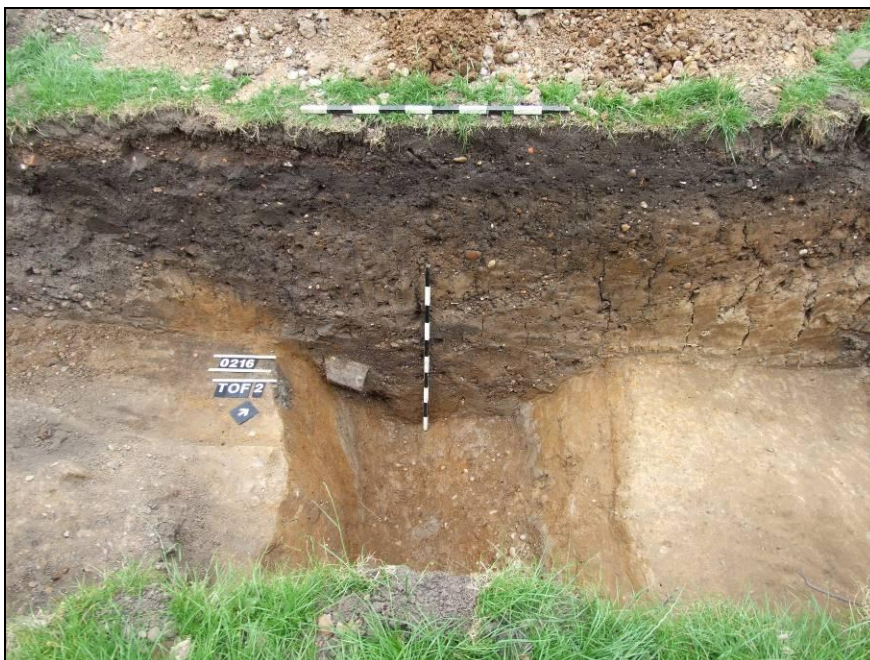
Plate 3: Section of large medieval ditch (0126) looking north west

Perhaps one of the most notable features relating to this phase was a substantial ditch (0126) noted at the western end of Area 01(b) at the foot of the knoll on which the building complex is set (Plate 3). This measured 3m wide at the surface and 1.7m deep. The ditch contained three fills: (0127), (0222) and (0221). The primary fill (0127), a firm mid orange/grey silty loam clay, produced many fragments of brown/green glazed ridge tiles dating to the 13th-16th century and several sherds of green glazed pottery dating to the 13-14th century. The secondary fill (0222) is probably the same as (0127) though more dry and compact, and the upper fill (0221) was a much more friable dark brown silty loam and may be the fill of a later re-cut [0220] suggesting its continual use. The dimensions and location of the ditch suggest that it could have been a substantial enclosure or boundary ditch. Roof tiles and glazed ridge tiles dating to between the 13th and 16th centuries were recovered from the fills of this ditch (see Appendix 2).

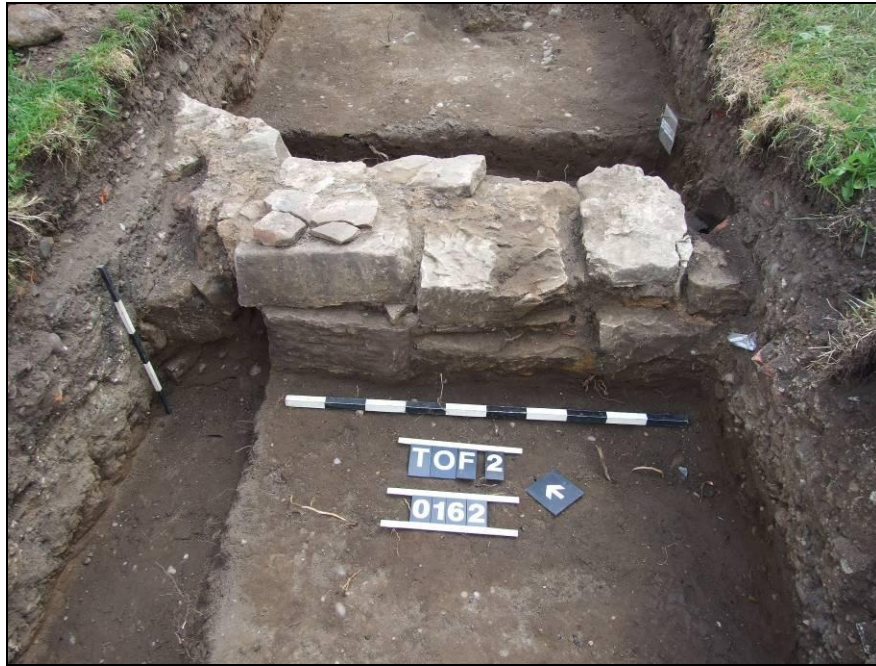
Plate 5: Stone boundary wall (0162) with drains removed looking north east

Also noted within Area 01(b) was a substantial north-south orientated un-mortared stone wall (0162). The wall itself measured 0.5m wide and 0.35m deep and consisted of two courses of large rectangular limestone blocks which were tooled on the western side (Plates 4 and 5). Several factors, such as the wall's location on the brow of the hill, its substantial structure, tooling on the western side and its orientation, suggest this is the western most part of a boundary wall that may have encircled the manorial complex. Later 18th/19th century drains were noted cutting the wall which may explain 18th/19th century clay pipe stems being recovered from around the wall. Green glazed 13th/14th century pottery was recovered from layer (0184) which abutted the lower courses of the wall (see Appendix 2).

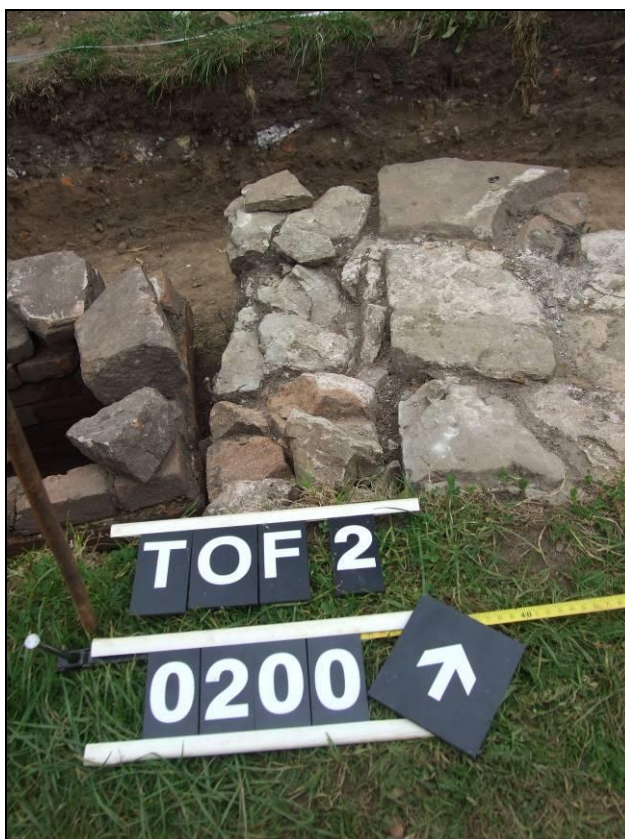
Plate 7: Stone foundation (0200) looking north west

Approximately 3m to the east of wall (0162) and on the same alignment, the un-mortared stone foundations for a building [0200] were noted underneath a later 18th/19th century foundation (0227/0116). This measured 1m x 2m x 0.2m deep (Plate 6). Foundation [0201] was also identified at the same level running at a right angle to [0200] (Plate 7). Noted and associated with these earlier foundations were the presence of tool markings characteristic of medieval masonry (though this does not negate the possibility of re-use, possibly in a 17th century context). Pottery recovered from (0184) and (0185) which both abutted the wall contained 13th/14th century green glazed pottery while 19th century white glazed ware was also recovered from (0184) (Elliot, Appendix 2).

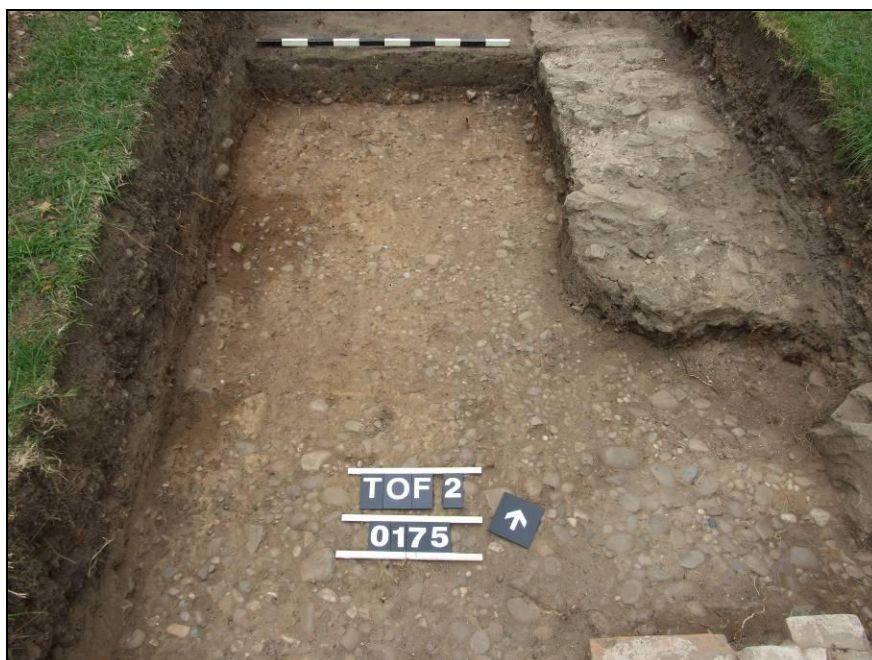
Plate 8: Compacted pebble surface (0175) looking NNW

Other features likely to relate to medieval activity on the site were two areas of compacted pebbles that may represent floor surfaces. At the southern end of Area 01(a) (0175) was observed (Plate 8) and (0189) was located at the northern end of Area 01(a) (Plate 9) suggesting a pebble surface may have once surrounded the manor buildings. Floor surface (0189) was stratified below 0.60m and 0.70m of 17th/18th material (0155,0154) with some finds coming from the stones themselves relating to the medieval period such as lead window cane and a possible medieval copper alloy buckle attachment. Furthermore (0175) was noted running below the stone foundations of 17th century building (0121) and below (0124) in

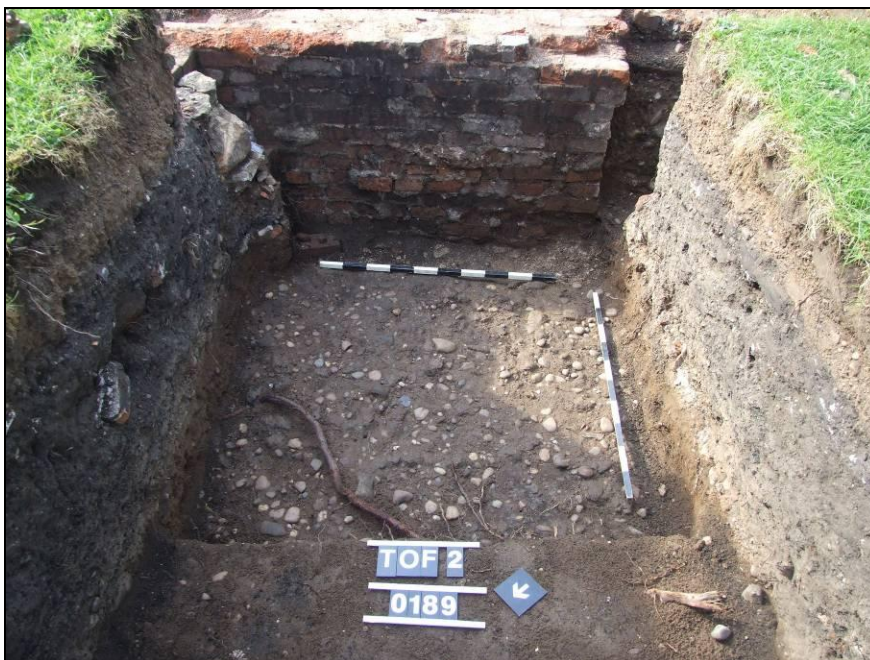
Plate 9: Compacted pebble surface (0189) looking SSE

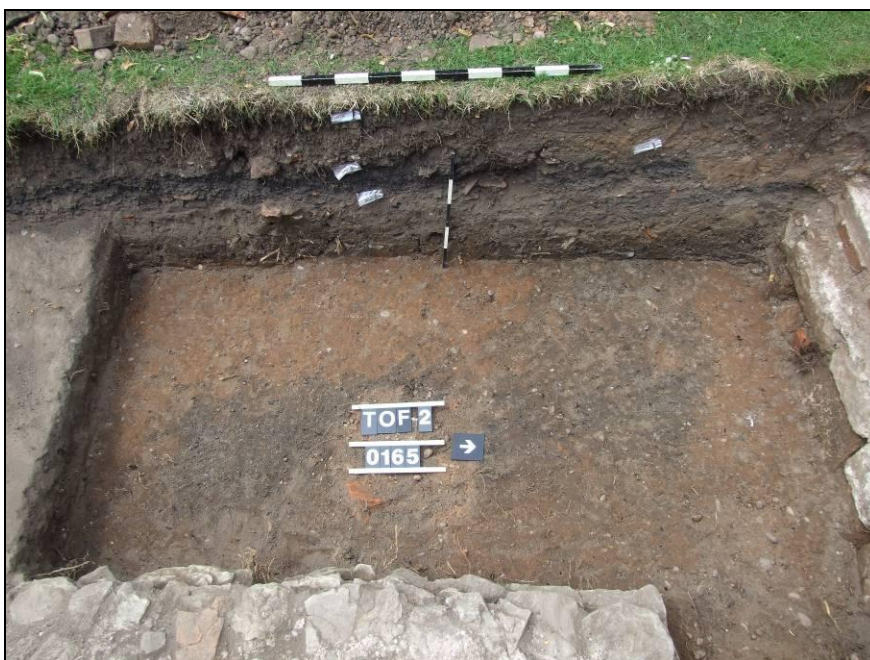
Plate 10: Gully/ditch (0165) pre excavation looking east

Also noted in Area 01(a) was a shallow curvilinear gully [0165] orientated north – south for 2m before turning east - west for 0.5m and continuing into the section (Plates 10 and 11). The function or purpose of this feature is unclear however it was sealed by (0124) which has been dated by the 1604-1649 coin.

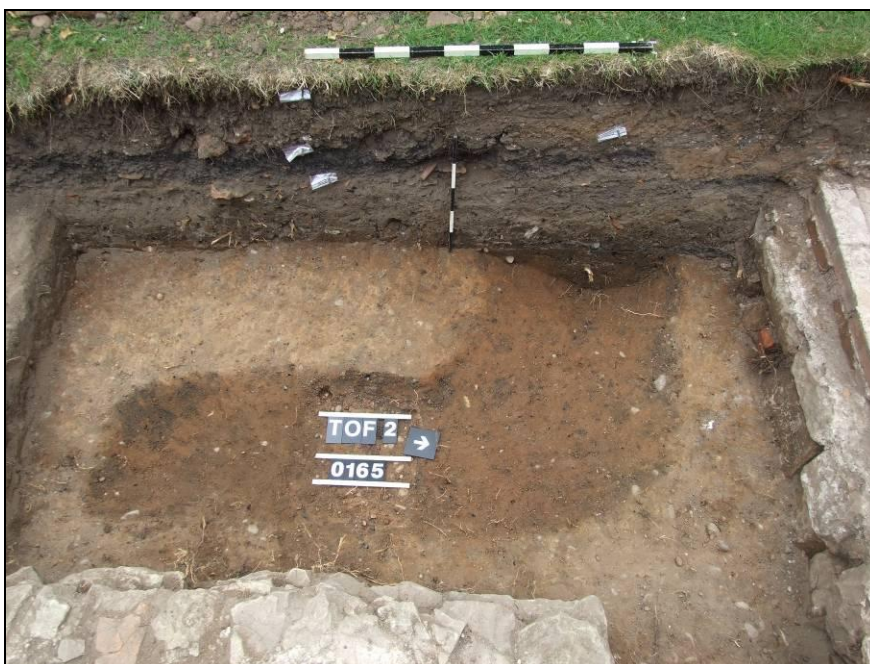
Plate 11: Gully/ditch (0165) post excavation looking east

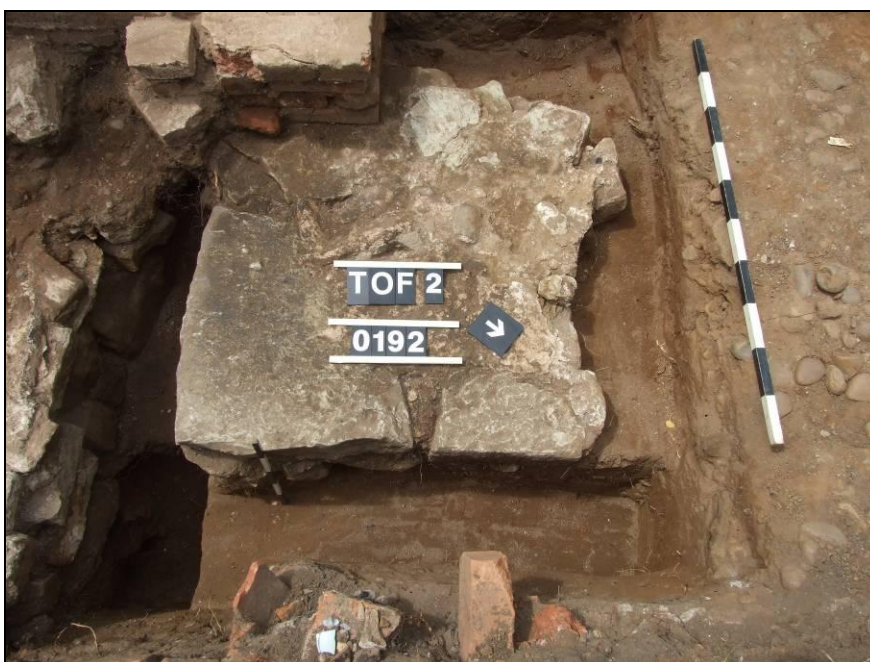
Plate 12: Limestone foundation plinth (0192) looking south west

A distinct stone feature (0192) was observed in Area 01(a) below 17th century contexts (0123 & 0215). This was a substantial isolated square stone platform made of large un-worked limestone blocks (Plate 12). This feature measured 0.5m x 0.4m and 0.2m in depth. There were traces of lime mortar on its surface suggesting something may have previously been bonded to it. This may be the foundation pad for a column base.

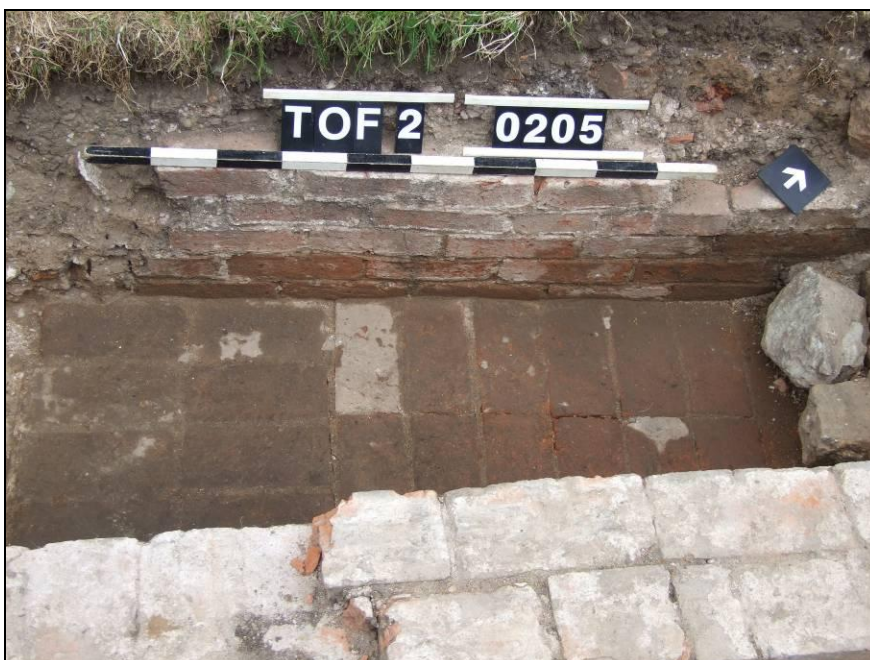
Plate 13: Northern end of wall (0205) with floor (0203) looking north west

An exterior wall of single brick construction from this period was noted to the east of the middle of Area 1(b) running roughly east-west for 1.4m (0205) before turning at the western end to run north-south for a further 1.6m (0206). This survived up to five courses (0.3m) high (Plate 13). As this structure was only of single brick construction it is likely there would have been no more than three further courses creating a lower course of brickwork for a timber framed building of wattle, daub and panel above.

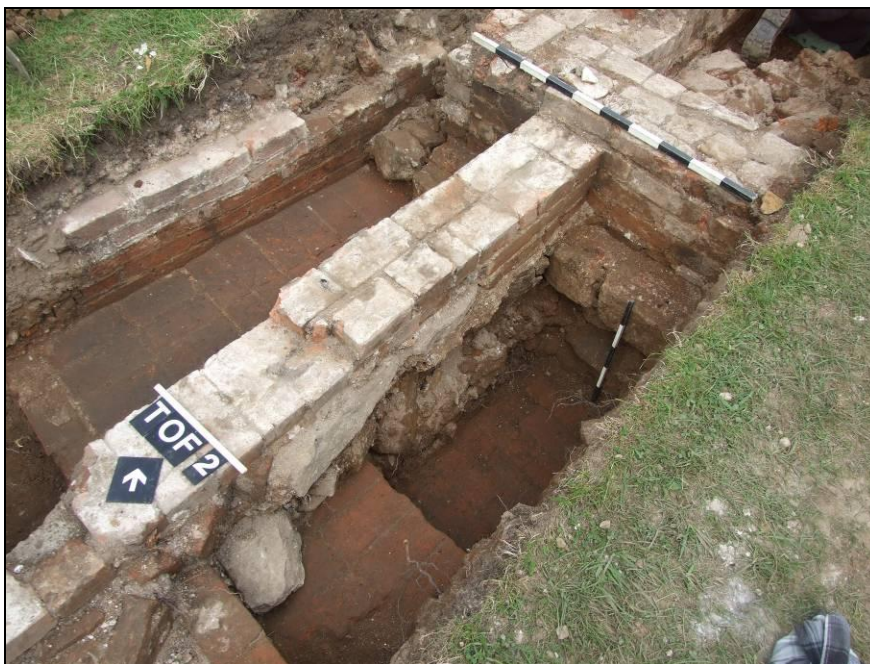
Plate 15: Georgian foundation walls (0113 & 0116) overlying 17th century floor (0203) looking north

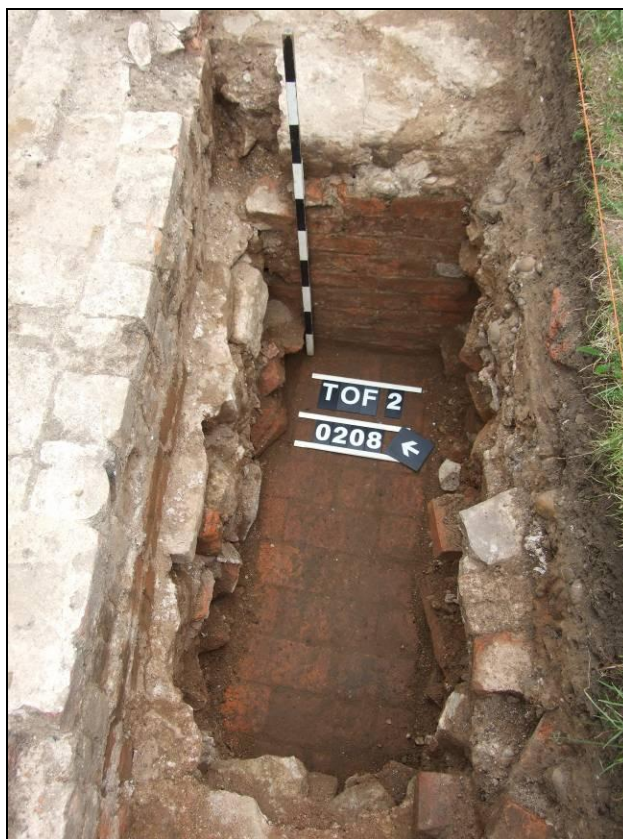
Plate 16: Red brick floor (0208) and divisional wall (0149) looking north east

To the east of the sunken larder, remnants of the floor plan (0149) of the 17th century buildings could be observed at a higher level in between and underneath later Georgian foundations. Some 0.3m east of (0149) was a further brick floor (0148) with coursing laid in alignment to the exterior wall (0205); this floor had clearly been cut through by later Georgian foundations (0113) and was also partially covered by later Georgian brick internal wall partition (0147) (Plate 17).

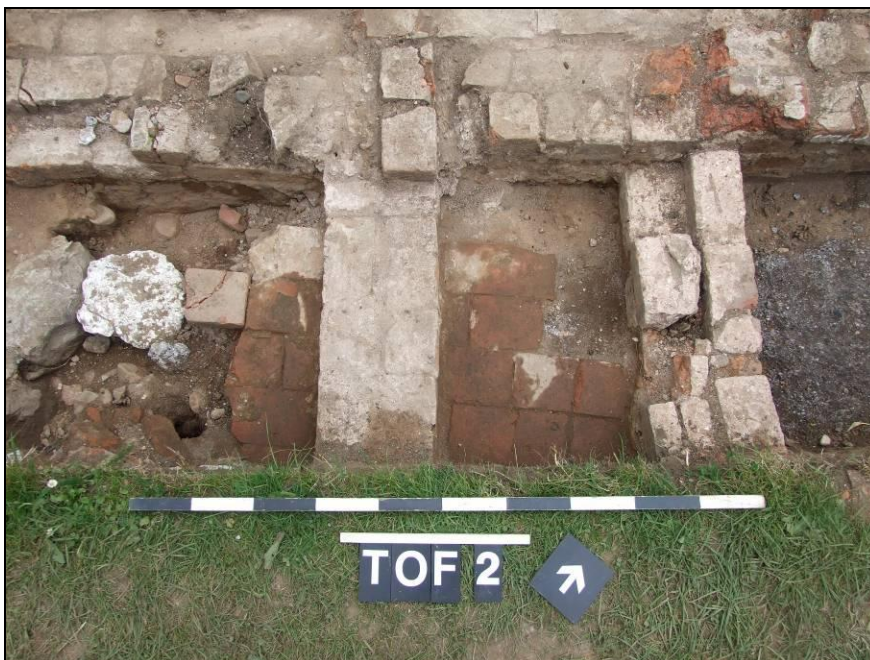
Plate 17: Georgian foundation (0113) cutting 17th century floor (0148) and later internal walls (0147) and (0115) overlying 17th century floor looking north west

residual. A sondage excavated next to foundations (0108) showed their base to be over 1.2m below the level of the surface of the excavation (Plate 32). Two further internal walls were recorded during excavation which were much less substantial. These were both in the northern room of the west wing of the building, approximately 1m apart orientated roughly north-north west - south-south east (Plate 17) and were recorded as [0115] and [0147].

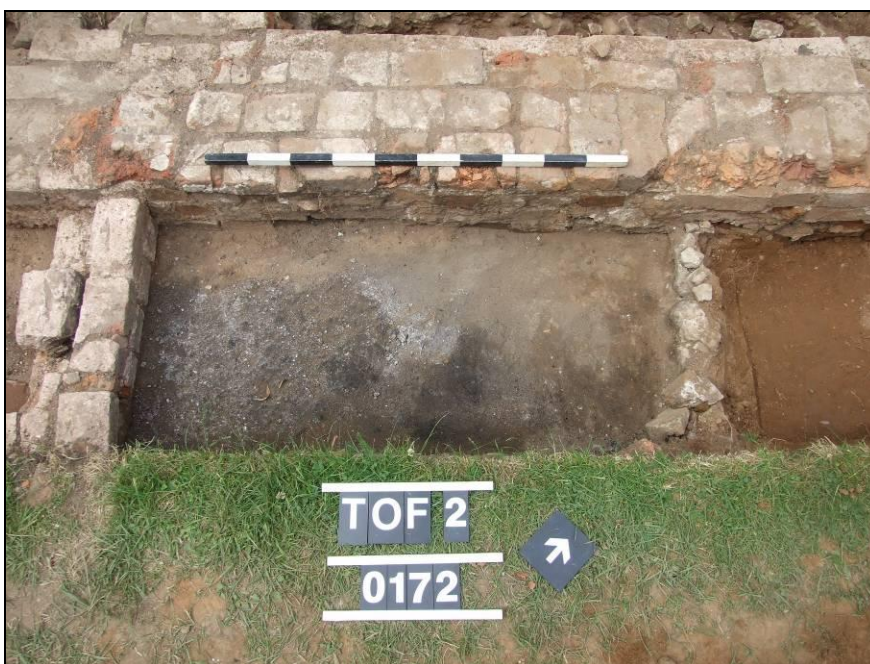
Plate 18: Compacted lime/ash floor (0172) cut by Georgian wall (0113) looking north west

Continuing a further 0.3m eastwards a compacted lime ash floor (0172) was observed, continuing the 17th century floor plan though possibly within another room space. The foundation cut for (0113) cut through this feature (Plate 18). Just inside Area 01(a) 0.5m east of (0172) the remnants of north-south orientated wall (0194) were recorded, this was on a parallel alignment with (0206) and wall (0205) may have connected these two walls before it was later truncated by (0113). This may have been an interior wall or the eastern exterior wall of the 17th century building (Plate 19).

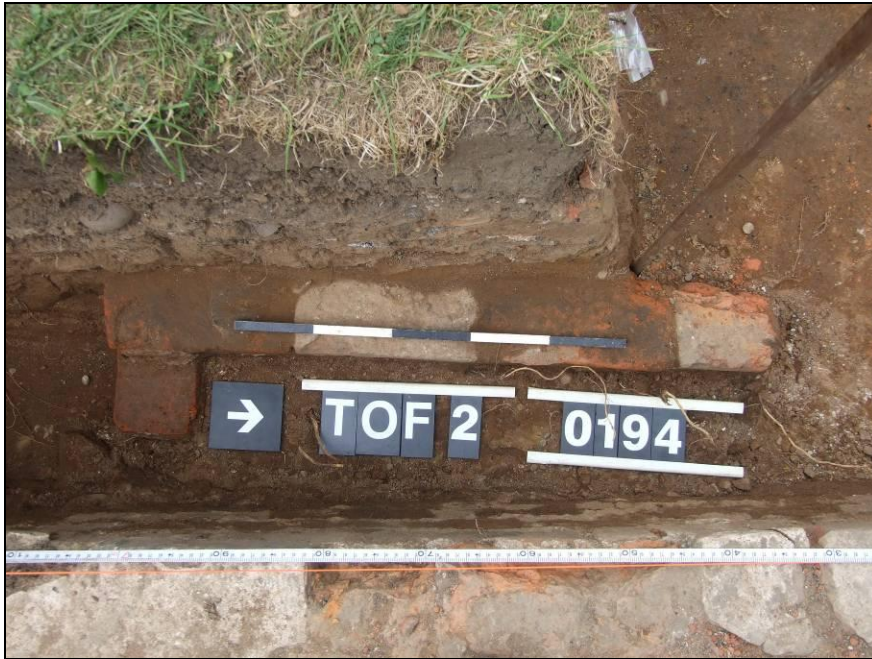
Plate 19: Wall (0194) looking west.

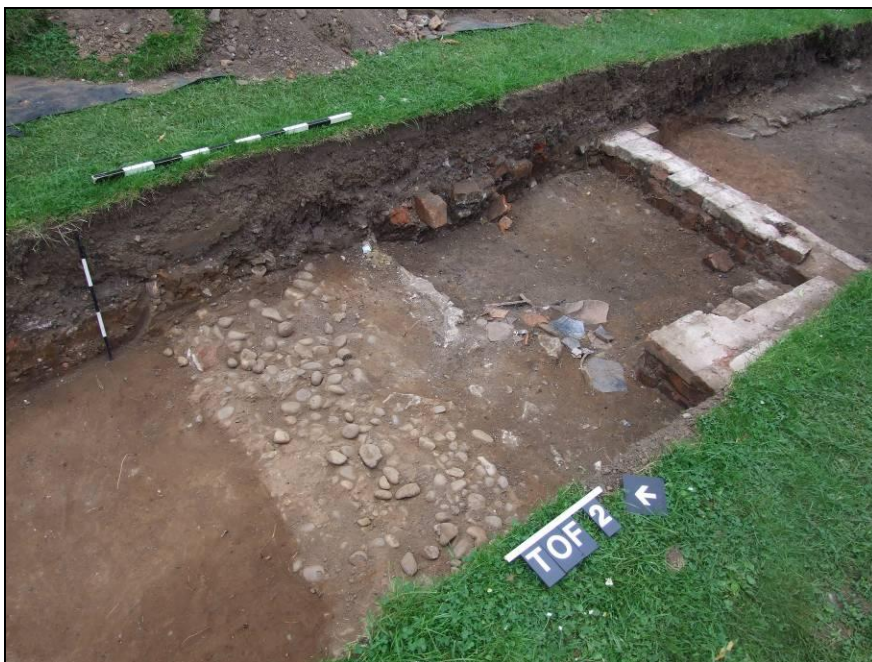
Plate 20: Pebble path/surface (0123) looking east

Furthermore 1.2m south of (0137) a clear and distinct large cobble path (0123) was noted (Plate 20). This was also within the footprint of the 18th/19th century farmhouse. It contained pottery including 18th century white salt glaze ware (see Appendix 2) which may have been intrusive. A quantity of 18th and 19th century pottery (Plate 21) was also identified to the south of this including sherds from a butter pot, coarse earthen ware and porcelain vessels (see Appendix 2), recorded as (0132). This pottery overlaid the possible medieval column base/post pad (0192), and may have been left there during the construction of the house.

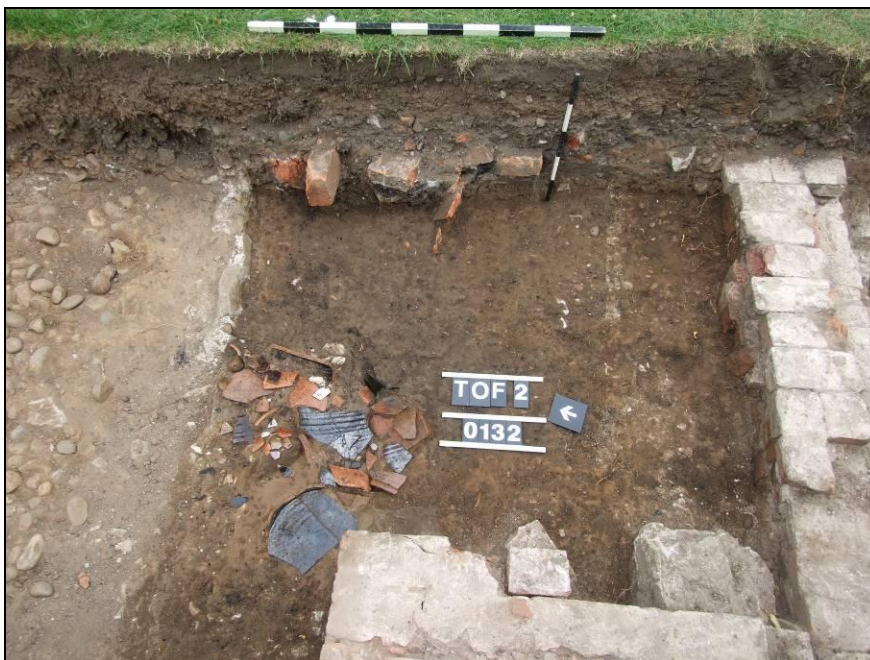
Plate 21: 18th century pottery dump (0132) looking north east

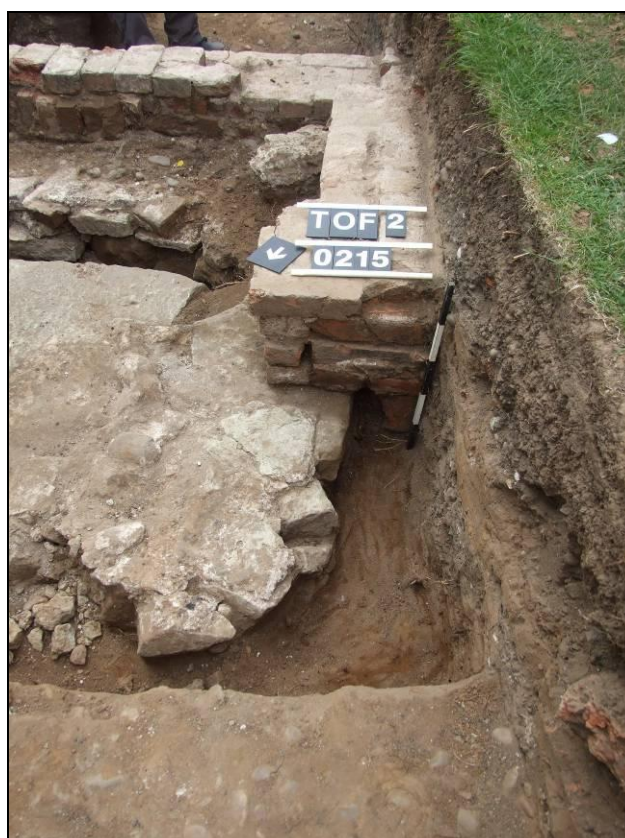
Plate 22: Wall (0215) overlying medieval plinth (0192) looking south east

Approximately 0.3m south of the cobble path surface, an area of brickwork (0215) was observed which was constructed using typical mid 17th century dimension bricks. It was cut by (0119, 0120) and partly overlay possible medieval column base (0192) (Plate 22)

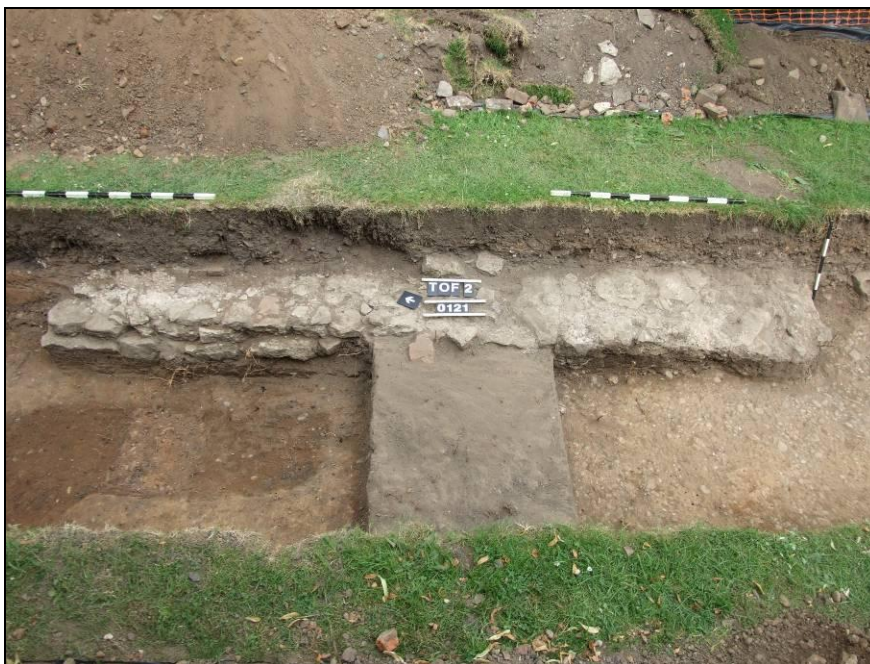
Plate 23: Stone foundation (0121) showing part of deposit (0124) at front looking north east

Toward the southern end of Area 01(a) a large stone foundation (0121) orientated north-north west - south-south east was observed which had traces of lime mortar on its surface and evidence of brick once mortared to it (Plate 23). This stone foundation was abutting (0124), a deposit of black ash rich silty loam from which a coin datable to 1604-1649 was recovered as well as red ware and delf ware pottery dating to the 17th/18th century (Elliot, Appendix 2). Given that this building is not represented on any 19th century maps and that it doesn't seem to respect the orientation of any later buildings it is thought this wall relates to the 17th century phase of the site.

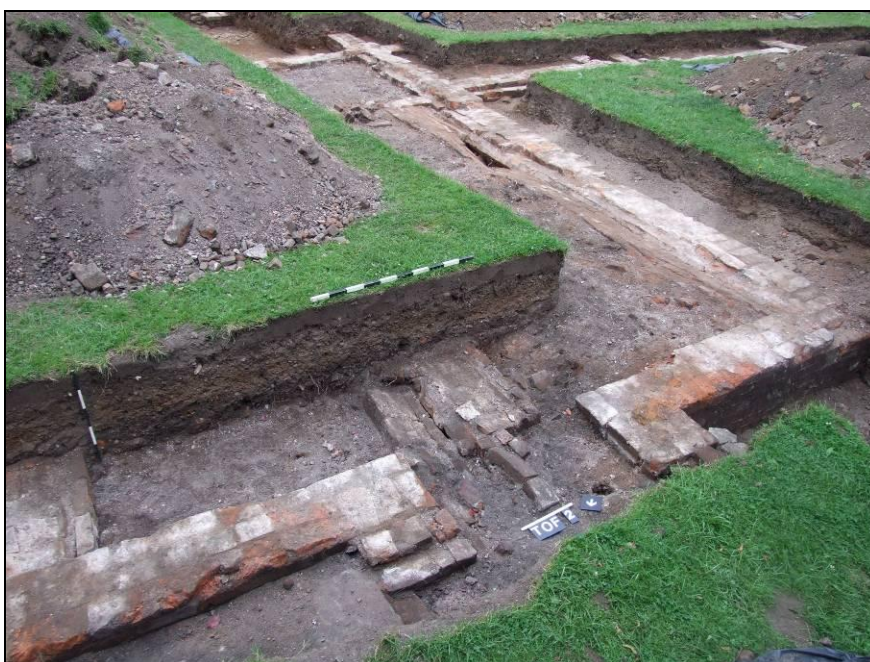
Plate 24: Foundation footprint and upper cellarage level of east wing of Georgian building looking south

During the late 18th century a three storey farmhouse was constructed on the site. It was of red brick, roughly 'L' shaped in plan with a classically symmetrical frontage. All three of the trenches excavated were dominated by the remnants of the footprint of this latest phase of building. The remains comprised external and internal lime mortared brick foundations and brick barrel vaulting which covered a cellar area that dominated much of Areas 1 (a) & (c).

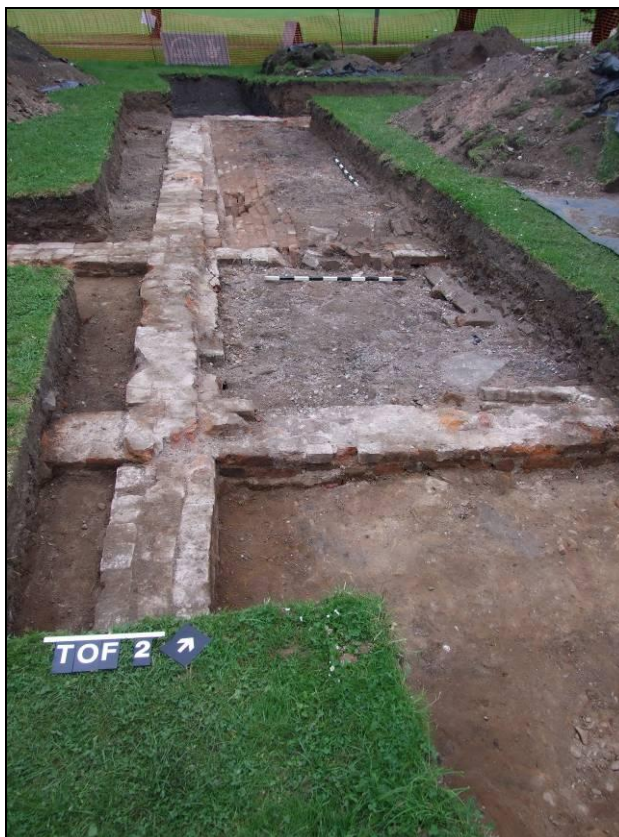
Plate 25: View of Area 1(a) showing internal walls and divisions of cellars looking north

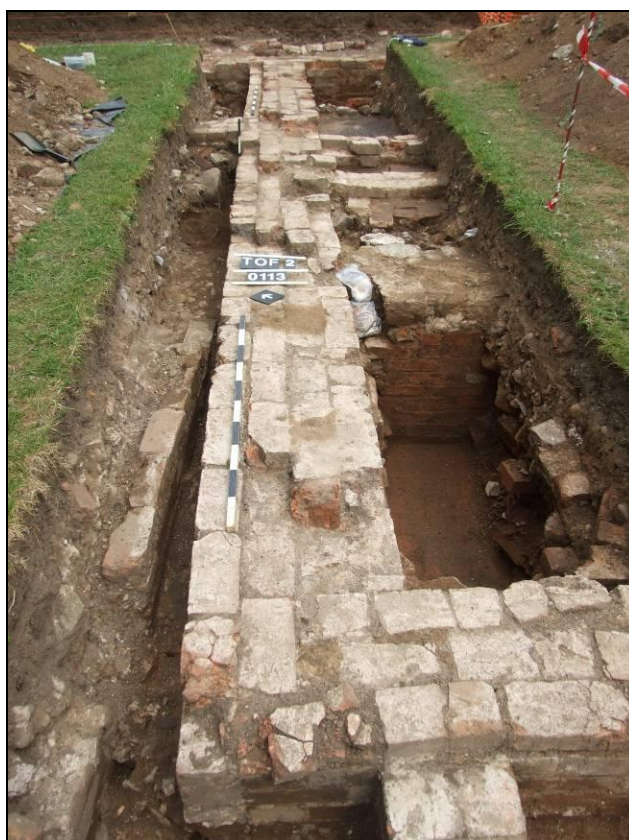
Plate 26: View of west wing of Georgian farmhouse foundations in Area 1(b) looking ENE

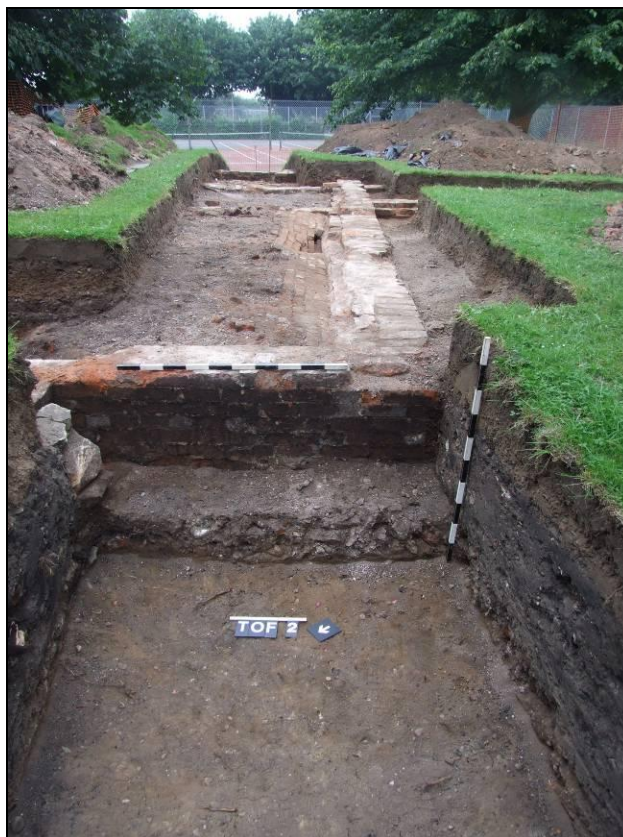
Plate 27: Partial elevation of (0112) facing south east

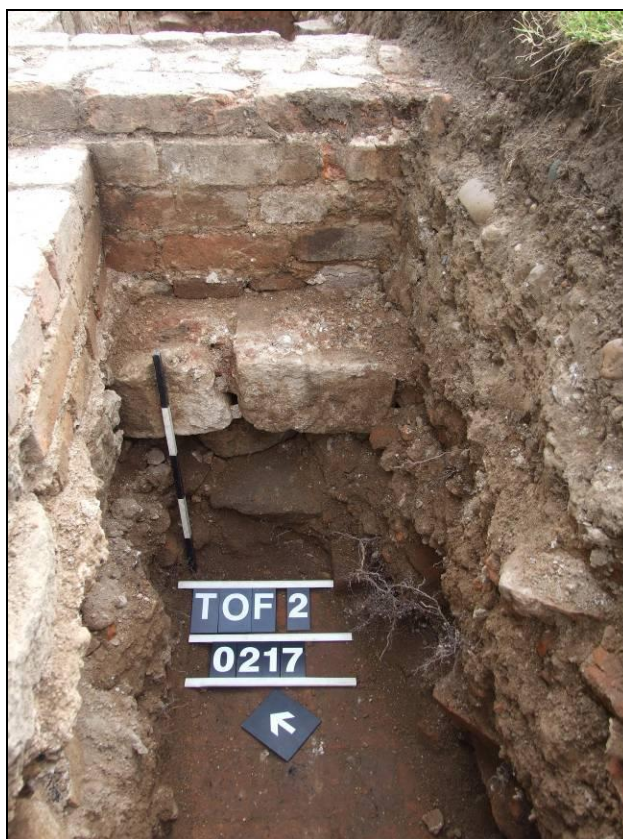
Plate 28: Georgian stone foundation (0217) under (0113) overlying 17th century rubble

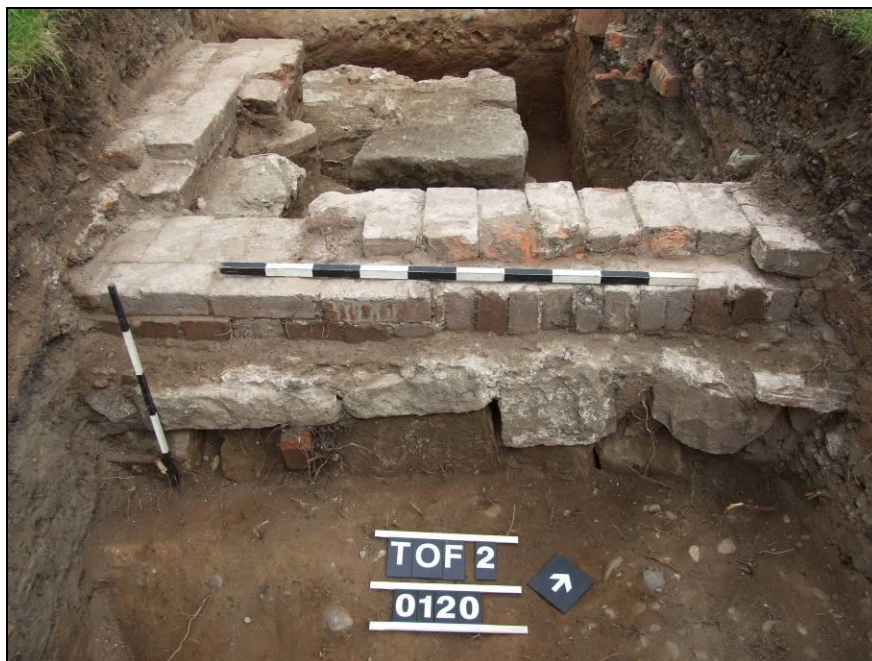
Plate 29: Stone foundation (0120) under brick foundation (0119) looking north west

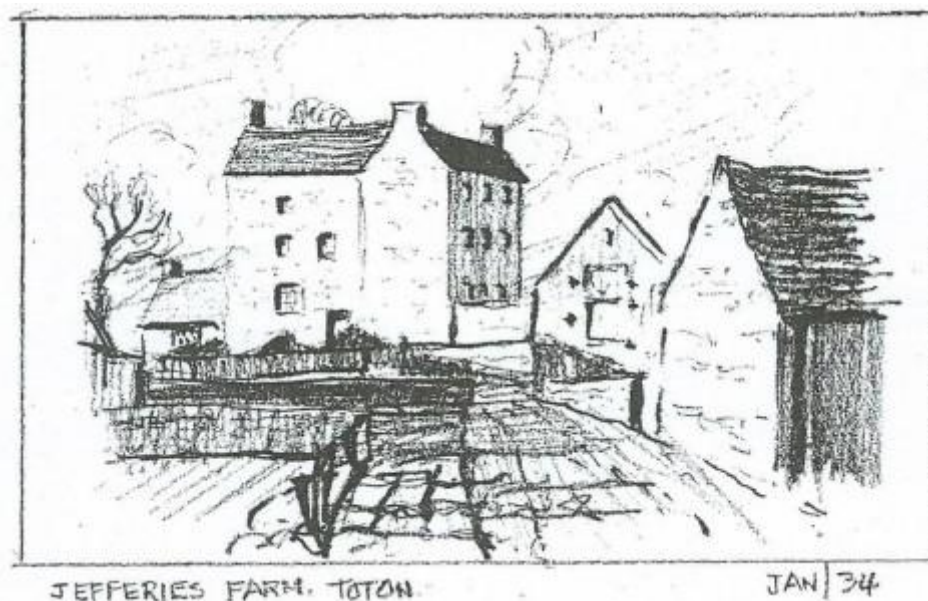
Plate 30: Sketch of Jefferies Farm January 1934 by Percy Barsby
(<http://totonunearthed.org.uk/totonmanor.html>)

Exterior wall foundations along the north of the building were identified ([0156], [0179], [0106], [0113]), generally orientated roughly east-north east - west-south west with short lengths of returning walls ([0105] and [0114]) orientated north west-south east (Plates 24, 25, 26, 27 and 28). A doorway was evident towards the north east of the building in the northern wall in Area 1(c) which accessed a barrel vaulted cellar. A short length of external wall foundation [0119] was also recorded which may represent the south of the building. This was built on lower stone foundation [0120] (Plate 29). Photographs and drawings of Manor Farm prior to its demolition show a doorway part way along the southern wall of the west wing and a further door may well have been present on the eastern wall of the east wing (Plate 30).

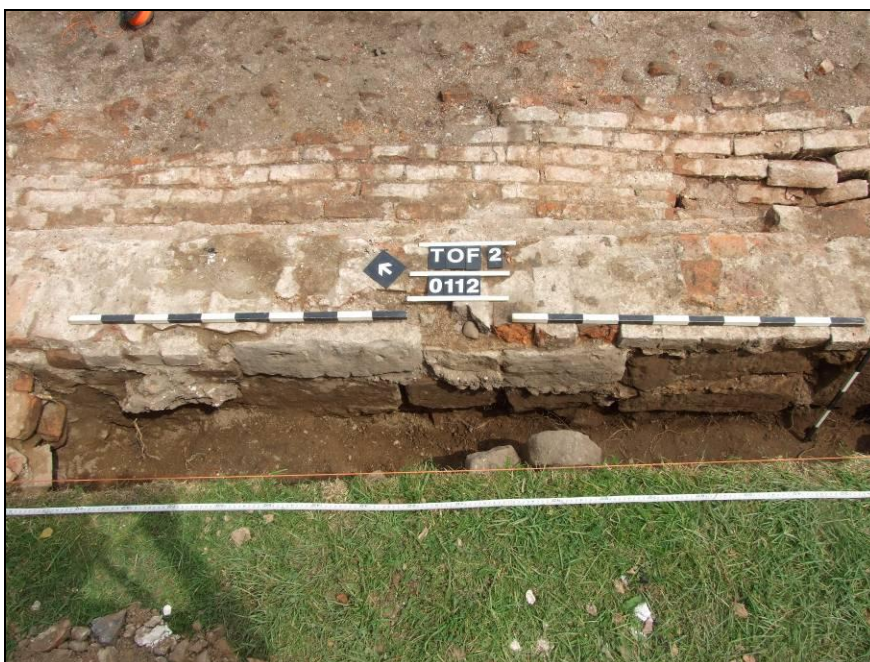
Plate 31: Foundation (0112) showing lower foundation (0232) looking north east

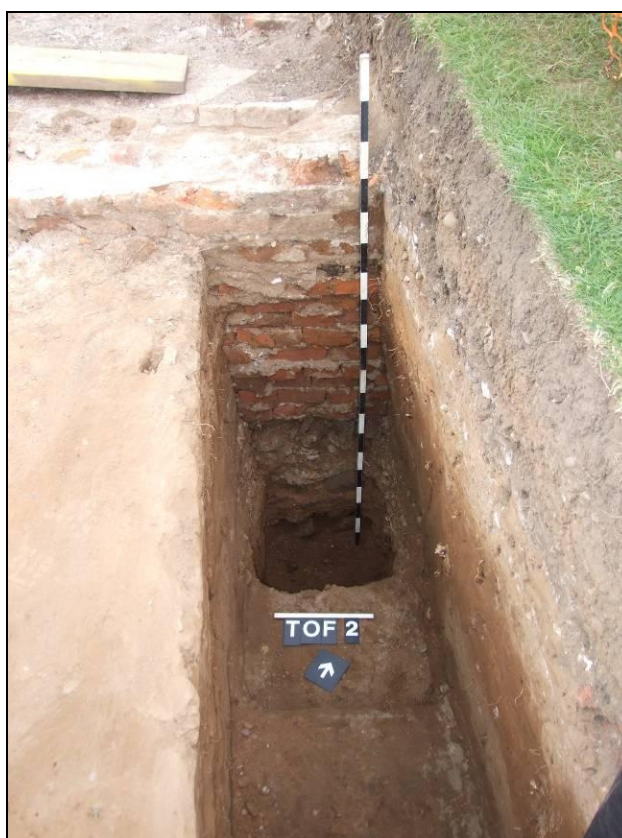
Plate 32: Sondage south of foundation (0108) showing (0223), (0224) and (0225) looking north west

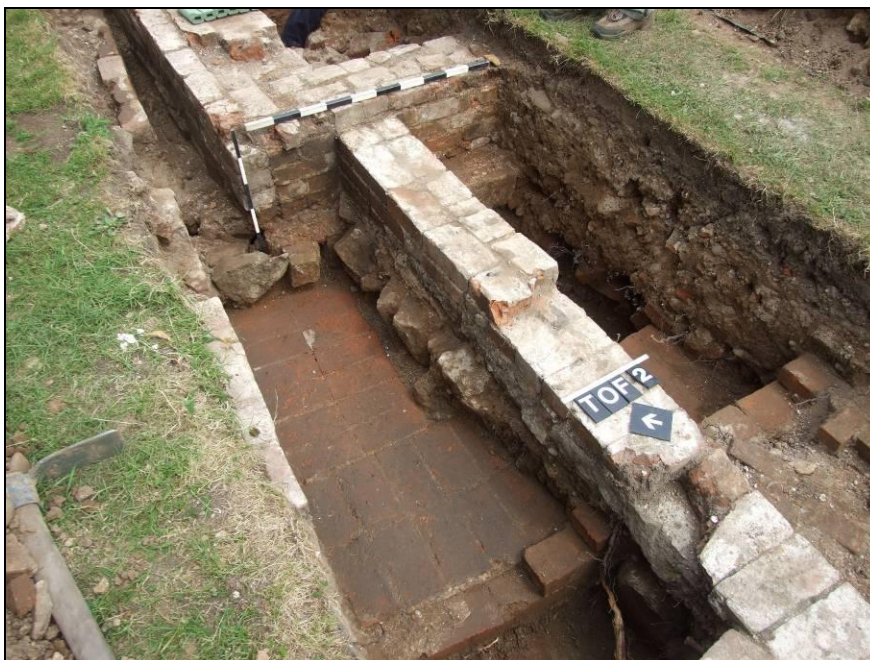
Plate 33: Wall foundation (0116) over 17th century floor (0204) looking north east

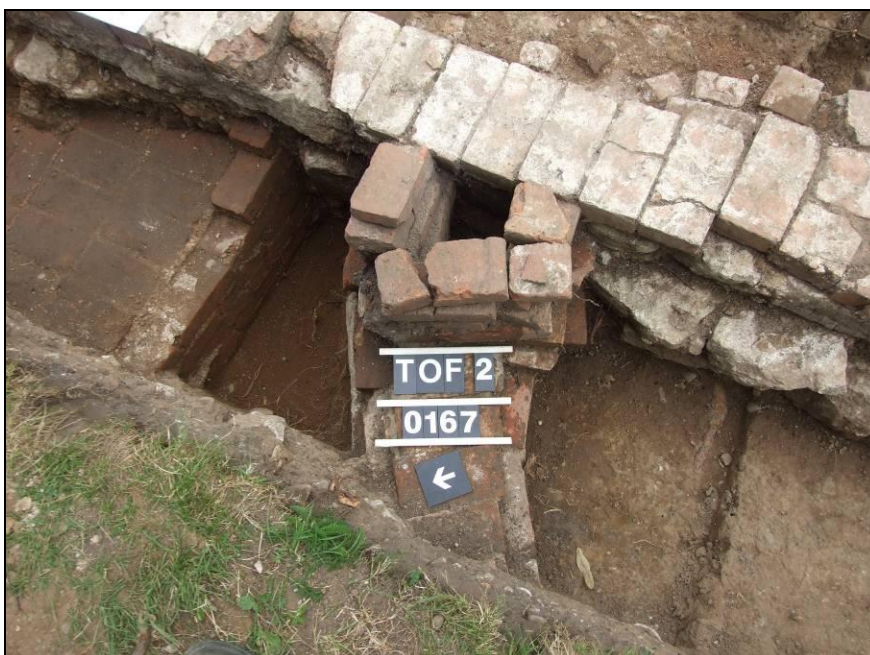
Plate 34: Downpipe drain outlet (0167) looking east

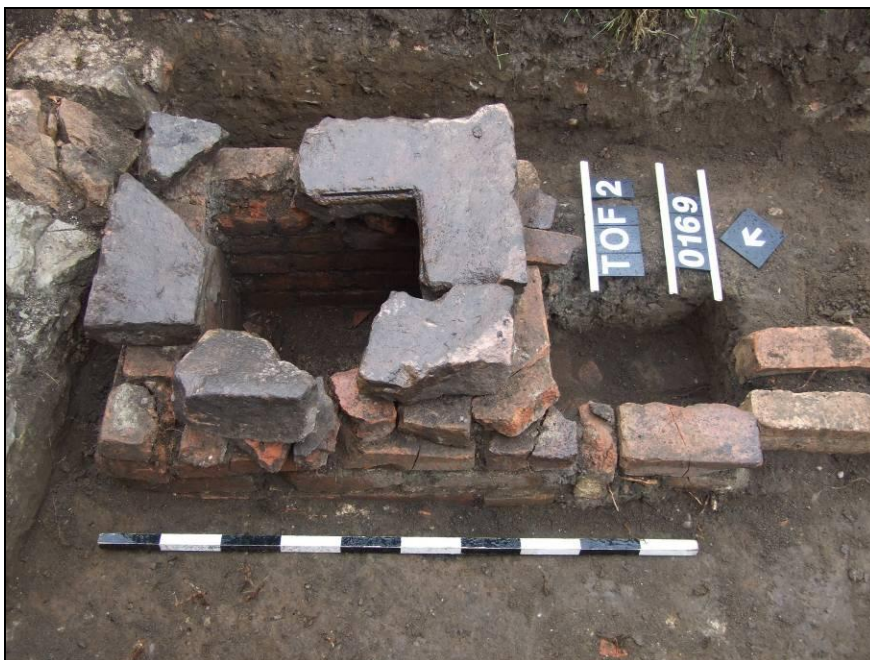
Plate 35: Drain (0169) looking south east.

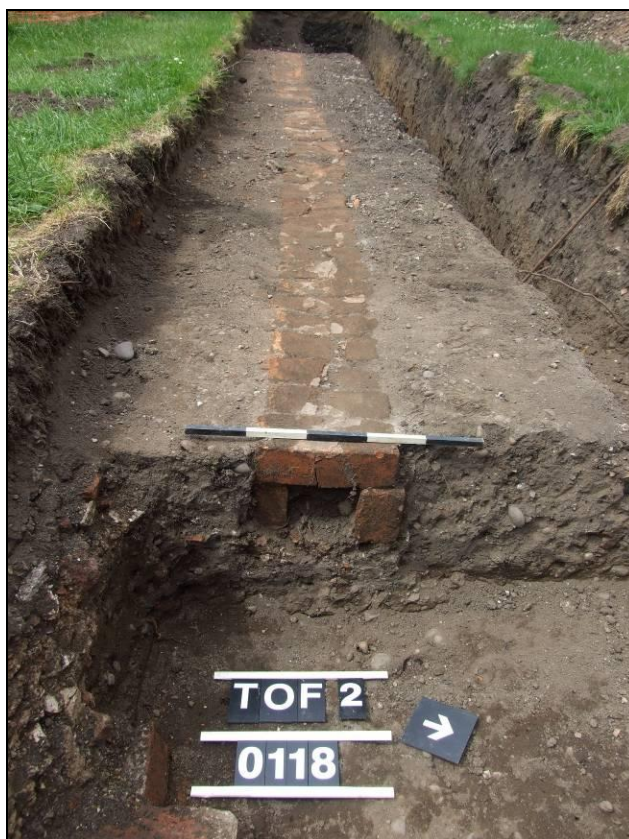
Plate 36: Brick box drain (0118) looking WSW

Red tubular ceramic 'land drain' [0174] was typical of those commonly used during the 19th century. It is thought to have replaced Georgian brick box drain [0118].
