TOTON UNEARTHED, TOTON, NOTTINGHAMSHIRE

Report on an archaeological evaluation on the site of 'Manor Farm' at Toton Manor Farm Recreation Ground, June-July 2014

TPA Project Code – TOF2

TPA Report No. 143/2014

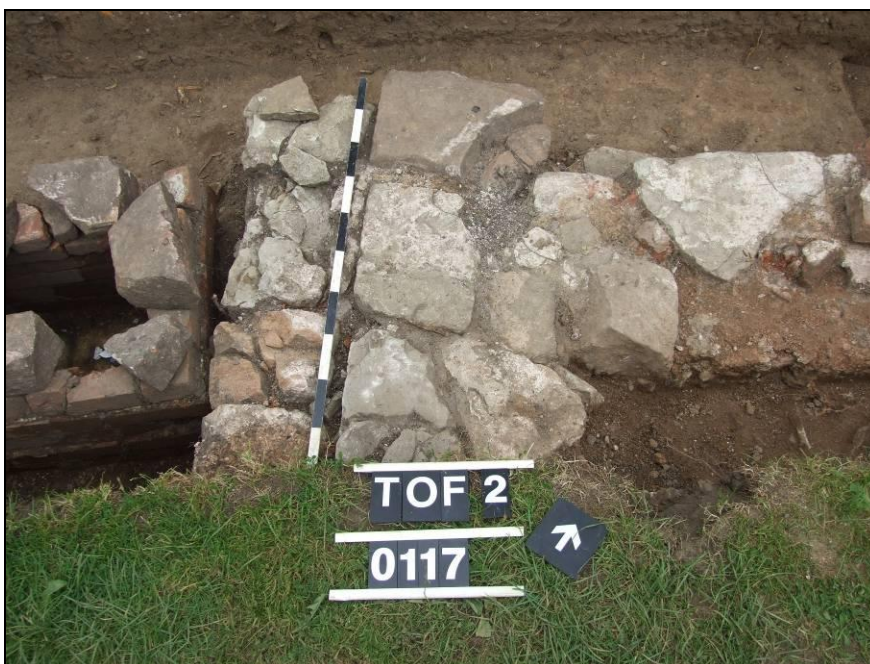
Plate 37: Stone floor or foundation (0117) looking north west

The western section of the house, the northern foundation wall of which was recorded during this excavation as [0116] is known from photographs of the building to have been single storey and this was evident from the foundation which was significantly less substantial than those for the rest of the building, being only a single brick length thick (Plate 33). It is thought that this room was a washing room. These foundations were sat on further stone foundation [0227]. A brick box drain, [0167]/[0202], was recorded to the north of this which probably took away water from a down pipe (Plate 34). The fill of this contained 19th century roof tile and 18th/19th century pipe stems (see Appendix 2). A further box drain, [0169], was recorded at the west of the building (Plate 35). This took water away down drain [0118] (Plate 36). It contained pieces of undated roof tile (see Appendix 2). Flat stone surface [0117] at the west of this part of the building may have been part of a floor or later foundation (Plate 37).

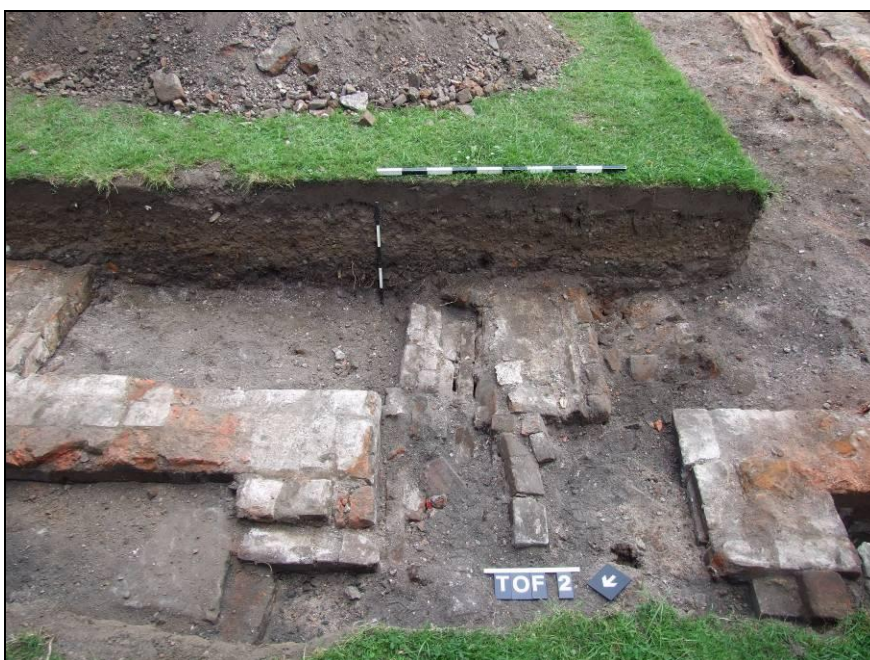
Plate 38: Opening for doorway to cellar between foundations 0106 & 0112 looking south east

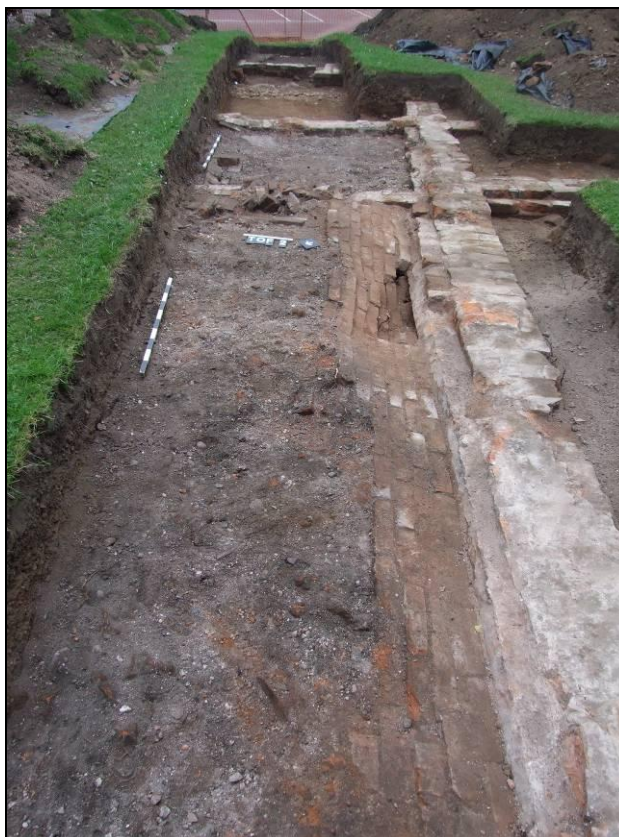
Plate 39: Area 1(a) showing collapsed red brick barrel vaulted ceiling (0107) and rubble (0102) infill looking south

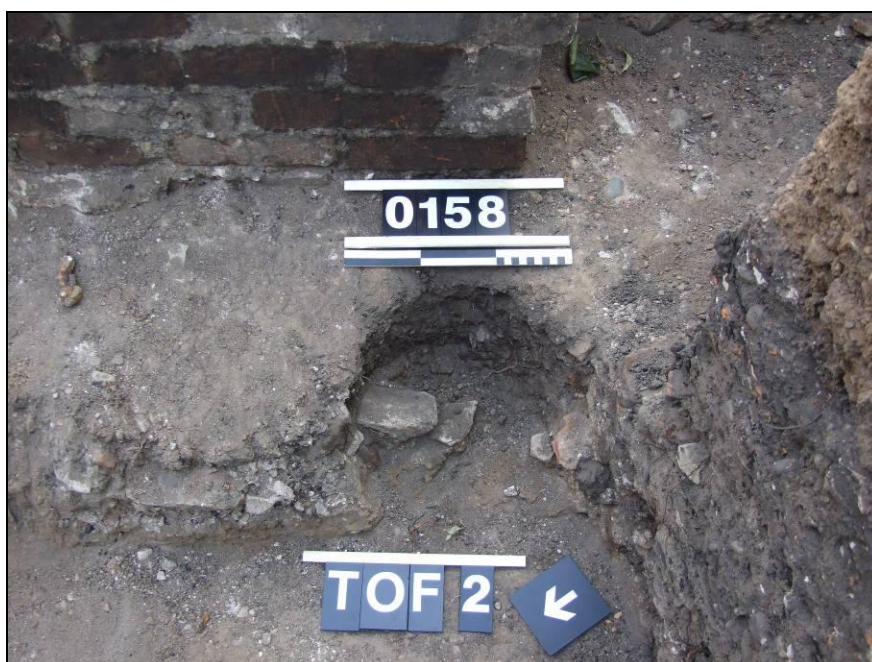
Plate 42: Post hole [0158] post excavation looking south east

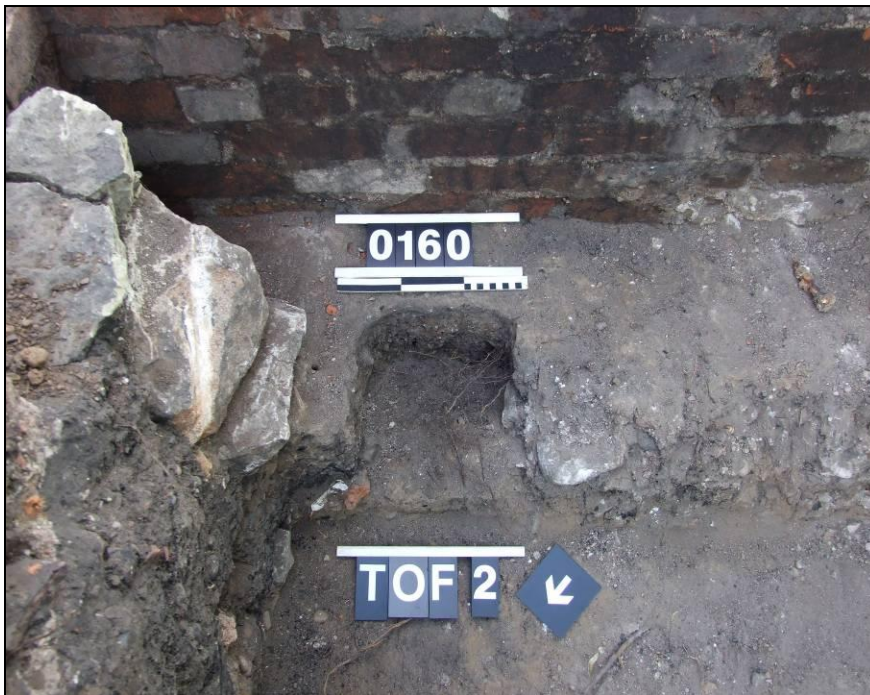
Plate 43: Post hole [0160] post excavation looking south east

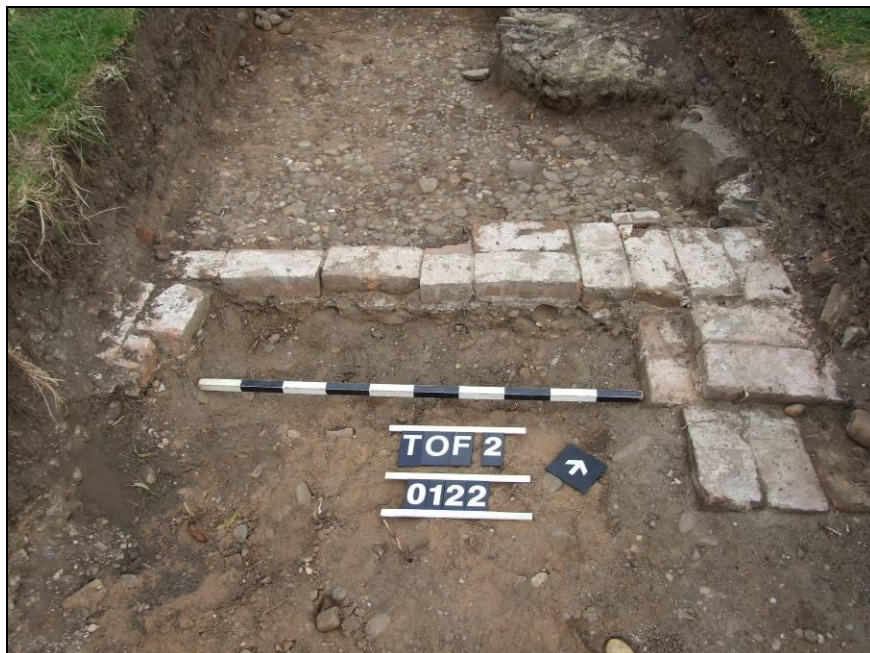
Plate 44: Retaining wall (0122) looking north west

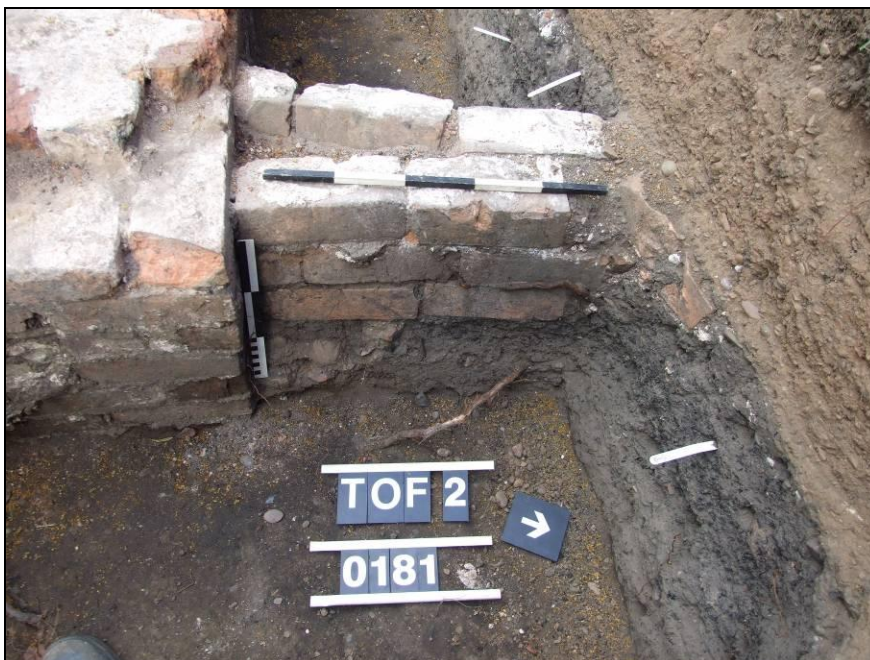
Plate 45: Victorian garden wall foundation (0181) looking west

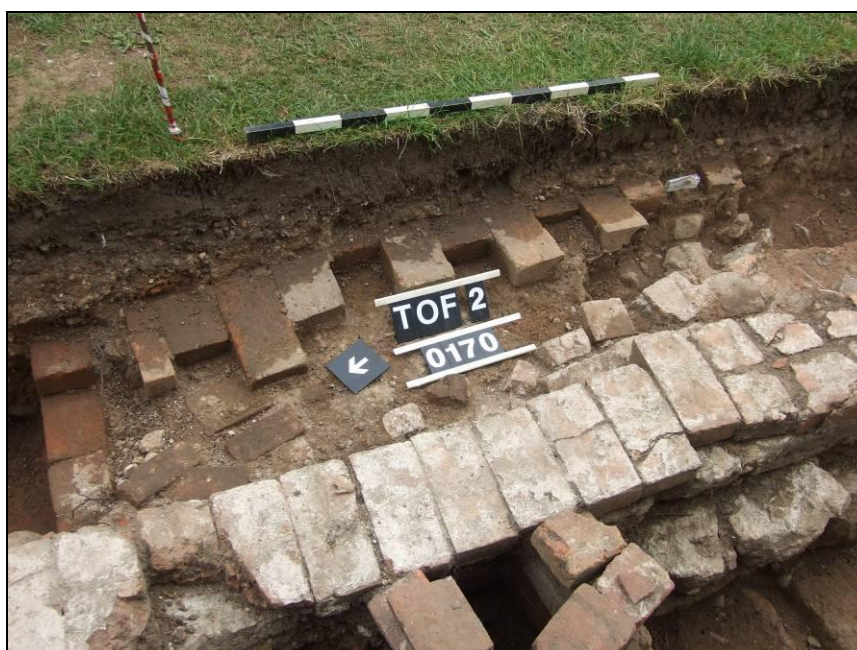
Plate 46: Victorian brick floor (0170) within foundation wall (0116) looking south east

Floor [0170] was constructed with engineering bricks (Plate 46) and located within the western end of the building in Area 1(b). It may have been part of repairs or refurbishment work. It overlay deposit (0163) which was building rubble containing Victorian waste.

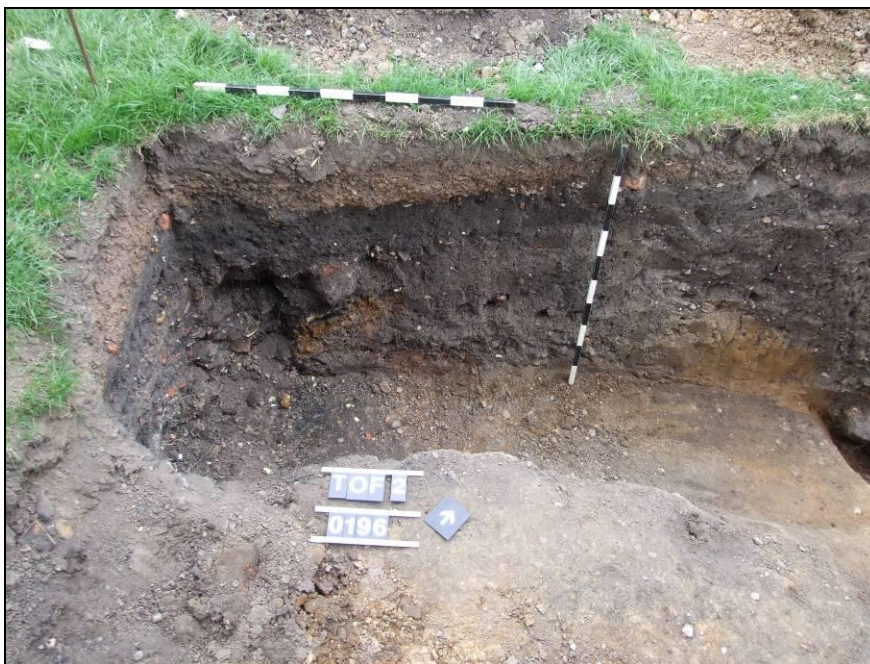
Plate 47: Victorian ditch [0196] looking north west

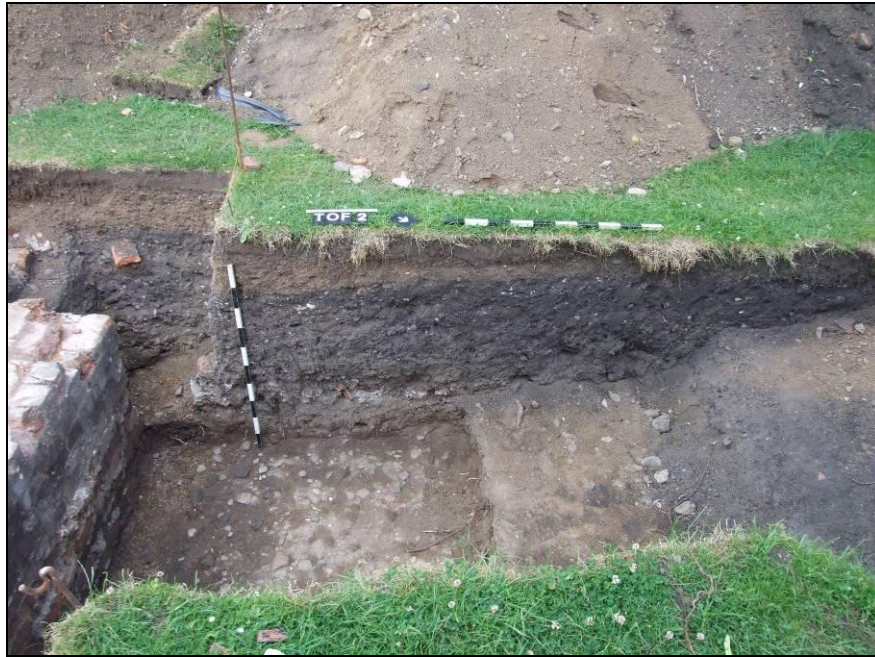
Plate 50: Section showing black ash deposit (0102) looking south west

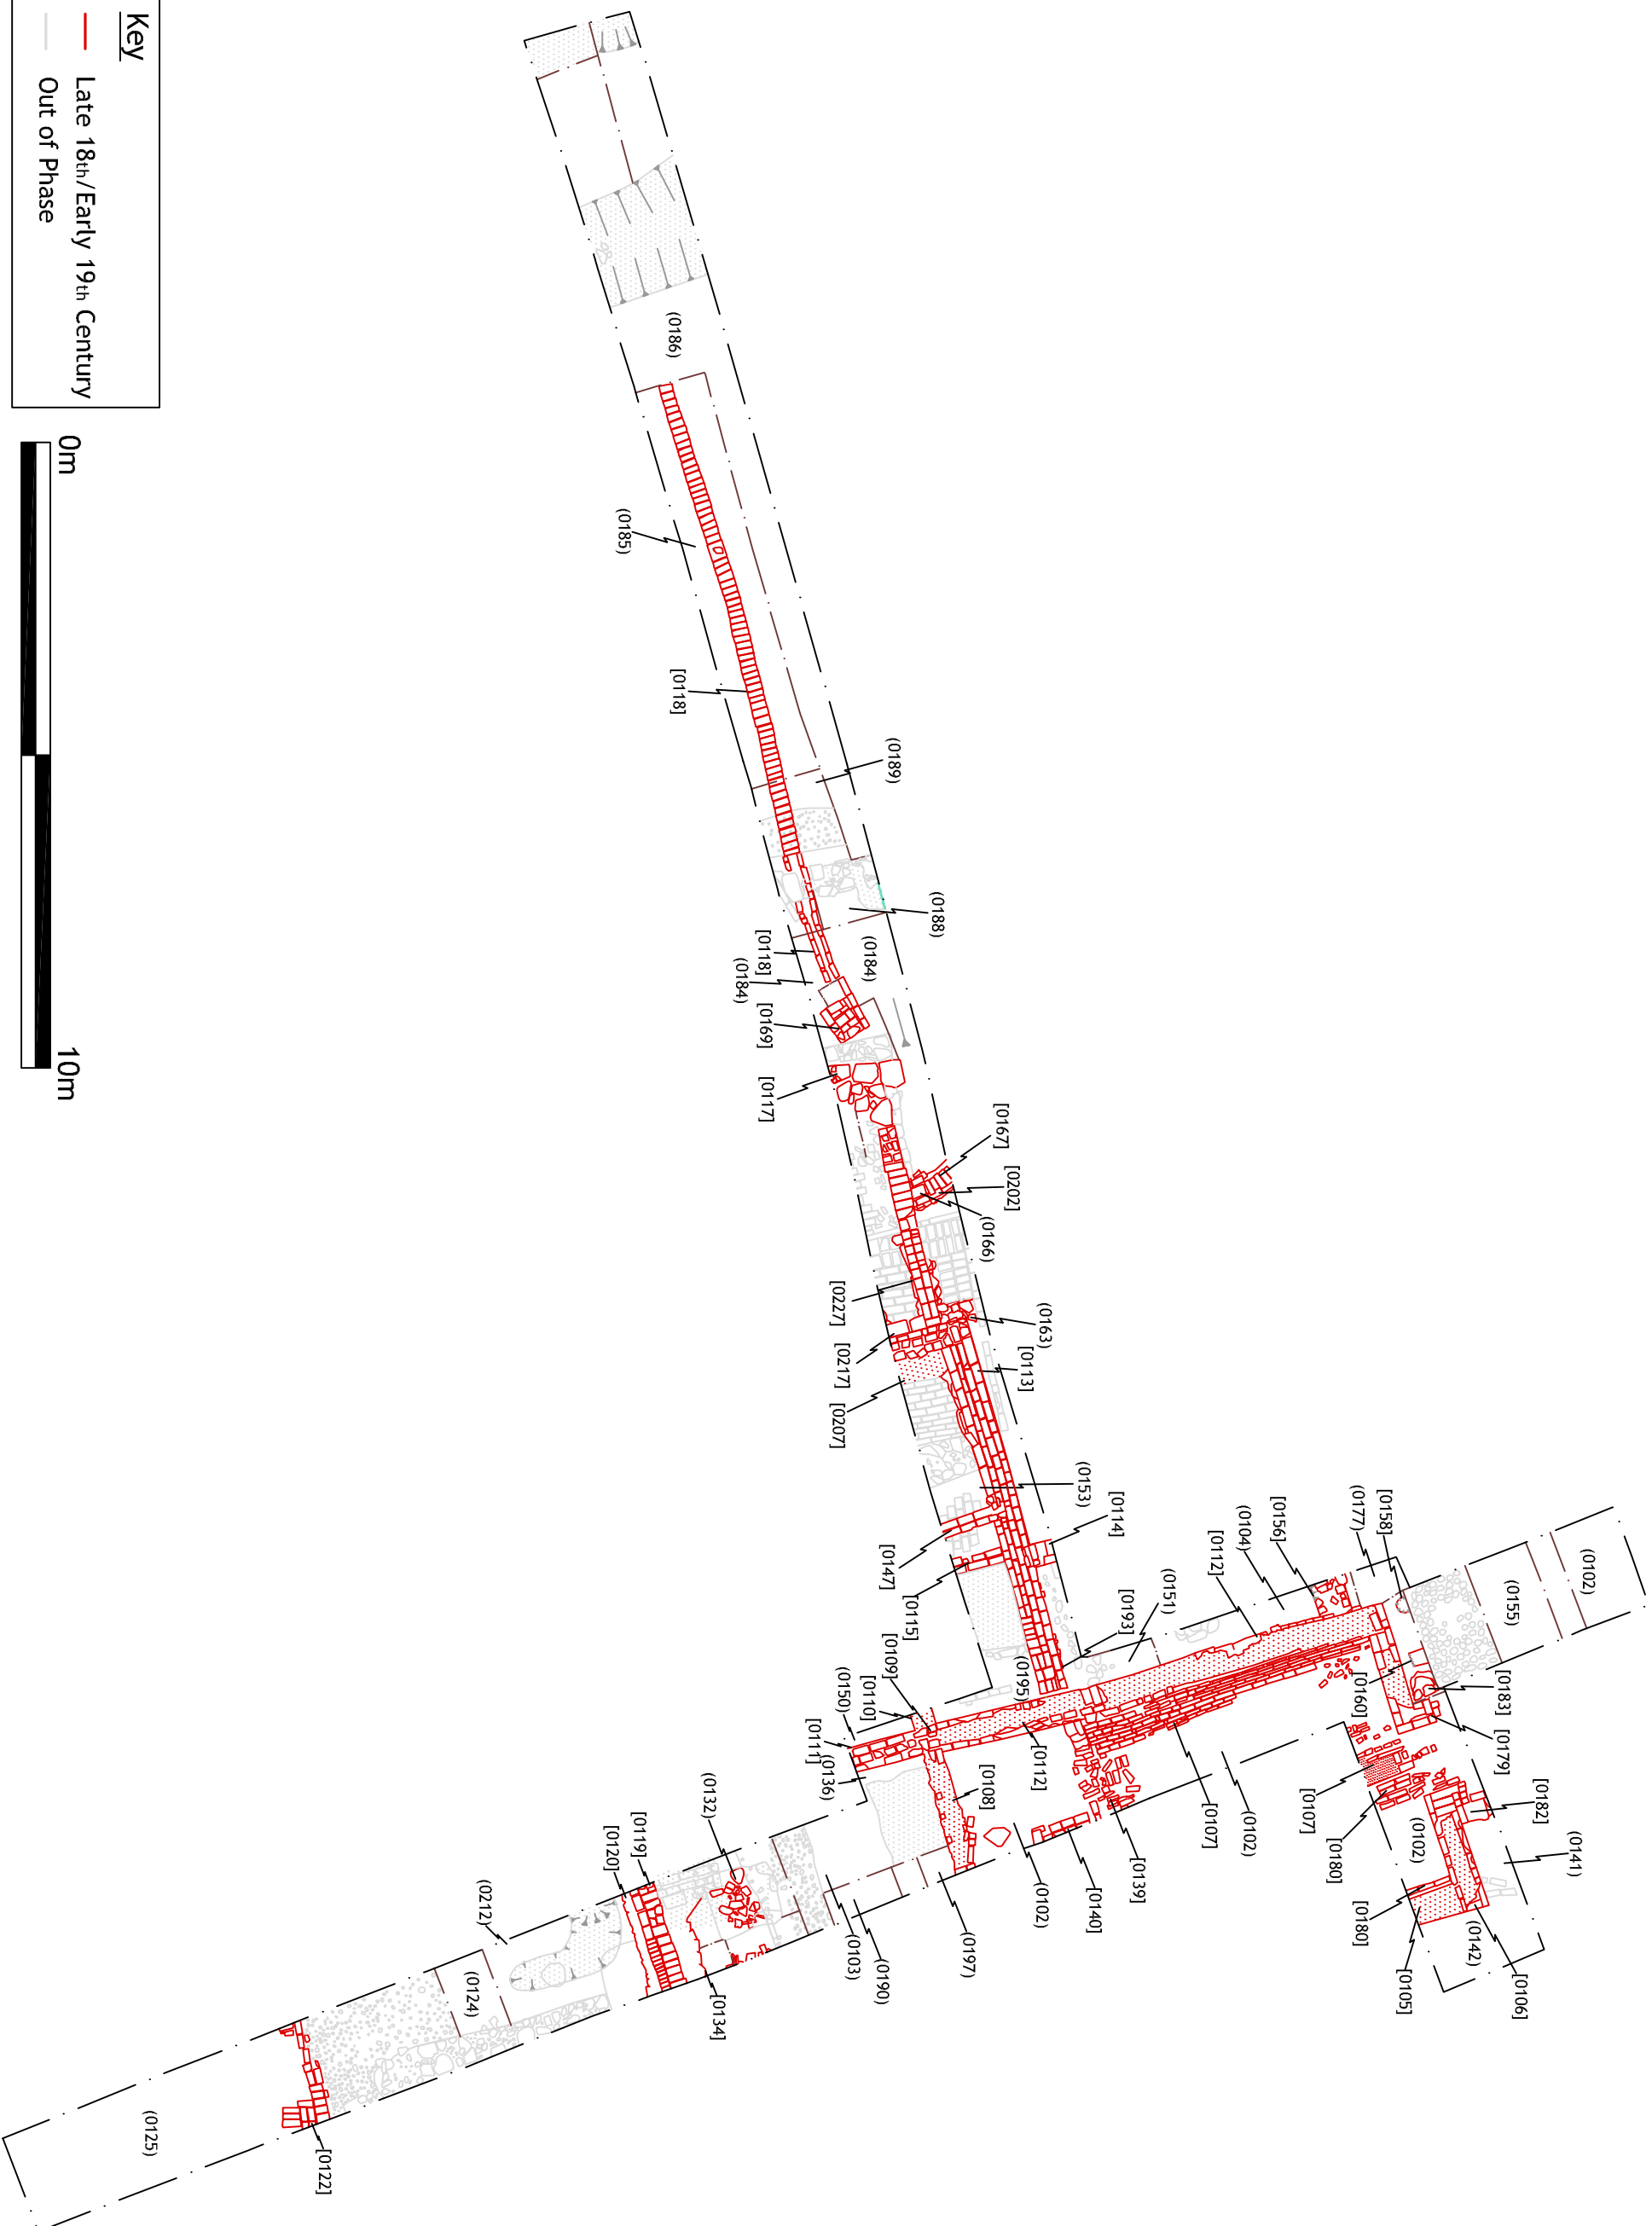
Figure 4: Site plan of the late 18th/early 19th century phase

The foundations of the 18th/19th century farm house had heavily disturbed all of the earlier features. They comprised the external walls of a large farmhouse as well as internal walls and a barrel vaulted cellar. Drains at the west of the site were recorded which presumably carried rain water from the roof of the house. Evidence of a portico styled entrance was identified to the cellar in the form of the base of a possible pillar either side of the entrance way at the north of the building. Mapping suggests that this building may have stood similarly from at least the late 18th century and so may have been a direct replacement for the 17th century

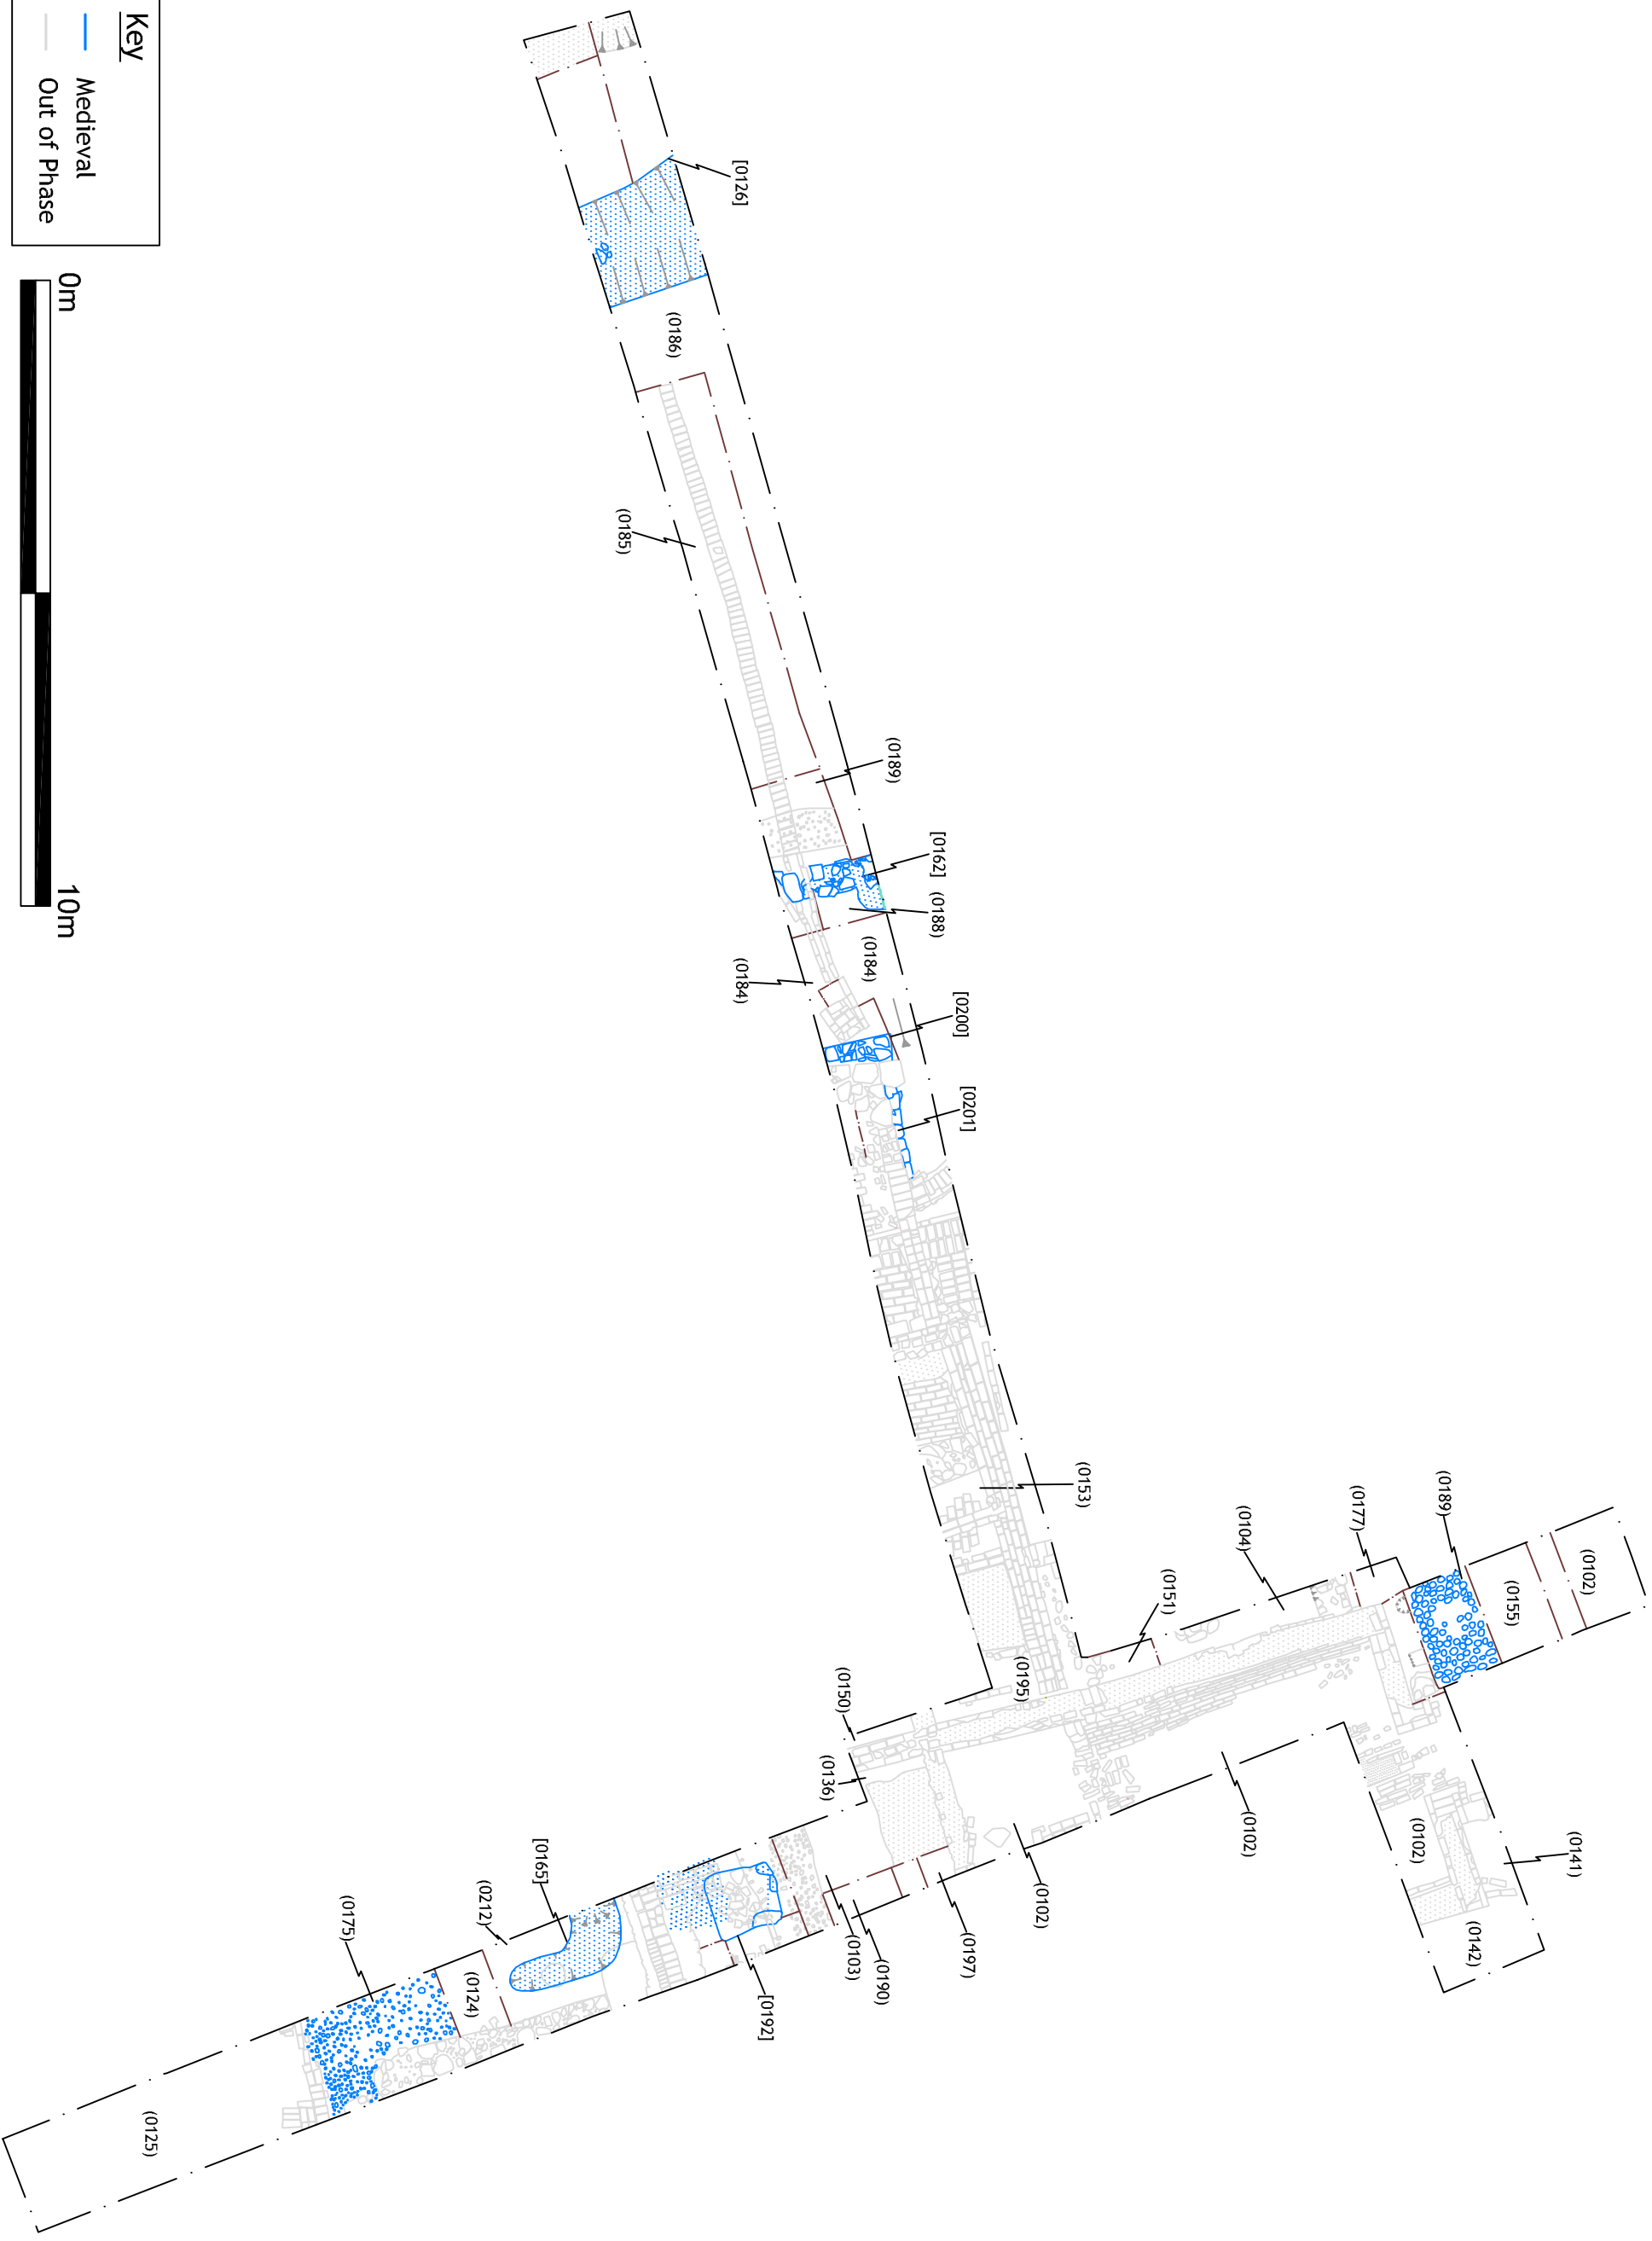
Figure 6: Site plan of the Medieval phase

The corner of a stone foundation of a building which may date to the medieval period was identified in Area 1(b) while a possible foundation plinth in Area 1(a) may also have dated to this period. A further wall and ditch towards the west of the site may have been related to medieval field enclosure while two areas of compacted pebble flooring may represent yards or working surfaces.
