Bingham Methodist Church, Bingham, Nottinghamshire

Historic Building Record

Report Number: 113/2014

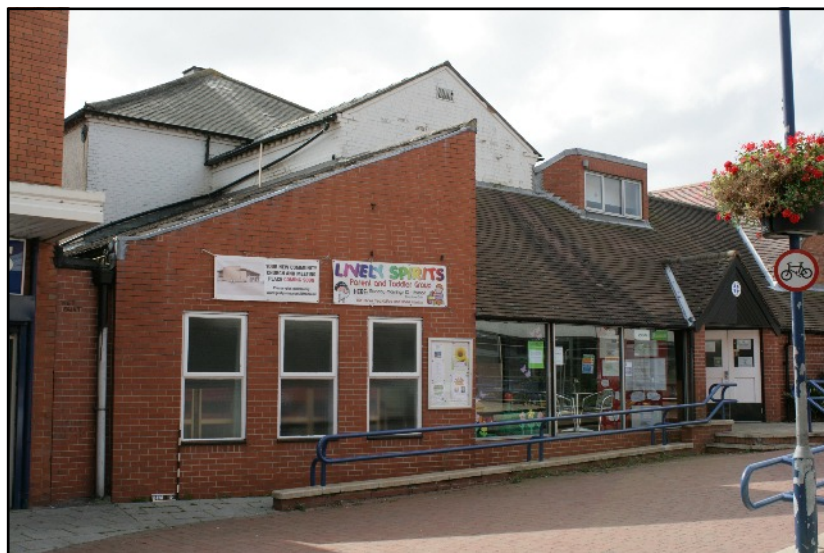
Plate 3. The north elevation of the Methodist Church complex, viewed looking south west.

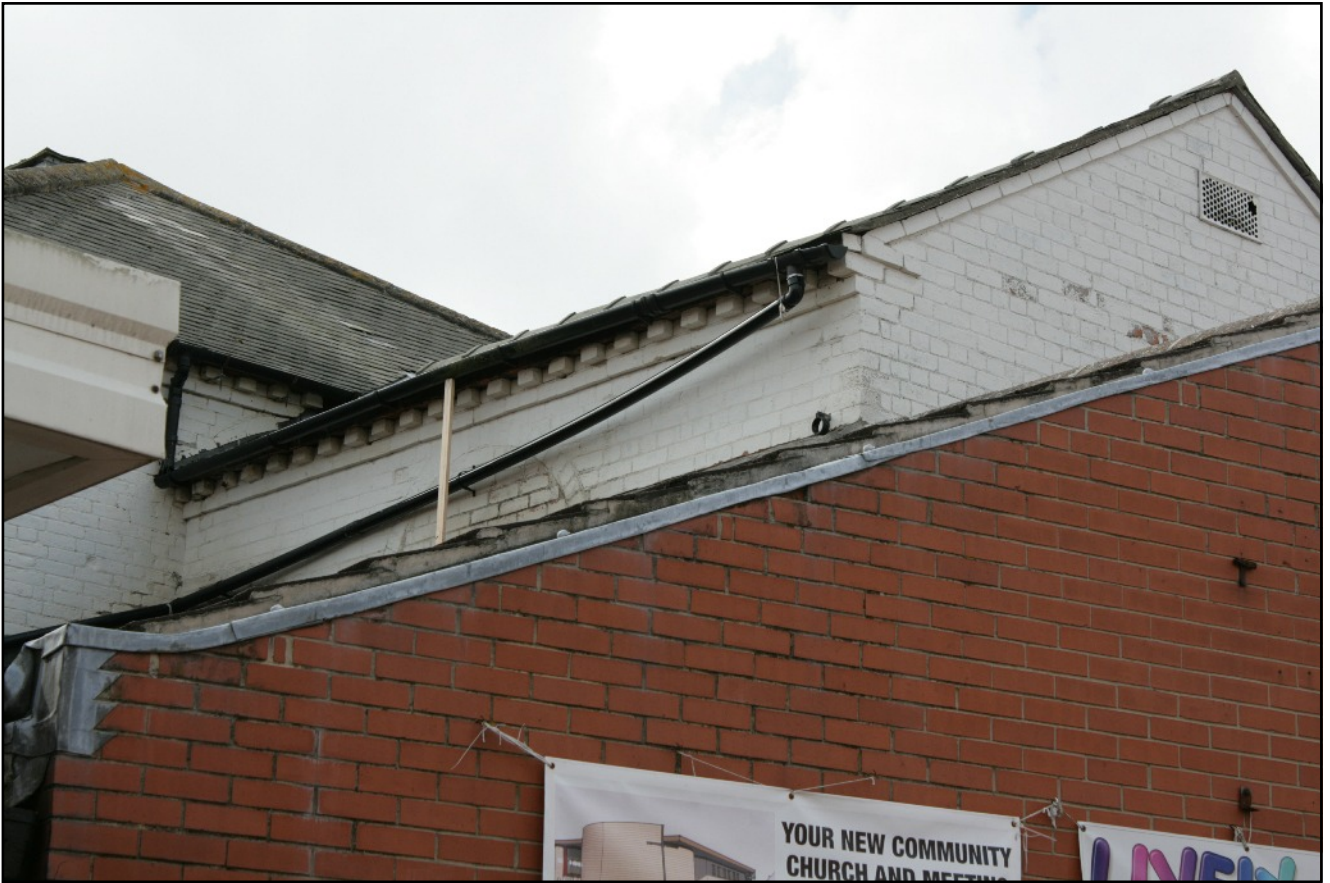
4.1.2 Abutting the north wall of the Georgian chapel is a square extension built in the same style as the earlier build discussed above. It is brick built in English Bond under a slate roof which is gabled. It also has dentil ornamentation below the eaves. An arched window, since blocked up, is located in the east wall.

Plate 4. Detail of the northern end of the two earliest phases of the building which are painted white. Note the blocked arch windows on both the north and east elevations, viewed looking, north east.

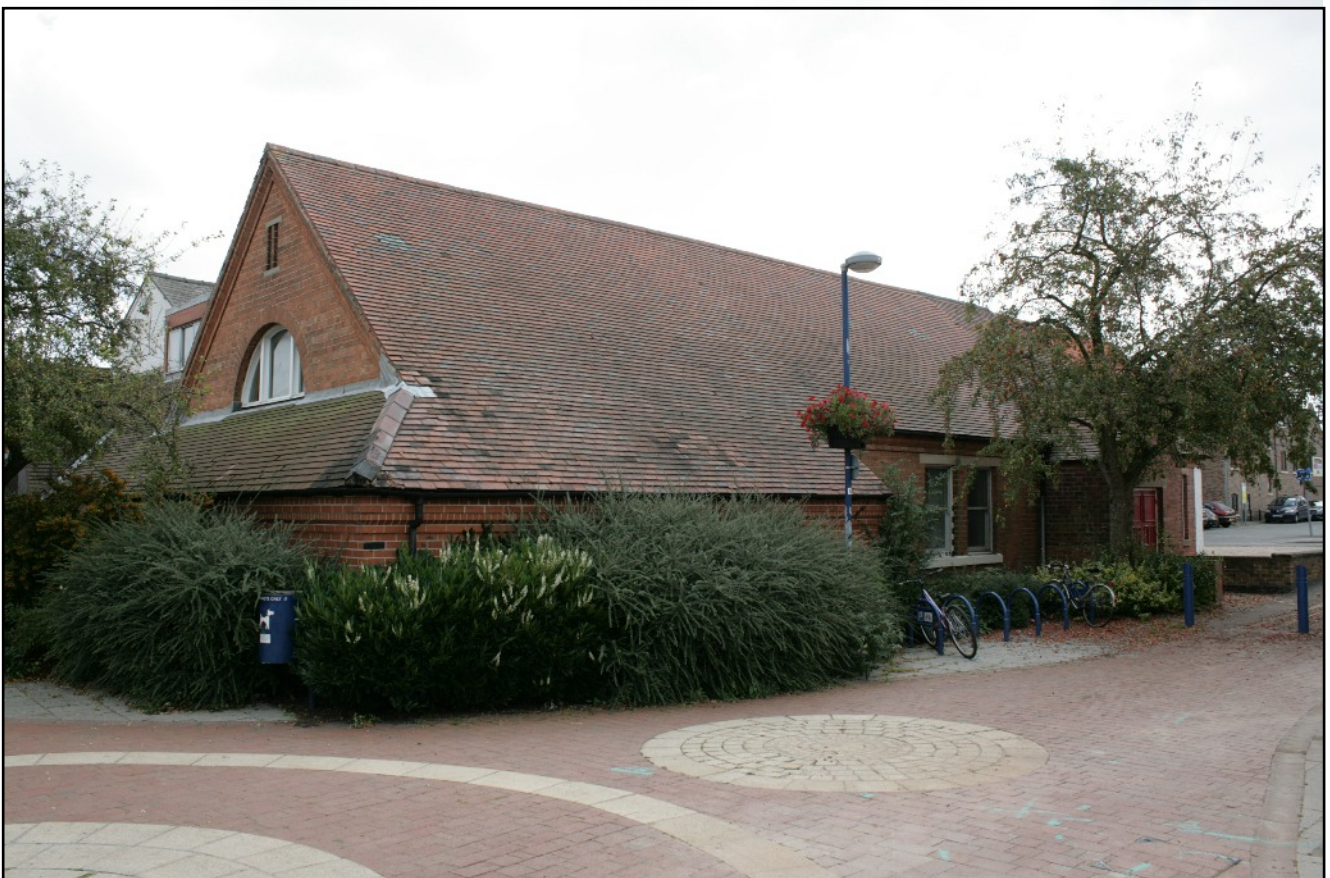
4.1.3 To the west of the chapel is the Sunday School, a building of two storey height orientated north to south. Inscribed bricks in the east wall suggest a date of 1898 for its construction. It is brick built in English Bond beneath a tiled gabled roof. Raised brickwork has been used decoratively beneath the eaves. In the north gable wall is an arched window with two, likely replacement, sash windows in the west wall. The building was extended to the south in the same style, probably during the early twentieth century, with the addition of a porch with double doorway and stone lintel fronting Needham Street. The roof is hipped at the south. Further alterations dating to the late twentieth comprise a sympathetic narrow single storey brick extension which extends around the northern part of the building.

Plate 5. The Sunday School, viewed looking south east.

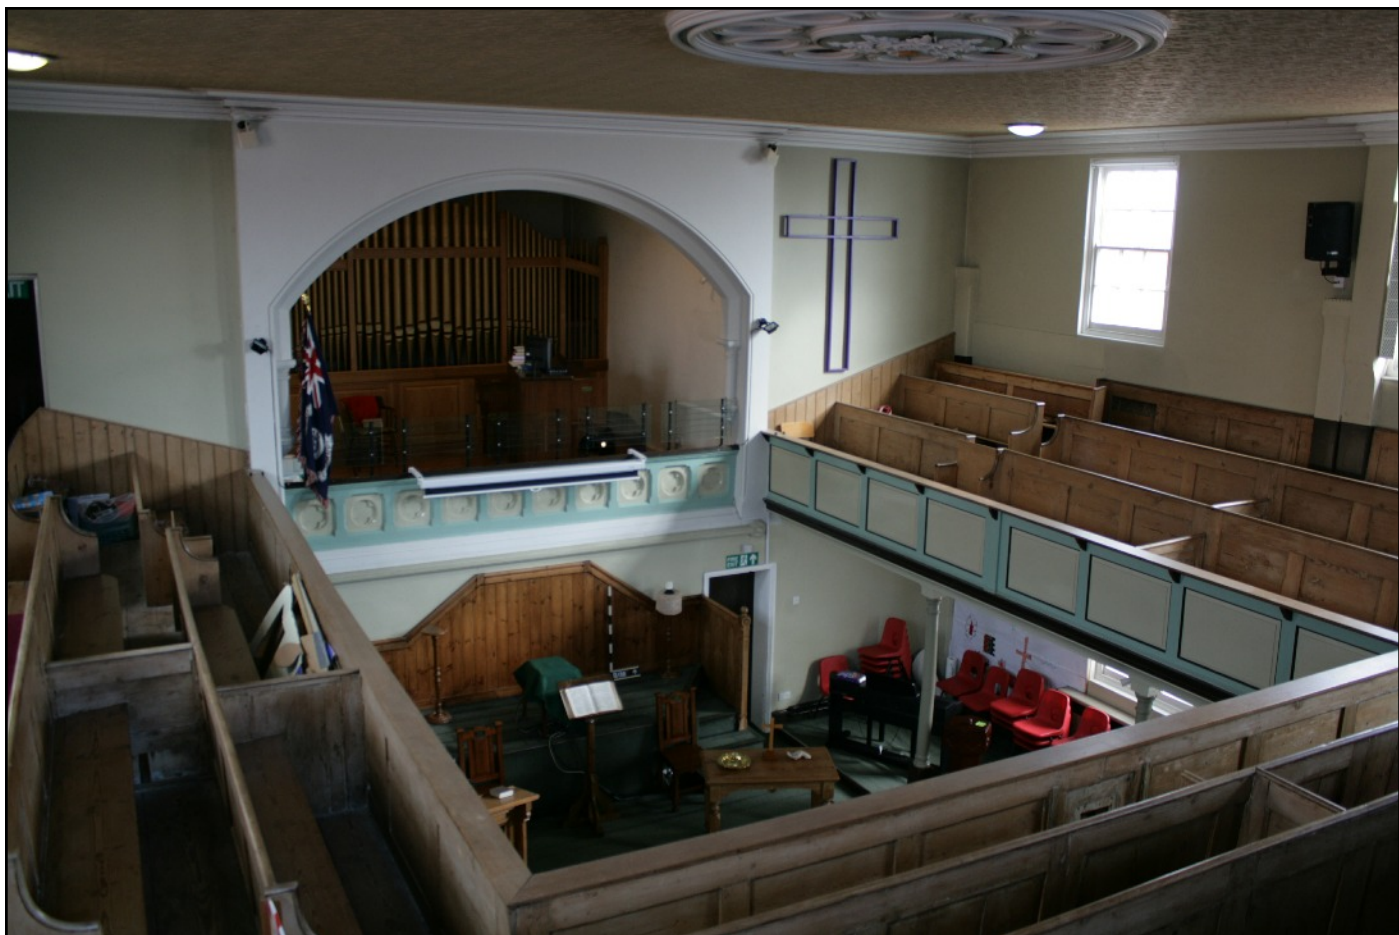
4.2.1 The Methodist Church complex is entered via the central doorway in the porch at the buildings south gable end. Four symmetrically placed doorways lead into the chapel, two providing access to the ground floor and two for the gallery. The chapel conforms to the 'auditory plan' in which its interior has been planned in order to enable the community to hear and see the preachers. Being a relatively large chapel its gallery extends along three sides of the building. The rostrum is devoid of a timber frontal or communion rail which is typical of chapels from this period, having being replaced, probably in the late twentieth century, with the current pine lectern, table used for the Communion and chairs. The later organ loft, forming a formal backdrop or frame to the rostrum area, would originally have been used for the choir with the current organ inserted in the twentieth century. The ground floor of the building has been re-seated in the Victorian period with simple pitch-pine pews. The panelled gallery is supported on seven cast-iron columns. Original pews in the gallery have survived previous refurbishments. As with many Methodist and Nonconformist chapels painting and graining has been used to pick out distinctive architectural features, including the cornice, organ loft and fine ceiling rose.

Plate 6. The organ loft set above the rostrum with the fine ceiling rose. Note the original pews in the gallery. Viewed looking north east.

5.1.2 The Georgian chapel retains much of its original interior, including original pews in the gallery, and as such may warrant further recording which could be undertaken during, or immediately prior to, demolition.

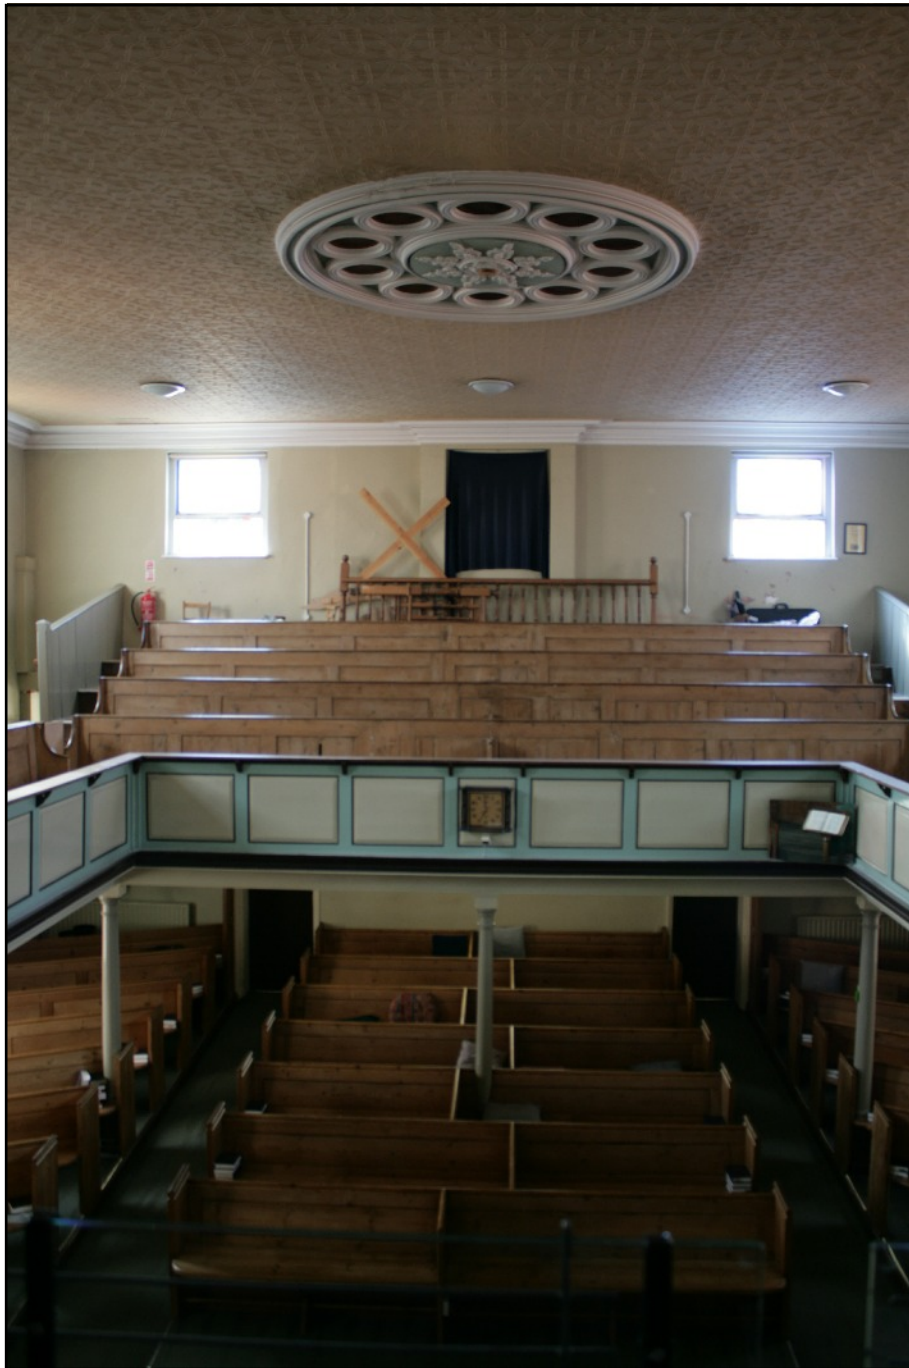
Plate 8. The interior of the chapel viewed looking south from the organ loft.

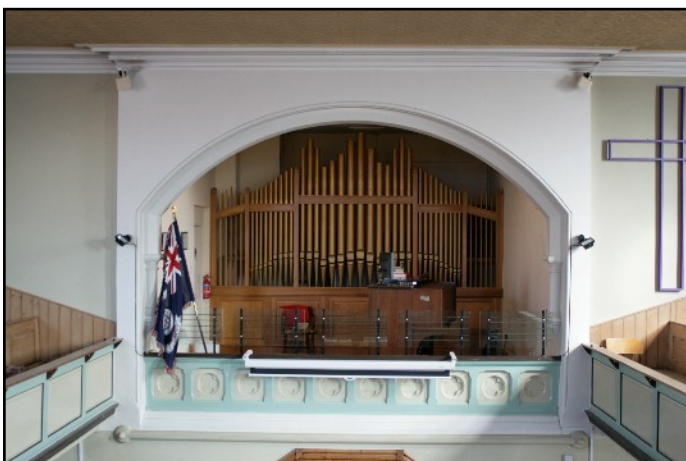
Plate 9. The organ loft, viewed looking north.

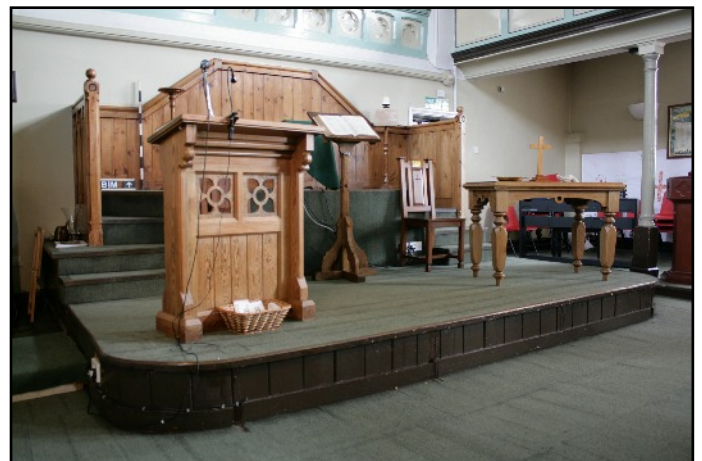
Plate 10. The rostrum with modern furniture, viewed looking north east.

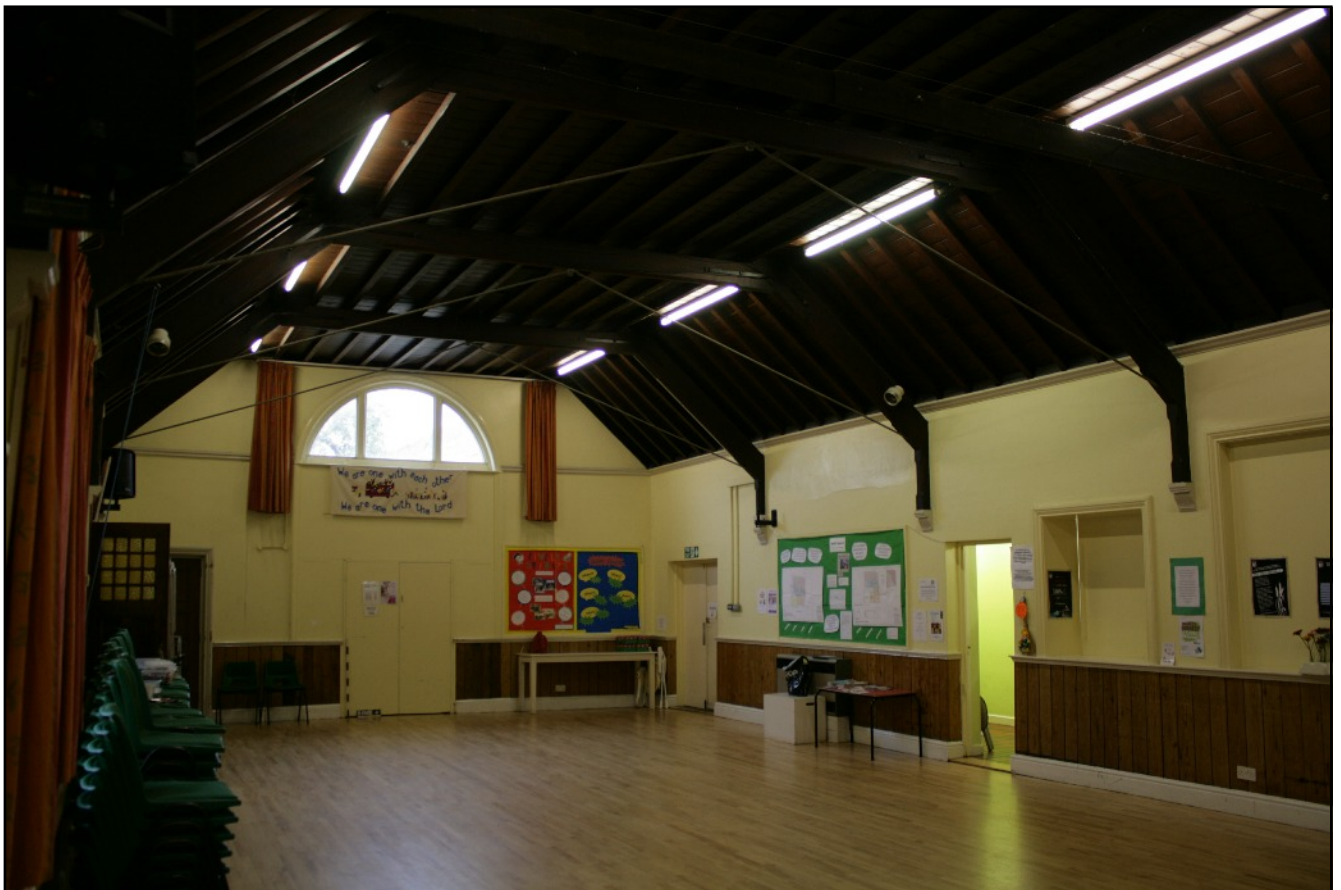
4.2.2 The Sunday School can be entered either via the southern extension or through the porch fronting Needham Street. It is a single room of five bays with four roof trusses resting on stone corbels. The roof structure is partially exposed, typical of buildings of late Victorian date. The original cornice and dado rail survive and a number of the original doors and fittings

are present. The floor is a modern laminate replacement. Three of the windows on the east wall have been blocked presumably when the kitchen was constructed. The southern extension to the Sunday School has been refurbished recently with a new false ceiling and laminate floor. The doors and windows are however likely to be original to the building.

Plate 12. The interior of the earliest phase of the Sunday School viewed looking north east.
