Greatford Sewer Scheme
Archaeological Monitoring and Recording
Prepared by T. Linington for Anglian Water
2014

Project Code – GFA TPA Report No. 62/2014

- Trent & Peak Archaeology was commissioned by Anglian Water to carry out a scheme of archaeological monitoring and recording of the works taking place to install the new vacuum sewer system in Greatford, Lincolnshire.

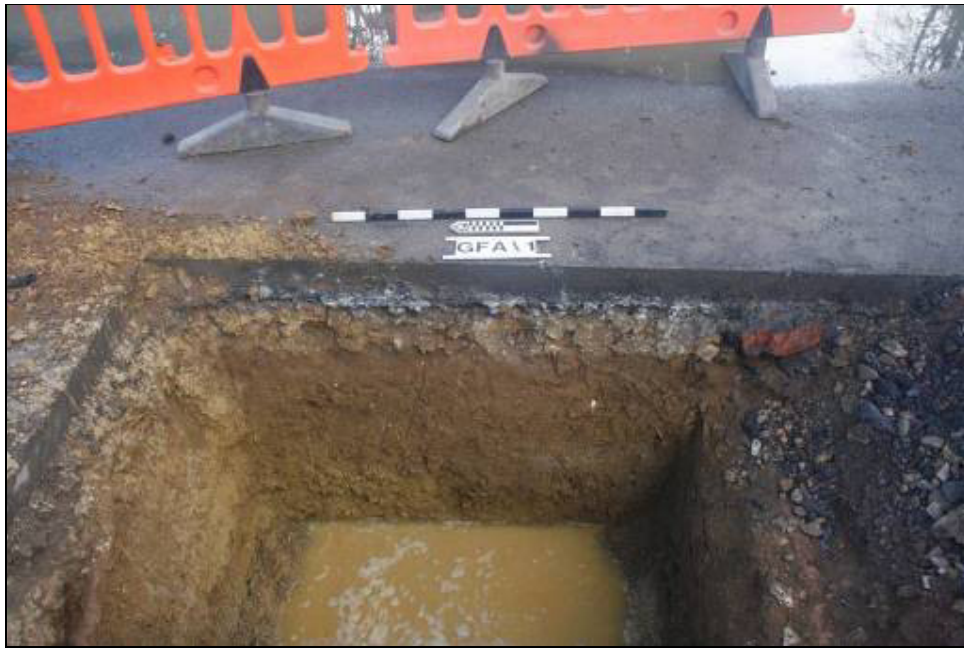
- 5.3.1 **Pot#1** was located on Carlby Road, outside Brooke Lodge. The excavated pit measured 1.6m x 1.6m and was 1.2m deep. After the removal of the tarmac (1023), sub base (1033) and hardcore make-up (1027) to a depth of 0.35m BGL, a probable alluvial deposit (1036), consisting of mid yellow-brown silty-clay, was observed. This material sealed a pit [1038] and fill (1037), at a depth of 0.90m BGL, consisting of mid yellow-brown clayey-silt. The date and use of the pit was unknown, due to no finds being recovered from its fill. The pit cut the natural gravel (1035 and 1010) at 0.90m BGL and continued both beneath as well as to the south outside the limit of our excavations and could not be further investigated due to the high water table. See Plate 1

Plate 1: Pot #1 looking east, showing pit [1038]

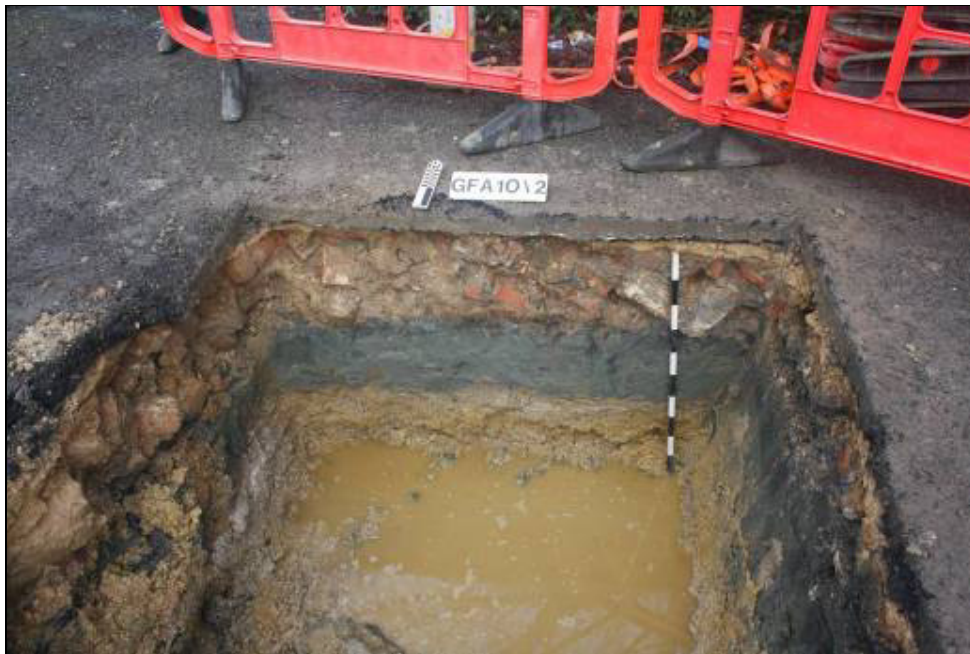
- 5.3.3 **Pot#3** was located outside Nos. 6, 7 and 8 Greatford Gardens. It measured 1.8 x 1.8m and was 1.2m deep. After the removal of the tarmac (1013), type one (1014) and demolition rubble/make up (1015) to a depth of 0.42m BGL, a firm mid blue-grey silty-clay (1041) was observed to a depth of 0.84m BGL. This layer either related to the use of this area for the cultivation of water cress prior to the 1970s or was an alluvial deposit from the nearby West Glen River. This material extended to a depth of 0.84m BGL, at which point it sealed the natural gravel deposits (1035). See Plate 2

5.4.7 The blue-gray clay which extended across the entire area, was interpreted as most likely being alluvial material, though it is possible it related to the use of the area for watercress cultivation in the middle of the 20th century. This material extended to a depth of between 0.70m and 0.84m BGL, and rather than there being a distinct change between it (1041) and the alluvium observed along Carlby Road (1034), a gradual change in colour was observed between these two deposits, supporting the suggestion that it was an alluvial deposit rather than being related to the watercress cultivation.

Plate 2: Pot #3 looking north, showing blue-gray alluvial clay [1041]

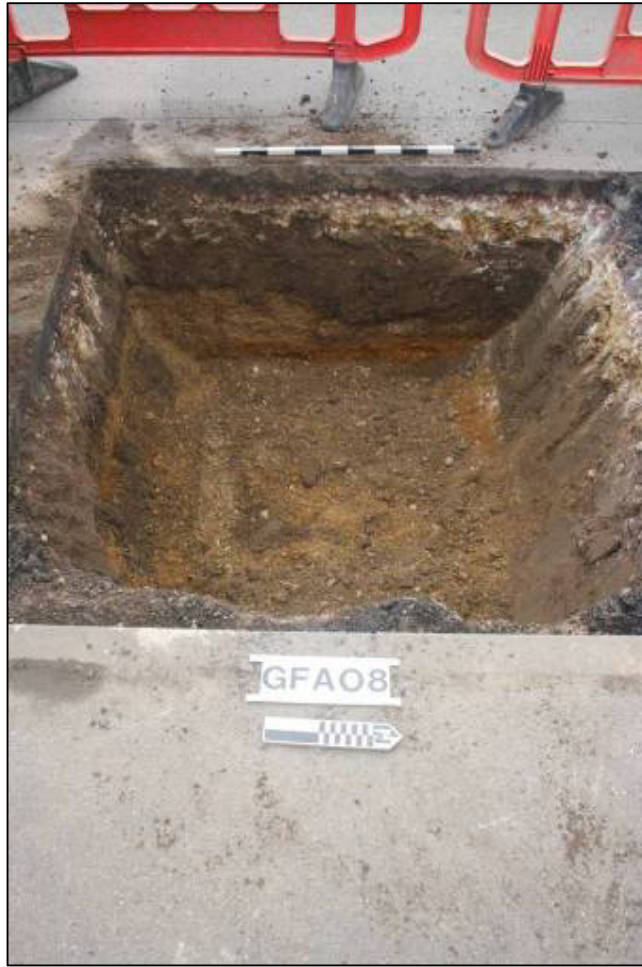
- 5.3.8 **Pot#8** was located outside The Hall Cottage on Carlby Road, ca. 20m south of the West Glen River. It measured 2.0m x 2.0m and was 1.2m deep. After the removal of the Tarmac (1059) and underlying Type One (1060) to a depth of 0.35m BGL, a layer of dark-brown clay-silt (1061) was observed to a depth of up to 0.90m BGL. However the material stepped up at the southern end of the pit, to a depth of 0.70m BGL. This step was also observed at a later date, when the trench for main sewer was excavated. It was interpreted as a natural terrace formed in the underlying natural gravel (1062), associated with a former course of the West Glen River. At 0.90m and 0.70m BGL respectively, the natural gravel (1062) was observed, and extended to at least the limit of our excavations. See Plate 3.

deposits were only observed to extend ca. 20m, at which point a natural terrace in the underlying gravel was observed and the alluvium petered out (see Plates 3 and 9), again this correlates with the finding of the BGS. These observations indicated that the floodplain was probably located to the north of the river and that occupation therefore would have been centred south of the river (probably around the area of the church). Due to the depth of the alluvium north of the river, it is quite possible that early features have survived later truncation, beneath the alluvium, however only one such feature was observed during these works and it is discussed below.

Plate 3: Pot #8, looking west showing natural terrace in natural gravel (1062)

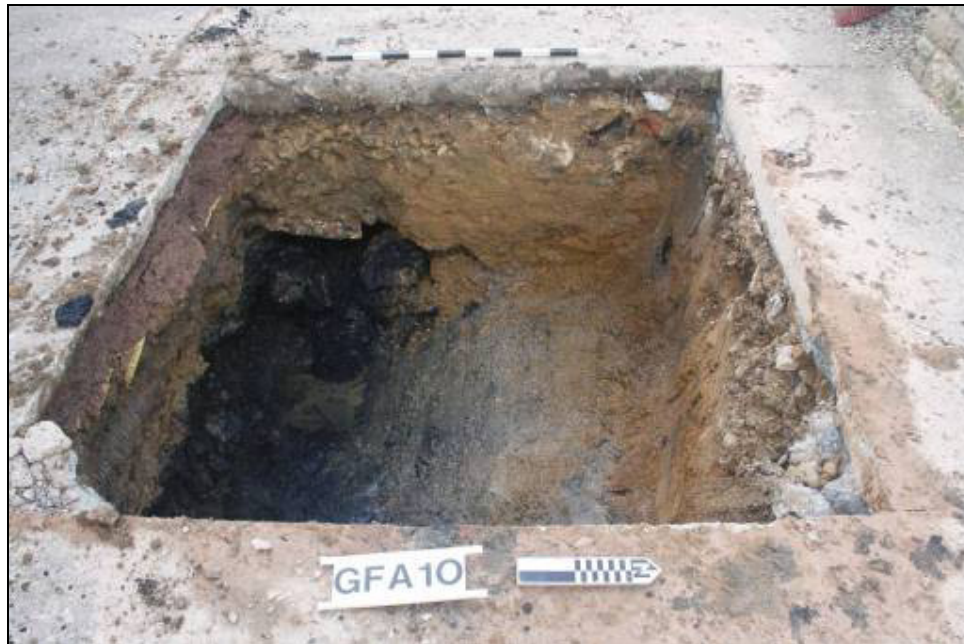
- 5.3.10 **Pot#10** was located in the pavement outside Carlingford House, on Main Street. It measured 2.0m x 2.0m and was 1.2m deep. After the removal of the tarmac (1059) and underlying compacted angular sandstone fragments, up to 150mm across, (1073), to a depth of 0.30m BGL, two things were observed. One being the backfill (1055), cut [1058] and infill (1057) of a 19th century (and still in use) culvert or drain, that was aligned east-west, (1056). This feature extended the full depth of the pit, and up to 0.6m from the southern extent of the pit. It cut a yellow-brown buried soil horizon (1053), which extended across the rest of the pit, to a depth of 0.90m BGL. Similarly to the observations made in Pot#9, it was unclear what this horizon related to. Whether it was associated with the construction of the surrounding buildings in the 18th/19th century or earlier was unclear. It was observed to be sealing the natural gravels (1062) at 0.90m BGL, which extended to at least the limit of our excavations. See Plate 4.

- A 19th/20th century culvert or drain [1058]. This feature was observed within Pot#10. It ran east-west on the northern edge of Greatford Main Street. While the construction of this feature indicated a 19th century construction, service plans showed that the drain was still being used as a storm drain and that in some places it had been replaced by a ceramic pipe.

Plate 4: Pot #10, looking west, showing 19th/20th culvert/drain (1056)

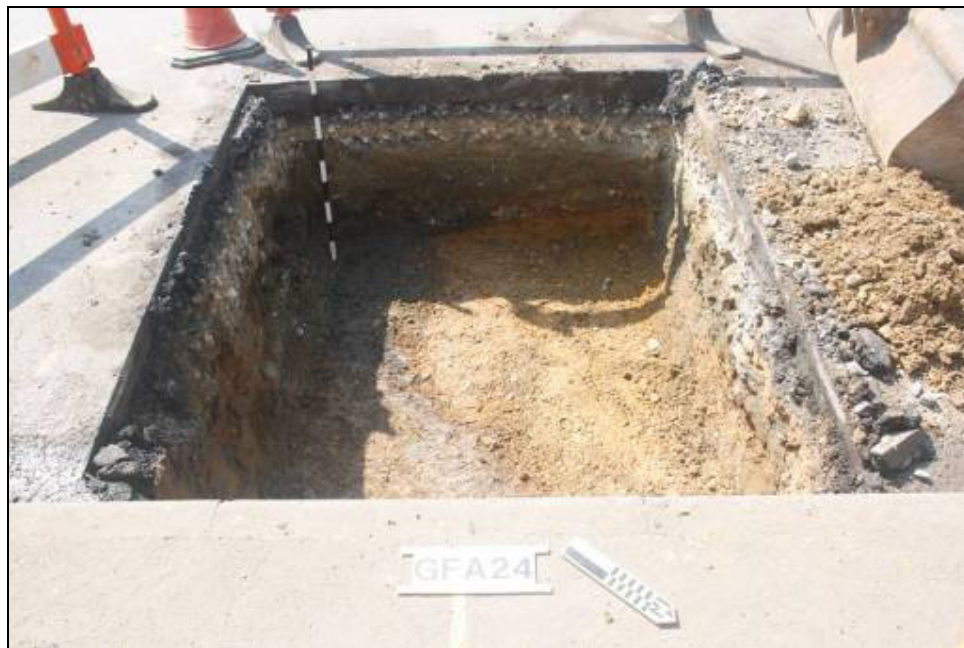
- 5.3.24 **Pot #24** was located opposite Glen Farm Cottage on Main Street. It measured 2.0m x 2.0m and was 1.0m deep. After the removal of the tarmac (1059) and underlying type one (1060) to a depth of 0.30m BGL, a layer of mid-grey-brown sandy-silt (1086) was observed. This material extended to a depth of 0.70m BGL and sealed a possible ditch [1078]. This ditch was 0.25m deep and at least 1m wide and was aligned north-south. The fill was a dark-grey clayey-silt with occasional cobbles (1077). The ditch cut the natural gravel (1062) at a depth of 0.6m BGL and the gravel and extended to at least the limit of our excavations. The plate shows the ditch cutting the natural gravel both in section and plan. See Plate5.

Plate 5: Pot #24 looking north-west, showing north-south aligned ditch [1078]

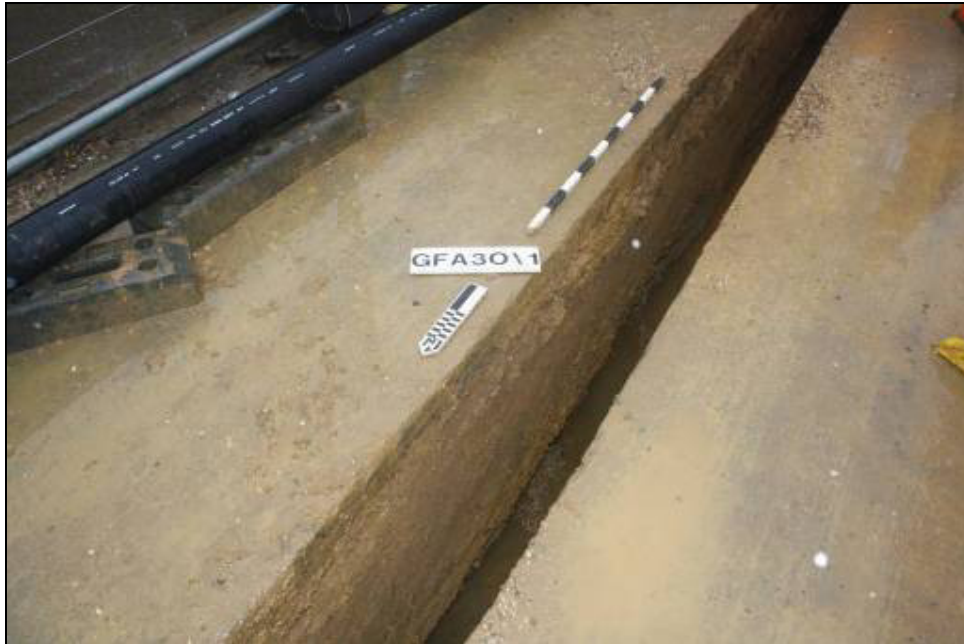
5.4.2 **Carlby Road North of West Glen River:** The area north of the river, along Carlby Road, revealed a uniform stratigraphic sequence throughout. After the removal of the tarmac (1023), the sub base (1033) and the underlying type 1 (1027), to a depth of 0.35m BGL, a buried alluvial deposit (1036), consisting of mid yellow-brown silty-clay, was observed. This same sequence was repeated throughout the area, with only the numbering of the buried alluvium changing in some places being numbered as (1034), so as to correspond to the numbering of the adjoining Vacuum Pot Pits. This material extended to a depth of between 0.70m and 0.90m BGL, at which point the natural gravel horizon (1035 and 1010) was observed. See Plate 6.

Plate 6: Representative section of vacuum sewer trench north of the West Glen River

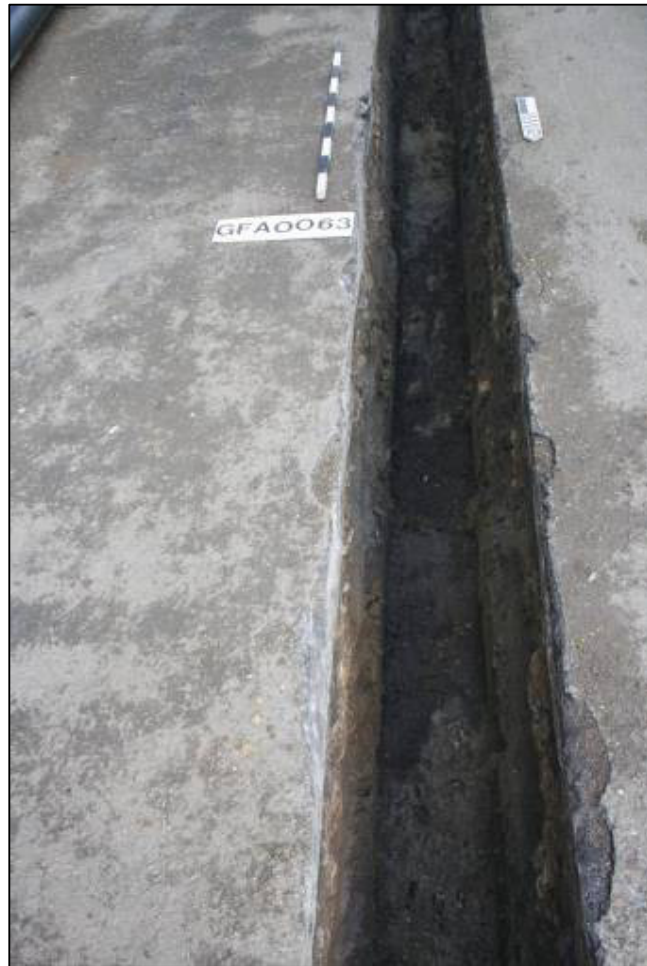
Plate 7: Vacuum Sewer Trench, north of West Glen River looking south, showing ditch [1064]

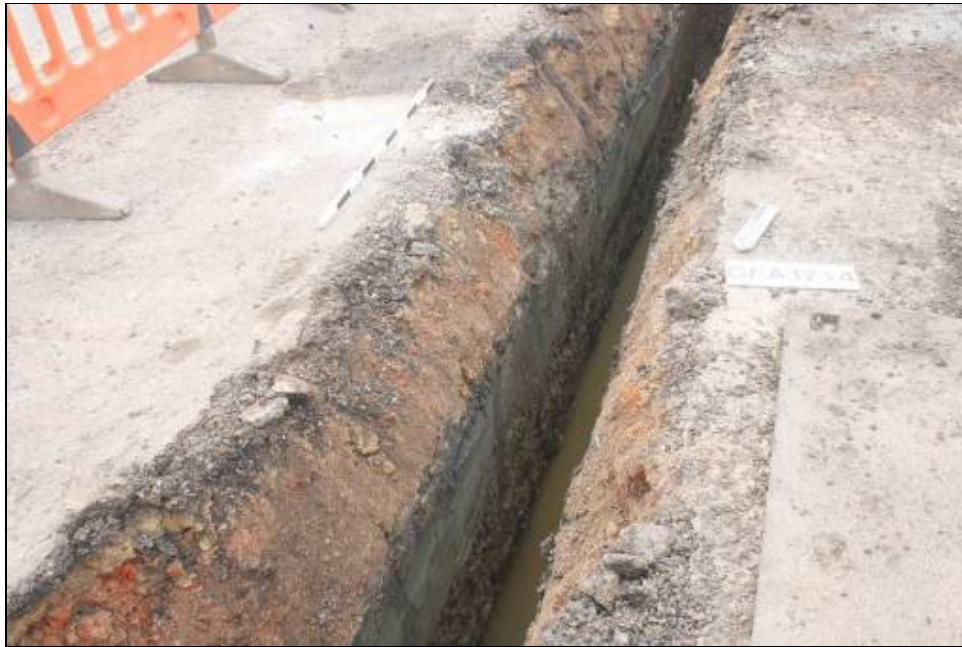
5.4.6 **Greatford Gardens:** The area within Greatford Gardens also had a relatively uniform stratigraphic sequence. After the removal of the tarmac (1013) and demolition rubble/make up (1015) to a depth of 0.40m BGL, a firm mid blue/gray layer of clay (1041) was observed. In some places there was a 0.05m thick band of Type One between the tarmac and construction/demolition rubble. The rubble was interpreted as ballast for the road.

Plate 8: Representative section of vacuum sewer trench in Greatford Gardens, looking south-east

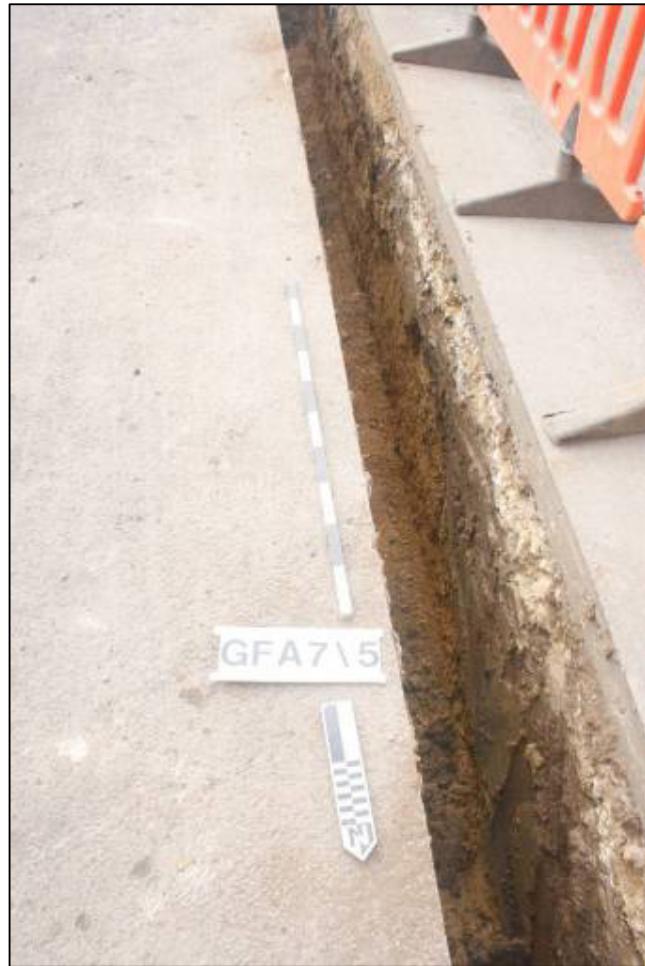
The area along Carlby Road, south of the river, saw two very distinct stratigraphic sequences. The first being from the river, to 20m south of the river. In this area, after the removal of the Tarmac (1059) and underlying Type 1 (1060) to a depth of 0.35m BGL, a layer of dark-brown clay-silt (1061) was observed up to a depth of up to 0.90m BGL. As observed in Pit#8 above, at this point (ca. 20m south of the West Glen River) the natural gravel horizon (1062) steps up from a depth of 0.9m BGL to eventually a depth of 0.35m BGL (see Plate9). By this point none of the dark-brown clay-silt (1061) was observed within the trench. This material (1061) sealing the natural gravel (1062), was interpreted as alluvial material in the old flood plain of the West Glen River.

Plate 9: Representative section of vacuum sewer, south of the West-Glen River

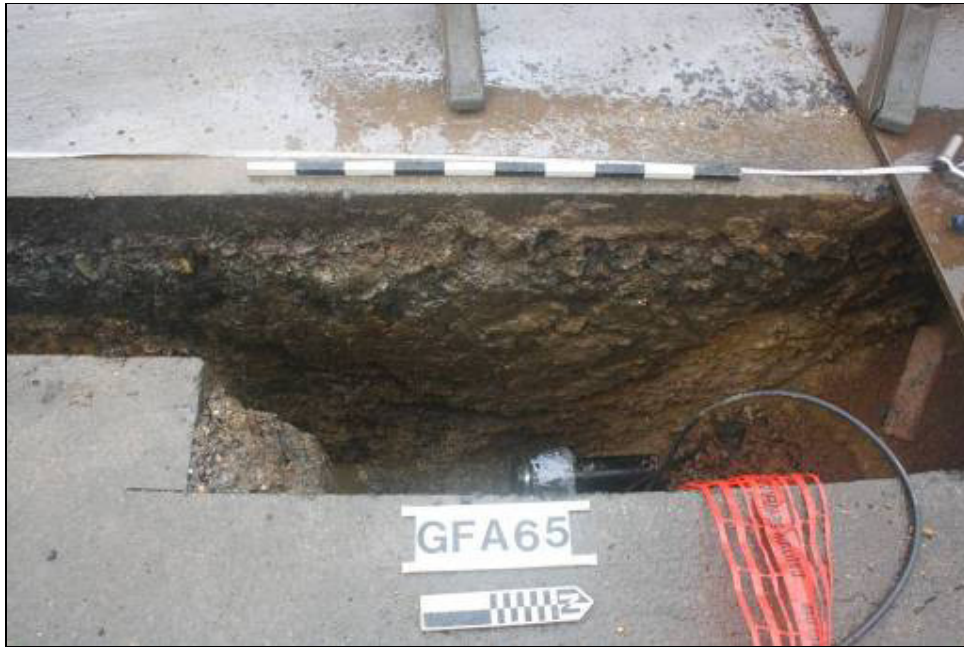
Plate 10: Ditch [0065] looking west

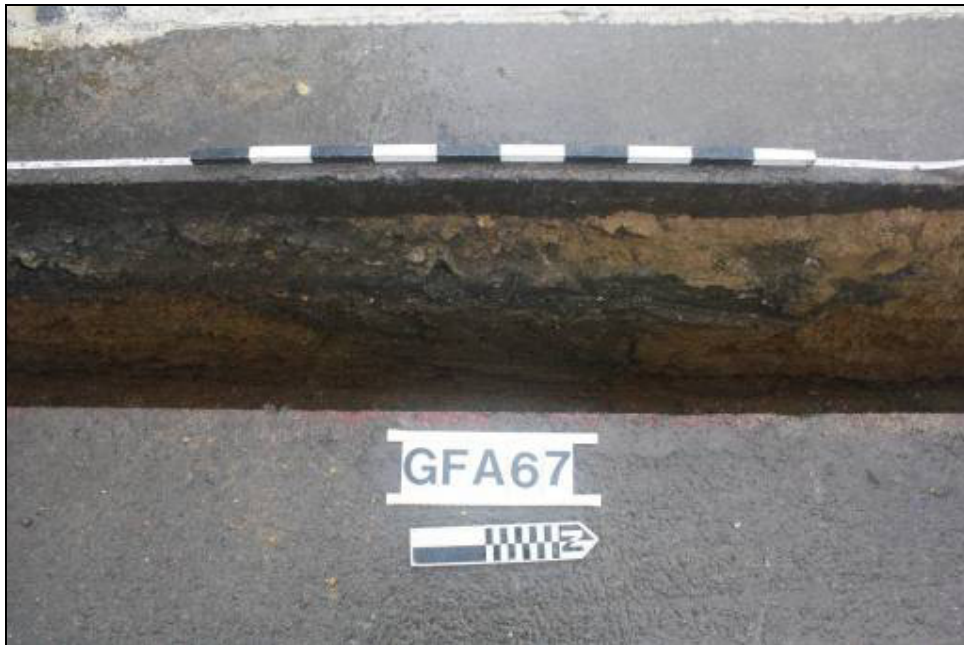
Plate 11: Ditch [0067] looking west

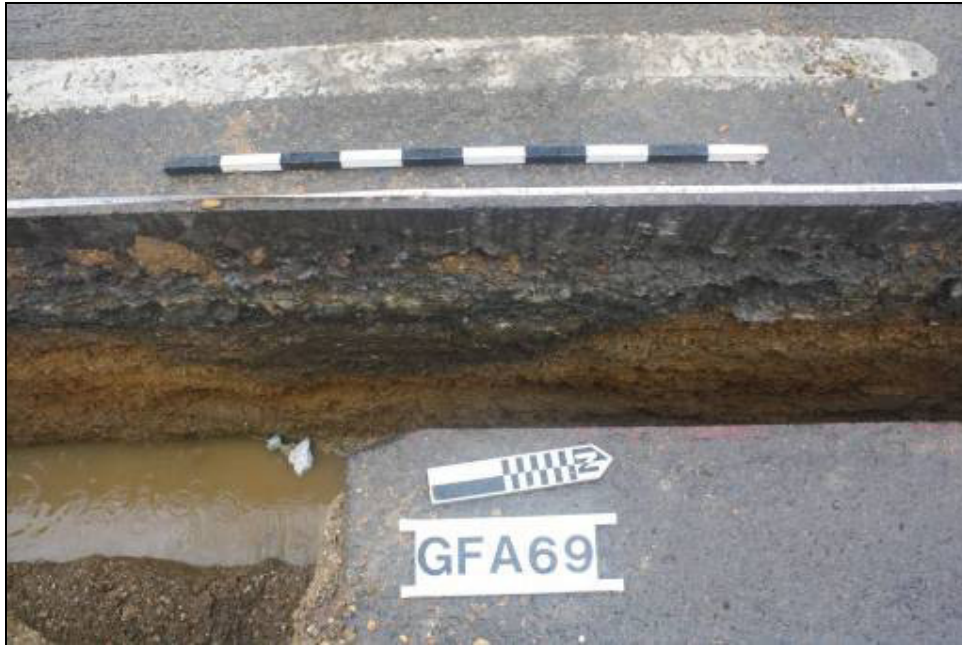
Plate 12: Ditch [0069], looking west

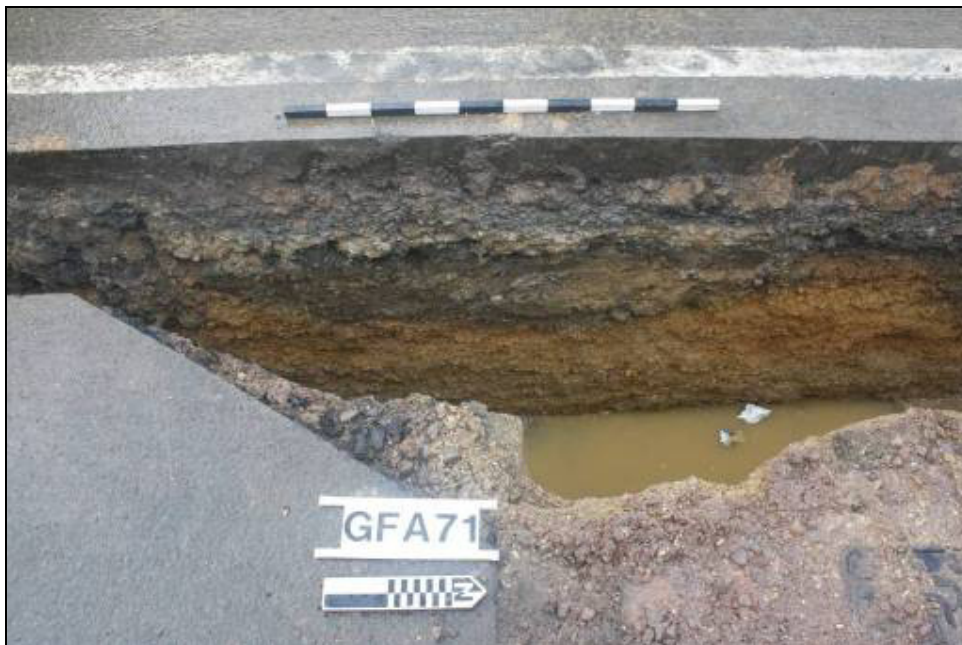
Plate 13: Ditch [0071], looking west

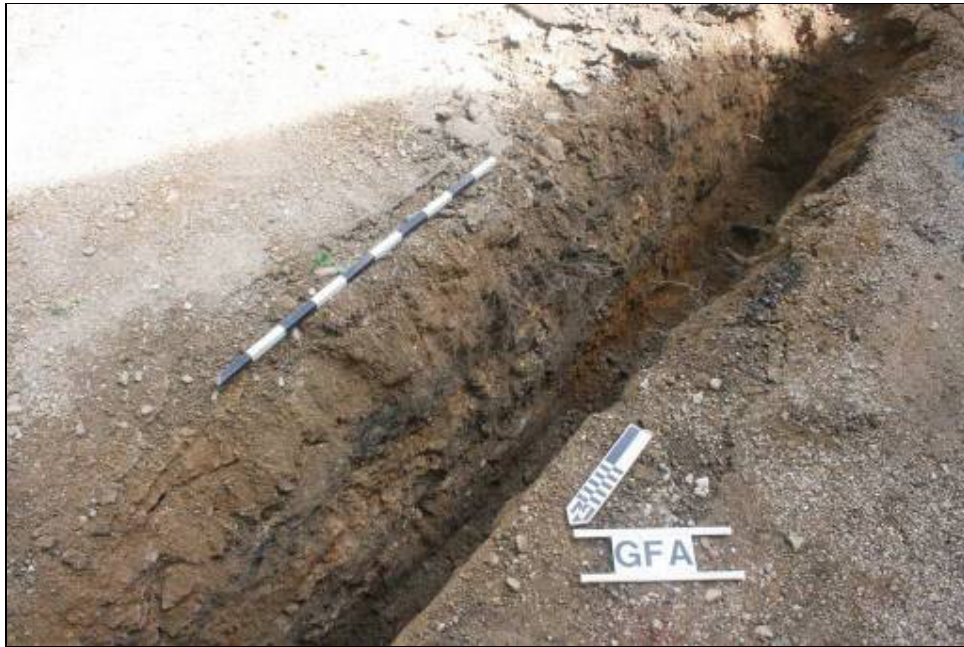
- 5.4.4 **Main Street:** Part of the Main Street area, was a short stretch of Trench just to the south of the church, running north-south. Along this stretch, work revealed that, the modern road makeup and general build up (1088), containing 20th century cabling and plastic fragments, extended to a depth of 0.80m BGL at which point the natural gravel (1062) was encountered. No features were observed along this stretch of trenching. See Plate 13.

Plate 14: Area just south of the church, showing modern build up

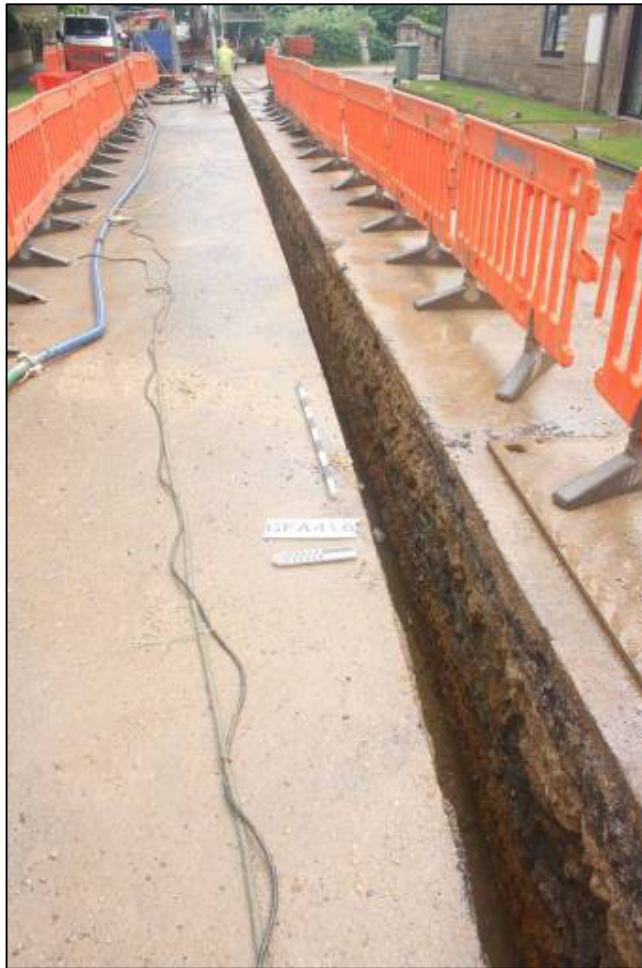
Plate 15: Representative section of vacuum sewer trench on Main Street, looking east

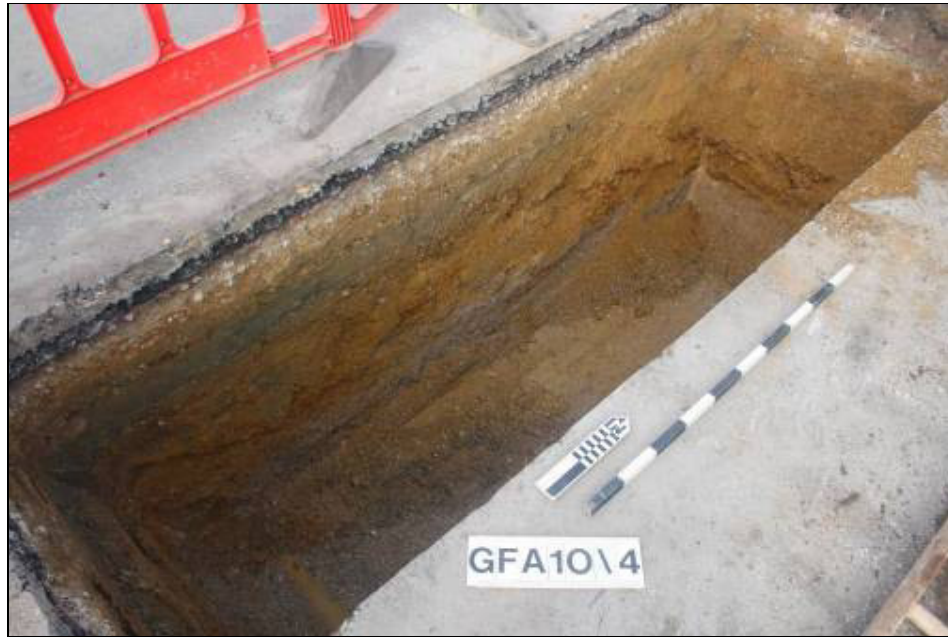
- 5.5.10 **Drill Reception Pit #2** was located just north of the Stowe Road Bridge over the draining ditch, it measured 3.0m x 0.8m, was 1.4m deep and was aligned north-south. After the removal of the tarmac (1044) and underlying type one (1045) to a depth of 0.30m BGL, a firm yellow-brown sandy-silt (1046) was observed. This extended to a depth of 0.80m BGL, at which point the natural gravel horizon (1047) was encountered, which extended to, at least, the limit of our excavations See Plate 16.

Plate 16: Drill Reception Pit #2 looking north-west

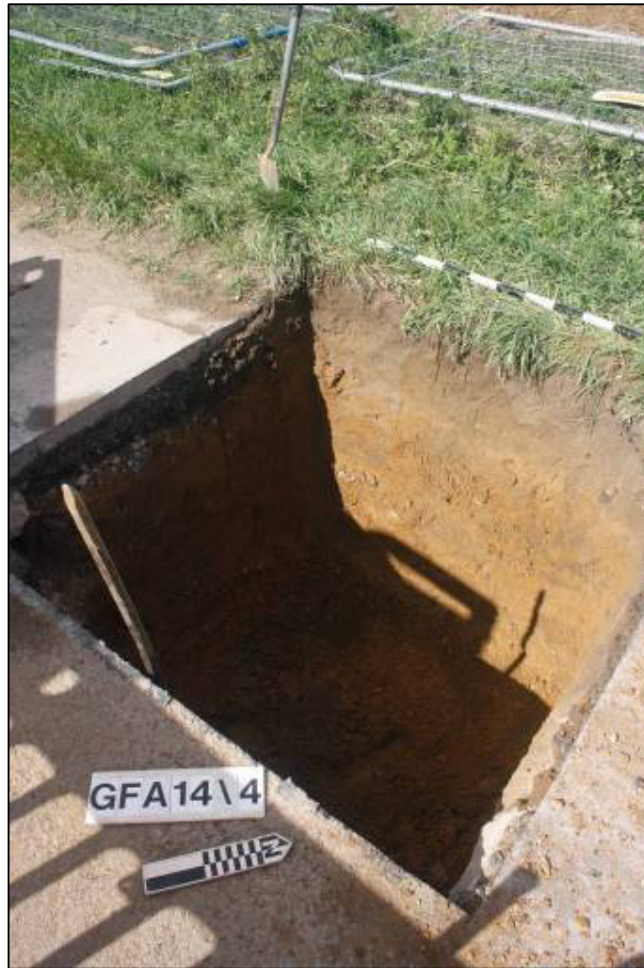
- 5.6.12 **Airvalve Pit #2** was located on Stowe Road, just west of the King Street crossroad. It was partly in the road, partly in the verge. After the removal of the tarmac (1044) and underlying type one (1045), to a depth of 0.3m BGL, a firm yellow-brown sandy-silt (1046) was observed. This extended to a depth of 1.30m BGL, at which point the natural gravel horizon (1047) was encountered, which extended to, at least, the limit of our excavations. The modern topsoil (1042) and subsoil (1089) in the verge, extended to a maximum depth of 0.4m BGL, sealing the above mentioned firm yellow-brown sandy-silt (1046). See Plate 17.

Plate 18: Airvalve Pit #2, looking north-west
