Forge Mill, Sandwell

Archaeological Monitoring of Engineering Test-Pits

Report Number: 044/2014

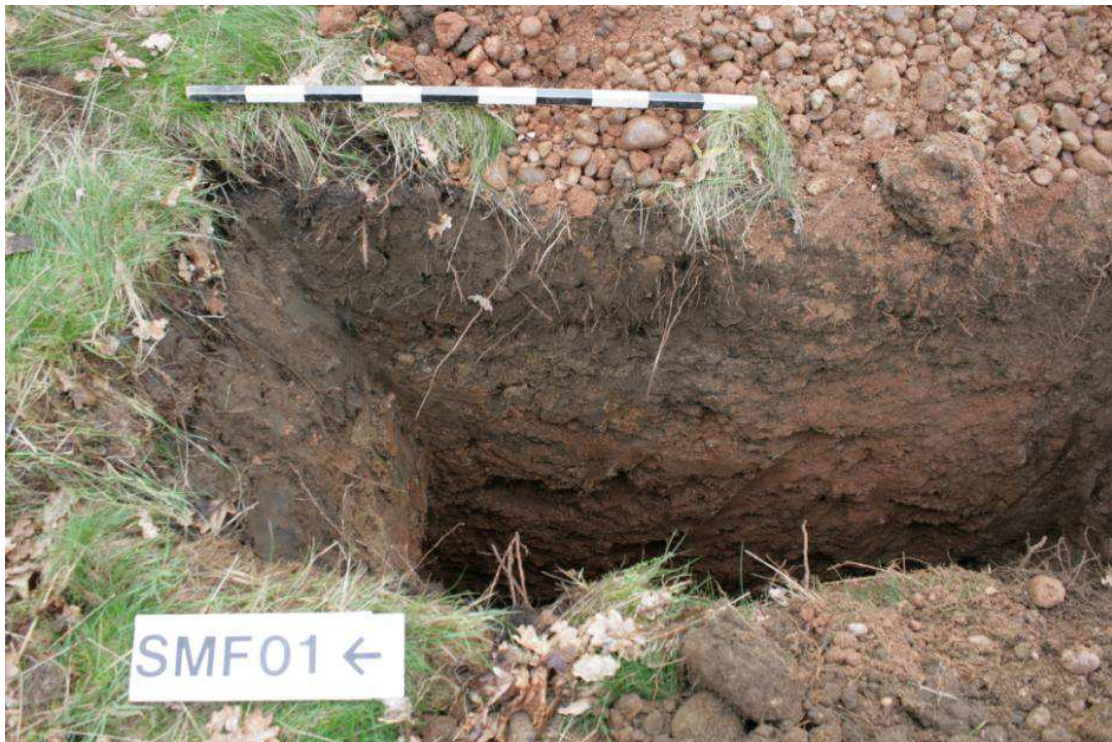
Trial Pit 01 (105 EA No)

- (101) 0m - 0.3m Top soil mid brown 7.5YR 4/2 brown silt loam, 10% rounded stones up to 40mm
- (102) 0.3m - 0.5m Subsoil 7.5 YR 5/3 brown sandy silt loam, 25% rounded stones up to 70mm in size
- (103) 0.5m - 3.5m Sands and gravels 10YR 5/4 yellowish brown to 5/8 yellowish brown sandy clay 30% rounded stones up to 80mm in size. Deposit loses clay component at c. 0.8m becoming sandy silt loam and gravels. At a depth of 1.9m it becomes sand and gravel. Waterlogged at 3.5m

Test-pits 01-04 lay on the south side of the River Tame towards the eastern end of the study area. In TP01-03 topsoil and subsoil of 0.5-0.6m depth overlay the natural drift deposits of sand and gravel. Topsoil was much shallower in TP04 with sand and gravel occurring at just 0.25m.

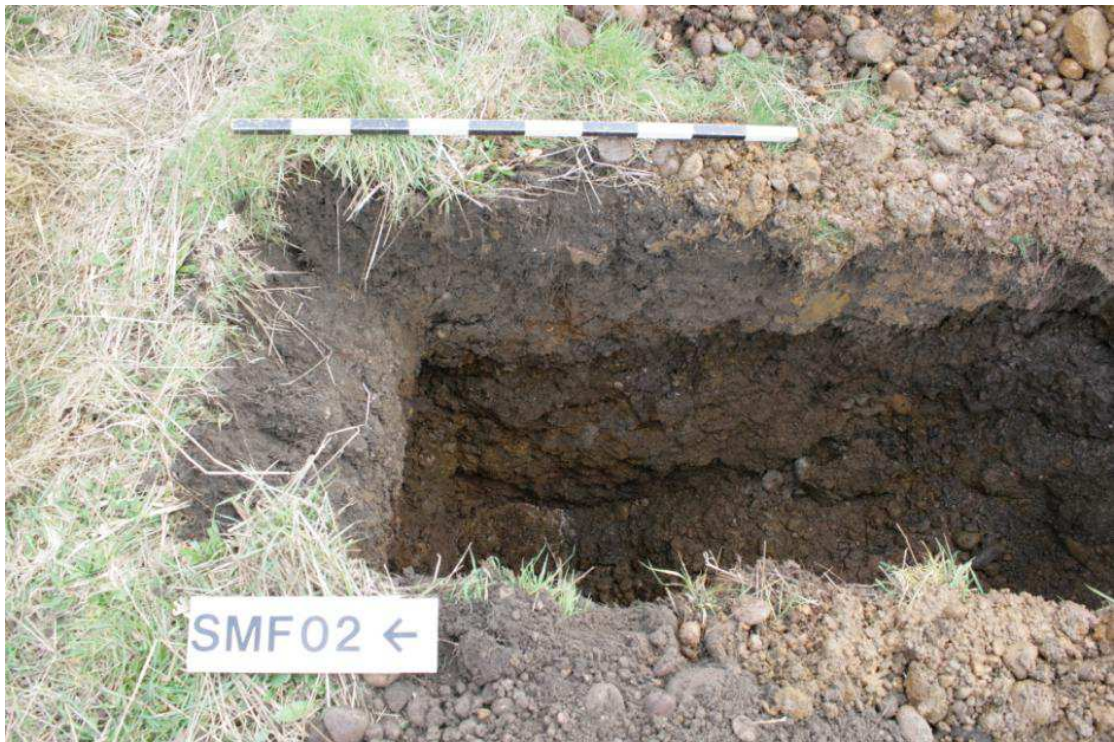
Trial Pit 02 (102 EA No)

- (201) 0m – 0.25m Top soil 7.5YR 3/1 very dark grey clay loam 5% rounded stones up to 30mm in size
- (202) 0.25m – 0.55m Subsoil 5YR 4/1 dark grey clay loam, 20% rounded to subrounded stones up to 60mm in size
- (203) 0.55m – 1.8m Sands and gravels 5YR 5/1 grey sandy clay 60% rounded pebbles up to 180mm in size. Deposit loses clay element by 0.9m becoming principally gravel with 30% sand. Increasingly waterlogged by 1.5m.
- (204) 1.8m – 1.9m Sand 10YR 5/6 yellowish brown. Waterlogged at 1.9m

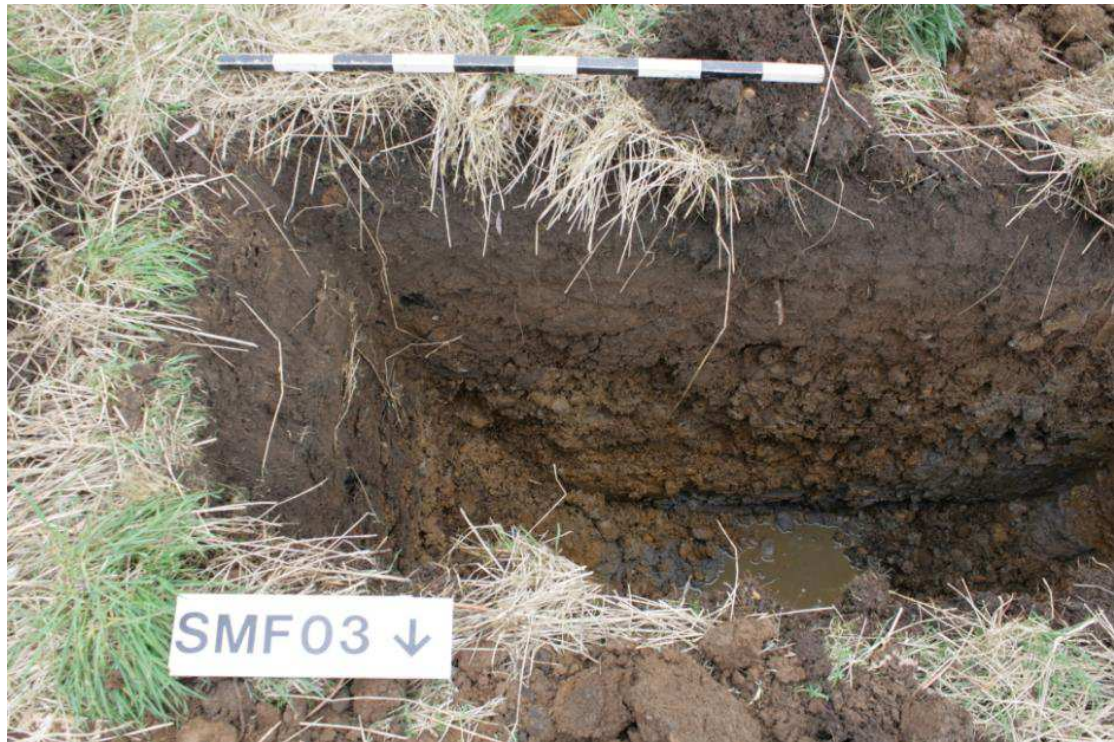
Trial Pit 03 (101 EA No)

- (301) 0m – 0.3m Topsoil 7.5YR 3/1 very dark grey clay loam
- (302) 0.3m – 0.6m Subsoil 10YR 4/3 brown clay loam, <2% rounded stones up to 20mm in size
- (303) 0.6m – 1.45m Start of sands and gravels 10YR 5/4 yellowish brown sandy clay 20% rounded pebbles up to 50mm in size, loses caly element by c. 1m
- (304) 1.45m – 1.6m Very sandy clay 5YR 6/1 grey with 5% patches 10YR 5/4 yellowish brown sandy clay
- (305) 1.6m – 3.3m Sands and gravels proper, sand 5YR 6/1 grey 60% pebbles up to 150mm. Pit waterlogged at 3.3m
- (306) 2.3m a pocket within the sands and gravels (e) of sandy clay 5YR 4/2 dark reddish grey mudstone with < 2% rounded stones up to 40mm, 10% dark black shale/organic mudstone

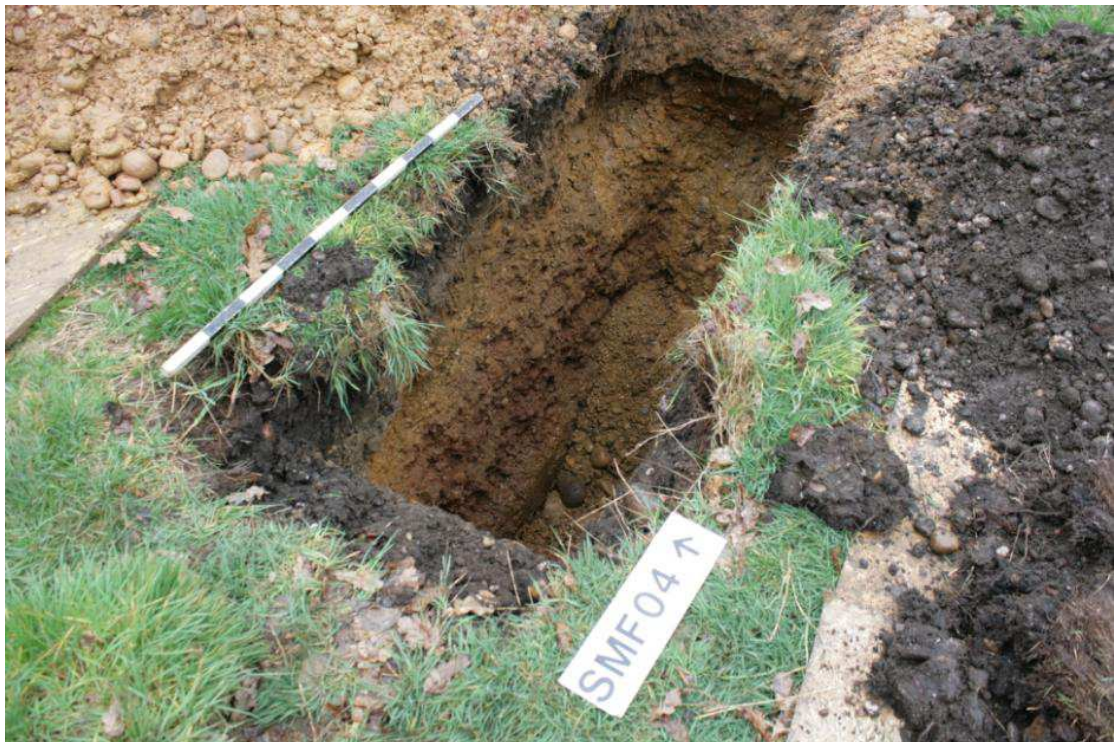
Trial Pit 04 (106 EA No)

- (401) 0m – 0.25m Topsoil 7.5YR 3/1 very dark grey loamy sand, 20% large pebbles up to 60mm in size
- (402) 0.25m – 1.2m Sands and gravels 5YR 6/8 reddish yellow very sandy clay, 60% stones rounded up to 100mm in size
- (403) 1.2m – 1.9m Sands and gravels 10YR 5/3 reddish brown sand, 60% stones rounded up to 100mm in size
- (404) 1.9m – 2.4m sands and gravels, sandy clay Gley 4/5BG dark greenish grey, 25% quartz gravel rounded up to 60mm in size

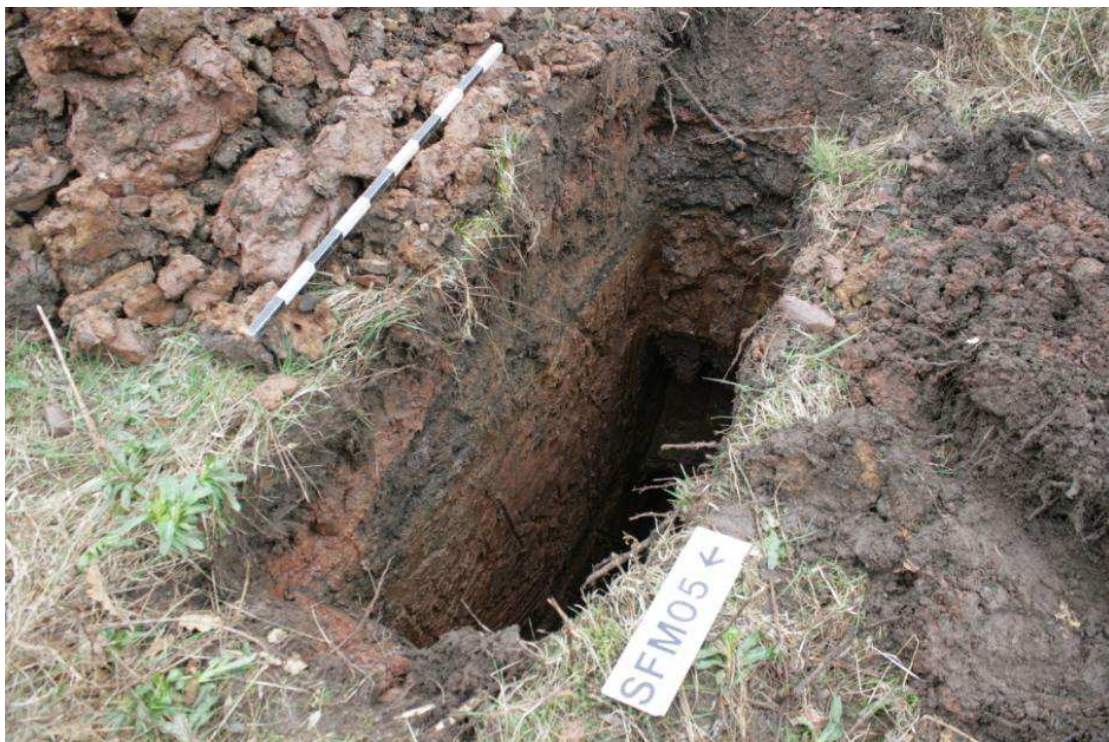
Trial Pit 05 (103 EA No)

- (501) 0m – 0.2m Topsoil 7.5YR 3/1 very dark grey silty clay, 2% rounded stones up to 40mm in size, 10% roots
- (502) 0.2m – 0.75m Re-deposited material, (TP located on old land fill site) a mix of 7.5YR 3/1 very dark grey silty clay and 7.5 YR 7/2 pinkish grey silty clay, 5% rounded pebbles up to 120mm in size, 7.5YR 4/2 brown silty clay.
- (503) 0.75m – 3.5 Natural boulder clay firm to hard sandy clay 5YR 4/4 reddish brown, 2% rounded stones up to 80mm in size, becomes increasingly clayey as depth increases. Occasional bands of 10YR 5/6 yellowish brown sand
- (504) 3.5m-4m Silty clay 5YR 4/2 reddish brown

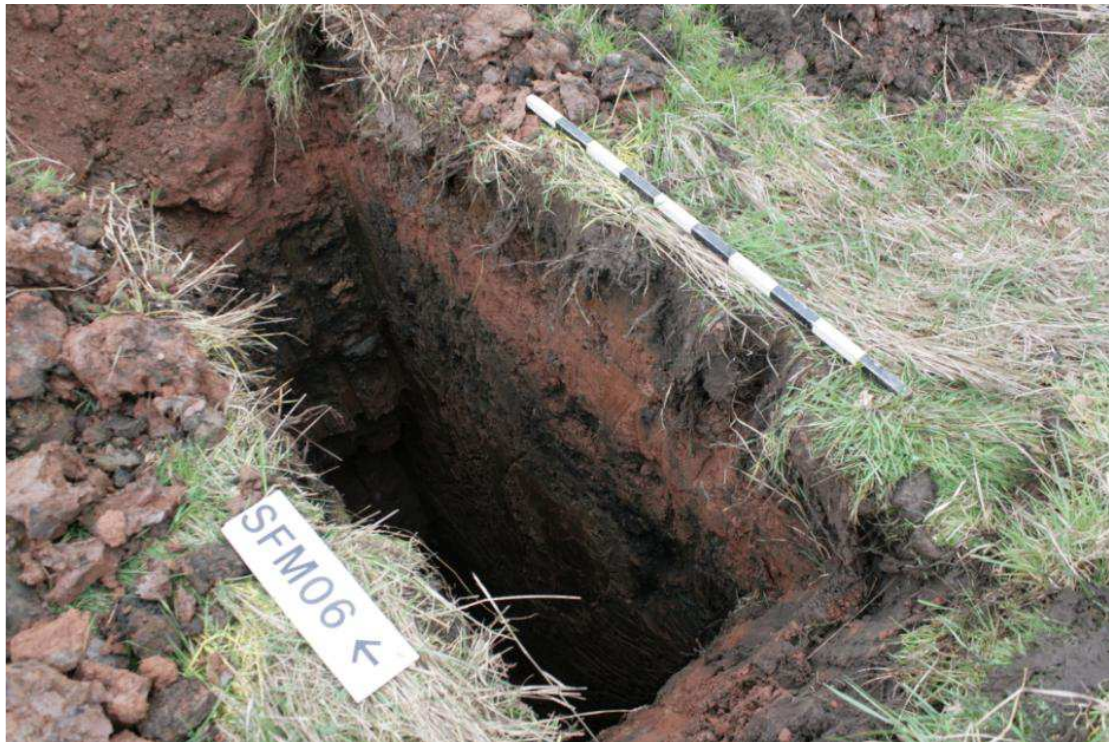
Trial Pit 06 (111 EA No)

- (601) 0m – 0.3m Topsoil 7.5YR 3/1 very dark grey silty clay loam, 2% rounded stones up to 25mm in size
- (602) 0.3m – 0.7m Capping layer for colliery deposit below sandy silt loam 10YR 4/4 dark yellowish brown <1% charcoal flecks, <5% rounded stones up to 30mm in size, <1% tiny brick fragments
- (603) 0.7m – 1.5m Colliery deposit/dredged material containing twigs, almost peat like Sandy clay 10YR 2/1 black to 10YR 3/1 very dark grey mottled with 10YR 4/3 brown and lighter grey 10YR 5/1.
- (604) 1.5m – 3.3m Natural boulder clay firm to hard sandy clay 5YR 4/4 reddish brown, 2% rounded stones up to 80mm in size, becomes increasingly clayey as depth increases.
- (605) 3.3m – 4m Silty clay 5YR 4/2 reddish brown

Test-pits 06-08 were placed on the north/east side of the river just to the northeast of Mill Lake. This area had apparently been subject to landscaping either in connection with the formation of Mill Lake and/or as a result of disposal of former colliery waste. A thin, 0.20-0.25m, topsoil overlay 0.6-1.2m of made ground below which firm to hard reddish brown sandy clay natural was encountered.

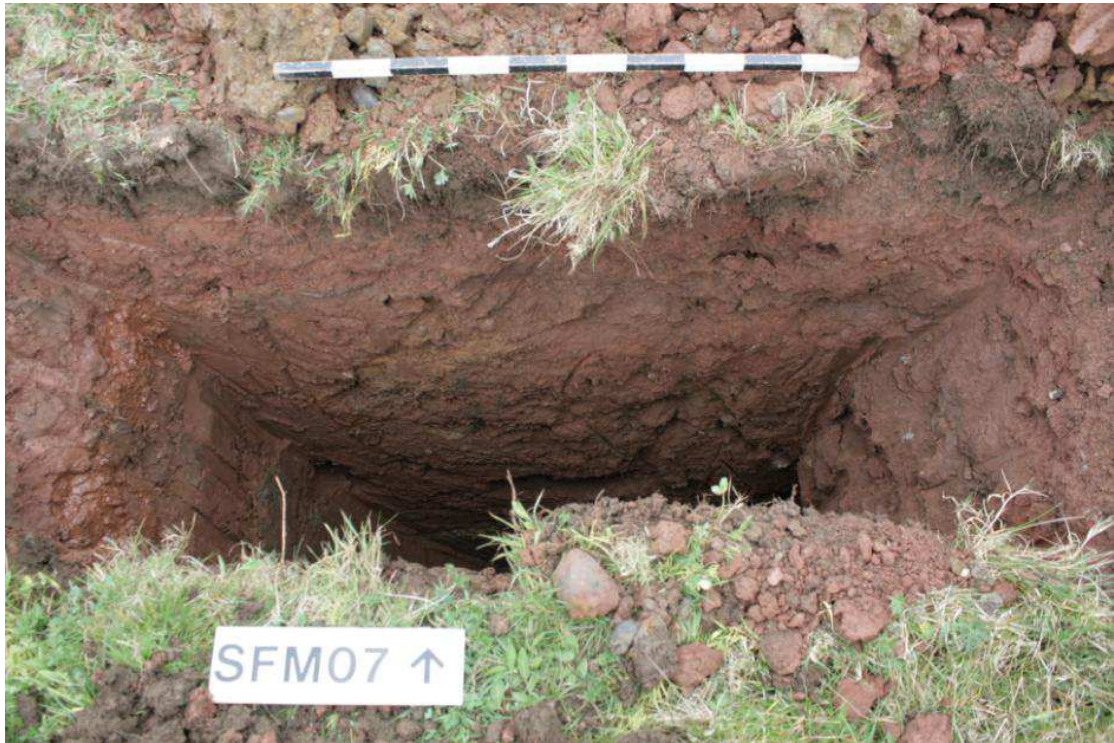
Trial Pit 07 (109 EA No)

- (701) 0m – 0.2m Topsoil silty clay loam 10YR 4/2 dark greyish brown
- (702) 0.2m – c. 1m Made ground? Top of natural boulder clay? sandy clay loam 5YR 4/6 yellowish red, 5% rounded pebbles up to 80mm in size
- (703) c. 1m- 3.2m Natural boulder clay firm to hard sandy clay 5YR 4/4 reddish brown, 2% rounded stones up to 80mm in size, becomes increasingly clayey as depth increases. Band of 10YR 5/6 yellowish brown sand at 2.3m of c. 0.2m width

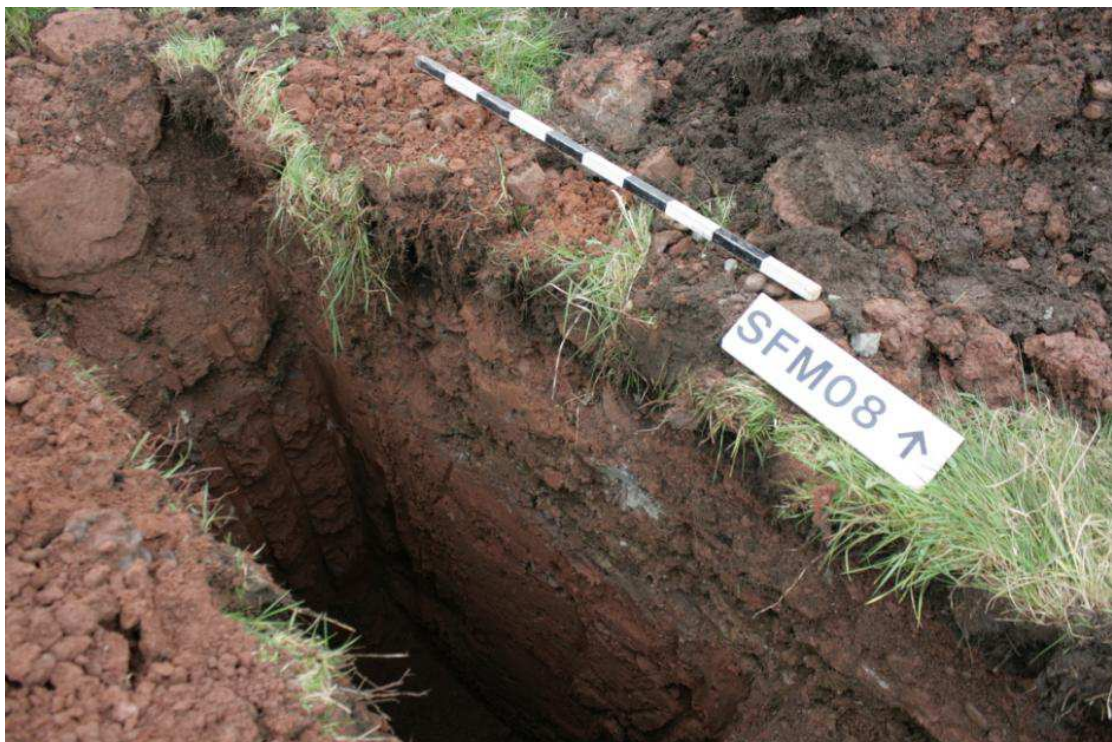
Trial Pit 08 (110 EA No)

- (801) 0m – 0.25m Topsoil 7.5YR 2.5 black slightly sandy, silt loam, 2% rounded to subrounded stones up to 40mm in size, <1% angular sandstone pieces up to 70mm in size
- (802) 0.25m – 0.80m Made ground sandy clay 7.5YR 5/3 brown to 5YR 4/4 reddish brown, 20% patches of clay 7.5YR 3/1 dark grey to 7.5YR 4/1 dark grey <1% black organic flecks like (c) in Trench 6, 10% rounded pebbles up to 40mm, <1% coal flecks. Concrete slab present (unexcavated)
- (803) 0.8m – 3.2m Natural boulder clay firm sandy clay 5YR 4/4 reddish brown, <5% rounded stones up to 70mm in size, becomes increasingly clayey as depth increases, occasional bands of 10YR 5/6 yellowish brown sand.

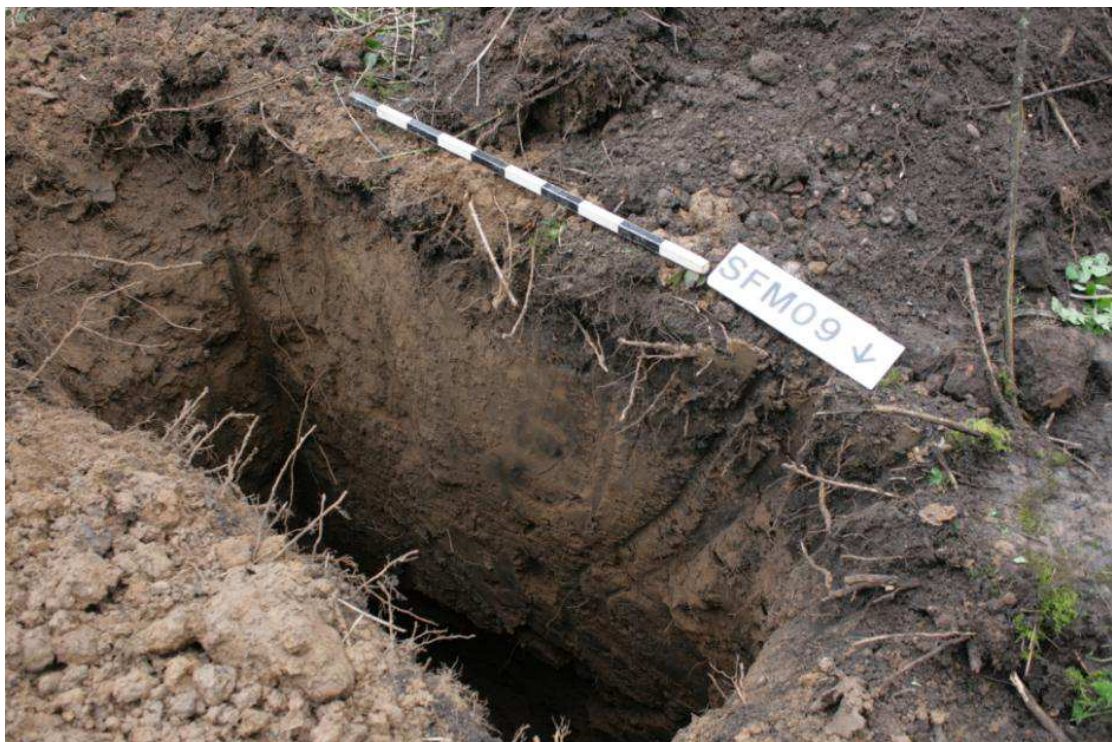
Trial Pit 09 (107 EA No)

Placed by the side of the road on an artificial bank raised above the floodplain to the south and railway to the north.

- (901) 0m – 0.35m Top soil 10YR 3/2 very dark greyish brown silty clay loam, 1% pebbles rounded up to 30mm in size, <1% angular pieces of sandstone, 5% roots, <5% brick and tile fragments
- (902) 0.35m – 0.7m Made ground sandy clay loam 10YR 4/3 20% mottles of 10YR 3/4 dark yellowish brown sandy clay loam, 2% rounded pebbles up to 30mm in size, 1% brick and tile fragments
- (903) 0.7m – 3.8m Made ground Very sandy clay 10YR 3/4 dark yellowish brown. c. 2m start getting large clay lumps of 10YR 3/4 dark yellowish brown.

Test-pits 09-10 also lay on the north side of the river, but further east, closer to the line of the railway. Although topsoil was slightly thicker, these two test-pits encountered a considerable depth of made ground (up to 3.2-3.8m in depth from the ground surface) presumably also related to colliery operations and/or construction of the railway line. A natural sandy clay was only reached in TP 10 at a depth of 3.2m.

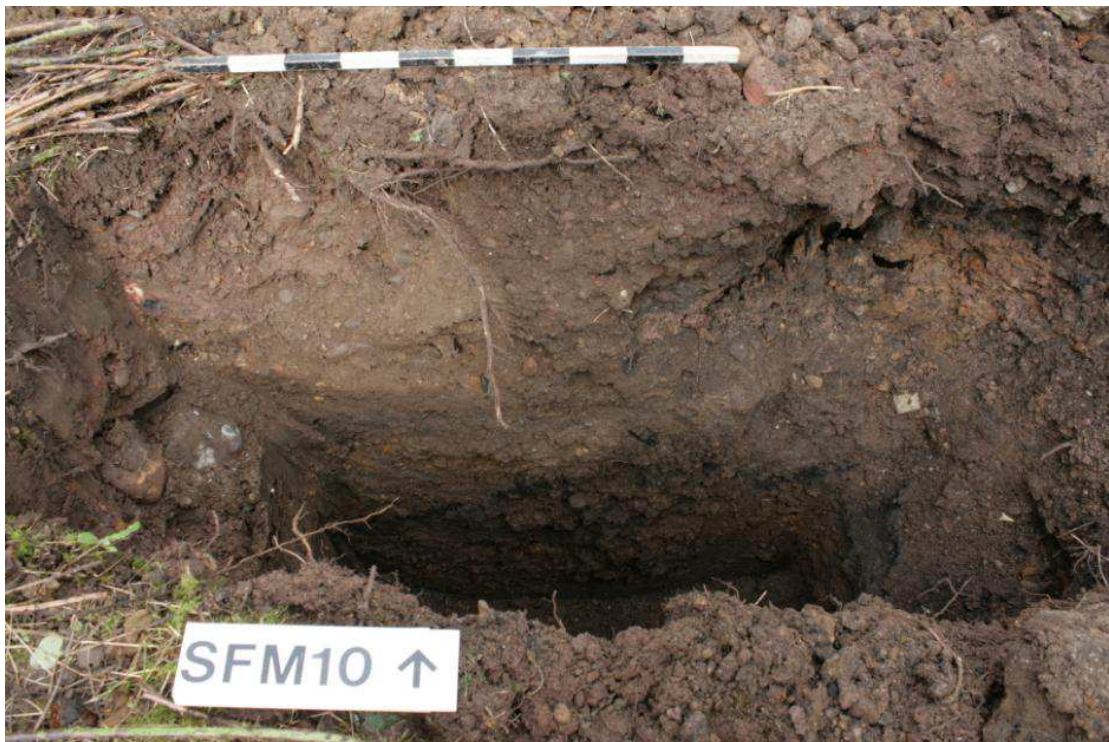
Trial Pit 10 (108 EA No)

- (1001) 0m – 0.3m Topsoil 10YR 3/2 very dark greyish brown silty clay loam, 1% rounded pebbles up to 30mm in size
- (1002) 0.3m – 1.8m Made ground - tip lines - sandy clay loam 10YR 4/3 brown, 10% bands of 7.5YR 3/1 very dark grey sandy clay loam, 30% gravels up to 120mm in size, <1% coal pieces up to 5mm in size, brick fragments present. 5% bands of 10YR 5/6 sandy clay loam yellowish brown and 7.5YR 6/1 grey sandy clay loam, 5% ash band
- (1003) 1.8m – 2.2m Reworked natural Silty clay 5YR 4/2 reddish brown
- (1004) 2.2m – 2.8m Organic 'pond' deposit – dredged material? Sandy clay loam 7.5YR 2.5/1 black
- (1005) 2.8m – 3.2m Re-deposited material? Sand 10YR 5/4 yellowish brown, 15% rounded pebbles up to 60mm in size
- (1006) 3.2m – 3.8m Natural? Sandy clay 2.5YR 5/1 grey

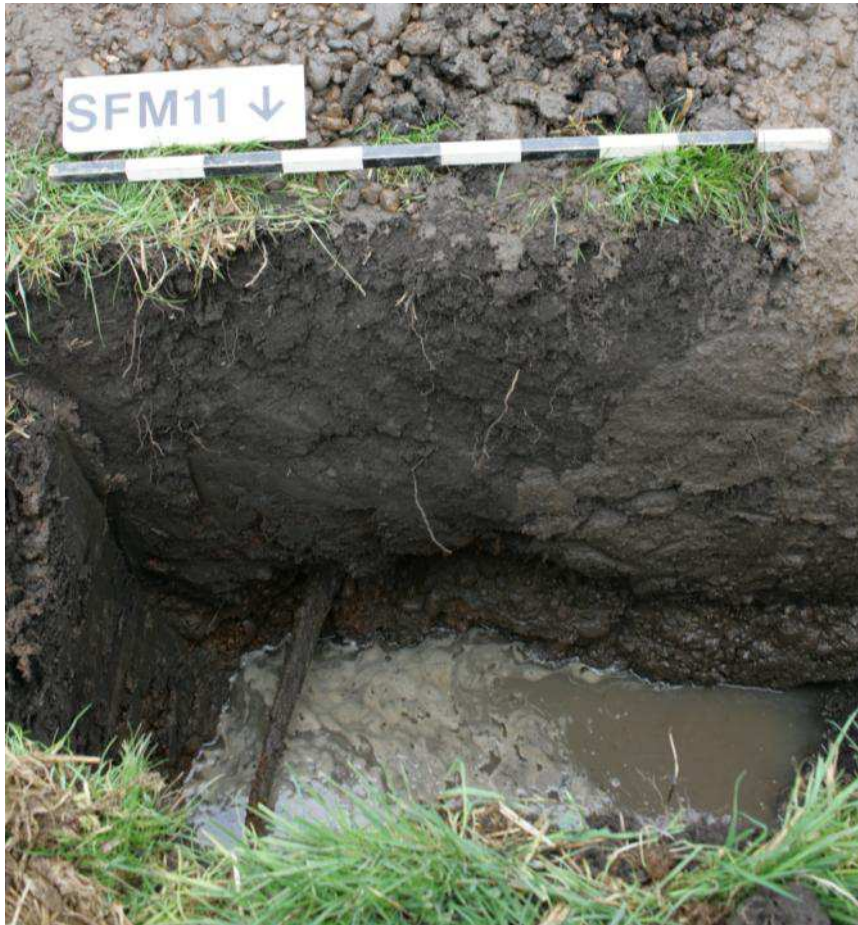
Trial Pit 11 (112 EA No)

- (1101) 0m – 0.7m Topsoil 7.5YR 2.5/1 black silt loam <1% rounded stones up to 40mm in size
- (1102) 0.7m – 2.1m Sands and gravels sandy clay 7.5YR 4/1 grey with mottles of sand 10YR 5/6 yellowish brown, 40% rounded to sub-rounded stones up to 90mm in size. Watertable at 1m. Horizontal timber at 0.95m – unable to retrieve or establish if worked. End of a tapered timber AAA recovered from top 0.2m of gravels ie between 0.7m and 0.9m depth. Deposit becomes sand after 1.3m with much larger rounded cobbles, up to 145mm at 2m

Test-pits 11-15 were excavated on the west side of the river in the flood plain north of the former Forge Mill. TP11 lay within the probable area of the former mill pond of Forge Mill (now filled in and level, but still slightly lower than surrounding ground). A deep, 0.7m thick, topsoil was recorded here immediately overlying sand and gravel. Waterlogged timbers were encountered within the top of the gravels. One piece AAA, with a tapered end, was retained, but it was unclear whether the larger piece had been worked and this could not be retrieved. TP12-15 lay north of the railway line in an apparently undisturbed (or much less disturbed) area of floodplain pasture. Here a natural sequence of topsoil–alluvial clay–sand and gravel was observed. Alluvium was up to 1.3m in depth. A single post-medieval pot sherd AAB was retrieved from the topsoil in TP15.

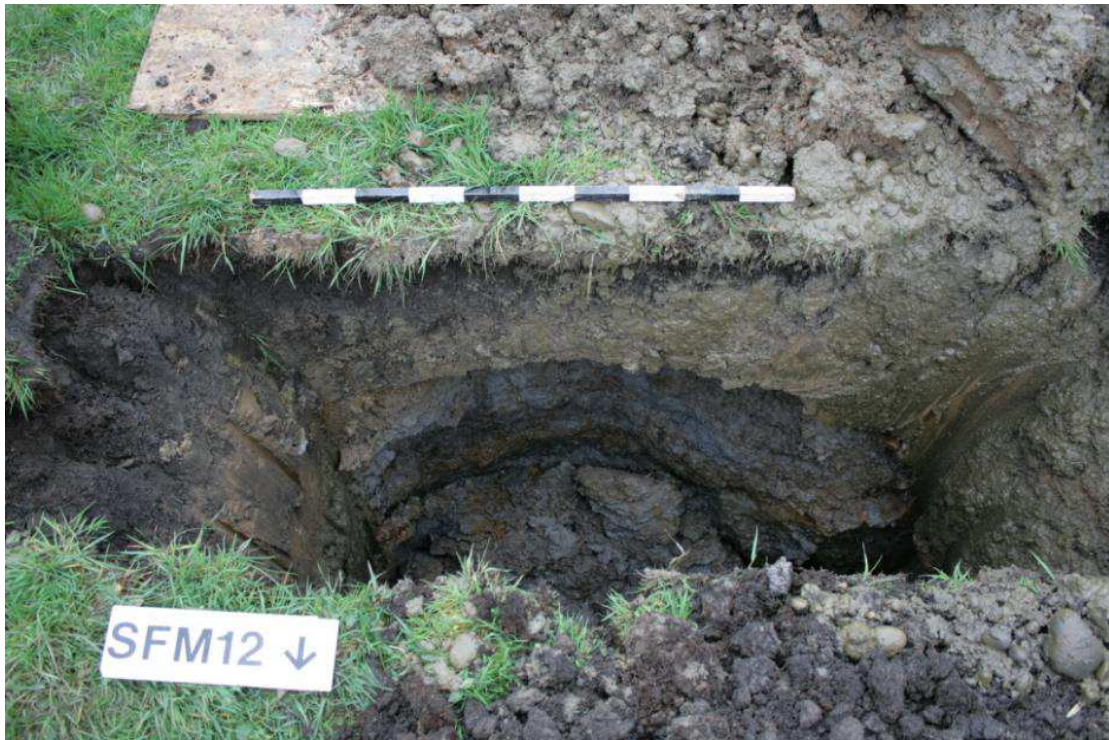
Trial Pit 12 (113 EA No)

- (1201) 0m – 0.25m Topsoil 10YR 2/2 very dark brown silt loam
- (1202) 0.25m – 0.6m Subsoil 10YR 5/2 greyish brown clay
- (1203) 0.6m – 1.7m Alluvial clay 10YR 5/3 brown clay with 10% patches of 2.5YR 5/1 gray and 10YR 5/6 yellowish brown sandy clay
- (1204) 1.7m – 2.8m Sands and gravels 2.5YR 6/1 grey to 4/1 dark grey sand, 40% rounded stones up to 50mm, 1% organic content comprising twig fragments up to 5mm in size. Gravel content increases to 70%-75% with depth

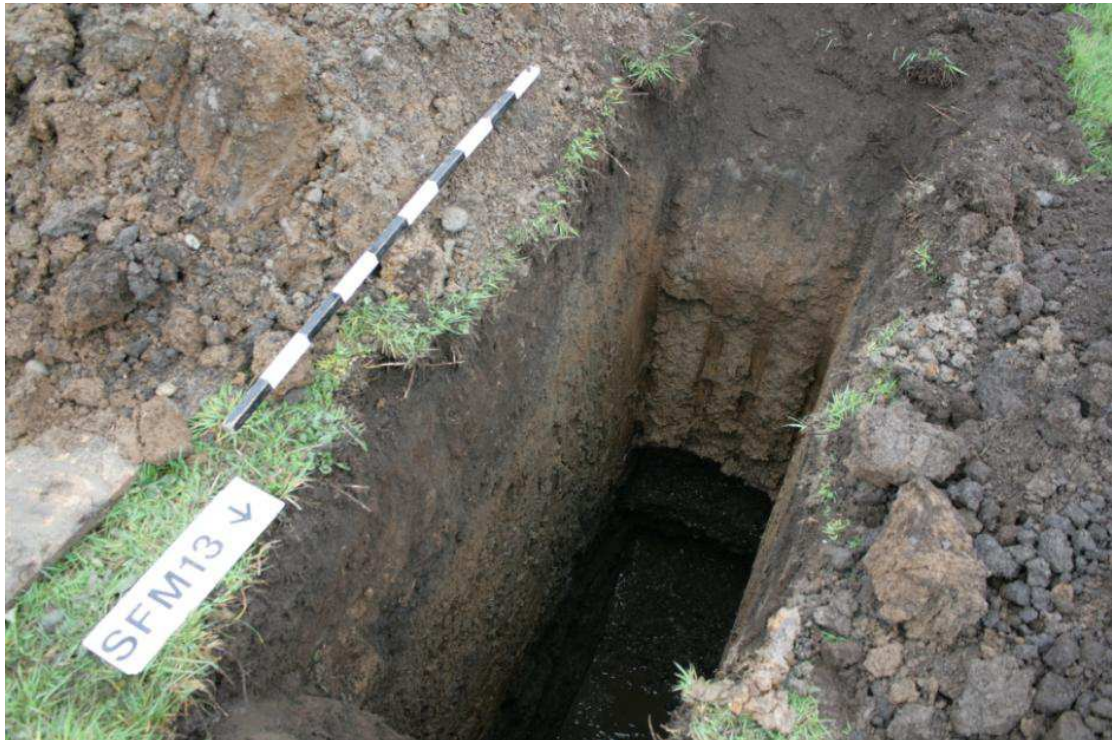
Trial Pit 13 (104 EA No)

- (1301) 0m – 0.5m Topsoil 10YR 2/2 very dark brown friable silt loam
- (1302) 0.5m -0.75m Alluvium 10YR 4/1 grey soft clay
- (1303) 0.75m – 1.2m Alluvium 10YR 4/3 brown soft clay
- (1304) 1.2m – 1.6 Alluvium 10YR 5/3 brown soft clay
- (1305) 1.6m – 1.8 Alluvium 10YR 5/6 yellowish brown soft clay
- (1306) 1.8m – 2.1m Sands and gravels 2.5YR 6/1 grey to 4/1 dark grey sand, 40% rounded stones up to 50mm, 1% organic content comprising twig fragments up to 5mm in size. Gravel content increases to 70%-75% with depth and pockets of black organic silty clay at 2.8m
- (1307) 2.1m – 3.3m Boulder clay 10YR 4/1 grey

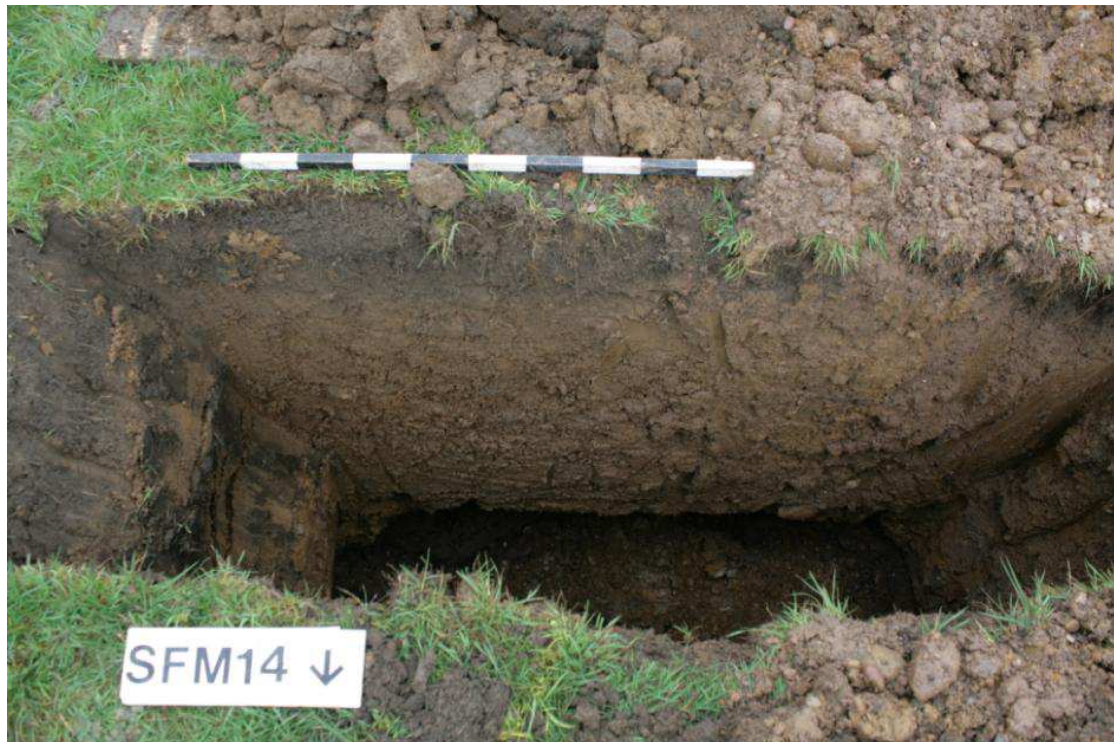
Trial Pit 14 (114 EA No)

- (1401) 0m – 0.25m Topsoil 7.5YR 4/2 brown soft silty clay
- (1402) 0.25m – 1.1m Subsoil 5YR 5/4 reddish brown soft clay loam
- (1403) 1.1m – 1.5m Alluvium Mix of 7.5YR 5/1 grey and 10YR 5/6 yellowish brown soft silty clay
- (1404) 1.5m – 2.7m Sands and gravels 1.5m-2m is sand with a clay element ie sandy clay 10YR 5/6 yellowish brown becoming sand, with 45% rounded pebbles up to 80mm in size, which increase in density as the depth increases to 70% towards base of pit. By c. 2m the deposit becomes 7.5YR 5/1 grey in colour

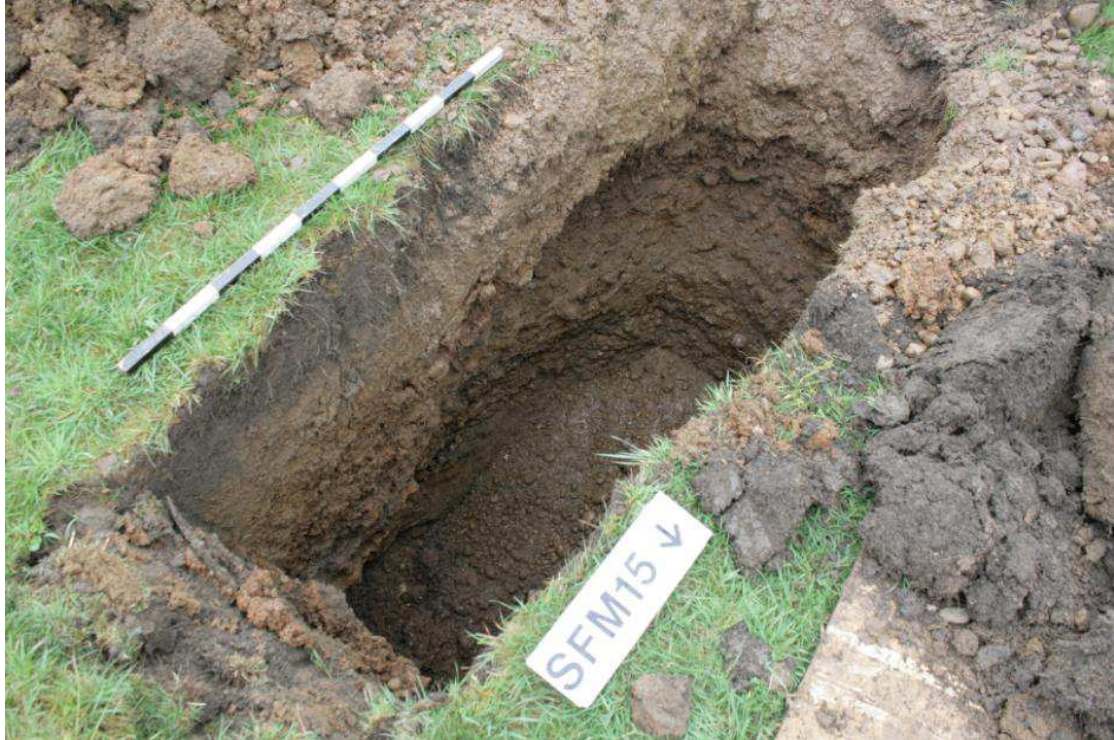
Trial Pit 15 (115 EA No)

- (1501) 0m - .025m Topsoil 10YR 3/1 very dark grey soft silty clay containing pot AAB
- (1502) 0.25m- 1m Alluvium? 5YR 5/4 reddish brown soft silty clay <1% tiny angular stones giving deposit a gritty texture
- (1503) 1m -2.6m Sands and gravels sandy clay 7.5YR 4/4 brown 50% rounded pebbles up to 80mm in size with pockets of sand 10YR 5/6 yellowish brown. By 1.4m there is no longer a clay element. Naturally occurring coal and black mudstone is present towards the base of the sand and gravel matrix.

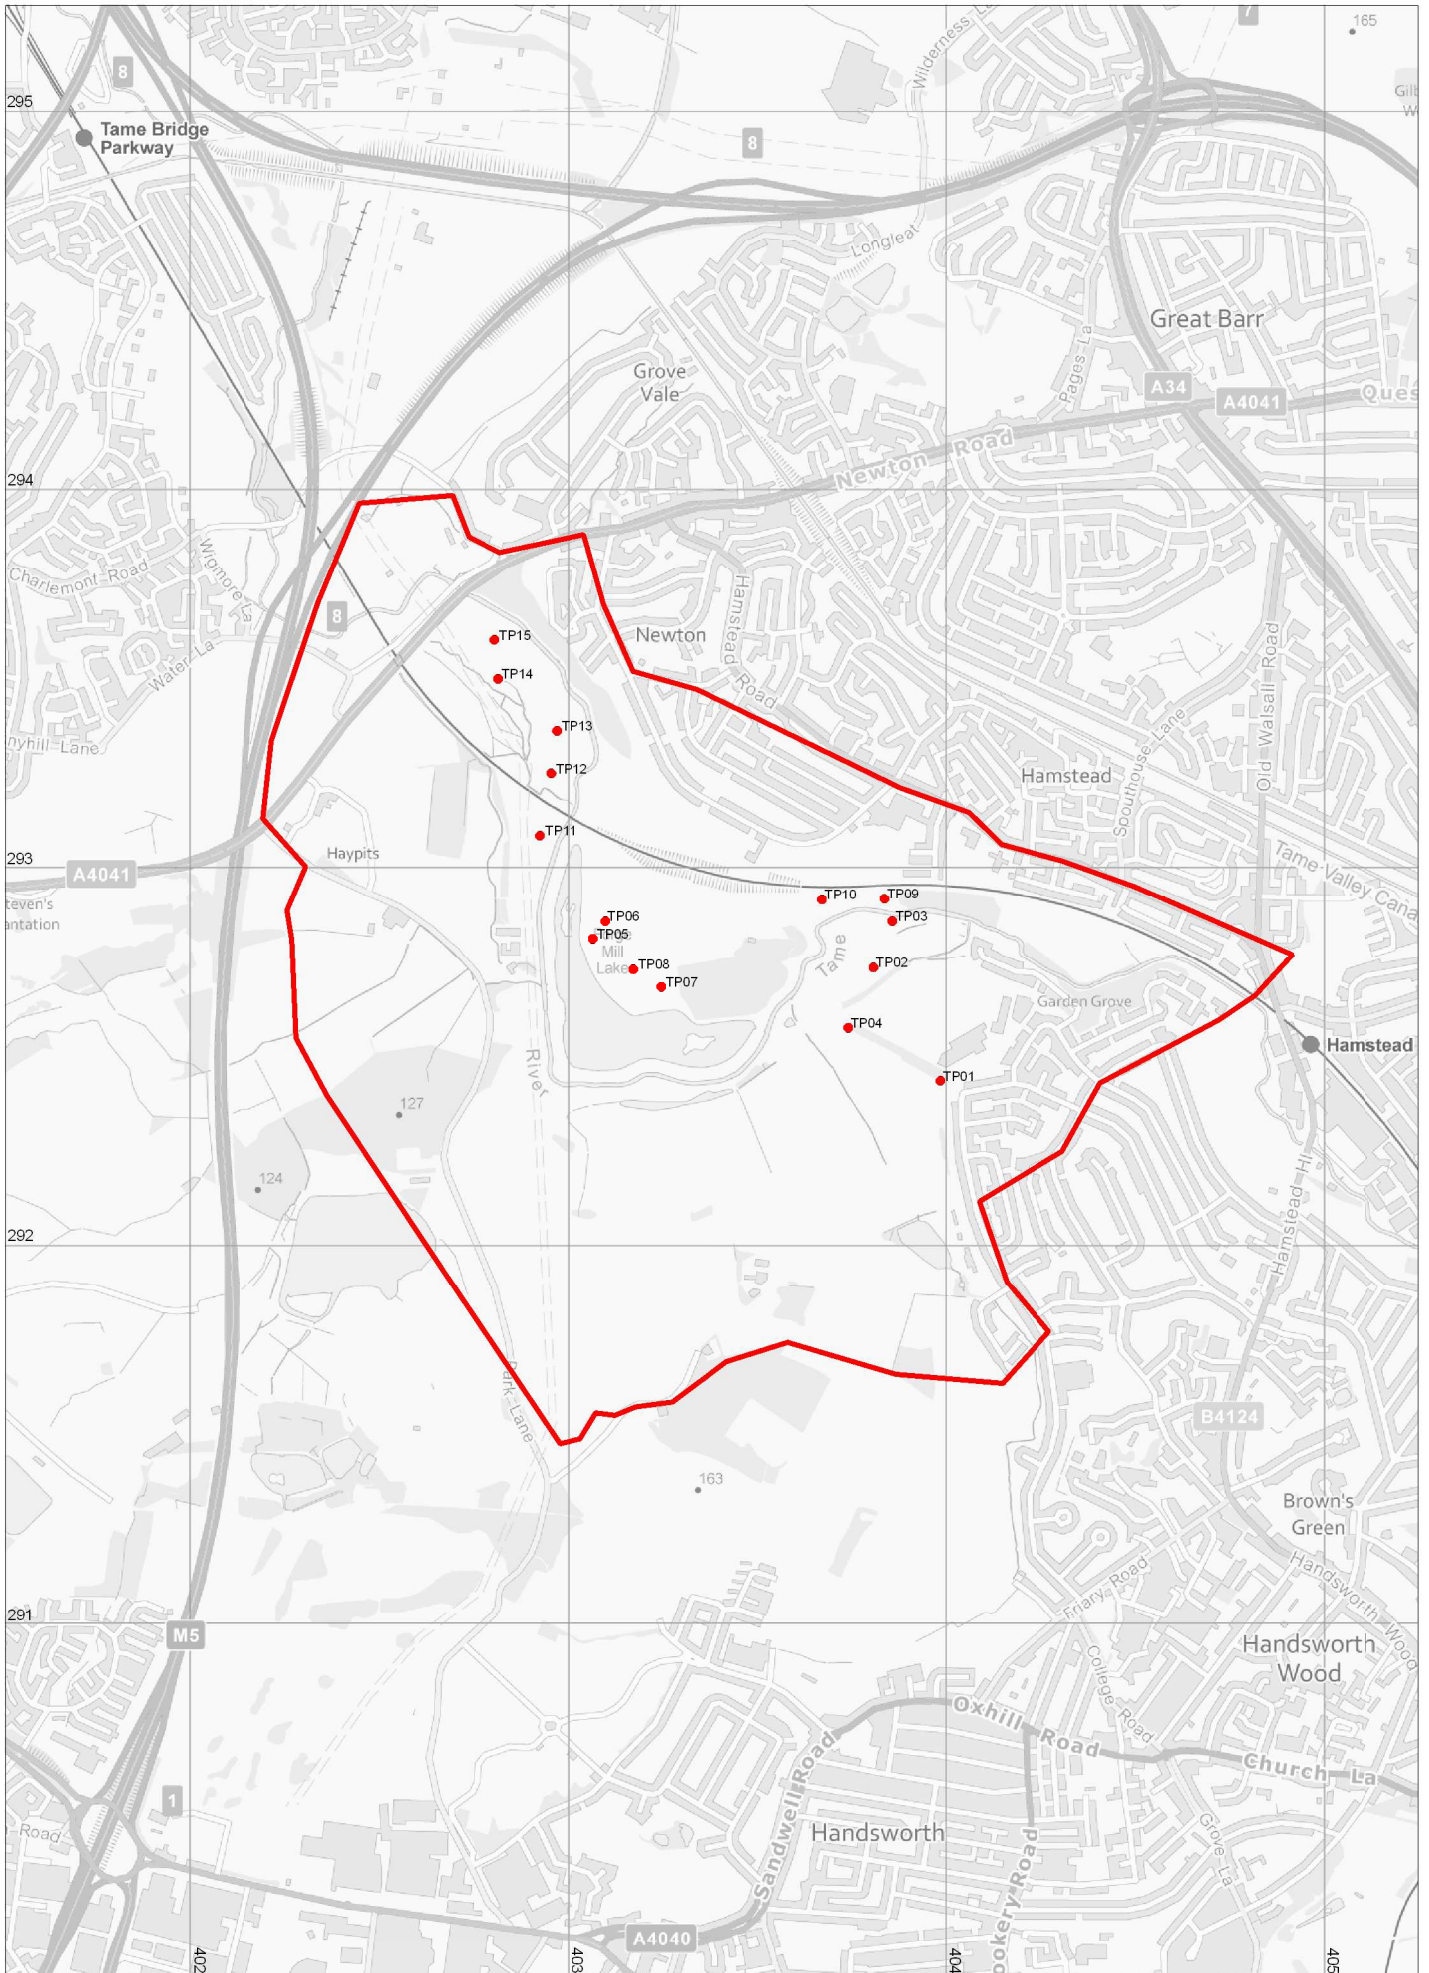
2.1.2 The locations of the test-pits are shown on Figure 2. Descriptions of the deposit sequences are given below accompanied by a photograph of each test-pit section. Drawn sections are illustrated in Figure 3.
