**A PHOTOGRAPHIC SURVEY OF
BEESTON MALTINGS,
DOVECOTE LANE, BEESTON,
NOTTINGHAMSHIRE**

M. Hurford and R. Sheppard

OS Grid Ref. SK 5323 3612
TPA Project Code: BMP
TPA Report No. 005/2013
April 2013

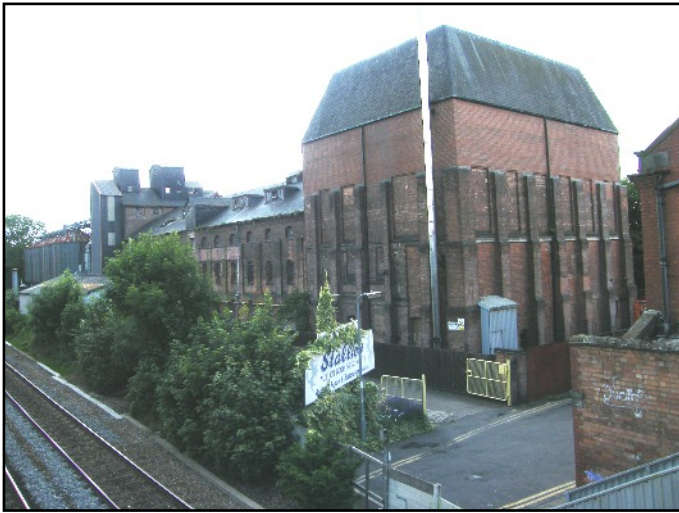
Plate 1: General view of Beeston Maltings, viewed looking west.

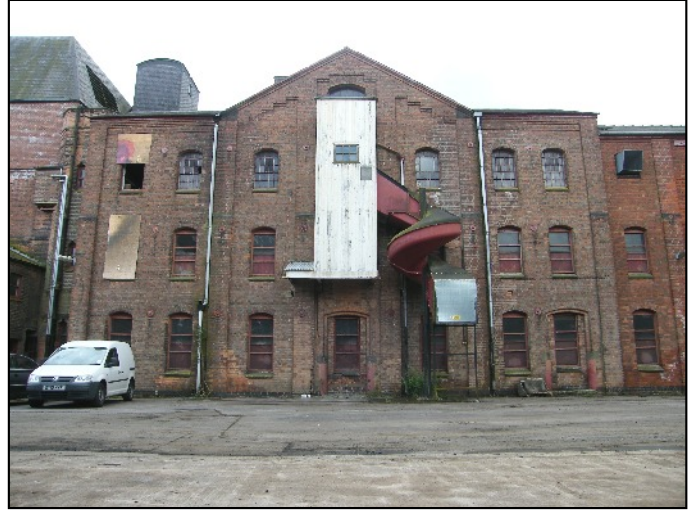
Plate 2: Part of the north-west elevation, viewed looking south-east.

The north-west elevation of the Main Range featured close to a projecting stair-turret a classic-style pedimented frontage central to a seven bays section (Plate 2). The cornice comprised three courses of raised brickwork. Further decorative brickwork was present beneath the garret in the form of raised brickwork in a step pattern. The windows were all tall, brick arched and with stone sills. Original window panes set in cast-iron frames were still present on the second floor. On the ground floor both the original central and south-west doorways had been converted to windows. A projecting lucam and later metal shoot were present in the middle of the façade. The appearance matched a drawing of 1898 shown in the Latham report that indicated that this part had been added.

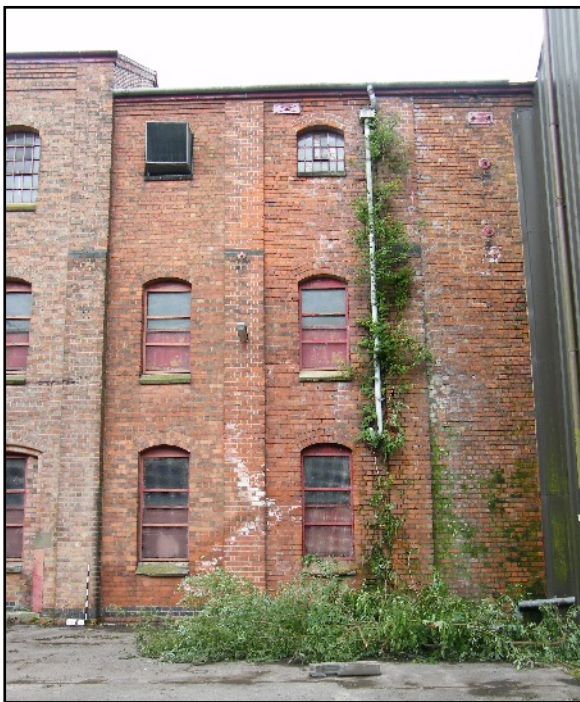
Plate 3: Another part of the north-west elevation with earlier facade to the left, viewed looking south-east.

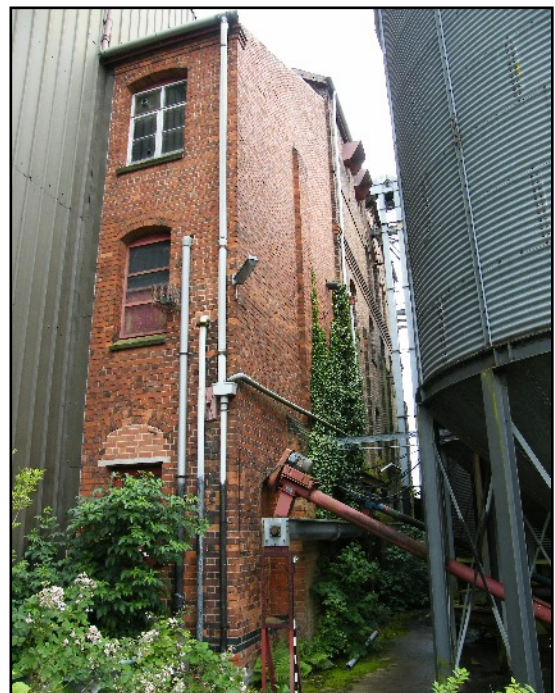
Plate 4: West corner of the maltings, viewed looking south-east.

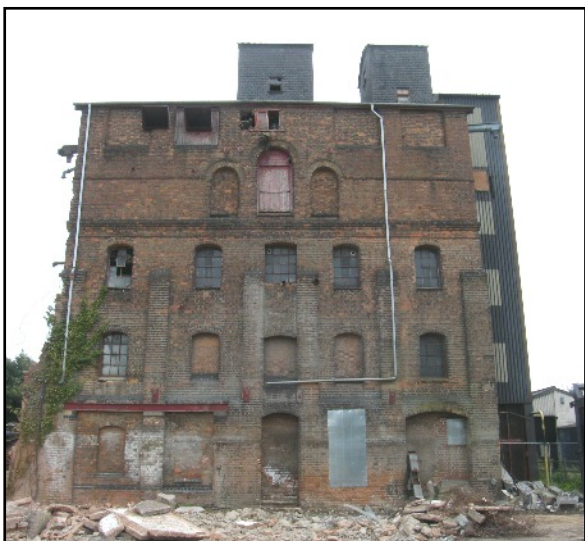
Plate 5: South-west elevation after the removal of the silos and demolition of part of the later north-west Range, viewed looking north-east.

The south-west elevation (Plate 5) was part of the original building and the principal facade to what was probably the brewery section. An original drawing made by the builders Wilson & Co. show that it was later heightened; prior to this it was of a similar height and breadth to the Main Range behind it. It was later to be five stories tall. The brick banding between the second and third floors indicate the base of the original pedimented front. The majority of the entrances and windows had been blocked, including all those on the ground floor, the principal exception being the windows of the second floor, which appeared to be original, and the third floor central doorway which retained its timber door.

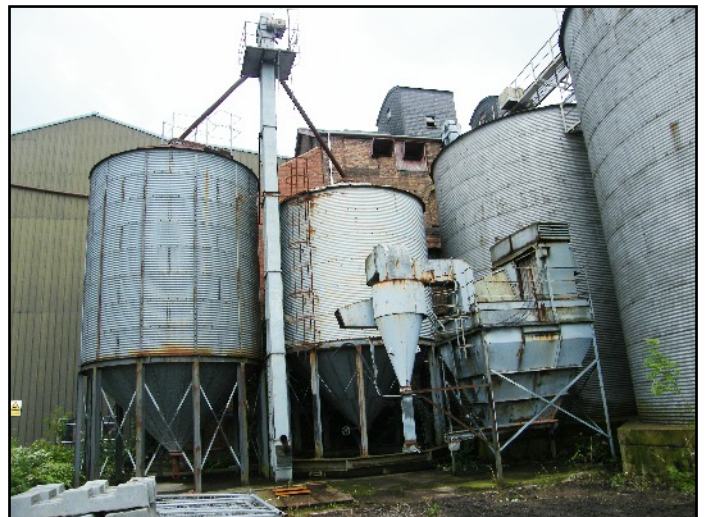
Plate 6: Modern silos located to the south-west of the maltings, viewed looking east.

To the south of the main building there were 10 modern silos (Plate 6). The majority of their ancillary components were present including the pipework feeding from the silos into the maltings through the south-west wall. Steel framed metal structures, also of late 20th century date, are present at the south-west end of the building abutting the walls of both the Main Range and North-west Range.

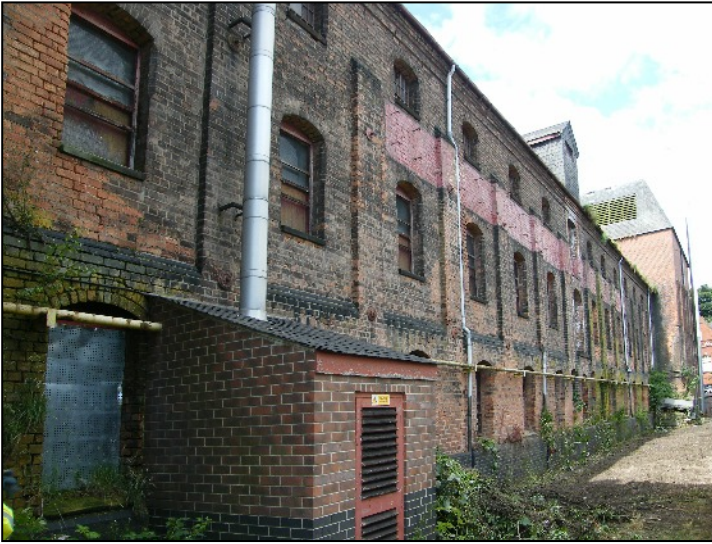
Plate 7: South-east elevation, viewed looking north-east.

The south-east elevation ran for 17 bays, as defined by buttresses and openings in all the bays. These included the 3-bay deep brewery section and the 14-bay long malting. It was partly obscured at the south-east end by a modern metal-framed hoist. The three storey height of most of the elevation featured squat windows with original cast-iron frames still in place in the top floor and taller windows in the lower floors. Because of this general appearance the building has previously been said to have appeared more like a textile mill than a traditional malting (Patrick 2012). However, inspection of the lower windows showed that they had been heightened by the removal of lower brickwork. Angled jambs showing in

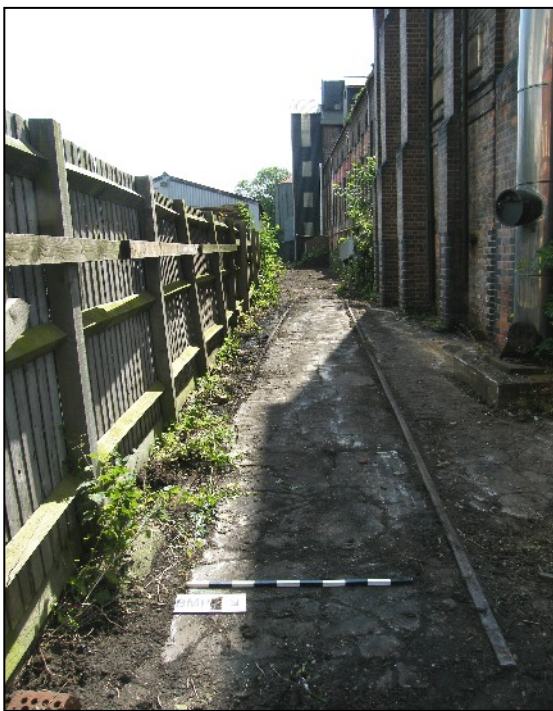
Plate 9: Railway track to the south-east of the maltings, viewed looking south-west.

Some changes had since occurred, such as the removal of two original hoists, the loss of a short pedimented frontage at the attic level of the brewery (before its heightening) and the blocking of several doorways behind where a hoist had been positioned (Plates 7 and 8). The remains of a single set of a railway siding running parallel to the maltings was found to be still present once vegetation had been cleared (Plate 9). At the north-east end of the elevation where it adjoined the projecting Malt Kiln House there was evidence for alterations. A former chimney had been removed and whilst the maltings' brickwork coursing matched that of the kiln the uppermost window position had clearly been moved; some irregular brickwork and part of a former brick arch showed at a high level (highlighted on Plate 10).

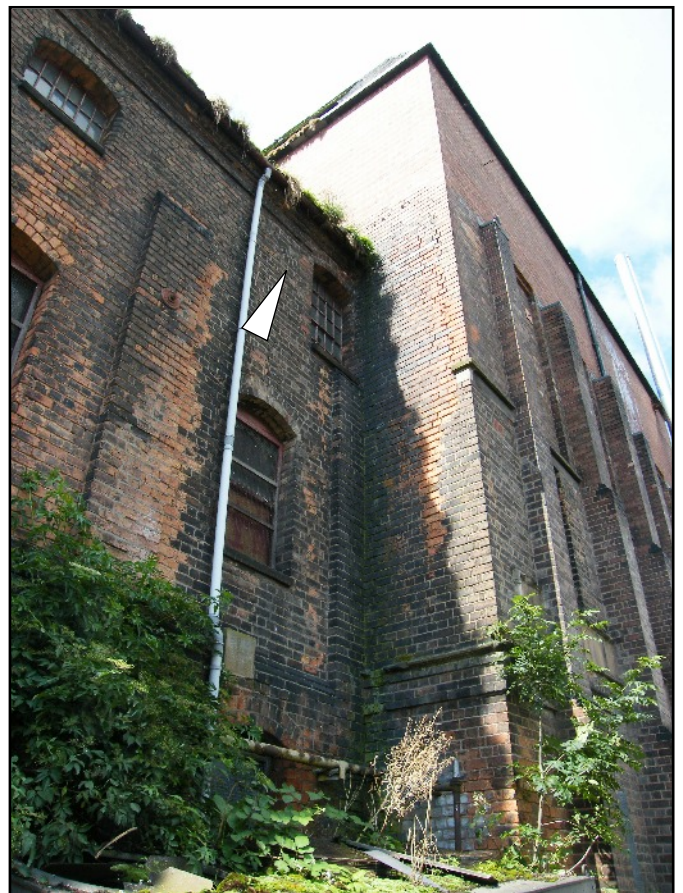
Plate 10: The south-east elevation of the maltings and the Malt Kiln House, viewed looking north.

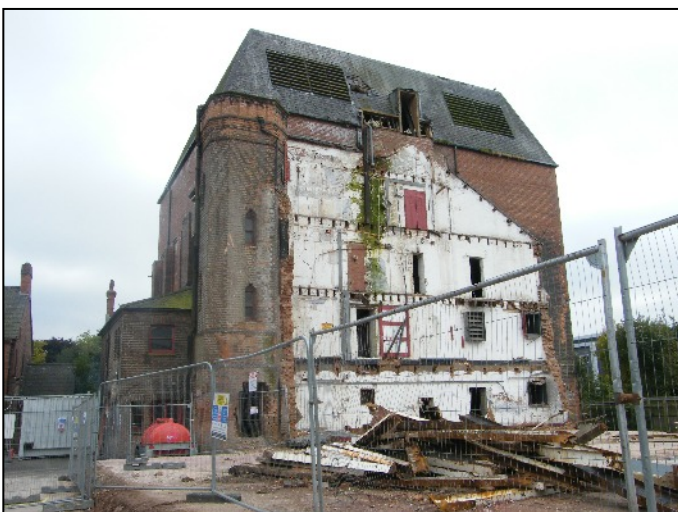
Plate 11: The Malt Kiln House after the demolition of the Main Range and North-west Range, viewed looking east.

The kiln section was accessed by doorways leading from each of the malting's floors (Plate 11) and from the outside ground level through a projecting turret containing a spiral stairway. This had been entered from the south-west side but another entry was later inserted on the west face. Although shown on the early plans it appeared to possibly abut the remnants of walling belonging to the earliest phase of the Main Range's north-west wall. However, its corner position and purpose for reaching the maltings' floor levels suggests it was probably original to the build. It had distinctive narrow windows with pointed tops and a flat top, later heightened (Plates 12, 13).

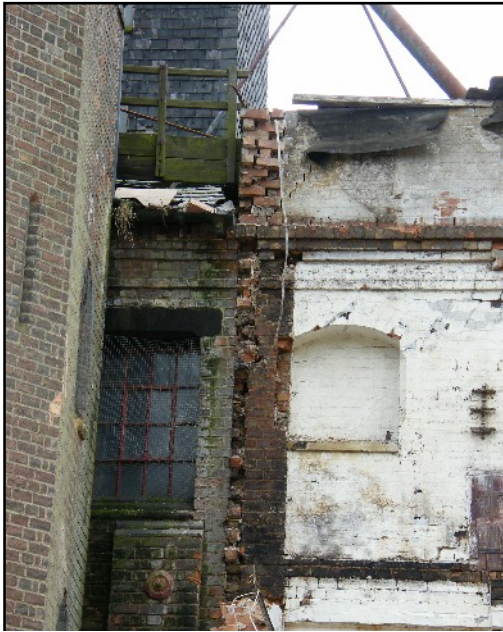
Plate 12: Position where stair-turret adjoined the Main Range's north-west wall and where the 1884 maltings extension was added.

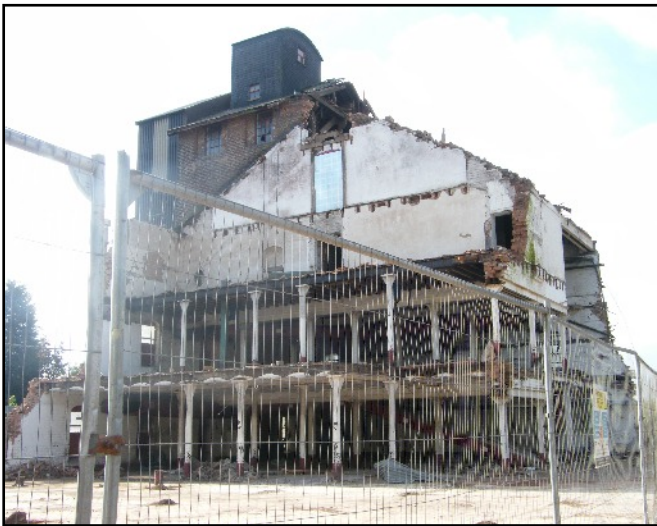
Plate 14: Interior of the Main Range at the south-west end, viewed looking south.

Most of the interior of the maltings was comprised of open floor areas. The timber floors of the main range were supported on metal columns, mostly original ones, and steel beams. Where internal walling had once been (e.g. where the brewery had started) three beams had been set together for added support (Plate 14). The slated roof was supported by

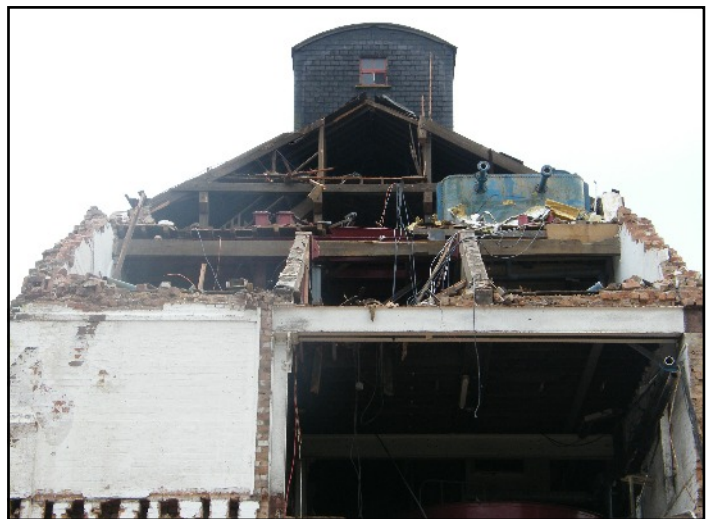
Plate 15: Roof structure of the Main Range at the south-west end, viewed looking south.

timber tie beams and uprights (Plate 15). Nearly all machinery and other internal furniture had been removed from the building prior to demolition, although a circular steep with a lower funnel remained in situ on the first floor at the south-west end of the building (Plate 16).

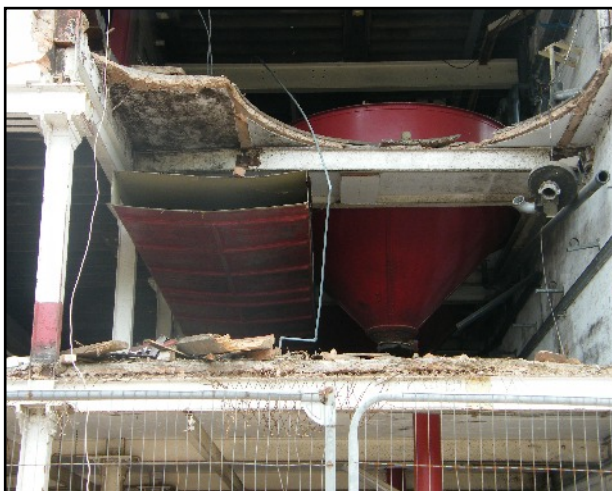
Plate 16: Metal funnel located in the south-west end of the Main Range, viewed looking south-east.

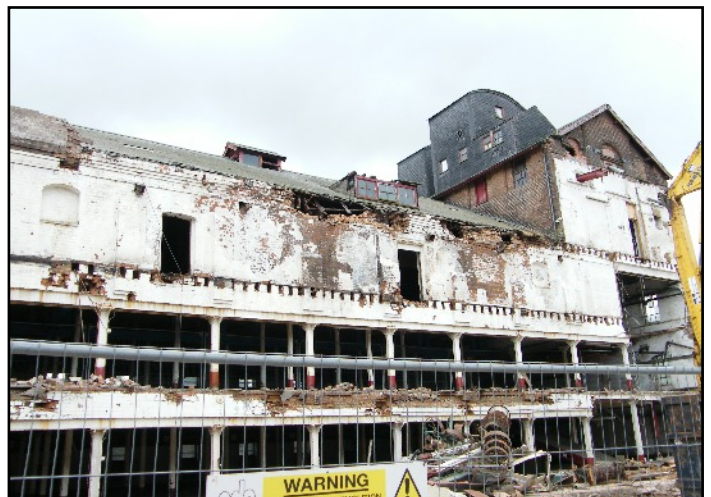
Plate 17: North-west wall of the Main Range, south western end, viewed looking south.

Removal of the adjoining 2-bay deep sections along the north-west side of the malting revealed part of the original outer face of the building, with squat windows (as found in the opposite wall) still showing along the full length of the uppermost level. Most of these had been blocked-up (Plate 17). Two doorways had been cut through at the upper level when the latest addition had been made. Prior to this there had been at least one kiln alongside the building at a lower level.

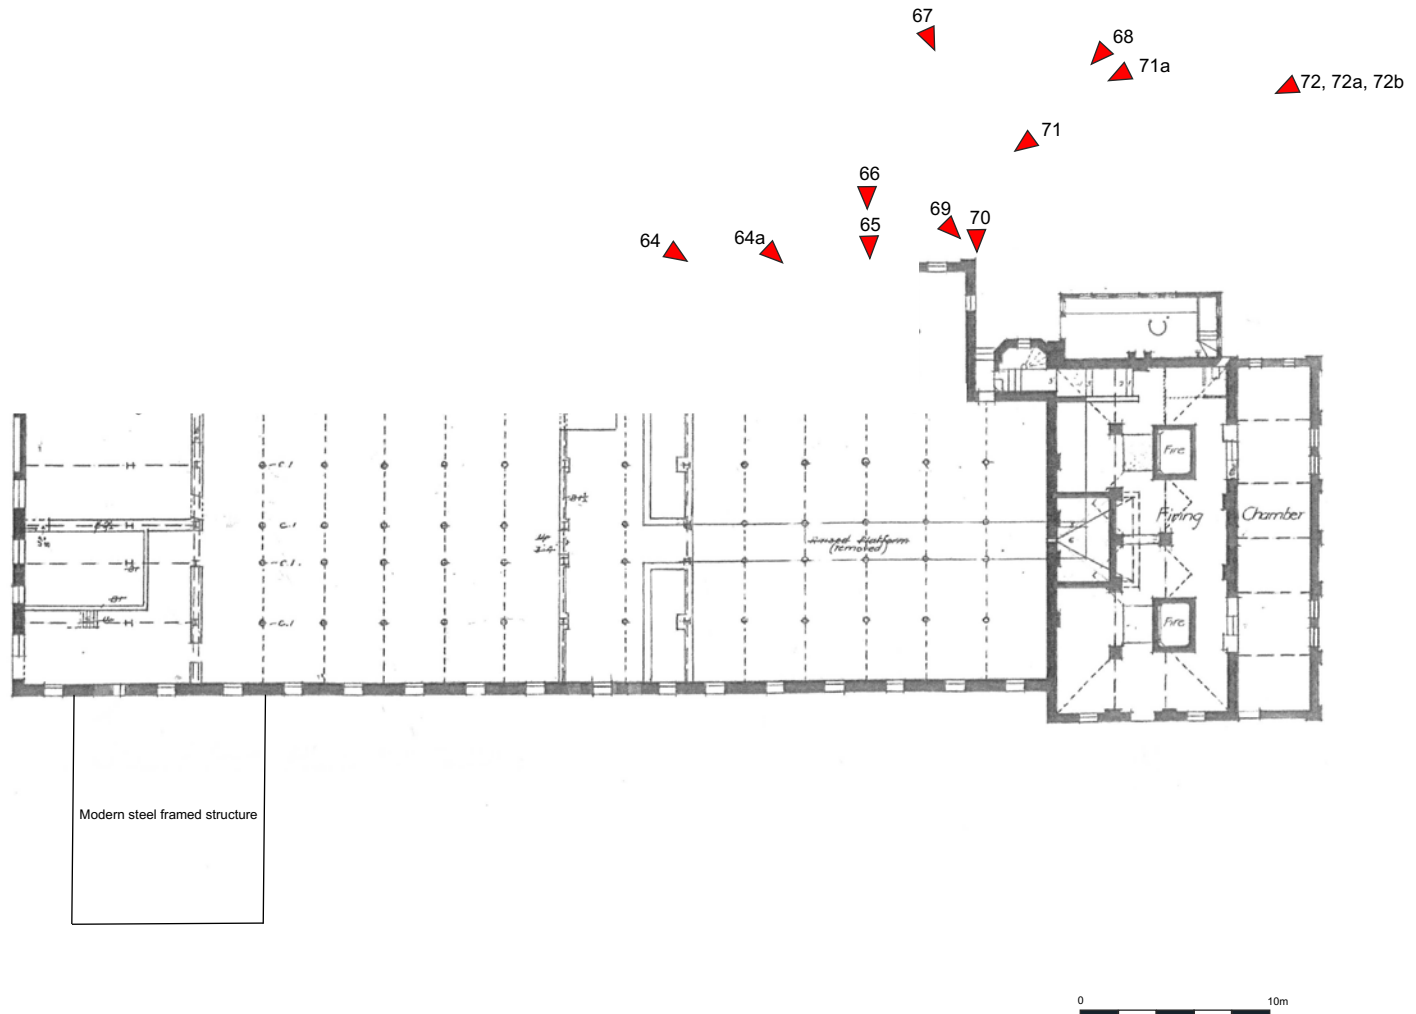
BMP Beeston Maltings, Dovecote Lane, Beeston, Nottinghamshire
Figure 6: Photographic viewpoints during second stage of demolition based on a 1923 plan of Evans, Clark & Wollatt Architects. Scale 1:400 at A4.
