FLORENCE SHIPLEY HOUSE, HEANOR DERBYSHIRE.

Report of Trial Trenching

Project Code - FSH

TPA Report No. 006/2013

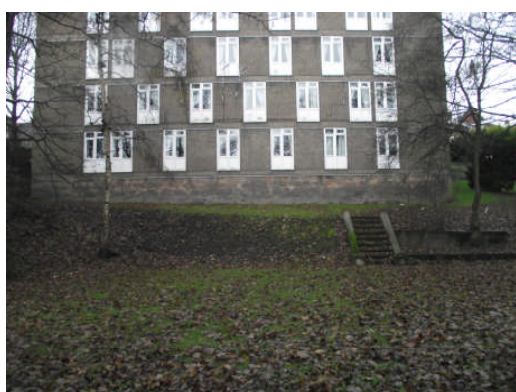
Plate 3. Florence Shipley House showing landscaped grounds and tennis court. Looking south.

3.1 The ground to the south of the current buildings appears to have been heavily landscaped probably in the late 19th/early 20th century when a tennis court was laid out.

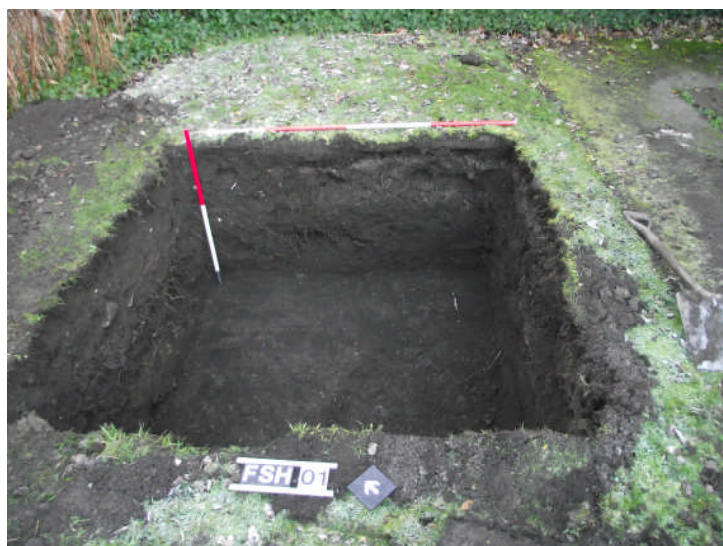
Plate 5, Area 01 excavated. Looking north-east.

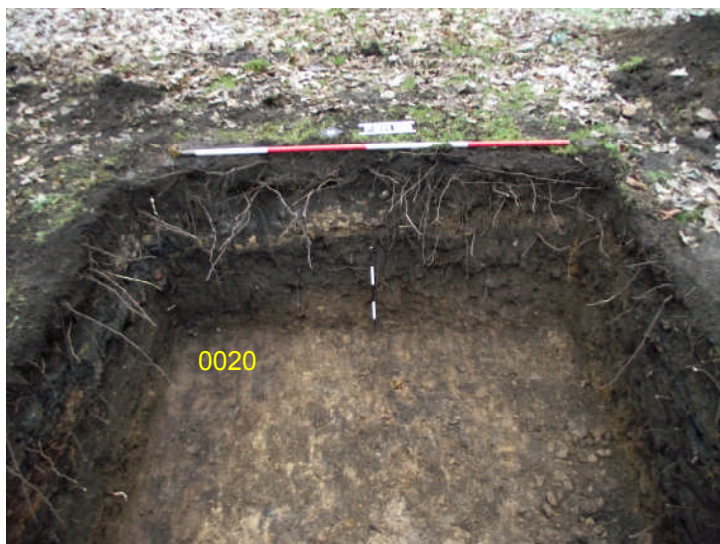
Plate 9. Area 05 excavated, showing linear 0020. Looking south-east.

6.5.1 Area 05 was excavated to a total depth of 1.1m. Two layers (0017, 0018) were recorded between the topsoil (0016) and the natural sandstone formation (0019). A potential linear feature (0020) was identified running north-west/south-east along the north-east edge of Area 05 (Figure 6). The feature (0020), comprised a possible ditch or gully c.0.10m deep, although its precise character and extent remain unclear as a full profile could not be recovered within the limits of the trial pit. A further feature, comprising a small pit or post hole (0021) was also recorded, cut into the base/surface of the ditch (Figure 6). The linear and pit may have formed contemporary elements of a possible boundary feature/structure or two distinct phases of activity. No finds were associated with either of the two features and they currently remain undated.

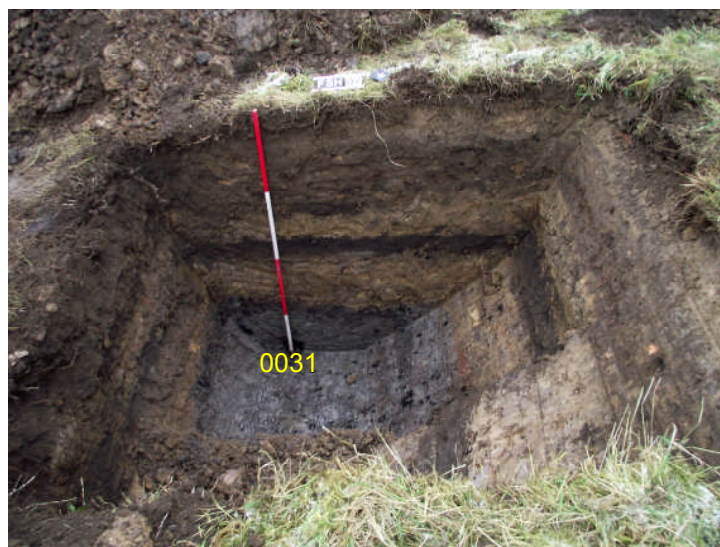
Plate 10. Area 07 excavated, showing coal deposit 0031.
Looking south-east

6.7.2 The basal layer exposed by the excavation, 0031, comprised a heavy grey clay mixed with ash and coal fragments. Within the constraints of the trial trenching it was not possible to expose the full depth of this deposit and its precise character and extent remain unclear.

6.7.3 A preliminary interpretation of 0031 is that it may relate to small-scale coal extraction activity (see Section 7).
