**THE FOUNTAIN GARDEN,  
BOLSOVER CASTLE,  
DERBYSHIRE:  
TRIAL-PITS FOR LOCATING  
A DRAIN, 2013**

OS Grid Ref. SK SK 4703 7072  
TPA Project Code: LCD  
TPA Report No. 012/2013  
February 2013

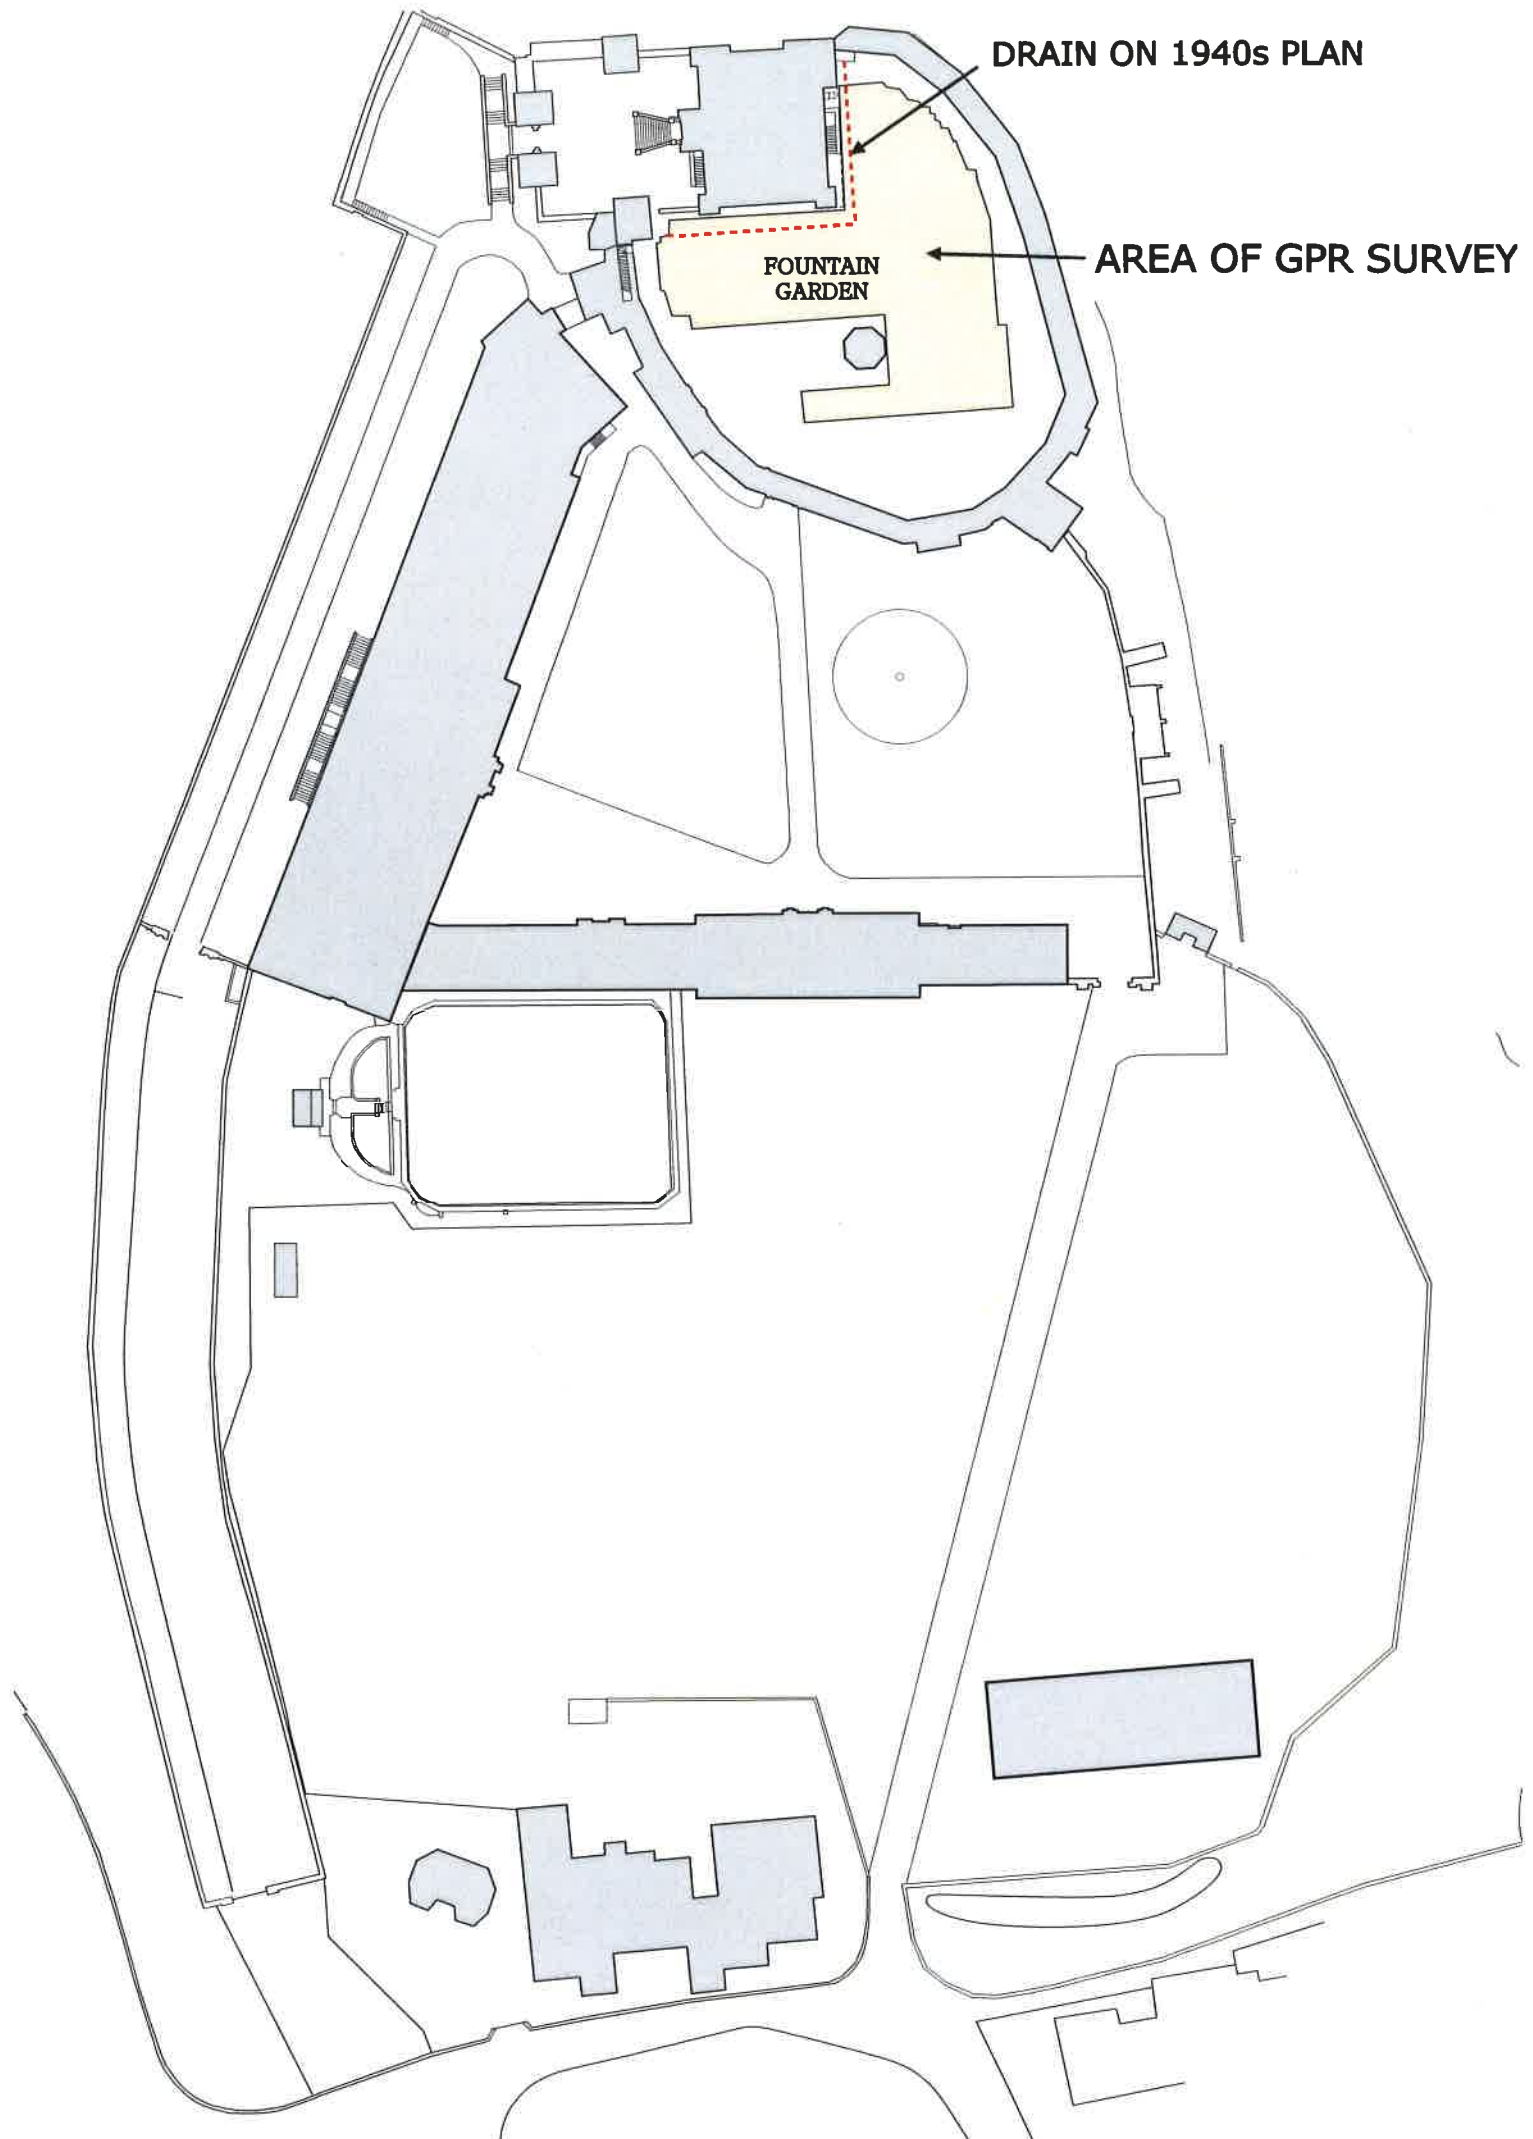
Figure 1: Plan of Bolsover Castle, Derbyshire, showing the approximate location of a drain in the Fountain Garden and the area surveyed in 2012 by Carey Consulting using GPR (ground penetrating radar). Scale 1:1,000.

On the 17<sup>th</sup> and 29<sup>th</sup> January 2013, Trent & Peak Archaeology excavated several trial-pits in the grounds of the Fountain Garden, Bolsover Castle, Derbyshire to locate a drain constructed in the 1940s (Figure 1). This was carried out on behalf of English Heritage.

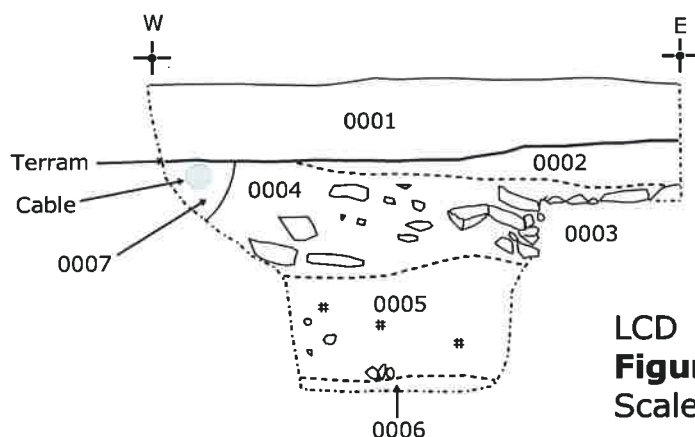
LCD Bolsover Castle, Derbyshire  
**Figure 05:** Trial-pit 01 south facing section.  
 Scale 1:20 at A4.

Layer 0003 extended for 0.62m to the west, where it was truncated by 0004, a north-south aligned cut up to 0.26m in depth, infilled with loose stone within a matrix of dark brown sandy silt loam; it contained a single fragmented piece of tile. A modern service 0007 (probably a redundant

electric cable), was encountered in the west of the trench beneath 0001 and cutting 0004. At a depth of up to 0.42m and beneath 0003 and 0004 there was 0.3m thick deposit 0005, a brown sandy clay loam with residual finds (clay pipe stems, tile and bone) in the upper 0.20m of the deposit. This deposit too may also have been encountered before in Fountain Garden and is interpreted as a relic soil (Sheppard 2000, 8; layer 0125). Deposit 0005 lay above natural dark yellowish brown sandy clay, encountered at a depth of 0.8m.

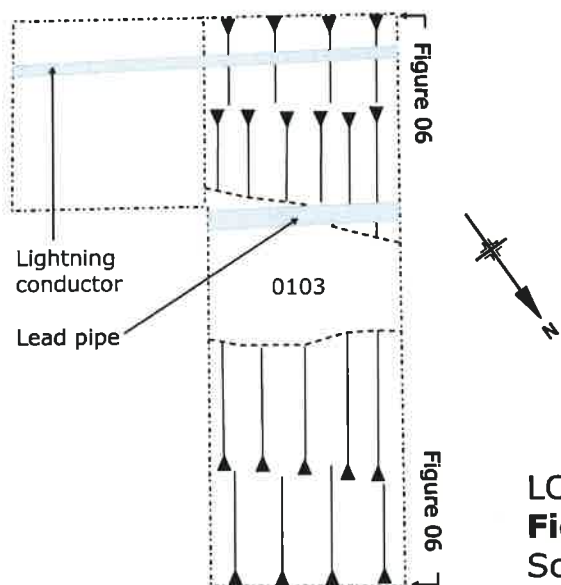
LCD Bolsover Castle, Derbyshire  
**Figure 06:** Trial-pit 02 plan.  
 Scale 1:20 at A4.

Trial-pit 02 was L-shaped and measured 1.5m x 1m, and was 0.5m in width and was up to 1.06m in depth. It was located to the north-east of the Little Castle adjacent to a known water tank and within the modern path. The trench targeted two NW-SE running linear anomalies detected during the GPR survey, one corresponding to the assumed course of the drain.

Removal of the compacted hardcore modern path and terram (0101) exposed a bedding layer up to 0.26m thick (0102), comprising very dark brown sandy silt loam. Placed at the base of 0102 close to the south-west edge of the trench was a NW-SE aligned metal lightning conductor. Beneath 0102 there was feature 0103, a NW-SE aligned service trench cutting the natural light yellowish brown sandy silt loam (0104) at a depth of 0.8m. Feature 0103 had been cut for and contained a lead pipe placed on the base of the cut at a depth of 1.06m. Pottery finds from 0103 indicates a likely Victorian date.

The drain was not present at this location and some doubt must be expressed as to whether it was actually extended as far as the 1940s plan shows.

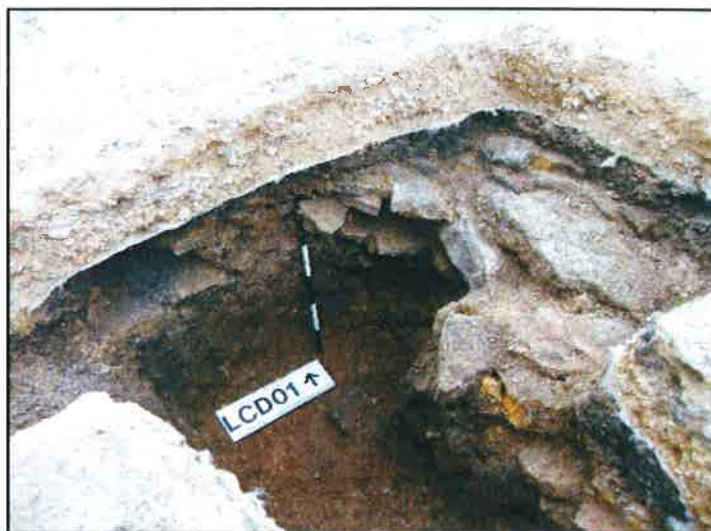
Removal of the compacted hardcore modern path (in the position of the original 17<sup>th</sup> century one), and terram (0001) exposed a bedding layer for the present path (0002), comprising very dark brown sandy silt loam which extended across much of the trench. Beneath 0002 in the eastern half of the trench at a depth of 0.3m there was a compacted rubble layer (0003), up to 0.22m thick. The layer may have been previously encountered during service excavations south of the Little Castle in 1999 (Sheppard 2000, 8; layer 0124). It may show as a general spread on the GPR survey results at 0.6m depth and it could be associated with the demolition of the Medieval Castle in the 17<sup>th</sup> century.

Plate 1: Trial-pit 01: south facing section, viewed looking north-east.

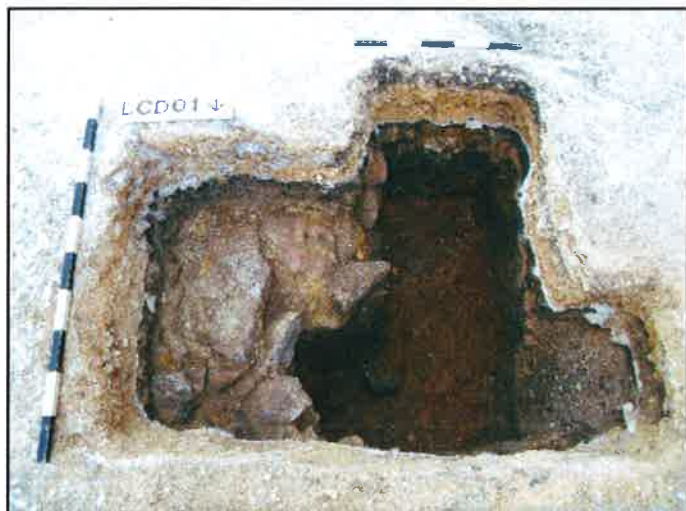
Neither the manhole cover or the drain itself were located. The presence of the cable and the known proximity of another cable trench dating from 1999 prevented further expansion of the trench to the south-west where further anomalies showed in the GPR survey and where a trench excavated by Northamptonshire Archaeology in 1996 had found a modern disturbance (Figure 3).

Plate 2: Trial-pit 01, viewed looking south.

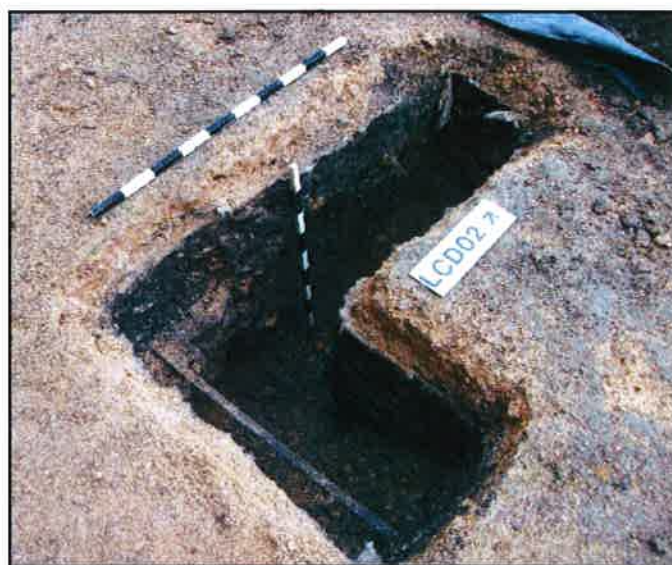
Plate 3: Trial-pit 02, viewed looking north.

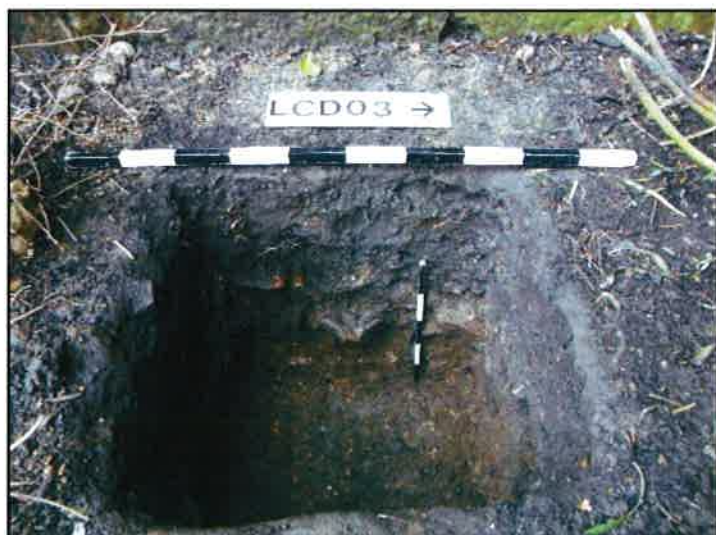
Removal of the black clay loam topsoil (0201) revealed subsoil deposit 0202 at a depth of 0.26m, comprised of dark greyish-brown sandy clay loam. Beneath 0202, at a depth of 0.42m, there was an olive-brown sandy clay loam deposit (0203) which extended beyond the base of the trial-pit at a depth of 0.8m. Small quantities of modern pottery were

The three deposits within the trench may all be associated with the landscaping of the Fountain Garden. However, the similarity between the fill of the Victorian service trench 0103 in Trial-pit 02, and the lowest deposit 0203 in Trench 03, suggests the possibility that the Victorian service pipe may have extended as far as here.

Plate 4: Trial-pit 03: south-east facing section, viewed looking north-west.
