**AN ARCHAEOLOGICAL WATCHING BRIEF  
AT EPPERSTONE MANOR, EPPERSTONE,  
NOTTINGHAMSHIRE, 2007-10**

**A Report for FC7 Ltd**

OS Grid Ref. SK 6498 4851  
TPA Project Code: EMR  
TPA Report No. 027/2013  
March 2013

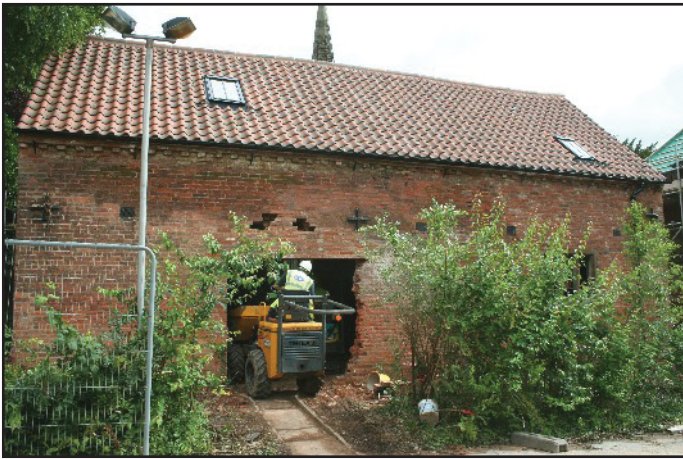
Plate 1: South elevation of the West Barn, viewed looking north-east

The west barn is a Grade II listed building which is shown on the 1734 estate map. It is a two storey brick building which is orientated east to west. The 0.4m thick walling is constructed in Flemish garden bond with bricks measuring 2 $\frac{3}{8}$  inches (60mm) thick and 9 $\frac{1}{2}$  inches (240mm) long, suggestive of it being of late 17<sup>th</sup>- early 18<sup>th</sup> century in date. Dentil ornamentation beneath the cornice is present. The building is of five bays with a pantile covered roof comprised of principal rafter trusses with collars, side purlins with windbraces up to the principals, and wall brackets which support the feet of the principal rafters as there are no tie-beams. The brackets are cut from grown crooks and are fastened to the feet of the principals by tusked iron pins with tenons over stout washers.

Original entrances were located on the west gable wall at the south end, since blocked up, and on the south elevation, since widened. A later doorway was inserted on the north elevation giving direct access to the road. Pitching holes are located in the east and west gable walls. An original stone three light mullion window was also present on the south elevation.

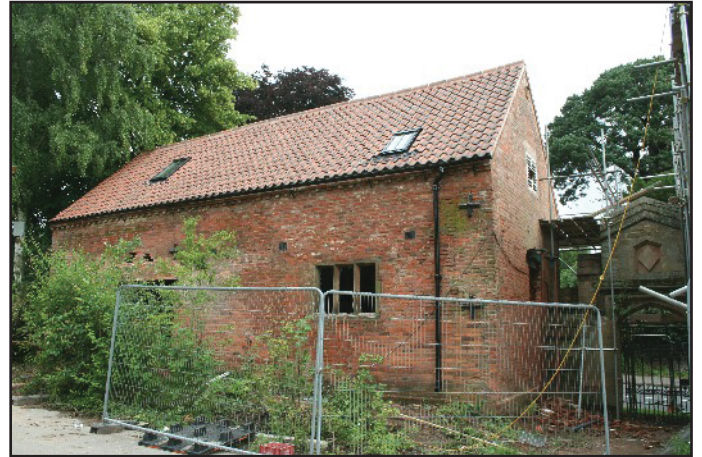
Plate 2: South elevation of the West Barn showing the stone mullion window, viewed looking north-west

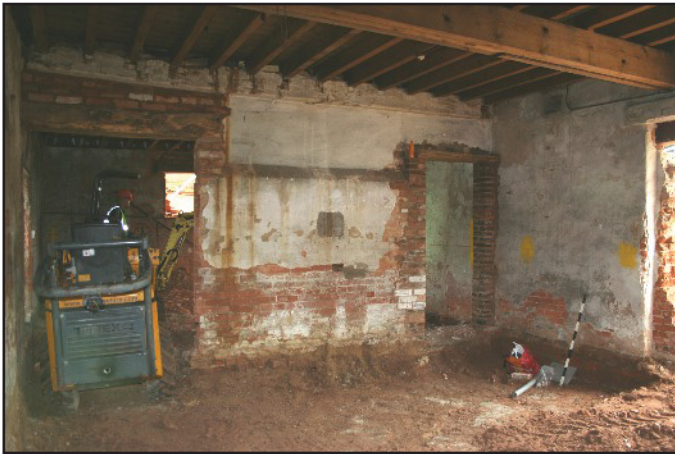
Plate 3: The inserted dividing wall in the West Barn, viewed looking north-east

On the ground floor a central wall divided the building into two rooms, the dimensions of the eastern most being 4.81m long by 5.84m wide and the western one 7.37m long by 5.81m wide. The ground floor room was 2.22m from floor to ceiling beam. The wall is a likely later insertion as it used a mixture of bricks measuring 2-3 inches thick. Two doorways are present within the wall providing access between the rooms. The floor was of brick.

The axial ceiling beam is original, although the joists for the first floor appeared to be replacements. Air vents were present within the brickwork at a similar height to the ceiling beam. The internal walls had been whitewashed, although the ceiling beams and joists remained unpainted. Later metal tie plates extended from the north to south elevations on both upper and ground floors, providing additional support to the building.

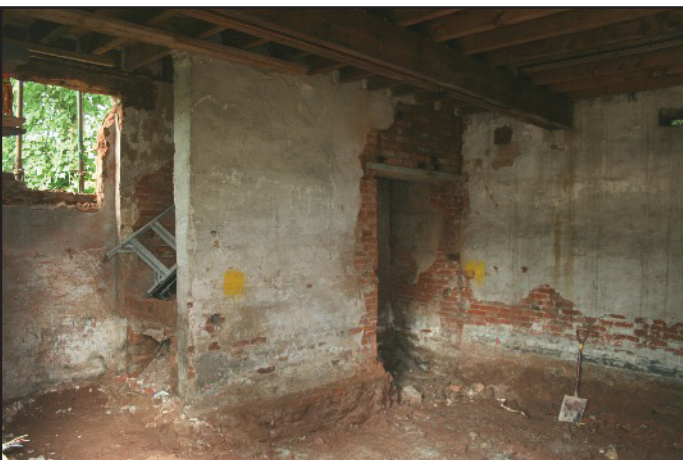
Plate 4: The location of the former stairway, now with a feeding trough within it, and small storage room to the right, in the West Barn, viewed looking north-west

Access into the hay loft was via an internal staircase abutting the west gable wall, to the north of which a small room existed beneath the stairs.

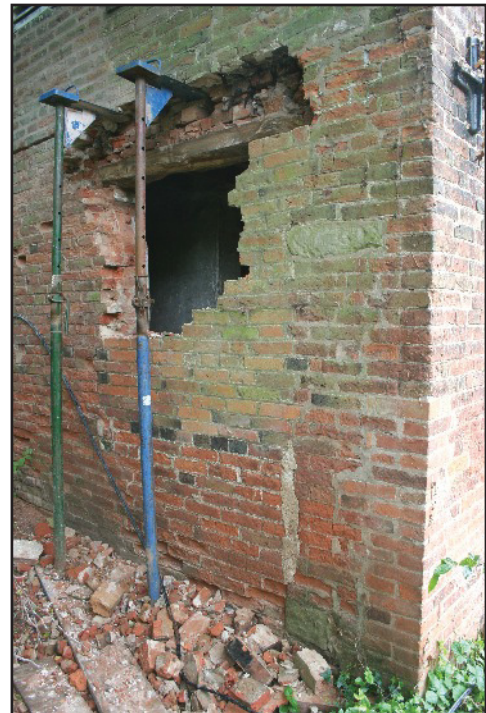
Plate 5: Former doorway in the west gable wall of the West Barn with wooden lintel and some stone quoins surviving, viewed looking south-east

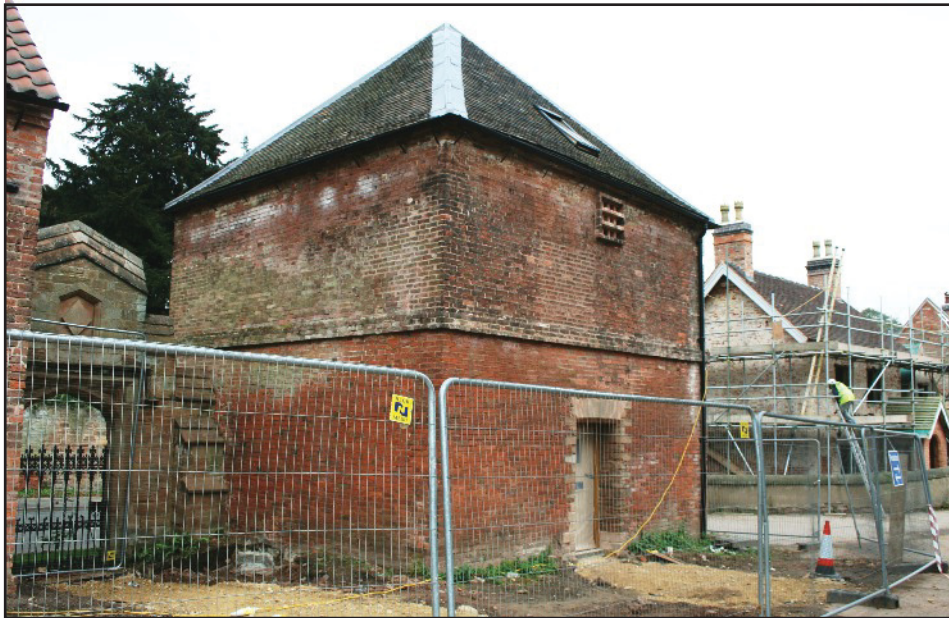
Plate 6: General view of the Dovecote, viewed looking north-east

The dovecote / pigeoncote is one of three Grade II listed examples in the village and is also shown on the 1734 estate plan. It is of red brick construction in an irregular Flemish garden bond and has a first floor string course with a pyramidal plain tile roof. An early-mid 17<sup>th</sup> century date for the building is suggested by the thin 2-2¼ inch (50-57mm) bricks used in its construction. The walls are thick at 0.8m. The doorway on the south elevation had a chamfered flush ashlar quoin surround and plank door, above which there was a single panel with raised brick surround and two rows of openings for birds. An arched doorway on the east elevation had been blocked.

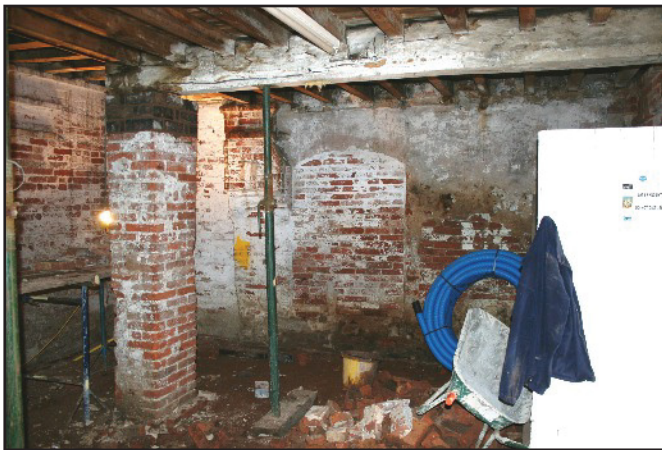
Plate 7: Interior of the Dovecote with the blocked arched doorway on the east elevation in the centre of the picture, viewed looking north-east

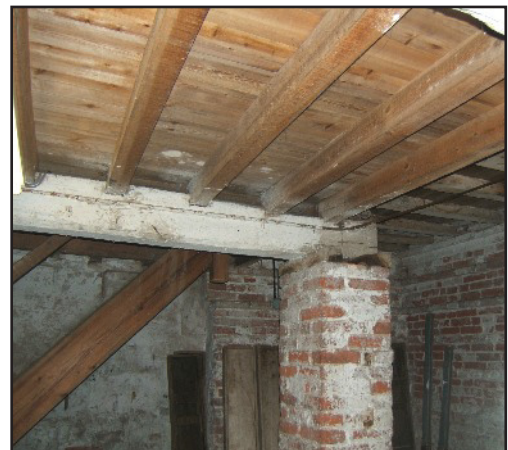
Plate 8: Original brick pier and ceiling beam with later joists, flooring and stair in the Dovecote, viewed looking north-west

Internally, the dovecote measured 5.2m by 5.8m. It had a later brick floor. Two original brick piers supported chamfered ceiling beams, although the joists and floor boards were later replacements. A secondary joist towards the rear of the structure was a reused rail from an earlier timber-framed building. Access to the first floor was via a stair located in the south-west corner of the building, the current timber stair being a later replacement.

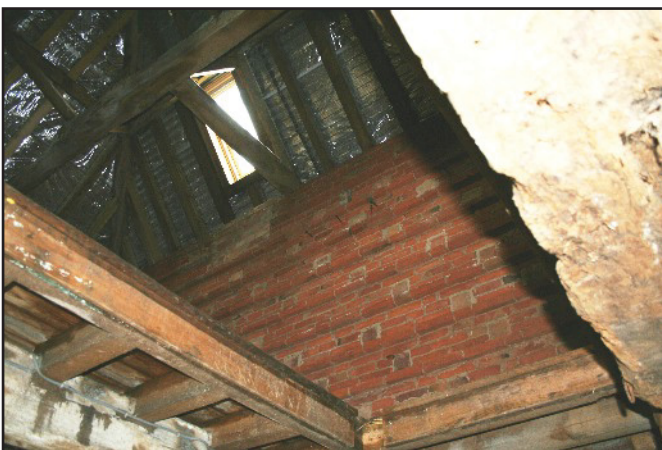
Plate 9: Upper floor nest boxes within the Dovecote, viewed looking south-east

The brick nest boxes and perches were carried on corbels. The roof structure consisted of a pair of tie-beams with struts to purlins and hip rafters.

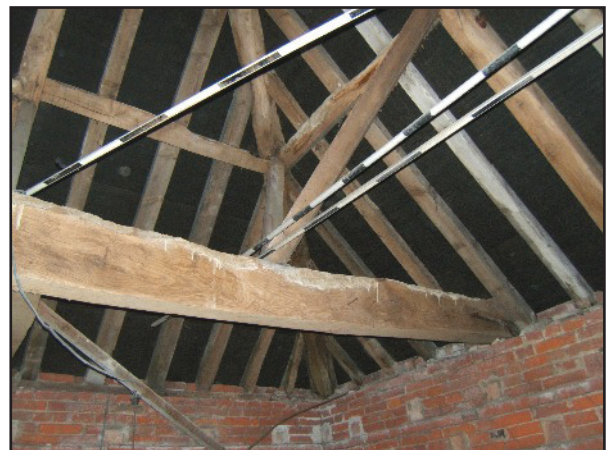
Plate 10: Roof structure of the Dovecote, viewed looking north-east

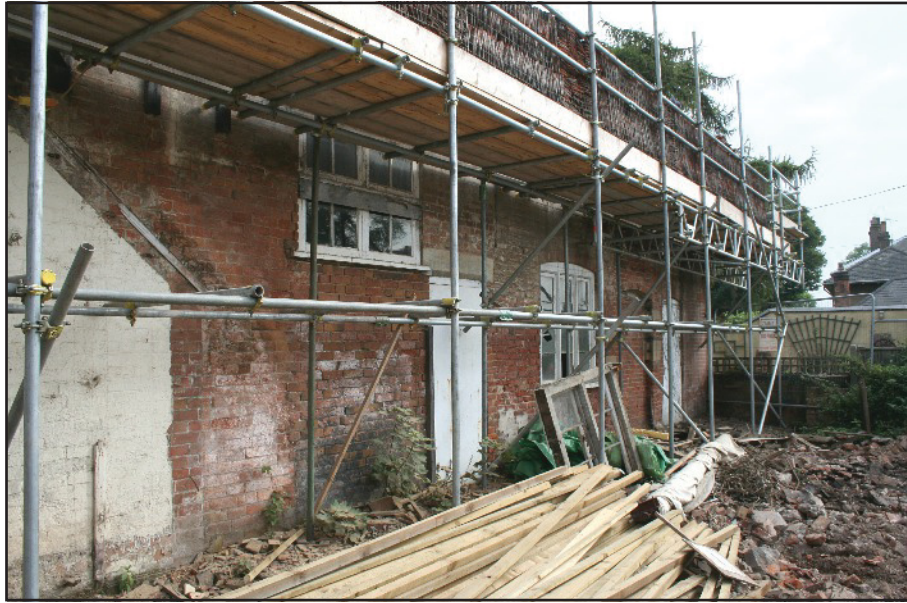
Plate 11: General view of the East Barn, viewed looking north-east

The barn is also shown on the 1734 estate map. It is a two storey building which is orientated east to west. It is built of red brick laid in irregular Flemish garden bond set on a rubble plinth. The bricks showing on the road-side average a thickness of 2 $\frac{1}{8}$  inches (53mm), a size indicative of 17<sup>th</sup> century date. Dentil ornamentation beneath the cornice is present. Four cross tie plates, the same as those in the West Barn, were also present. The building is 22.15m and 8 bays long and 6.5m across.

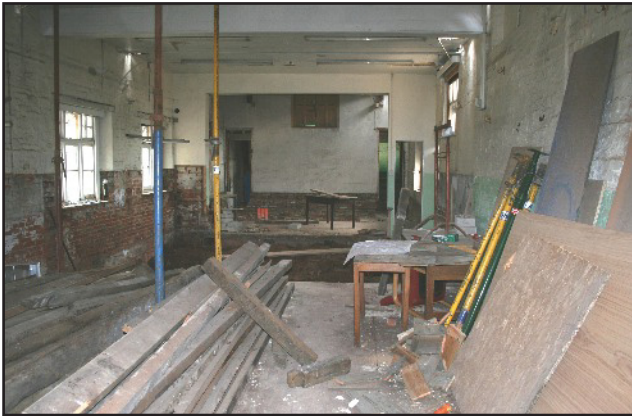
Plate 12: Interior view of the East Barn, viewed looking east

The building has a pantile roof comprising original oak principal rafter trusses which have collars and tenoned or threaded purlins (the type of purlin could not be ascertained due to later metal supports obscuring the timbers), with pairs of windbraces up to the principals. The east end was originally a stable, the double stable door being located in the south wall, now blocked, although the pintles and catches for the door survived. The barn is much altered, with the insertion of fenestration and later brickwork showing on the south side. The interior was much altered to create a village hall with a stage.

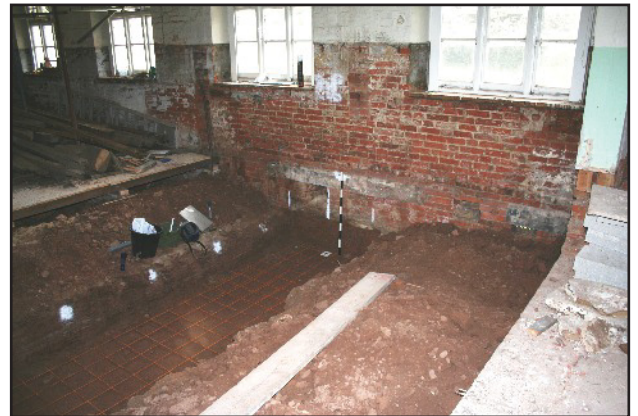
Plate 13: The north-to south aligned trench located in the centre of the East Barn, viewed looking north-west

The existing floor within the central part of the building was taken up during the renovation work. It comprised a plank floor resting upon joists which were supported on sill timbers, which in turn rested on brick sills which ran longitudinally to the building. Re-deposited clay and rubble lay directly beneath the floor. A north to south aligned trench 1.4m in width was excavated across the centre of the building. At a depth of 0.4m an earlier red tiled floor was encountered. No finds were recovered to assist with the dating of either floor.

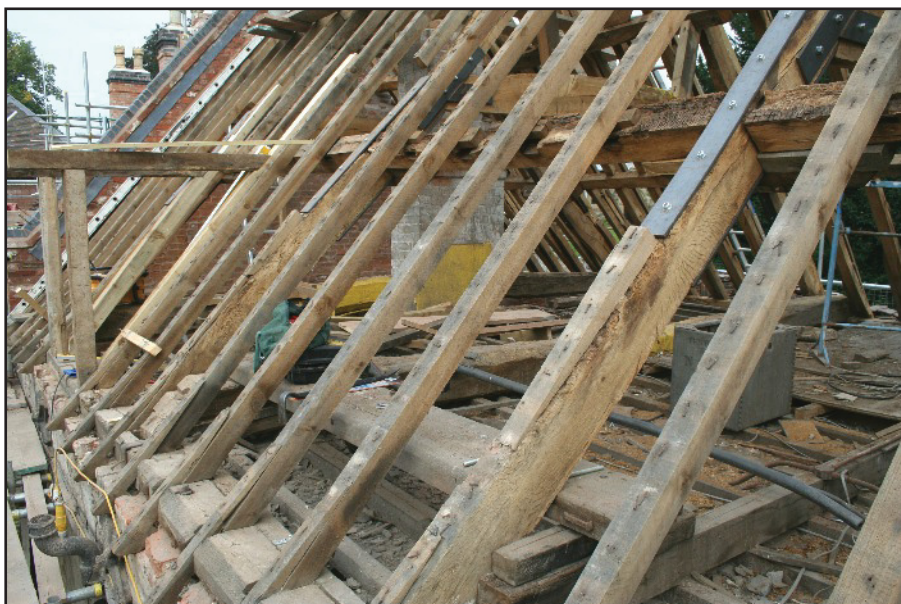
Plate 14: General view of the East Barn's roof, viewed looking north-west

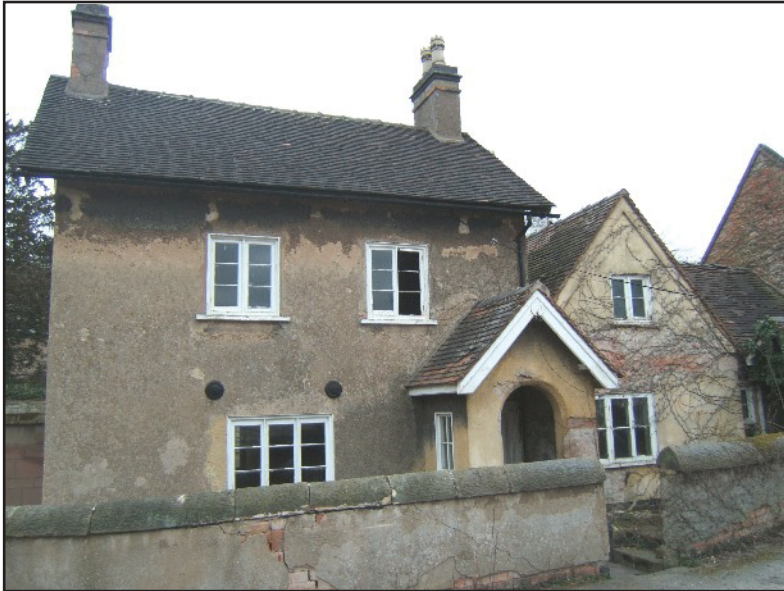
Plate 15: General view of the Cottage with the west extension to the left and the earliest phase of the building to the right, viewed looking north-east

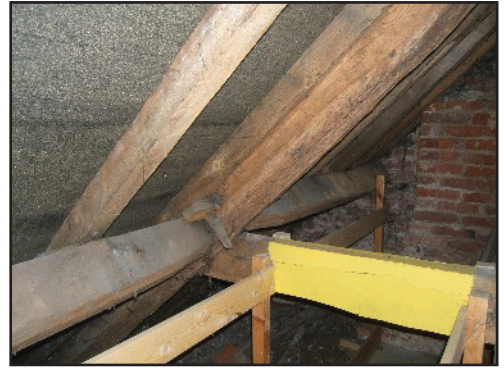
Plate 16: The roof of the 19<sup>th</sup> century extension to the Cottage, viewed looking north-east

The estate plan shows that the cottage had been extended both on its west and east sides by 1734. The west side (A and B) was built with bricks 2⅜ inches (60mm) thick and up to 10¼ inches (260mm) long, suggesting a date in the first half of the 18<sup>th</sup> century, not long before the estate plan. This 4-bay addition created additional living space with a room to either side of an off-central corridor (later fronted by a porch), and a roof-structure with the original part (C) still gable-fronted to the road, and the addition's roof running parallel to it. Part A and B has a later slate roof comprising three principal rafter trusses and collars with threaded staggered purlins. The north wall is buttressed towards the street.

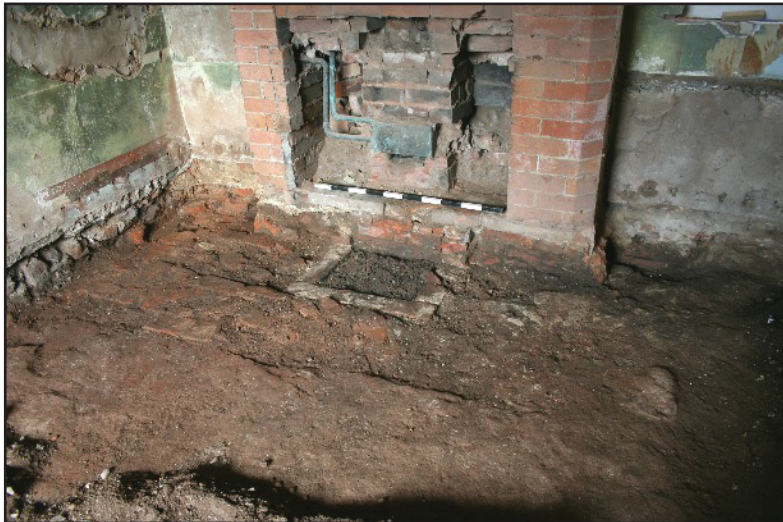
Plate 17: The ash pit and later fireplace in the Cottage, C, viewed looking north-west

The ground floor of C was reduced by 400mm, revealing an ash pit with an internal space of 360mm x 480mm in front of the fireplace. This was made of mortared bricks with a moulded edge and still retained an ashy fill; no dating material came out of the pit. The bricks here, in the lower part of fireplace and some still surviving parts of a contemporary brick and stone floor surface were of 2½-2⅝ inch (63-67mm) thickness, indicating an historic origin. The floor level had been later raised with soil and brick and tile fragments.

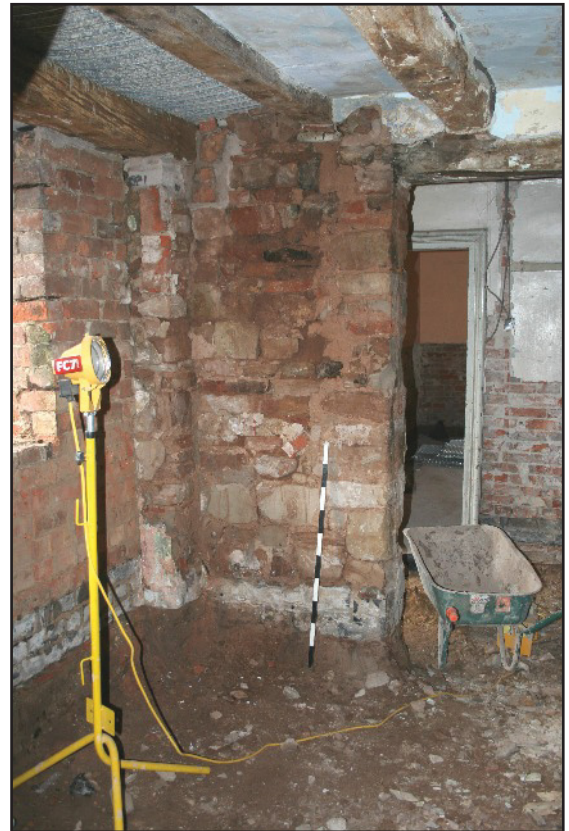
Plate 18: South-west corner of the ground floor of the Cottage, C, viewed looking south-west

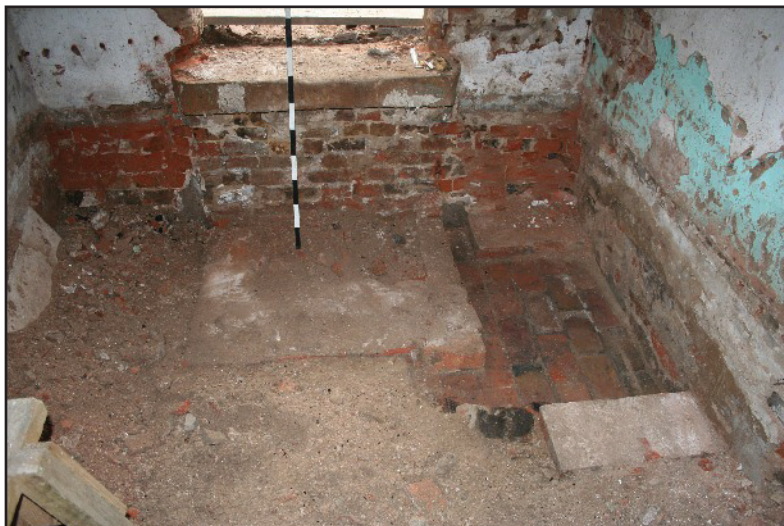
Plate 19: Exposed brickwork in the floor of the Cottage, E, and doorway, viewed looking south

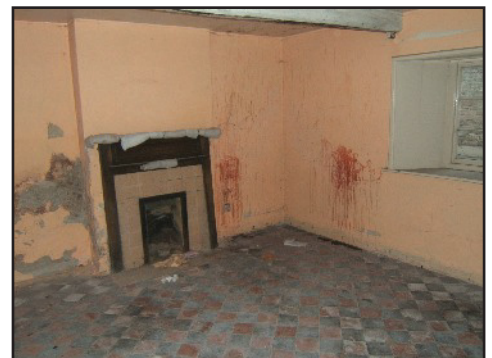
Plate 20: The fireplace and red and black tiled floor in the Cottage, A, viewed looking north-west

An infilled doorway is visible on the exterior west wall providing access into A to the south of the fireplace. The former stairs were located at the northern end of B. A black and red tiled floor was present in the ground floor of A which was set in 0.12m of sandy rubble, which in turn rested upon a 5cm thick foundation of sandy clay containing tile, brick and plaster fragments which lay above the natural clay. The ground level in B was also reduced to reveal similar deposits.

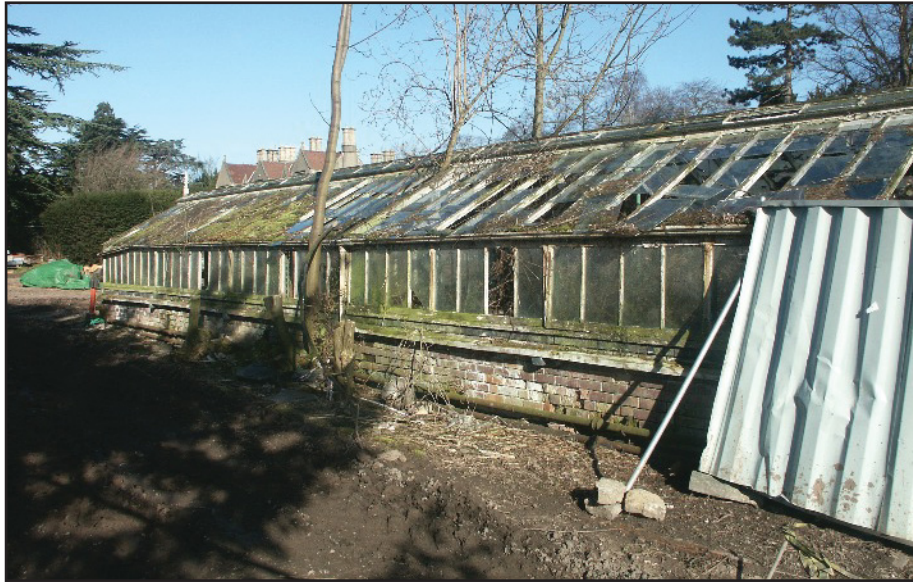
Plate 21: General view of the Hot-house, viewed looking north-west

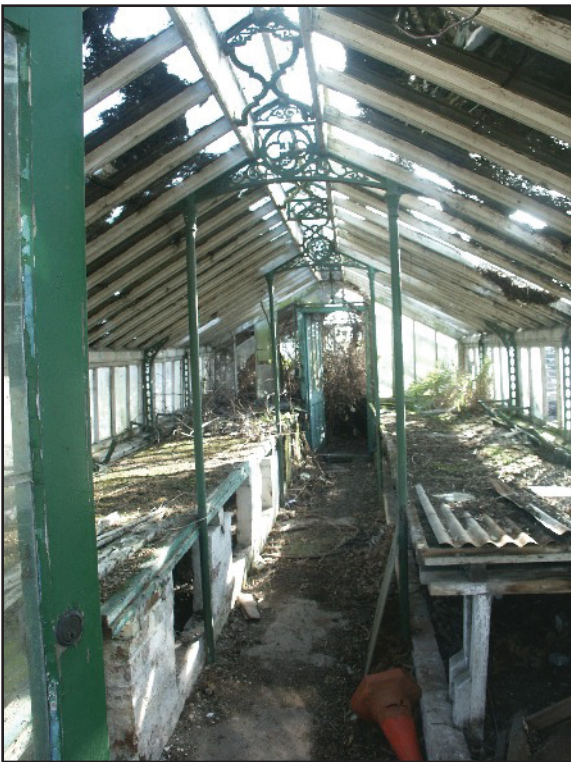
Plate 22: General view of the interior of the Hot-house, viewed looking west

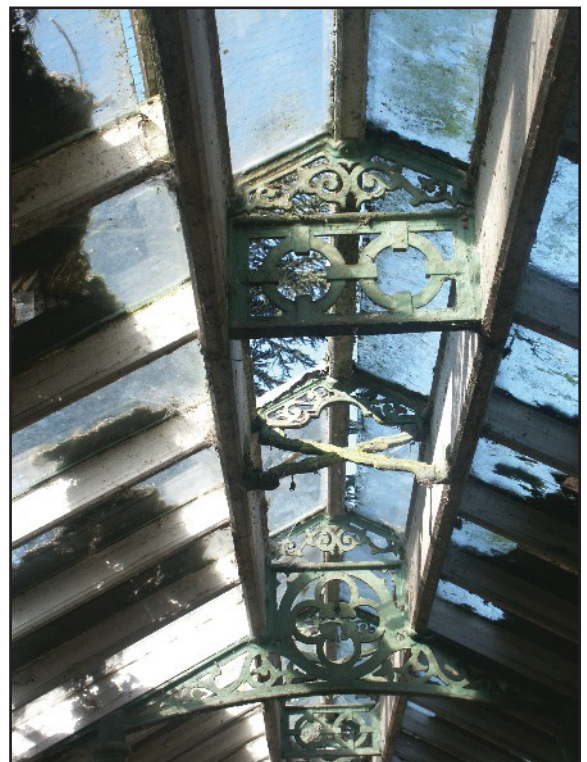
Plate 23: Decorative cast iron work in the apex of the Hot-house, viewed looking west

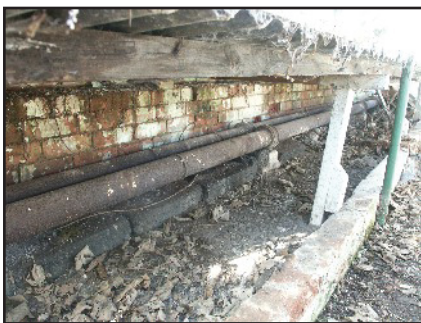
Plate 24: Heating pipes beneath the southern benches in the Hot-House, viewed looking south-west

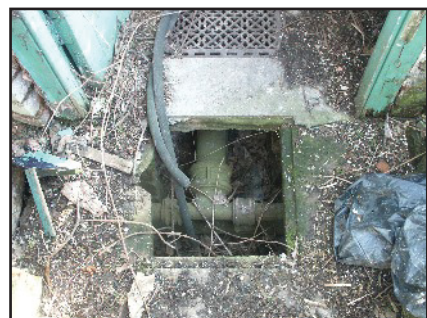
Plate 25: Heating pipe beneath the centre of the Hot-house, viewed looking west

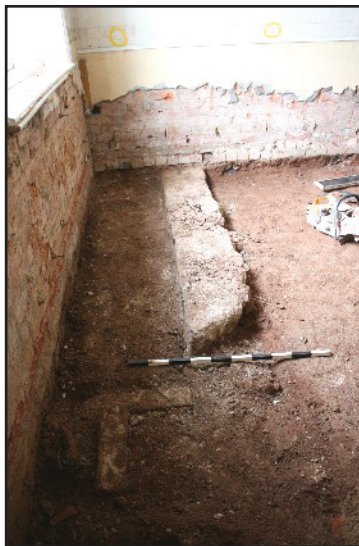
Plate 28: Walling pre-dating the addition of the House Keepers Room to Epperstone Manor House, viewed looking east

The floor of the House Keeper's Room was reduced by up to 0.5m revealing in the north-east part of the room an east to west aligned stone wall. It was 0.4m wide and up to 0.15m in height. It was abutted on its north side by two thin north-south aligned brick walls, both a half brick thick, with vestiges of gypsum flooring remaining between them. The walling had been removed in the north-west corner of the room when a ceramic land-drain had been inserted to run north-east to south-east across the room. The stone wall had extended further westwards as its foundation was seen in the corridor north of the Scullery.

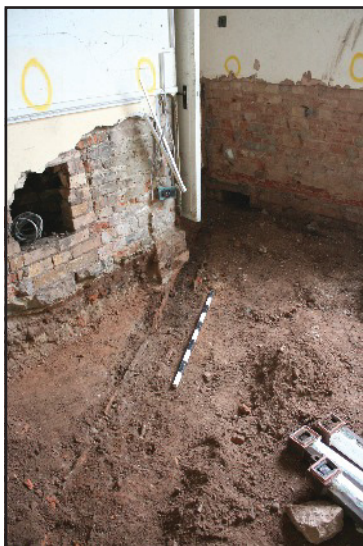
Plate 29: The drain beneath the walls and fireplace in the House Keepers Room, Epperstone Manor House, viewed looking east

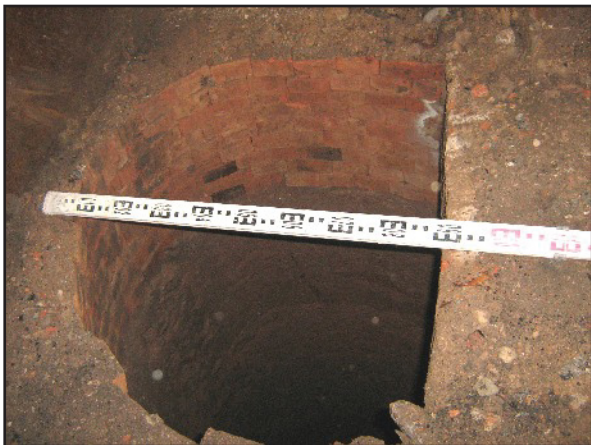
Plate 32: The well within Building Plot 23, viewed looking north

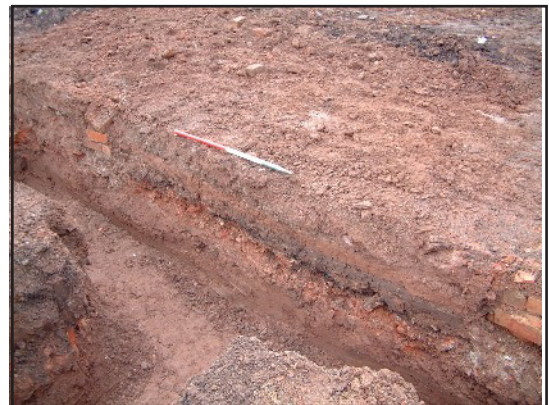
Plate 33: Two walls within the south-west facing section of Building Plots 27 and 28. Note the concrete foundation indicating they belong to the 1950's garage, viewed looking west

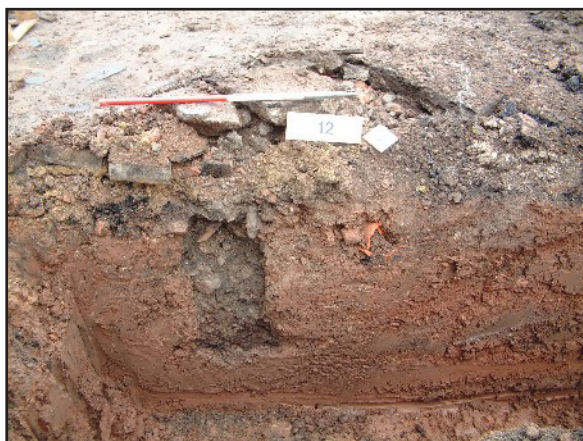
Plate 34: The modern pit within Building Plot 24, viewed looking south-east

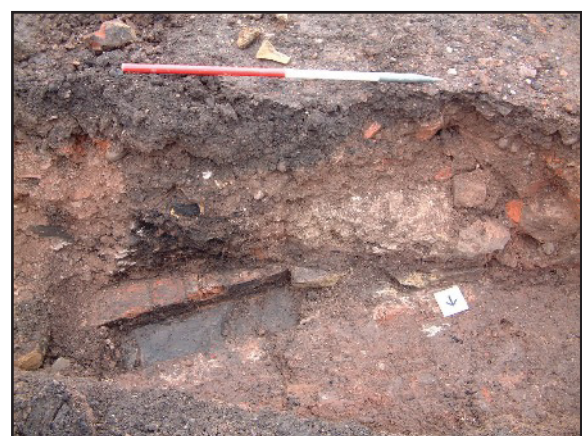
Plate 35: The culvert within Building Plot 25, viewed looking south-west

Within Plot 25 a north-east to south-west aligned culvert was uncovered at a depth of 0.8m. It had a sandstone base and capping with brick sides and lay within a foundation trench beneath the levelling layers. In total, the feature was 0.5m in width with the internal drain being 0.22m wide. Given its location it is likely to be part of a drainage system associated with the farm building located directly west.
