MANSFIELD TOWN HALL, MANSFIELD NOTTINGHAMSHIRE.

Report on a watching brief on trenching at the base of the south-east elevation of the Town Hall,

TPA Report No. 038/2013

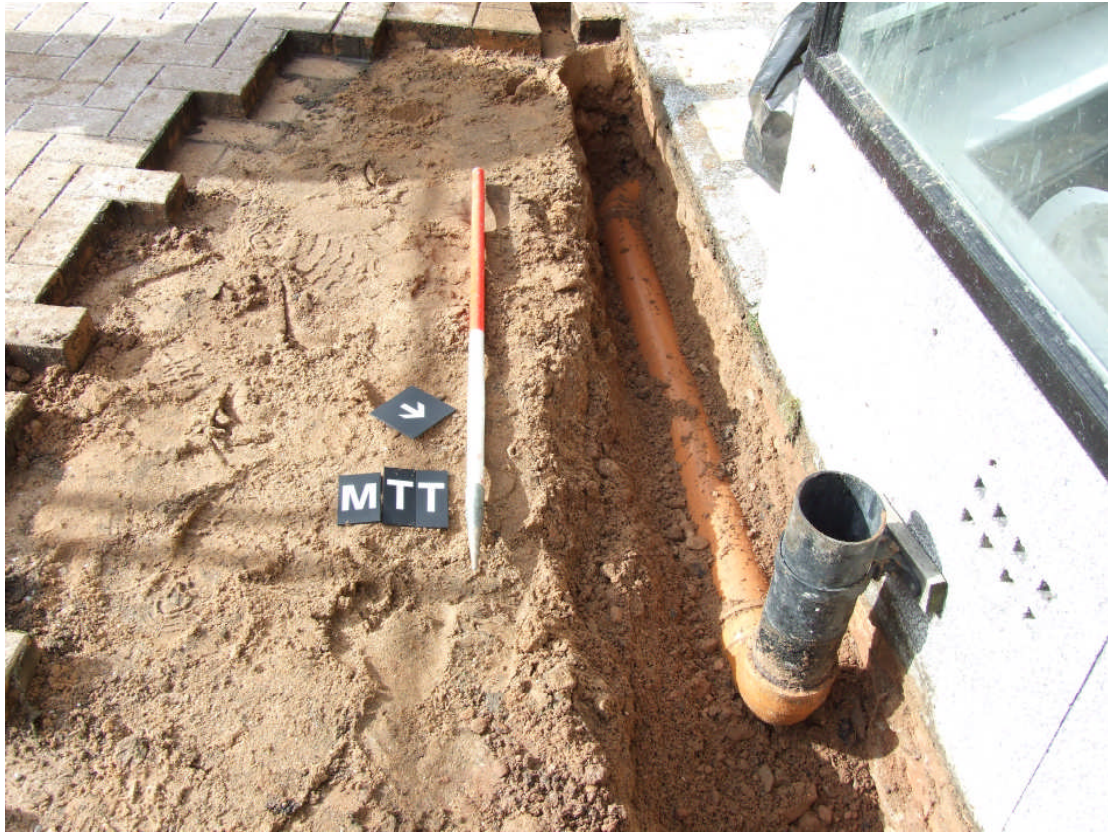
Plate 1. South-east facing section of trench with vent pipe in situ. Looking south-west.

5.3 A recently installed plastic vent pipe was revealed 100mm below the paving. This had been inserted after the paving. There was no discernible evidence of the cut for the pipe except for the tarmac and modern detritus which has been interpreted as the back fill for the trench, Figure 3.

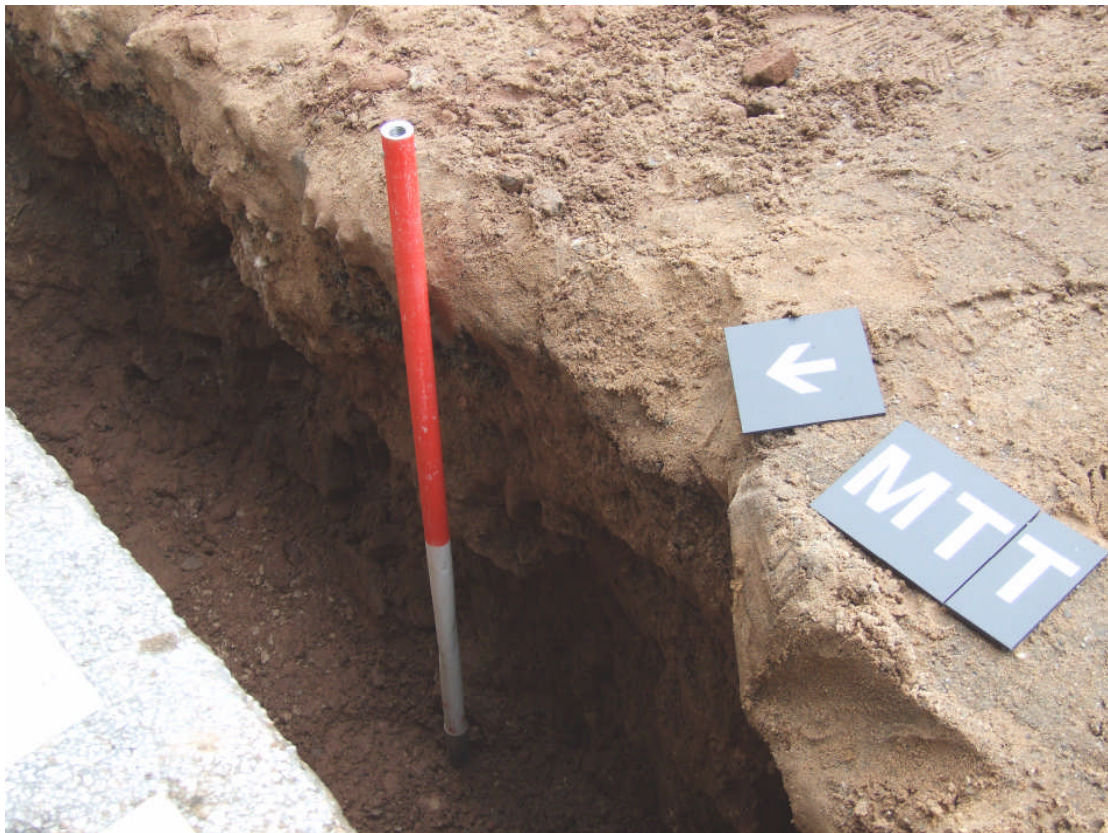
Plate 2. North-west facing section of trench. Looking north-east.
