THURVASTON FARM. DERBYSHIRE

Report on an Archaeological Watching Brief in the Scheduled Area of a Shrunken Medieval Village

TPA Report No.052/2013

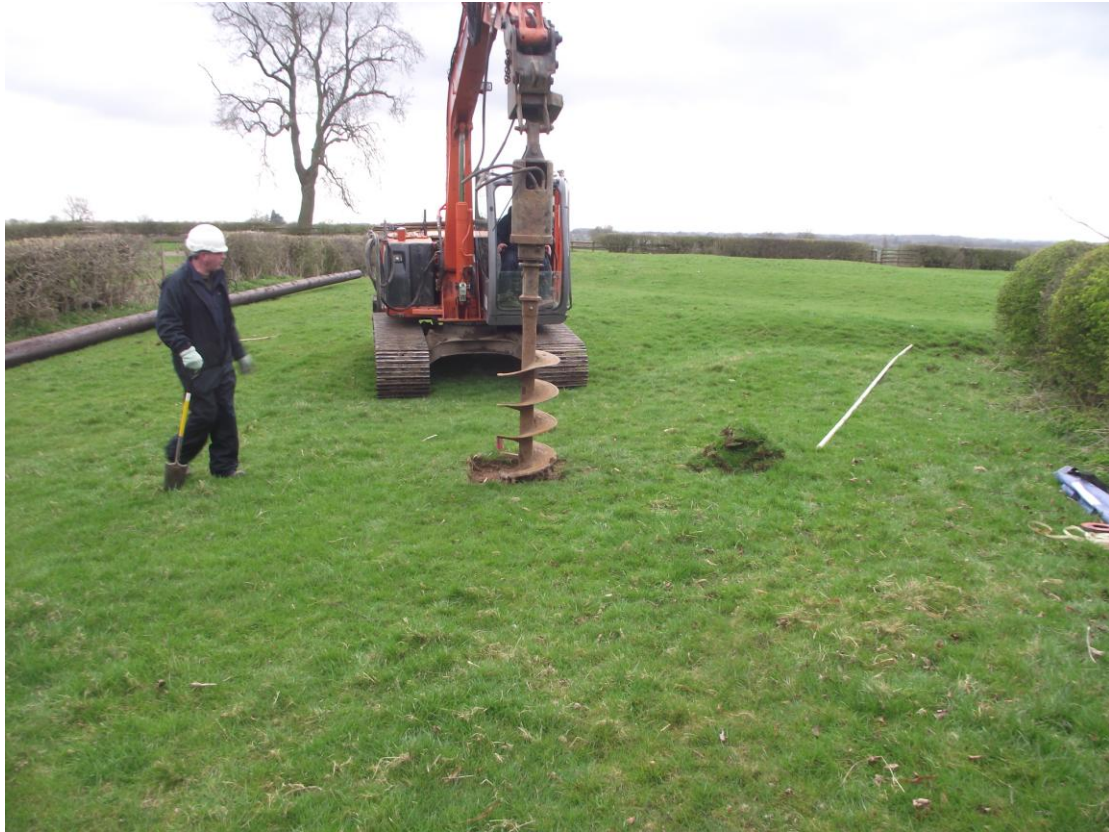
<i>Context</i>	<i>Depth</i>	<i>Description</i>
0001	200mm	mid brown silty loam, topsoil
0002	2.3m observed	red/brown silty clay

6.1.1 No artefacts were recovered as a result of the excavation and no observable features in the excavated pit (Plate 1, Plate 2).

Plate 1. Augering in Area 01. Looking west.

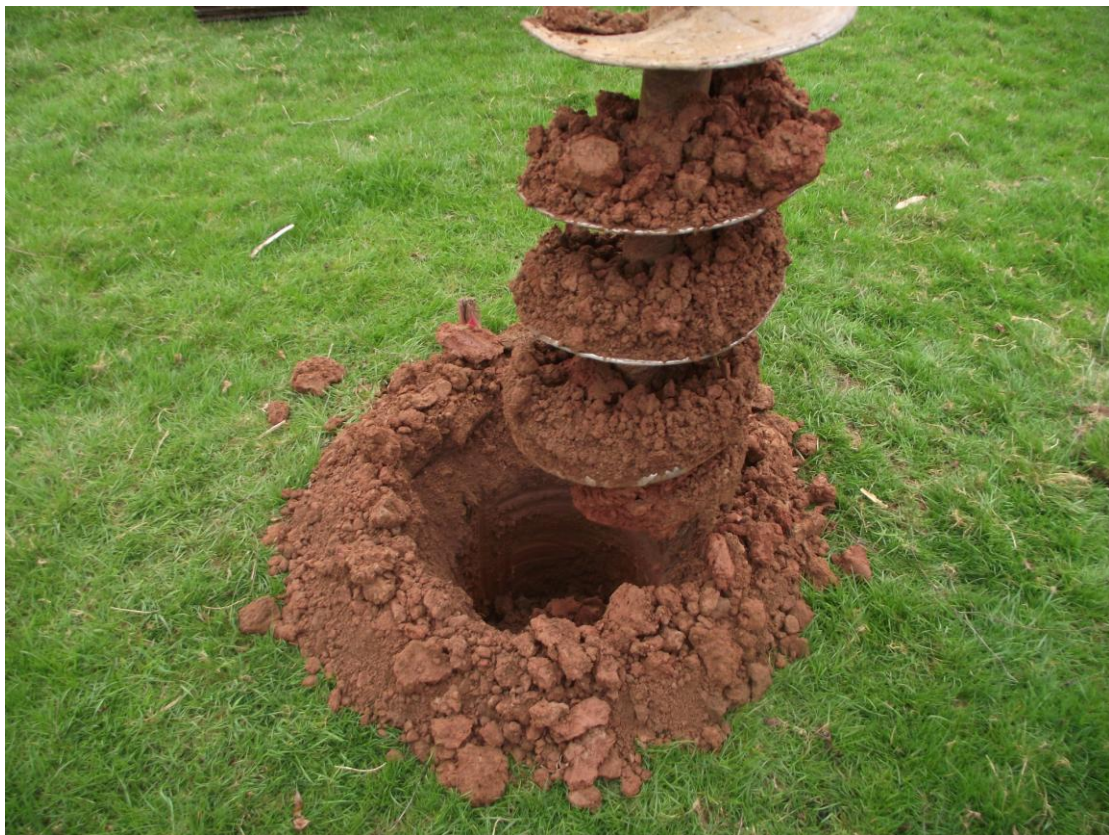
Plate 2. The auger bringing soils to the surface.

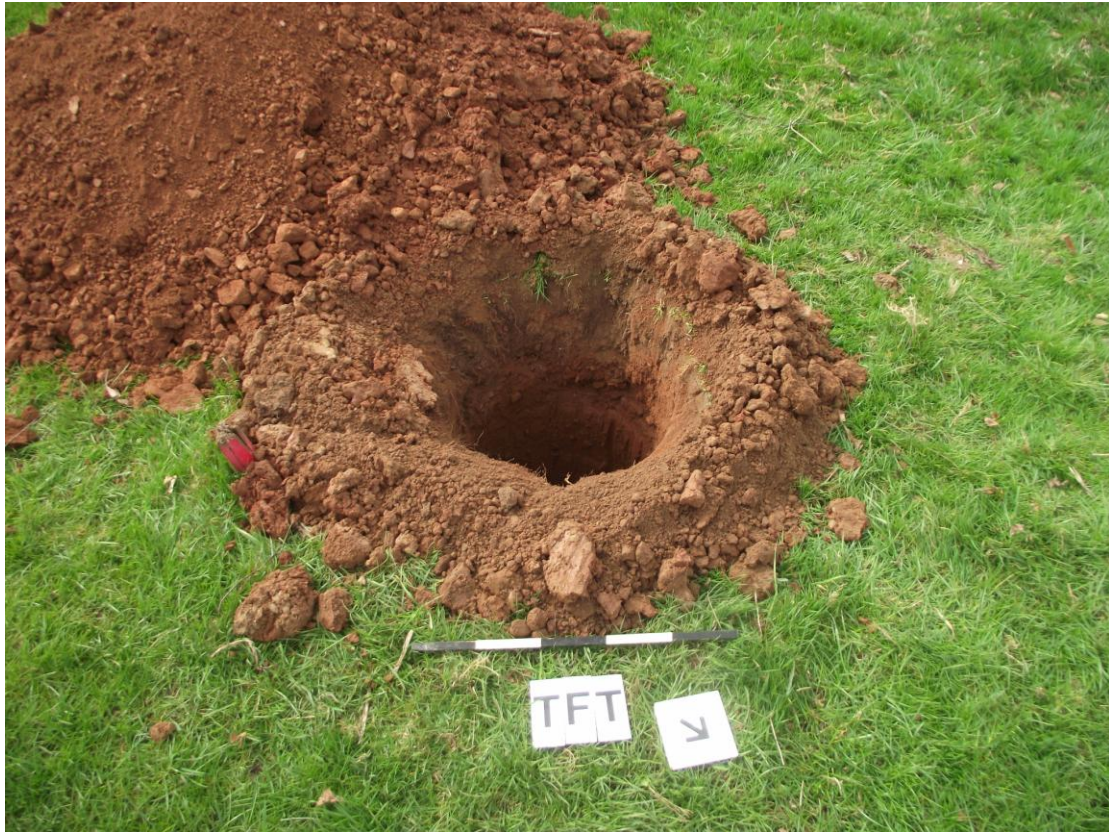
Plate 3. Area 01 on completion of augering. Looking south west.

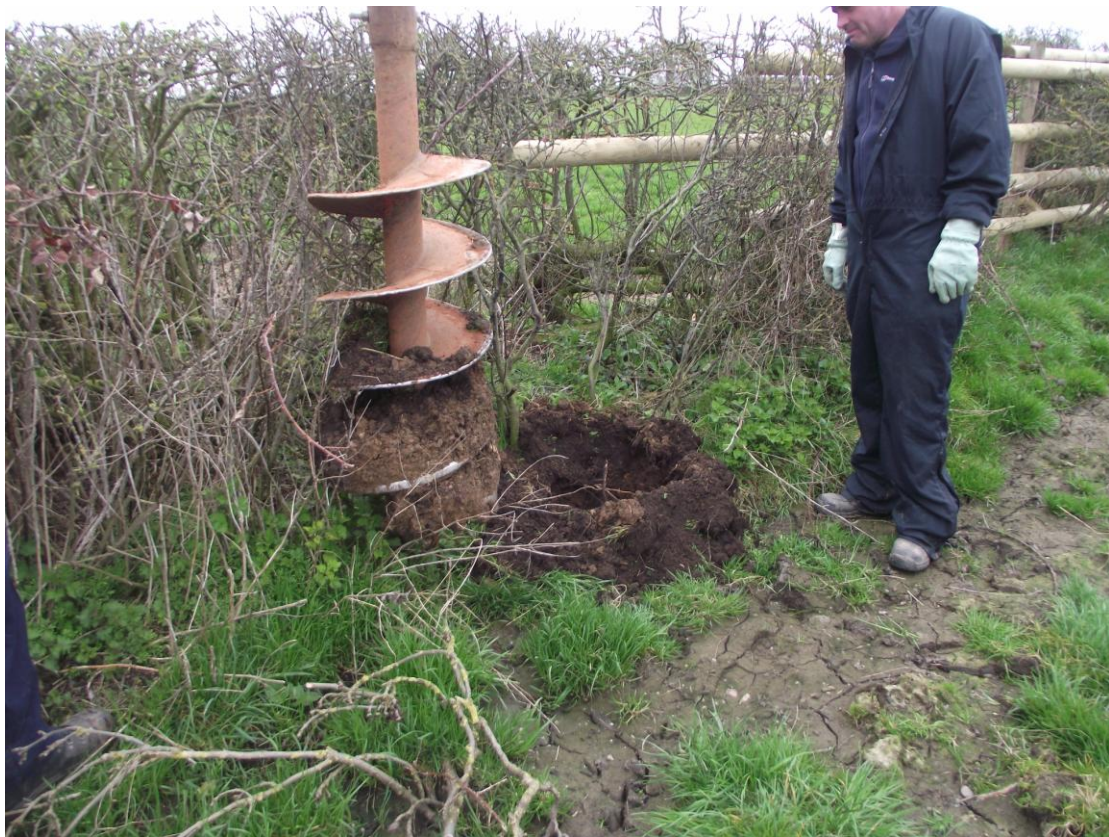
<i>Context</i>	<i>Depth</i>	<i>Description</i>
0003	200mm	dark brown loam, topsoil
0004	2.2m observed	yellowish red clay with inclusions of limestone fragments

6.2.2 There were no artefacts revealed as a result of the excavation and no observable features uncovered in the pit (Plate, 4 Plate 5).

Plate 4. Augering in Area 02. Looking south east.

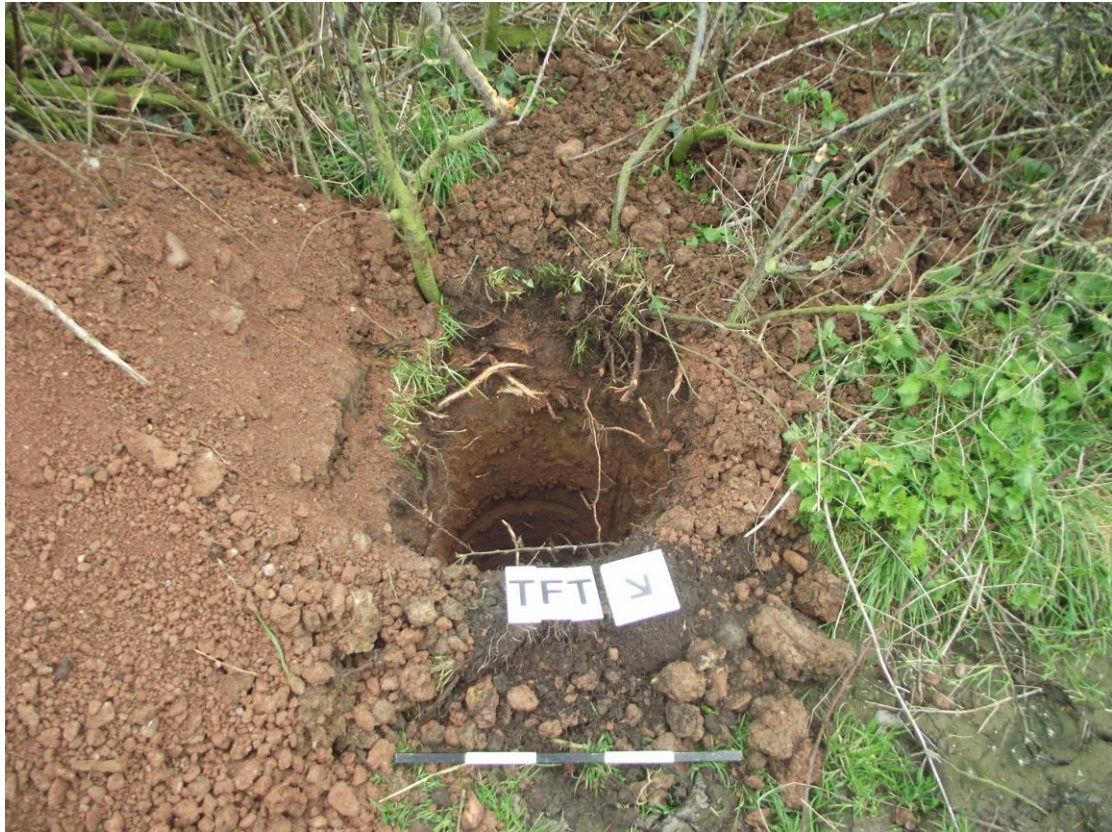
Plate 5. Area 02 on completion of augering. Looking south west

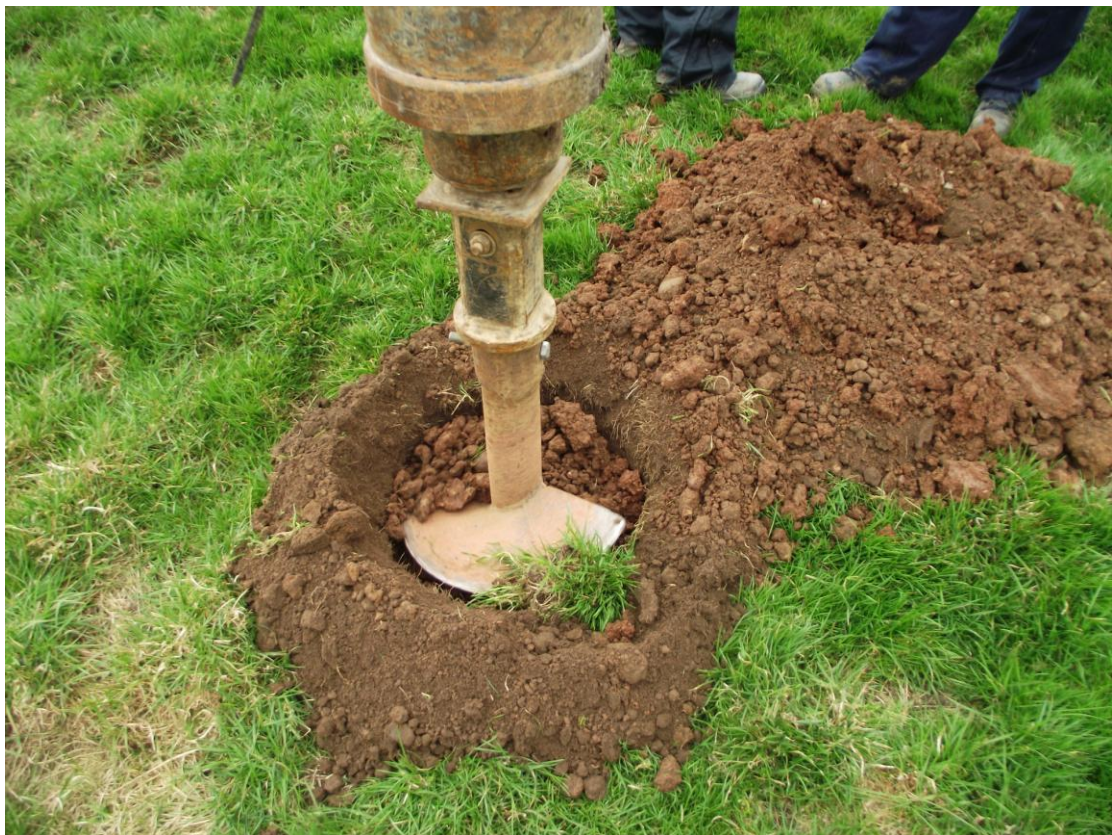
<i>Context</i>	<i>Depth</i>	<i>Description</i>
0005	250mm	mid brown loam, topsoil
0006	100mm	yellow silty clay subsoil
0007	2.05m observed	red clay

6.3.2 No artefacts were recovered as a result of the excavation and no observable features uncovered in the pit (Plate 6, Plate 7).

Plate 6. Augering in Area 03.

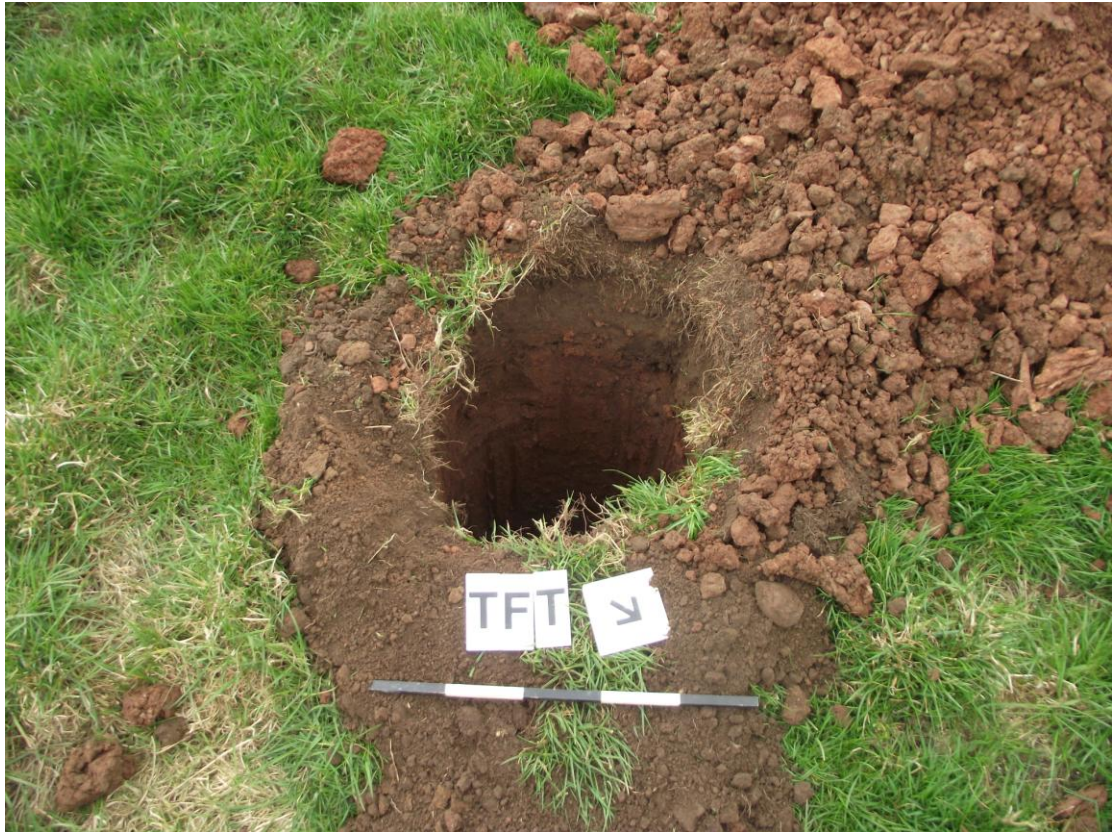
Plate 7. Area 03 on completion of augering. Looking south west.

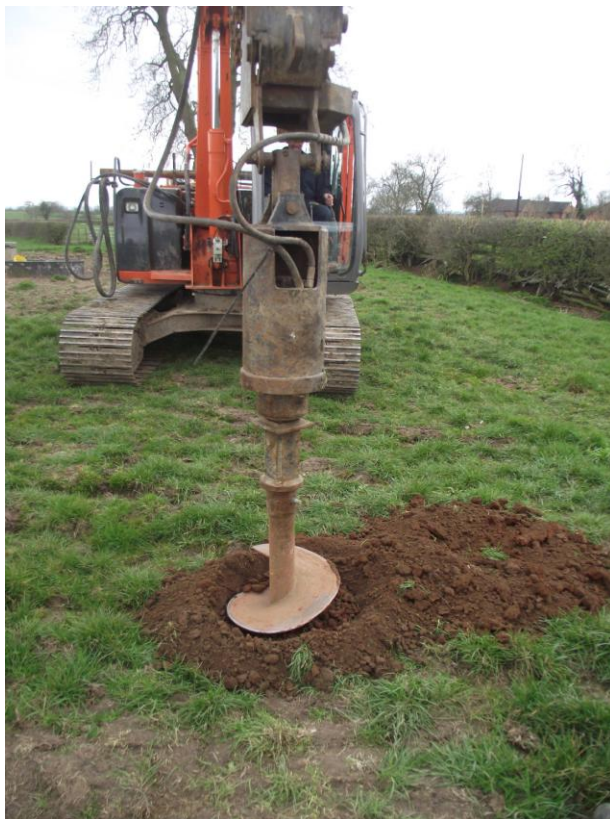
<u>Context</u>	<u>Depth</u>	<u>Description</u>
0008	200mm	dark brown loam, topsoil
0009	2.2m observed	red clay

6.4.2 No artefacts were recovered as a result of the excavation and no observable features uncovered in the pit (Plate 8, Plate 9).

Plate 8. Augering in Area 04. Looking south east.

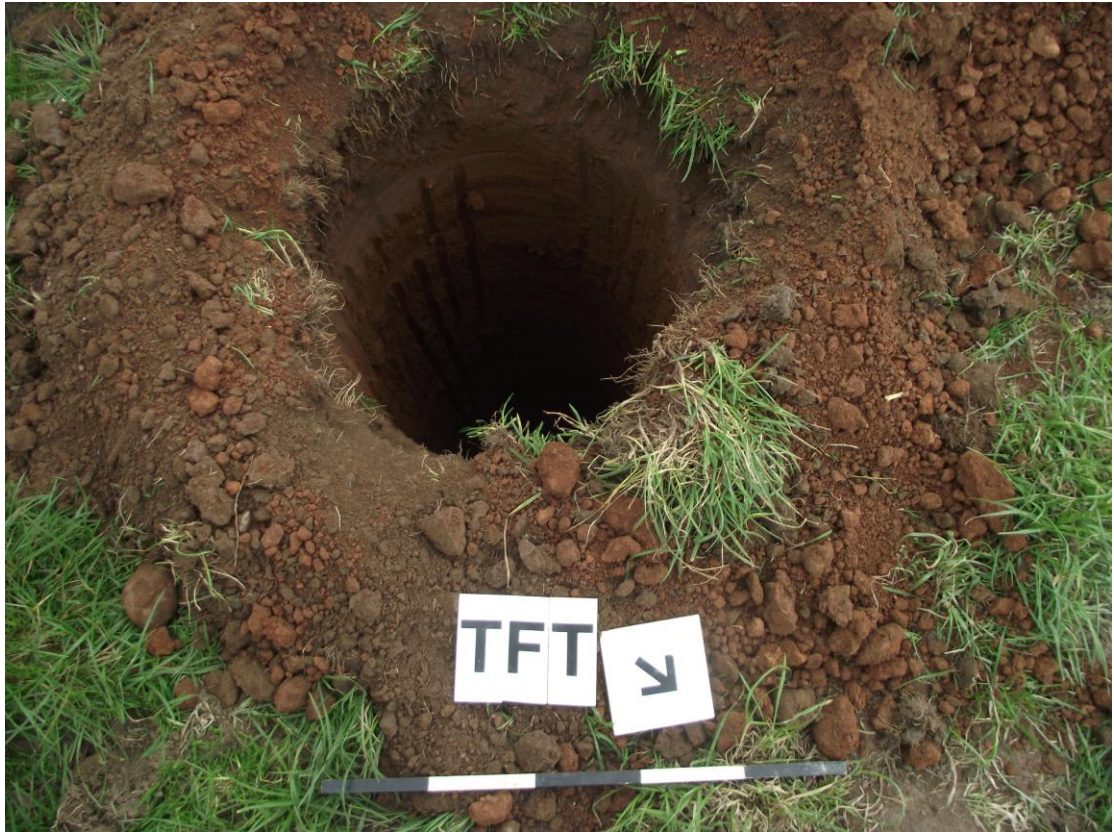
Plate 9. area 04 on completion of augering. Looking south west.

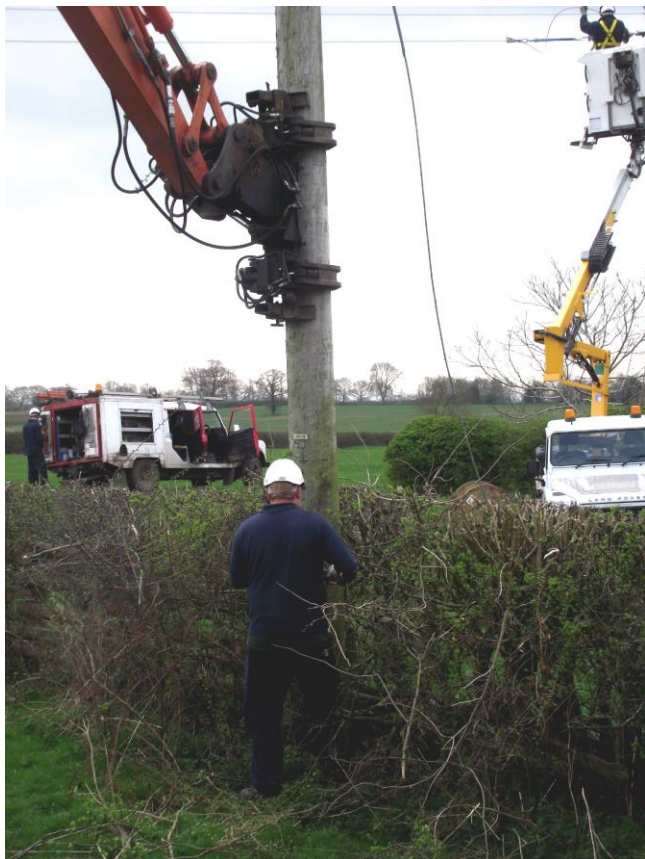
Plate 10. Removing redundant cable pole. Looking south west.

7.5 The method of removal of the original and now redundant posts did not result in any ground disturbance (Plate 9, Plate 10). The two in the Scheduled Area, Area 01 and Area 04, were cut to the level of the surrounding hedgerow and the stumps left insitu to be used as additional fence posts. The same procedure was adopted for a third post, Area 02, outside the Scheduled Area. A fourth, Area 03, was removed and the resultant pit backfilled with material excavated from Area 03.

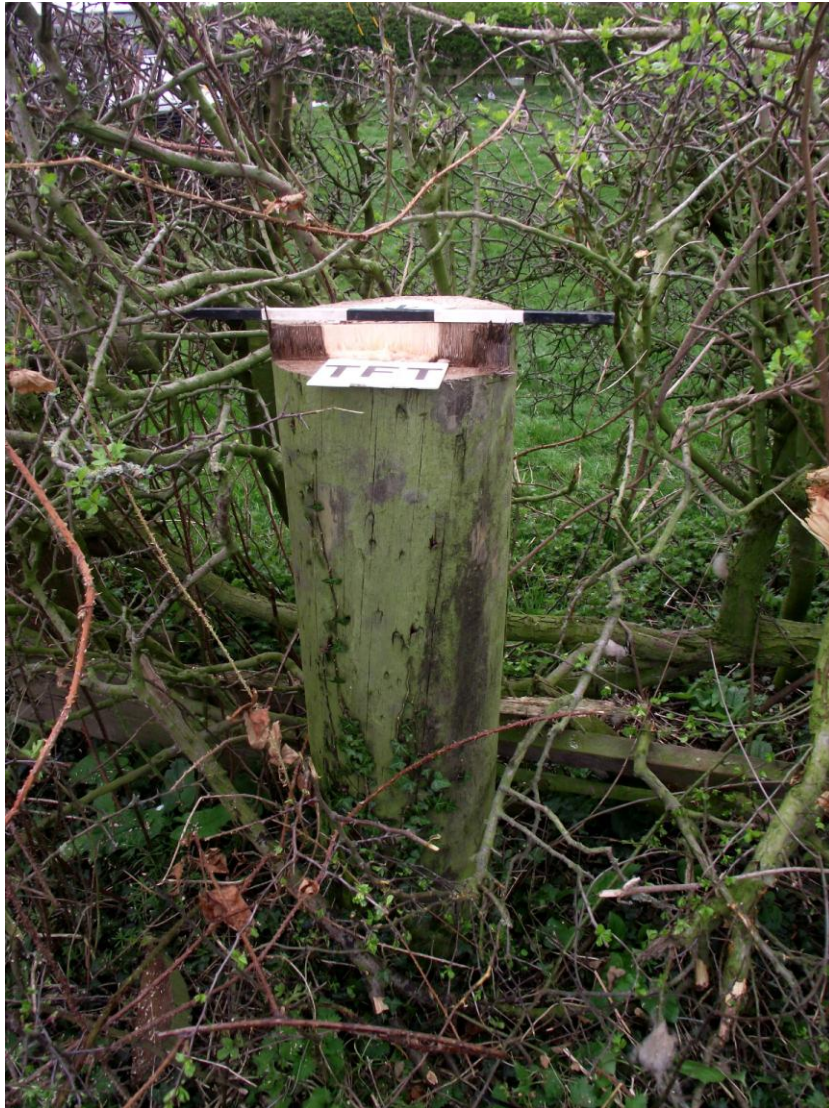
Plate 11. Redundant cable pole cut to the level of the hedge and left *in situ*. Looking south.
