TOWN STREET, SANDIACRE DERBYSHIRE.

Report of an Archaeological Evaluation and Watching Brief

TPA Report No. 089/2013

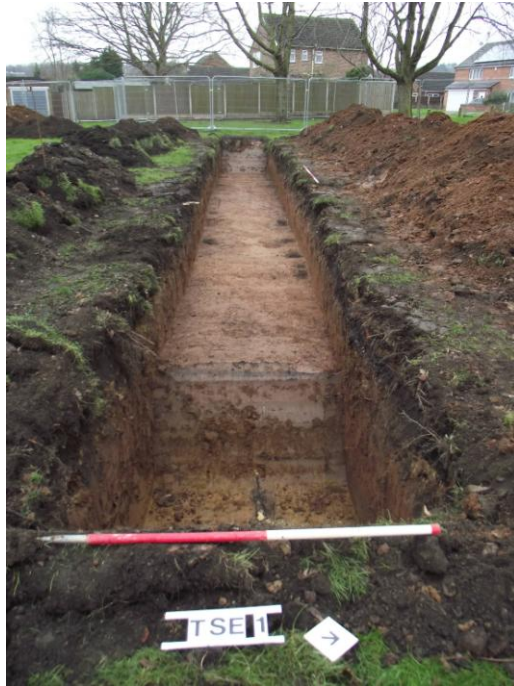
Plate 1. Area 01, Looking west.

6.1.1 Area 01, orientated east west, 18.5mx x 1.8m was excavated to a depth of 1m with deeper sondages at the eastern and western extent, (Figure 3, Plate 1 and Plate2).

6.1.3 The upper layer of top soil, (0007), is probably relatively recent and connected with landscaping of the area following the building of the flats complex in the 1960's. The layers immediately below the topsoil, the two deposits of clinker ash,(0008 and 0010), may be associated with demolition prior to the 1960's development although the deposits themselves may have originated in domestic contexts that could be dated to the 19th century houses evidenced on the 1885 OS.

6.1.4 There were no finds present in Area 01 and no cut features.

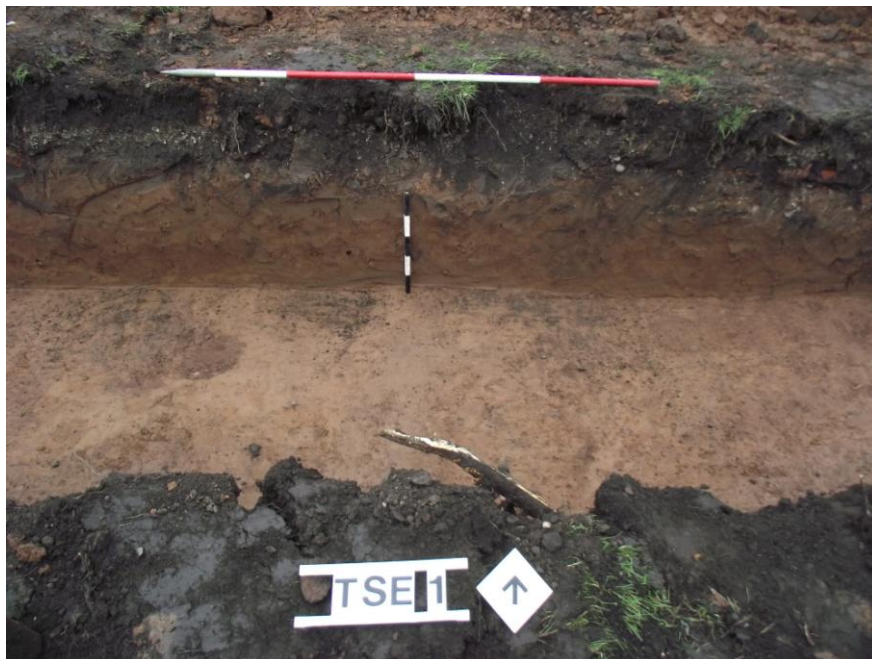
Plate 2. Representative shot of south facing section. Looking north.

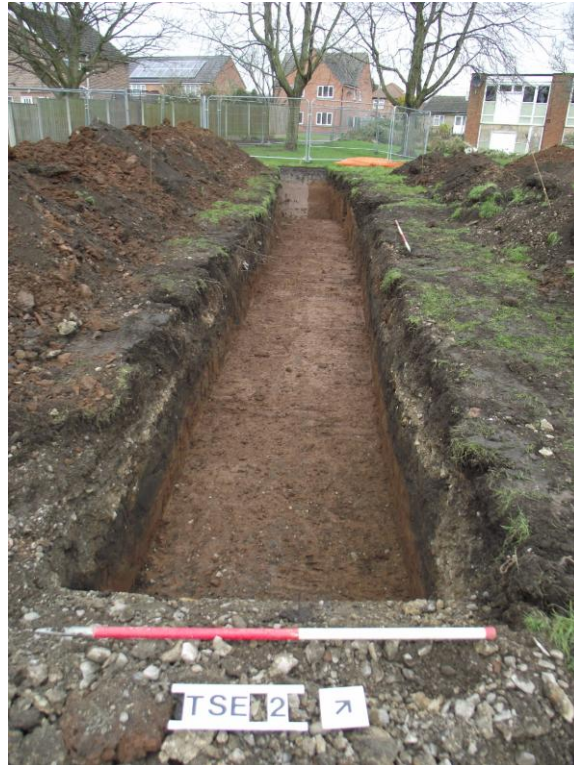
Plate 3. Area 02. Looking north west.

6.2.1 Area 02 orientated north-west/south-east; 18.5m x 1.8m was excavated to a depth of 1.10m with a deeper sondage at the north-west extent, (Figure 4, Plate 3).

6.2.3 Below the topsoil, (0015), were layers of demolition rubble, (0016, 0017, 0023), whose origin is either from the demolition of the 19th century houses or from surplus material left over from the 1960's development. It is likely that both are present but it was not possible to assign the layers to a particular episode.

6.2.4 Two small pits, (0020 and 0021) were observed in the south-west facing section of Area 02. They were not present in the opposite, north-east facing section. The glass refuse in 0021 dates from around the early 20th century and is interpreted as domestic refuse related to the 19th century housing that had stood on the site. The other pit, (0020), was filled with two layers of clay but contained no datable material.

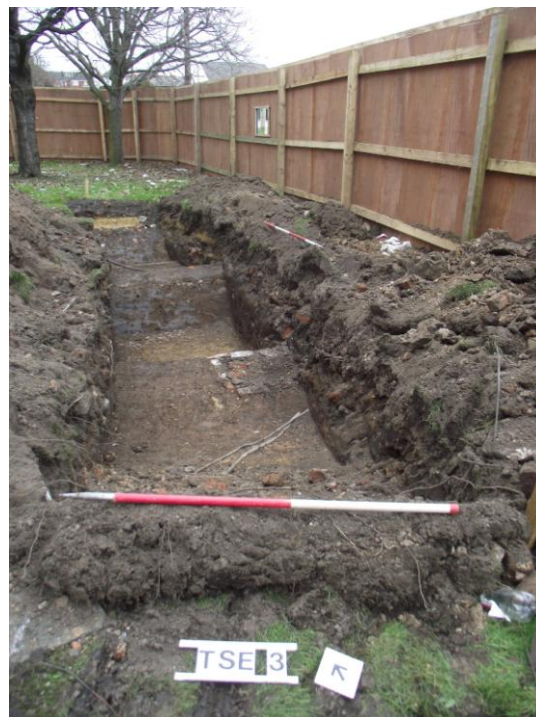
Plate 4. Area 03. Looking north.

6.3.1 Area 03, orientated north /south, 8.5m x 1.8m was excavated to a depth of 1.3m. (Figure 5, Plate 4 and Plate 5)

6.3.3 The stratigraphy observed in Area 03 comprised layers of demolition rubble and disturbed redeposited habitation deposits. The rubble and the disturbed habitation deposits almost certainly arise from the demolition of the 19th century street frontages and the subsequent redevelopment in the 1960's. The Area was crossed by television cables and service trenches which can be dated to the late 20th century, the excavation of which has contributed to the disturbed nature of the stratigraphy.

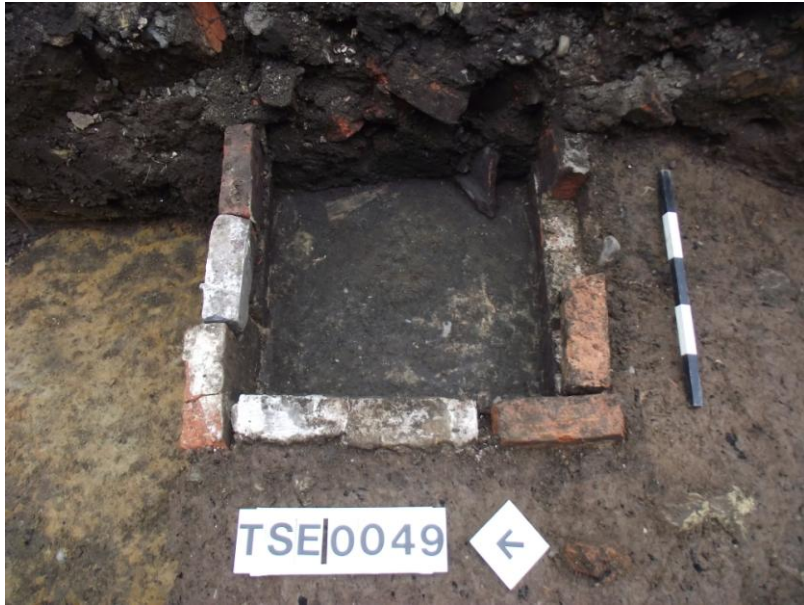
Plate 5. Area 03, hearth remains, 0049. Looking east.

6.3.4 In the base of Area 03 the partial remains of a fireplace, (0049), were recorded. This has been interpreted as belonging to the 19th century housing on the frontage of Town Street and had been left in situ when the rest of the buildings were demolished. The remaining structure was brick built, a single course in width and two courses high. Three sides of what had probably been a rectangular structure were visible in the base of the trench, its fourth side probably beyond the limit of the excavation. The surviving part of the fire place, (0049), was probably at floor level but no remains of a floor were present in the base of the trench.

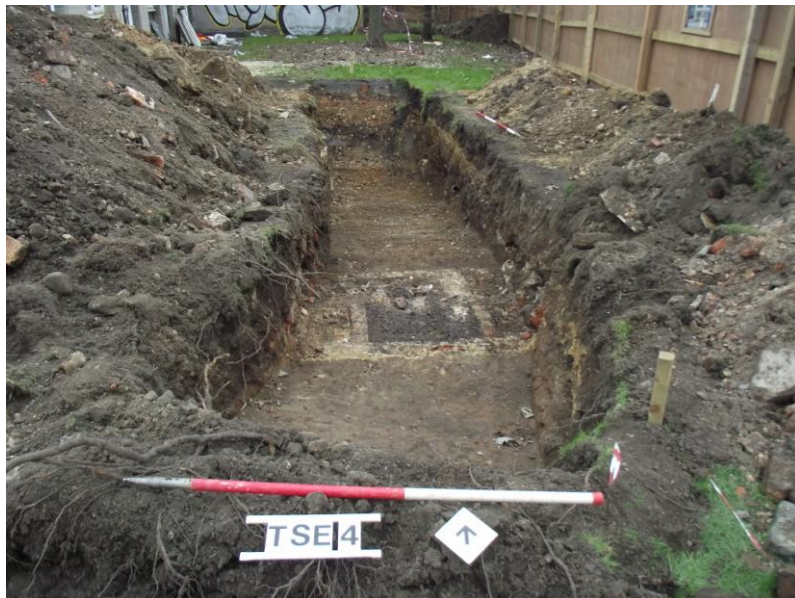
Plate 6. Area 04. Looking north.

6.4.1 Area 04, orientated north south, 8m x 1.8m was excavated to a depth of 1.3m. (Figure 6, Plate 6 and Plate 7).

6.4.2 Topsoil, (0026), and subsoil, (0027), were removed to reveal a series of layers that reflect the demolition of the 19th century houses and the development that took place in the 1960's. The top soil and the sub soil were probably laid down in the 1960s as part of the development.

6.4.3 Layers below the top and sub soil, (0029, 0030, 0031, 0032, 0033, 0034) have been interpreted as re deposited and are made up of demolition layers which incorporate material that had probably built up during occupation, (0030, 0032, 0034) and then disturbed and redeposited during the 1960s building work.

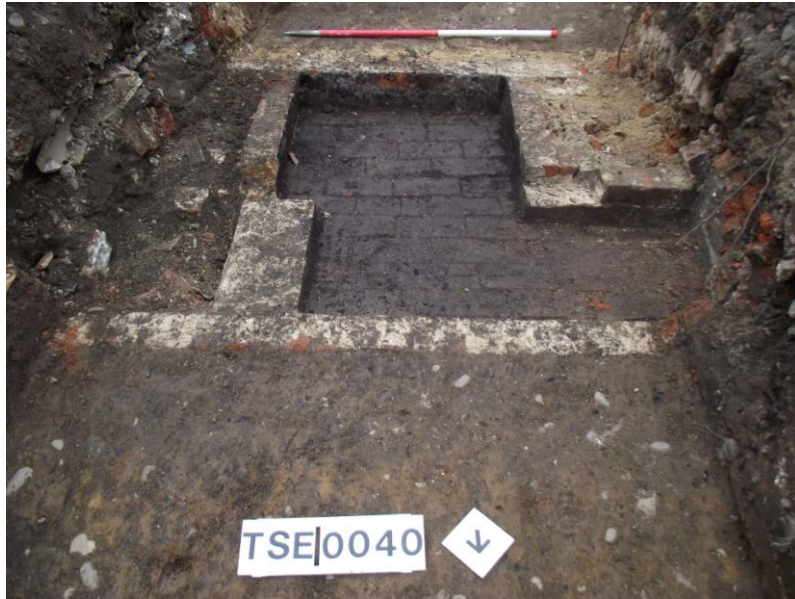
Plate 7. Area 04, hearth, 0040 and brick base, 0041. Looking south.

6.4.5 In the base of the trench the brick surround of a hearth, (0040), was recorded. A central portion of this was excavated to reveal a brick base, (0041). bonded with a black ashy mortar. This has been interpreted as being part of one of the 19th century houses that fronted on to Town Street.

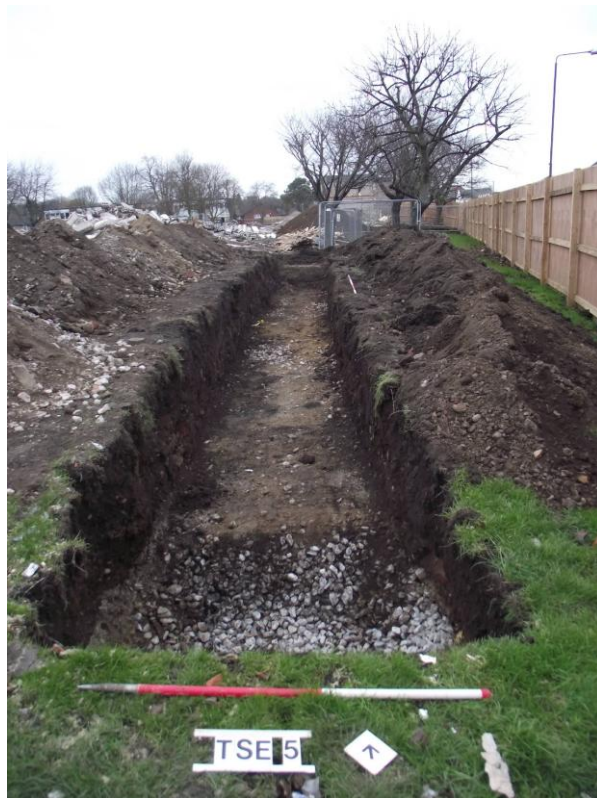
Plate 8. Area 05. Looking north.

6.5.1 Area 06, orientated north/south, 22m x 1.8m was excavated to a depth of 1.10m with a deeper sondage at its southern extent, (Figure 7, Plate 8).

6.5.2 The upper layers recorded in the trench section, (0001, 0002), are probably the result of landscaping at the time of the 1960s development and comprise a top soil and a subsoil. Below this is what has been interpreted as a demolition layer, (0003), arising from the demolition of the 19th century buildings on the Town Street frontage.

6.5.3 IN the sondage at the southern extent of the trench the backfill of a modern service trench was observed. This comprised redeposited elements of the demolition layer, (0004), which overlay a layer of white/grey aggregate, (0005), which acted as a cushion for the pipe beneath it. No cut for the service trench was visible in the section and it is likely that it was put in at the time of the 1960s development and the ground above subsequently built up to provide a level surface surrounding the flats.

6.5.4 There was no surviving structural evidence for the demolished 19th century buildings in Area 05, however the existence of the demolition layers, (0003 and 0004), indicates their presence along the frontage.

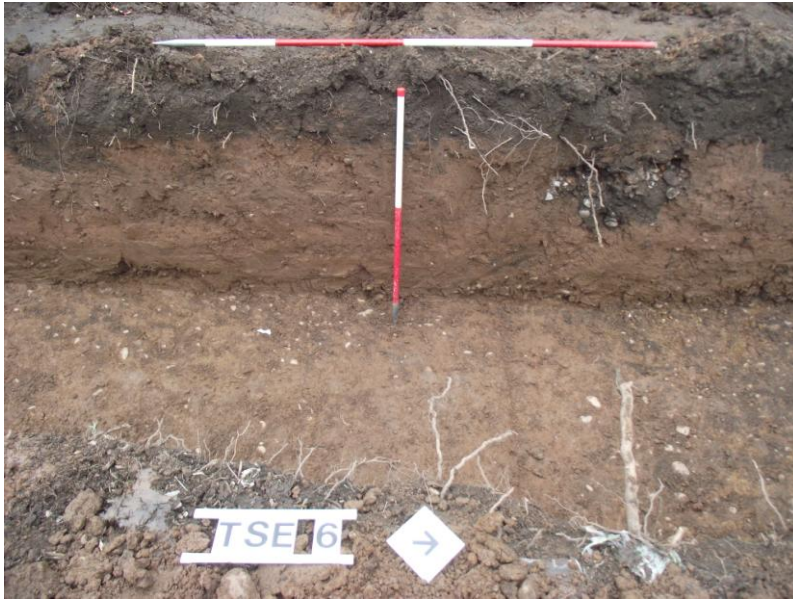
Plate 9. Area 06, east facing section with pit, 0046. Looking west.

6.6.1 Area 06, orientated north/south, 14.5m x 1.8m was excavated to a depth of 1.2m with a deeper sondage at its southern extent, (Figure 8, Plate 9 and Plate 10).

6.6.3 A small pit, (0046), was recorded in the trench section which, in its primary fill, had a quantity of glass and brick fragments. These were too degraded to be able to provide a certain date but have been interpreted as modern. It is uncertain whether the pit relates to the demolished 19th century structures or whether it relates to the 19th and 20th century housing to the immediate west of the site

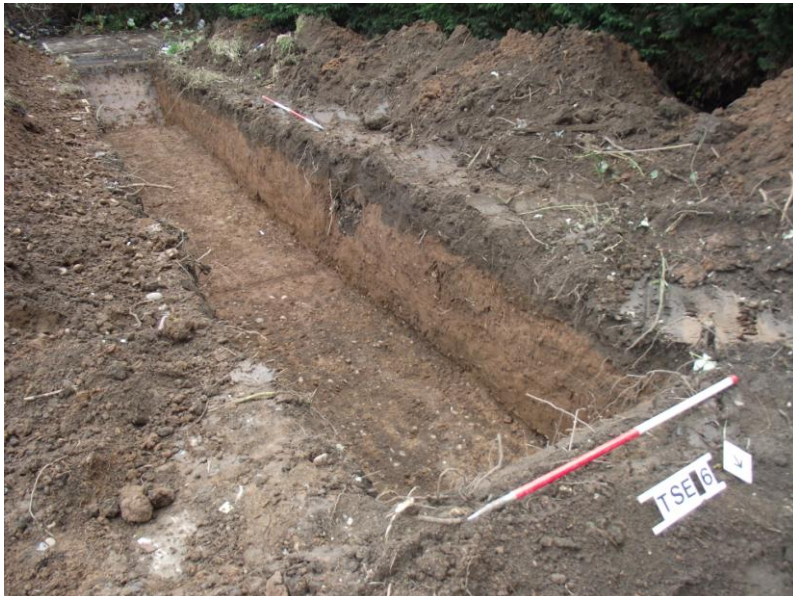
Plate 10. Area 06, east facing section. Looking south west.

6.6.2 The stratigraphy recorded in Area 06 was a relatively undisturbed sequence comprising a top soil, (0042), overlying a sub soil, (0043) above two layers of gravelly clay, (0044), and sand and gravel, (0045). The lower two layers correspond to the natural in the area.

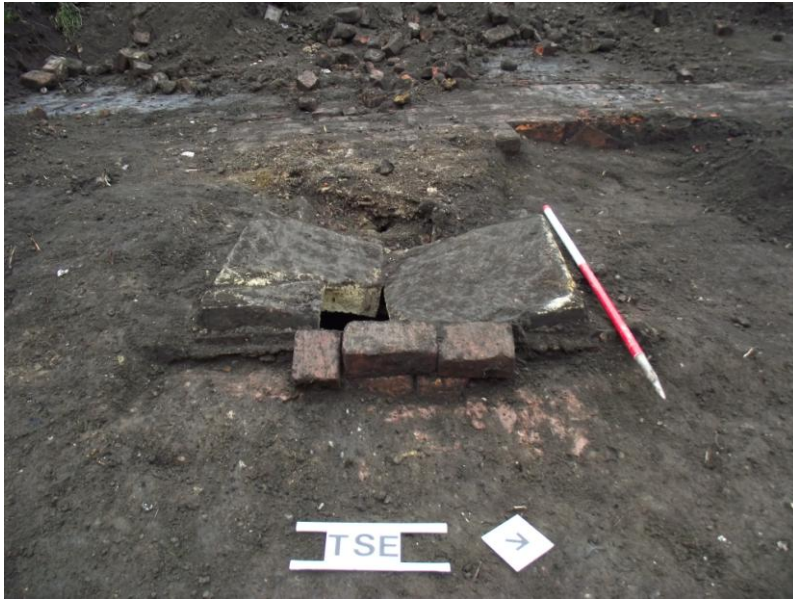
Plate 11. Area 07, the well with broken sandstone cap in place. Looking west.

6.7.1 During top soil stripping a capped well was revealed, 50m to the south west of Area 04. The well had been covered with a sandstone cap but this had been broken and subsequently moved out of position by the machine.

6.7.2 It is probable that the well was associated with the 19th century buildings and in all likelihood on the inside of one of them. There is no well marked on the 1885 OS (1st Edition).

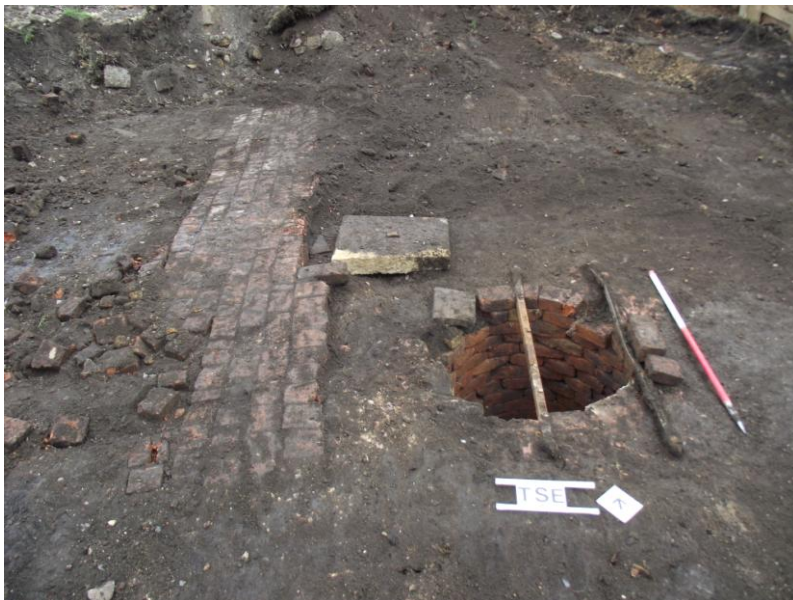
Plate 12. Area 07, the well with cap removed and remains of brick flooring. Looking north.

6.7.3 There were no artefacts recovered from the well itself. It was not possible to access the deposits in the base of the well for health and safety reasons. There was no further ground reduction at this location to expose the shaft of the well an enable access to the base from lower down the structure. Once it was recorded by photograph and its location recorded by GPS the well was filled in with concrete and capped prior to the new build commencing.
