ST NICHOLAS CHURCH, TUXFORD, NOTTINGHAMSHIRE:

ARCHAEOLOGICAL RECORDING OF GROUNDWORKS WITHIN THE CHURCH

Project Code: TUX
Report Number: 121/2013

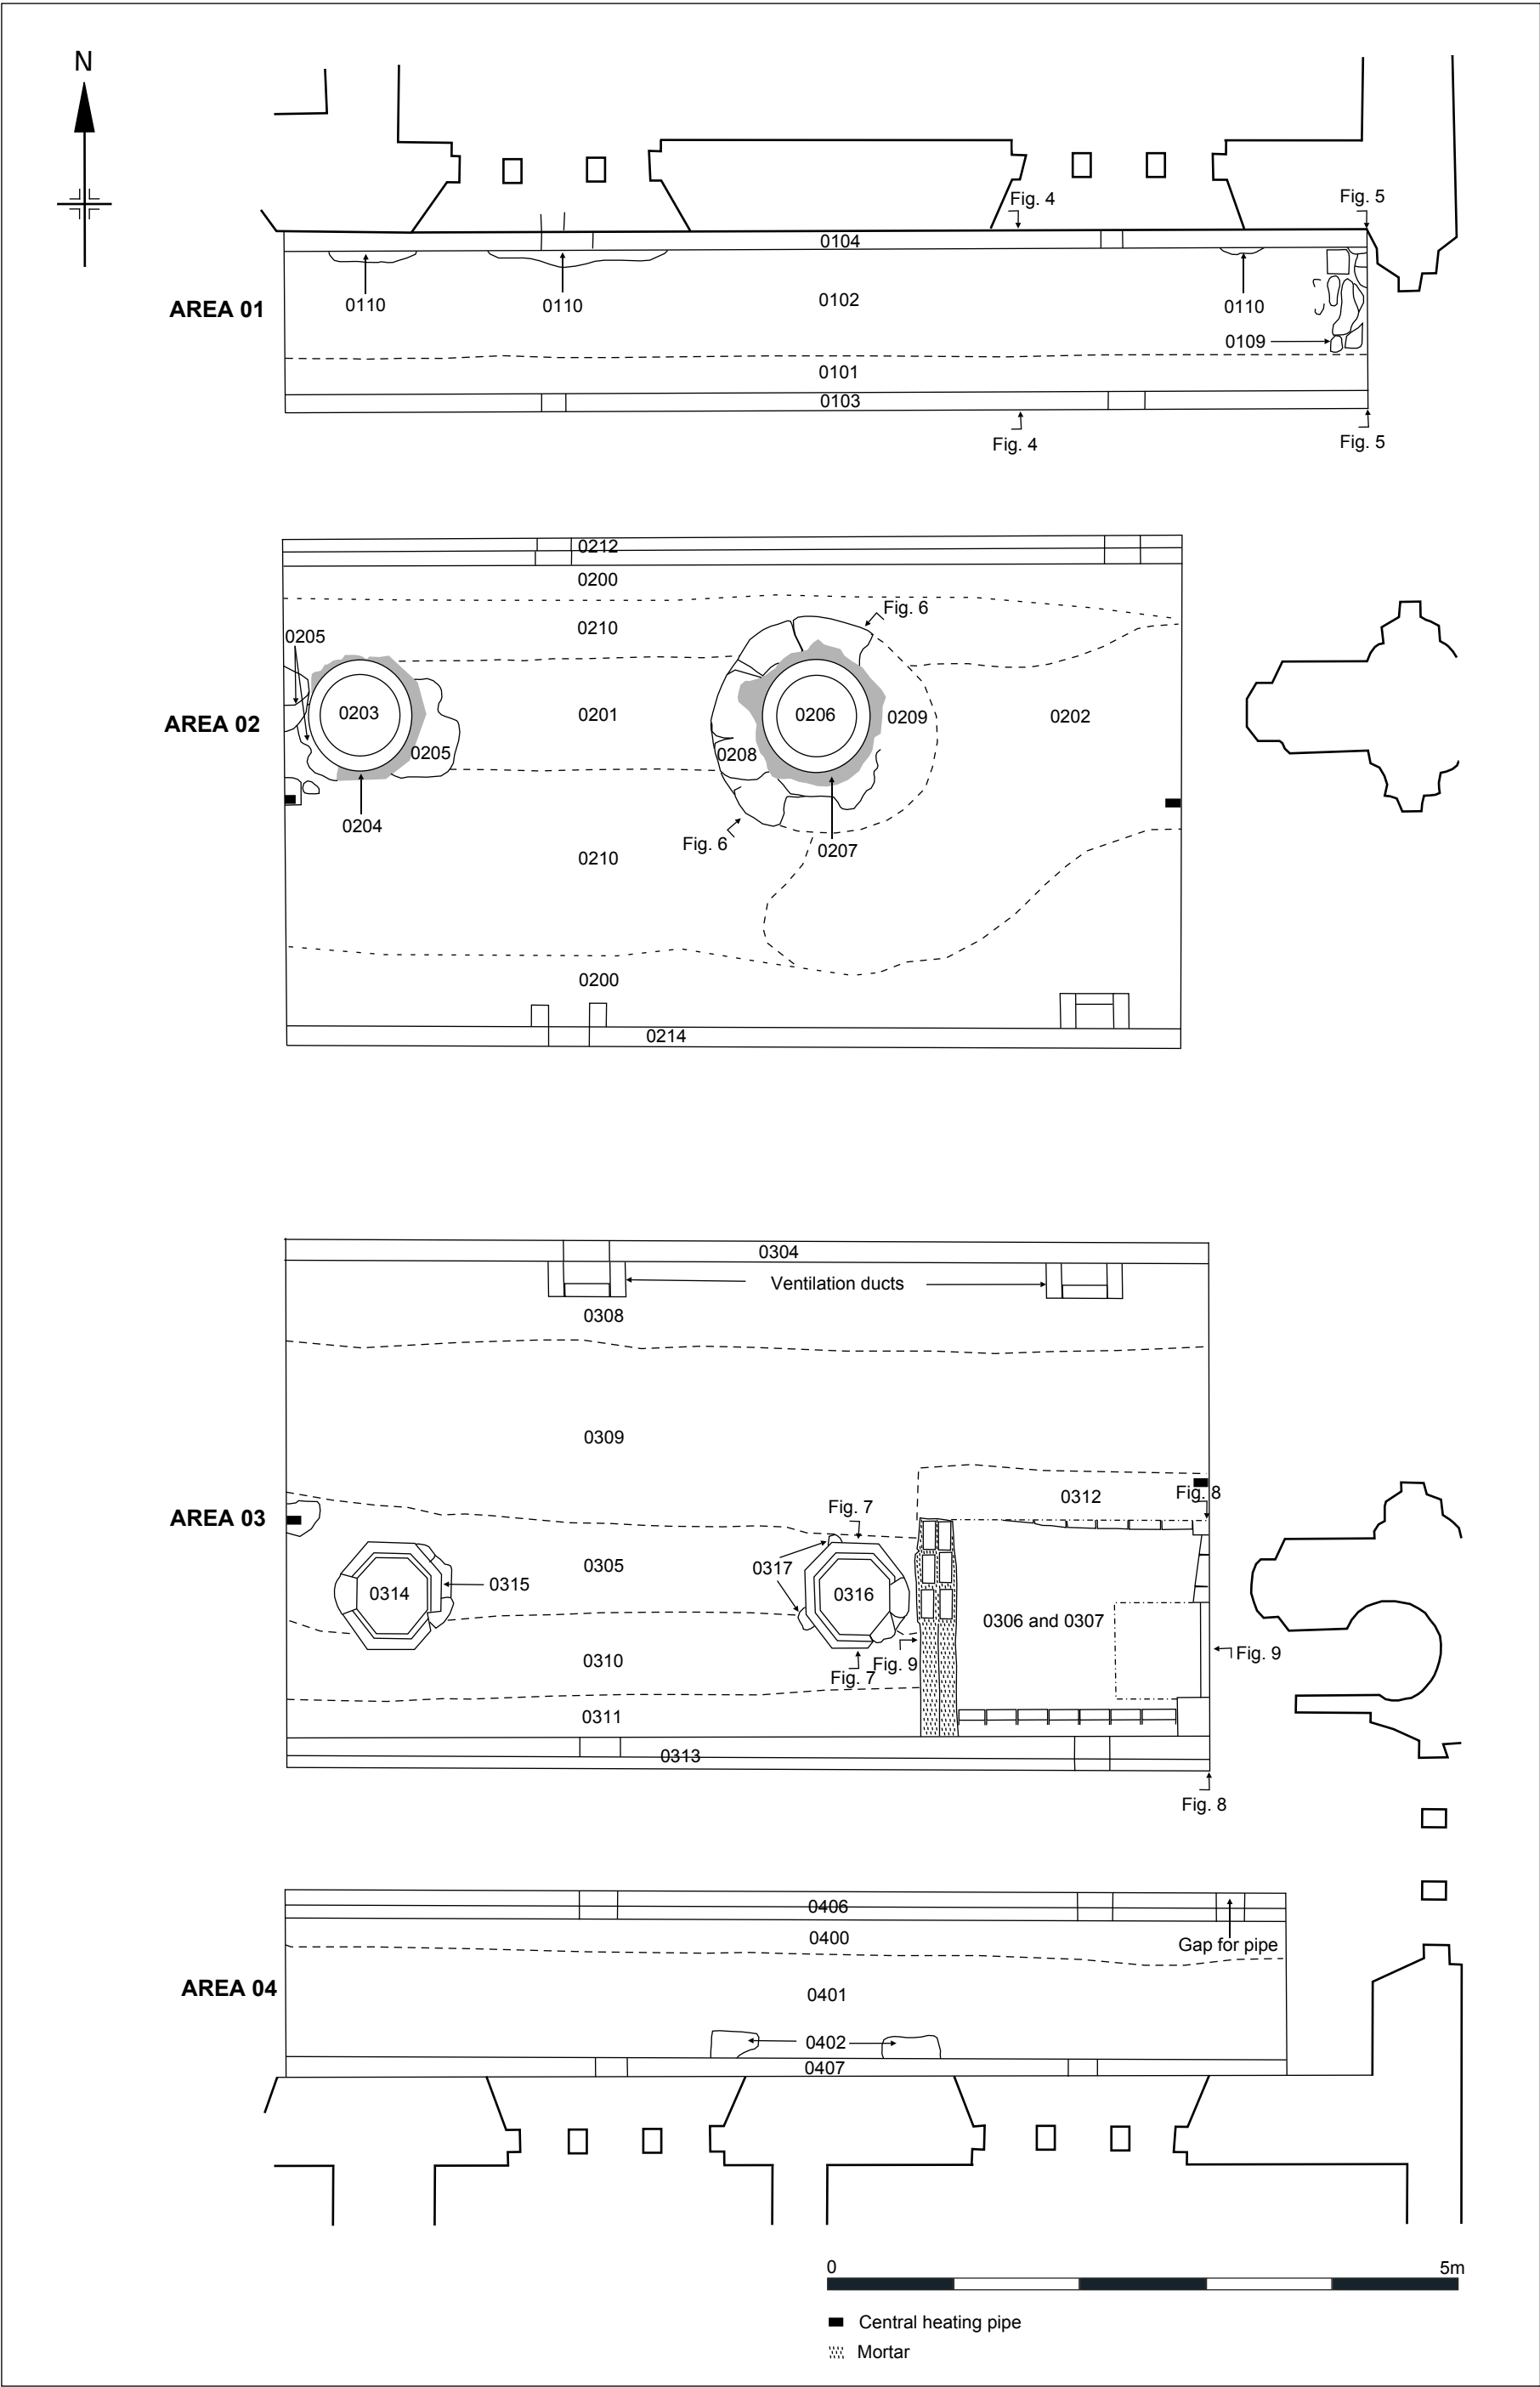
TUX St. Nicholas Church, Tuxford, Nottinghamshire
Figure 3: Post excavation plan
Scale 1:50 at A3

The basic stratigraphic sequence was the same across all four areas and comprised a compact rubble spread (0100, 0211, 0300 and 0408) beneath the floorboards which was up to 0.25m thick and made up of brick fragments, mortar, plaster and limestone in a matrix of pinkish grey to light brown friable sandy loam. Pottery within the rubble indicated that the layer was associated with the refurbishments of 1893. The rubble lay on a principal layer of redeposited grey silty clay loam (0102, 0202, 0210, 0309, 0310, and 0401) of likely 19th century date. This was covered by several similar silty clay loam spreads (0201, 0305, and 0318) and truncated by foundation trenches (0101, 0200, 0308, 0311, 0400) for the brick walls (0103, 0104, 0107, 0111, 0212, 0213, 0214, 0215, 0303, 0304, 0313, 0405, 0406, 0407) used to support the floor. The walls extended along each of the four sections within each area. They were of three courses and made of 3 inch thick mass produced bricks and reused 2½ inch brick. Each of the walls that

extended west to east had two gaps within them which may have been designed to aid ventilation beneath the floor or may alternatively have been for no longer extant service pipes.

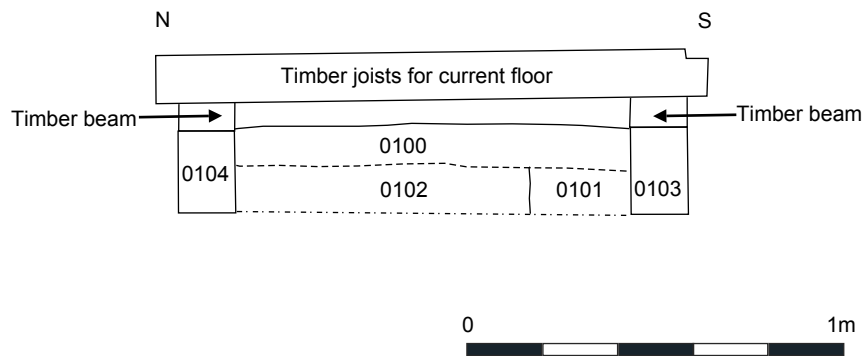
TUX St Nicholas Church, Tuxford, Nottinghamshire
 Figure 4: Area 01 west facing section through the 1893 floor and deposit 0102
 Scale 1:20 at A4

5.1.3. Beneath the eastern window a single disarticulated skeleton comprising two femurs, 2 tibias and a partial skull were found scattered over an area 1m x 1m, within the Victorian deposit 0102. Further incomplete disarticulated remains within this layer accounting for at least two individuals were encountered at the far west end of the area and above foundation 0109.

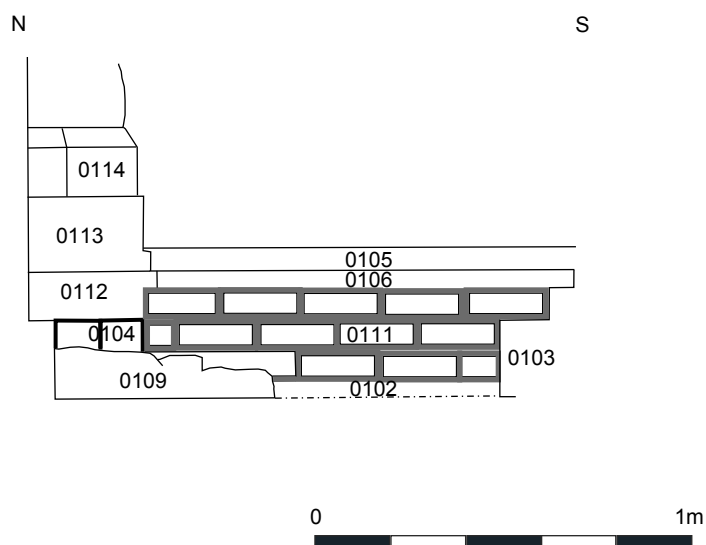
TUX St Nicholas Church, Tuxford, Nottinghamshire
 Figure 5: Area 01 east end west facing section
 Scale 1:20 at A4

5.1.1. Excavation at the east end of the north aisle exposed north to south aligned stonework 0109 constructed of angular grey sandstone (Skerry) pieces bonded with dark reddish brown clay. It exceeded 0.4m in width and was truncated to the south by the Victorian wall footing 0101. The stonework 0109 had also been reused as a foundation for the Victorian walls 0104 and for 0111 which supported the mortar foundation 0106 for the current sandstone floor 0105. It also supported the medieval sandstone footing 0112 for the northern column 0113/0114 which forms part of the arch leading into the White Chapel. The stonework 0109 is therefore likely to be the foundation for the original east wall of the aisle and the nave which was substantially altered in the 14th century to allow entry into the White Chapel.

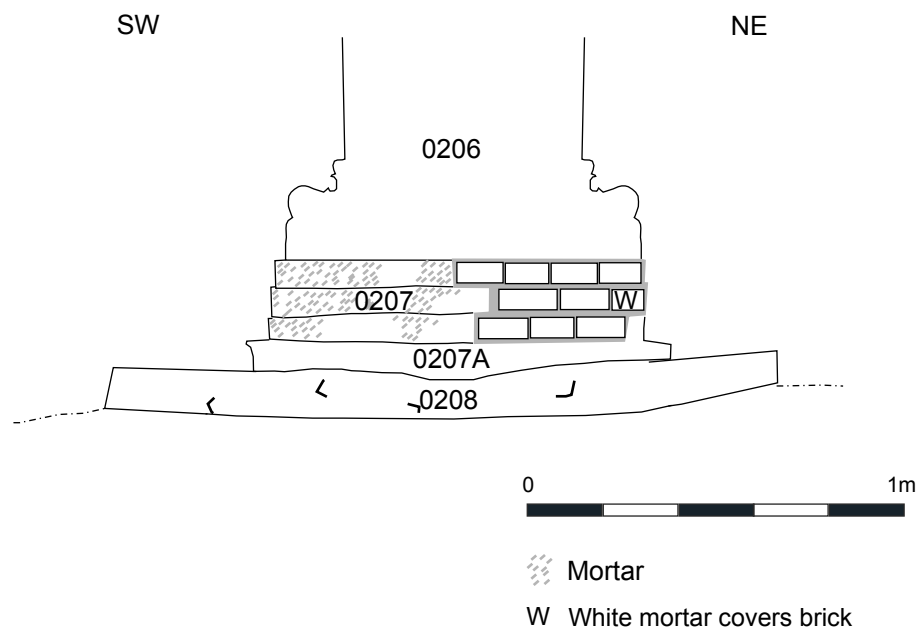
TUX St Nicholas Church, Tuxford, Nottinghamshire
 Figure 6: Area 02 east column 0206 south-east facing elevation
 Scale 1:20 at A4

5.3.1. The reduction of the floor levels in Area 02 revealed that the majority of the original grey sandstone (Skerry) foundations 0205 and 0208 of the rounded columns 0203 and 0206 respectively of the north arcade had been replaced by ones of brick 0204 and 0207. Four courses were present, generally laid in header bond, the bricks being reused and measuring 2½ inches thick and 4¾ wide with a number having a white paint or thin plaster adhering to them. The mortar used on the upper three courses of 0207 was white in contrast with the lower course 0207A which was a very hard grey with mottles of light grey. The brick courses were laid either directly onto the underlying silty clay loam deposits or upon surviving original foundation stones. A lower deposit 0209, possibly the original foundation pit for the column 0206 and comprising yellowish brown sandy clay, was encountered beneath the stone foundation 0208. The remodelling of the columns was necessitated by the installation of a central heating pipe, probably in 1872, which extended immediately south, the trench for which truncated their stone foundations thus requiring the brick underpinning.

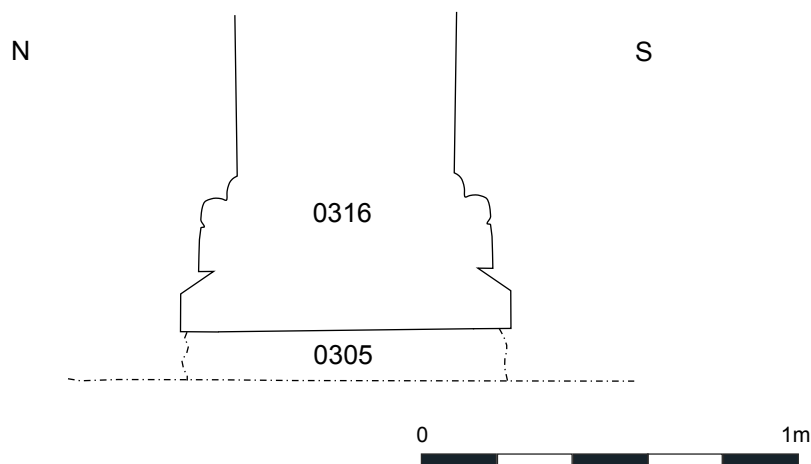
TUX St Nicholas Church, Tuxford, Nottinghamshire
 Figure 7: Area 03 east column 0316 west facing elevation
 Scale 1:20 at A4

5.4.1 In contrast to the northern columns the octagonal south arcade columns 0314 and 0316 were largely intact and still supported by their original sandstone (Skerry) foundations 0315 and 0317 respectively.

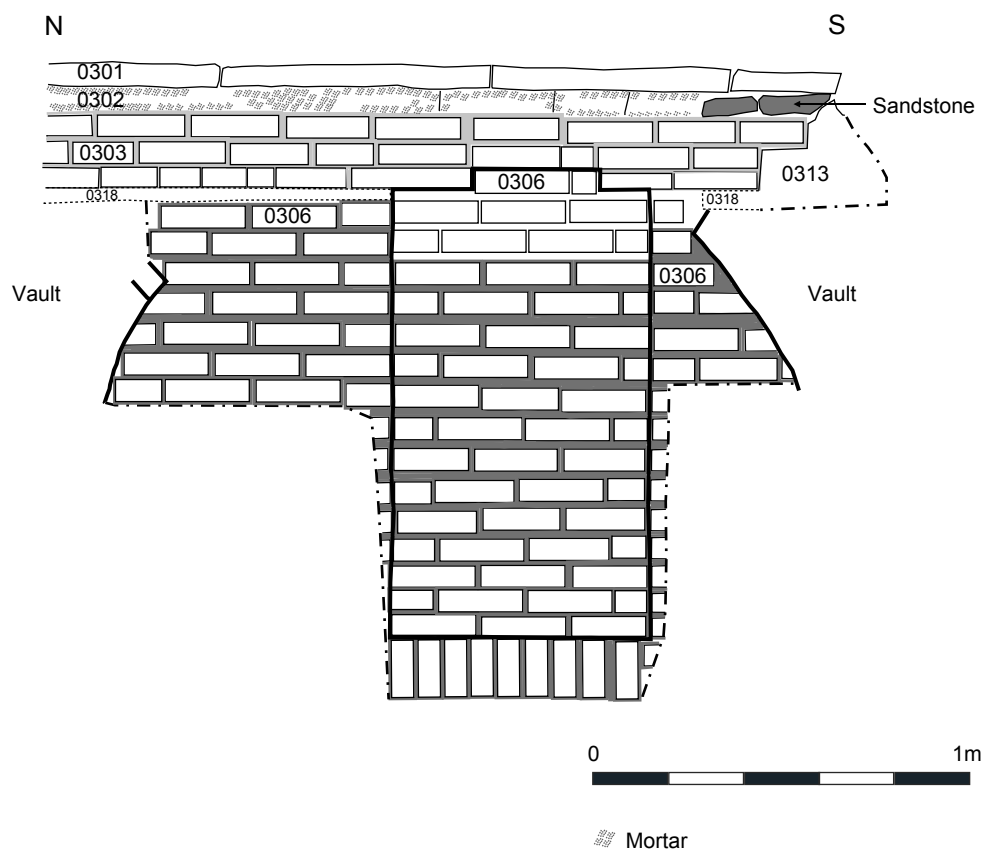
TUX St Nicholas Church, Tuxford, Nottinghamshire
 Figure 8: Area 03 burial shaft 0306 east wall west facing section
 Scale 1:20 at A4

5.4.2. A north to south aligned brick burial vault or shaft 0306 was encountered in the east end of the south arcade beneath 19th and 20th century disturbance. It measured 2.24m long and exceeded 1.82m in width and would have originally been around 1.40m in depth, the top c. 0.20m of its barrel vaulted roof having being truncated during Victorian refurbishments. It had a 0.66m wide recess which extended down the centre of the east wall terminating 0.20m from the brick floor. The bricks measured 9½ x 2½ x 4¾ inches, consistent with a late 18th or early 19th century date, and were laid in stretcher bond. The vault is likely to have held up to two individuals, however it had been emptied and backfilled to prevent the later Victorian floor from subsiding. The fill comprised grey silty loam 0307 which contained a single skull and a few further bone fragments.

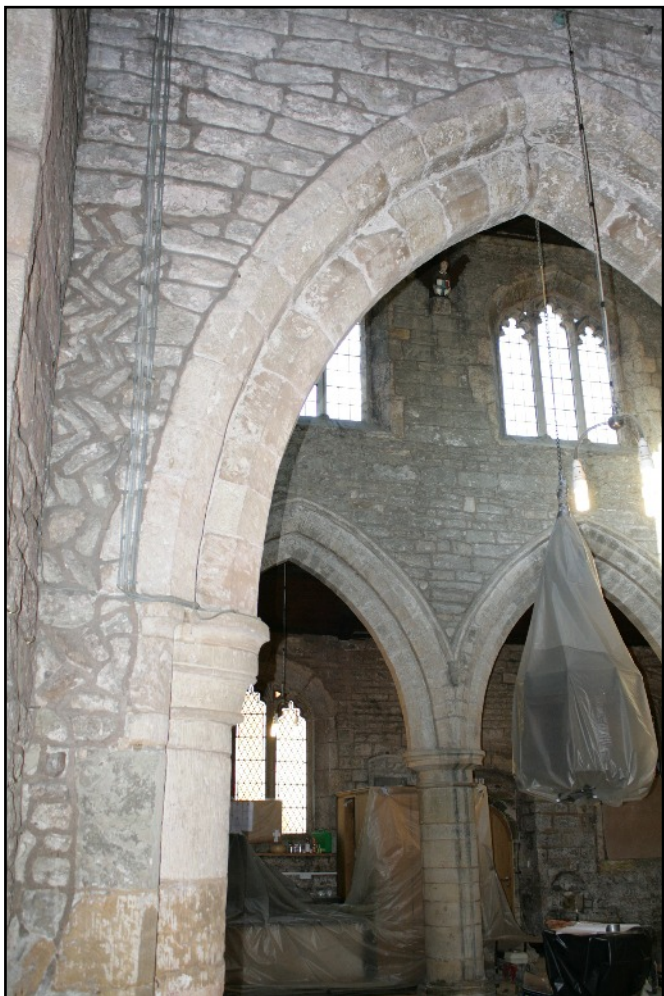
3.1.4. Potentially the earliest fabric within the church comprises herringbone work (Plate 1) at the west end of the south aisle, in the arcade wall close to the tower (Standish 1907). Within Nottinghamshire and Lincolnshire its use is often of 11th to 12th century date e.g. the churches of Littleborough, Carlton-in-Lindrick, East Leake and Lincoln Castle. The herringbone work, given its location, may therefore relate to the nave of the chapel of ease.

Plate 1. The herringbone stonework present at the west end of the south aisle in the arcade wall close to the tower, viewed looking north-east.

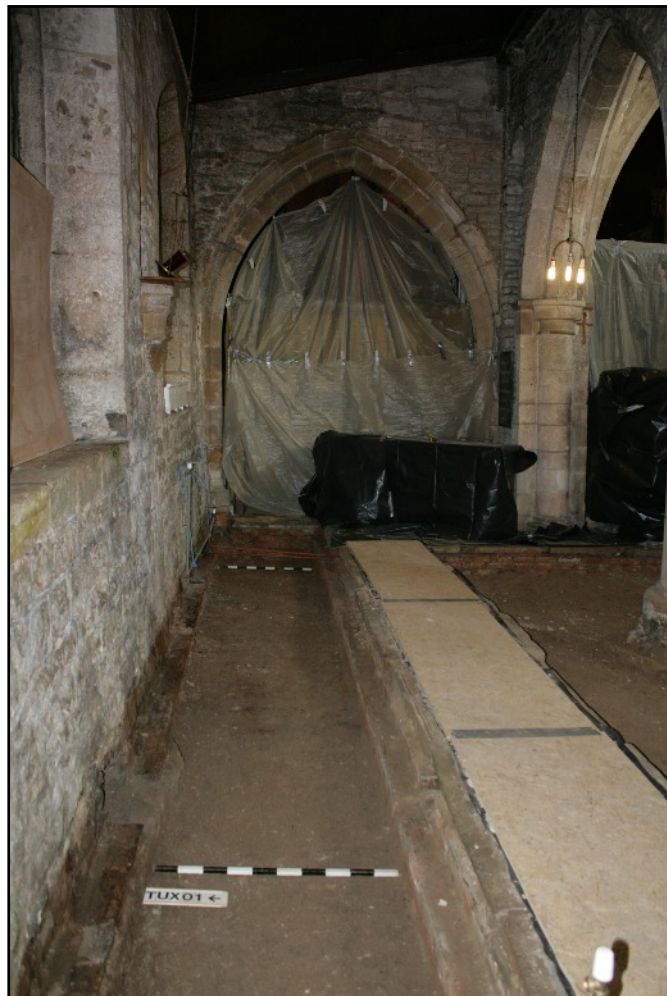
Plate 2. General view of Area 01 after excavation, viewed looking east.

Plate 2: General view of Area 01 after excavation, viewed looking east.

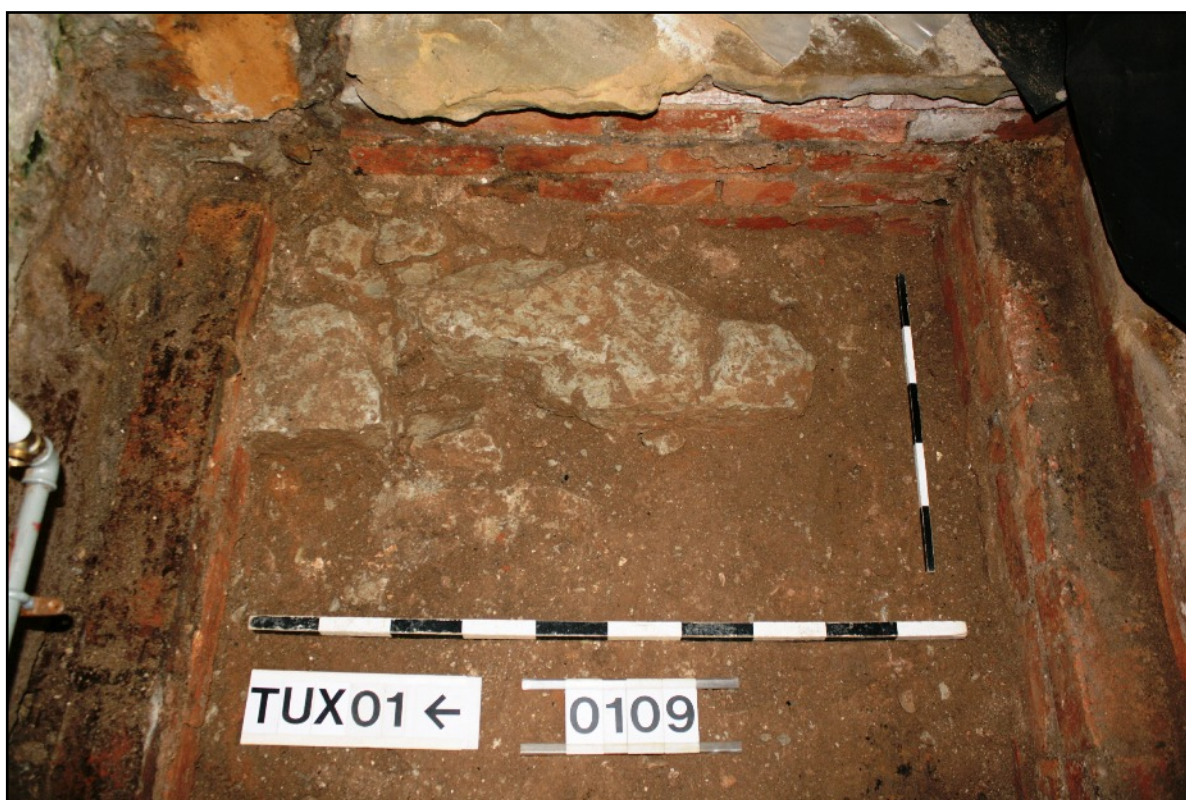
Plate 3. Wall foundation 0109 in Area 01, viewed looking east.

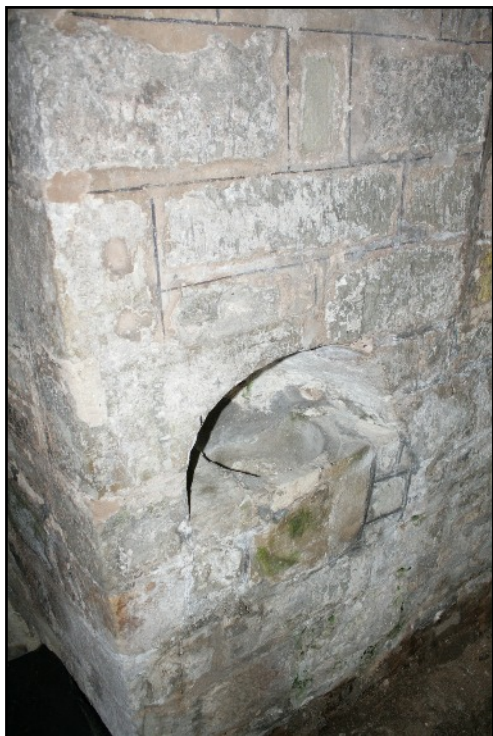
5.1.4. A stoup is present within the north wall at the western end of the area adjacent to the doorway. No associated below ground features were exposed within the vicinity of the stoup.

Plate 4. The stoup in the north wall at the western end of Area 01, viewed looking north-east.

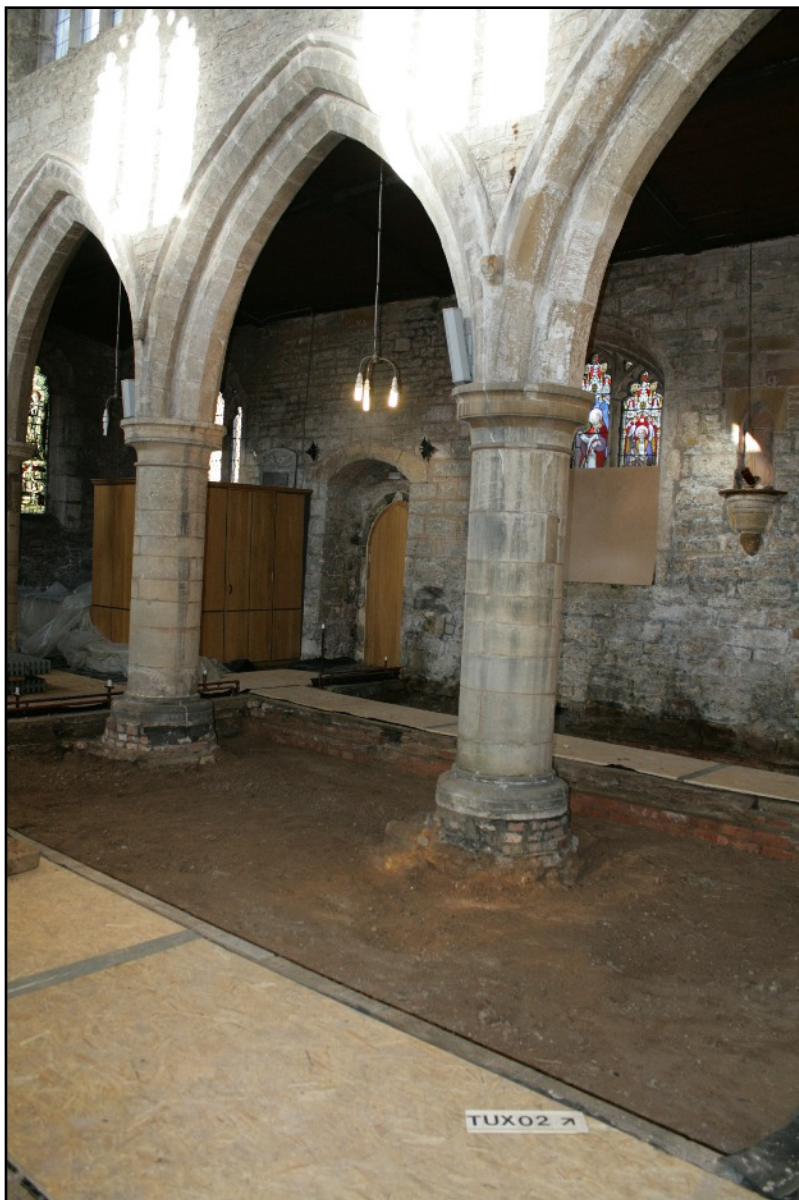
Plate 5. General view of Area 02 after excavation, viewed looking north-west.

Plate 5: General view of Area 02 after excavation, viewed looking north-west.

5.3 Area 02 (Figures 3 and 6; Plates 5 and 6)

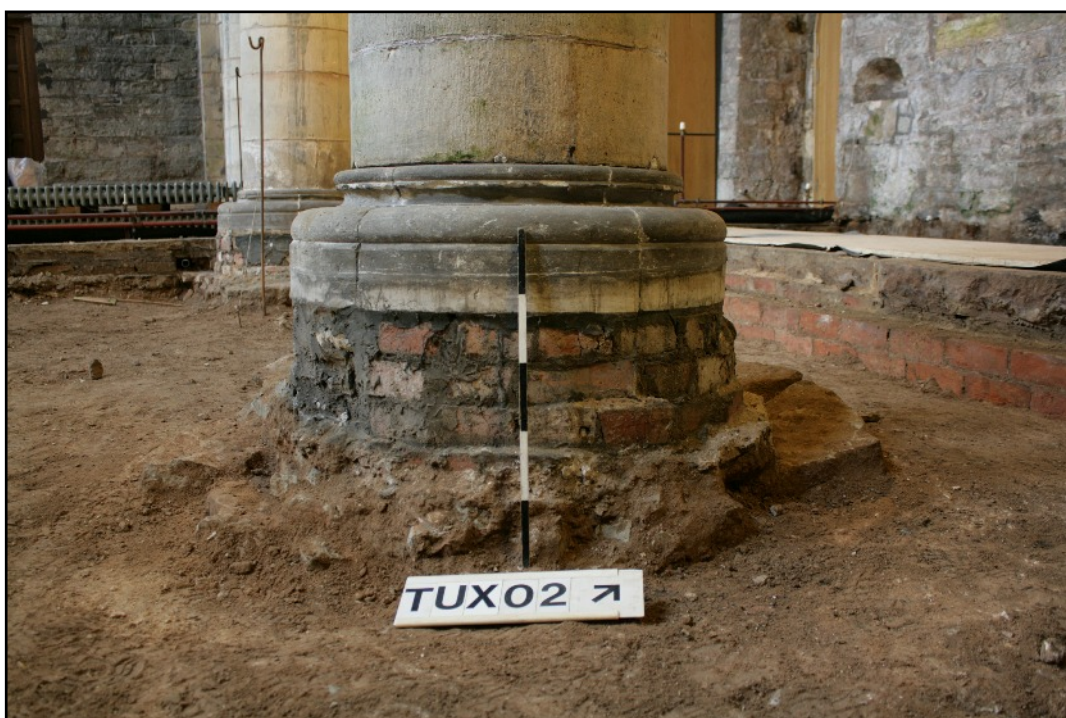
Plate 6. Detailed view of the foundations of column 0206 in Area 02, viewed looking north-west.

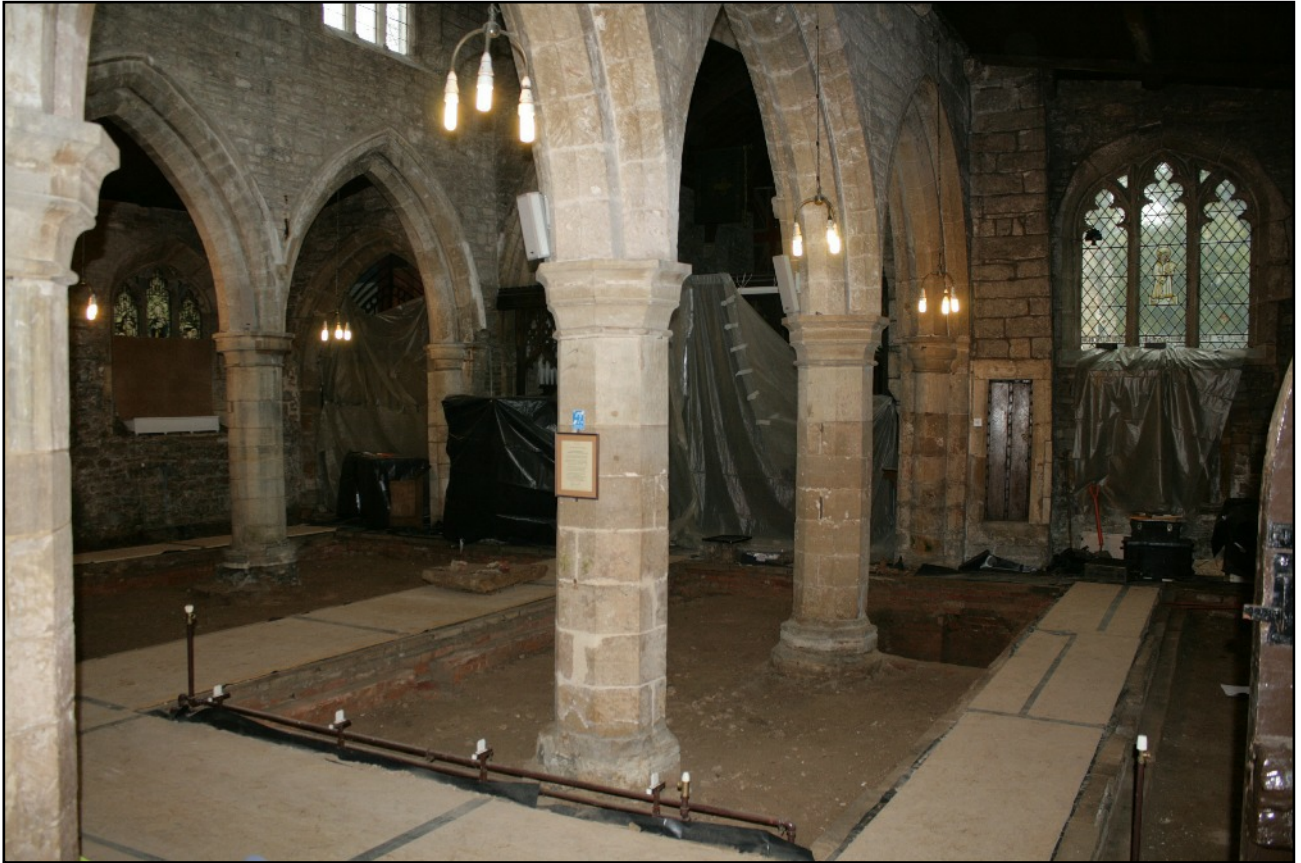
Plate 7. General view of Area 03 after excavation, viewed looking north-east. Note the virtually complete foundations to the columns.

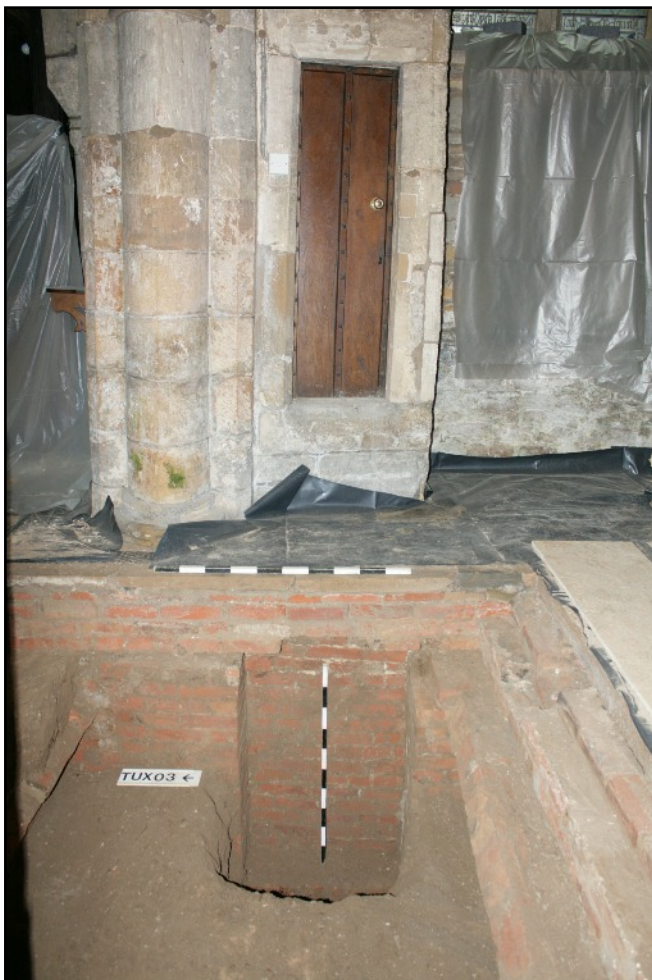
Plate 8. The burial shaft 0306 in Area 03 after excavation,

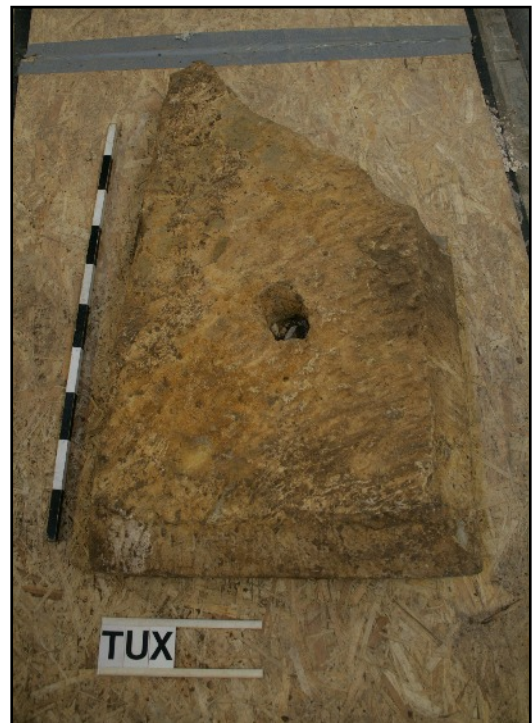
5.4.3 Amongst the Victorian finds within the rubble layer 0300 was an incomplete piece of worked stone measuring 1.08m x 0.65m and 0.12m thick which had a circular hole in the middle. It was chamfered on two sides and had a flat top and base. The characteristics of the artefact suggest that it was probably part of a plinth course, possibly medieval in date.

Plate 9. Worked chamfered stone from 0300, possibly medieval in date.

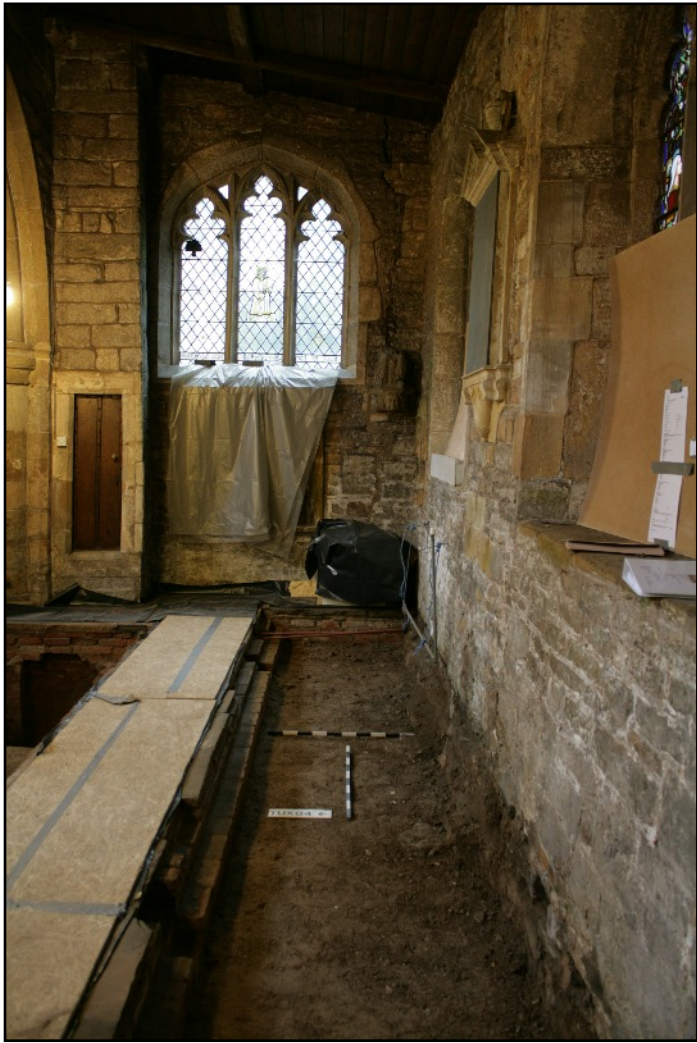
Plate 10. General view of Area 04 after excavation, viewed looking east.

Plate 10: General view of Area 04 after excavation, viewed looking east.

The South Aisle (Figure 3 and Plates 10 and 11)

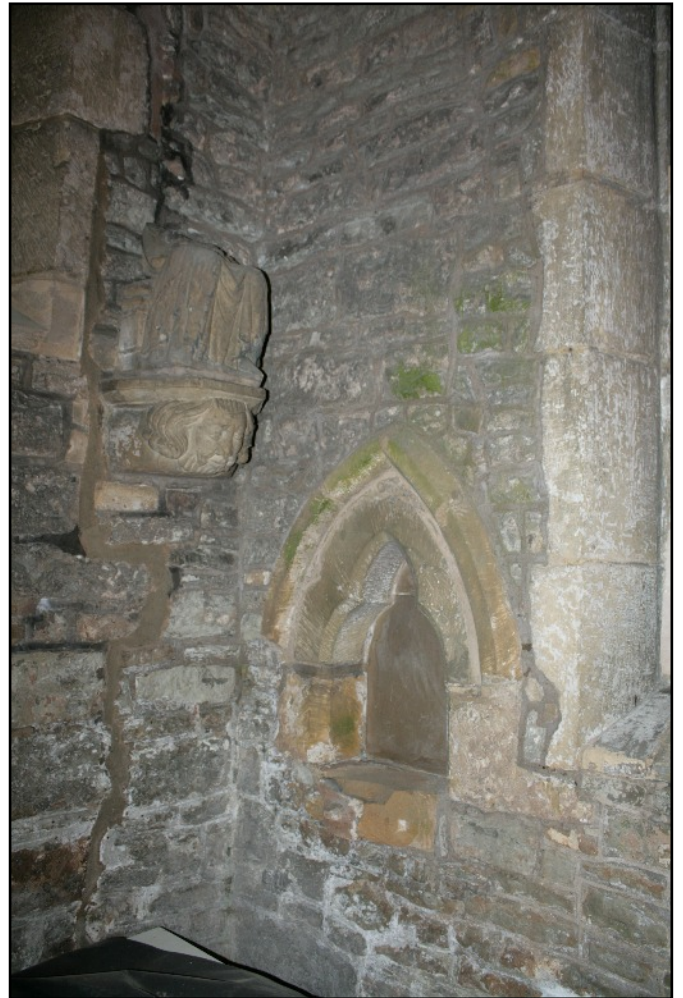
5.5.2. A piscina is present within the south wall at the eastern end of the area. On the east wall there is carved stone corbel of a man's face gazing down on the area with a repositioned piece of decorative masonry placed above. As in Area 01 the absence of a stone altar normally associated with a piscina suggests that the excavations were at an insufficient depth to disturb any surviving medieval archaeology.

Plate 11. The piscina and carved stone corbel in the south-western corner of the south aisle Area 04, viewed looking south-east.
