Repton Precinct, New Teaching Block, Repton, Derbyshire

Report On An Archaeological Watching Brief

Report Number: 009/2015

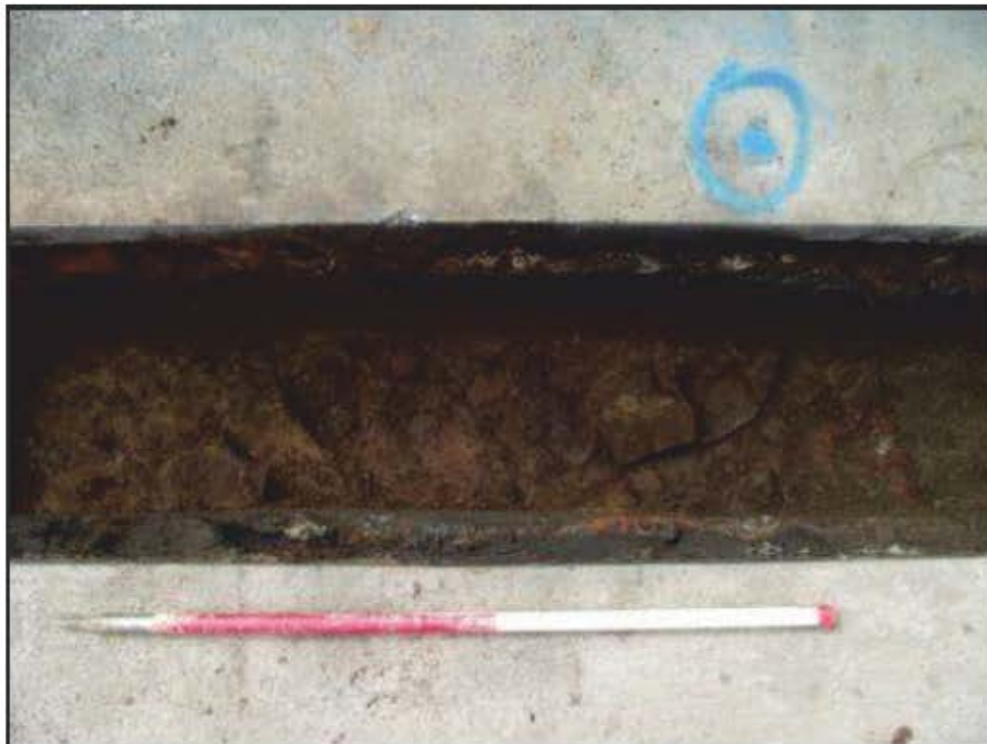
Plate 2. East facing photograph of Wall (0018) and features [0014] [0012]

- 5.7 A partially exposed feature, [0014], was identified which extended from under the eastern baulk. This was filled with (0013), a mixed white greyish red clay. An understanding of the shape of the feature could not be gleaned on account of it being cut by [0012]; an easterly oriented relict water service trench. This was filled with (0019), a mixed whitish grey silty clay. As the formation level was reached and no further intrusive impact was expected to occur, the features were not excavated beyond this depth.

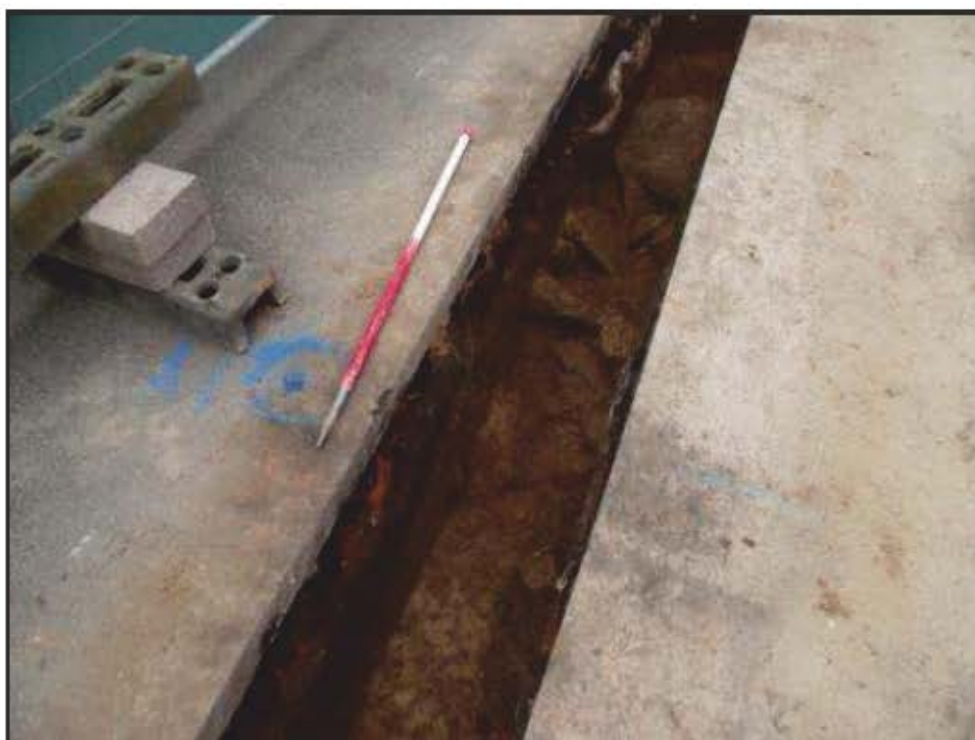
Plate 3. South-west facing photograph of Pit (0006) and wall (0010)

- 5.5 The more superficial contexts encountered in the Service Trench C correspond to Test Pit 1, with contexts (0001)-(0003) occurring in similar depths and consistencies (table 1). Beneath context (0003) however was (0016), a dark grey soft silty clay measuring 80mm in thickness. This was sealing walls, (0010), (0017), (0023) and pit (0006) (Figure 3 & Plate 3).

- 5.6 Wall foundations (0010) and (0017) were contained within cuts [0008] and [0011] respectively (Figure 3). The sandstone walls were at right angles to each other, with (0010) extending south-westerly and (0017) progressing north-easterly. For the most part, only a single course appeared to remain and whilst an undisturbed 2.1m width of (0010) existed, only a 1.5m width of wall (0017) remained due to later disturbance. Portions of the wall were regarded as been in reasonable condition with faced fragments of masonry extending up to the limit of the cut without interruption. Higher levels of disturbance were identified towards the centre of the wall and in places were represented by very few fragments of masonry. Each of the walls had an associated interstitial packing. Context (0009) the fill within wall (0010), was recorded as a light brown silt, (0018), the fill within (0017), as a light brown clayey silt. The relationship between these two walls could not be identified as they extend beyond the trench. The similarity of the features does strongly suggest that they are contemporary and the return of the wall exists just beyond the eastern extent of the trench.

- 5.9 The partial extent of a roughly circular feature 850mm by 150mm extended from the eastern limit of the trench was identified just to the south of wall (0010). On balance, the feature has been interpreted as a pit on account of its shape and the fact that no other parts of it could be seen extending into the main area of the development suggesting that it terminates under the undisturbed soil baulk. The fill of the pit, (0007), was a soft dark grey silty clay. Not enough of the feature was exposed to lend itself to an interpretation and it was not excavated as the formation level for the gas main was reached. All of these features were sealed by (0016).

- 6.5 Located just the south of wall (0010), pit [0006], which may have been contemporary with both features, was sealed by the same deposit, (0003). Despite that fact that the features are very close to each other, no physical relationship could be observed definitively.

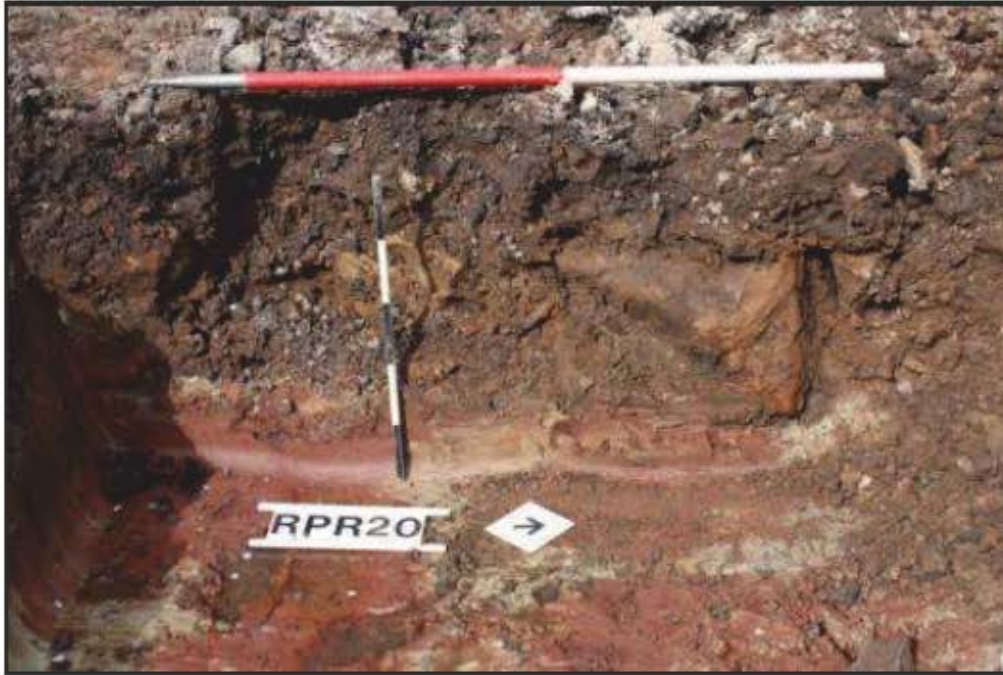
Plate 5. East facing photograph of western section of Test Pit 2

- 5.13 Two roughly faced stones and compacted stones, believed to represent a wall, (0020) were identified in Test Pit 2 approximately 0.7m below the modern ground surface (Plate 5). Beyond the limit of the foundation pit, the wall was not exposed in plan. The wall appeared to be very heavily disturbed.

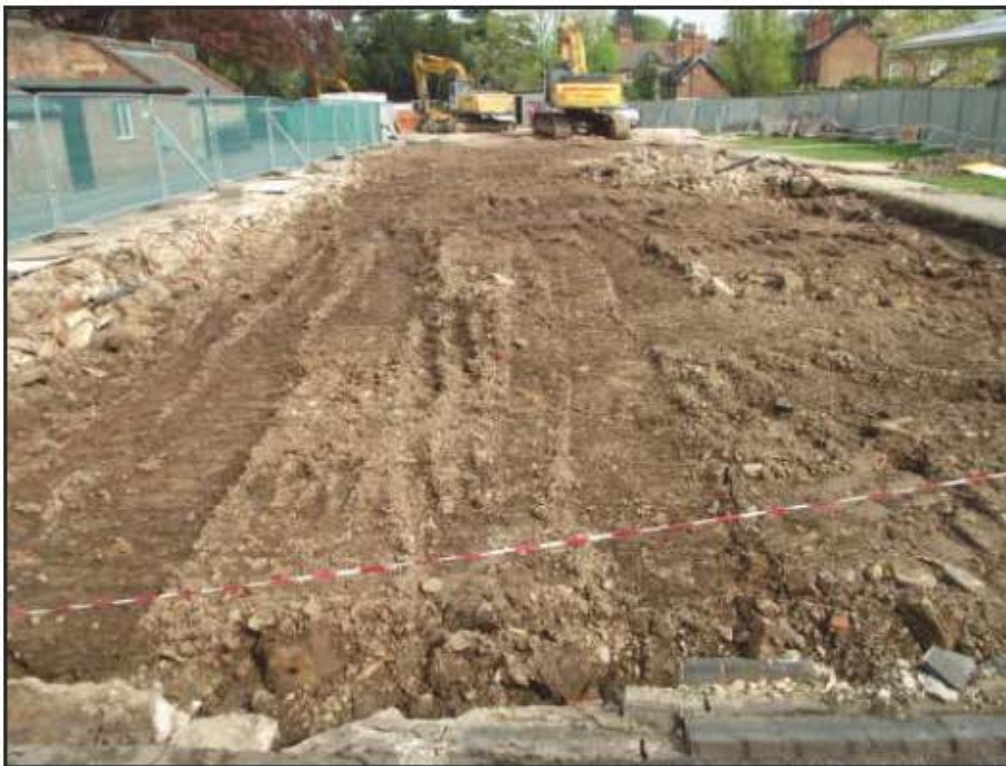
Plate 6. South facing photograph of the main area reduction

- 5.12 The main area was reduced in measured spits under the constant monitoring of an archaeologist. With the exception of wall (0023), which is discussed above, nothing of archaeological significance was observed.

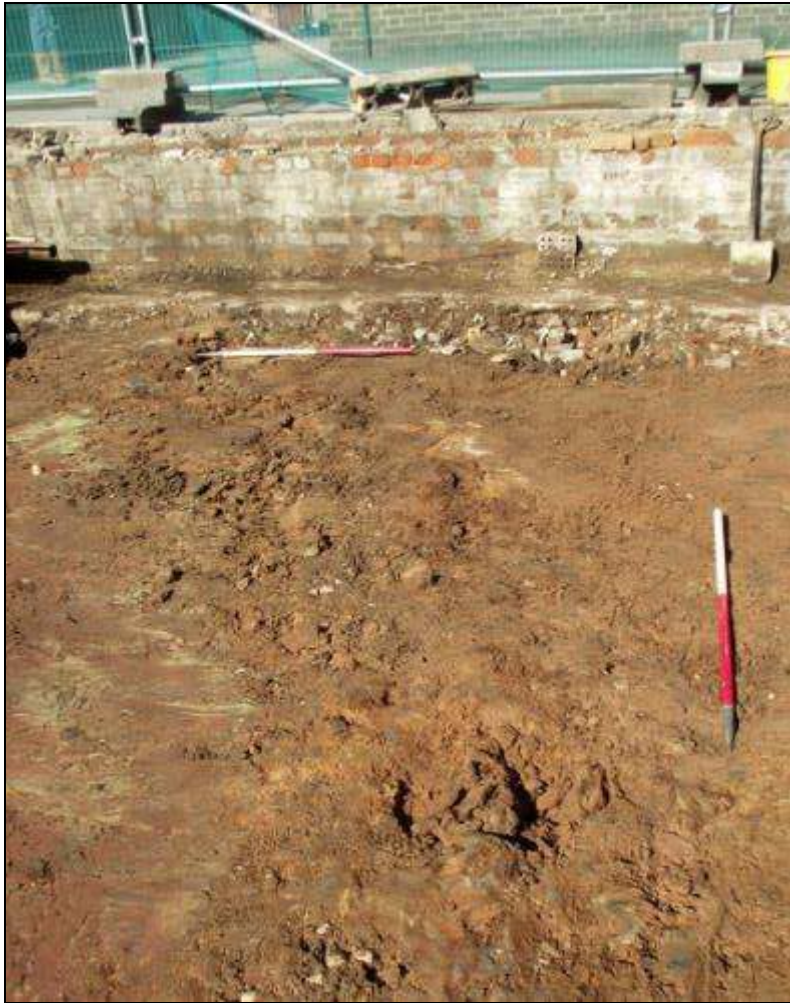
Plate 8. East facing photograph of wall [0024]

- 5.8 A third wall, (0023), was observed in the service trench but was very badly disturbed. The wall was also identified in the main part of the excavation during the measured ground reduction where it was found to be in much better condition than that detected in the trench (Figure 4). The portion of the wall which was discovered in the main part of the excavation extended east-north-easterly and displayed a 90° turn to the north-north-west. Wall (0023) was constructed out of sandstone blocks, the same material as walls (0010) and (0017) and was contained within cut [0024]. These foundations were

identified at formation level and were left in-situ. No further intrusive works which threatened the integrity of the surviving wall were undertaken and the wall will survive beneath the new teaching block.

- 6.3 The wall which was observed in the main area, (0024) was much more fragmented than (0010)/(0017). There was a distinct east-south-east orientation to the structure with a less distinct turn to the south-west-south. The spatial arrangement of wall (0024) and (0010)/(0017) (possibly running parallel and at broadly similar heights) suggests that they may be related. Wall (0024) could possibly be an outer structure with wall (0010)/(0017) being located in the centre. Alternatively they could represent different phases of a structure.
