# Wollaton Hall, Wollaton, Nottingham

An Archaeological Watching Brief

Report Number: 129/2013

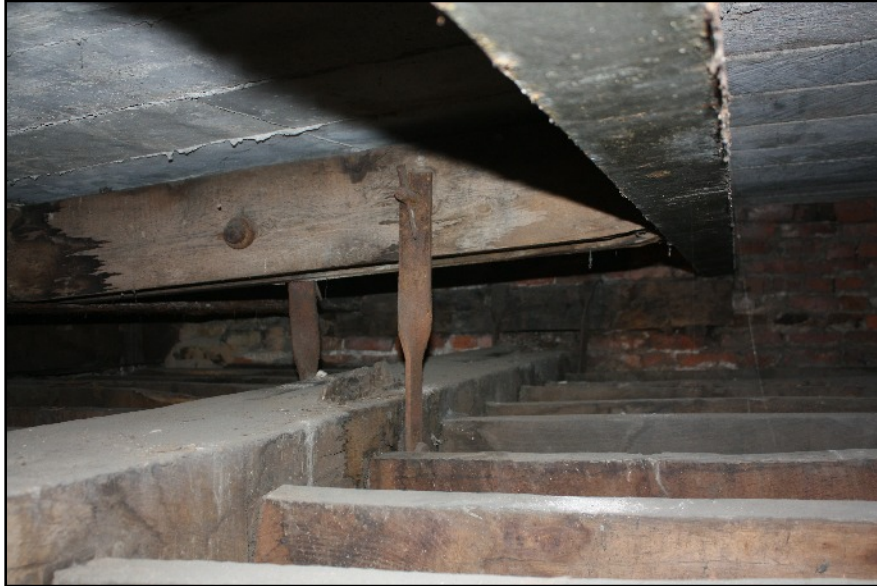
The roof comprises 15 concrete planks extending north to south. They are retained by two west to east orientated metal girders and a central west to east orientated oak timber beam located adjacent to the north wall. The empty mortices for a barefaced soffit tenon with diminished shoulder indicate that it is a reused former ceiling beam. Timber beams embedded in the west and east wall support the girders. A further timber is also present between the two girders to add structural integrity. Metal ties extend from the timbers to the ceiling beam and joists below for additional support. The height of the void measures 630mm from base of the joists to the concrete planks.

**Plate 1:** View of the void within the South-west corner tower showing the timber and metal girder supports for the concrete plank floor and the additional metal ties between the later timber and the original ceiling beam below. Viewed looking north-east.

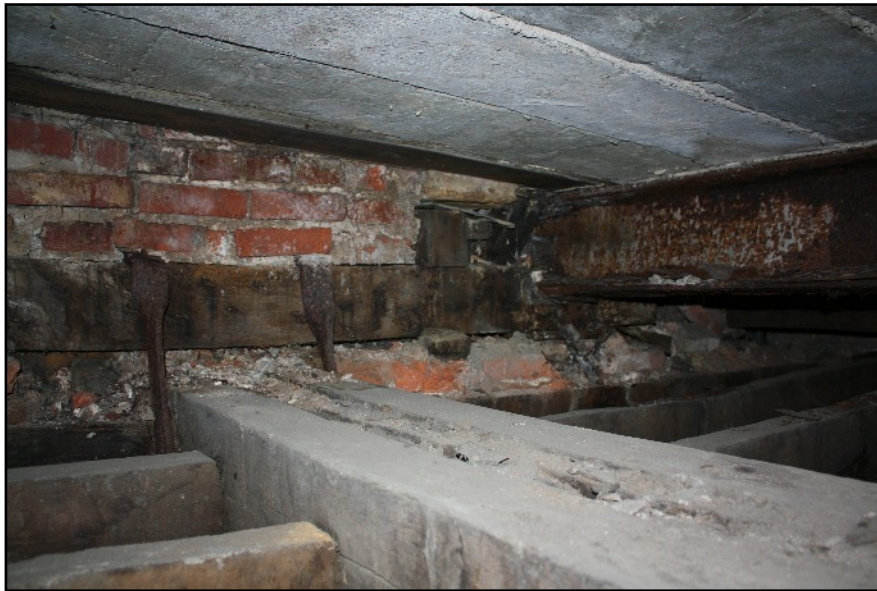
**Plate 2:** Northern metal girder supported by a timber embedded in the west wall in the void of the South-west corner tower. Note the metal ties between the wall timber and joists below. Viewed looking north-west.

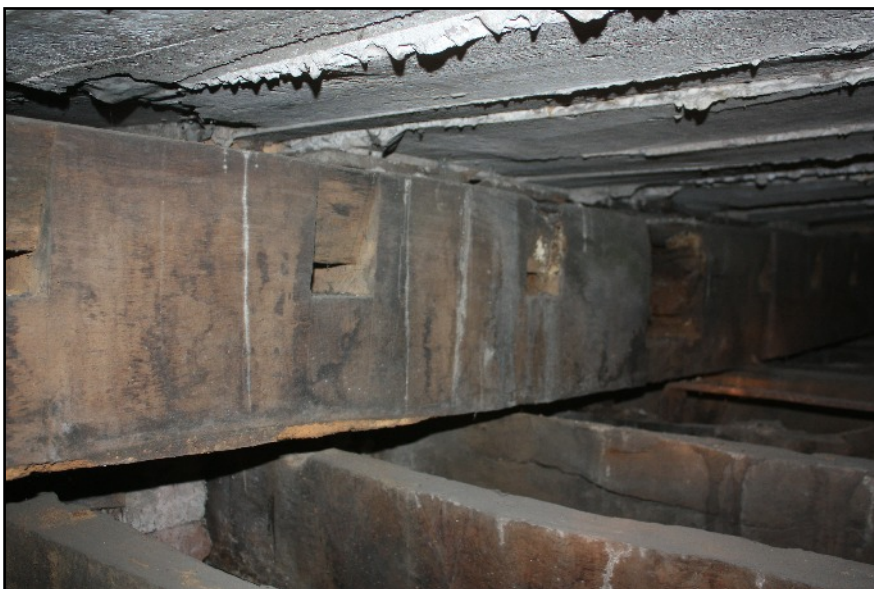
**Plate 3:** Detail of the re-used ceiling beam supporting the concrete roof in the void of the South-west corner tower. Viewed looking north-east.

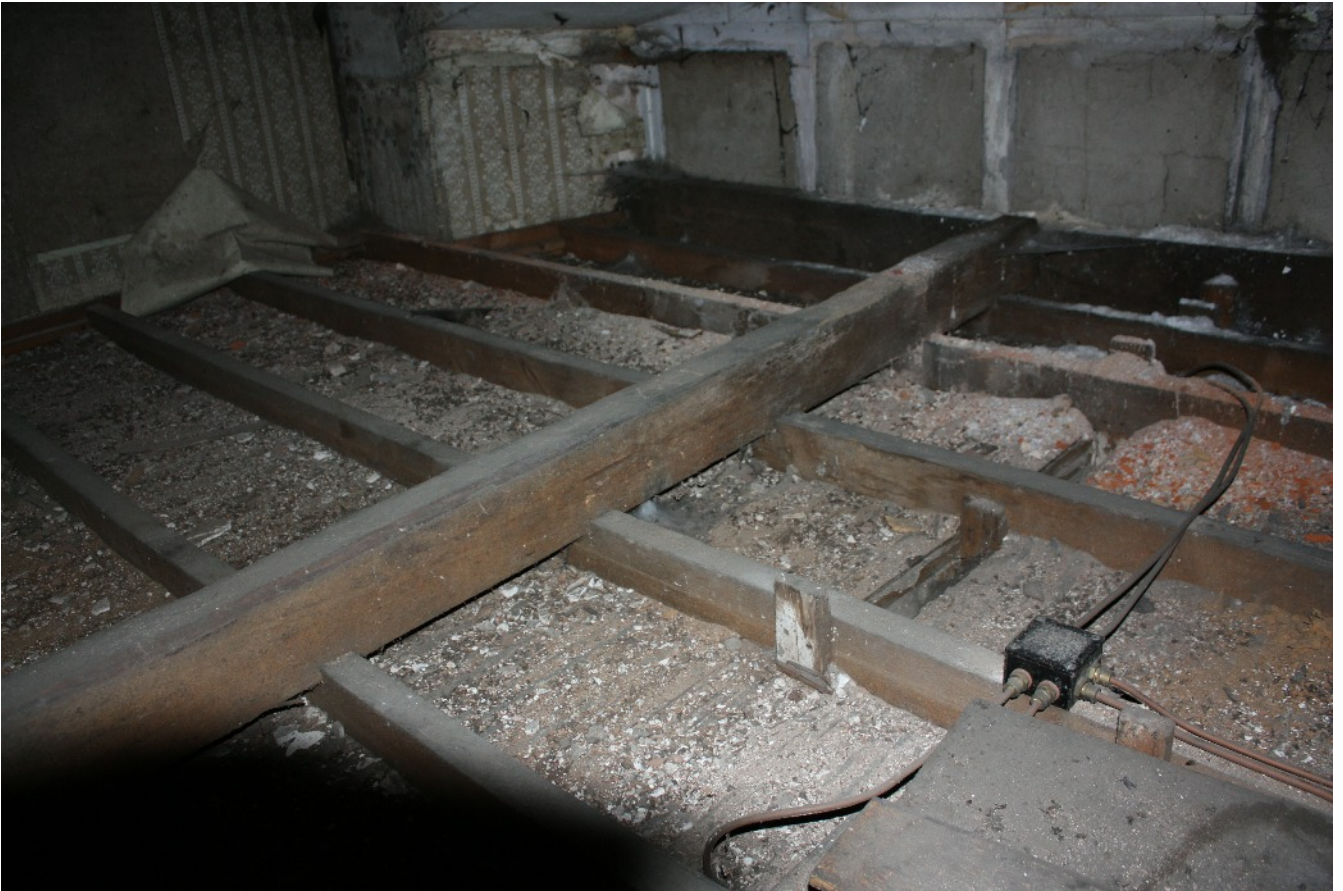
Unlike the other three corner towers, the South-west tower has an additional upper room beneath the ceiling created by an inserted floor, the level of which interrupts the windows in the south and west walls, which have been blocked, presumably when the floor was constructed. The floor is made of machine sawn softwood timber cut to a smaller size than that used in the ceiling above. The room itself has been decorated with wall paper indicating that it had a domestic function. Two phases of wall paper are present, the later extending to the ceiling above. However, the earlier terminates 750mm (29½ inches) lower, suggesting the presence of a former false ceiling. Such a reduction in height would render the room too low for habitation. Therefore, it is likely that the earlier wallpaper is that which adorned the walls of the South-west tower prior to its refurbishment which included the insertion of the floor.

The carpentry of the inserted floor in the South-west tower appears to be later than the renovations undertaken between 1801-32 by Wyattville, possibly of early 20<sup>th</sup> century date. Further analysis of the wallpaper is likely to produce a more secure date for the alterations within this part of the tower.

**Plate 4:** View of the floor structure of the inserted floor structure within the South-west corner tower, viewed looking south-east.

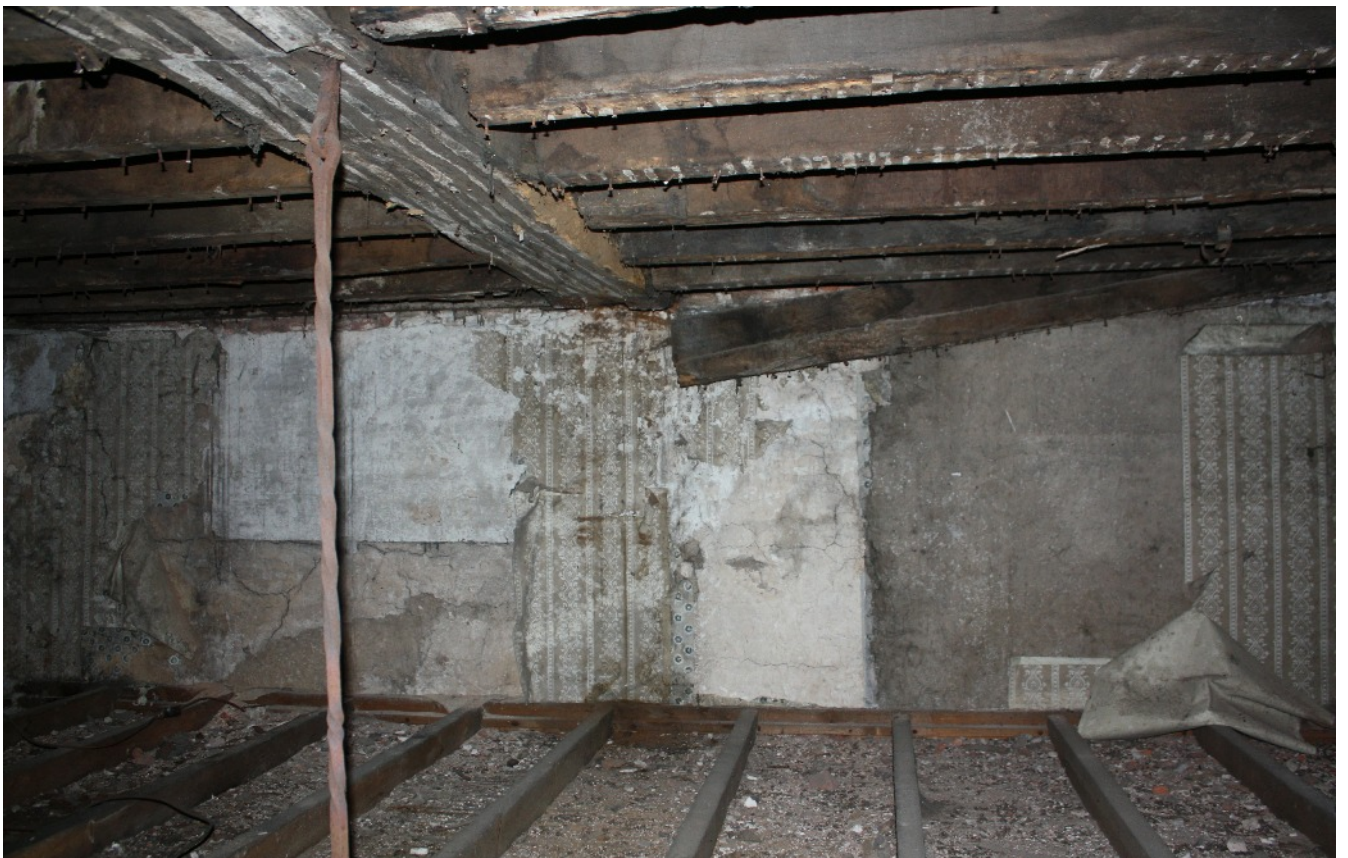
**Plate 5:** East wall of the Upper Room in the South-west corner tower illustrating the differing wall paper heights, viewed looking north-east.

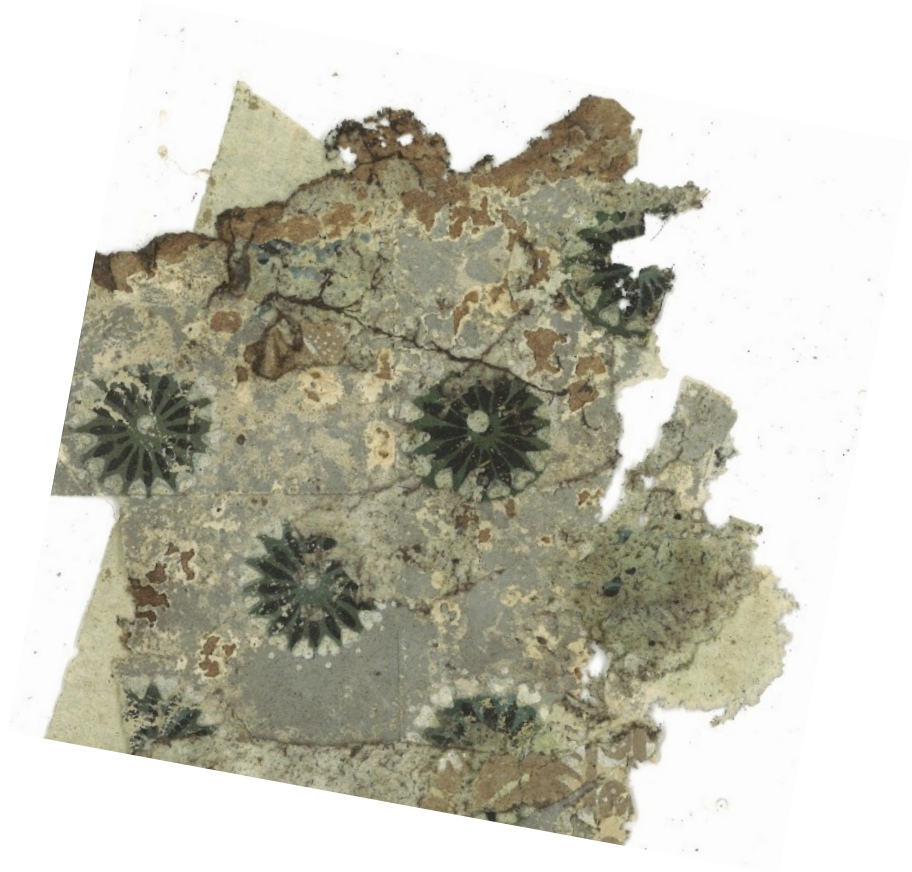
**Plate 6:** Detail of the earliest phase of wall paper from the Upper Room in the South-west corner tower.

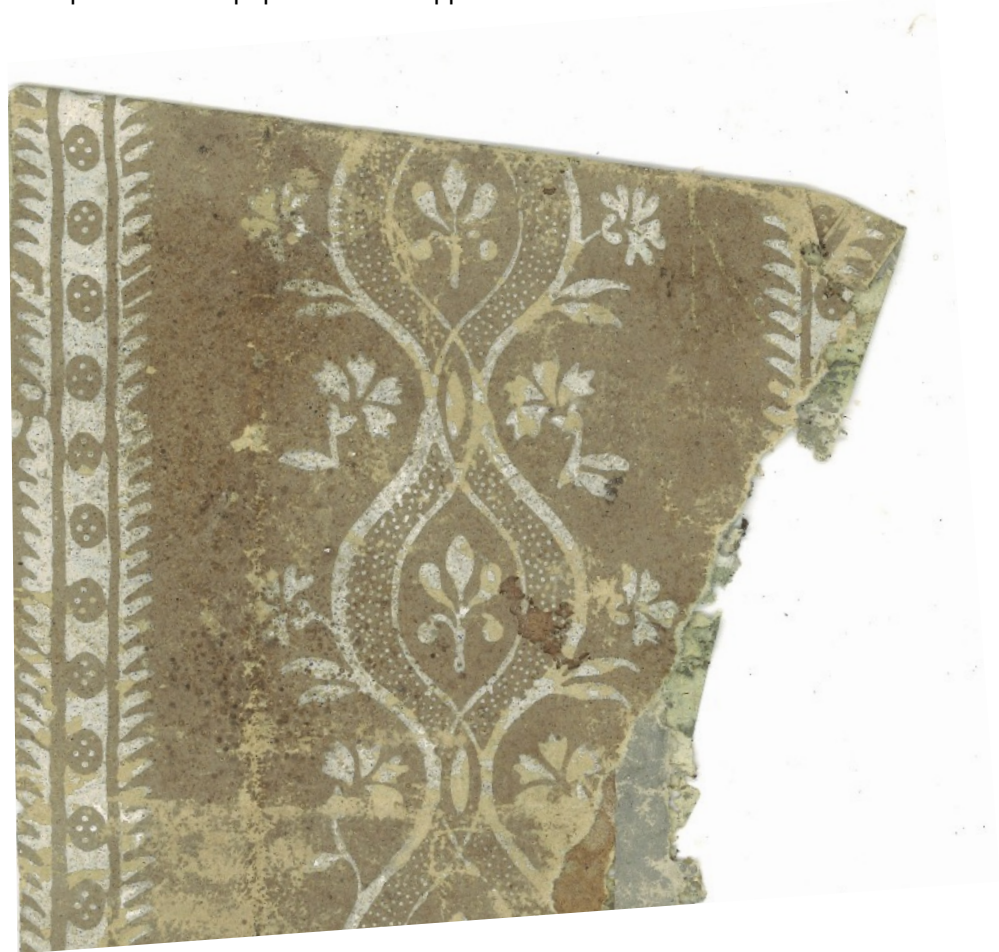
**Plate 7:** Detail of the latest phase of wall paper from the Upper Room in the South-west corner tower.

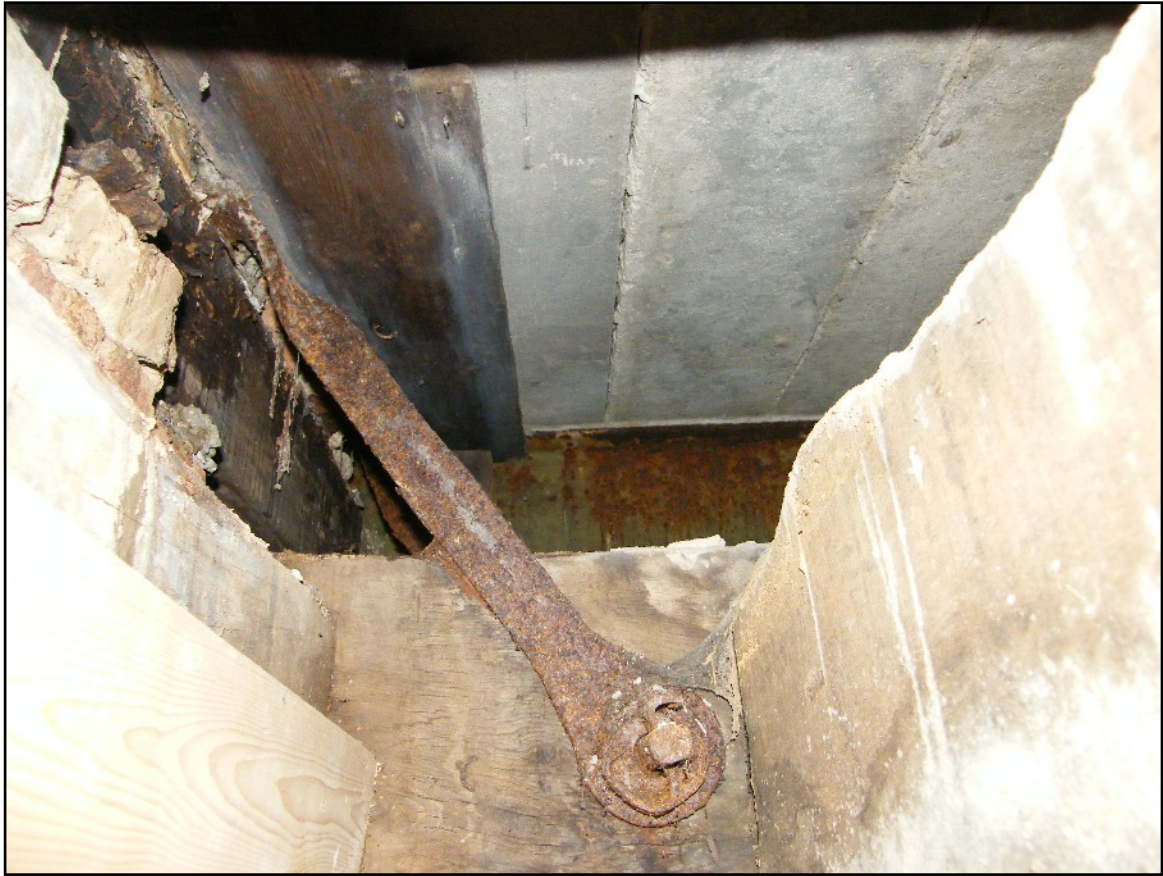
The void between the base of the ceiling joists and the concrete planks above is 600mm. As in the other towers bricks exceeding 2½ inches thick were encountered within the void indicating that the walls had been rebuilt. Metal ties like those present in the South-west tower were present extending between a modern machine sawn timber embedded in the west wall and the earlier oak ceiling beam beneath. The ceiling beam was orientated west to east and the joists viewed were all contemporary with it. The lath ceiling is again 5mm thick and covered with 20mm of plaster.

**Plate 8:** Metal tie in the South-east tower extending from a modern machine sawn timber in the west wall down to the original oak ceiling beam below. Viewed looking north.

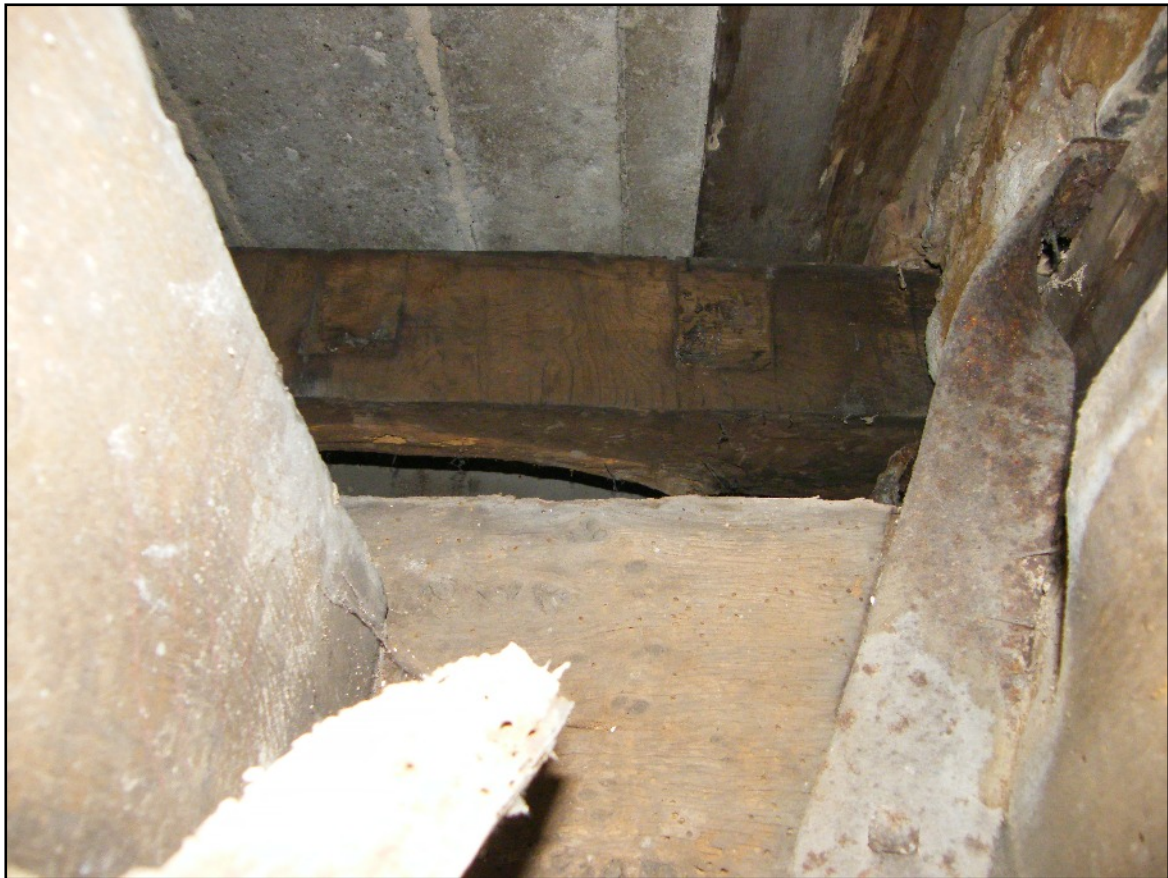
The void between the base of the ceiling joists and the concrete planks above is 610mm. The roof and ceiling structure is identical as in the other towers with the concrete planks being supported by steel girders, in this case encased in concrete, and as in the South-west tower a reused timber, possibly a ceiling beam. It is orientated west to east and runs south of the main ceiling beam. The brick walling, as in the other towers, has been partially rebuilt. Metal ties have been used for added structural stability. The original timber ceiling is oak with the

**Plate 9:** The reused timber beam in the North-east tower supporting the concrete planks, viewed looking south. Note the metal tie extending from the timber embedded in the brickwork of the west wall to the main ceiling beam.
