Bainbridge Methodist Church, Eastgate, Bishop Auckland, County Durham

Historic Building Record

Report Number: 097/2015

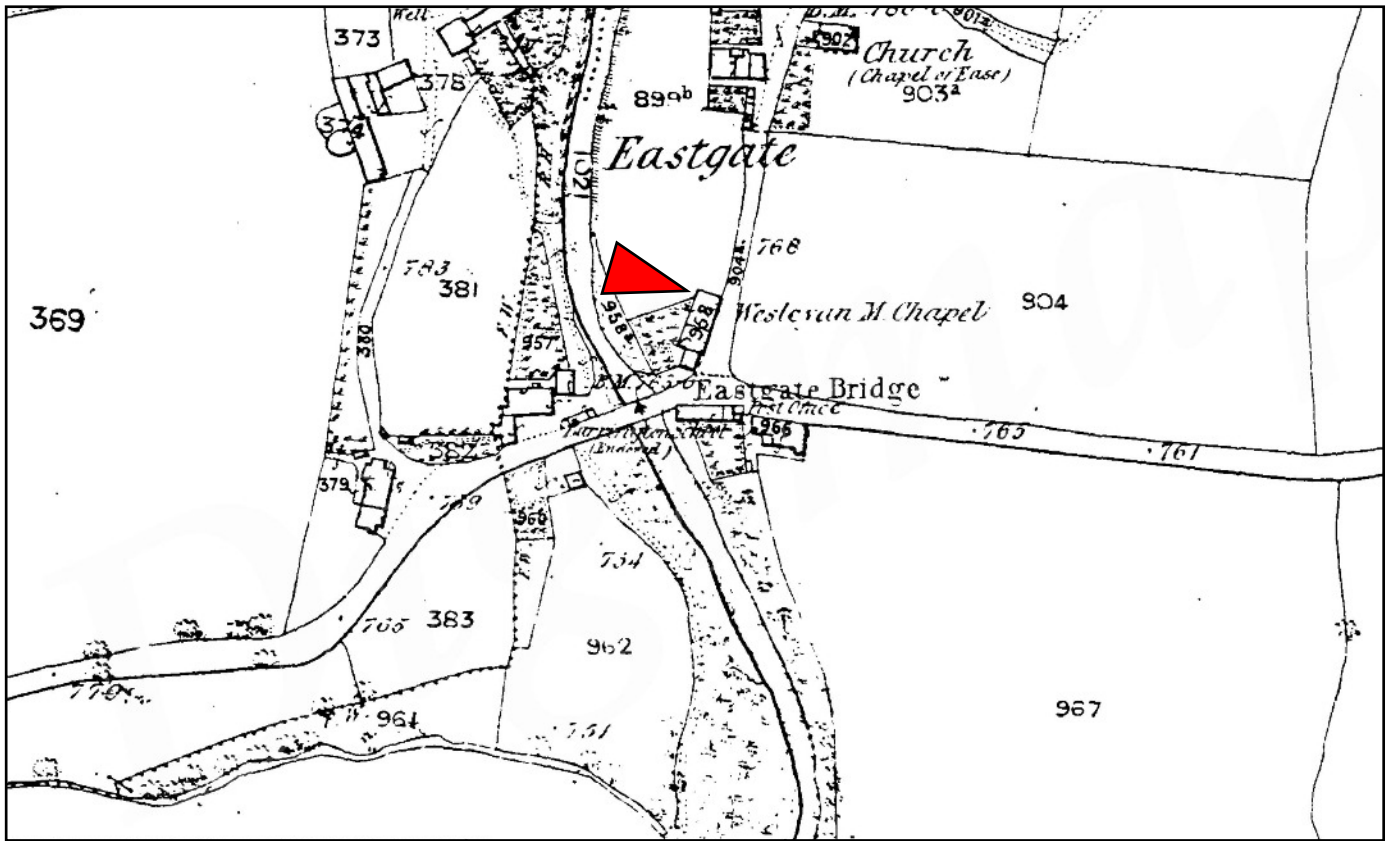
Figure 2: Bainbridge Methodist Church highlighted on the First Edition Ordnance Survey map of 1859.

3.3.1 Historic maps depicting the Bainbridge Methodist Church were consulted. A date range of 1859 to the present was obtained showing that the building comprised two principal building phases. The First Edition Ordnance Survey map of 1859 depicts the Wesleyan Methodist Chapel as a simple rectangular building abutted to the south by The Willows. This chapel is likely to be the one mentioned in the 1819 Title Deeds. A boundary extends from just below the north-west corner of the chapel to a small plot adjacent to the Rookhope Burn. The building remains unchanged until the publication of the 1896 Ordnance Survey map that shows a rectangular extension having been constructed onto the north-west half of the north gable wall of the earlier chapel. A structure extends from the east elevation to the road. A small addition has been made to the north-west corner of the original chapel. A new boundary encloses the additions to the west and north with two small outbuildings erected against the western boundary. The original Wesleyan Methodist Chapel is now described as a Sunday School. There is no change to the Church until the publication of the 1979 Ordnance survey map which shows that the two outbuildings are no longer extant.

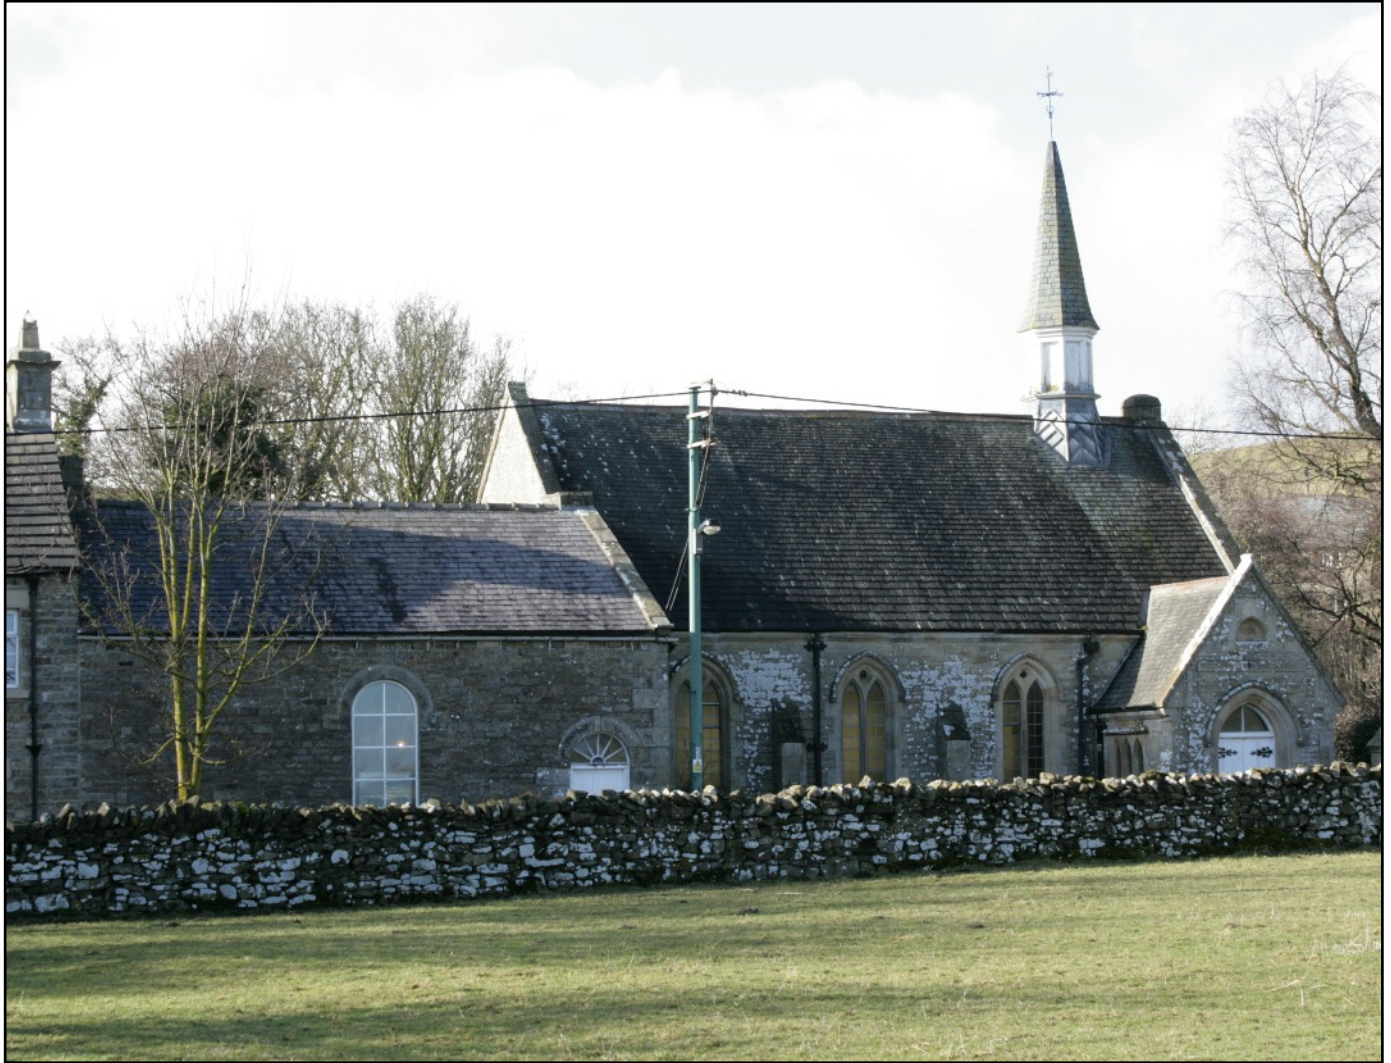
4.1.1 The earliest phase of the Church is the Sunday School, formerly the chapel. It is a square single storey building which is orientated north to south and built of coursed squared sandstone with quoins and ashlar dressings under a slate gable roof with ridge tiles. The eastern side of the north gable and the western side of the south gable have stone coping and a stone kneeler. A single window with a semi-circular head is present in the west and east elevations and a doorway with a matching fanlight in the east elevation. The lower stone courses of a former bellcote are present in the north gable. The southern part of the roof abuts the chimney belonging to the building which was replaced by The Willows in 1843, the chimney presumably retained as its removal would have been structurally damaging to the Sunday School. On stylistic grounds it is likely to date to the late Georgian period between 1800 and 1820. A porch was added to the west elevation, the stonework is identical to that of the chapel indicating a date of 1891. The walls were subsequently raised and concrete lintels used for the window and door. The roof is of slate.

4.1.3 Abutting the Sunday School is the Church, built in a Gothic style. It is a rectangular single storey building of four bays which is orientated north to south with a contemporary porch on the east elevation bearing the inscription above the doorway, '1891 Cuthbert Bainbridge Memorial Wesleyan Chapel'. The building is constructed of coursed squared sandstone with quoins and ashlar dressings under a slate gable roof with ridge tiles. Stone coping, kneelers and plain undecorated cornices are present on both the chapel and porch. The windows in the east and west walls of the Church are of geometric design forming two lancets with a quatrefoil above. The north gable wall has three lancet windows, the central one being taller. A cill, decorated with leaf stops, extends beneath the windows. The porch has three plain lancet windows in the north and south walls. The principal entry into the building is via the porch which has a two-centred arched doorway, the soffit and jambs of which has been chamfered in the style of an ogee variant, terminating in a runout stop towards the base of the door. All the windows and doorway, with the exception of the lancet windows of the porch, have a hoodmould with stops, the stops being naturalistic in design representing a folded leaf above. Buttresses which are contemporary with the Chapel are present on the west and east walls. An octagonal flèche, or turret, is present extending through the ridge at the northern end of the Church. It is of timber construction, the base encased in lead and the middle section being of painted timber with the upper spire having a hanging tile covering. The structure is surmounted by a weather vane. It is possible that the flèche is a later addition to the building, replacing an earlier finial that would have been mounted on the stone base present at the apex of the north gable. The stone wall extending around the east of the Church abuts the building, though still could be of late nineteenth century date.

Plate 1: General view of the Wesleyan Methodist Church at Eastgate with the earlier phase of c. 1819 to the left and the later Gothic style Cuthbert Memorial Wesleyan Chapel of 1891 to the right. Viewed looking north-west.

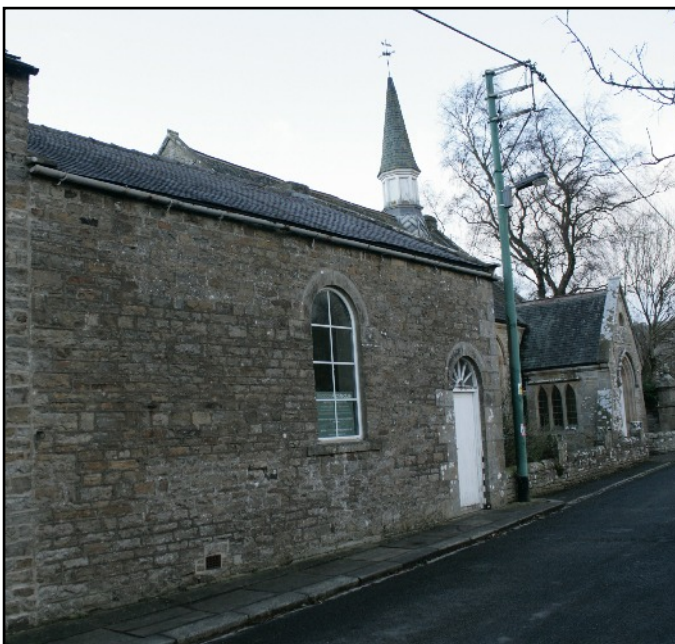
Plate 2: The east facing section of the Sunday School, viewed looking north-west.

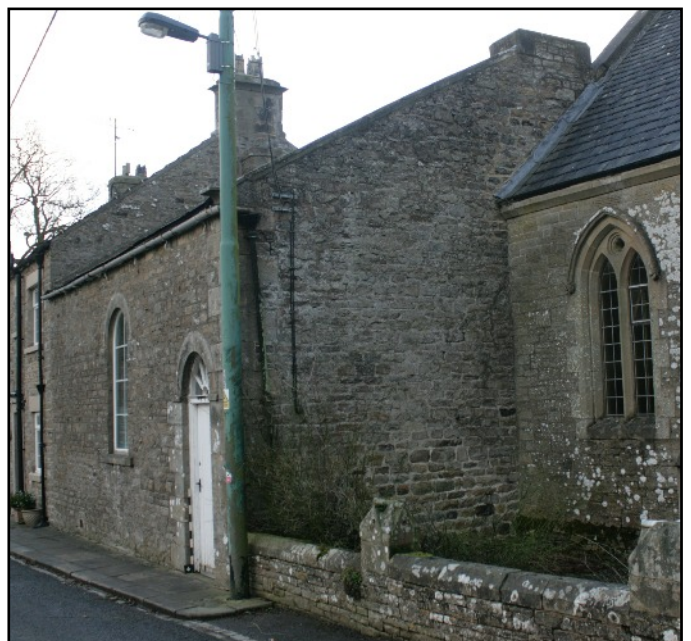
5.1.1 The earliest phase of the Bainbridge Methodist Church is the Georgian chapel that was probably commissioned by William Bainbridge and dates to c. 1819. The style of the building is typical of the period with other nonconformist chapels in County Durham sharing its architectural details and proportions. Arched doorways and windows were used elsewhere in the region including the former Baptist Church at Middleton in Teesdale dating to 1827 (Stell 1994, 66), the Wesleyan Chapel at Gainford dating to 1834 (Stell 1994, 64) and the Methodist Church at Houghton-le-Spring dating to 1786 (Stell 1994, 66). The same type of stone coping and a stone kneeler is present at the Baptist Church at Hamsterley dating to 1774. It is not unusual for nonconformist chapels to be found abutted by dwellings or even in a continuous terrace of houses as at Hamsterley mentioned above. The presence of a potential bellcote however is a rare feature.

Plate 3: The possible former bellcote in the north gable wall of the Sunday School, viewed looking south-west.

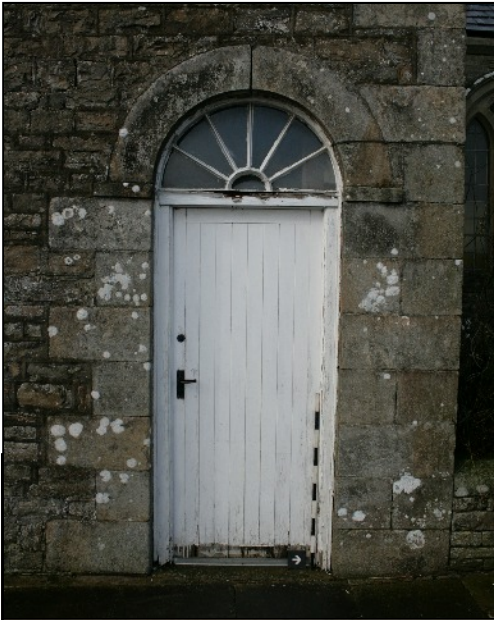
Plate 4: Doorway in the east elevation of the Sunday School, viewed looking west.

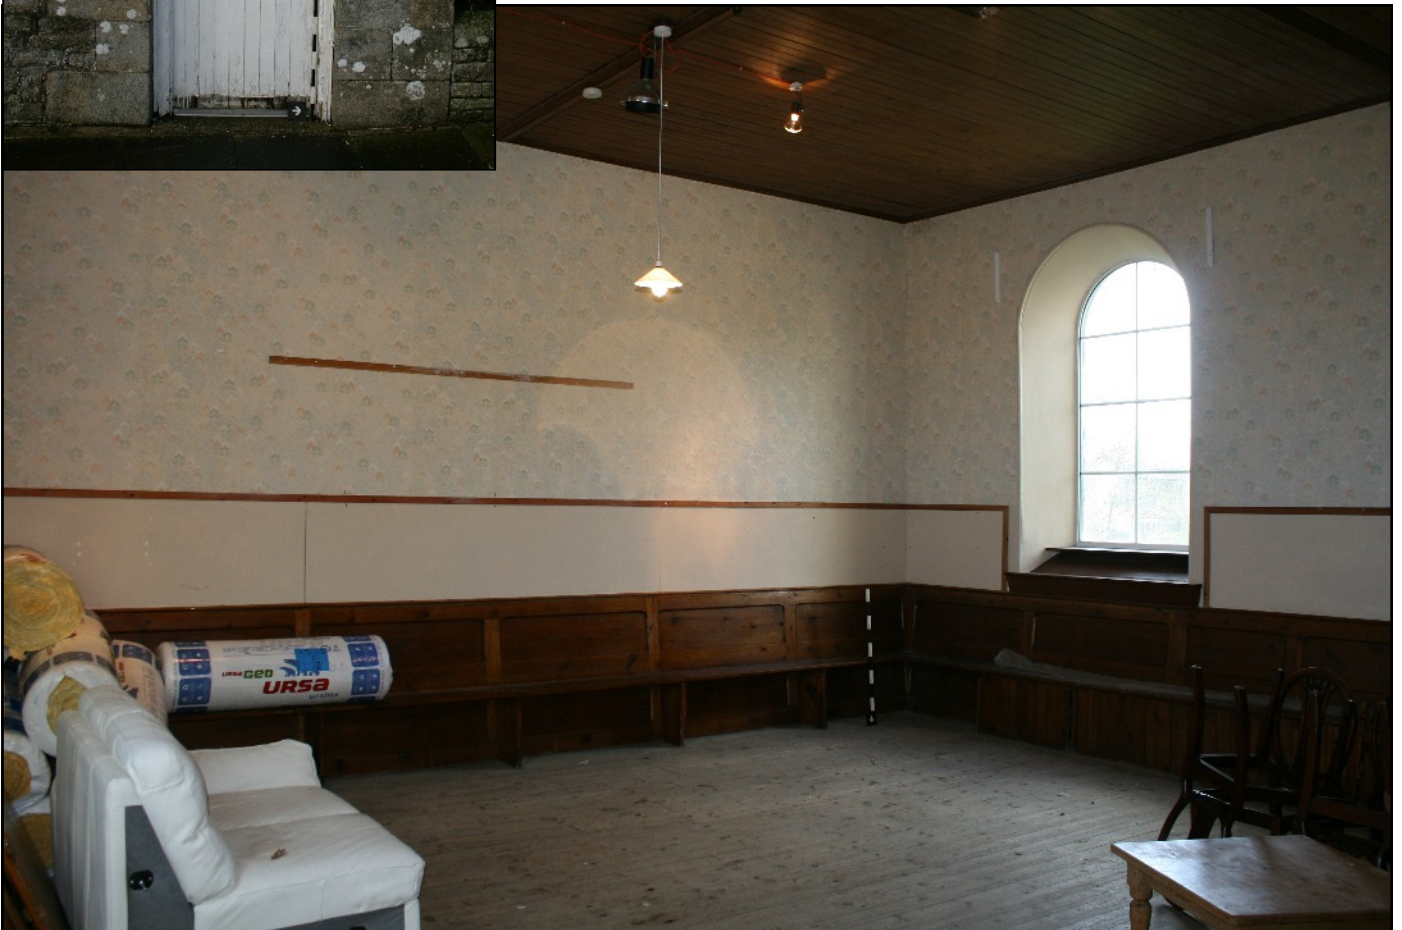
4.2.1 The Sunday School is entered via the doorway in the east elevation which leads into a small lobby created by the insertion of a modern partition wall. The main room has bench seating on the west, east and south walls. The doors leading into the porch in the west wall and into the later Church in the north wall have the same chamfers and stops as the bench seating and are thus likely to be contemporary. As the doorway between the Church and Sunday School is a insertion dating to 1891 the benches and doors probably date to this time indicating that the Sunday School, which was formerly the Chapel, was unsurprisingly remodelled at this time. The Sunday School has a softwood plank floor and timber ceiling. There is evidence for a small hole in the north of the ceiling which may have been for a rope to operate bells in the bellcote.

Plate 5: General view of the interior of the Sunday School, viewed looking south-west.

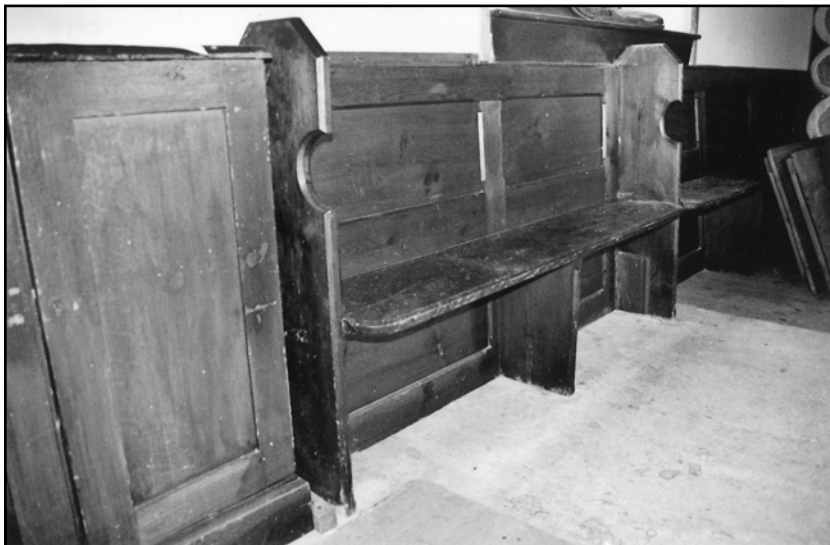
Plate 6: Pitch-pine pews and cupboard in the Sunday School which are contemporary with the furnishings of the later Bainbridge Memorial Chapel.

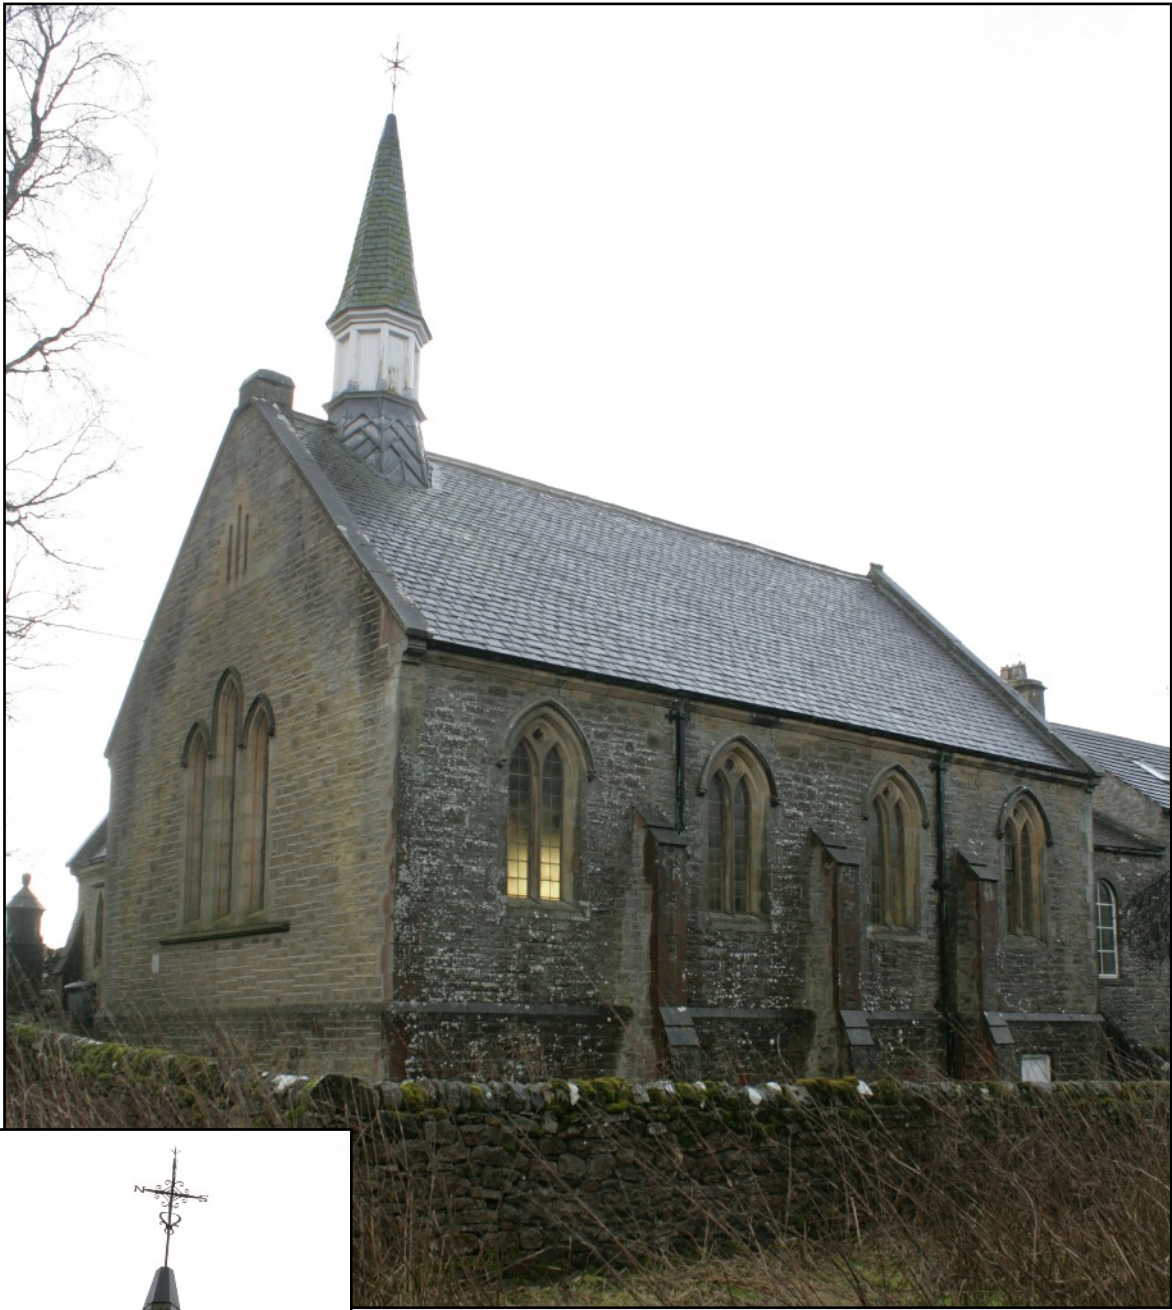
Plate 7: General view of the Cuthbert Bainbridge Memorial Chapel, viewed looking south-east.

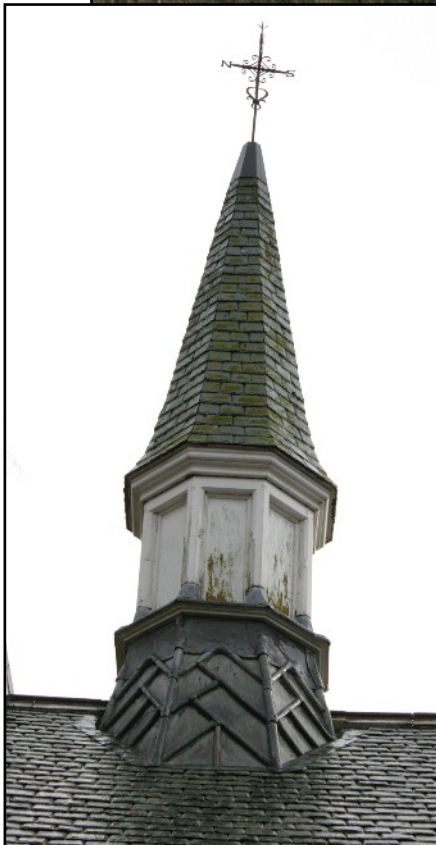
5.1.2 The Cuthbert Bainbridge Memorial Chapel of 1891 conforms to the Gothic architectural style prevalent during the late nineteenth century. Of note is the octagonal flèche, or turret.

Plate 8: Detail of the octagonal flèche, viewed looking east.

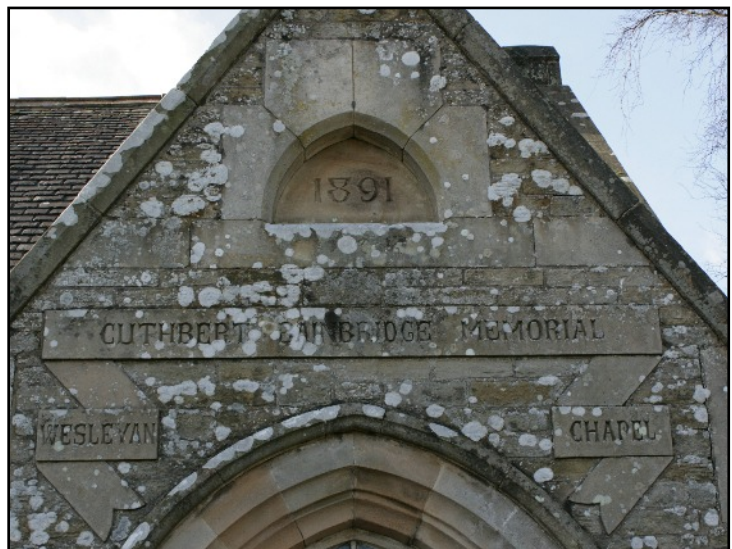
3.2.2 An engraved commemorative stone above the main entrance of the porch in the northern part of the church states, '1891 Cuthbert Bainbridge Memorial Wesleyan Chapel' thus providing a likely date for the extending of the church.

Plate 9: The inscription above the porch doorway.

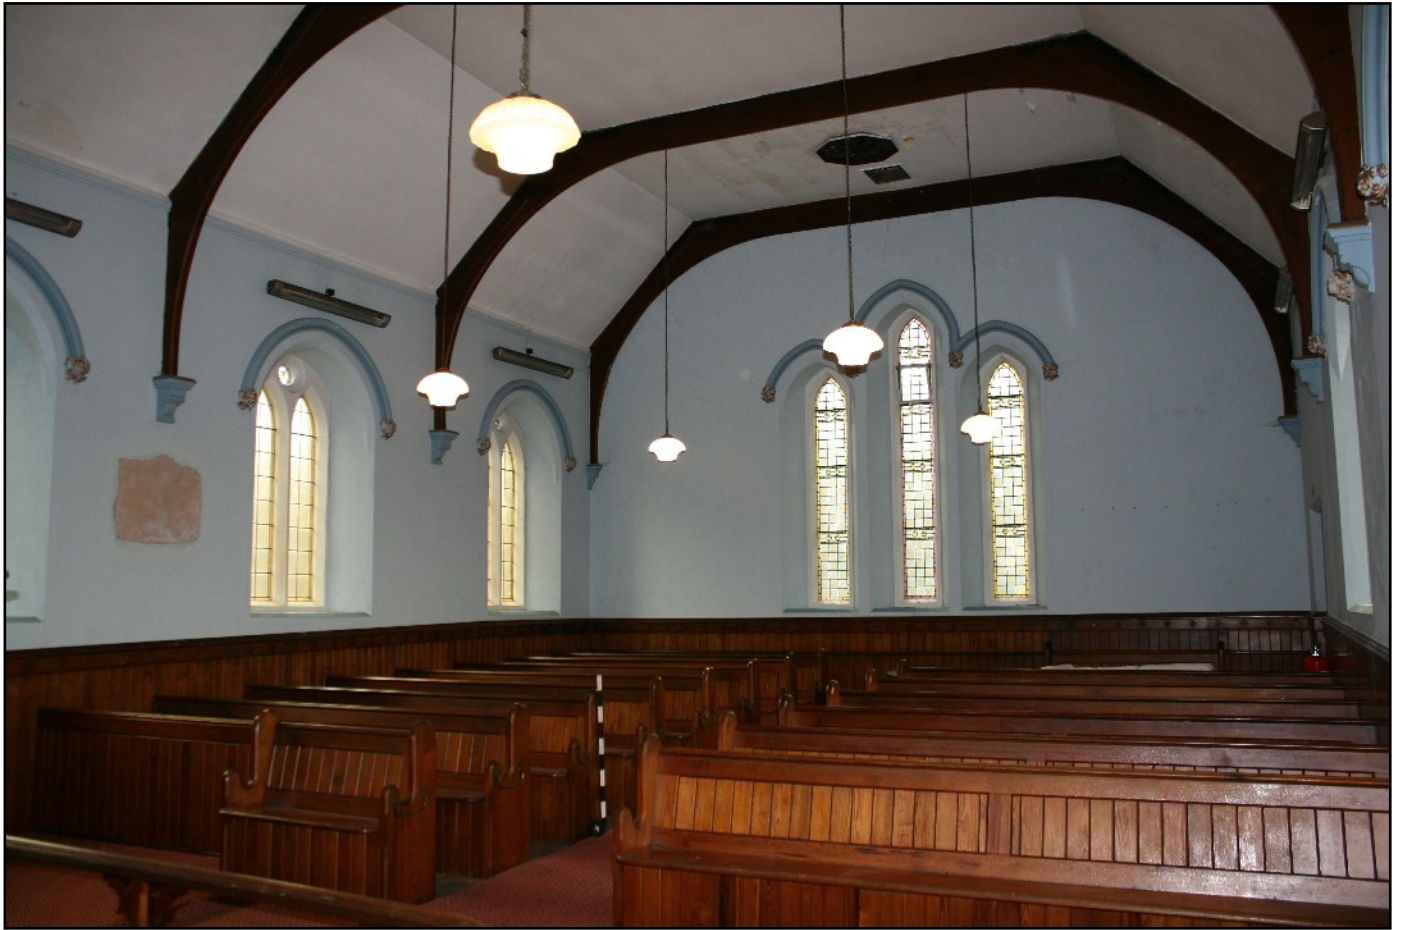
4.2.2 Entry into the later Church is via the porch at the rear of the building fronting the minor road. The Church is a single room of three bays with four trusses resting on stone corbels. The roof structure is partially exposed and is typical of late Victorian design.

Plate 10: Interior of the Cuthbert Memorial Chapel, viewed looking north-west.

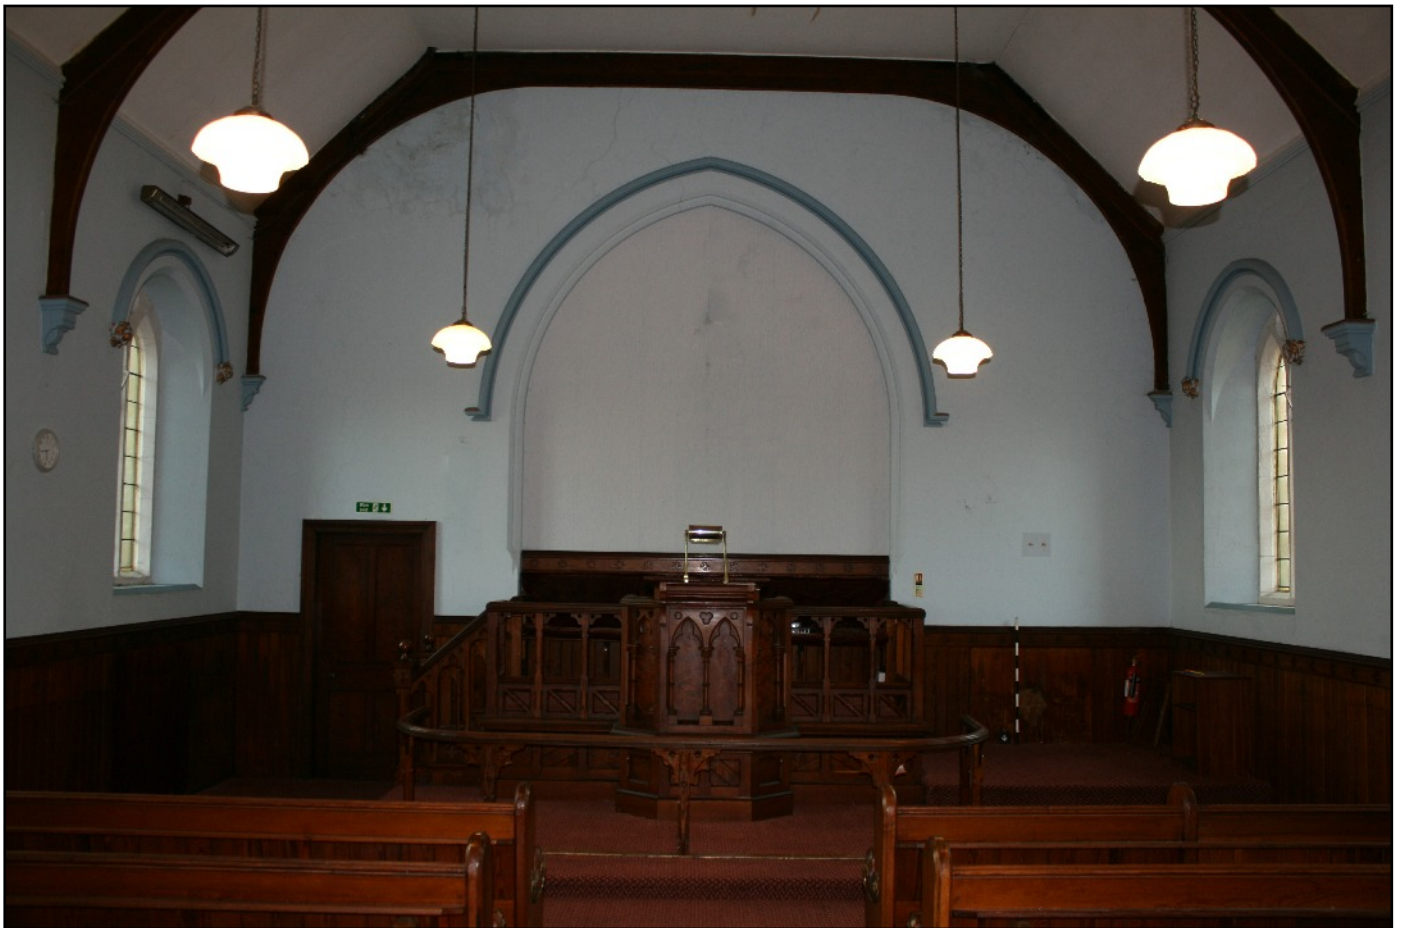
Plate 11: Interior of the Cuthbert Memorial Chapel, viewed looking south.

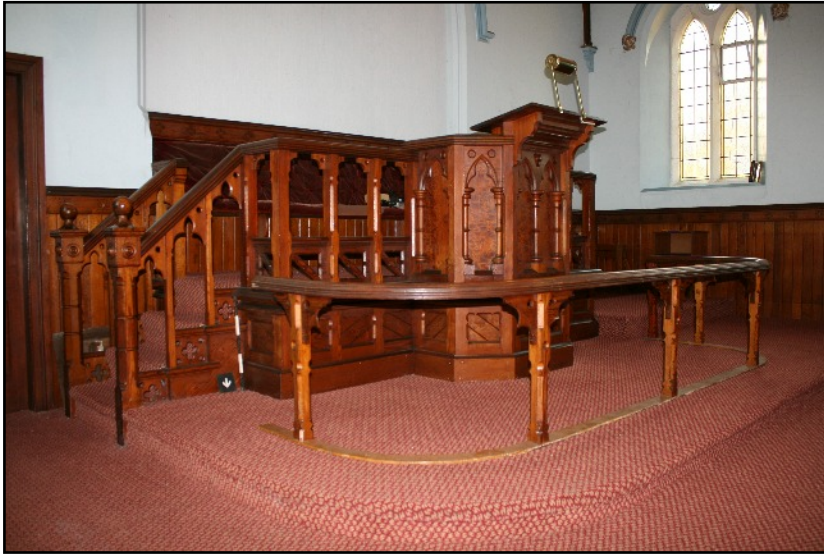
4.2.3 The Church conforms to the 'auditory plan' in which its interior has been planned in order to enable the community to hear and see the preachers. The two rows of pews are arranged to face the front where there is a railed rostrum with seating for several speakers behind the pulpit. The flooring is raised to the west of the rostrum suggesting a choir or musician's corner though alternatively this may have been where former leader's pews were located.

Plate 12: The Rostrum, viewed looking south-west.

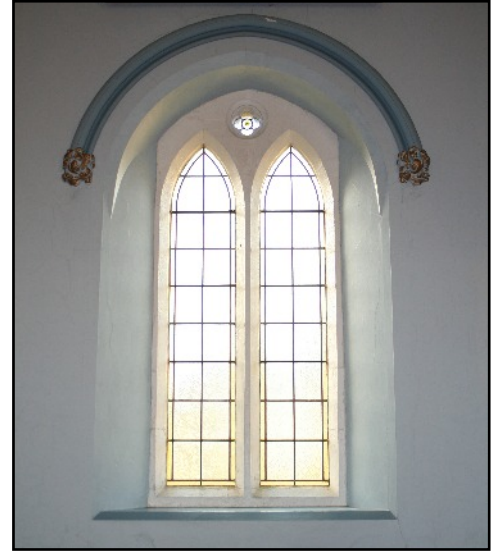
4.2.4 The windows of the Church all have a hoodmould with floral stops painted gold. Stained glass is used sparingly with only the quatrefoil in the lancet windows in the west and east walls being coloured. A limited used of stained glass has been used in the lancet windows in the north gable wall to produce a simple design. Timber panelling extends around the lower half of each of the walls with a decorative motif of circles. All of the timber used within the Church is pitch-pine. The walls of the Church are a light blue with a darker shade used to highlight decorative features such as the corbels. The ceiling is white with two intricately cast iron air vents located at either end of the room.

Plate 13: The southernmost window in the west wall, viewed looking west.

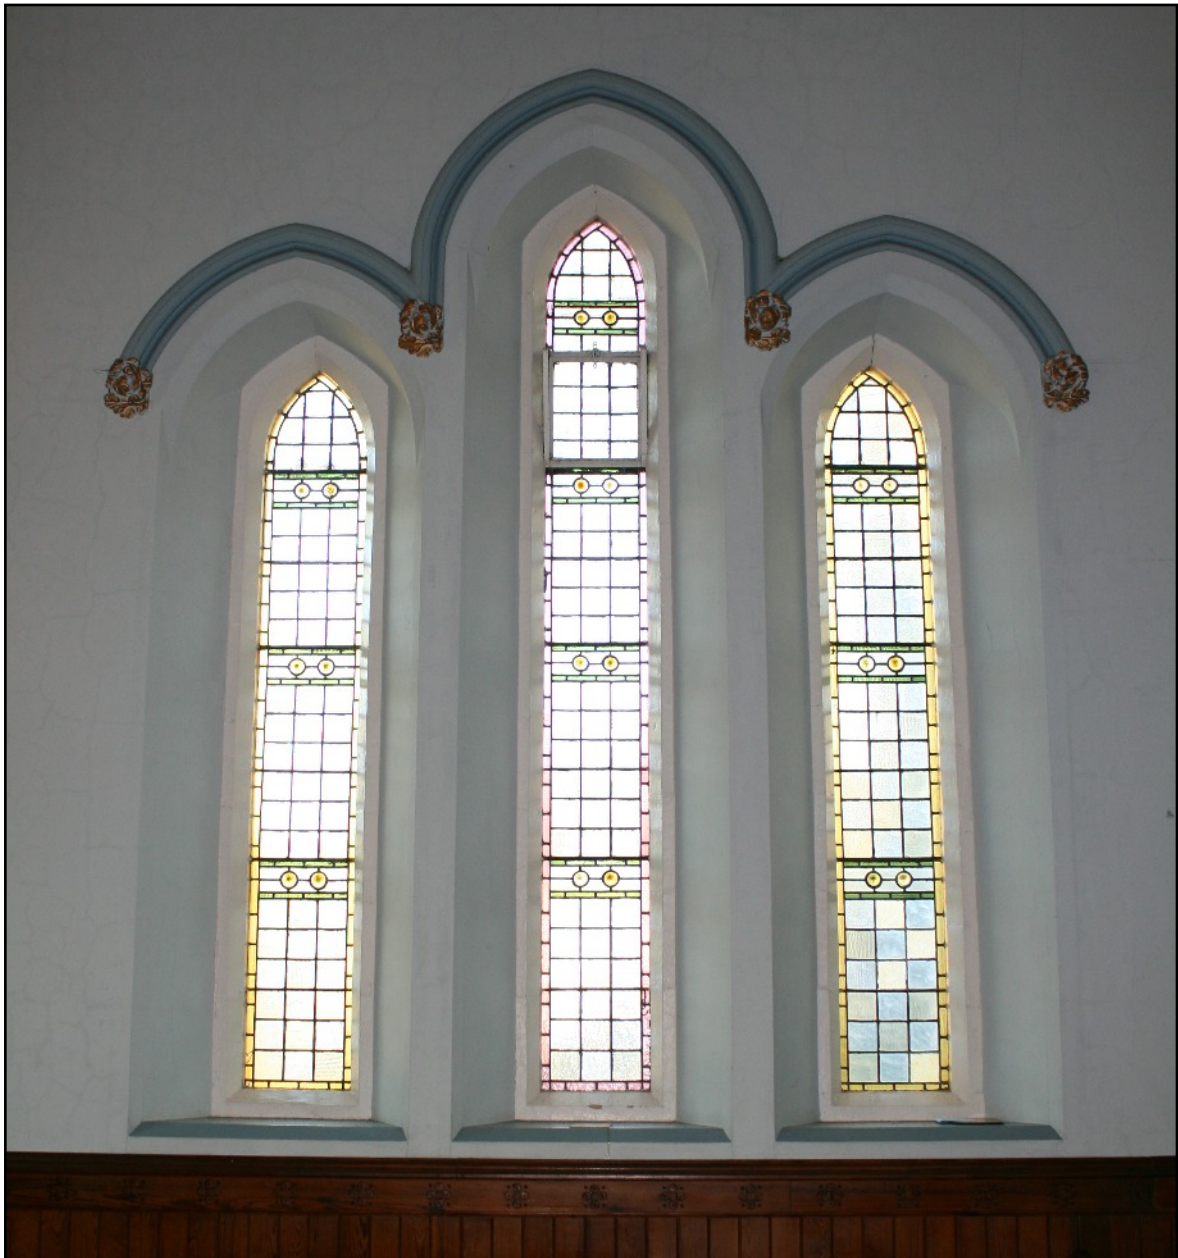
Plate 14: The lancet windows in the north gable wall, viewed looking north.
