Hermitage Mill, Hermitage Lane, Mansfield

Historic Building Record

Report Number: 077/2015

© Trent & Peak Archaeology

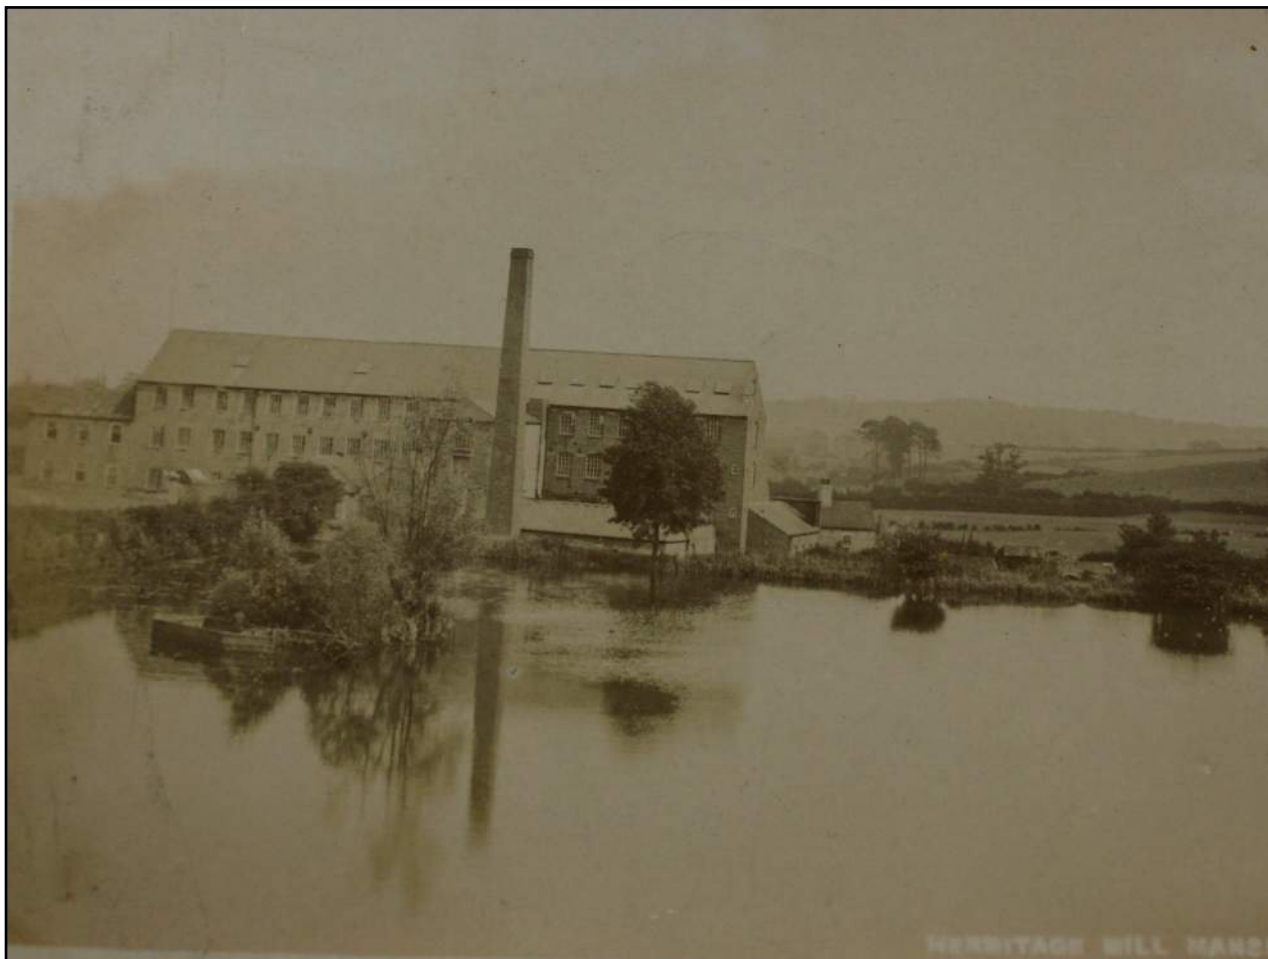
Plate 1: A photograph of the west elevation of Hermitage Mill viewed looking east taken before 1916.

3.1.6 A photograph taken before 1916 (Plates 1), collected by The Industrial Monuments Survey (1963, 1973), depicts the western elevation of the mill, looking east from across the mill pond. The photograph shows 3 clear building phases to the main mill building at that time. The original eighteenth century stone mill building in the centre can be seen to have three visible floors with a steeply pitched roof suggesting a possible fourth floor. To the south a brick extension mimics the mill's construction, adding extra space to all floors. By contrast, whilst the northern extension is built from stone, implying an earlier date, it is only two storeys in height. Also visible in the photograph are several outbuildings or extensions abutting the western elevation of the mill. The most notable of these is located close to the join between the stone and redbrick sections of the mill; aligned east-west, it is between 2 and 3 storeys high. To the south are two smaller single storey buildings, which are largely obscured by the Mill Pond undergrowth, with a further single storey structure, aligned north-south, running

parallel to the red brick portion of the mill building. The purpose or function of these smaller buildings is not clear, as is the case with the single storey lean-to extension propped against the southern elevation. Immediately behind the lean-to structure is what appears to be a small cottage, or at least a single storey extension with its own chimney stack. A large, freestanding, square industrial chimney, taller than the mill itself is located adjacent to the western elevation of the main building. The setting of the mill is completely rural with no further buildings visible of the site boundary.

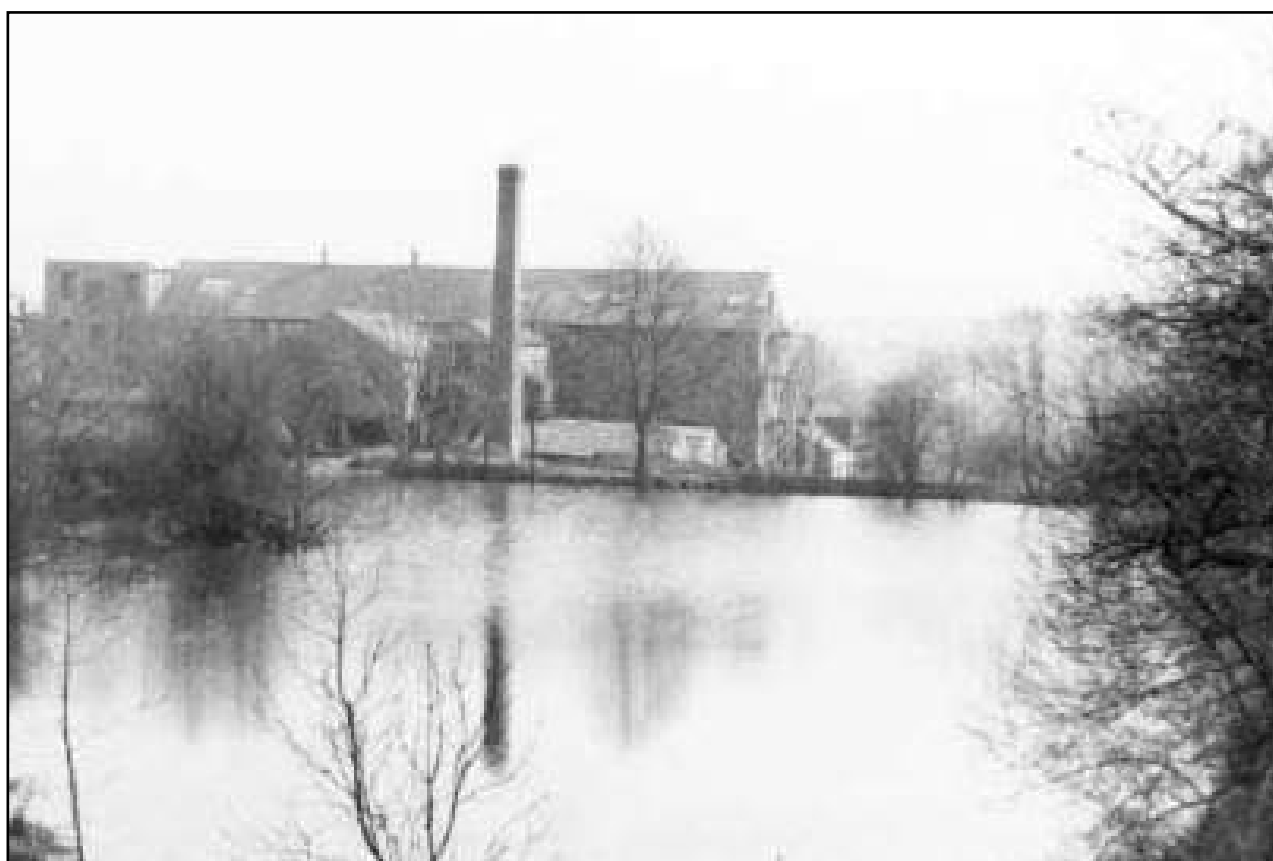
Plate 2: A photograph of the west elevation of Hermitage Mill viewed looking east taken in 1950.

3.1.7 A photograph recovered from Picture the Past photographic archives shows the mill shortly before it ceased operation in 1950 (Plate 2). Taken from a similar angle and distance as the older photograph recovered from Nottinghamshire Archives, the image shows that the two storey stone extension at the northern end of the structure has been extended to four storeys in height. Its roof is now flat, rather than pitched, with the fourth floor built along the same design as the three below. This resulted in large windows allowing far more light into the interior that had previously been possible where a pitched roof provided an additional functional storey. The design of the alterations is such that the lower floors from the original extension were retained. Additionally, the two smaller, single storey buildings abutting the western elevation have been replaced by a single, two storey extension.

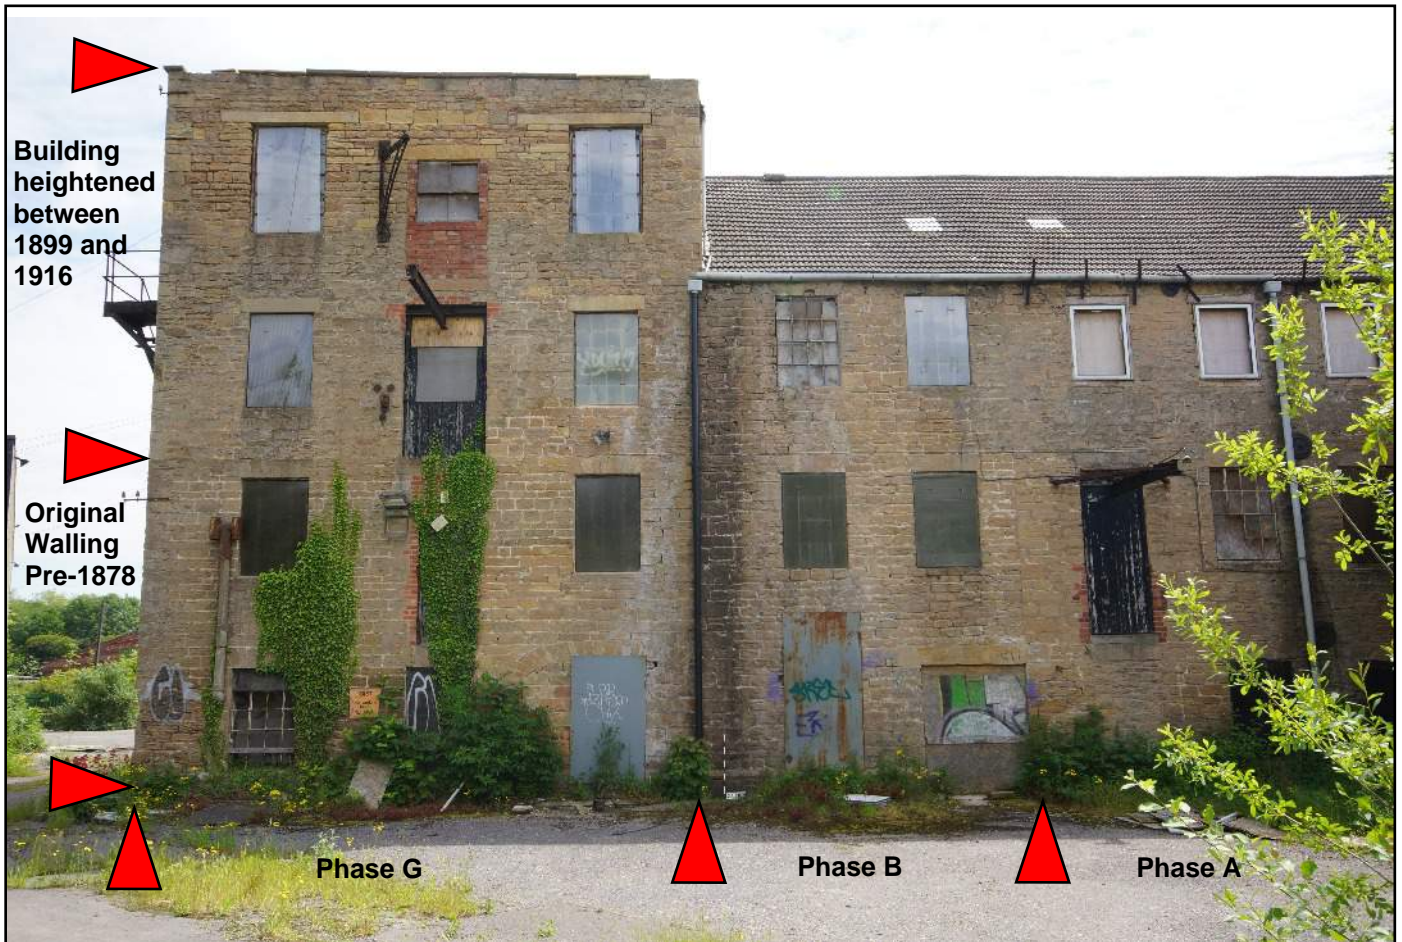
Plate 3: General view of the northern end of the western elevation, viewed looking east.

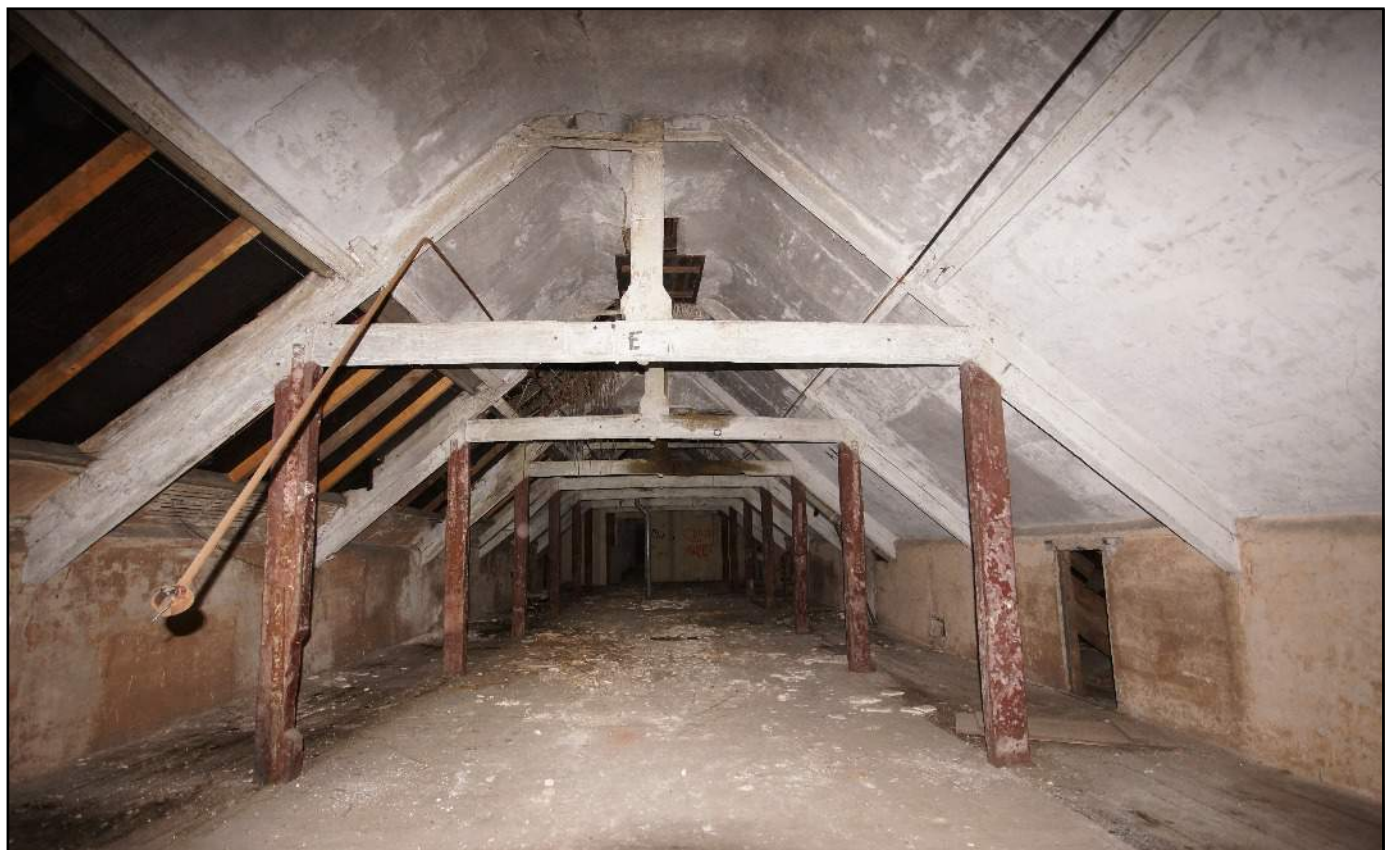
Plate 4: General view of the roof of Phase A, viewed looking south.

4.2.1 Internally the roof has nine softwood trusses each comprising a king post rising from a tie beam to plank ridge with staggered purlins trenched into the principal rafters which have a collar. The roof structure and floor has no evidence to suggest the presence of drive belts operating within the room and the floor boards have nothing to indicate former machinery. There are gaps in the timberwork of the ceiling on the eastern side of the roof which could be former skylights like the three visible on the eastern side of the roof shown on the pre-1916 photograph suggesting that the room may have been used for both sorting and storing cotton.

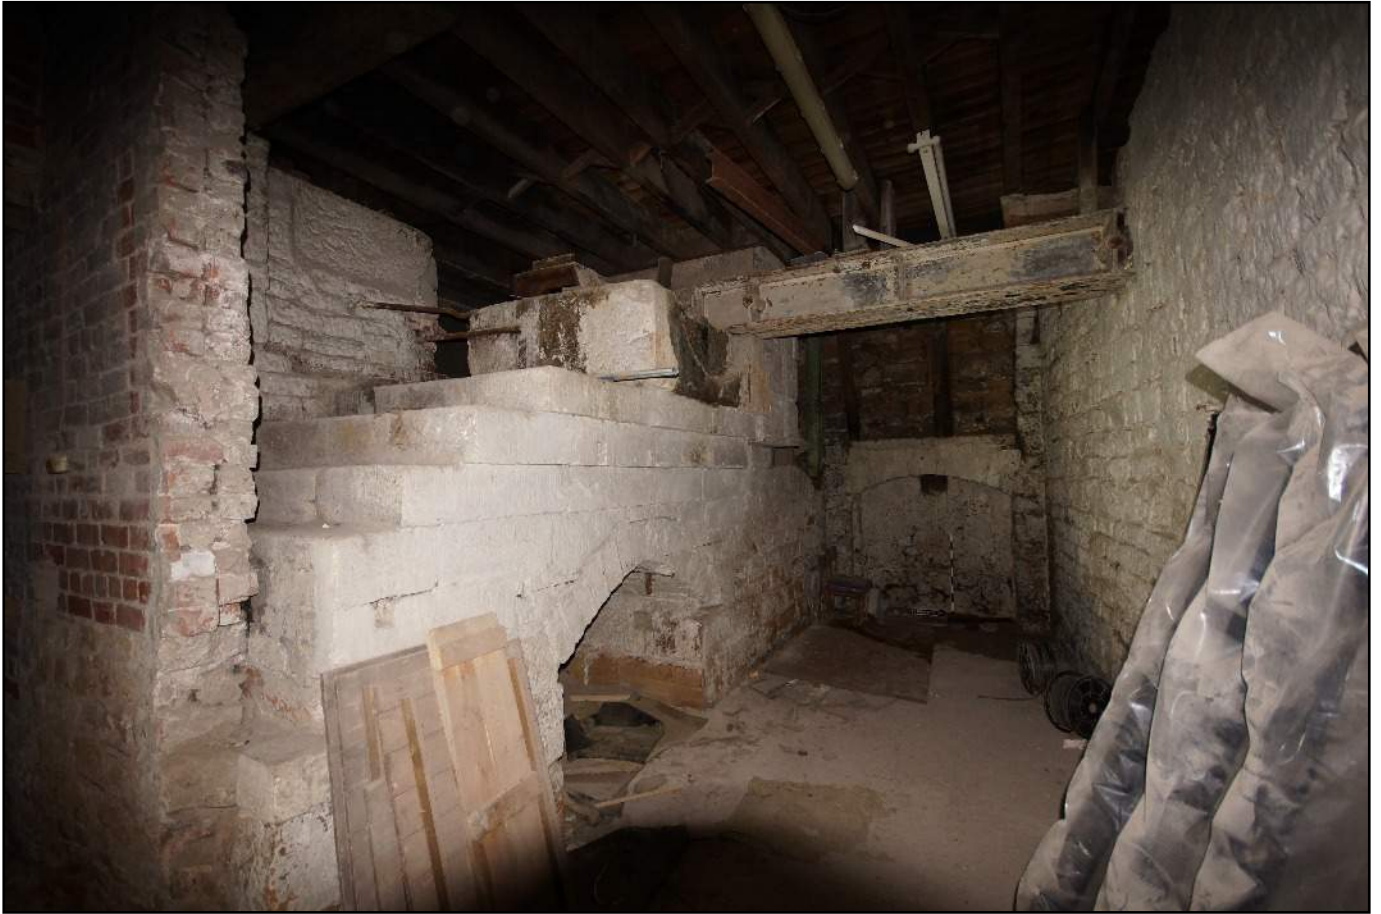
Plate 5: The wheel pit viewed looking south-west.

4.2.5 The lower ground floor comprises a west to east aligned wheel pit constructed in stone. It was designed for a single wheel powered by water emerging from the low archway in the west wall. The depth of the archway suggests that mill had an undershot waterwheel. The water originated in the mill pond to the west which fed the head leat that extended to the mill. Control of the flow of water would have been through sluice gates on the leat. The tail leat was located to the west of the waterwheel escaping through the former archways in the bases of the north, east and south wheel pit walls. To the south of the wheel pit is the contemporary stone structure housing the metal gearing mechanism, fragments of which survives. The layout of the wheel pit and the location of the gearing mechanism at Hermitage Mill is the same as that recorded in 1843 at Field Mill, also located on the River Maun.

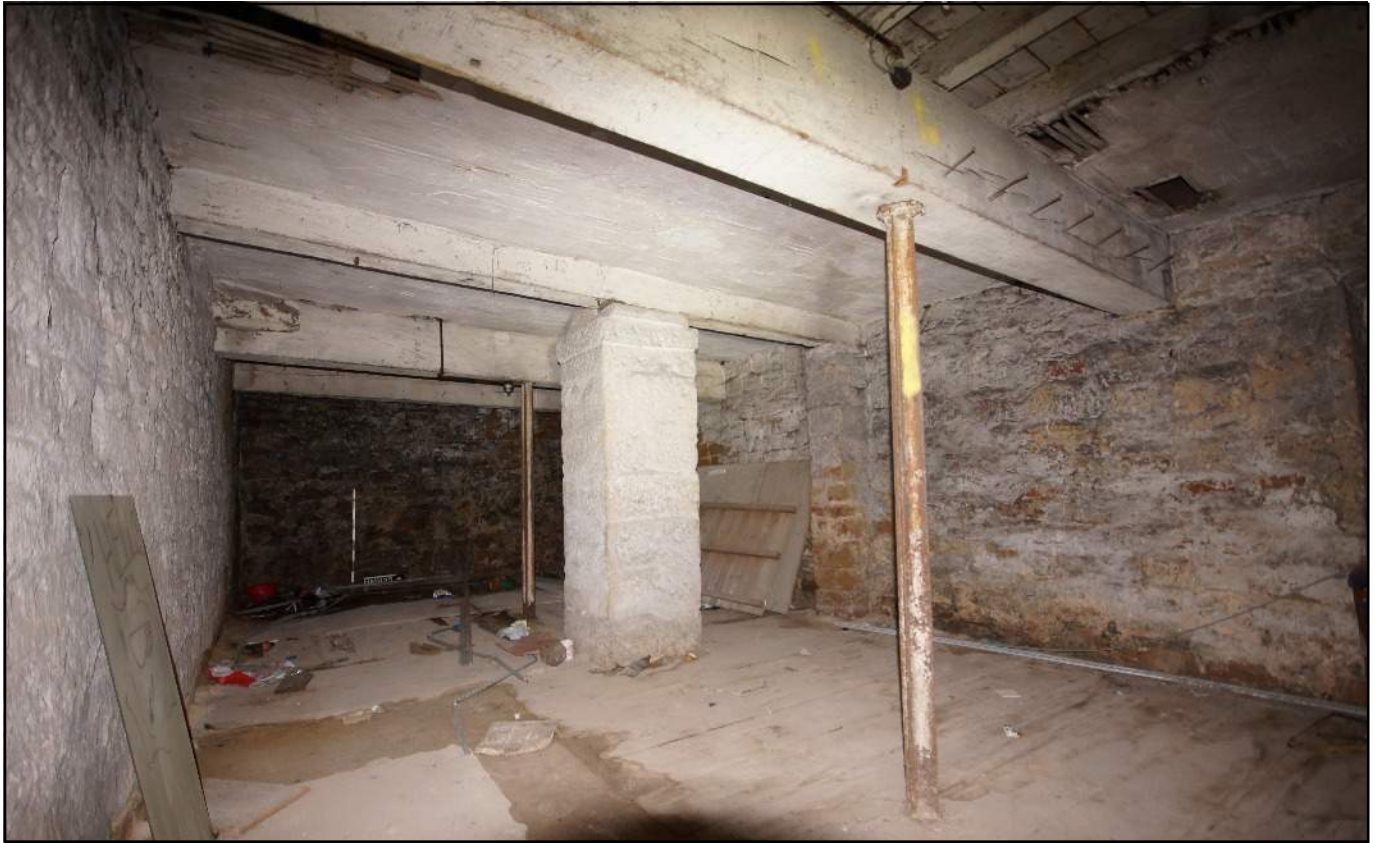
Plate 7: General view of the room to the north of the wheel pit, viewed looking north-west.

4.2.7 A room is present in the northern half of the lower ground floor, accessed via an inserted doorway, or enlarged window, in the north wall of wheel pit. It has a stone floor, partially covered in timber and whitewashed stone walls. A central pillar supports the ceiling above with additional support provided by a single Samson post. Baltic timber marks are present on a number of the ceiling beams though paint obscures much of the detail. In the north wall is a former window and in the east wall a former doorway. As with the wheel pit the stone walls and central pillar have been lowered for the floor above.

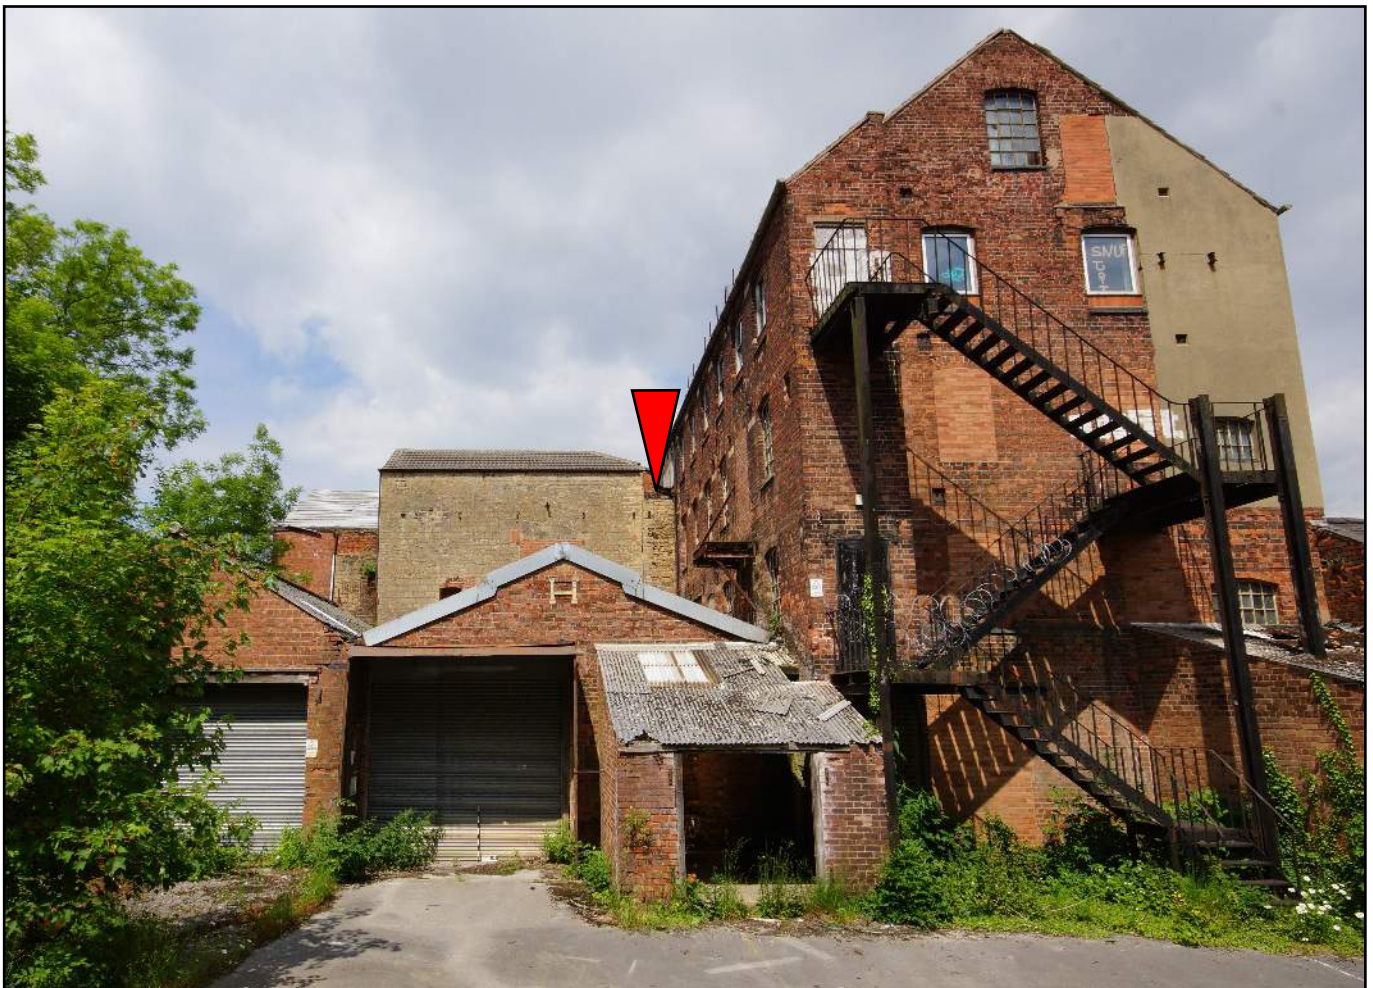
Plate 8: The mill from the south, the arrow indicating the location of the chimney possibly relating to Phase A, viewed looking north.

4.2.8 Of note to the south-west of the mill is a stone built square feature that extends to the eaves of the mill. It is abutted by the engine house (Phase C) and the brick extension to the mill (Phase E). There can be little doubt that it is a former chimney probably associated with a hot air heating system. Though the relationship between it and Phase A could not be established the two are likely to be contemporary as both are constructed in the same way using the same materials and pre-date the other building phases.

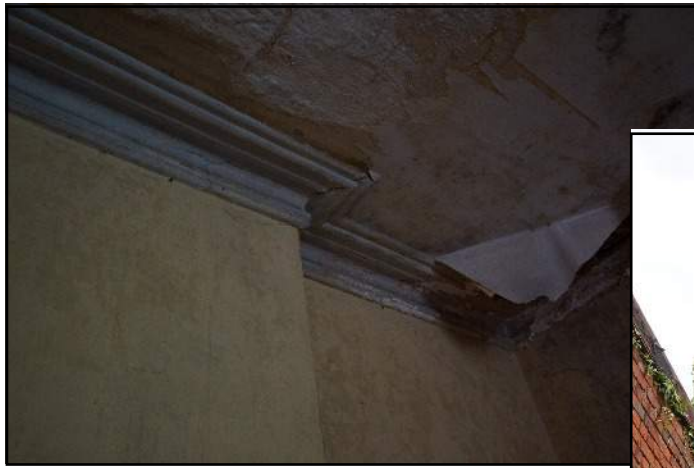
Plate 9: The cornice and wall paper in the first floor of Phase B.

4.3.1 The extension provided additional manufacturing space to the west of the centrally located staircase. Those rooms to the east were separated from the manufacturing side of the mill and were probably offices. The room on the first floor retained its decorative cornice and wallpaper indicating that this was a higher status room, possibly the managers office.

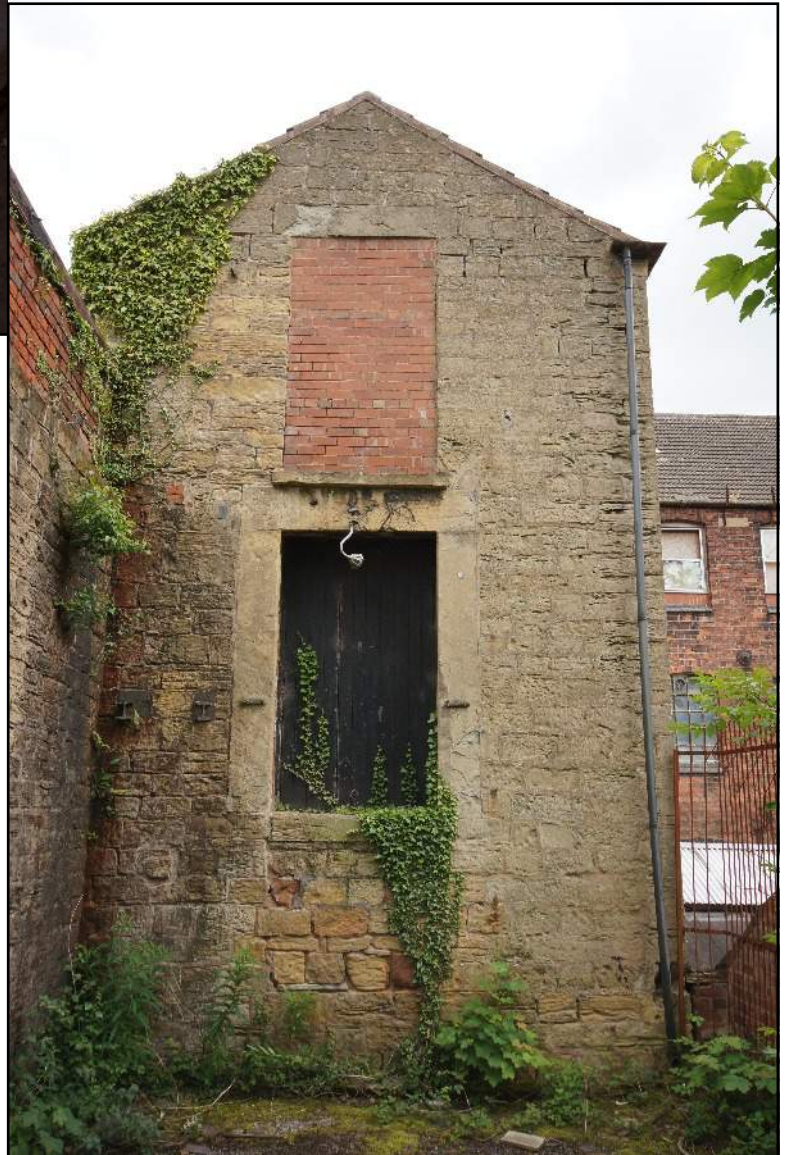
Plate 10: The west gable of the engine house, viewed looking east.

A stone built engine house was constructed to the south-west corner of the mill, probably replacing an earlier building associated with the chimney of Phase A. Again, this building is present on the 1878 Ordnance Survey map though it is likely to have been a relatively new building as waterwheels were still in operation on the river Maun as late as 1843 as demonstrated by the illustration produced that year of the wheel pit and gearing mechanism from Field Mill. It was originally a three storey building (lower ground floor, upper ground floor and first floor) of three trusses and four bays with a roof hipped to the east and gabled to the north, currently of concrete tiles. The south elevation has the roof line of a former building and a large doorway, which appeared to be a later insertion, blocked with brick. Two doorways are present in the west elevation, the upper one also blocked with the brick and the lower one closed with a timber shutter.

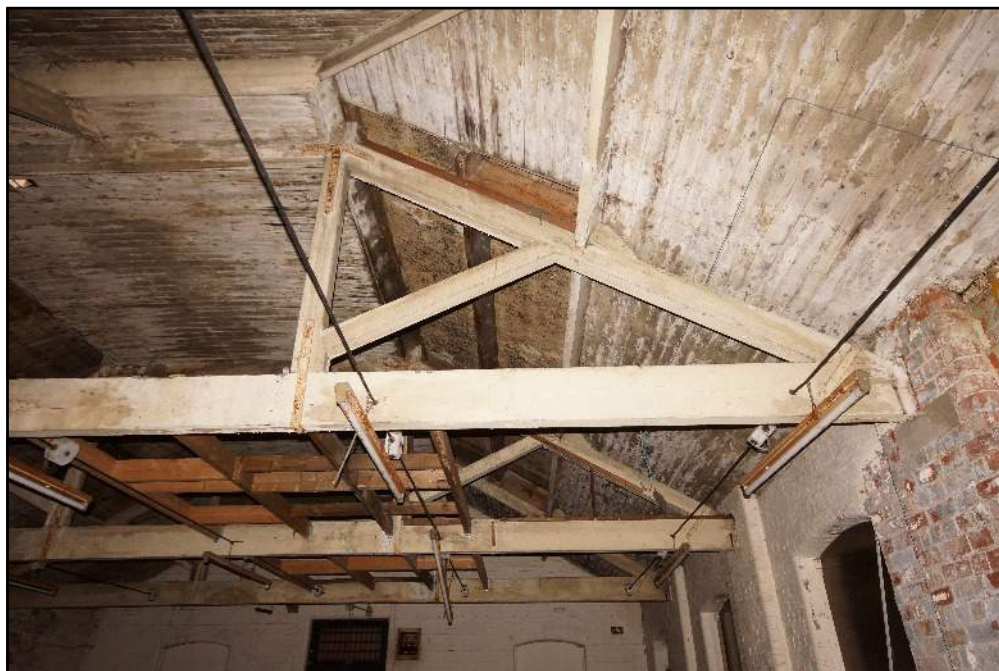
Plate 11: The roof over Phase D viewed looking south-west.

4.5.1 The building is of four bays with three queen strut trusses. Straight struts rise from the queen struts to the principal rafters which have back purlins on cleats. Due to an unsafe flooring this phase of the building could not be safely entered.

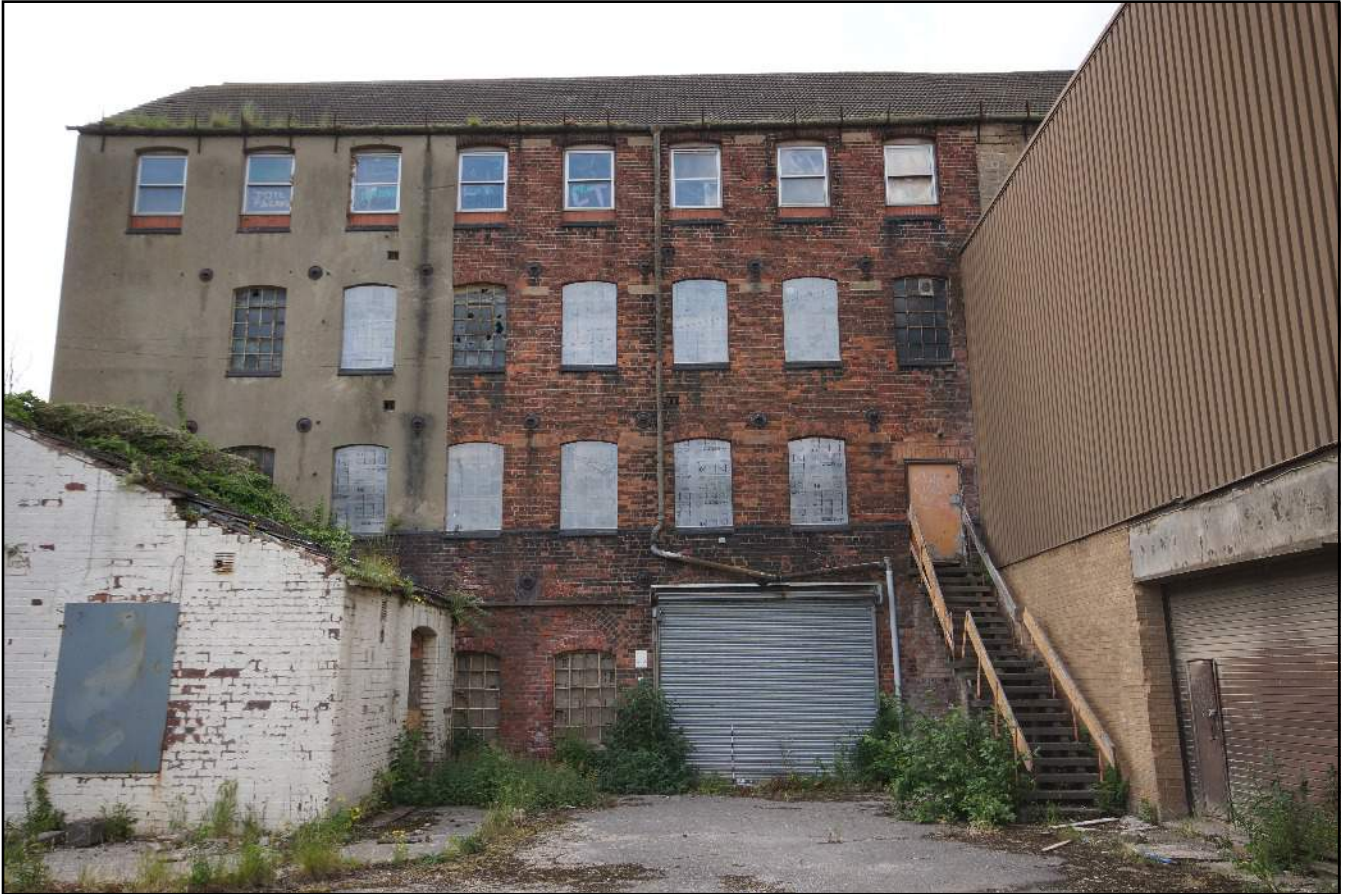
Plate 12: The southern brick extension Phase E viewed looking west. Note that the mill is abutted by the sub-station Phase H, the white brick building on the left and the modern shed Phase M.

The mill was extended in brick to the south prior to 1878. This addition comprises eight bays. It is brick built and of three storeys plus a basement (a lower ground floor, upper ground floor, first floor, second floor and third floor/roof space). The segmental windows of the first three floors retain many of their original cast iron glazing bars, the second floor windows have all been partially infilled and modern glazing inserted. An upper ground floor window on of the west elevation and a first floor window of the east elevation have been converted into doorways. As with other phases of the mill a number of the windows have been infilled with brick in recent years to prevent vandals entering the building. The gabled roof is of concrete tiles.

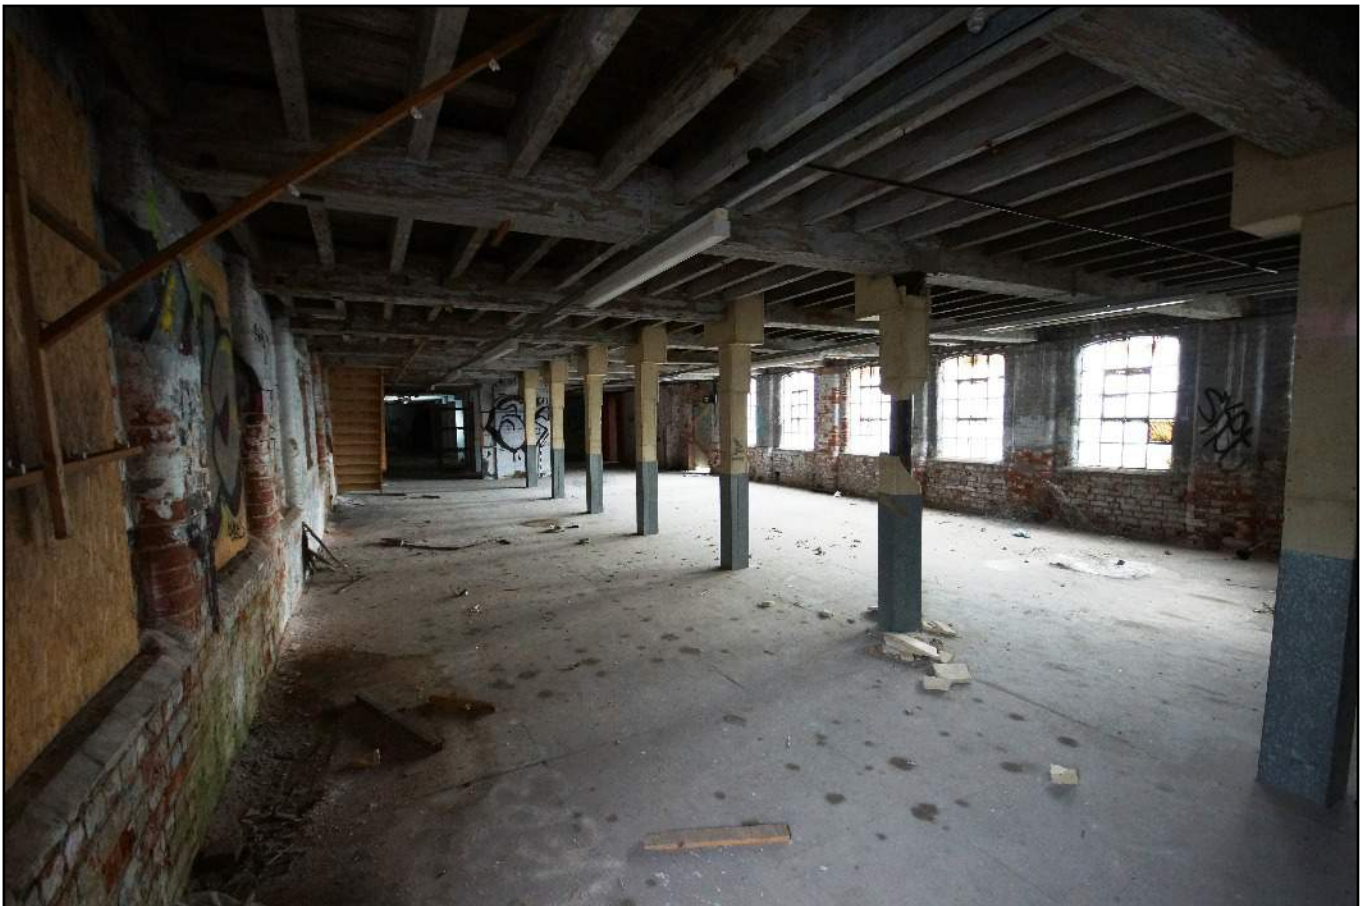
Plate 13: The upper ground floor of Phase E, viewed looking north-east.

4.6.4 As with the floor above, the original Samson posts of the upper ground floor have been replaced. The floor-beams have non-structural timbers present for the suspension of a drive belt indicating that processing machinery was positioned down the eastern side of the room, if not the western side also. A number of the floor-beams have Baltic timber marks.

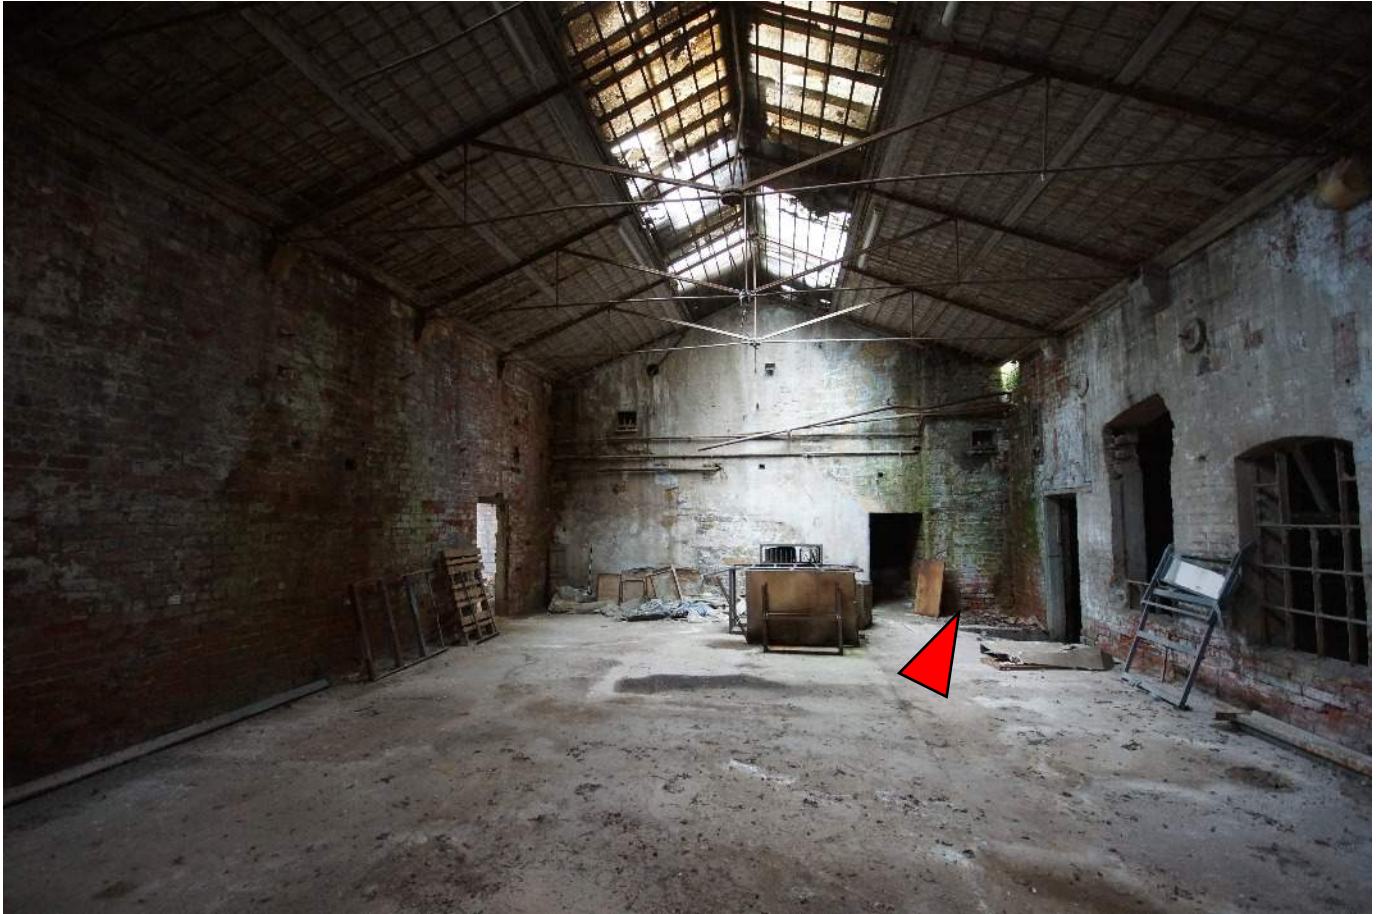
Plate 14: The interior of the boiler house, Phase F, viewed looking north. Note the earlier chimney highlighted by the arrow in the right hand corner of the room which is abutted by the wall of the engine house Phase C and the wall of the mill Phase E.

4.7.1 Phase F has been interpreted by the Germane Properties Survey as the former boiler house. Cartographic analysis indicates that it was built between 1878 and 1899. It is a brick built with a gabled roof. A large modern entrance has been inserted into its south gable wall. Internally it is of six bays with five metal trusses which rest on stone corbels. No original fixtures or fittings are present. The brickwork of the building clearly abuts the stonework of the engine house (Phase C) and walling of the mill (Phase E).

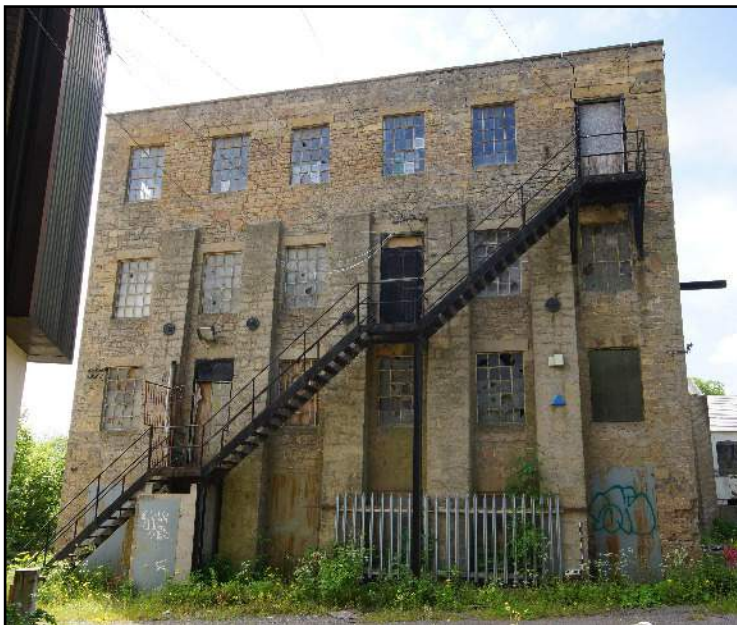
Plate 15: The north elevation of Phase G, viewed looking south.

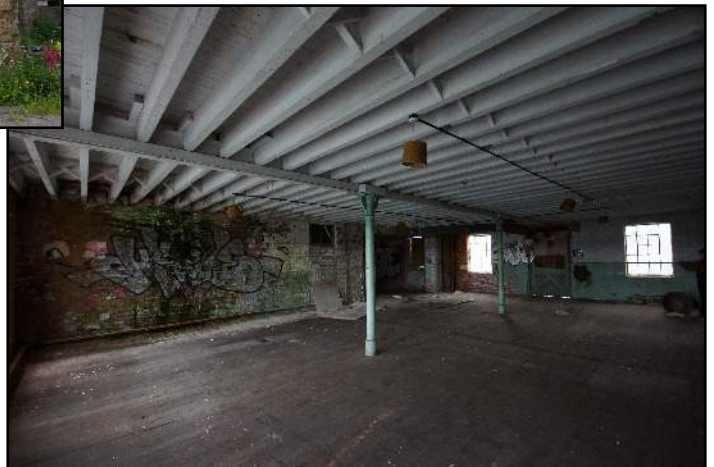
Plate 16: General view of the second floor of Phase G, viewed looking south-west.

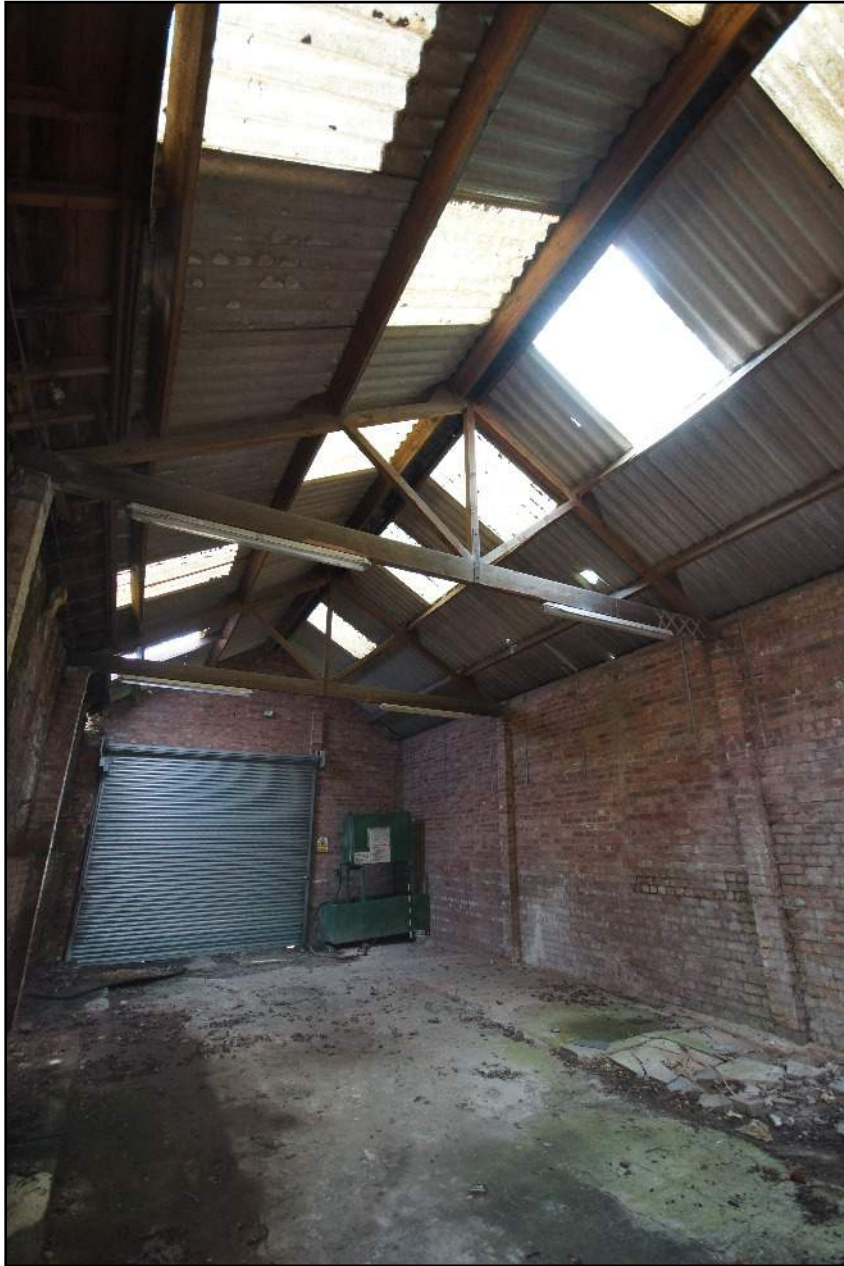
Plate 17: The interior of the Phase I, viewed looking south-west.
