Hermitage Mill, Hermitage Lane, Mansfield

Historic Building Record

Report Number: 077/2015

© Trent & Peak Archaeology

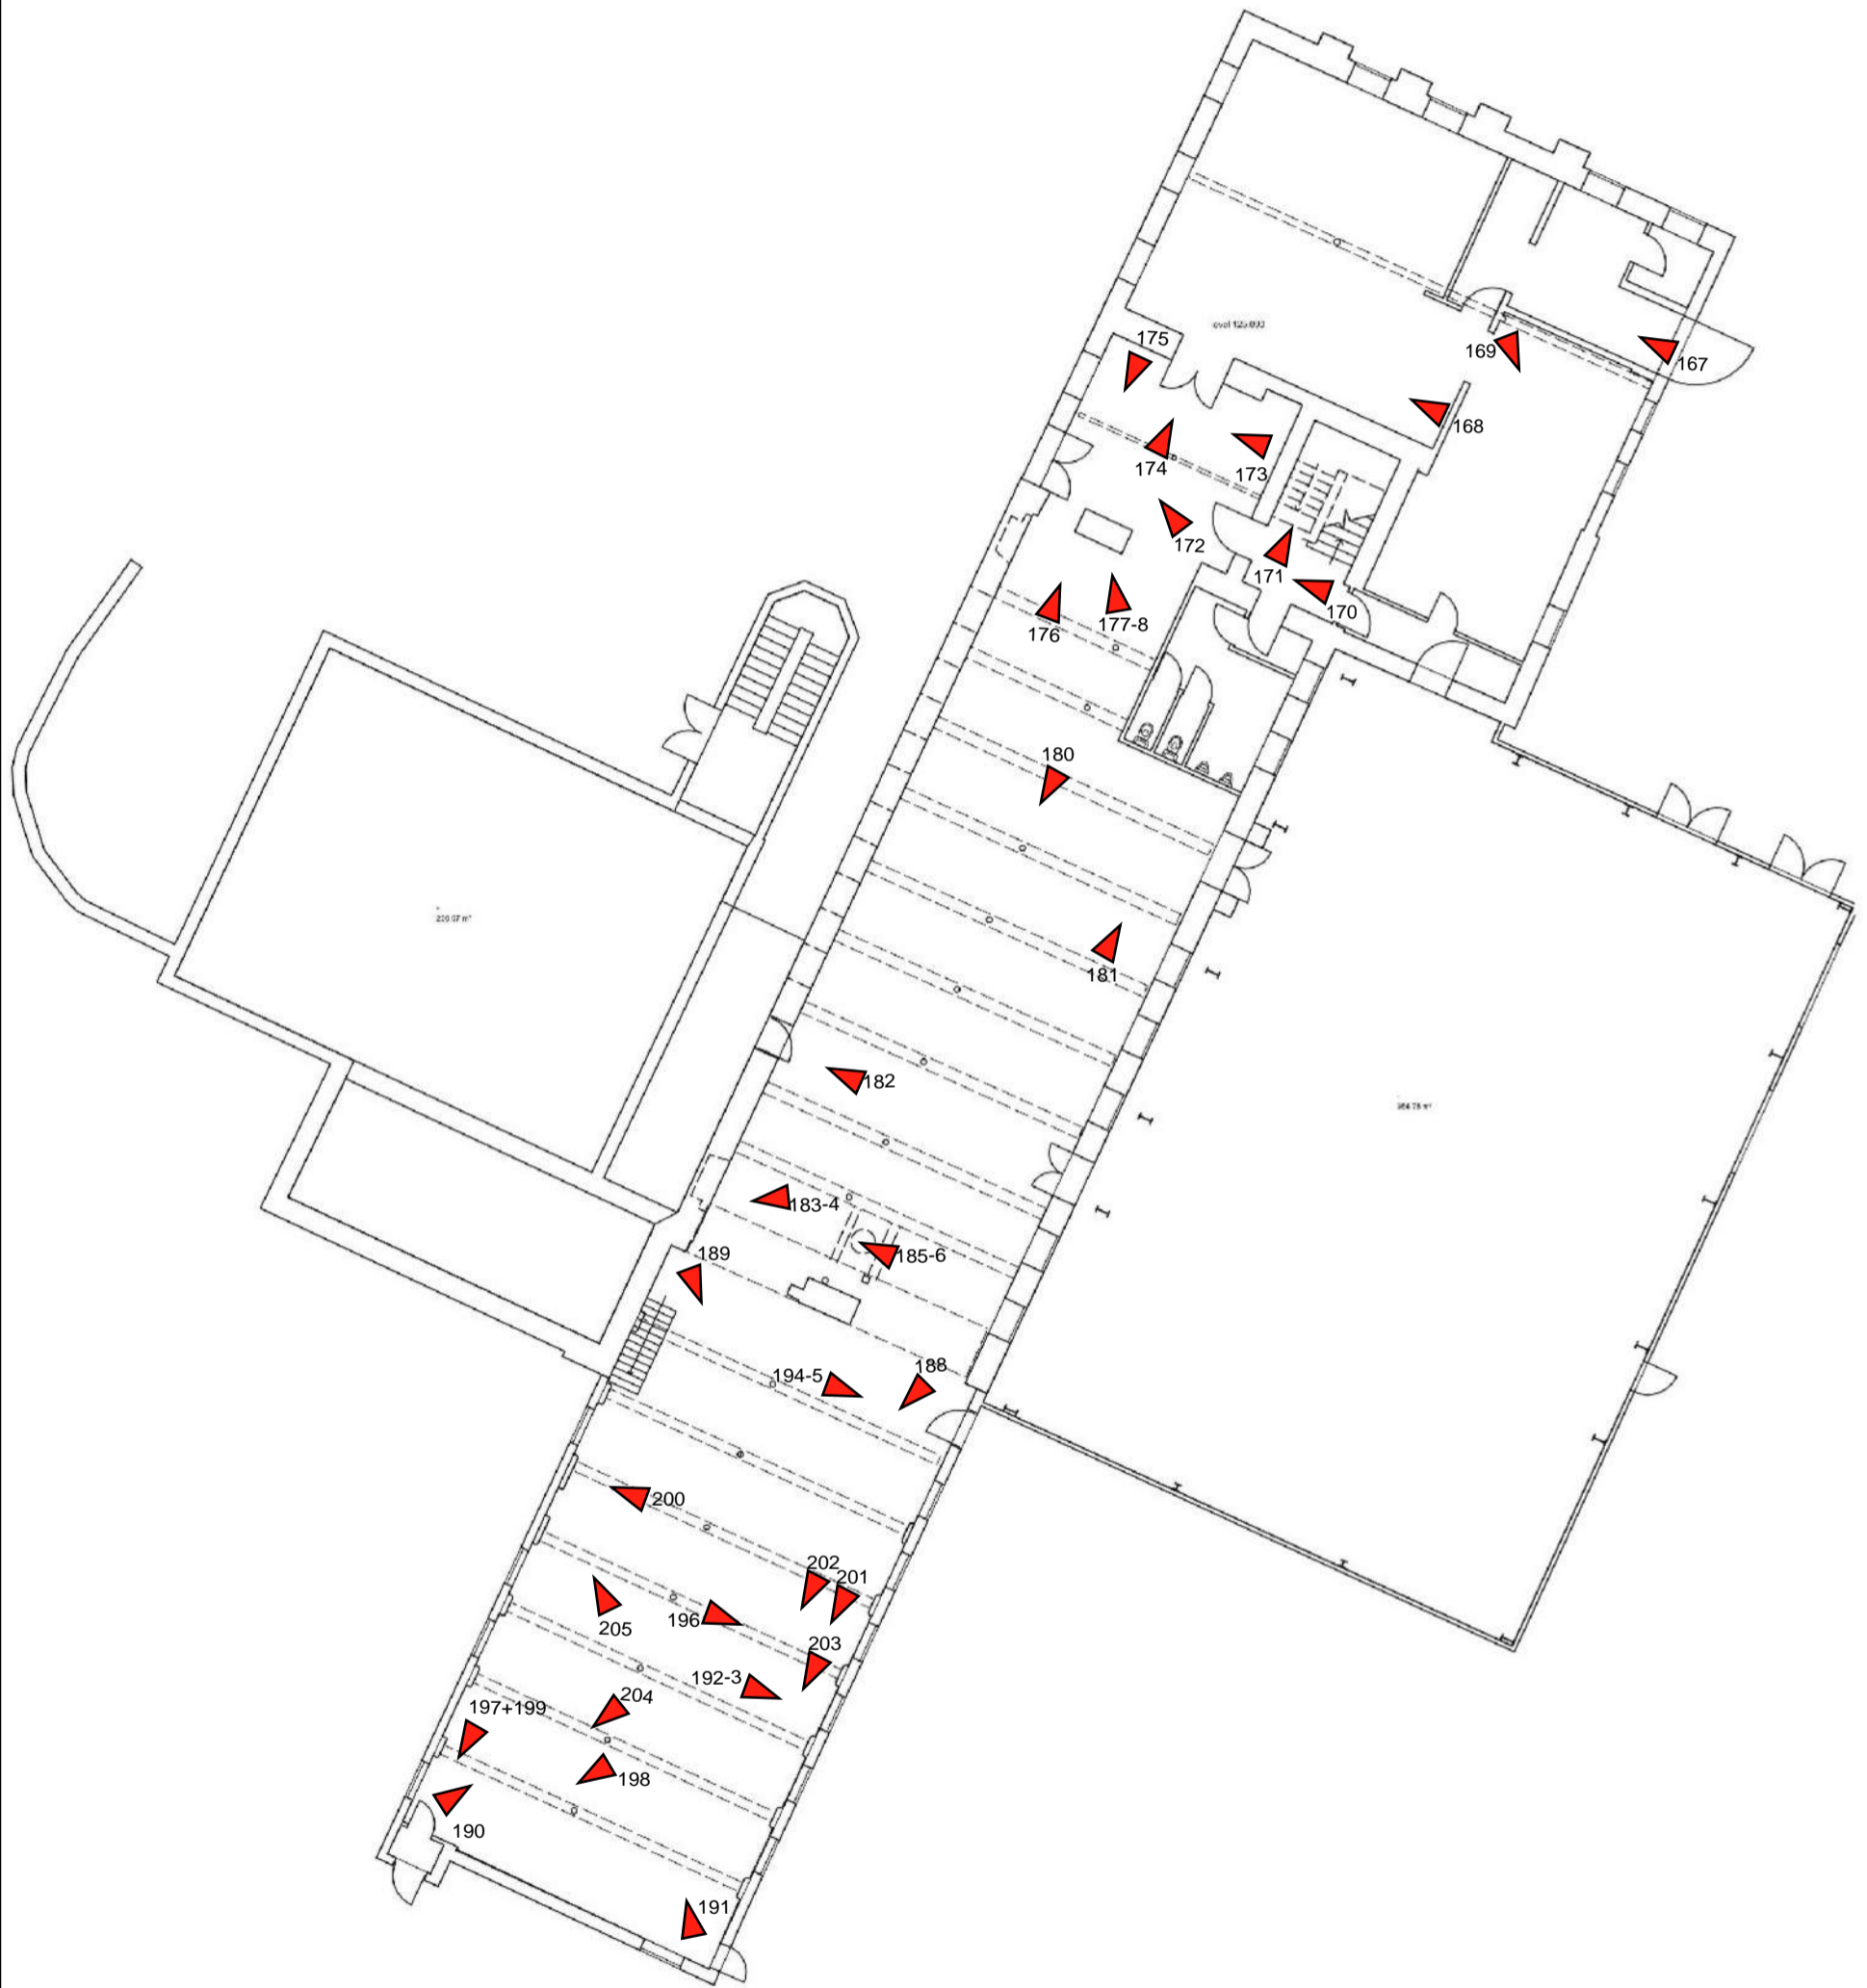
Figure 12: Plan of the existing upper ground floor with the photographic viewpoints indicated, based on a drawing provided by the client. Scale 1:200 at A3.

Phase A comprises the central 10 bays of the former mill. It is stone built and of three storeys plus a basement (a lower ground floor, upper ground floor, first floor, second floor and third floor/roof space). The windows of the east elevation have three piece lintels with a flush keystone in contrast to those on the west elevation which have plain stone cills and lintels, the second floor windows are replacements with concrete lintels. All the upper ground floor and first floor windows of the east elevation have been blocked with modern bricks. On the west elevation one window on the first floor has been converted into a doorway to enable material to be winched to and from the ground floor. The frame of the hoist survives which appears to be twentieth century in date. A number of cast iron glazing bar windows of like late nineteenth or early twentieth century survive. The roof is of concrete tiles.

4.2.4 As with the floor above, the original Samson posts of the upper ground floor have been replaced by ones encased in concrete. A trap door is located in the ceiling in the southern part of the room where the processed goods could have been lowered from above. The northern part of the floor is of stone suggesting that textiles were dyed in this part of the building. The southern half of the floor, which is located above the wheel pit in the lower ground floor, is a later insertion dating to when the waterwheel was decommissioned and removed (see below). It is constructed of timber planks overlaid with modern tiles and so it cannot be ascertained with certainty whether machinery was present in this part of the building. The ceiling beams above however have no evidence suggesting the presence of former drive belts indicating that this part of the mill was possibly used to store the woven textiles prior to dyeing.

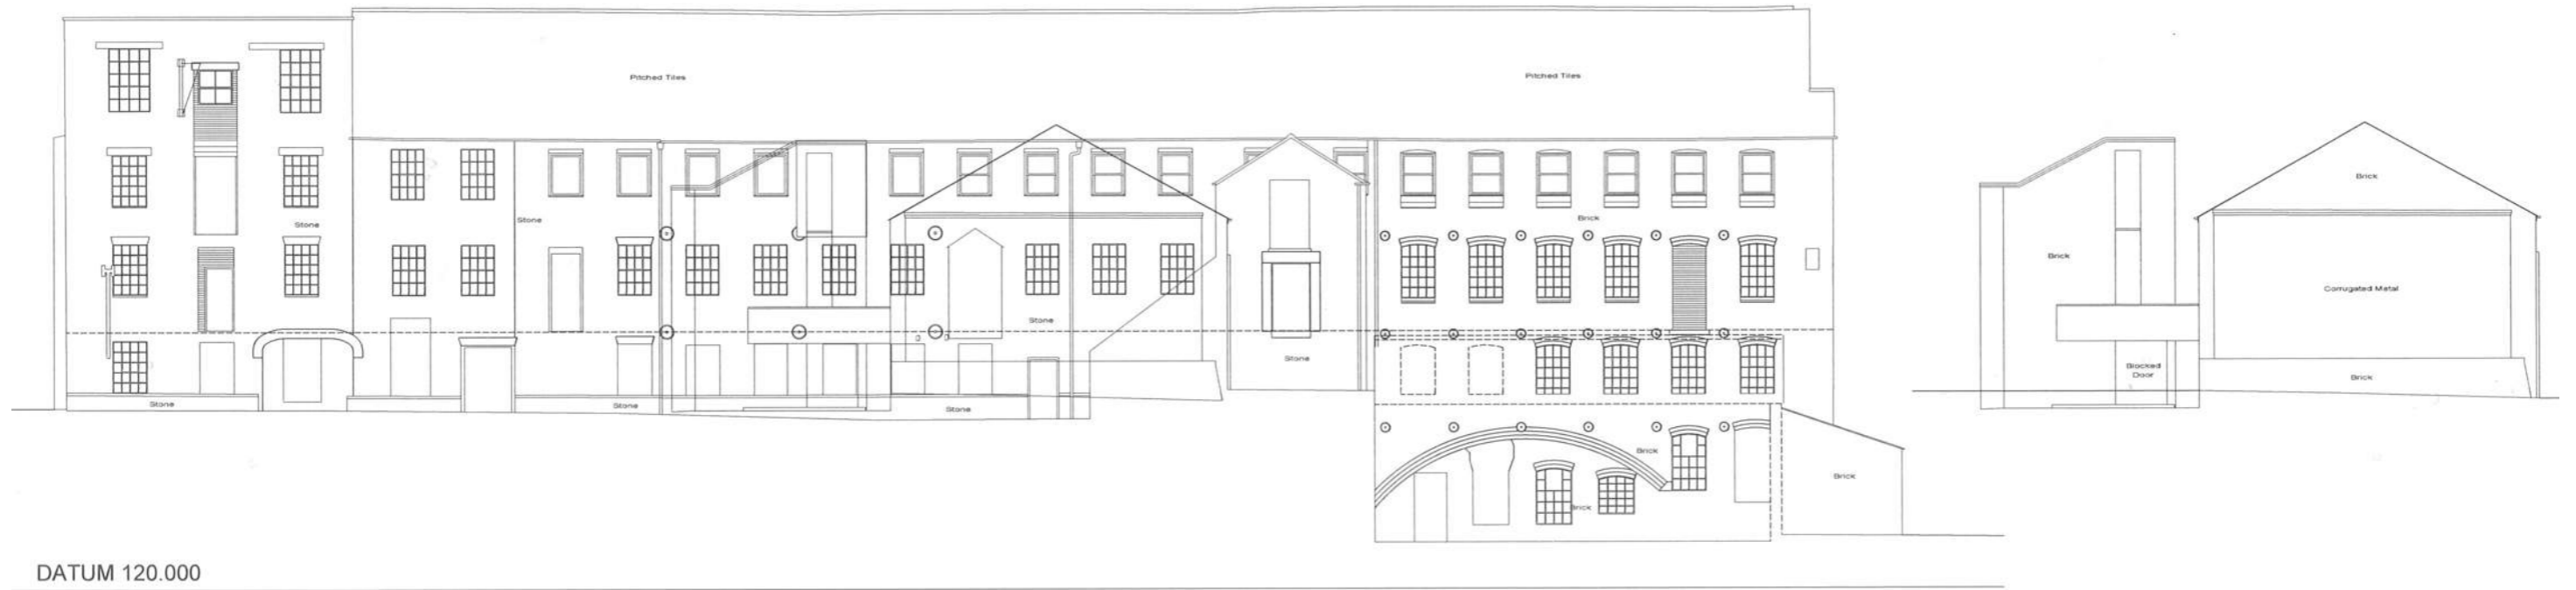
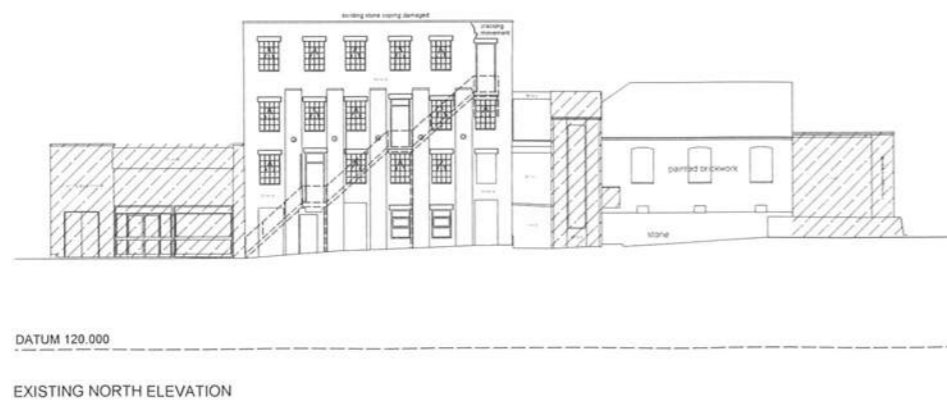
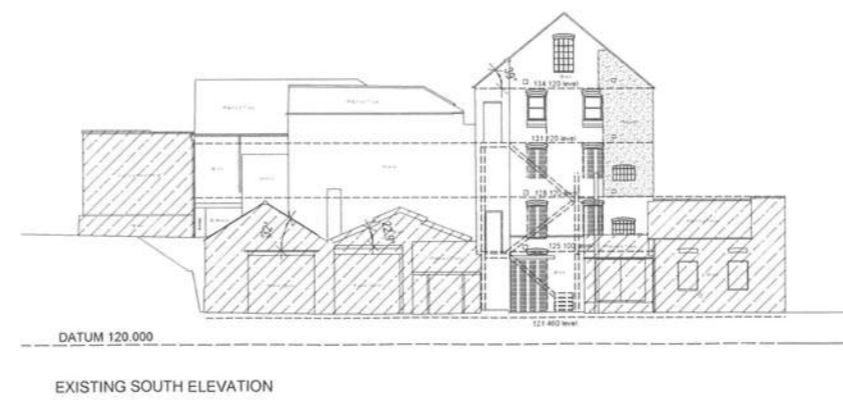
Figure 17: Elevations of Hermitage Mill based on drawings provided by the client. Scale 1:200 at A3.

EXISTING WEST ELEVATION

EXISTING NORTH ELEVATION

EXISTING SOUTH ELEVATION
