# An Archaeological Watching Brief at St Michael and All Angels Church Appleby Magna, Leicestershire

**For Peter Rogan Associates**

Report Number: 106/2016

TPA Project Code: AML

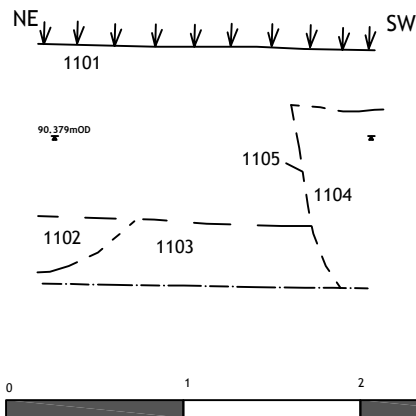
Figure 5. North west facing section of Area 11.

- 1101 Topsoil - mid brown silty loam
- 1102 Yellowish brown sandy silt
- 1103 Solid red clay with blue limestone inclusions
- 1104 Fill of possible grave - mixed elements of 1101 and 1103
- 1105 Cut of possible grave

- 5.39 A soakaway 2m x 2m x 1.3m was hand excavated. The soakaway had been previously excavated as part of the 1975 drainage works.
- 5.40 At the south west edge of the excavation a possible grave cut, 1104, was observed the base of which extended below the limit of the excavation. There was no disturbance to the possible intact burial that may have been contained in the grave.
- 5.41 At the north east extent of the excavation a quantity of disarticulated human bone was recovered. The human remains were left with the church authorities for reburial.
- 5.42 The most likely explanation for the presence of disarticulated human remains is that they were included in the backfill of the 1975 excavation.

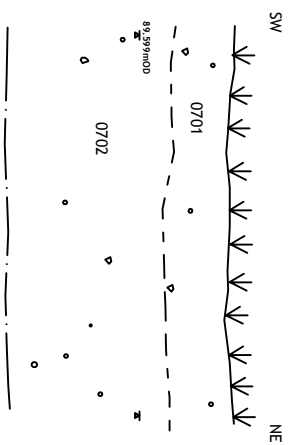
Figure 7. Area 07 Representative north west facing section.

0701 Topsoil - dark brown grey sandy silt with occasional rounded and angular pebbles.  
0702 Mid brown sandy silt with occasional rounded and angular pebbles.

- 5.33 Drainage trench, Area 07 was hand excavated along the line of an existing drainage trench with an average depth of 450mm and width of 350mm. Only the backfill of the original trench was removed exposing the ceramic pipe work that had been laid in it as part of the 1975 drainage works.
- 5.34 A small quantity of disarticulated human remains were removed from the excavated backfill and left with the church authorities for reburial.
- 5.35 The most likely explanation for the presence of the disarticulated remains is that they were included in the original backfill of the 1975 trench.

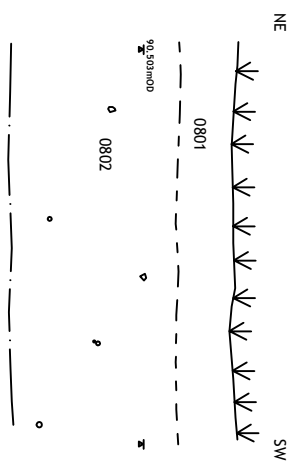
Figure 8. Area 08 Representative south east facing section.

0801 Topsoil dark grey sandy silt.  
0802 Mid brown sandy silt with occasional small rounded and angular pebbles.

- 5.36 Drainage trench Area 08 was hand excavated along the line of an existing drainage trench with an average depth of 450mm and width of 350mm. Only the backfill of the original trench was removed exposing the ceramic pipe that had been laid as part of the 1975 drainage works.
- 5.37 A small quantity of disarticulated human remains were removed from the excavated backfill and left with the church authorities for reburial.
- 5.38 The most likely explanation for the presence of the disarticulated remains is that they were included in the original backfill of the 1975 trench.

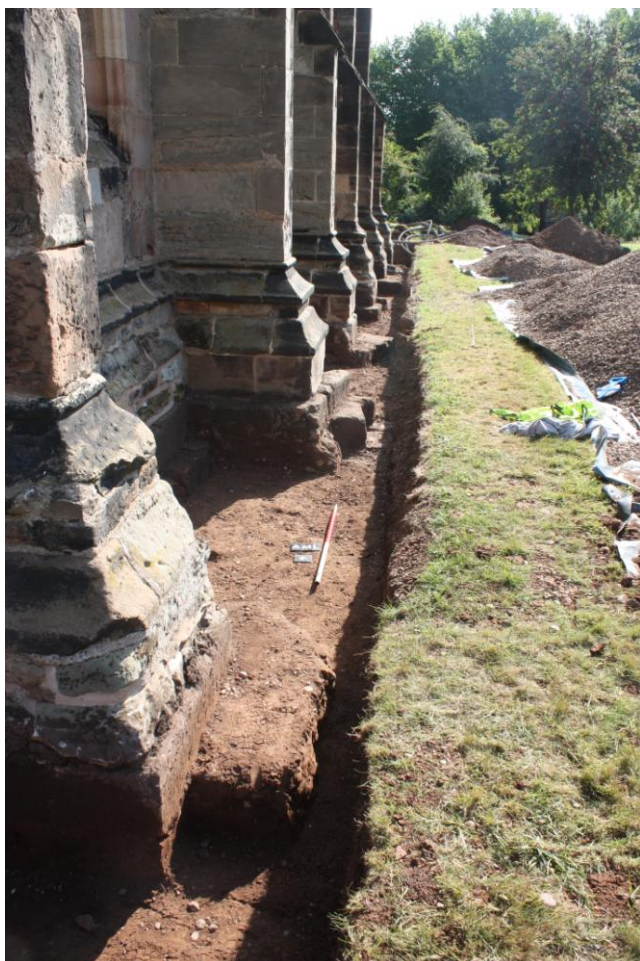
Plate 4. Area 01. View along south facing wall of south aisle after excavation. Looking east.

- 5.2 A trench was hand excavated along the entire length of Area 01 to an average depth of 450mm from the modern ground surface. The excavation of Area 01 followed the course of the excavation carried out in the 1975 refurbishment.

- 5.3 The buttresses along the south wall, Area 01, formed five bays and the foundations of them were partially revealed along with the foundations of the wall itself.

- 5.4 The foundation courses were substantial comprising undressed masonry with large slabs underpinning the six buttresses. The ground to the south of Area 01 slopes marked to the south and the substantial foundations were probably employed to prevent slippage of the wall.

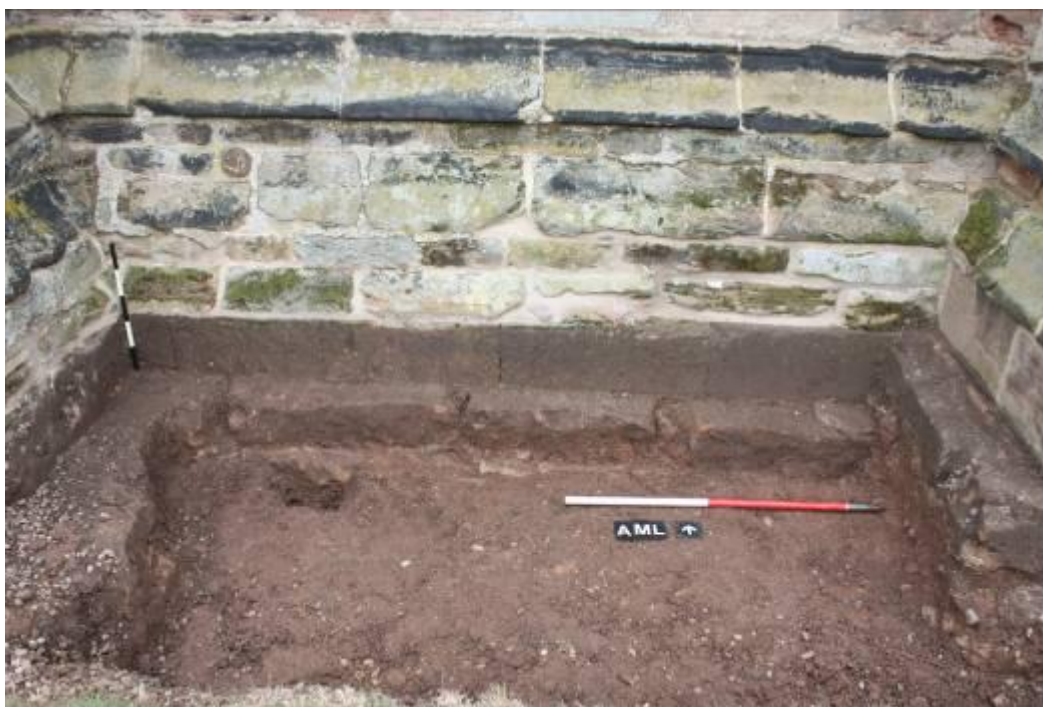
Plate 5. Area 01. Detail of excavation along the south of the church showing exposed foundations. Looking north.

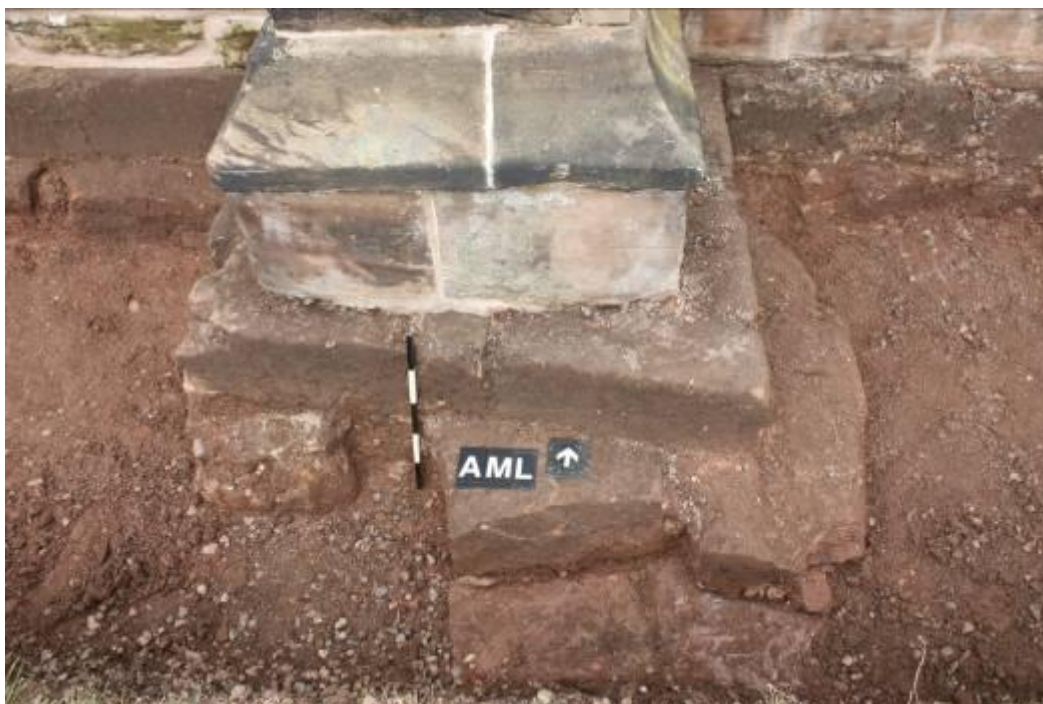
Plate 6. Area 01. Two slabs protruding from beneath the foundation of the buttress. The south porch is believed to have been situated in the bay to the left of the buttress. Looking north.

- 5.5 The buttress between bay 2 and bay 3 appears to lie on the eastern foundation of the demolished south porch. Protruding from the base of the buttress were two flat slabs. These were observed in the base of the current excavation and roughly correspond to the observation made by Parsons in 1975 (Plate 6 and 7). The buttress itself appears to be more recent than the others being noticeably less affected by the elements. There was no sign of the possible grave reported by Parsons but this may be accounted for by the fact that the current excavation did not penetrate as deeply as that in 1975 in which a depth of 1m was recorded as opposed to 450mm in the excavation in 2016.

- 6.3 Possible remains of the demolished south porch were observed in Area 01. These took the form of two flat slabs that extended from the third buttress from the western corner of the south facing wall of the south aisle to beyond the limit of the excavation. There were no finds associated with these slabs which would assist in establishing a date for them.

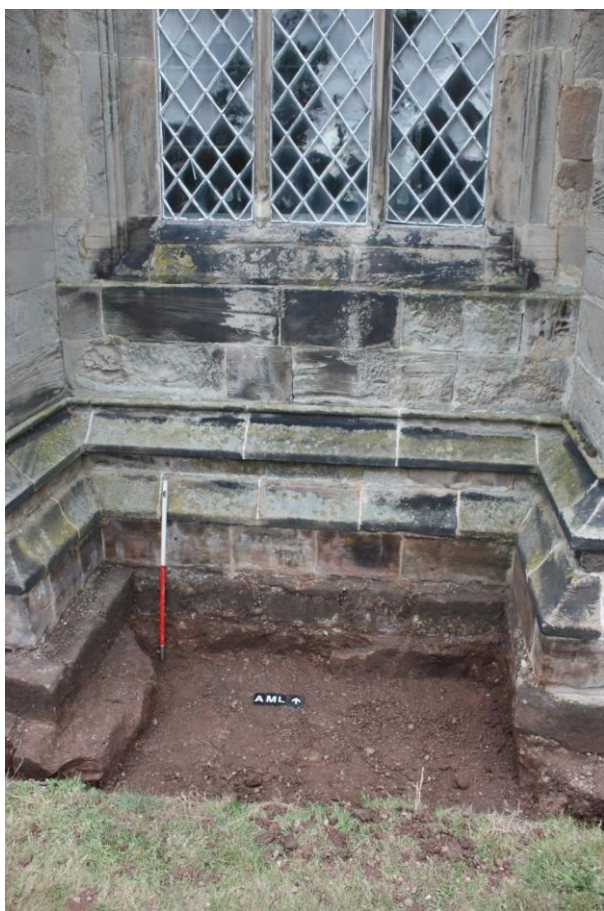
Plate 7. Area 01. South facing wall at the location of the now demolished south porch. Looking north.

- 5.6 The demolished south porch appears to have occupied most of what now comprises bay 2 of the south wall. Whilst this cannot be clearly observed from the outside of the church, inside, where plaster has been removed from the wall brickwork blocking can be observed in the space corresponding to bay 2 (Plate 8).

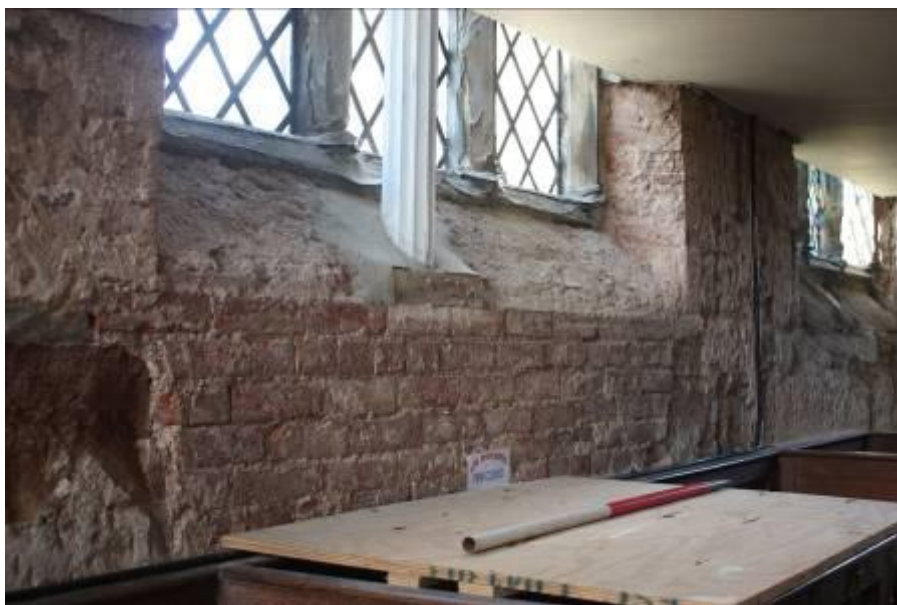
Plate 8. Area 01. Interior of the church showing the bricked up entrance of the south porch. Looking south west.

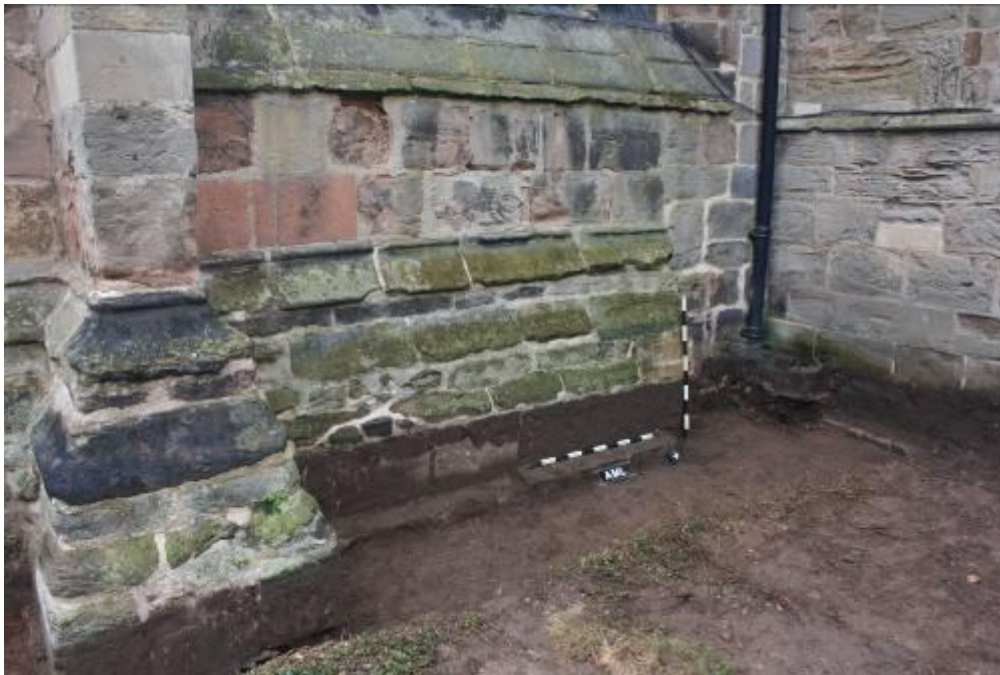
Plate 9. Area 02 showing exposed foundations. Looking north west.

- 5.8 A trench was hand excavated along the entire length of Area 02, 6.7m, to an average depth of 450mm from the modern ground surface. The excavation of Area 02 followed course of the excavation carried out in the 1975 refurbishment.
- 5.9 This revealed the foundation course of the wall which compares with the observations made in Area 01 and suggests that the two are contemporary (Plate 09).
- 5.10 A small quantity of disarticulated human bone was recovered from the back fill of the 1975 excavation comprising incomplete long bones and fragments of skull. These were removed and stored in the church for the church authorities to make such arrangements for their reburial as deemed by them to be appropriate. There were no artefacts recovered that

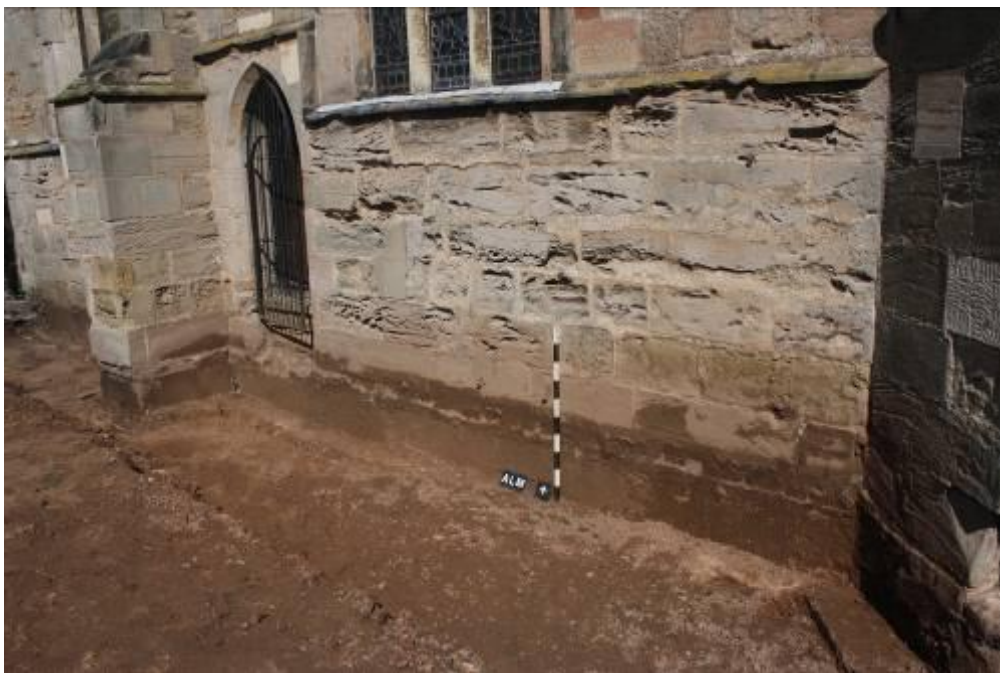
Plate 10. Area 03 showing top of foundation. Looking north west.

- 5.11 A trench was hand excavated along the entire length of Area 03, 10.9m, to an average depth of 450mm. The excavation of Area 03 is situated along the south facing wall of the chancel which had not been disturbed during the 1975 excavation.
- 5.12 The excavation revealed the lower and foundation courses of the wall. These comprised well dressed masonry blocks, 300mm in depth below which were undressed blocks only the surface of which were exposed, Plate 10.
- 5.13 There were no artefacts recovered that would help in establishing a date range for the construction of the south facing wall of the chancel or any subsequent alterations that may have been made. A small quantity of disarticulated human bone was recovered from the excavation. This was stored in the church and left for the attention of the church authorities.

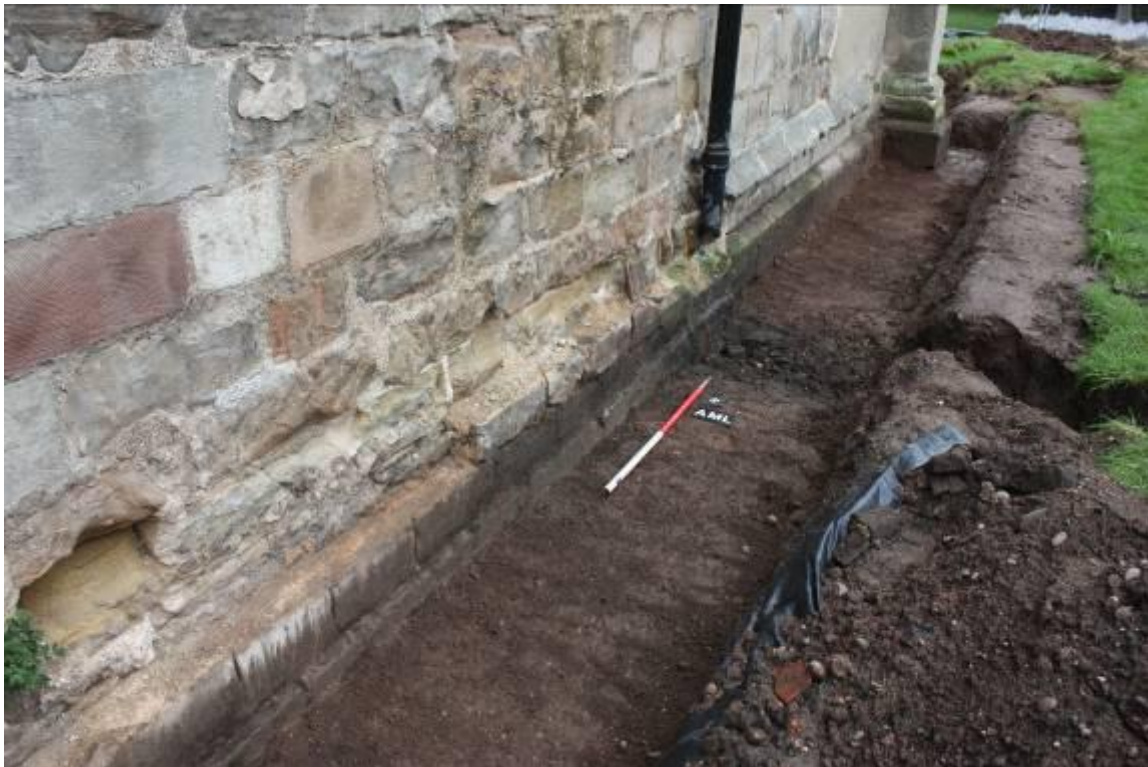
Plate 11. Area 04. Oblique view of, east facing wall of chancel and Appleby Chapel. Looking north west.

- 5.15 The excavation revealed the foundation courses of both the chancel and the Appleby Chapel. The chancel and the Appleby Chapel are divided from one another by a modern cast iron drainpipe, Plate 11.

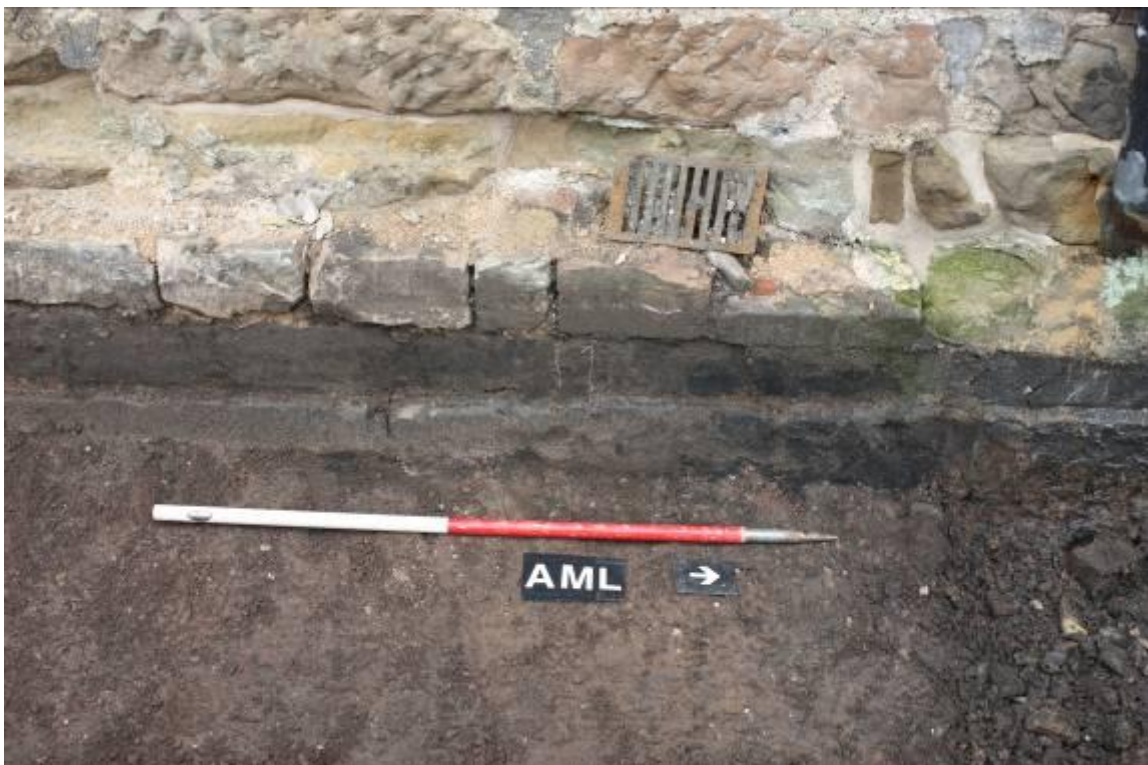
Plate 12. Area 04. Detail of foundation course of east facing wall of the chancel. Looking west.

- 5.16 The lower and foundation course of the chancel are similar to those described in Area 03 with dressed masonry blocks above undressed blocks, Plate 12. In Area 04, chancel, the lower foundation course was only revealed when a sondage was excavated to reveal the base of the lower course exposed by the excavation, Plate 13.

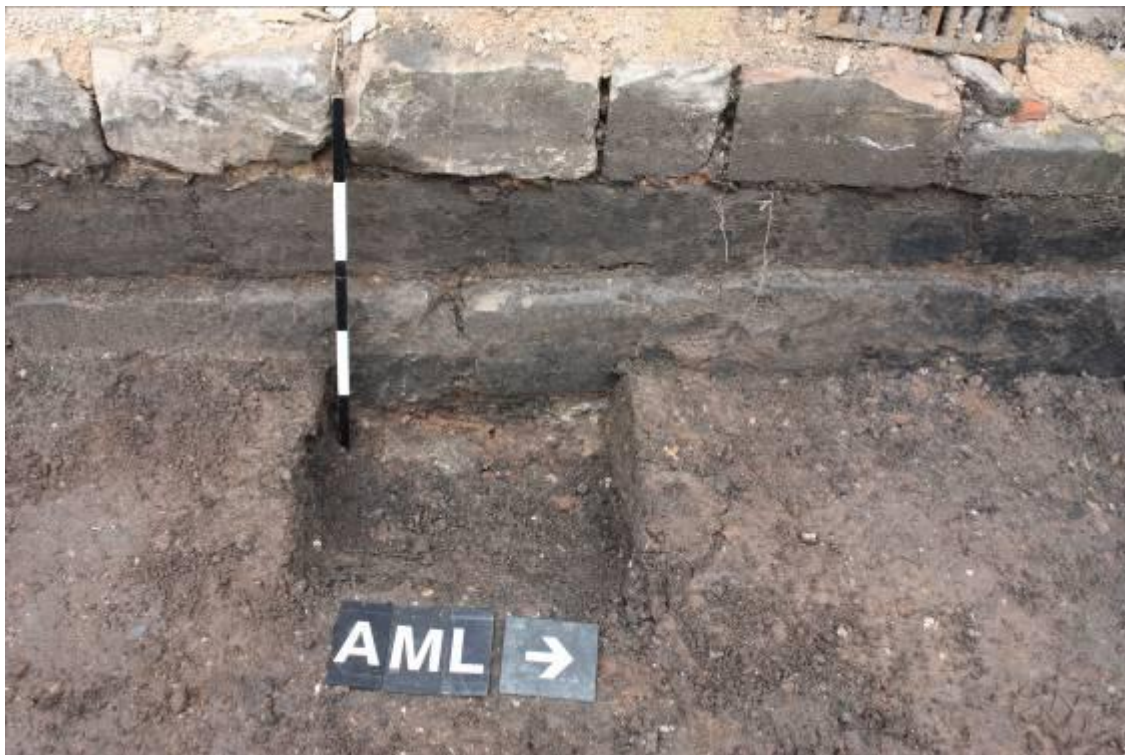
Plate 13. Area 04. Detail of foundation of east facing wall of the chancel with sondage excavated to expose its full depth. Looking west.

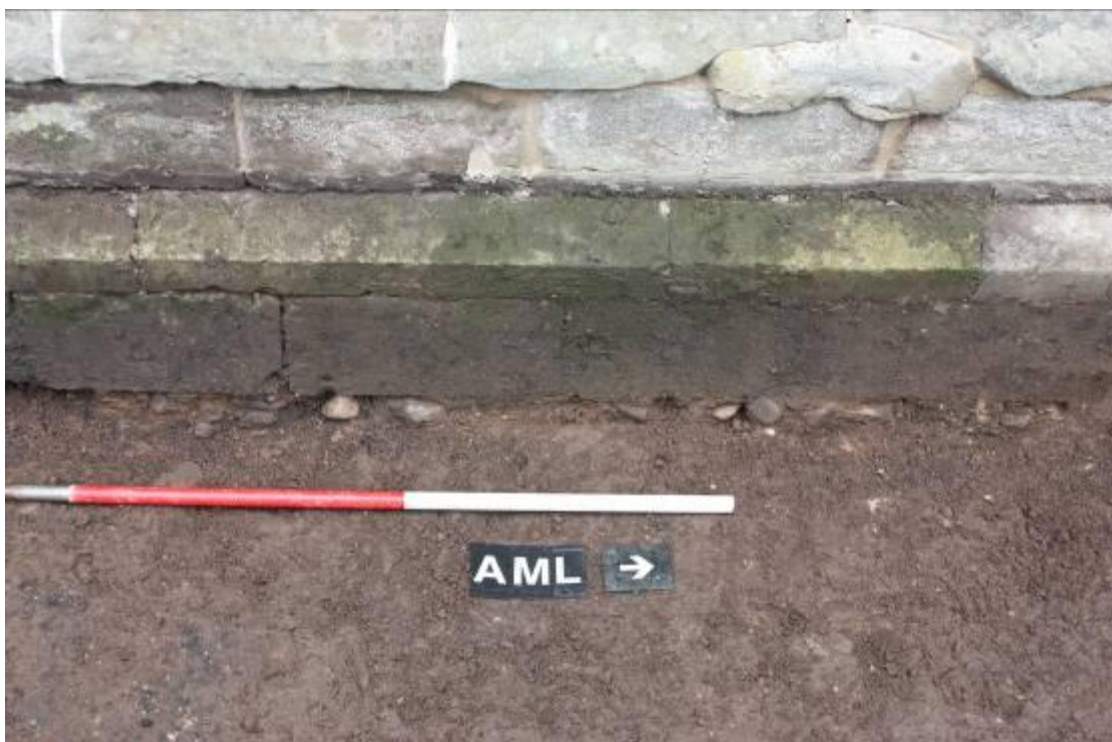
Plate 14. Area 04. Detail of pebble foundation of east facing wall of the Appleby Chapel. Looking west.

- 5.17 The exposed lower course and foundation of the Appleby Chapel were markedly different from the exposed courses in Areas 01, 02 and 03. Well dressed blocks, above which lay a chamfered course, sat upon a foundation of rounded pebbles, Plate 14. The depth of this foundation was exposed in a sondage that was excavated and was revealed to be an average depth of 200mm. Plate 15.

- 6.4 Area 04 (east facing wall of the chancel and Appleby Chapel) and Area 05 (north facing wall of the Appleby Chapel) had not been excavated during the 1975 drainage works. In Area 04 a significant change in the construction of the foundations was observed between the chancel and the chapel. The chancel foundations were similar to those observed in Area 01, Area 02 and Area 03, well dressed masonry blocks resting on undressed blocks. Where the chancel abutted the chapel a clear change was observed with the masonry above ground standing on a foundation constructed of large rounded pebbles. This form of construction was also noted in Area 05 and ended abruptly at the point that Area 05 joined Area 06 (north facing wall of the north aisle).

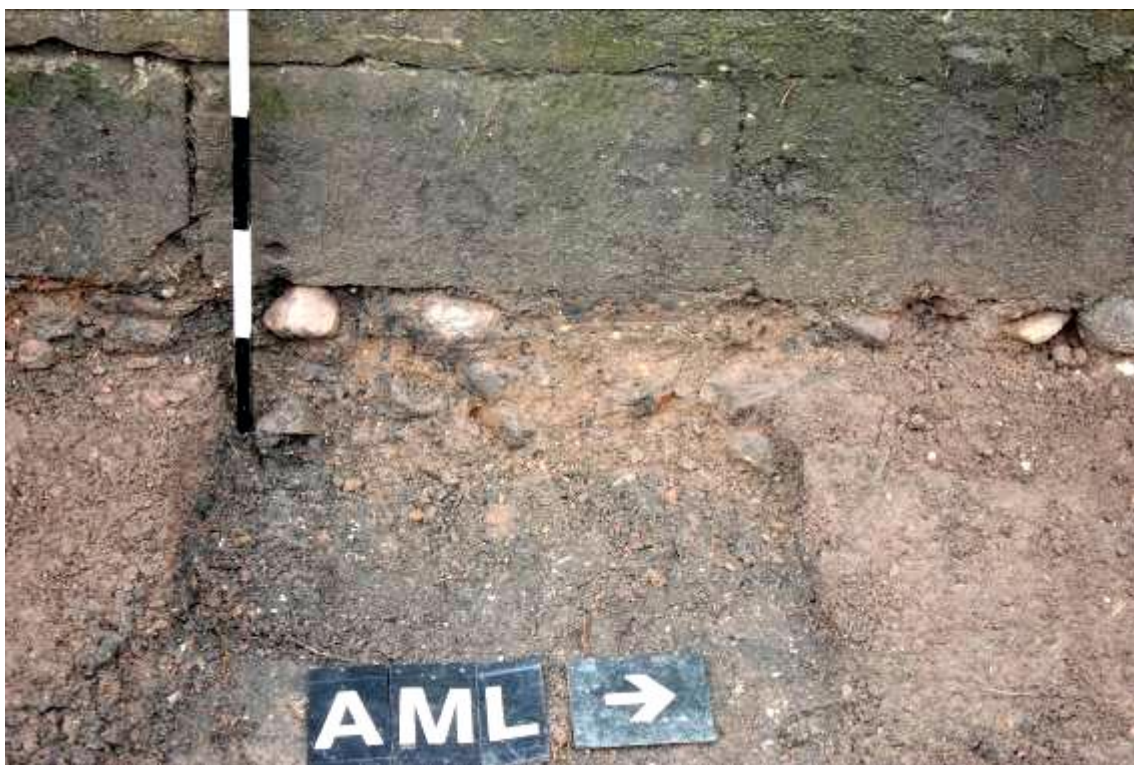
Plate 15. Area 04. Detail of east facing wall of Appleby Chapel with sondage showing extent of pebble foundation. Looking west.

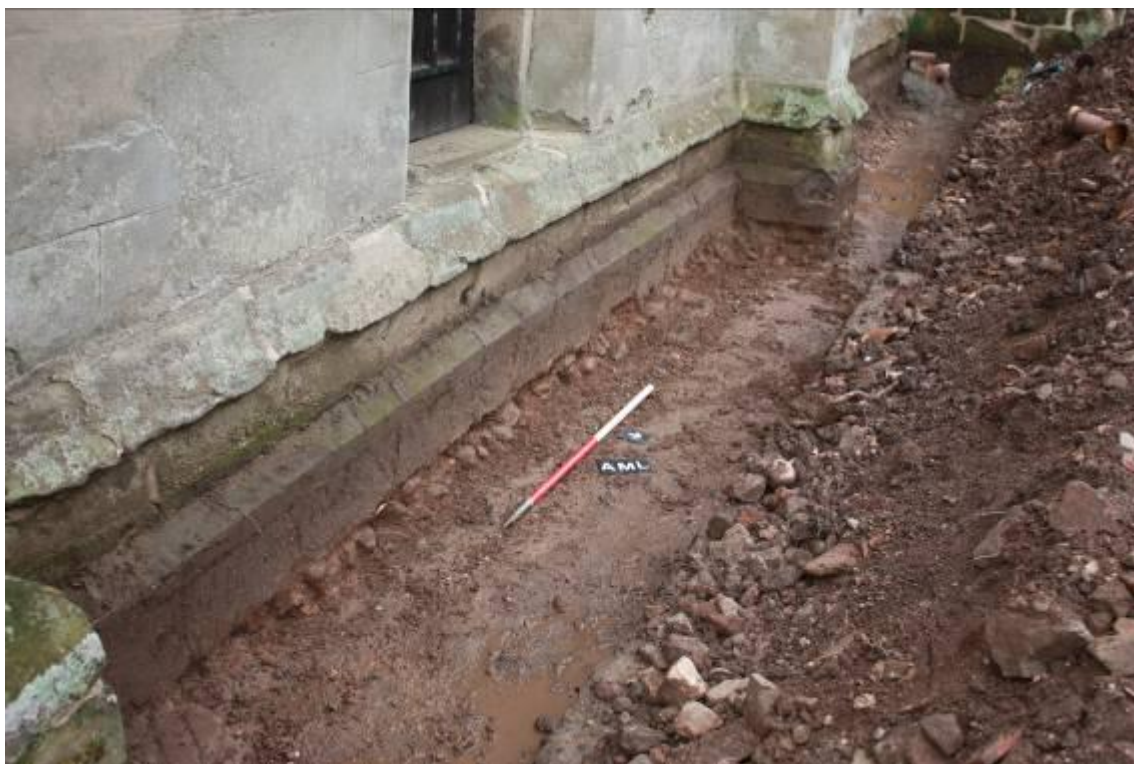
Plate 16. Area 05. Oblique view of north facing wall of Appleby Chapel showing pebble foundation. Looking south west.

- 5.19 4.6.1 A trench was excavated along the entire length of Area 05, 12.00m, to an average depth of 450mm. The excavation of Area 05 is situated along the north facing wall of the Appleby Chapel and had not been disturbed during the 1975 excavation.
- 5.20 The exposed lower courses of Area 05 are the same as those described in Area 04, Appleby Chapel, comprising well dressed blocks below a chamfered course sat upon a foundation of rounded pebbles, Plate 16 and Plate 17.
- 5.21 The foundation course revealed by the excavation of Area 05 shows a marked difference from the foundation courses revealed in Areas 01, 02, and the chancel in Area 04 and suggests a different phase in the construction of the church.

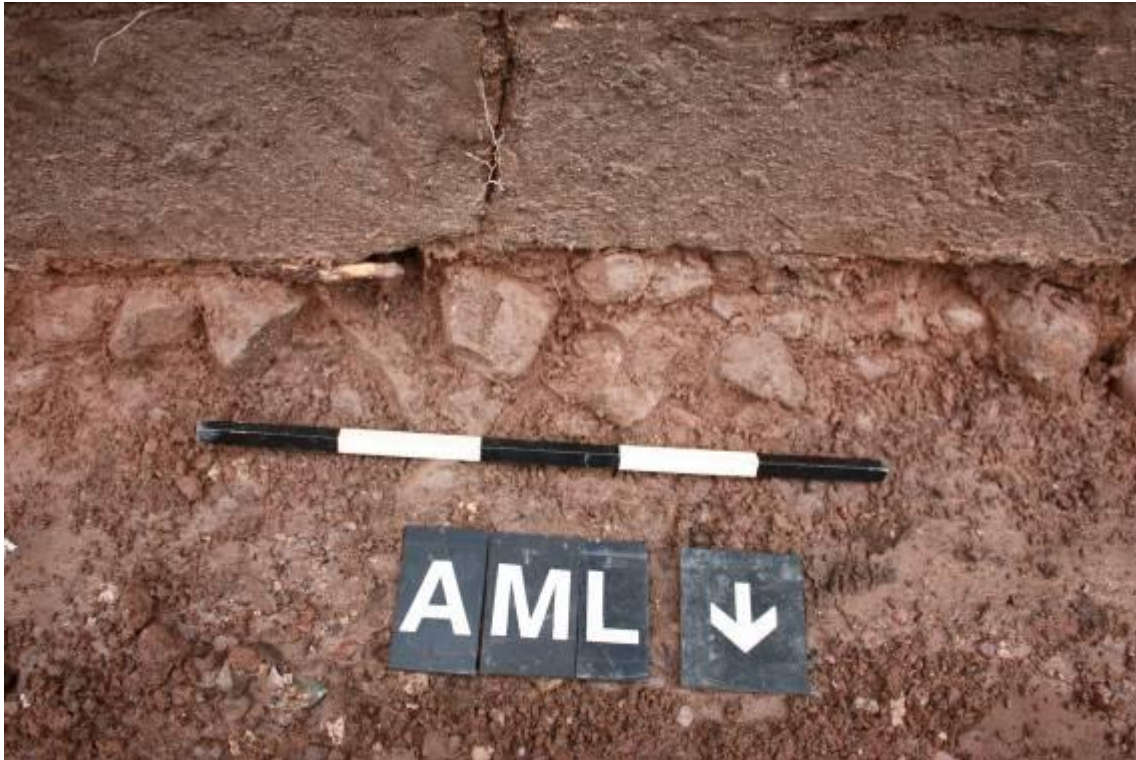
Plate 17. Area 05. Detail of pebble foundation of north facing wall of Appleby Chapel. Looking south.

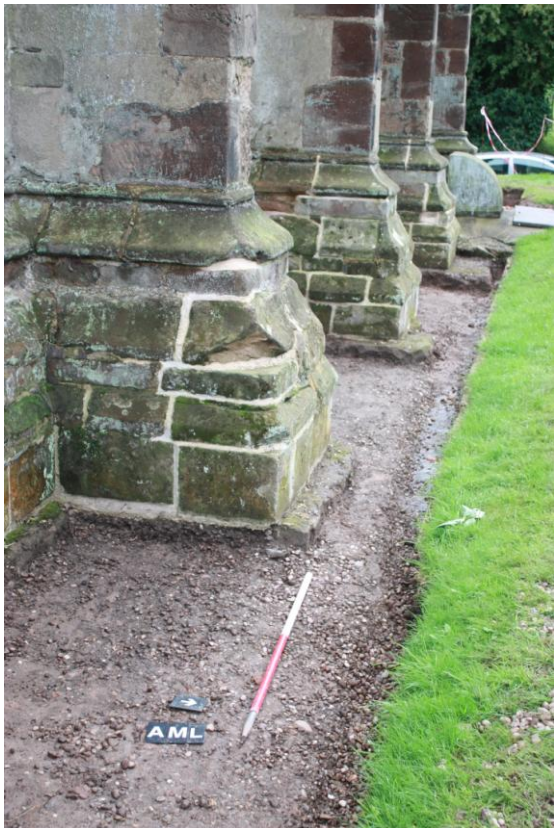
Plate 18. Area 06. Oblique view showing shallow excavation and the gravel infill from the 1975 drainage works in situ. Looking west.

- 5.23 A trench was hand excavated along the north facing wall of the north aisle in the area that had been excavated in 1975, 15.7m, to an average depth of 125mm. The depth of the excavation in Area 06 limited the opportunity for archaeological observation with only the upper parts of the course below the modern ground level being exposed, Plate 18. Much of the material that had been inserted during the drainage works in 1975 was left insitu.
- 5.24 There were no artefacts recovered during the course of the excavation that would help in dating the construction of the north wall of the nave. No human remains were uncovered as a result of the excavation.

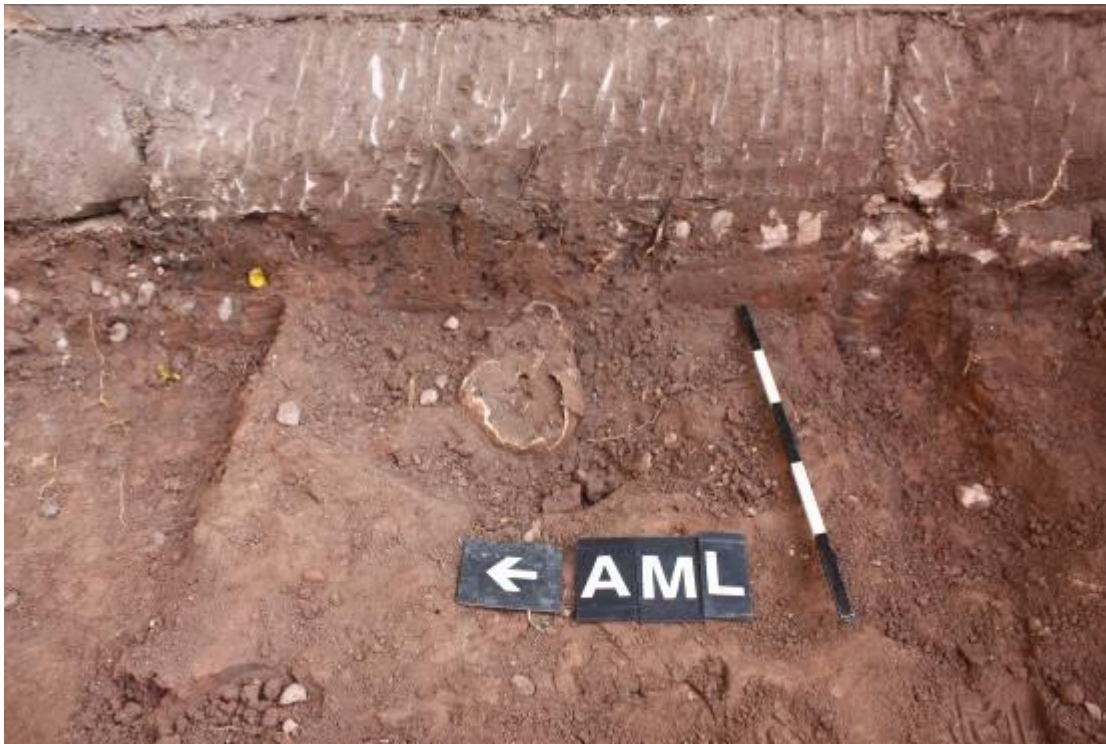
Plate 19. Area 09 showing skull of possible intact burial protruding from beneath the foundation of the south aisle. Looking east.

- 5.26 At 5m south of the junction of Area 09 and the west tower a skull was observed protruding from below the foundation course of the wall of the south aisle. The position of the skull suggested that a possible intact burial, orientated east/west, lay beneath the foundations of the south aisle and therefore could reasonably be interpreted as predating it (Figure 6, Plate 19)

- 5.27 It was not possible to excavate beneath the foundations of the south aisle to establish whether or not the skull was part of an intact burial. Its orientation however (east/west) suggests this especially as compared with other disarticulated remains observed elsewhere whose orientation was completely random.

- 5.28 There was no observable grave cut which would have established clearly that the skull belonged to an intact burial. Despite this the skull was treated as if it was part of a burial.

- 6.6 Further possible support for the suggestion the current church structure stands on the site of an earlier site was observed in Area 09 (west facing wall of the south aisle). Here in the excavated drainage trench a human skull was recorded protruding from a layer beneath the base of the foundation. There was no sign of a grave cut and apart from the skull no observable skeletal remains. The skull itself was orientated east/west and tilted slightly backwards as if it had been originally placed in a coffin or had had a support behind the head. The remains were treated as an intact burial and have remained insitu. If the skull is part of an intact burial then clearly it predates the building of the south aisle and suggests that prior to the earlier 14th Century a smaller structure served as the church and that the current building sits over parts of what had been an earlier graveyard.

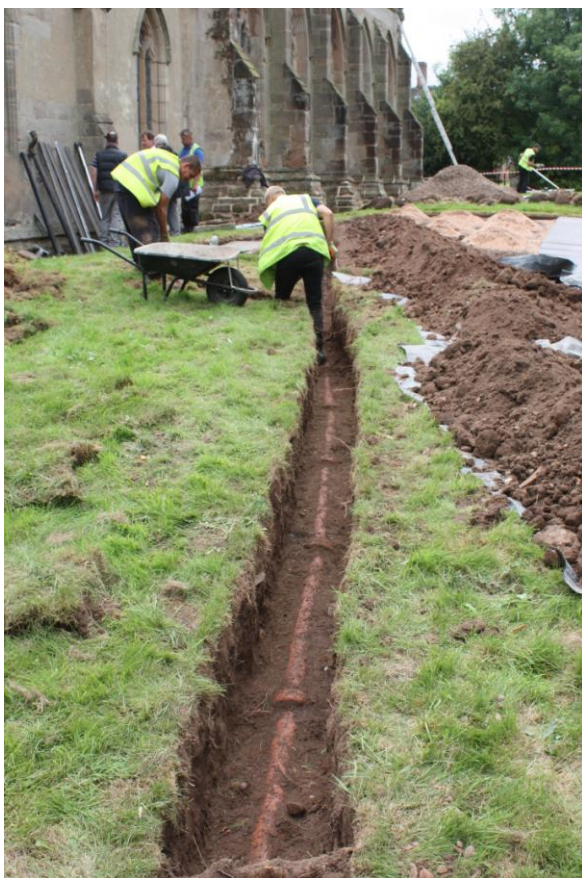
Plate 20. Area 07. Drainage trench showing existing ceramic pipes laid in 1975. Looking south west.

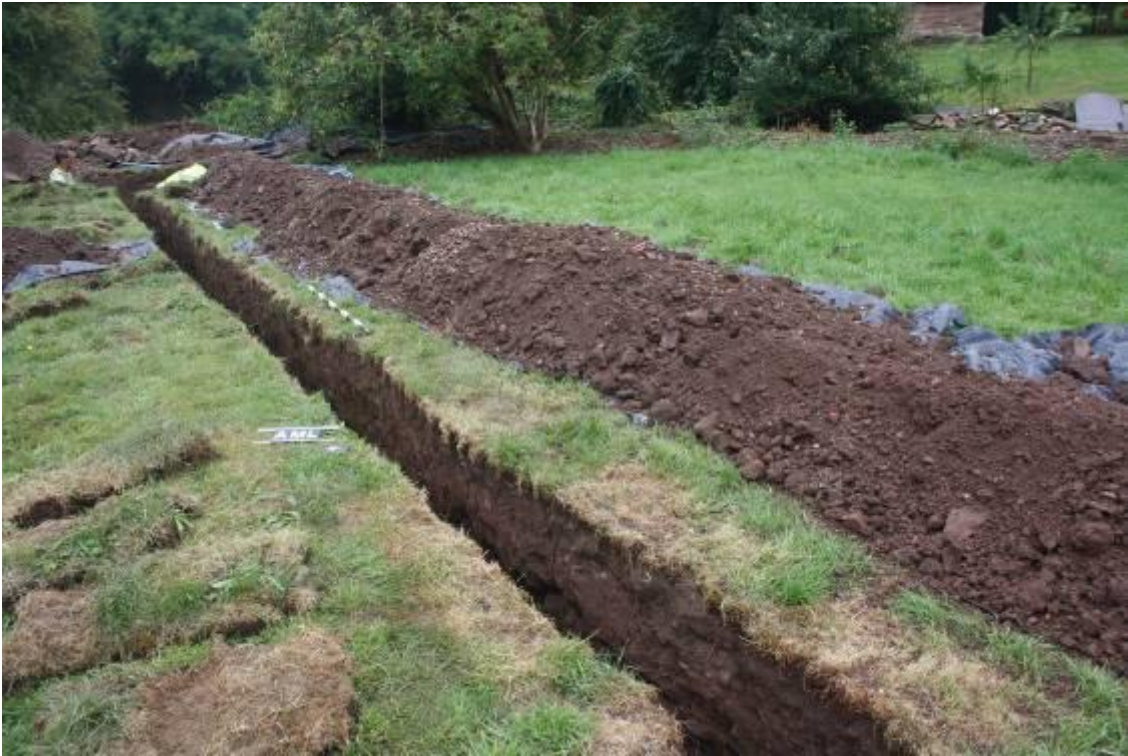
Plate 21. Area 08. Drainage trench overall view. Looking east.

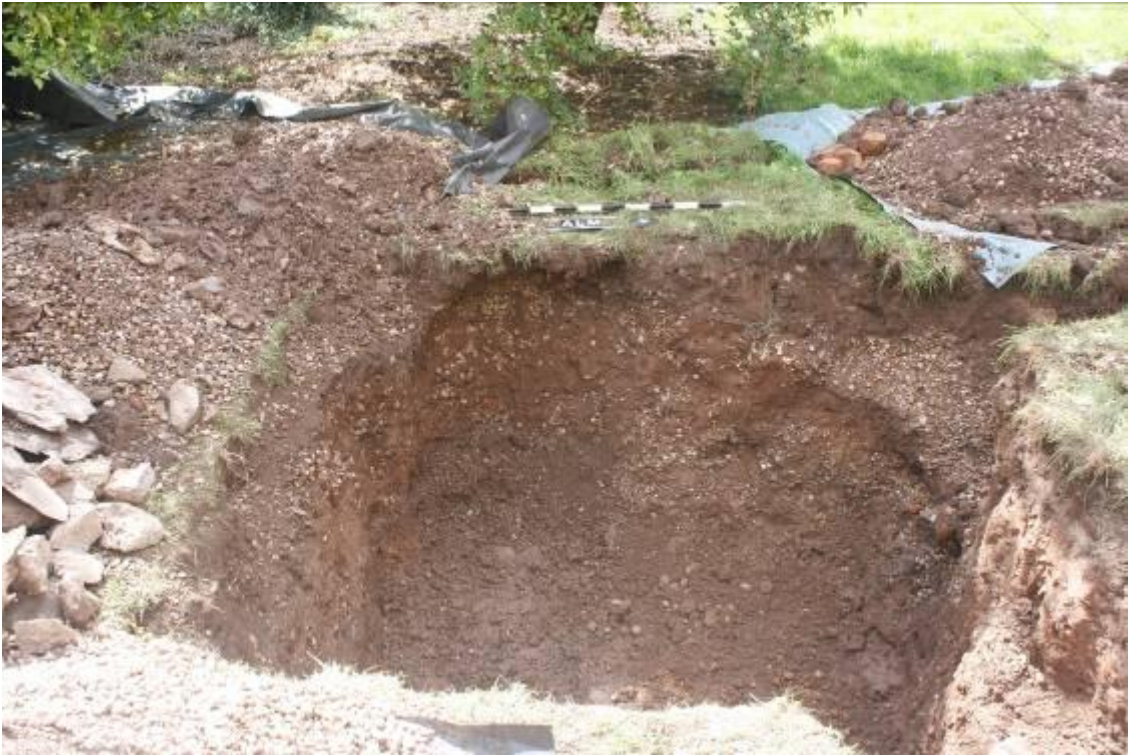
Plate 22. Area 12, soakaway showing unstable section. Looking south.

- 5.43 A Soakaway 2.5m x 2.5m x 2m was hand excavated in the same location as the 1975 excavation.
- 5.44 The depth of the excavation and the highly fragile nature of the sections of Area 12 provided only limited opportunity for detailed recording.
- 5.45 A quantity of disarticulated human remains were recovered from the material excavated from the soakaway. These were left with the church authorities for their reburial.
