Report on an Archaeological Watching Brief at the Church of St. Mary and St. Laurence, Bolsover

Report Number: 100/2016

TPA Project Code: MLB1

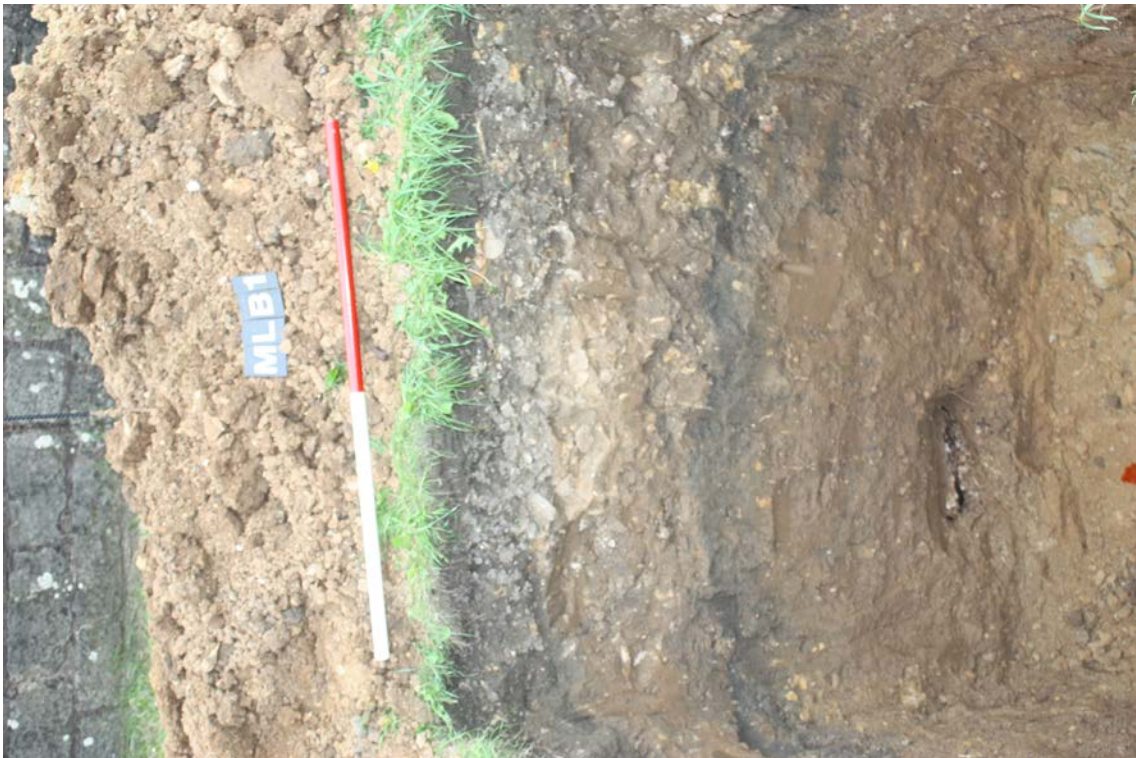
Plate 1: Area 1 soakaway showing the human skull at the base

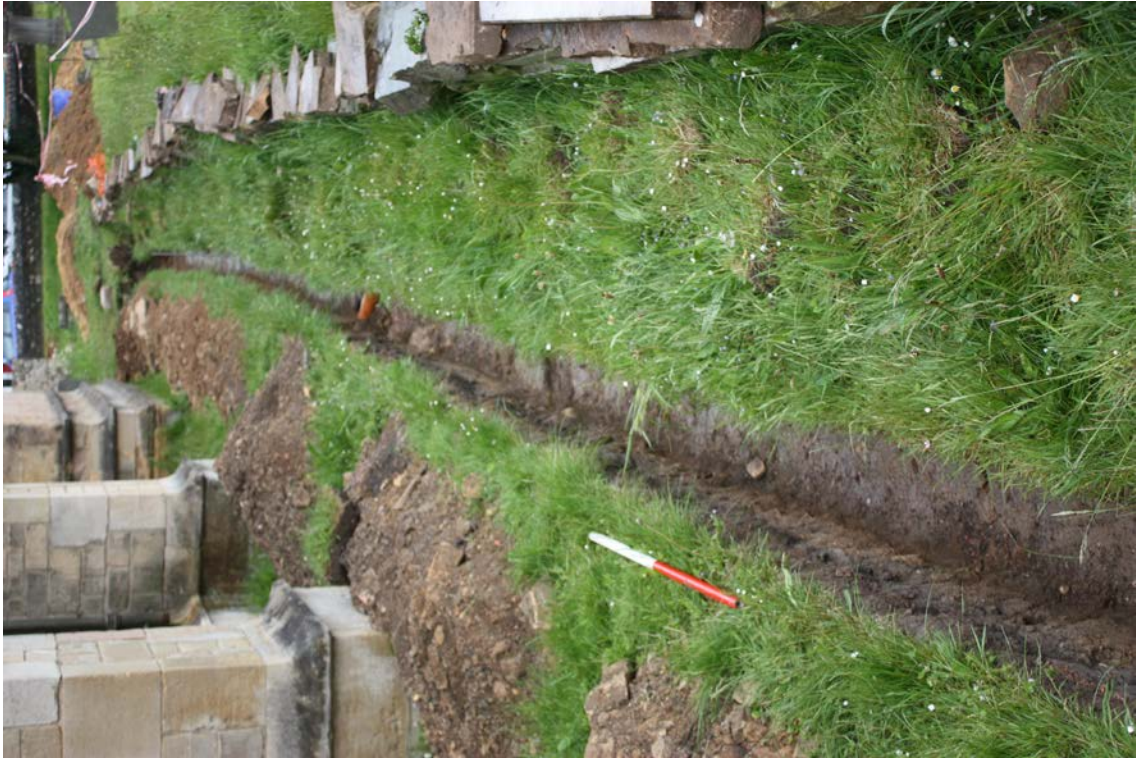
6.2.2 A coffin board was uncovered 80mm from the base of (0204). There were no other coffin fragments or fittings observed and no indications of an intact skeleton associated with the board. It is likely that this is a redeposited artefact resulting from ground disturbance in the immediate area.

Plate 2: Area 2 showing the coffin board visible within the section
