**St. Helen's House, 89 Market Street, Ashby-de-la-Zouch,  
Leicestershire**

Historic Building Record

Report Number: 011/2017

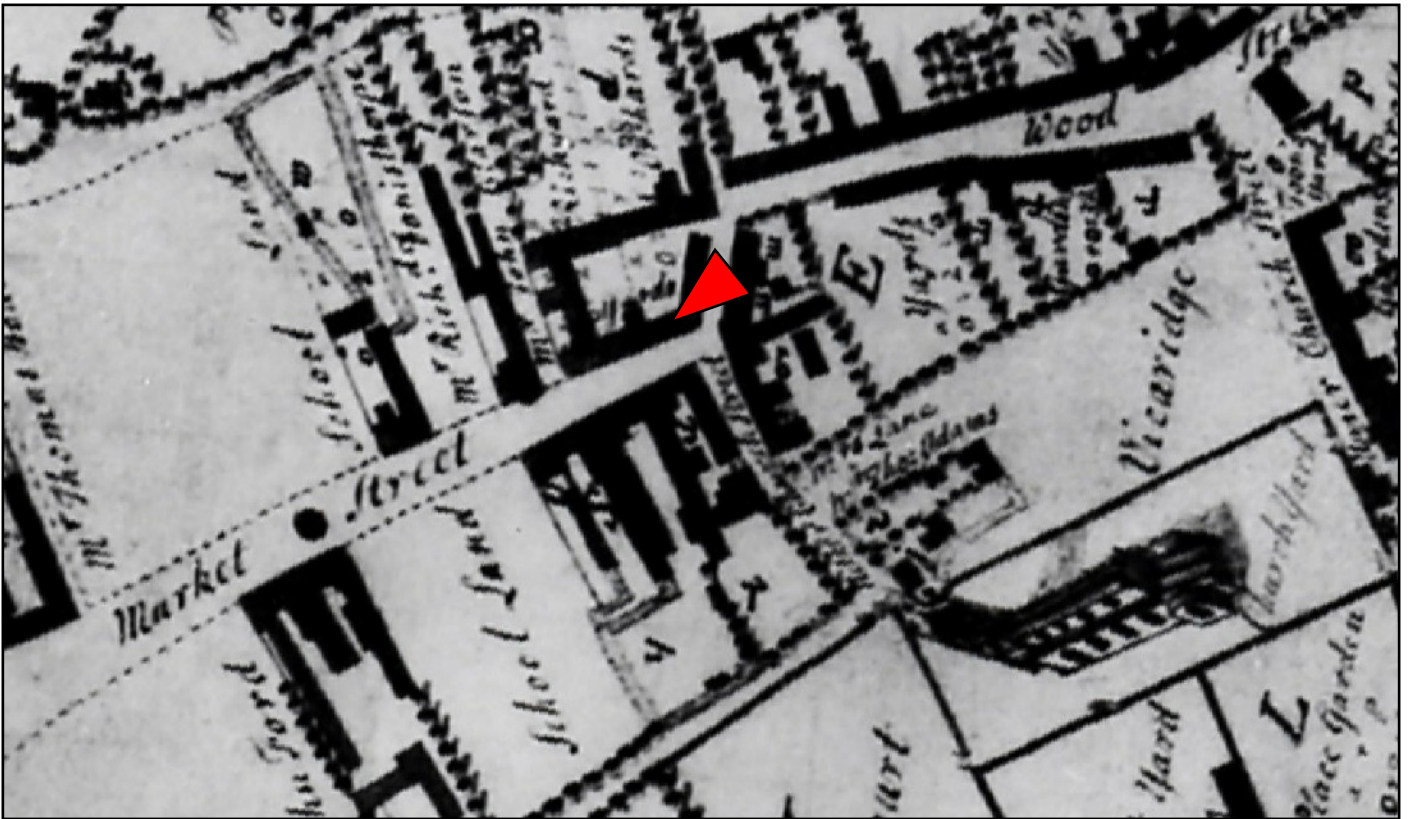
Figure 2: St. Helen's House as depicted on the 1735 Hastings Map. Not to regular scale.

3.3 A building fronting Market Street in the location of St Helen's House is depicted on the 1735 Hastings map (Figure 2). It is a rectangular building with a central rear projection. By the publication of Wood's map in 1837 this building had either been remodelled or, more likely, demolished and replaced by the current St. Helen's House and West Range (Figure 3). A small square building had been erected to the east of the West Range which had itself been extended by 1884 (Figure 4), and the East Range had been built by the time of the publication of the Second Edition Ordnance Survey map of 1903 (Figure 5). It is tempting suggest that the construction of the East Range was necessitated by its conversion into a grammar school. In addition, a further square building had been built to the north of the East Range by this time. There is little change depicted on the 1923 Ordnance Survey map (Figure 6) with the exception of some remodelling to the west gable of the house. The west elevation and north gable of the West Range had been altered by the publication of the 1971 edition Ordnance Survey map (Figure 7) and the northern half of the East Range remodelled. The northern half of the West range was demolished after 1971 and a new office block constructed on its footprint. An extra building was also added at the northern end of the East range (Figure 1).

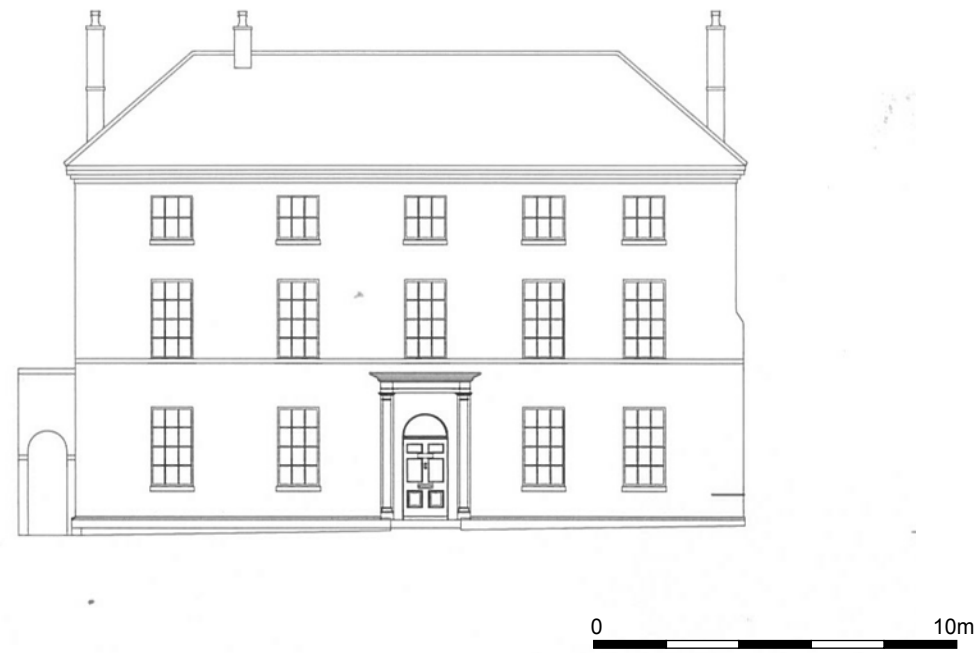
**Figure 10:** The south frontage of St. Helen's House based on drawings provided by the client. Scale 1:200 at A3.

4.1.3 The south frontage, which is not perfectly symmetrical, is rendered and incised with narrow lines to imitate fine masonry and painted white. A string course divides the ground and first floor and an ovolo cornice is present beneath the eaves. The elevation has four vertical rectangular windows with modern replacement 12-light sash windows and a central doorway on the ground floor, five windows identical to those below on the first floor and five smaller square windows containing modern 6-light sash windows on the second floor. The door is of typical Regency style being six panelled with a short top section and large middle section, both with later glass insertions, and a medium bottom section with a raised central part and sunken bevelled edges. Above the door is a fanlight which has had the original glazing bars removed and a single piece of glass inserted. The brass fittings of the door relate to when the building was a grammar school. The porch, the columns of which are restored, is in the Tuscan order. This was again popular during the Regency period. A low blue brick wall topped with iron railings extends around the frontage. The alley to the west is accessed through a brick archway.

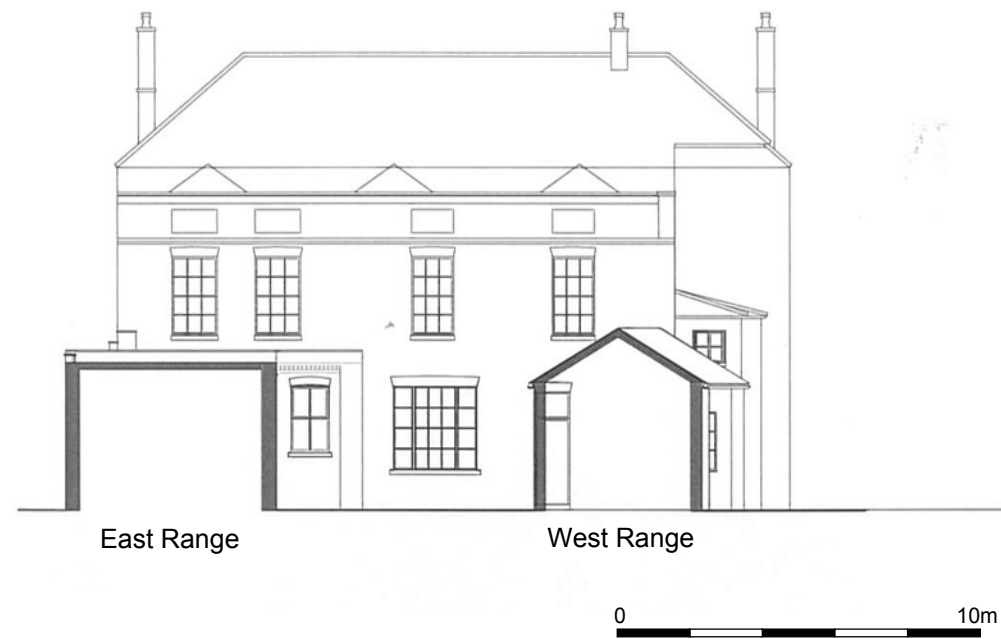
**Figure 12:** The north elevation of St. Helen's House based on drawings provided by the client. Scale 1:200 at A3.

4.1.8 The north elevation is partially obscured by the two ranges. As with the south elevation mentioned above, it is not symmetrical. The bricks are 9 x 4 x 2<sup>7</sup>/<sub>8</sub> inches in size and laid in Flemish bond. A brick parapet is present topped with V-shaped tiles. It has a ground floor entrance and a large central square window containing a modern 20-light window. The first floor

has four vertical rectangular windows of the same dimensions as those in the south elevation, with modern 12-light sash windows. All of the windows have a stone cill and flat arch head, and the doorway likewise has a brick flat arch head.

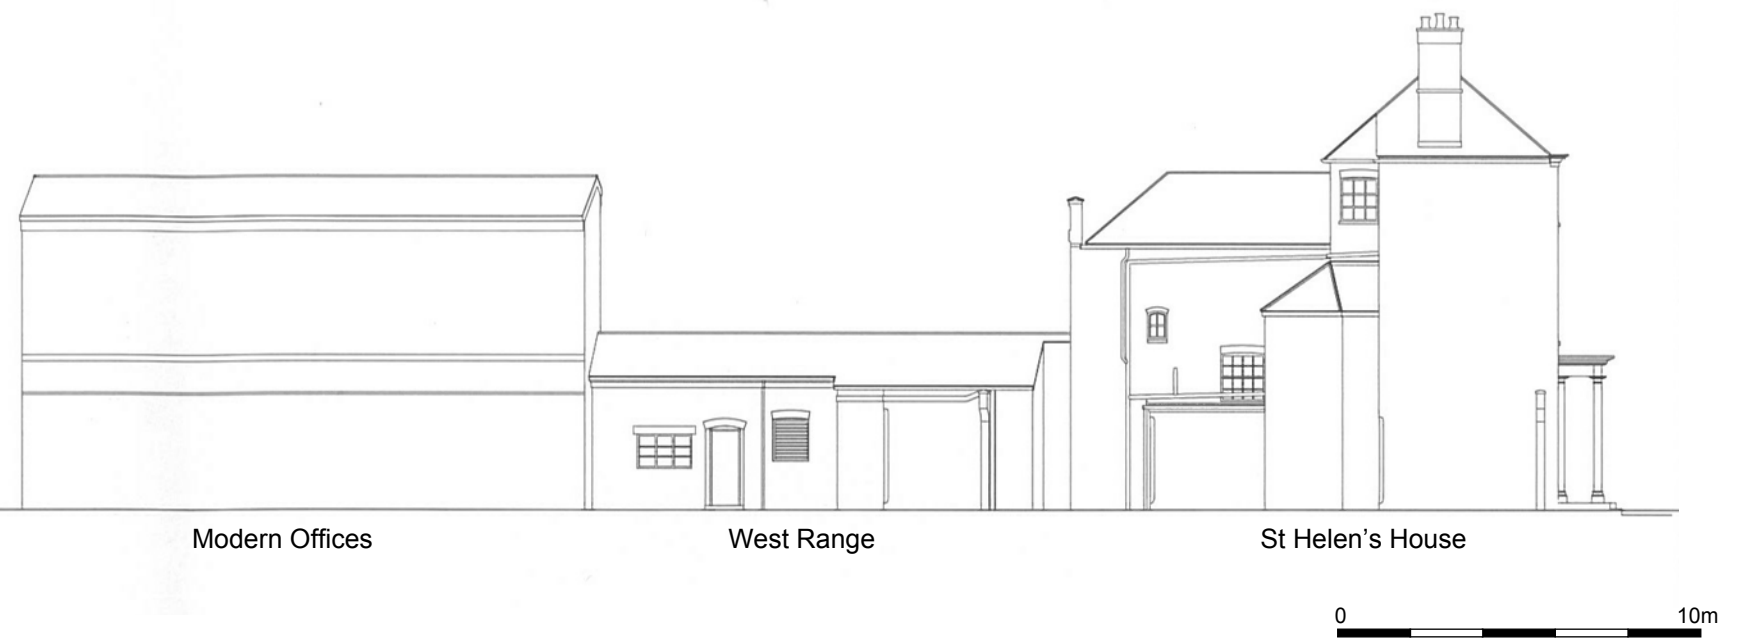
**Figure 13:** The west gable and elevation of St. Helen's House and the west elevation of the West Range based on drawings provided by the client. Scale 1:200 at A3.

4.1.5 Rendering is absent from the west gable, although it has the same dentil cornice that is present in the east gable. The bricks measure 9 x 4 x 2<sup>7</sup>/<sub>8</sub> and are laid alternatively in three to four courses of stretcher to one course of mixed header and stretcher. Lighting the second floor corridor is a 9-light sash window, one of only three original windows surviving within the property, beneath a segmental head comprising single header bricks and a brick cill.

4.1.10 The brick bond and dentil cornice of the west elevation is the same as that present on the southern element of the house. It retains two original windows, a first floor 16-light sash window lighting the service stair and a 4-light sash window illuminating a small room on the first floor. Both windows are beneath a segmental head comprising single header bricks and brick cill.

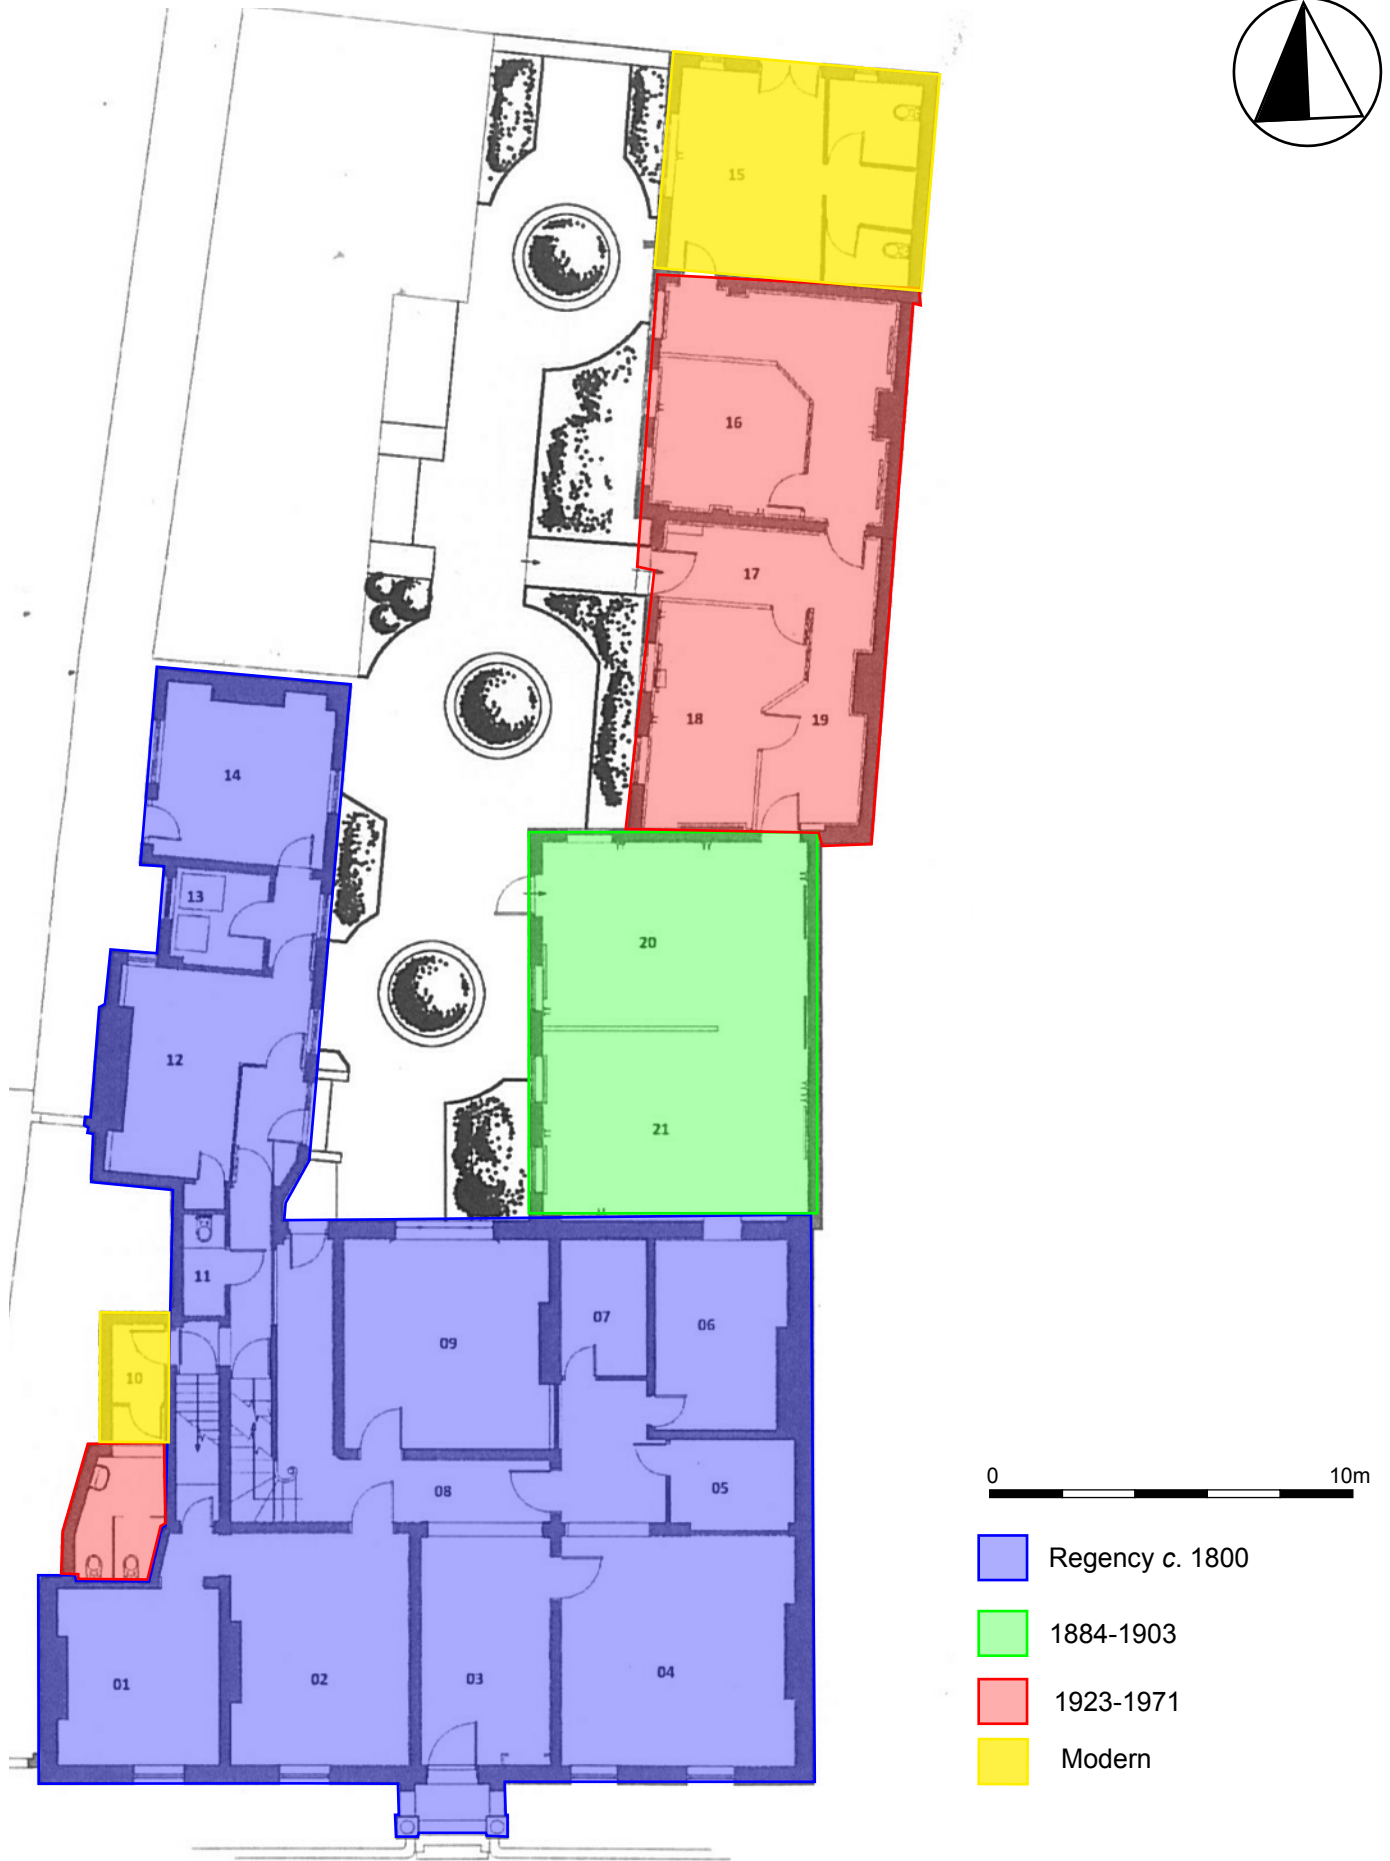
Figure 15: Phased plan of St. Helen's House based on a drawing provided by the client. Scale 1:200 at A4

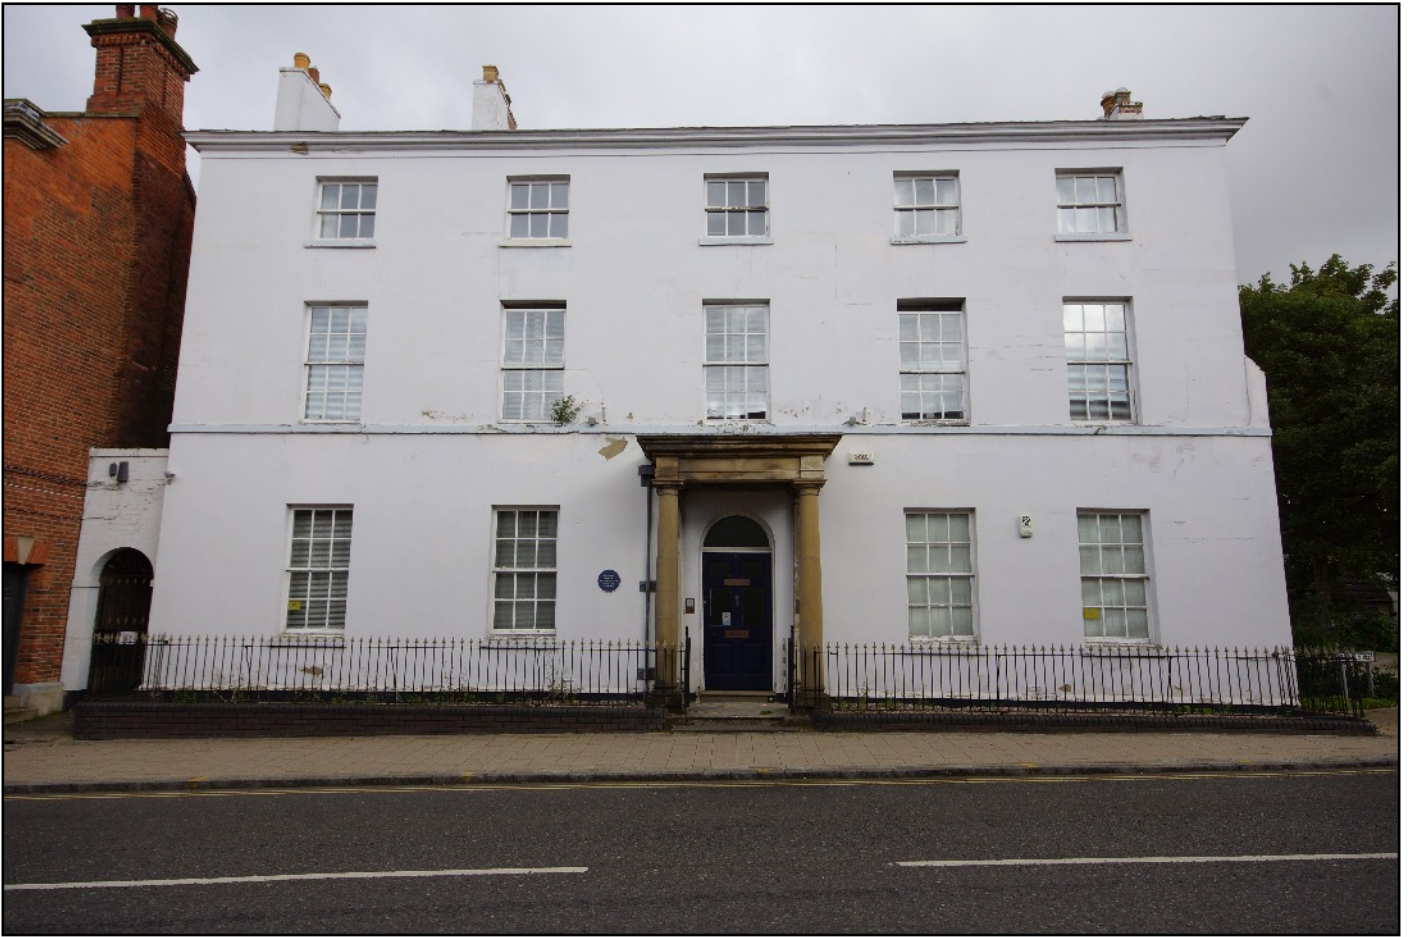
**Plate 1:** The south frontage of St. Helen's House, viewed from Market Street looking north.

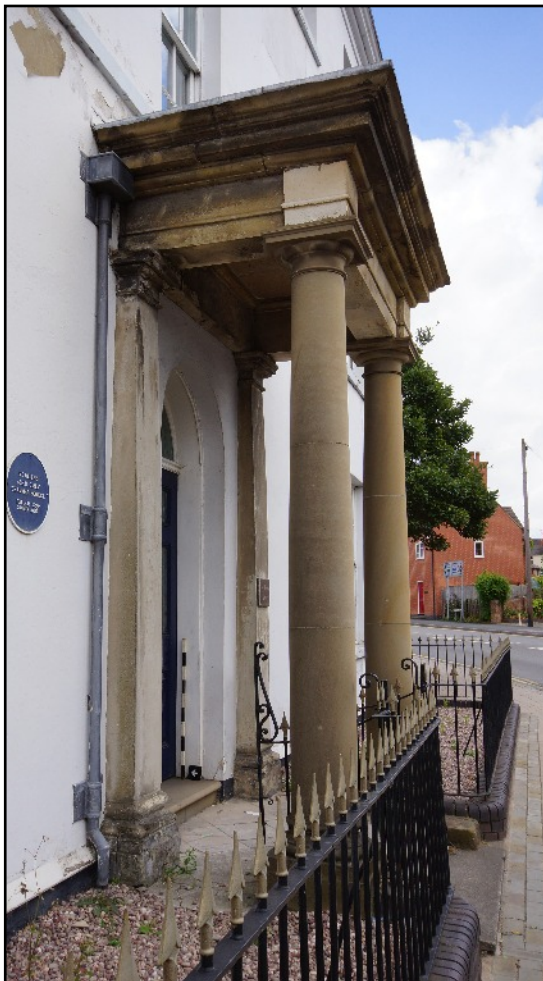
**Plate 2:** The Tuscan porch of the south frontage, viewed looking north-east.

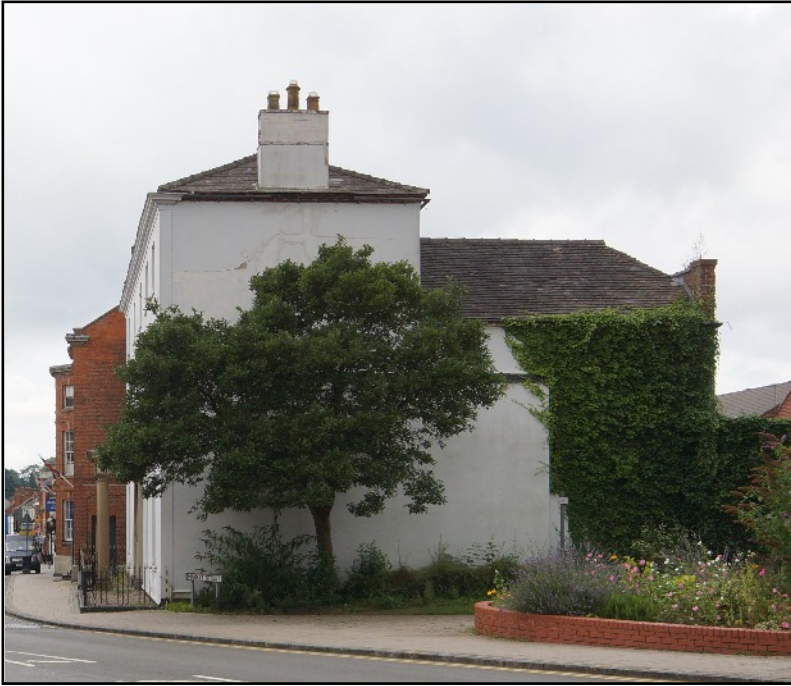
4.1.4 Like the south elevation, the east gable is rendered. It has a dentil cornice in brick. A narrow buttress of first floor height, rendered and topped with slate, extends across the gable and part of the east elevation of the northern element of the house.

**Plate 4:** The east gable and elevation of the north element of St. Helen's House, viewed looking west.

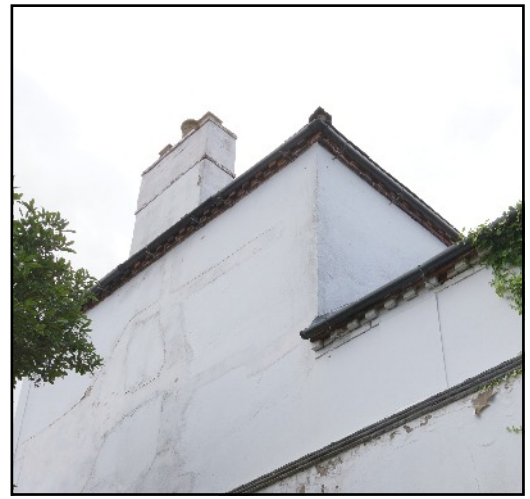
**Plate 5:** The dentil cornice extending across the east gable and elevation, viewed looking west.

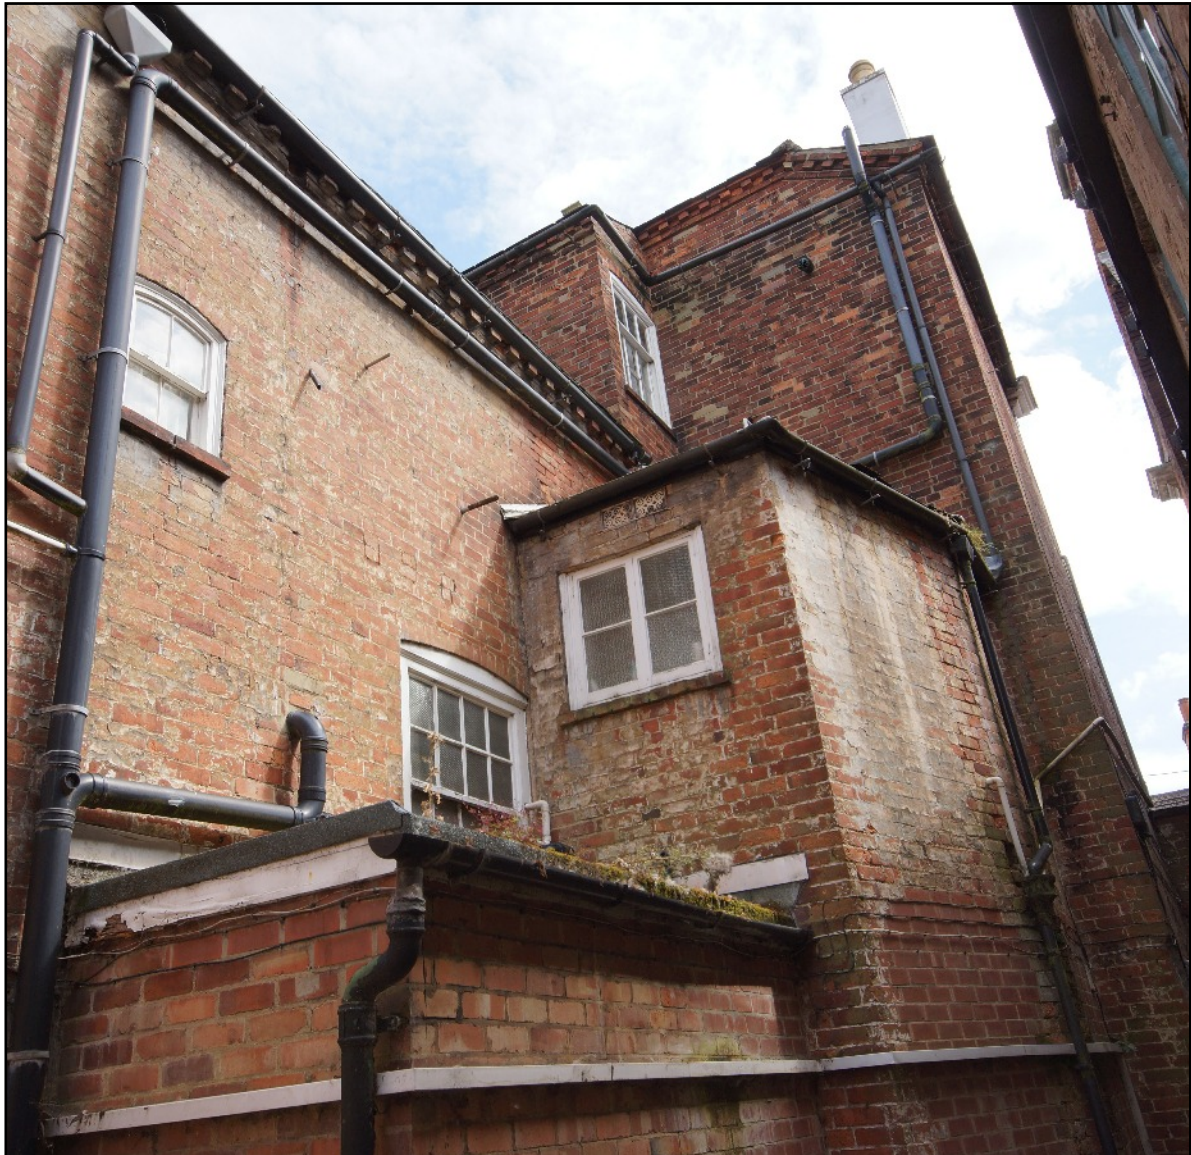
4.1.11 Abutting the west elevation and gable of the house is a two storey brick extension with a pitched slate roof. It has a single 4-light casement window with a brick cill in its north elevation and a former window below, obscured by a modern extension. A former ground floor doorway infilled with modern brick is present in the west elevation. Cartographic evidence suggests that it dates to between 1923 and 1971.

**Plate 6:** The west gable and elevation and later two storey extension, viewed looking south-east. Note the dentil cornice extending around both the gable and elevation and the three sash windows which are the only surviving original windows in the building.

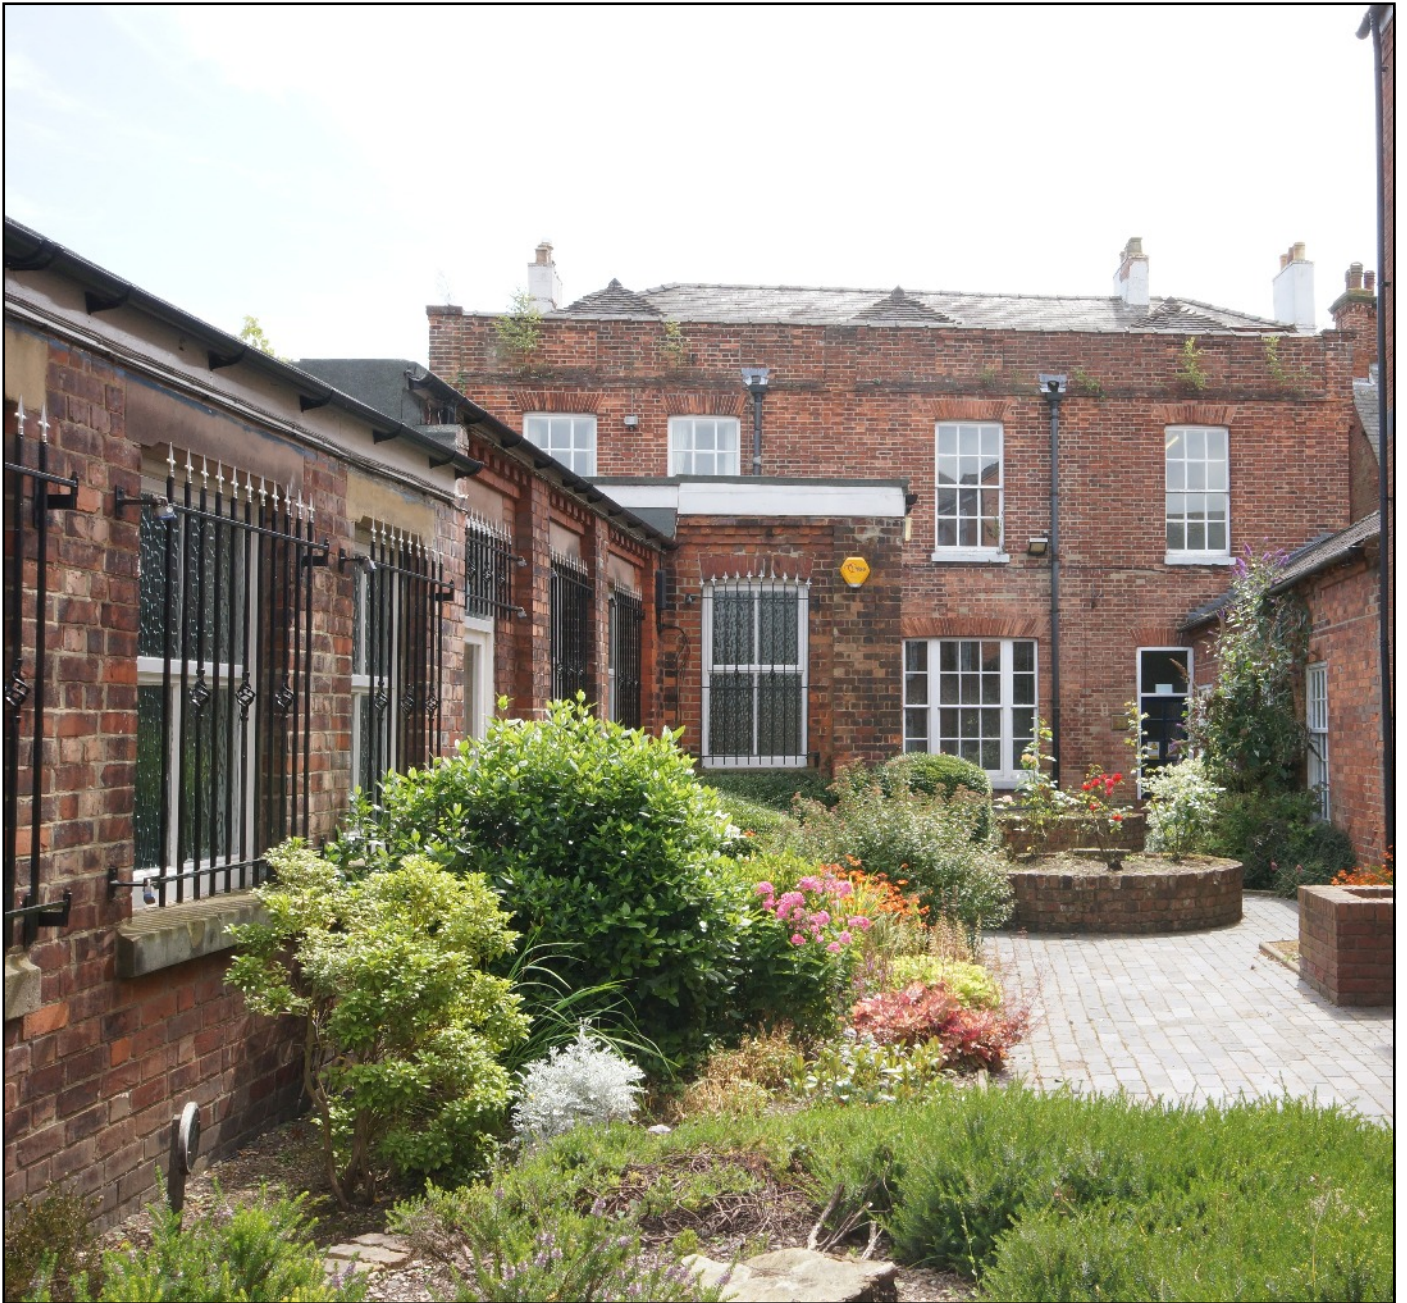
**Plate 7:** The north elevation of St Helen's House with the East Range in the foreground and the West Range also partially visible, viewed looking south.

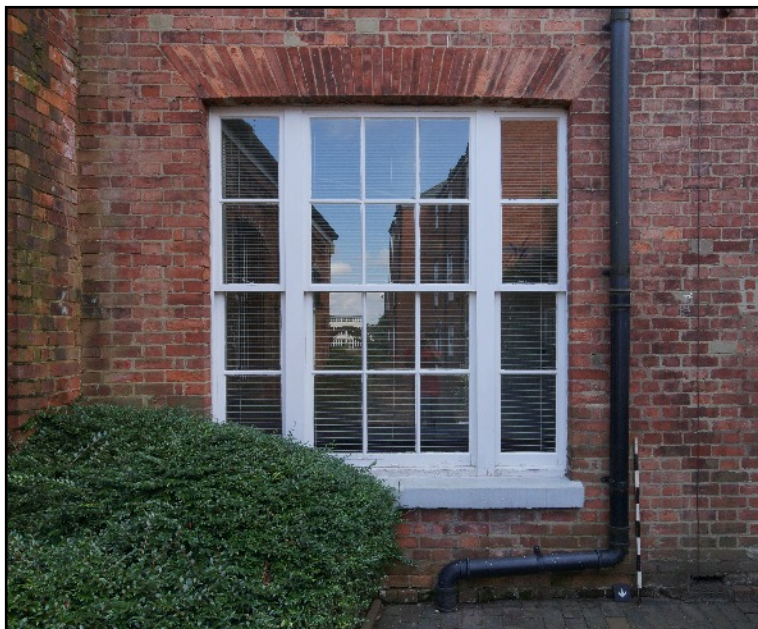
**Plate 8:** The ground floor window in the north elevation, viewed looking south.

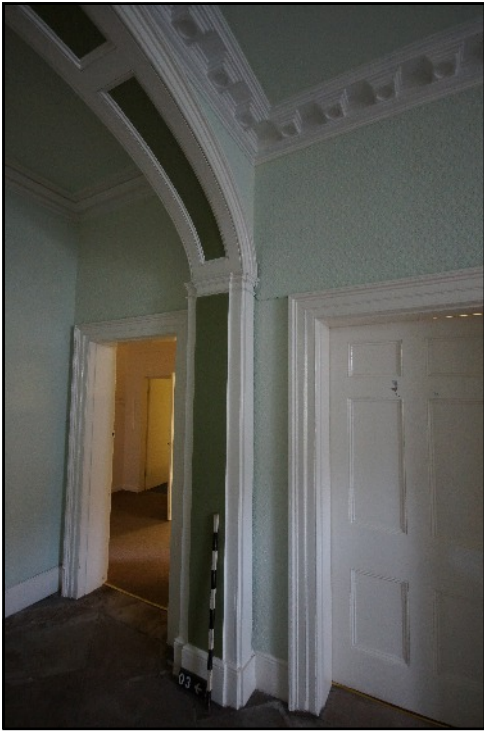
4.2.2 Entrance Hall 08 is accessed from Market Street. A depressed arch with fine mouldings on both the columns and arch marks the division between this room and Hallway 08. The room retains its original dentil cornice, York stone floor and skirting board. The six panel door and architrave leading into Room 04 appear original. Within Room 04 the fireplace surround has the classic Regency form of fluted jambs and lintel with bulls-eyes in the corners. The original skirting and decorative fleuron cornice still survive as does the architrave around the windows which is also present in the other rooms on the ground floor. Beneath the window is a box containing the weighted sash shutter. The shutters provided security and privacy but would also protect the precious furniture and fabrics from fading. After the middle of the 18<sup>th</sup> Century internal hinged shutters were common, stored in recesses on each side of the window. The design found in St. Helen's is of a later date, again suggesting a Regency date for the building. Rooms 01 and 02 are of lower status than Room 04, being smaller in size and lacking a cornice. The skirting board has also been removed from Room 01 and the fireplaces from both rooms covered. However, both do have moulded picture rails, six panel doors, architraves around the windows and doors and a weighted sash shutter as in Room 04.

**Plate 9:** The depressed arch and cornice of Hallway 08 and architrave and door leading into Room 04, viewed looking north-east.

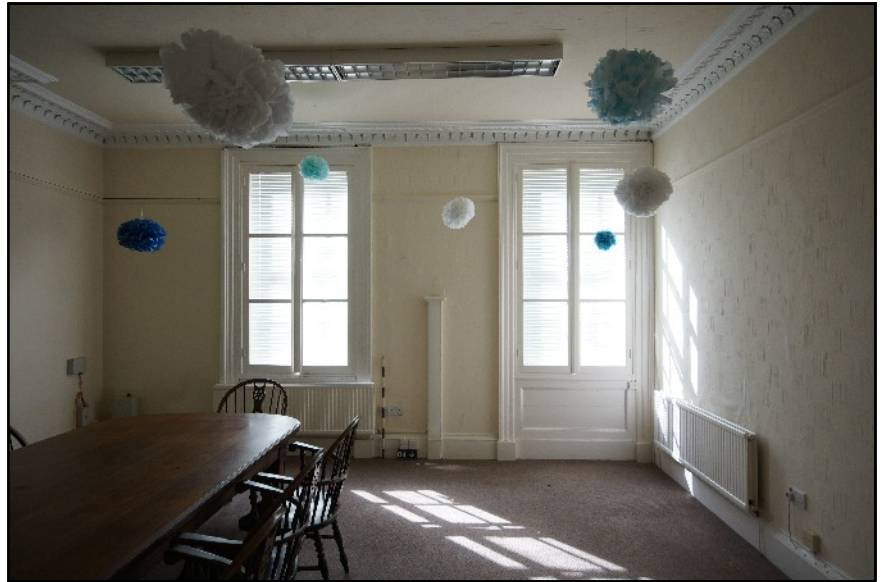
**Plate 10:** General view of Room 04, viewed looking south. Note the surviving boxes for the shutters beneath the windows.

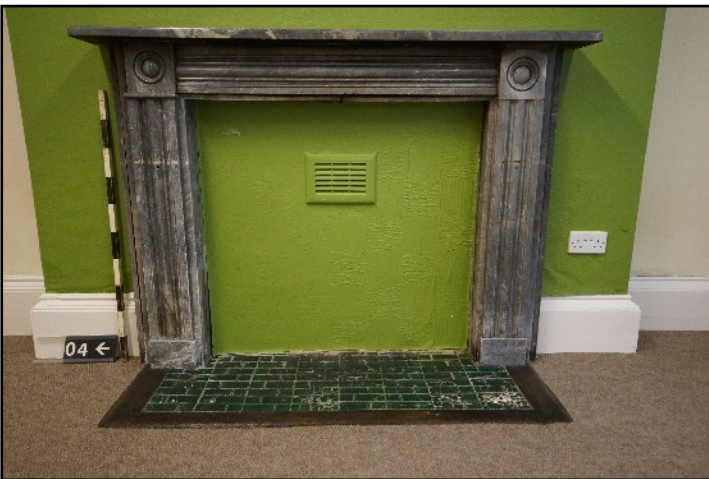
**Plate 11:** The Regency fire surround in Room 04, viewed looking east.

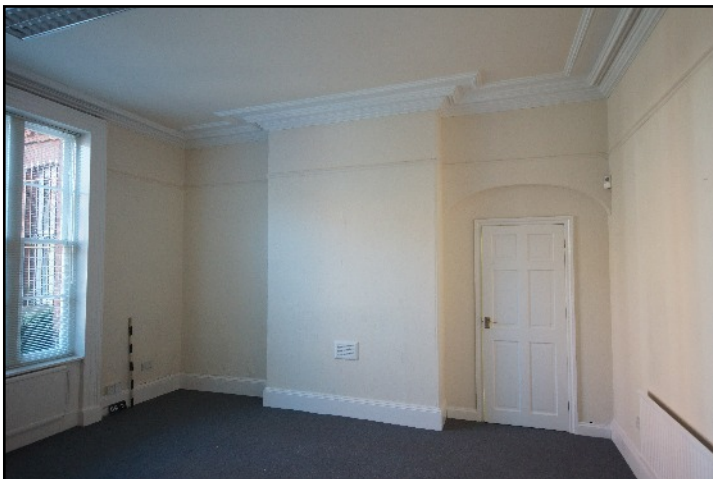
4.2.4 Room 09 was a high status room sharing the same cornice and picture rail as the room originally located behind Room 04. It also retains its boxed sash shutter and window architrave. The six panel door and architrave in the south wall is original, though the door in the east wall and much of the skirting board is modern.

**Plate 13:** General view of Room 09. The door into Hallway 08 is a later insertion, viewed looking north-east.

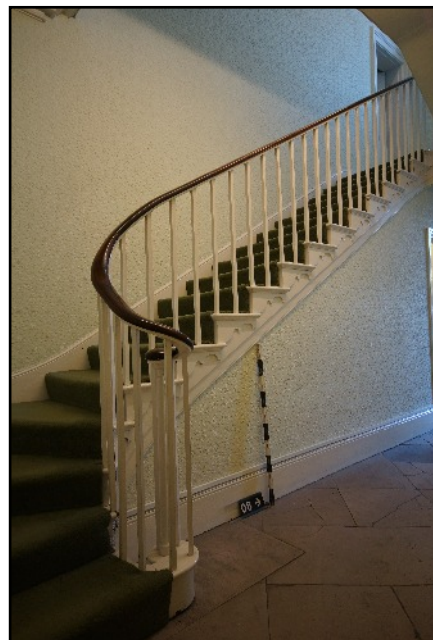
4.2.5 The York stone floor continues from the Entrance Hall 03 through into the L-shaped Hallway 08 which retains its cornice and skirting board. The open string staircase is typical of the Regency period with plain iron balusters resting directly on the treads, with decorative brackets, hardwood handrail and spiral end on the ground floor. In contrast, the Servants Stair 31, accessed directly from the West Range or through a doorway from Hallway 08, is a simple narrow straight flight of stairs with a plain wall mounted handrail. It is lighted by an original window, discussed above.

**Plate 14:** The staircase in Hallway 08, viewed looking north-west.

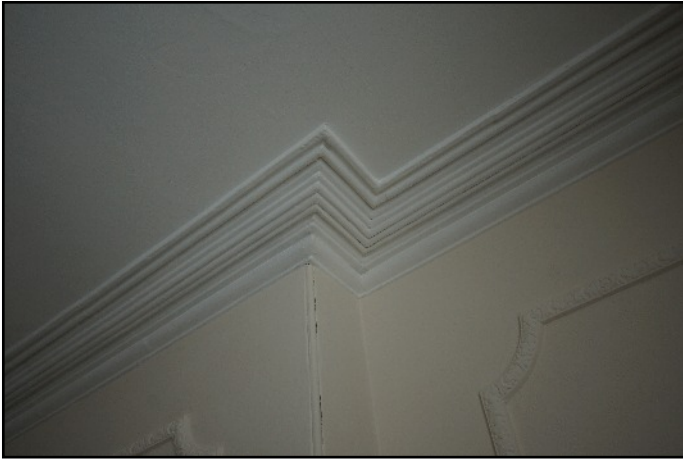
**Plate 15:** The plaster cornice in Room 25.

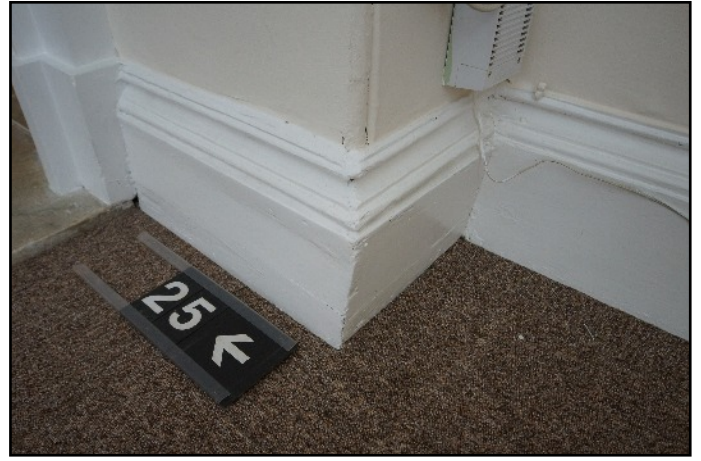
**Plate 16:** The skirting board in Room 25.

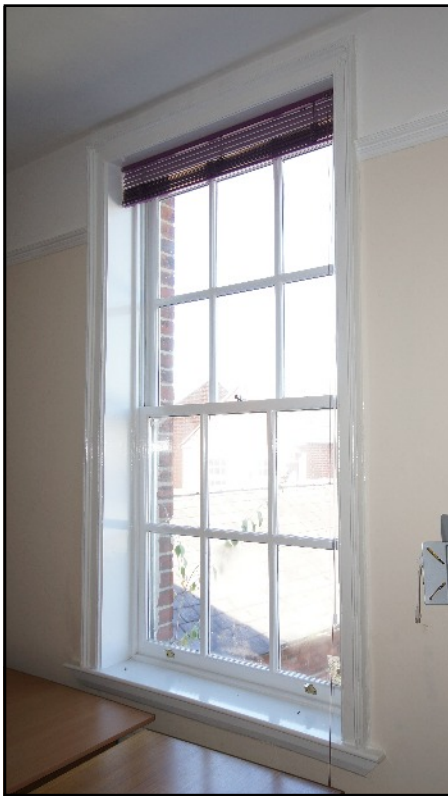
**Plate 17:** The modern window and original architrave and picture rail in Room 27.

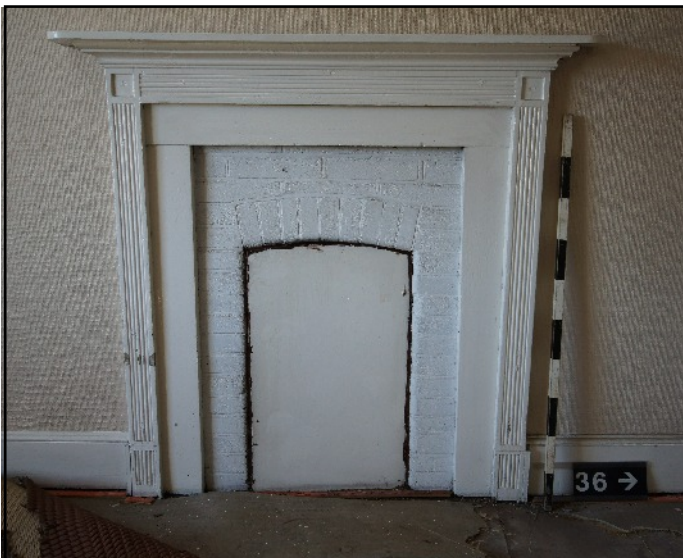
**Plate 19:** The Greek influenced fireplace surround in Room 36, viewed looking west

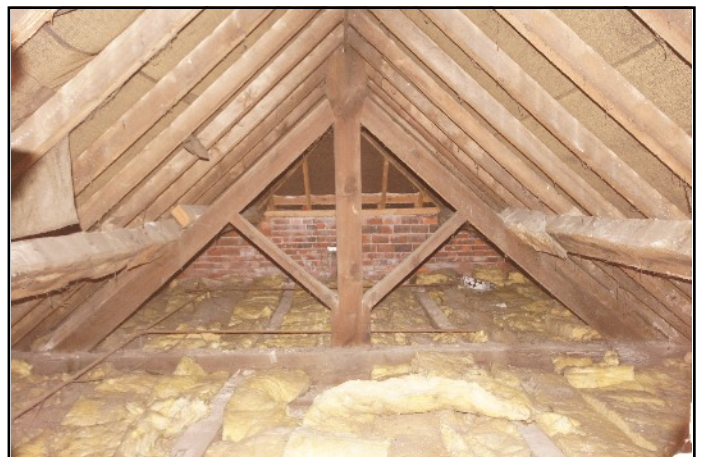
**Plate 20:** The king post roof over Room 26, viewed looking north.

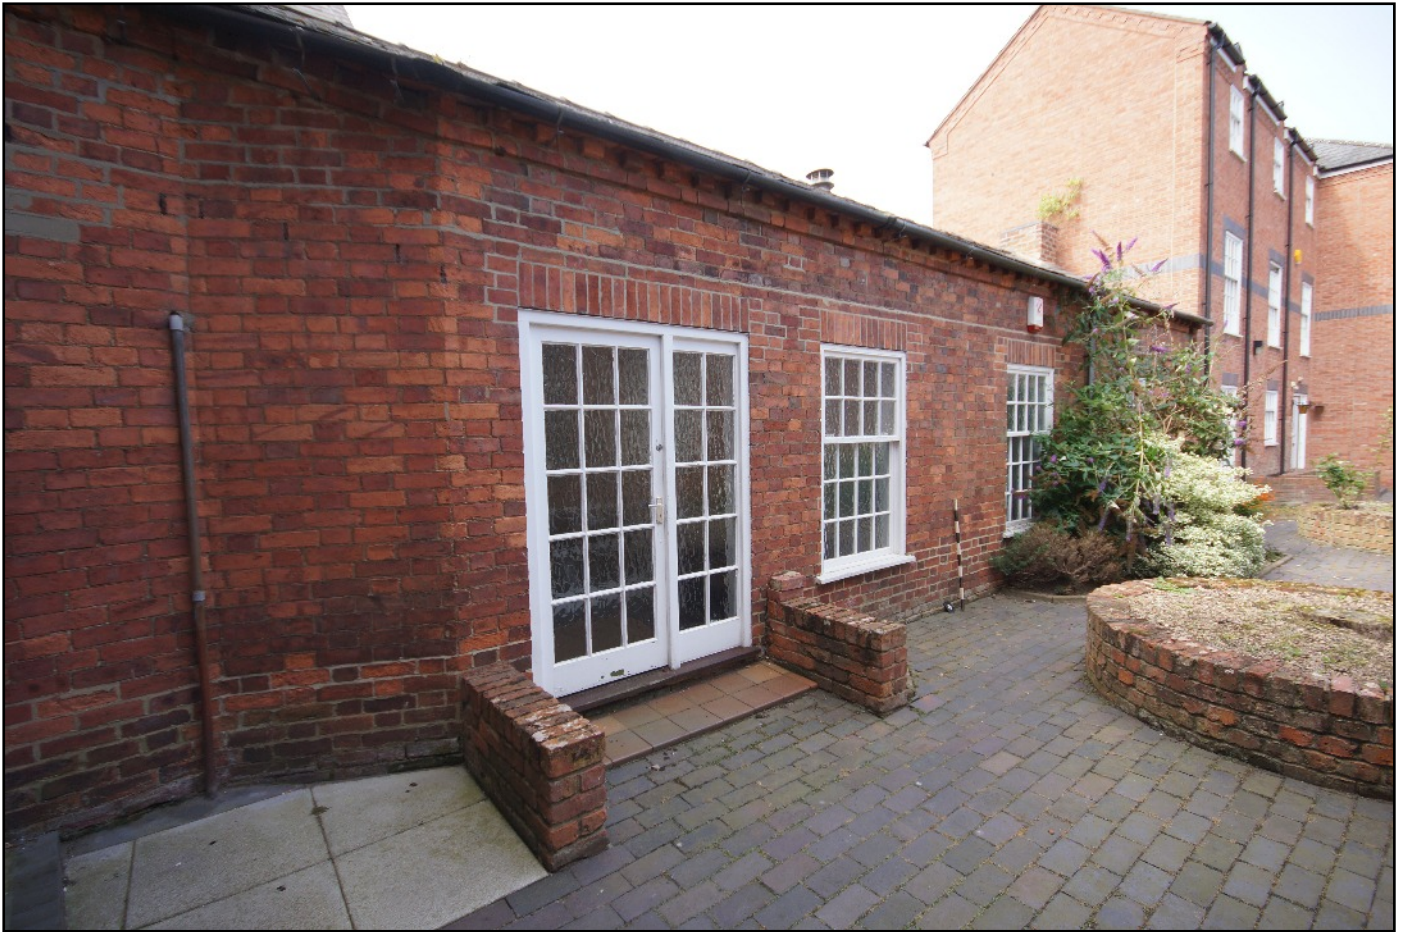
**Plate 21:** The east elevation of the West Range, viewed looking north-west.

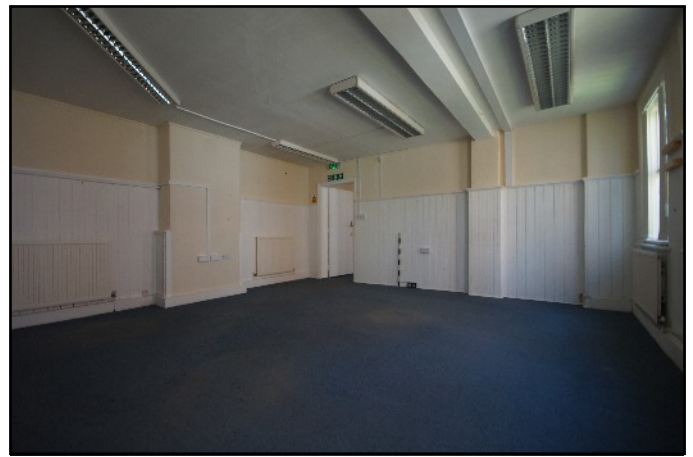
4.4.7 Phase III is a single room with timberwork identical to that found in Phase II. It too has a modern suspended ceiling.

**Plate 25:** The interior of the East Range Phase III Room 16, viewed looking south-east.

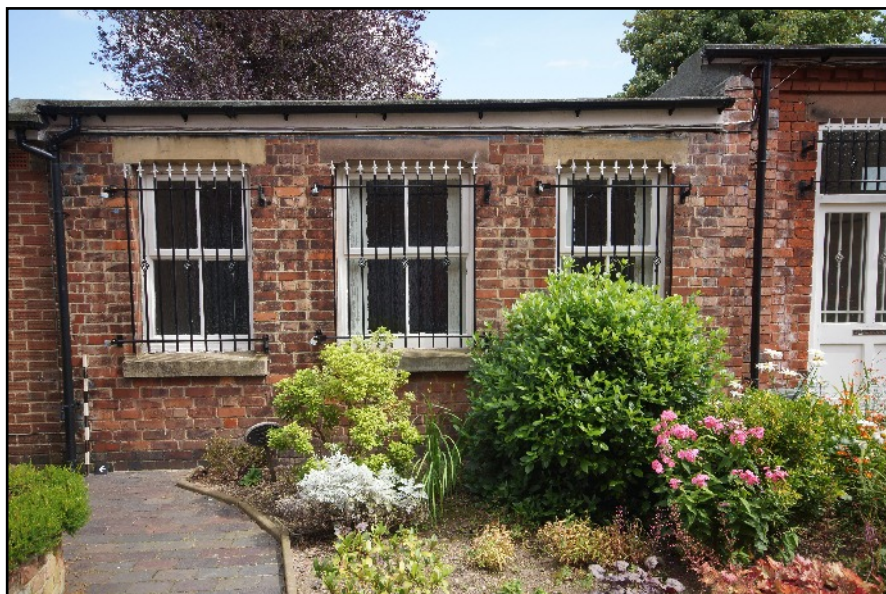
4.4.6 Phase III is located between Phase II and Phase IV. It is a single storey brick building of three bays. The bricks measure 9 x 4½ x 3 inches and are laid in Flemish bond. It has three windows similar to those found in Phase III. No dentil cornice is visible, though it could be present beneath modern timberwork supporting the guttering.

**Plate 26:** The west elevation of the East Range Phase III, viewed looking east.
