An Archaeological Watching Brief at the Church of St. Mary the Virgin, Nottingham

Report Number: 085/2017

Document Type: Final Report

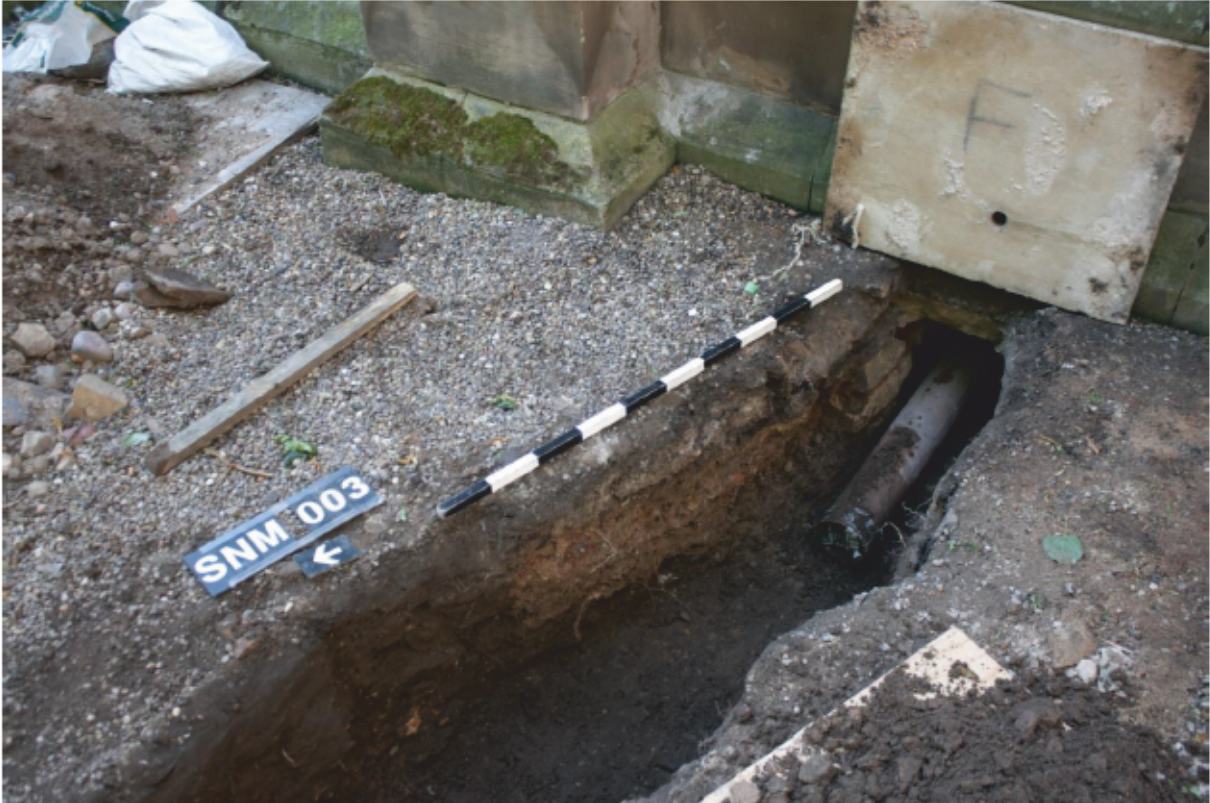
Plate 5: West facing section of the trench showing grave cut [0003], viewed looking south-east.

6.1.2 The foundations of the north wall of the Chapter House had been truncated by modern drainage (Plate 5).

6.1.4 Grave cut [0003] was located towards the southern extent of the trench and truncated deposit (0002) (Figs. 5 and 6; Plate 5). It was east to west aligned with vertical edges and measured 1m in width and greater than 0.5m in depth. The lower fill (0005) was comprised of dark grey silt loam with occasional inclusions of rounded pebbles. The upper fill (0004) consisted of light pinkish brown sandy silt loam with frequent inclusions of rounded pebbles. Two in-situ human femurs measuring 44cm in length were encountered in the lower fill (0005). A fragment of mid reddish orange roof tile with numerous small black iron oxide inclusions was also recovered from (0005). This fragment is undiagnostic and could be medieval or Post-medieval in date.
