Archaeological Excavations at the Confetti Building site, Convent Street, Nottingham

Report Number: 106/2019

TPA Project Code: NTC2

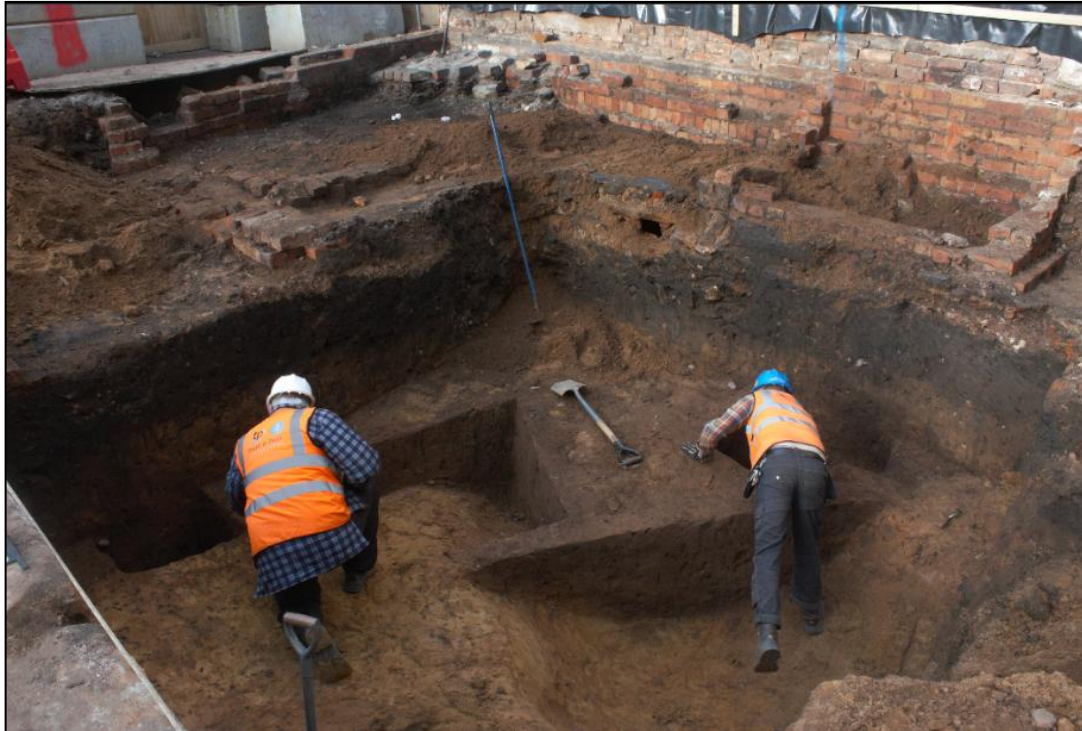
View looking to the northwest during excavation. Corn dryer [0104] can be seen in the foreground, with ditch [0106] running from the left of the image. Immediately above these features is the darker, 19th century made ground (0127). Modern structures are visible at the top of the picture.

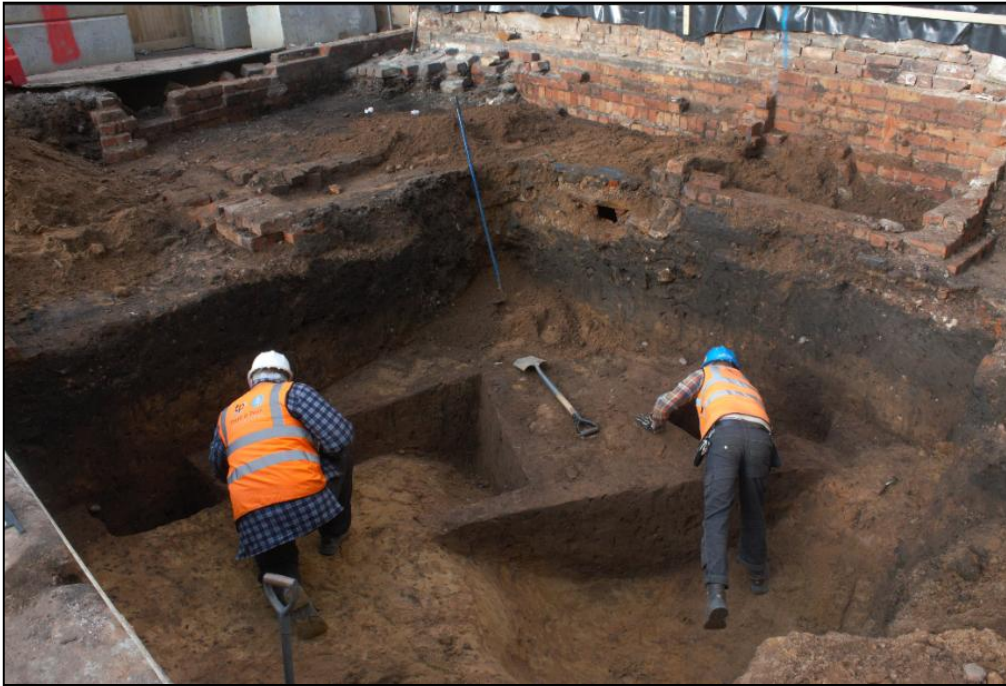
Plate 1: View looking to the north-west during excavation. Corn dryer [0104] can be seen in the foreground, with ditch [0106] running from the left of the image. Immediately above these features is the darker, 19th century made ground (0127). Modern structures are visible at the top of the picture

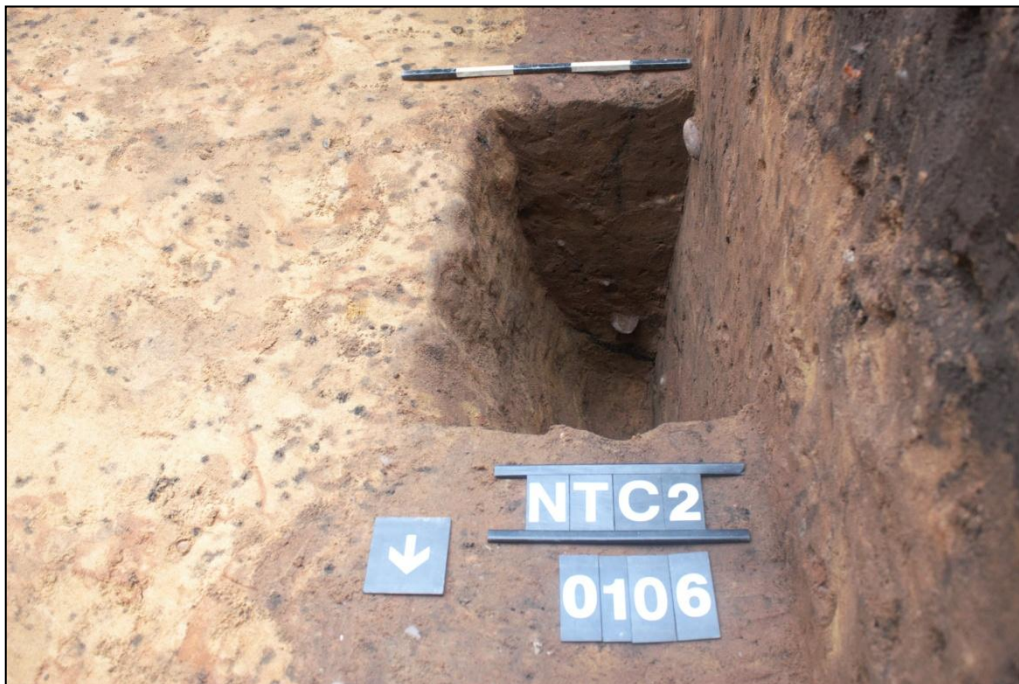
Plate 2: North-facing section of Ditch [0106]

- 6.8 The earlier of the ditches, [0106] was aligned south-south-west to north-north-east, and was observed for a length of approximately 2.5m (Figure 2a, Plate 2). It was sectioned in three places, a north-facing section, a corresponding south-facing section 0.3m to the north of this, and an east-facing section about 1.2m to the north. A full profile was not obtained, but an approximately half section was seen (Figure 2a, Figure 6a – Drawings 1-3, 5), suggesting that it would have been at least 0.8m wide and, at its northern end, was at least 1.4m deep. It had steeply sloping, near-vertical sides and a concave base. The primary fill, seen in the north and east-facing sections, was (0137), a light yellow-brown sand, with occasional charcoal flecks, between 0.04-0.1m thick. This fill contained pottery suggesting a mid-12th to mid-13th century date (NSP - Sandy, DNEOT, Peterborough-type Shelly ware), along with a fragment of brick/tile. It was overlain by a thin black silt with frequent charcoal (0136), which had also been deposited from the eastern side of the ditch, although it appeared to terminate within the east-facing section. However, neither fill was present within the south-facing section. Instead, the basal fill there, (0135), was a light brown sand with occasional charcoal and small stones, but with no finds. This is the same fill that covered (0136) and (0137) in the east-facing section. All of these contexts seem to have slumped in from the eastern side of the ditch.

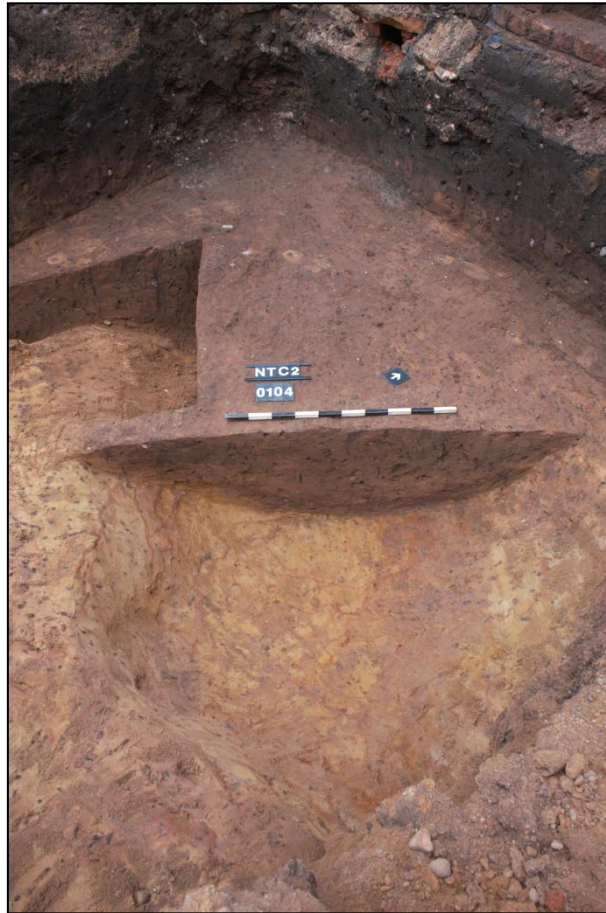
Plate 3: View of south-east facing section across probable corn drier [0104]. The rough oval shape can be seen, in addition to two possible stake holes at the bottom left-hand corner and traces of burnt reddish sandstone within the cut.

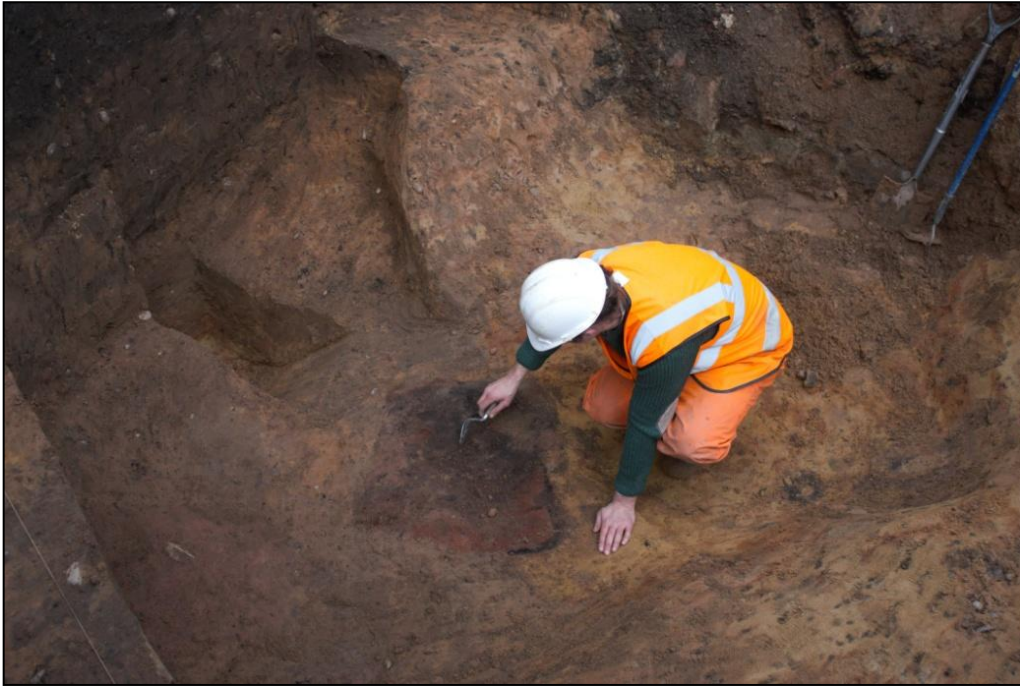
Plate 5: Working shot, looking northeast, of area over burnt area [0236] and posthole [0243] being excavated. Ditch [0108], which can be seen running from the top left the image towards the middle of the bottom edge, partly truncates [0104].

- 6.11 At the base of the north-western end of the feature was a slight hollow, originally recorded as a cut [0236] (Figure 2a, Figure 6a – Drawing 6; Plates 4-6). Over this was (0242) a layer of charcoal and burnt material and then (0237) a reddish-orange-brown sandy silt, up to 0.05m thick. The deposit recorded in the field as (0241), which appeared to be a basal deposit, instead appears to represent parts of (0237), which have filtered down through (0242). Archaeobotanical analysis of remains retrieved from (0241) indicated the presence of significant quantities of cereals and weed seeds. These suggest that the deposit represents the remnants of waste, possibly from crop processing.

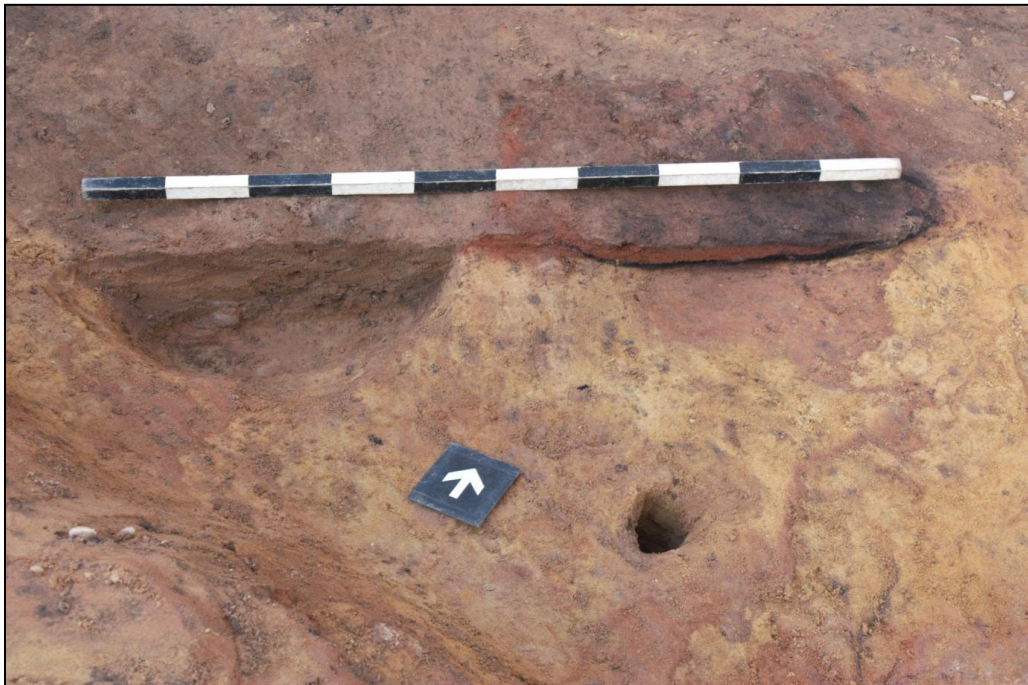
Plate 6: South-east facing section through posthole [0243] and burnt area [0236], with stake hole [0235] towards the bottom right of the image.

- 6.12 Abutting this area of burnt deposits was [0243], a small, circular posthole, measuring 0.54m in diameter and was up to 0.22m deep. It had an asymmetrical profile and a slightly concave base. Approximately 0.3m to the south-east of these features was [0245], a stakehole of 0.1m diameter. The fills of both of these features, (0244) and (0246) respectively, were similar, being greyish-brown silty sands, with no finds. These were similar to (0117), which was 0.08m thick and covered the base of [0104] and it may be that they were all in fact the same deposit. From this context came seven sherds of pottery (NSP type, STANLY), suggesting a date between the mid-12th to mid-13th century.

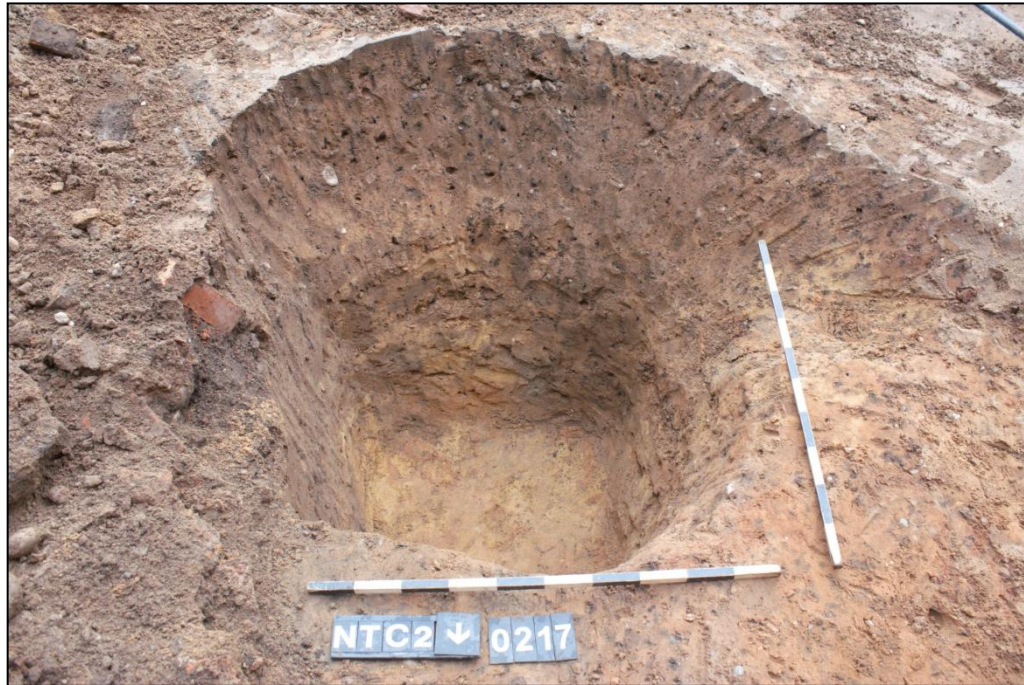
Plate 7: View of pit [0217], looking south. The construction cut [0295] for surface [0267] can be seen at the bottom and bottom right of the picture.

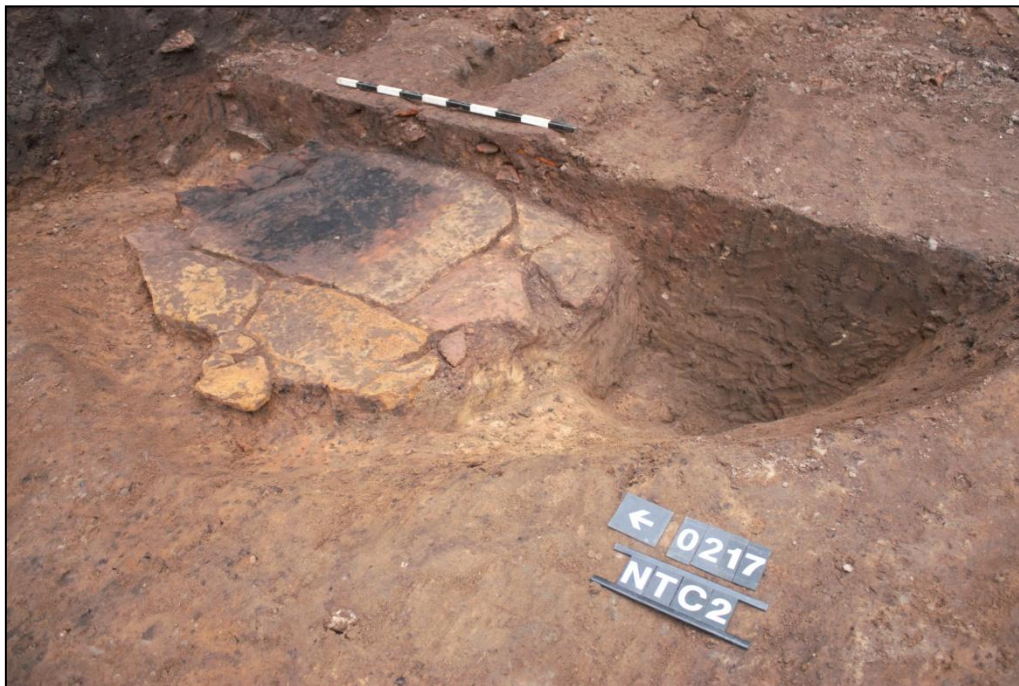
Plate 8: Oblique view of west-facing section across pit [0217] and stone/tile surface [0267]

- 6.19 Sandstone platform [0267] overlay levelling layer (0269) in cut [0295] (Figure 2b, Figure 6b – Drawing 8; Plate 8). Construction cut [0295] was oval in plan, over 2.2m long by 1.1m wide and up to 0.3m thick, though the eastern extent lay beyond the limit of excavation. Above this was fill (0269), apparently a levelling layer, was a thin deposit of mid-grey silty sand and pebbles. The platform itself was 1.41 metres long and 1.08 metres wide, although it was at least partially damaged, or partially dismantled. The hollow area around the western and northern sides of this cut indicate that further stones/tiles would have been present, perhaps forming some form of wall around the surface itself. The surface consisted of 11 individual flag stones and tiles surrounding a large central flag stone and was irregular in shape, although the surface extended beyond the section, as well as some stones/tiles likely having been removed. The central flagstone and the tiles arranged along its northern side had clear scorch marks and the stone and tiles themselves had also been heat affected.

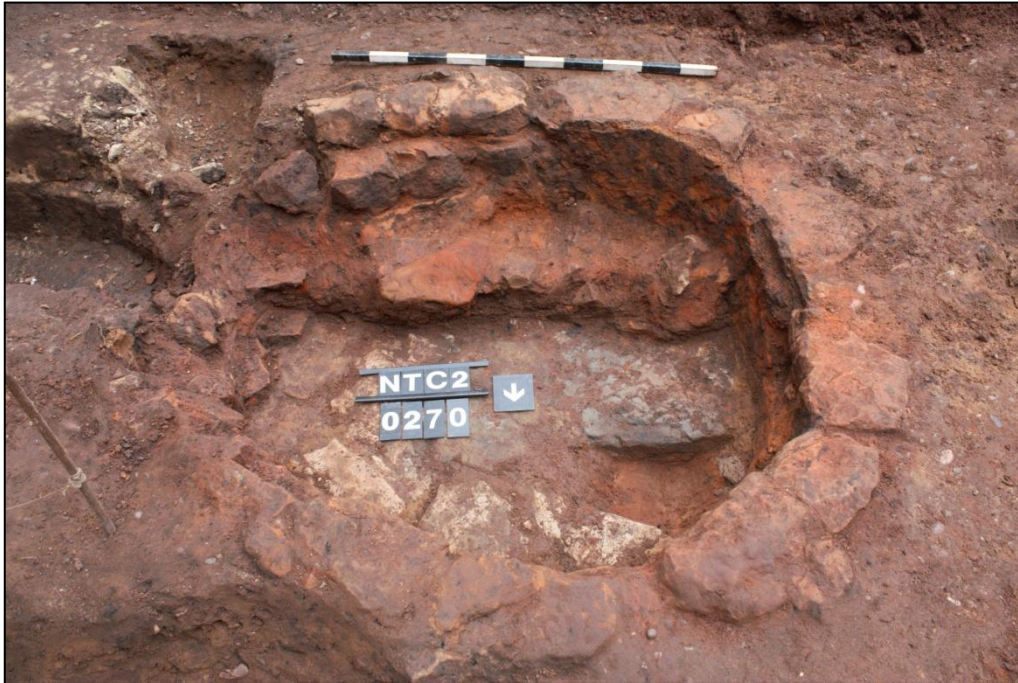
Plate 9: North-facing section through chamber of probable corn dryer [0207], showing red clay fill (0270), probably representing part of the collapsed superstructure

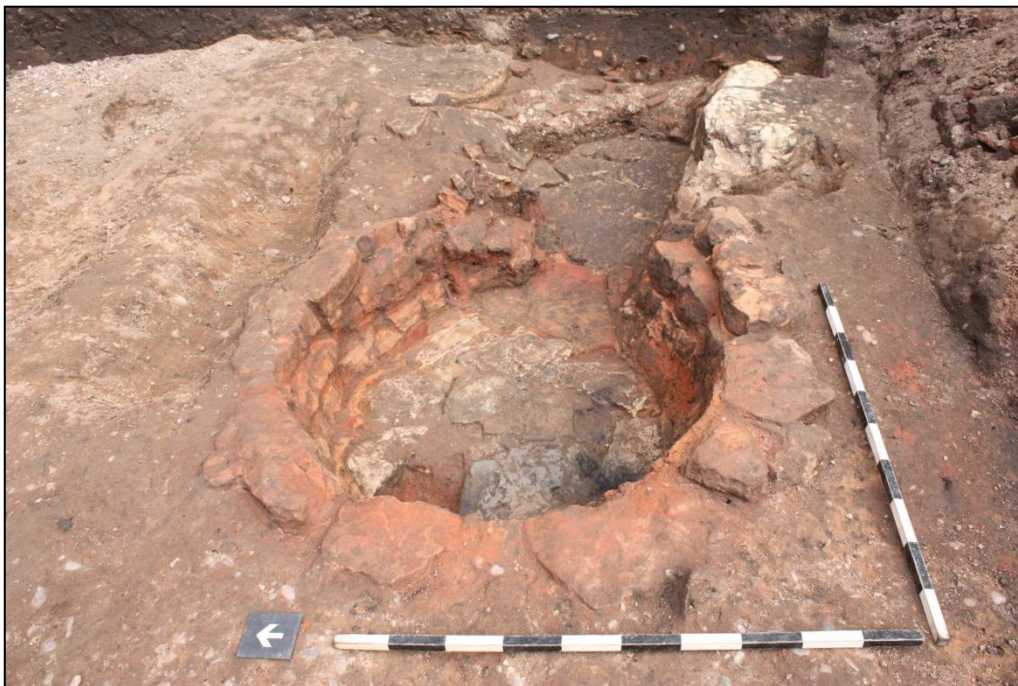
Plate 10: Looking east, with chamber of [0207] in the centre and flue extended beyond it towards the top of the image

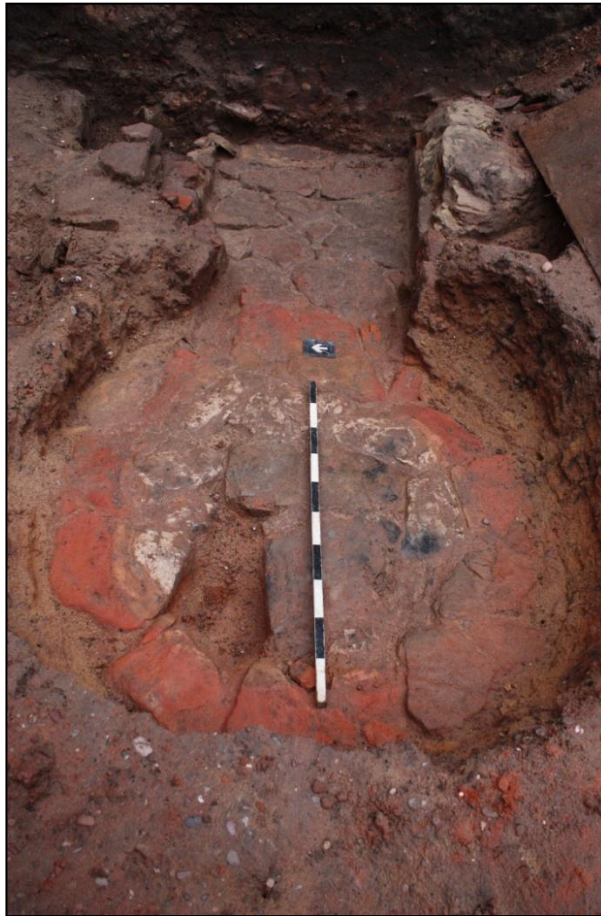
Plate 11: Looking east, with stones of wall around chamber of [0207] having been removed.

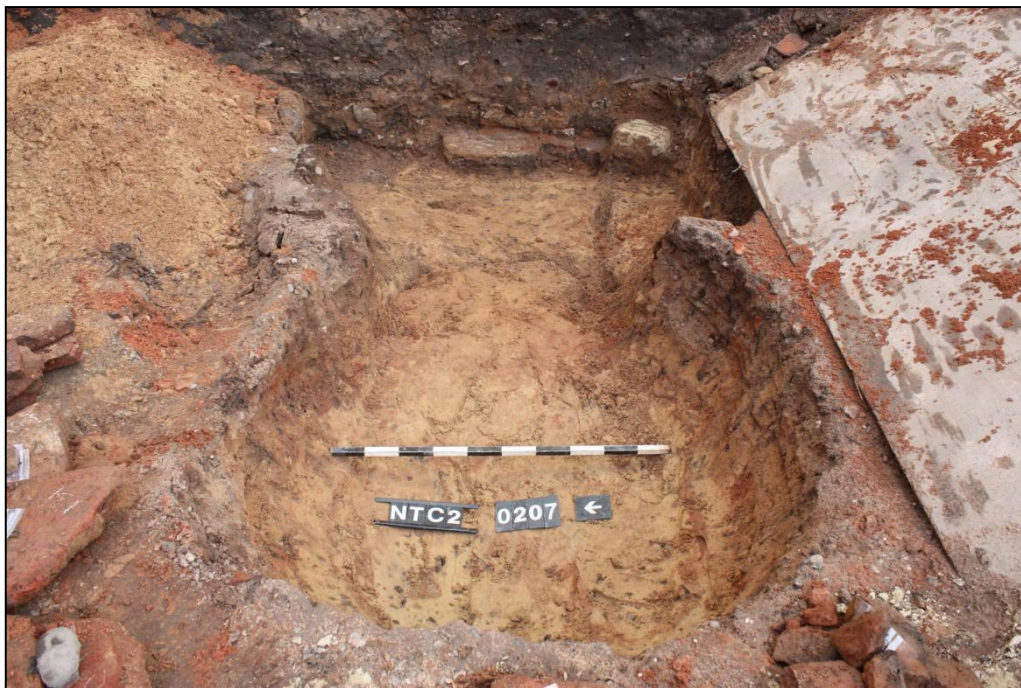
Plate 12: View of cut [0300] into natural bedrock for corn dryer [0207], with all stones removed, looking east.

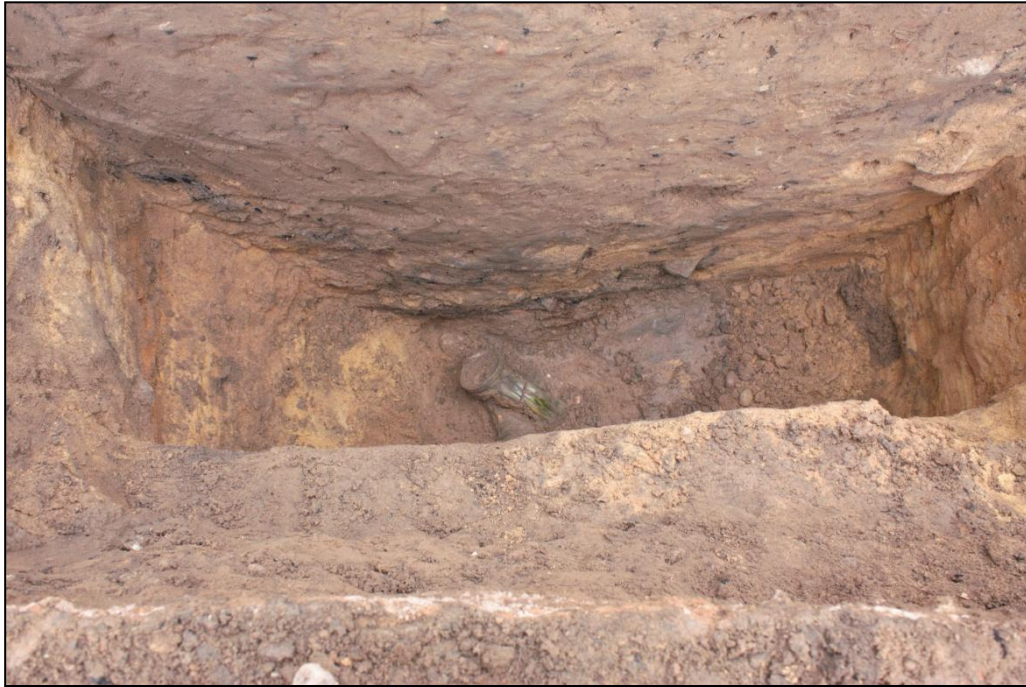
Plate 13: Mid-excavation shot of green-glazed jug found within fills of ditch [0273]. The south-facing section of the ditch is visible at the top of the image.

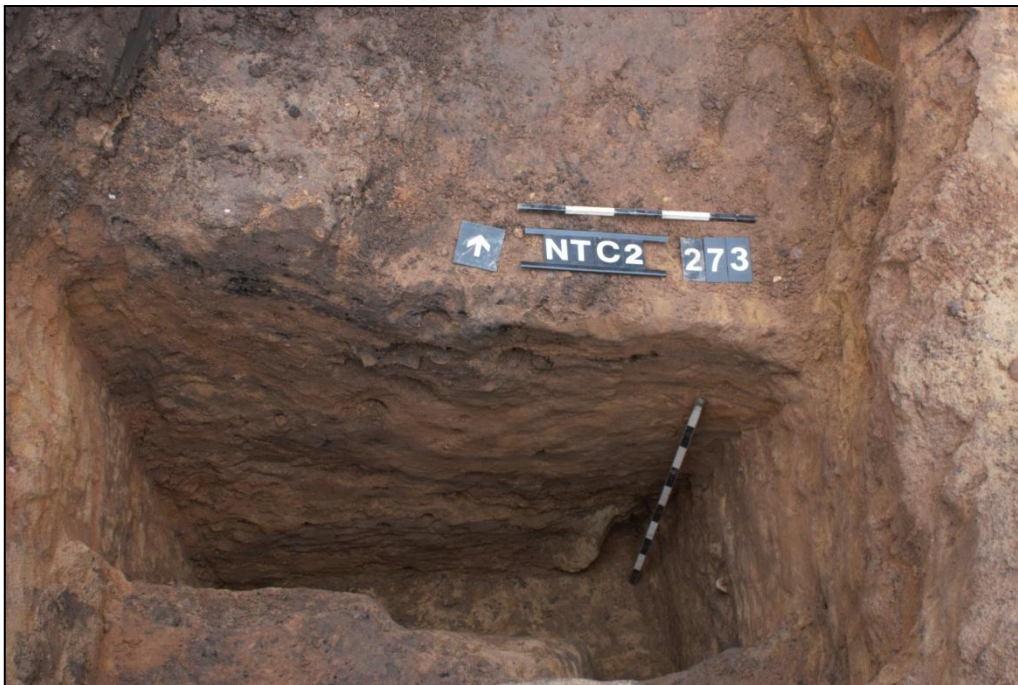
Plate 14: View of lower parts of south-facing section of ditch [0273]

- 6.27 This feature was near the western border of the site and ran broadly on a north-north-east to south-south-west alignment. It was on a similar but slightly different alignment to [0106]; the relationship between these features is uncertain but associated pottery suggests that [0273] was later. Only a 1.5m long stretch of this ditch could be observed and part of the western side had been truncated by the cut [0055] for a concrete manhole. It was over 2.5m below the stripped ground surface. Seen in the south-facing section, near its surface, it had slightly asymmetrical sides, the west side being steep and the east side being convex (Figure 2b, Figure 8b – Drawings 13-15; Plates 13-15). However, after about 0.5m, both sides were steep and near vertical, before reaching a flat base. By contrast, the north-facing section showed that a block of the natural sandstone had been left in the centre of the ditch, with channels created either side of it (Plate 14).

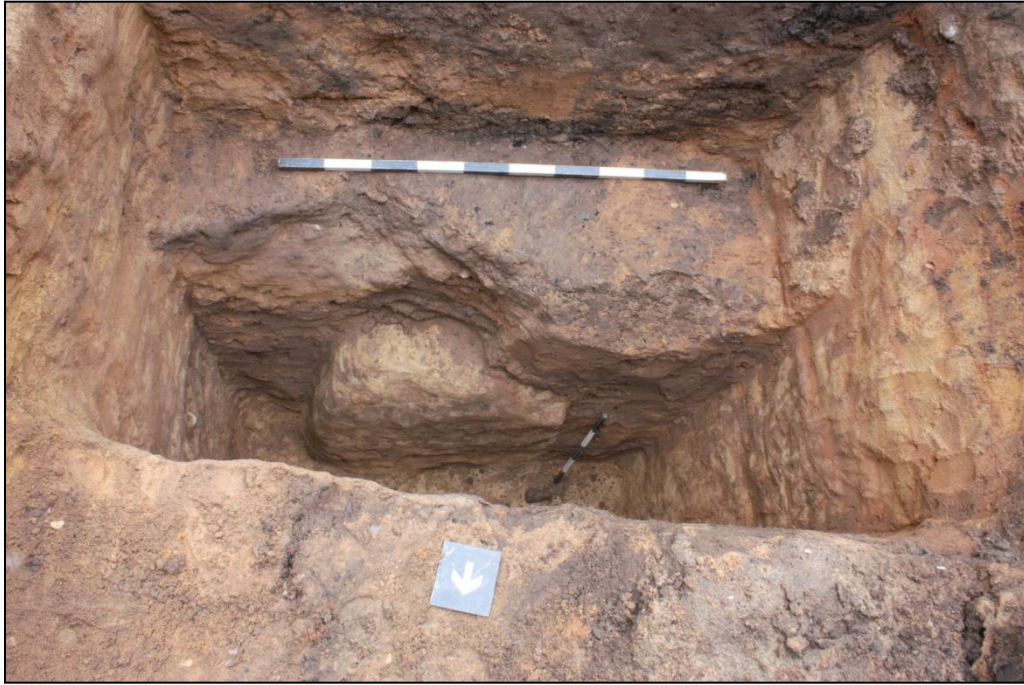
Plate 15: View of lower parts of north-facing section of ditch [0273], showing sandstone bedrock protrusion at base of ditch.

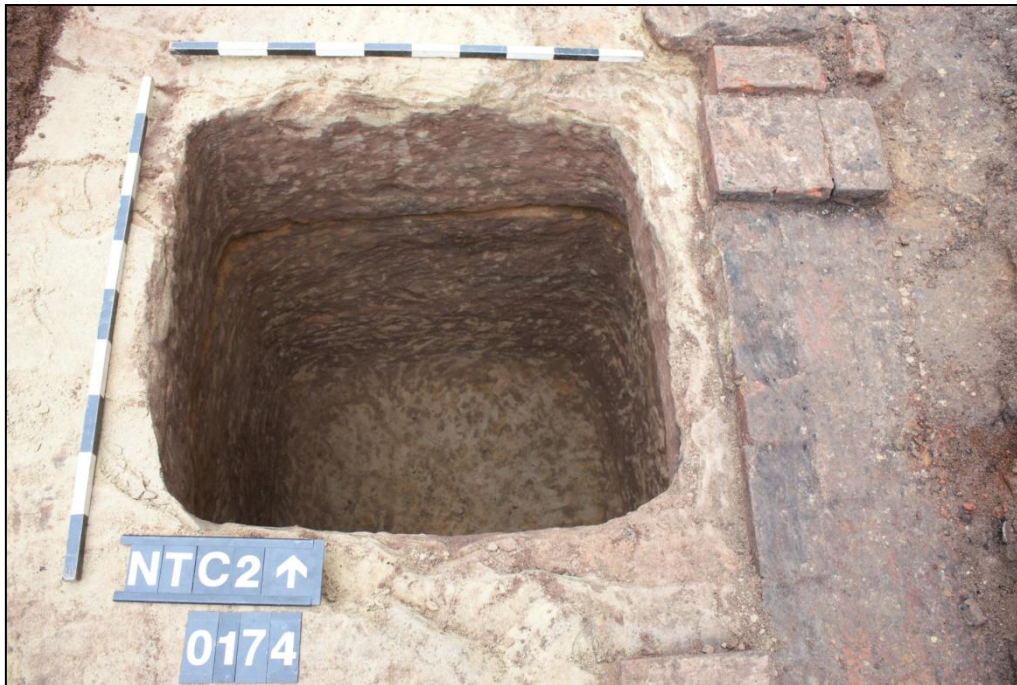
Plate 17: Post-excitation view of pit [0174], taken from the south side of the feature. Phase 3 wall [0188] can be seen on the right-hand side of the image.

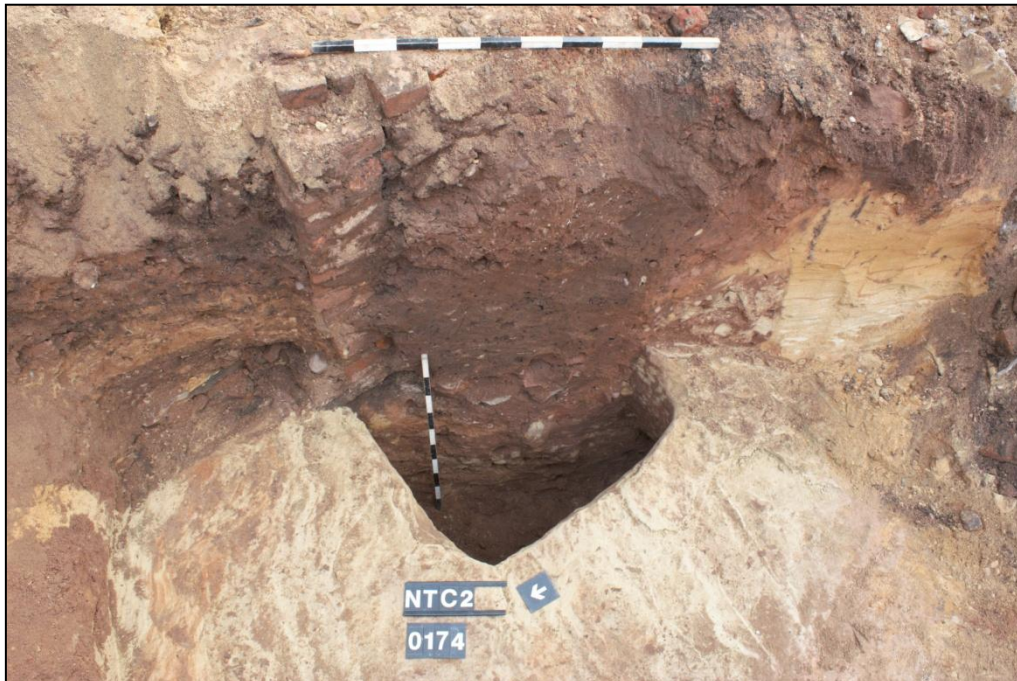
Plate 18: Mid-excitation view of pit [0174], looking southeast. The truncation of the feature by construction cut [0150] can be seen.

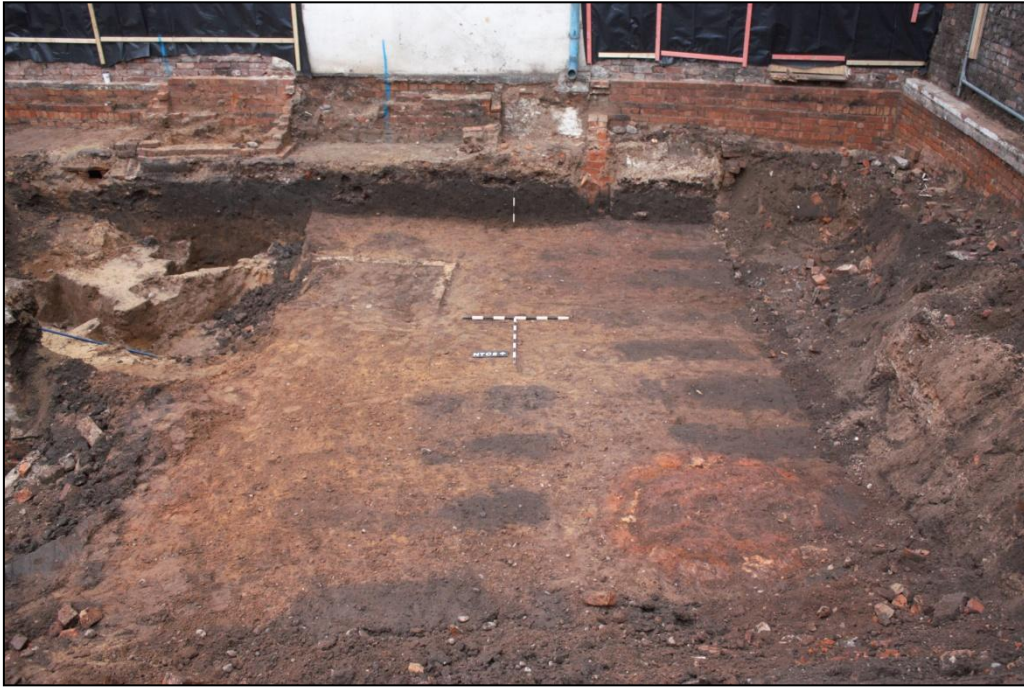
Plate 19: Pre-excavation view of Phase 2 features, the dark fills of which can be seen across the centre of the image. The upper parts of Phase 1B corn dryer [0207] can be seen at the bottom right-hand corner, with Phase 3 cellar [0025] towards the top, right-hand corner.

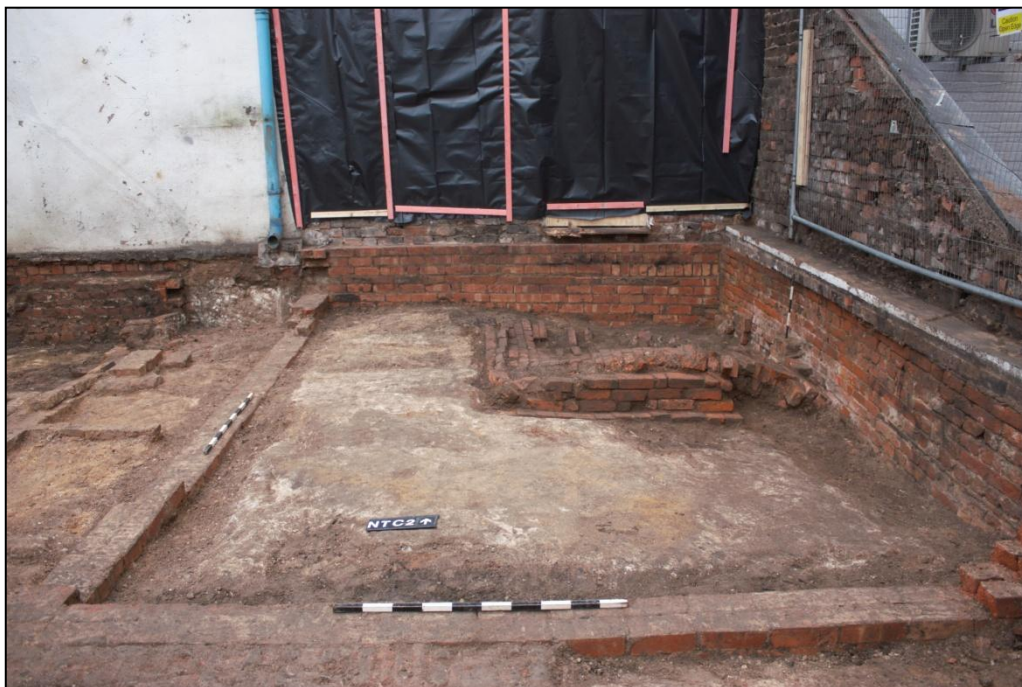
Plate 22: Looking north, view of floor (0023), cut by Phase 4 walls [0016] (running from bottom left towards centre of picture) and [0022] (running across the bottom) and brick vault [0010]. Floor (0024), which is probably a continuation of (0023), can be seen on the left-hand side.

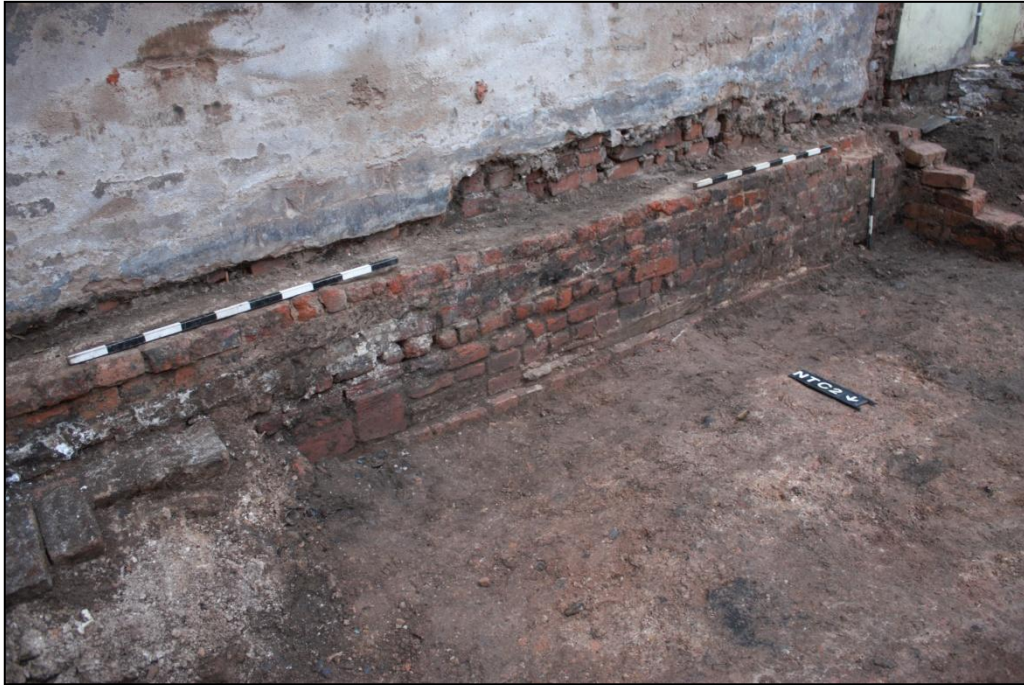
Plate 23: View of elevation of Phase 3 wall [0086], looking towards the southeast.

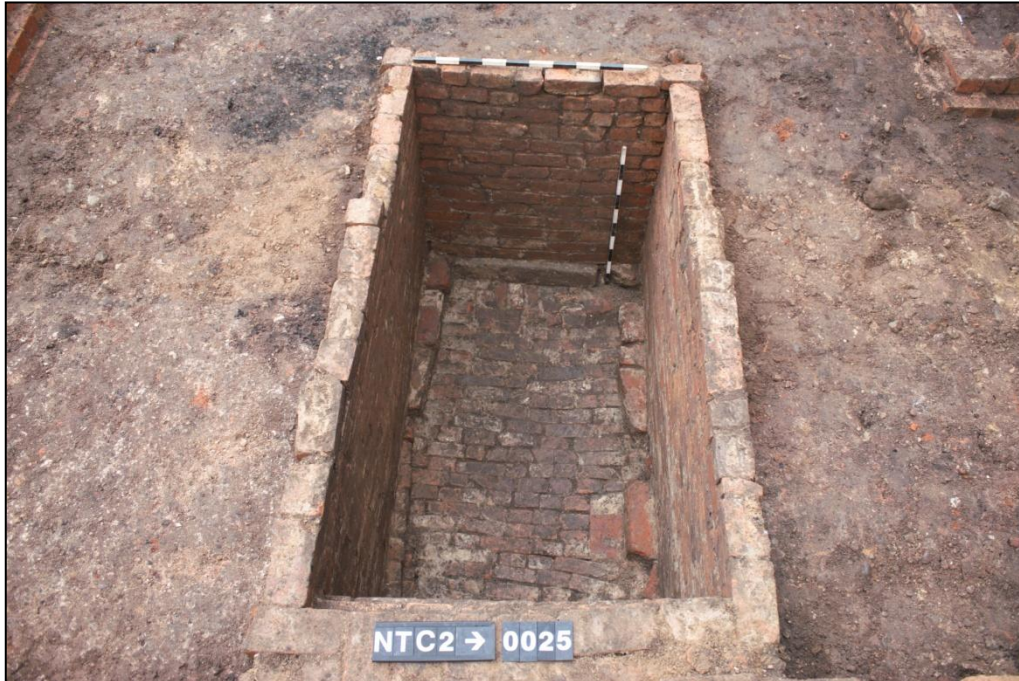
Plate 25: View looking into cellar [0025], taken from eastern side of cellar.

- 6.56 Abutting wall [0019] to the west was Victorian (based on brick thickness of over 3 inches) cellar [0025] (Plate 25). The construction cut for this was [0028], at the base of which was (0029), a loose, yellow-orange sand that served as a bedding foundation for the cellar walls themselves. The cellar itself consisted of a single skinned tied-in rectangular wall, measured 2.8m long by 1.3m wide, and a maximum depth of 3.75m, coming down to a brick and mortar floor [0032] (Figures 3b and 10b). Traces of whitewash were on the walls, and a total of 15 courses of brick were surviving. Directly above the cellar floor, reused bricks had been used as a platform for the vertical courses, and consisted of a reused lintel and other bricks [0030]. The presence of whitewash on the walls could indicate its use as a coal store, although there were no traces of coal dust, perhaps suggesting it was a cold store connected with the slaughterhouse. The lower infill of the cellar, context (0020), was a mid-brown silty sand with frequent stones, that was similar to made ground layer (0045) (see below). It contained a range of pottery, including Georgian material (Creamware, Pearlware), but the majority suggesting a 19th century date (Banded ware, BGCW, Cane Coloured Ware). It is likely that the earlier material was residual, perhaps disturbed when the building associated with the cellar was being demolished, or represents pottery retained for some time before deposition. A small collection of CBM also came from this context.

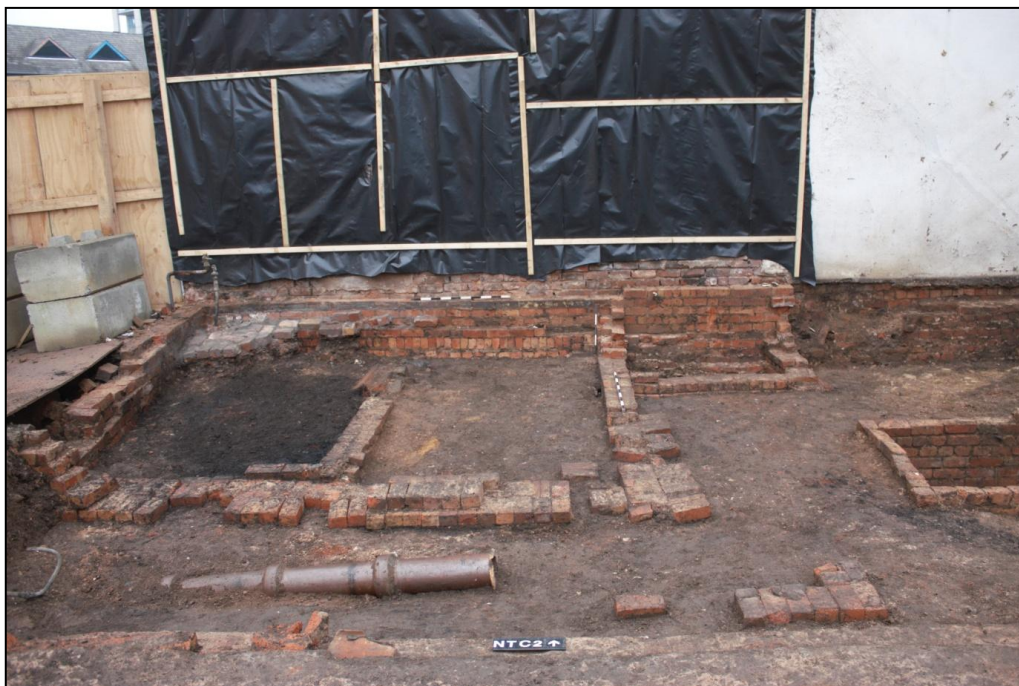
Plate 26: View looking to the north of Phase 4 walls [0037], just to the north of the drain pipe and [0040], extending from [0037] to site boundary, with Phase 3 walls [0038] and [0042] within them.

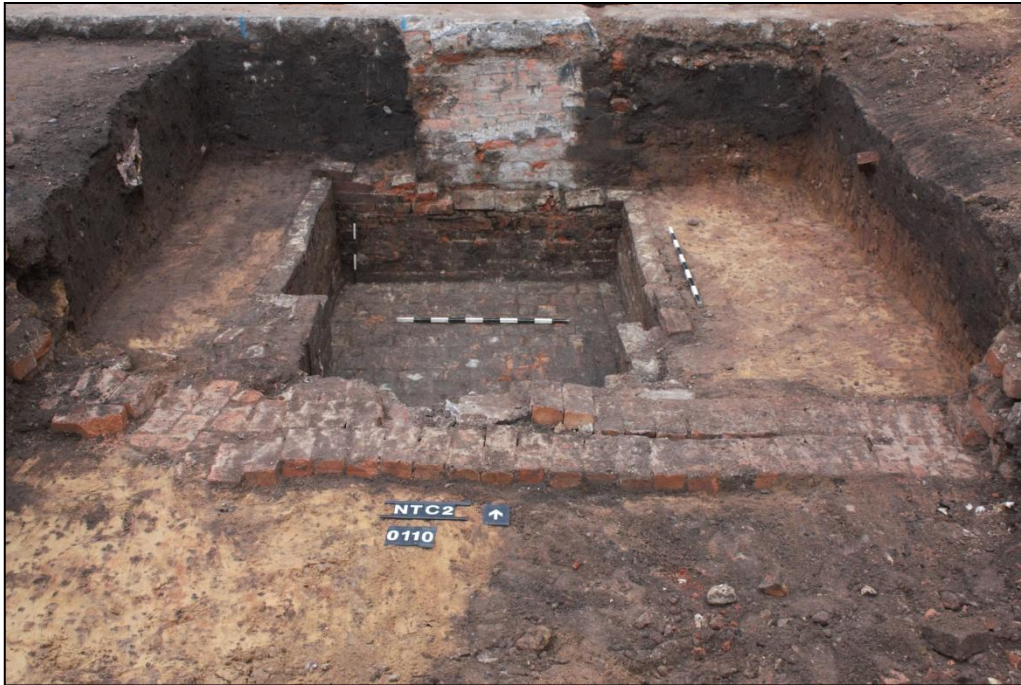
Plate 27: View of Phase 3 cellar [0110], looking towards the north, with Phase 4 wall [0081] running across the centre of the image.

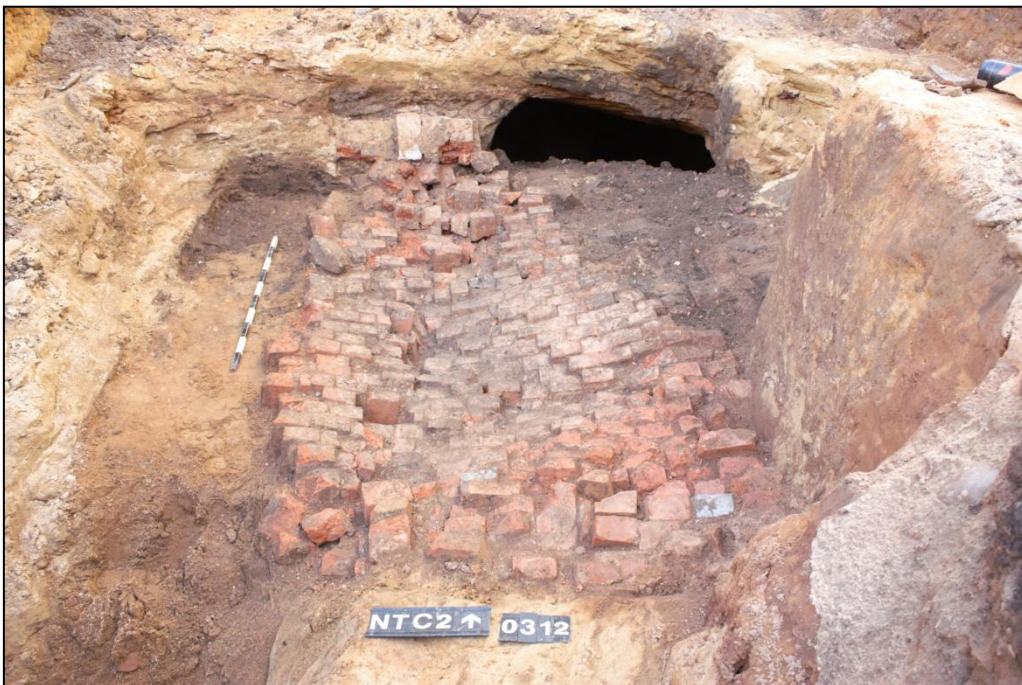
Plate 30: View of brick vault [0312], looking towards the north. The bases of the vault can be seen adjoining the bedrock at the top of the picture.

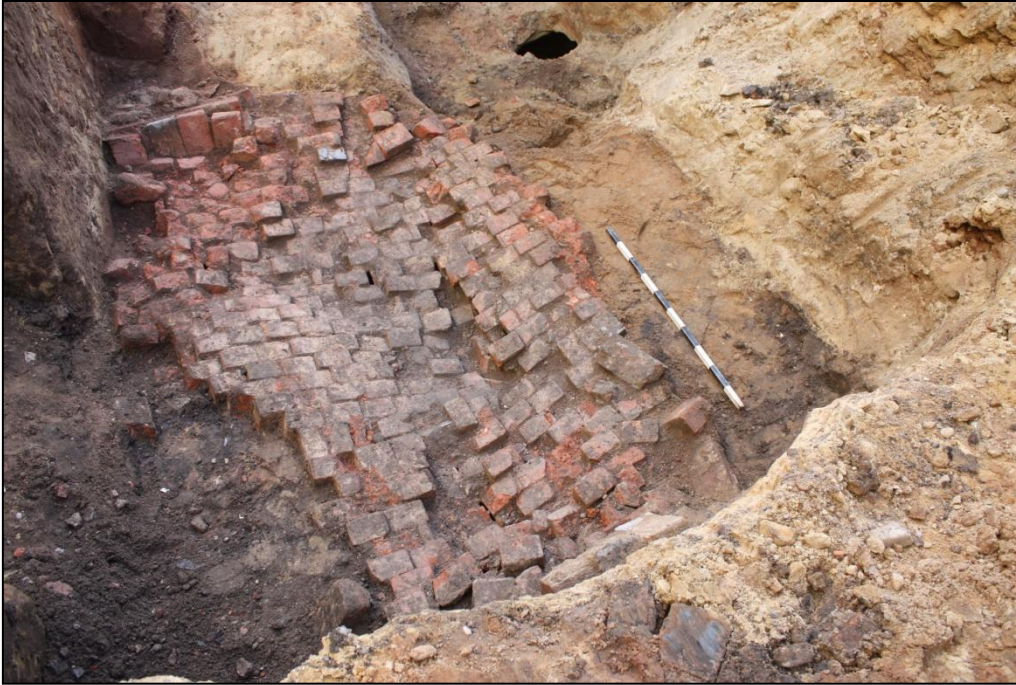
Plate 31: View of brick vault [0312], looking towards the southwest. The bases of the vault can be seen adjoining the bedrock at the top left-hand corner of the picture.

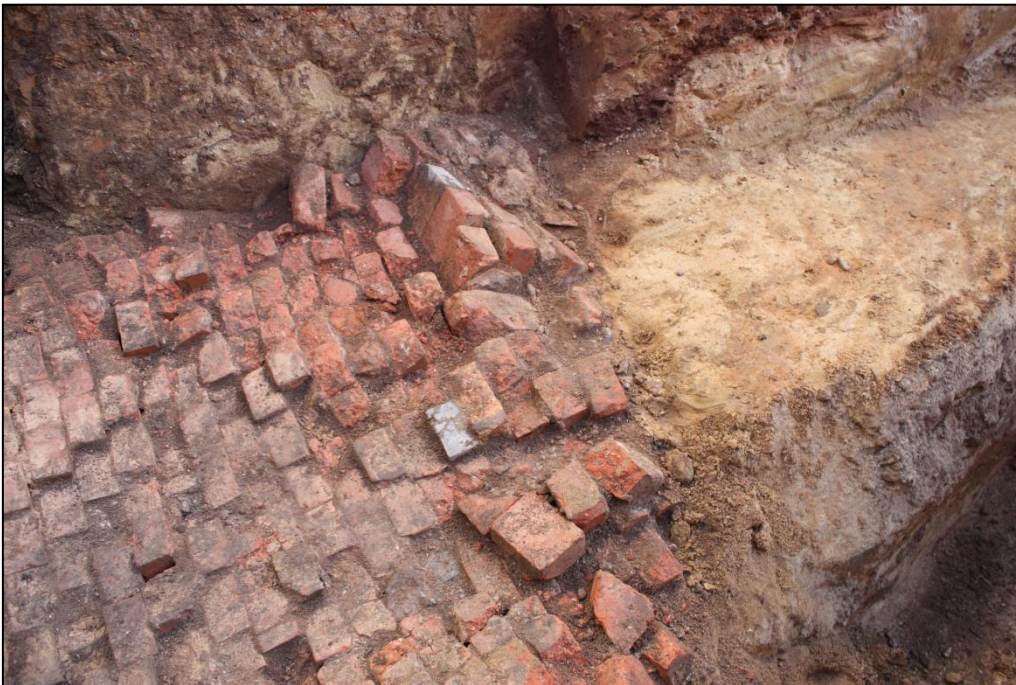
Plate 32: Detail of base of brick vault [0312], where it adjoins the bedrock on the southern side of the structure, showing the angled bricks in situ, with the rest of the vault having collapsed.

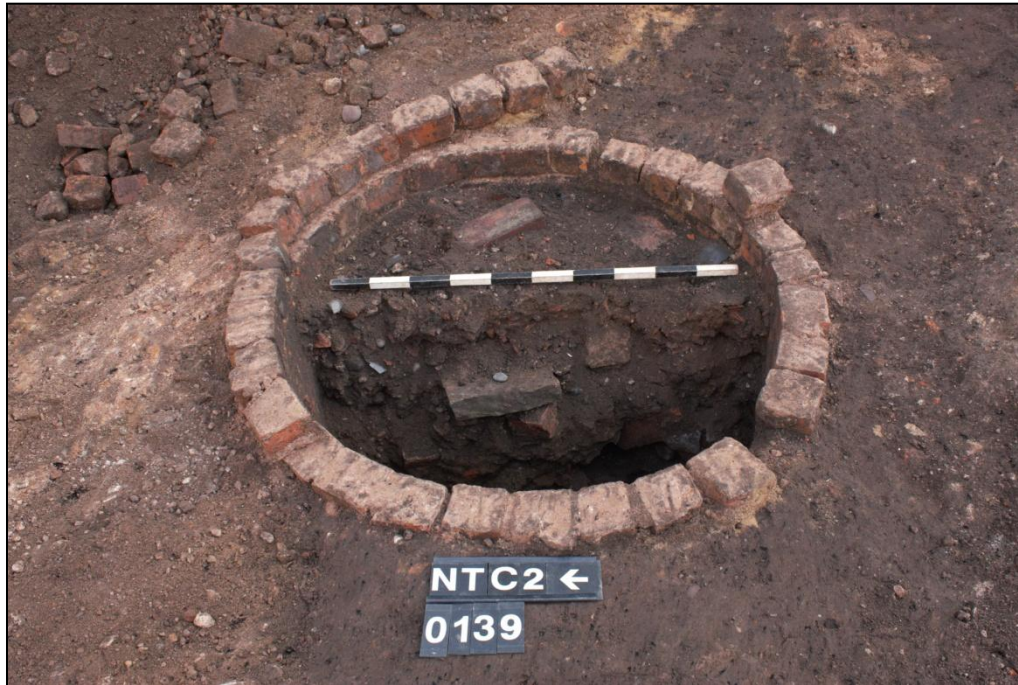
Plate 33: West-facing section through shaft [0139], showing its fill (0140), containing large pieces of CBM.

- 6.63 Situated between modern walls [0067] and [0144] was a circular brick feature, [0139], formed of a single course of bricks and measuring 1.965m in diameter (Figure 10d – Drawing 38; Plate 33). It was originally assumed to be a Victorian well, but instead appears to be related to the cave beneath this area, perhaps as a ventilation shaft, or for raising/lowering barrels between the cellar. The bottom of the shaft, near where it joined the cave, was filled by (0154), a loose, dark grey silt with frequent CBM, which also produced a sherd of Redware type pottery (dating from the 18th to early 19th century). Above this was (0140), a mid-brown silty sand, containing Banded Ware, Brown Salt Glazed Stoneware, Cane Coloured Ware, Stoneware and Whiteware, consistent with a 19th century date. The glass from this context is broadly consistent with this, albeit it of a late 19th century date, although there was mid-20th century glass present. The latter is potentially intrusive, or the result of later (modern) disturbance.

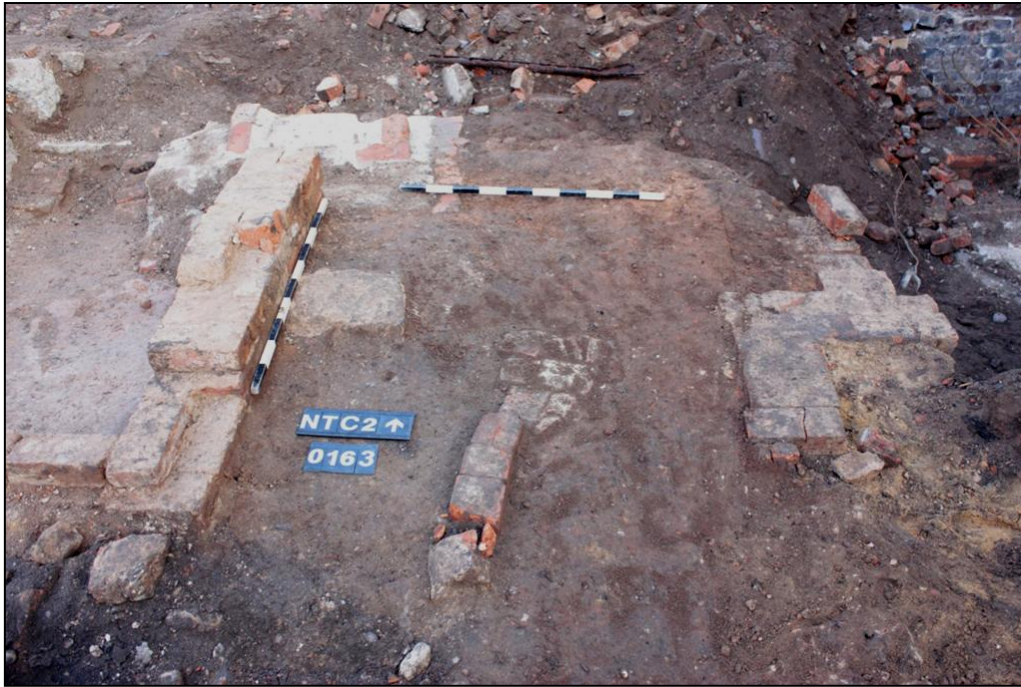
Plate 35: View of easternmost part of wall [0138] (on left), with possible floor [0163] in centre and wall [0188] on the right, together possibly a passageway through the Woodlark public house.
