Archaeological Excavations at the Confetti Building site, Convent Street, Nottingham

Report Number: 106/2019

TPA Project Code: NTC2

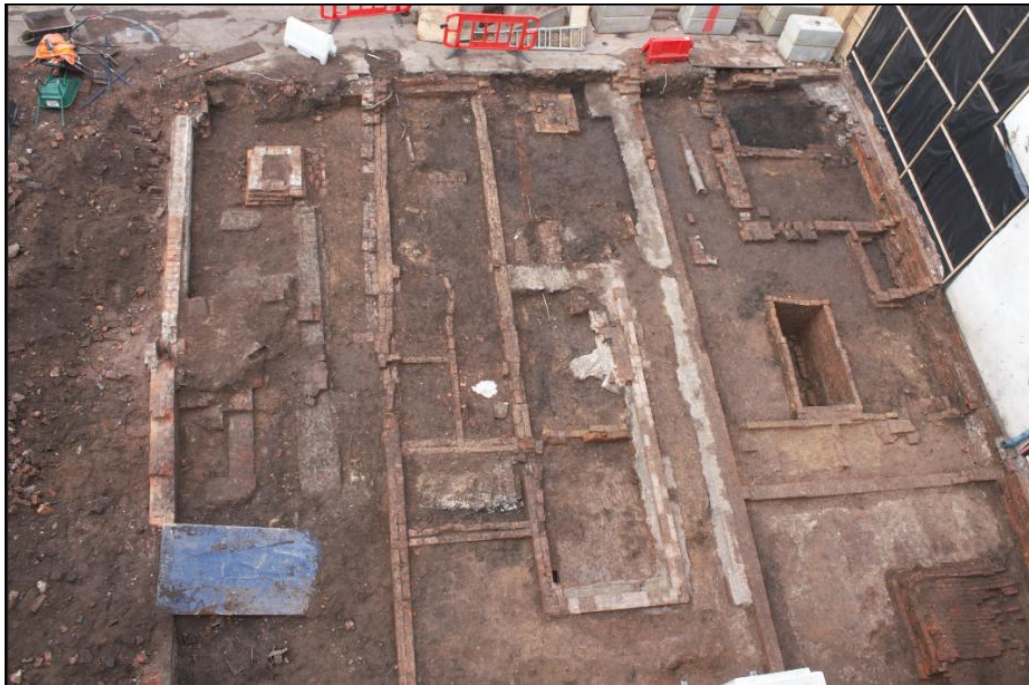
Plate 36: Aerial view of the northern end of the site, looking from the east, showing a mixture of Phase 3 and 4 features. Wall [0022] can be seen running from the top to bottom of the picture on the right hand side, with [0016] extending off of it. In the centre of the picture are Phase 4 features, including wall [0060] just to the left of centre, with [0060] near the left-hand side.

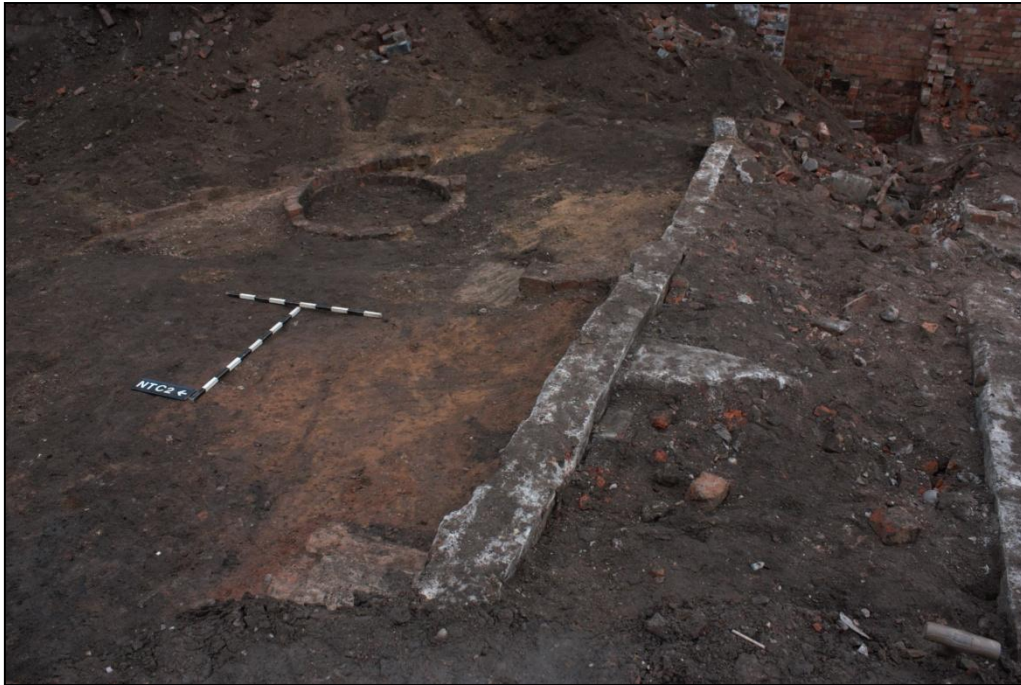
Plate 37: Looking towards the northeast, view of walls [0143] and [0144] on right-hand side, with ventilation shaft [0139] towards the top, left-hand corner.

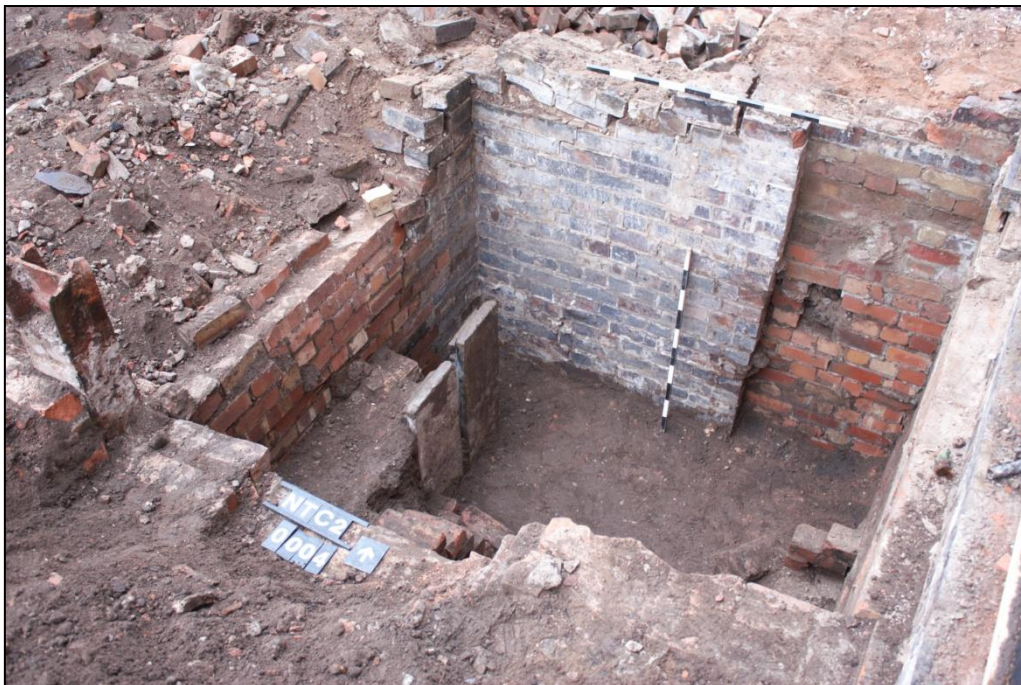
Plate 38: View of walls [0007] and [0008] in 'cellar' [0004], looking northwest, showing blue and red-bricks representing more than one structure. Fill partly excavated.

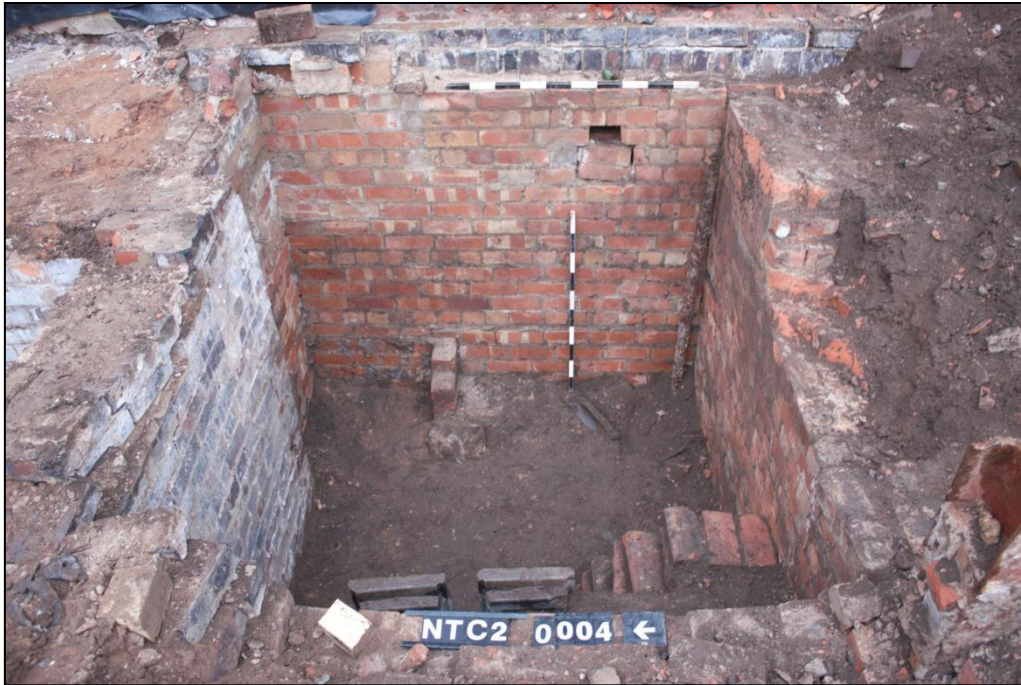
Plate 39: View of eastern wall [0009] of 'cellar' [0004], looking east, showing blue bricks running across the upper courses. Fill partially excavated.

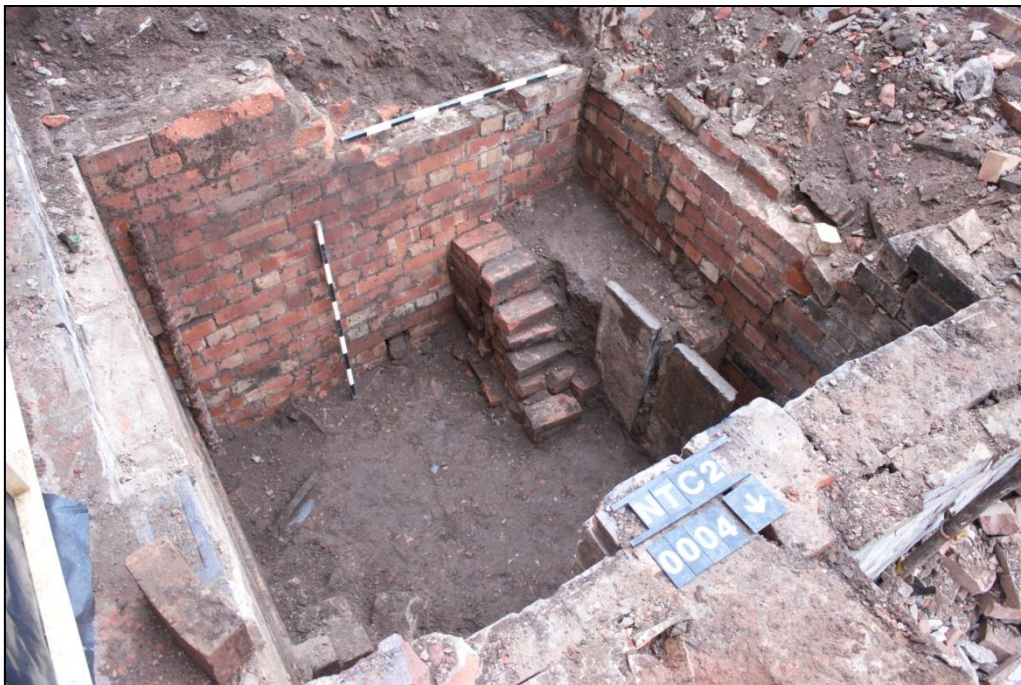
Plate 40: View of southern wall [0006] (on left) and western wall [0007] (on right) of 'cellar' [0004]. Fill partly excavated, showing brick pile placed in the corner.

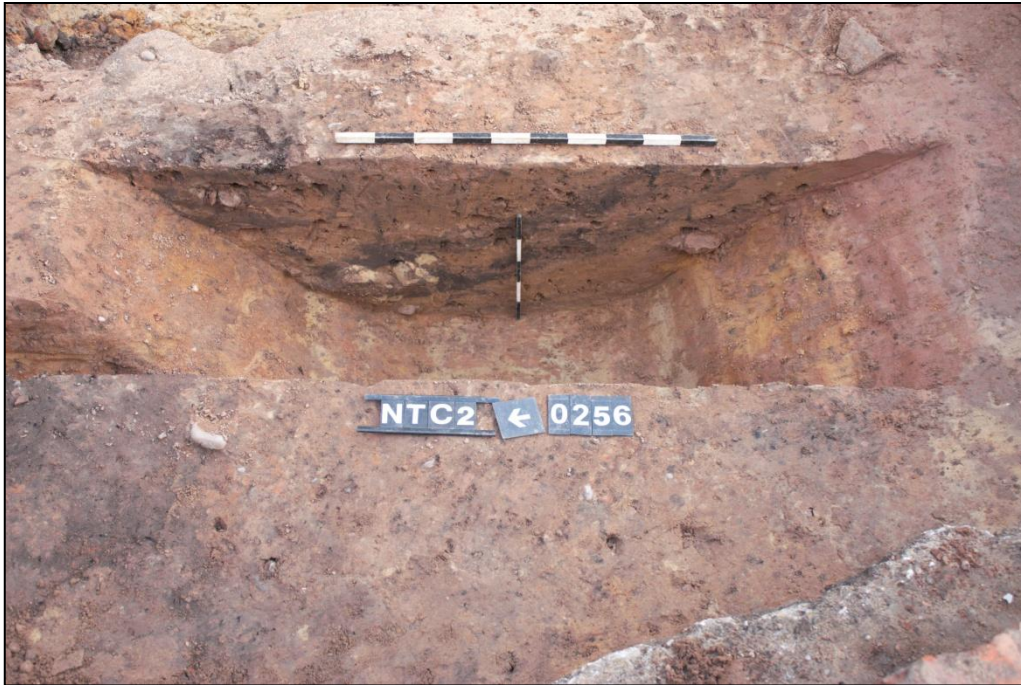
Plate 41: North-east facing section of ditch [0256], with pit [0261] cutting it on the left-hand side.

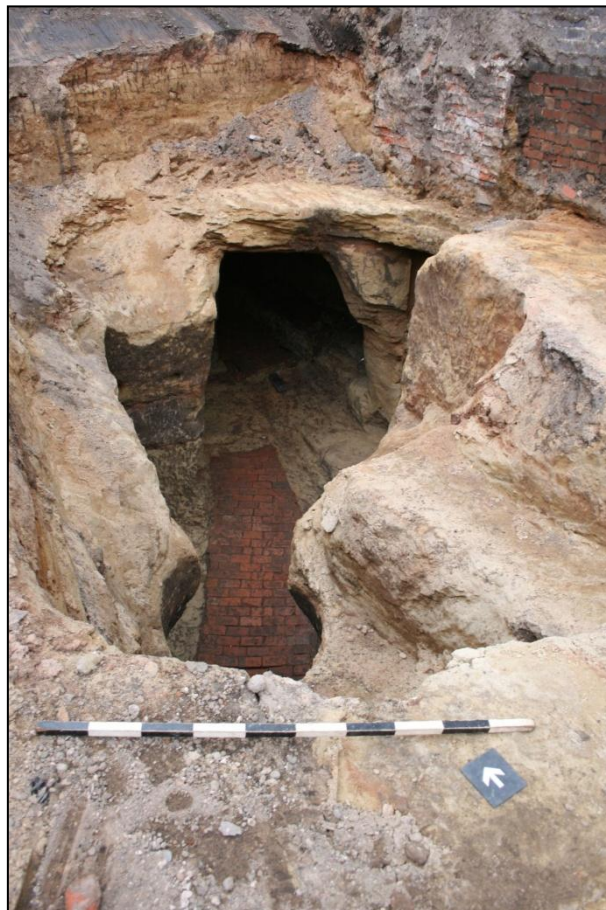
Plate 42: Looking into the cave system from the surface. Phase 3 shaft [0139] can be seen, with the passageway and brick floor visible below.

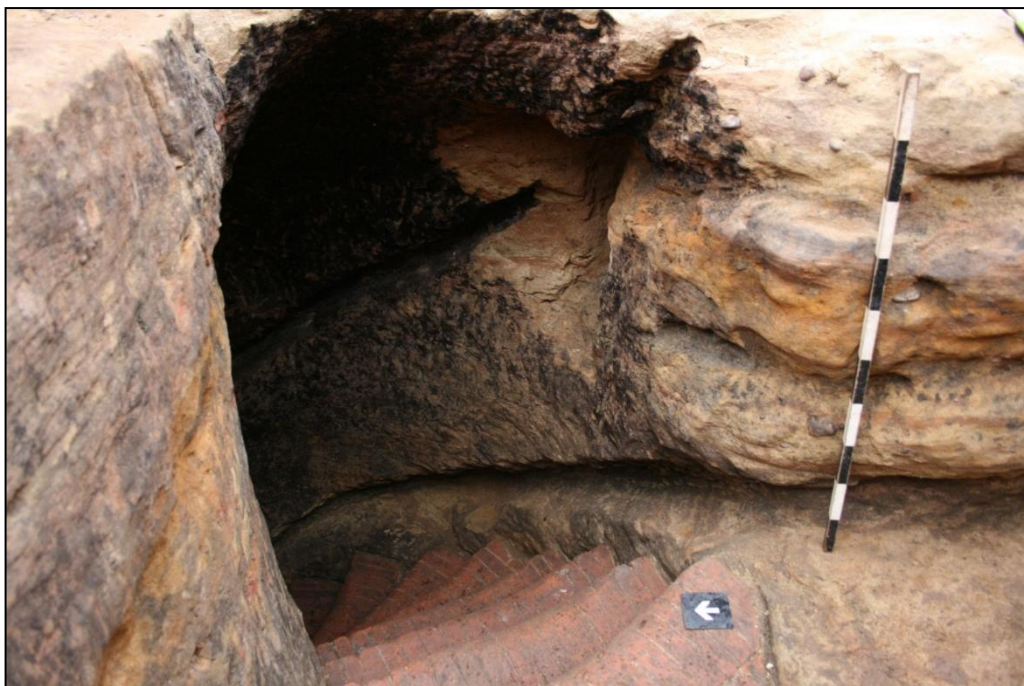
Plate 44: View down the stairway into the cave system, with groove in wall visible just above the steps, with handrail above.

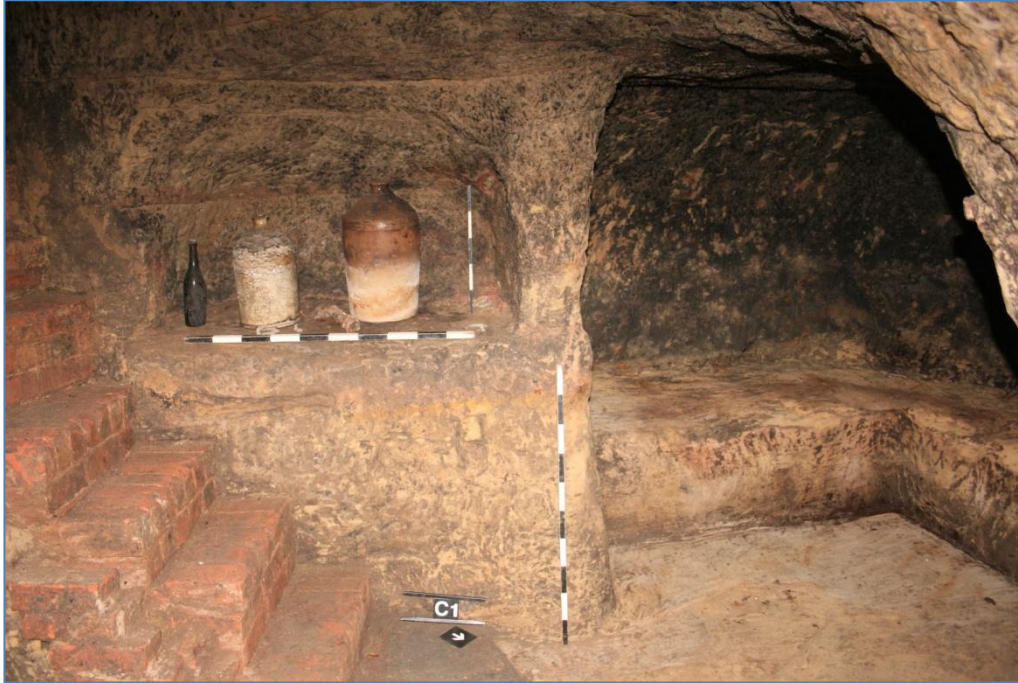
Plate 45: Looking southwest at the niche [0329] at the base of the cave entrance stairs (on the left of the picture), with chamber 2 and a possible thral on the right-hand side of the picture.

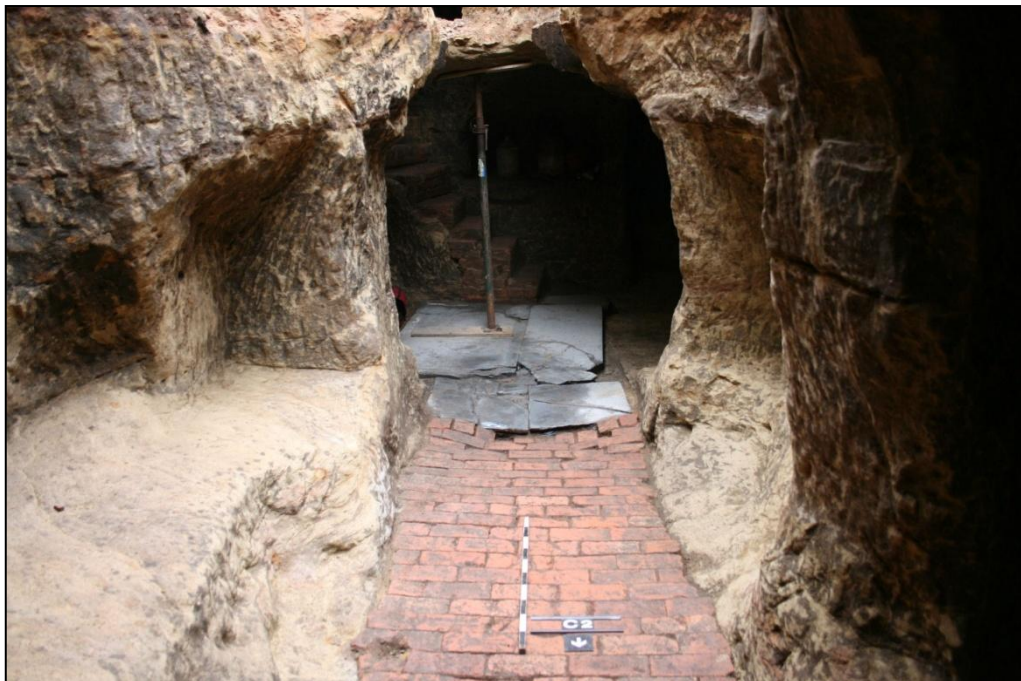
Plate 48: View to the south, looking along the brick-covered passageway running through chamber 7 (bottom part of photograph), towards the slate flooring near the base of the staircase, within chamber 4. The location of well [0360] is evident from the depression where the two floor surfaces join.

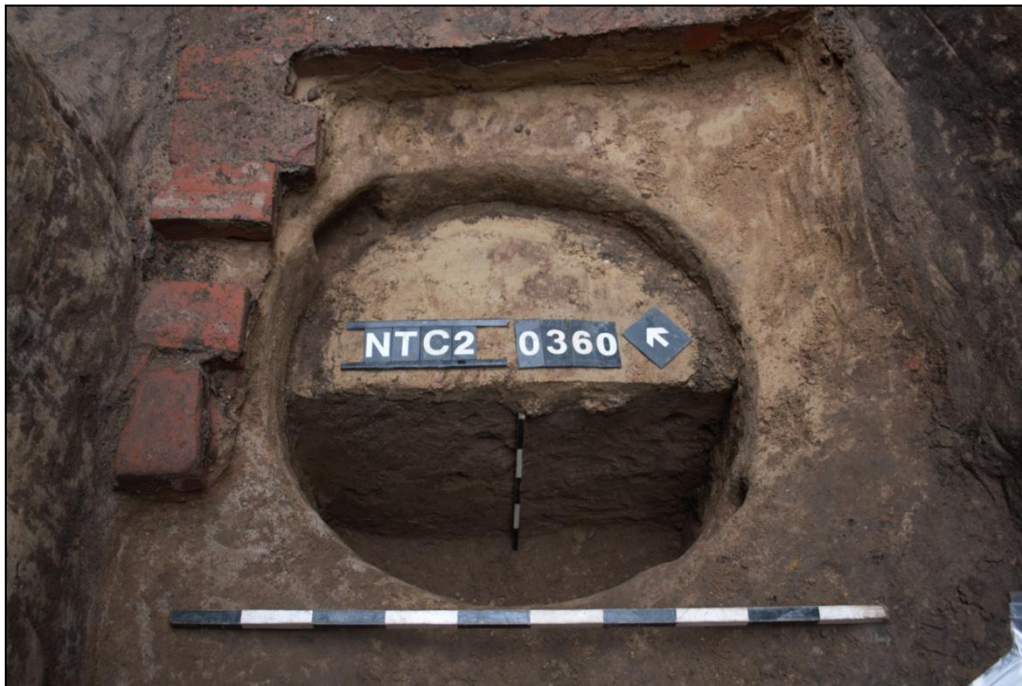
Plate 49: View of well [0360], partially excavated, showing parts of the brick floor that partially overlay it.
